PROJECT MEMORANDUM SYCAMORE-PEÑASQUITOS 230-KV TRANSMISSION LINE PROJECT

Date: November 16, 2017
To: Billie Blanchard, CPUC Project Manager
From: Sheila Hoyer, CPUC Monitoring Supervisor
Subject: Weekly Report #45 – November 5 to November 11, 2017

SDG&E Sycamore-Peñasquitos 230-kV Transmission Line Project: Daily Inspection Report

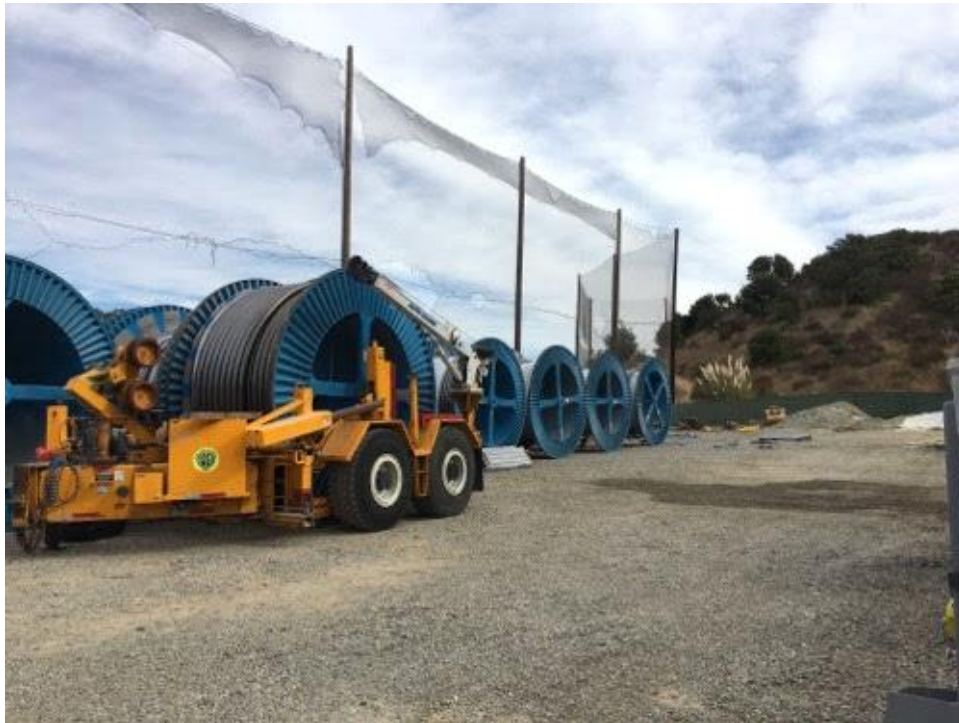
Caption Cable spools at Driving Range Yard.

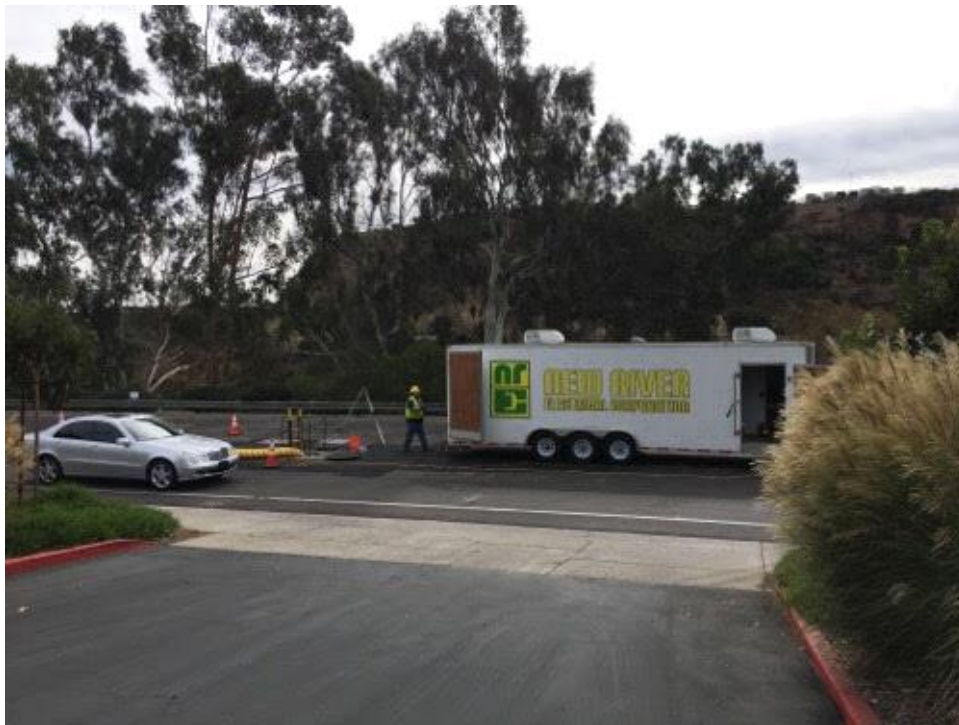
Cable/vault work on Carroll Canyon Road.

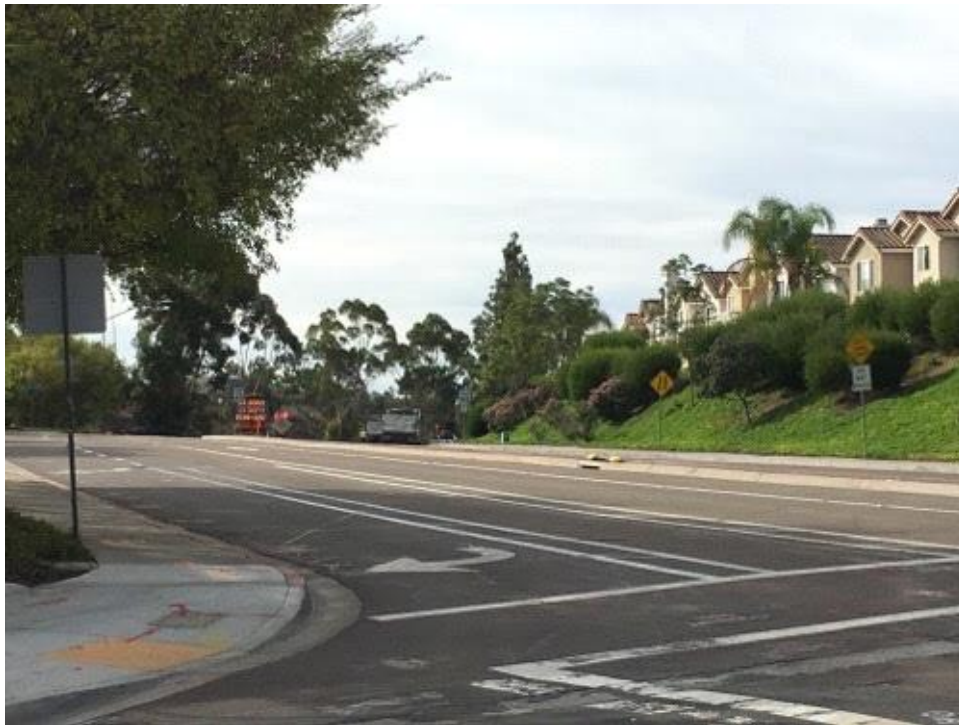
Eastern edge of work/traffic control before intersection at Spring Hill Road.

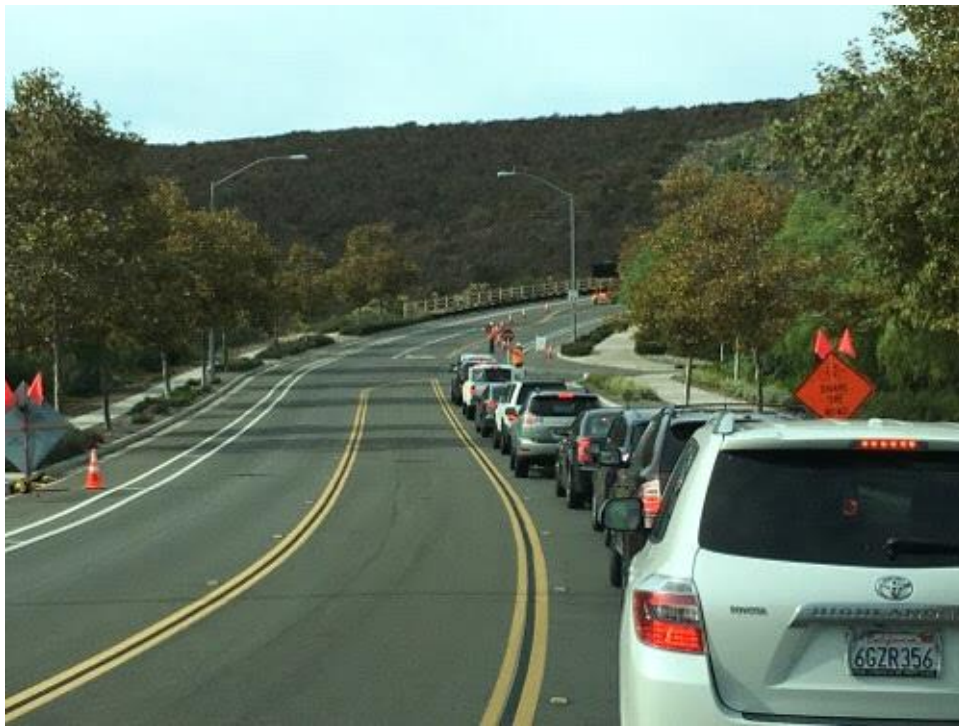
Caption Traffic control on Stonebridge Parkway.

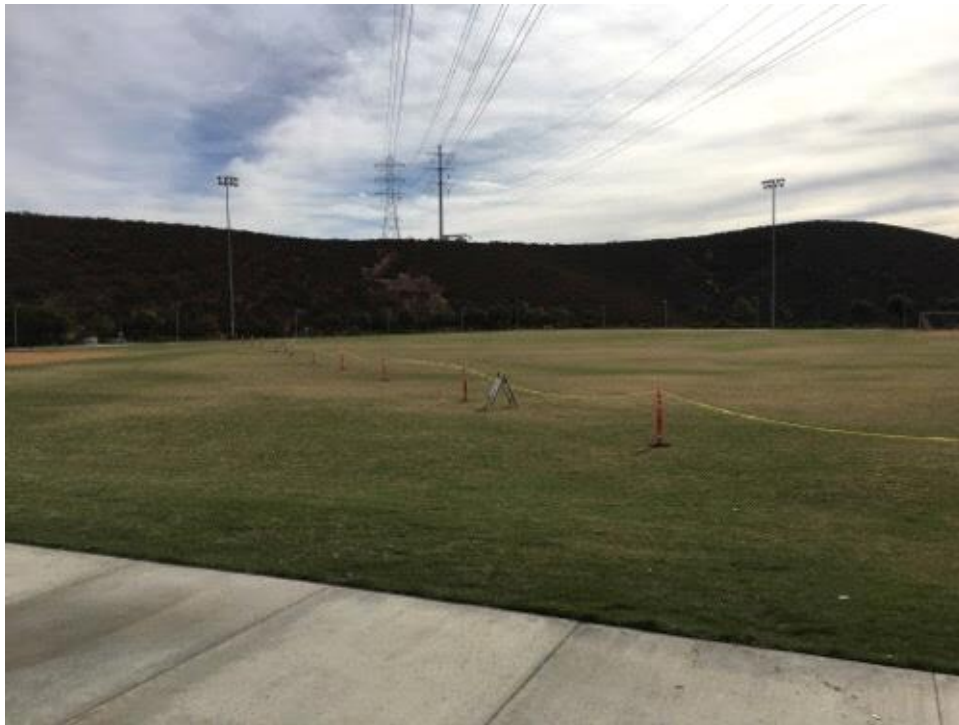
Caption Portion of Sycamore Canyon Park closed between P04 and P05.

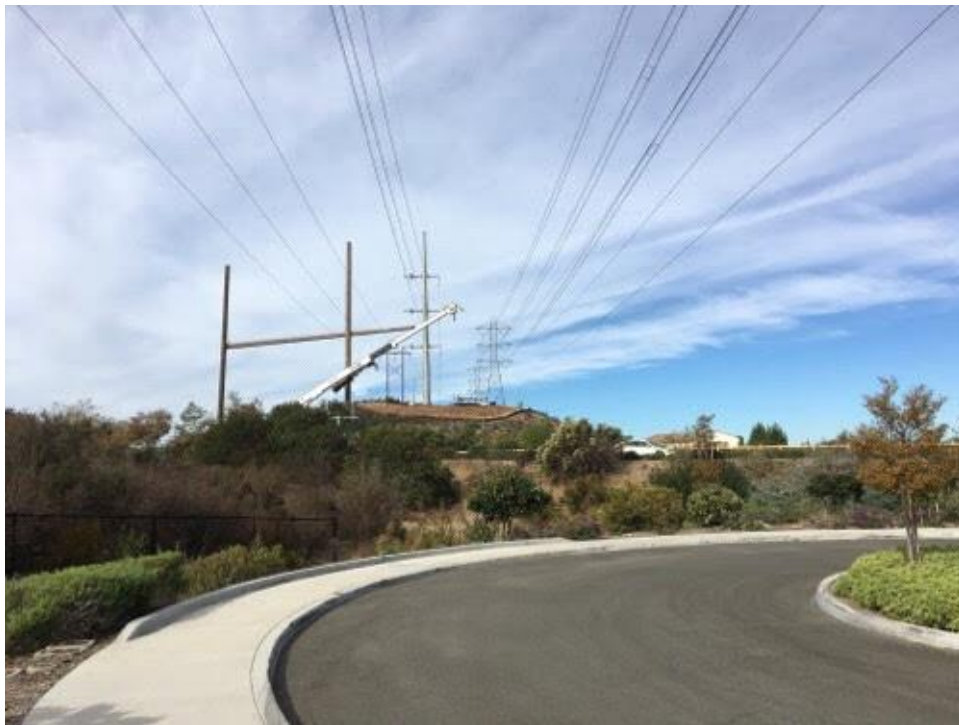
Caption Overhead view looking at P05.

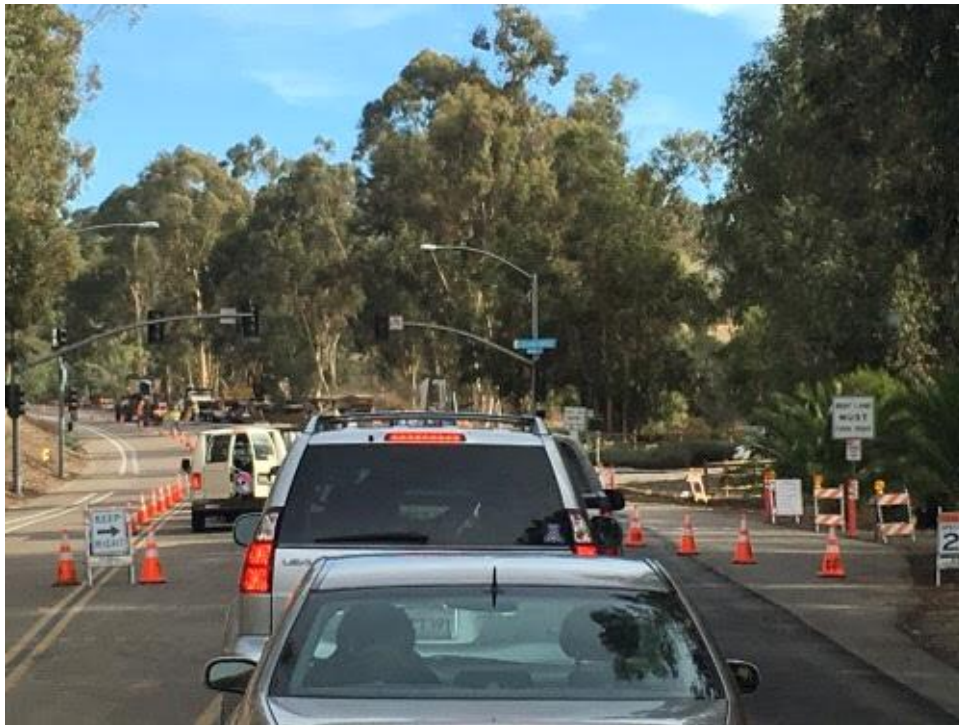
Caption Traffic control at western edge of work on Pomerado Road.

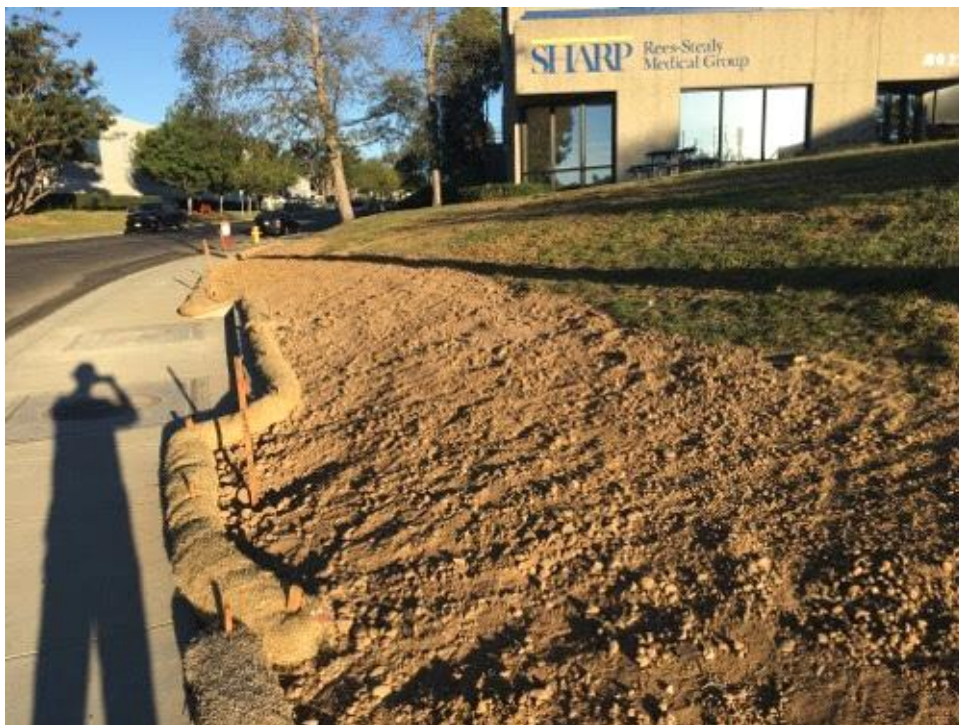
Caption Activity Road BMPs, now staked and trenched in place.

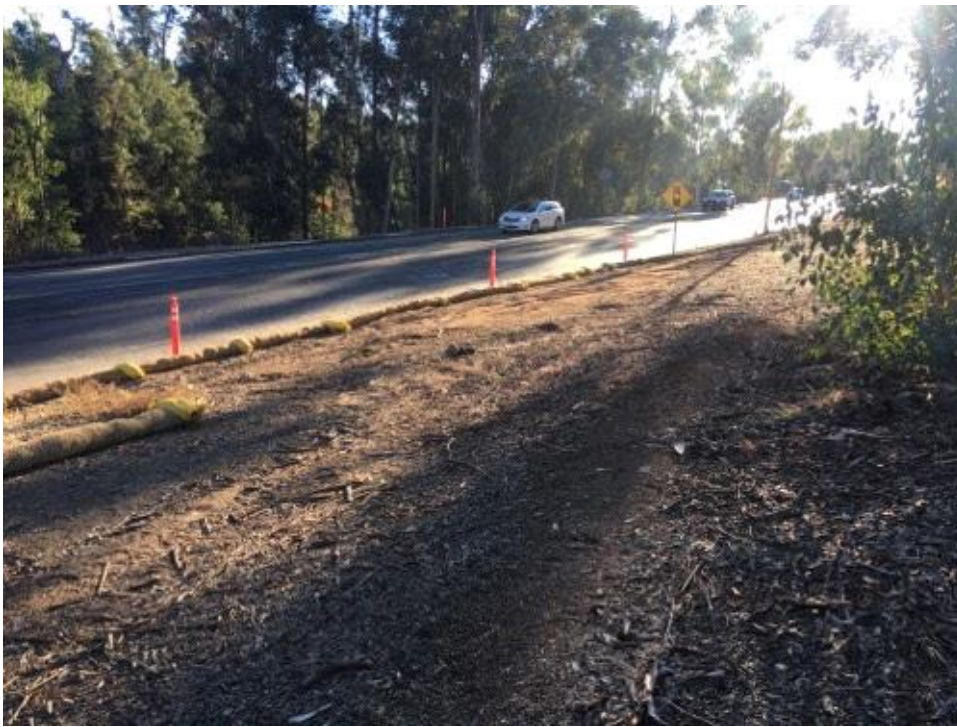
Caption Area still needs to be trenched and staked.

| Q7 Notes | BMP maintenance in progress, some areas have been trenched and staked and other still need to be completed. Work will be completed likely by the end of next week. |

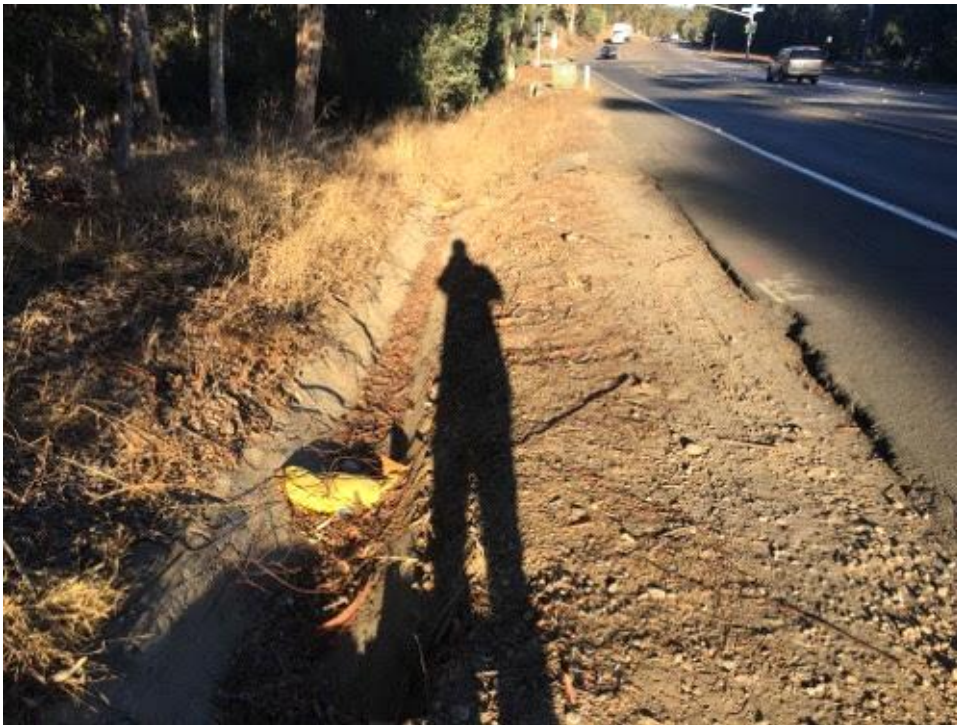
Caption Leaf litter in drain, City has requested these areas be maintained.

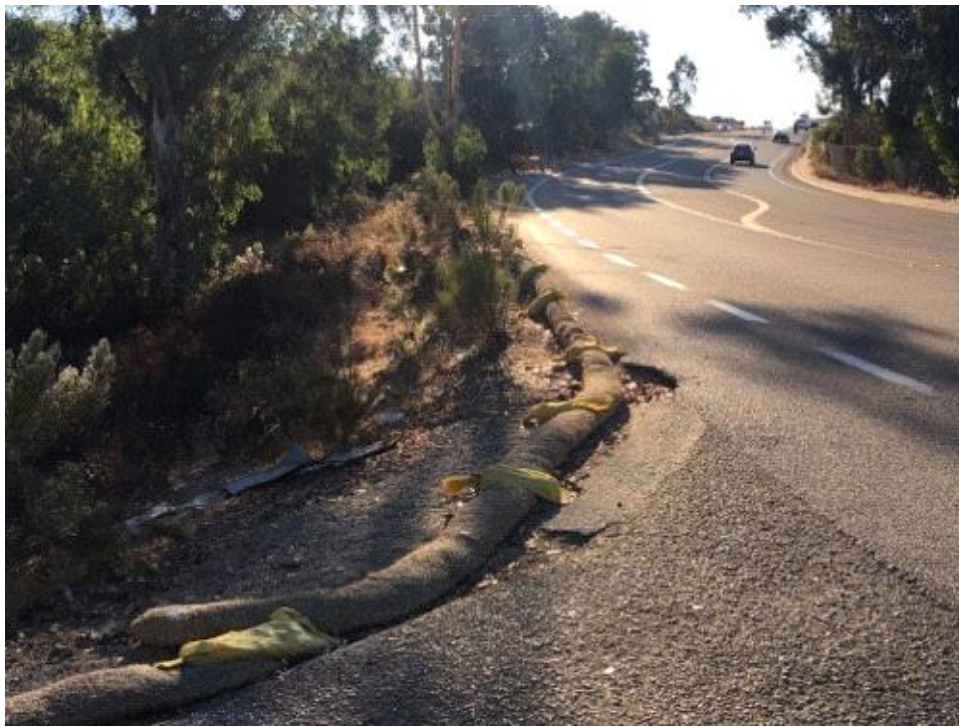
Caption Fiber Roll acting as curb, not staked but no soil disturbance south of the road.

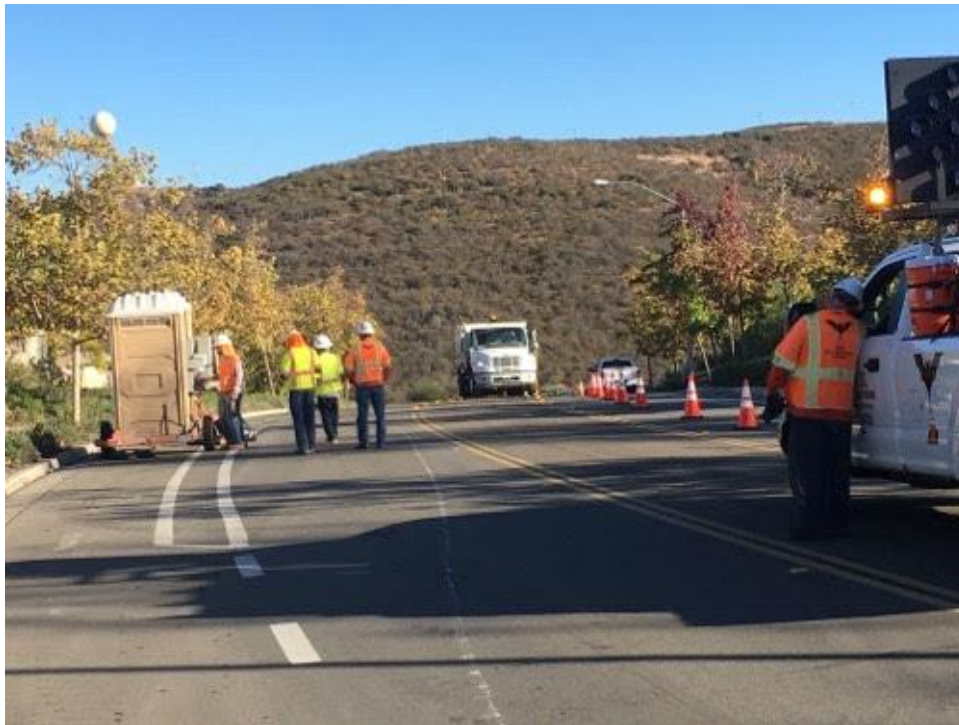
Caption Street sweeper cleaning Stonebridge Parkway work site.

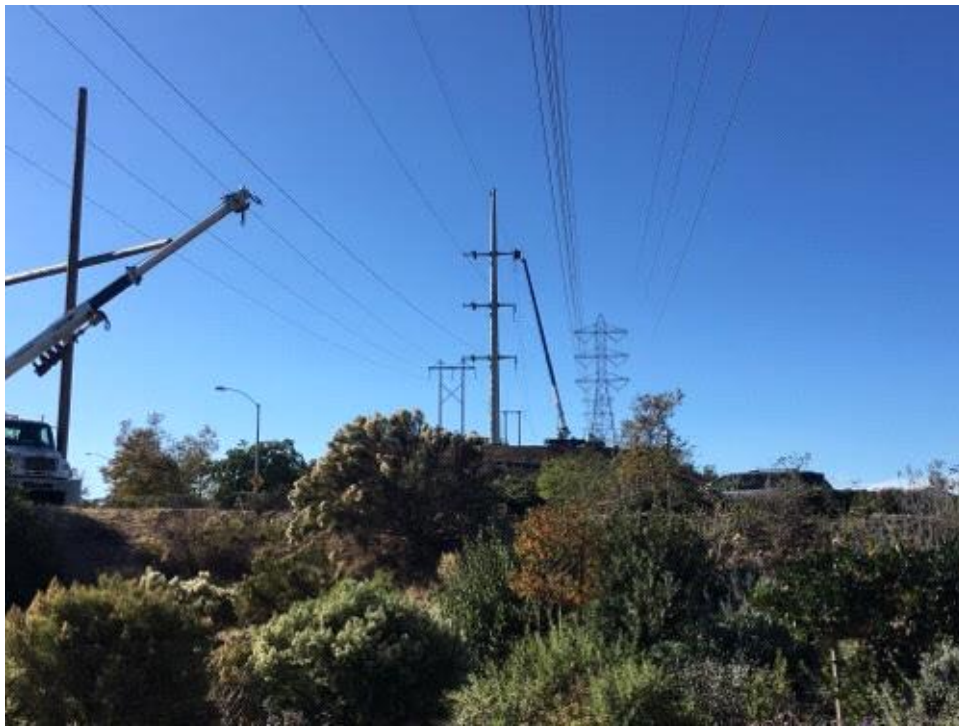
Caption Overhead wire work at P05.

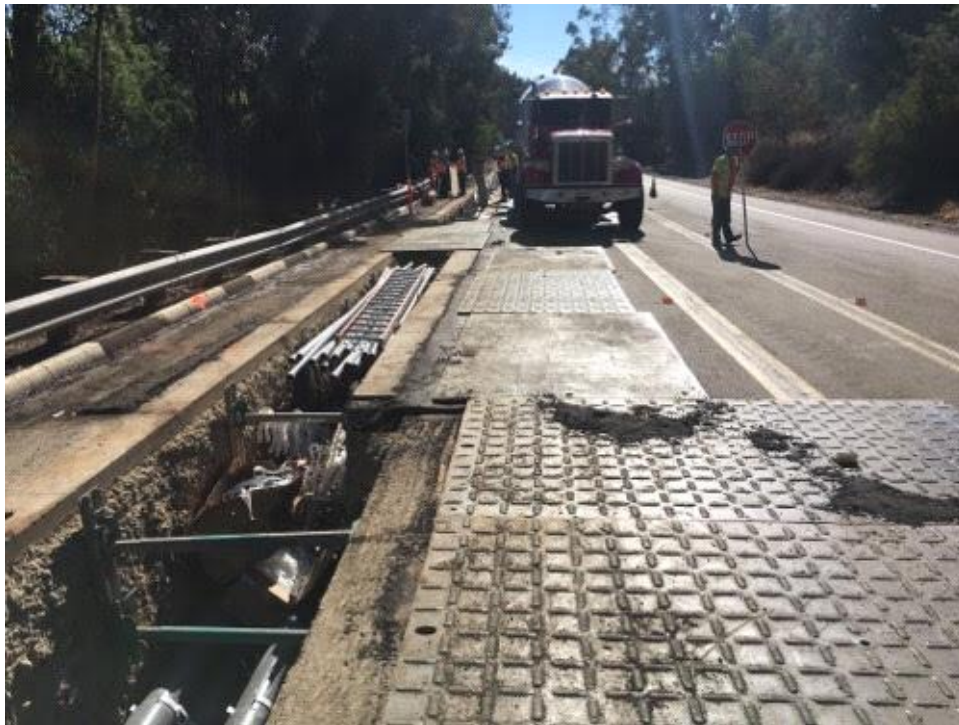
Caption Trench and concrete work on Pomerado Road west of Semillon Blvd.

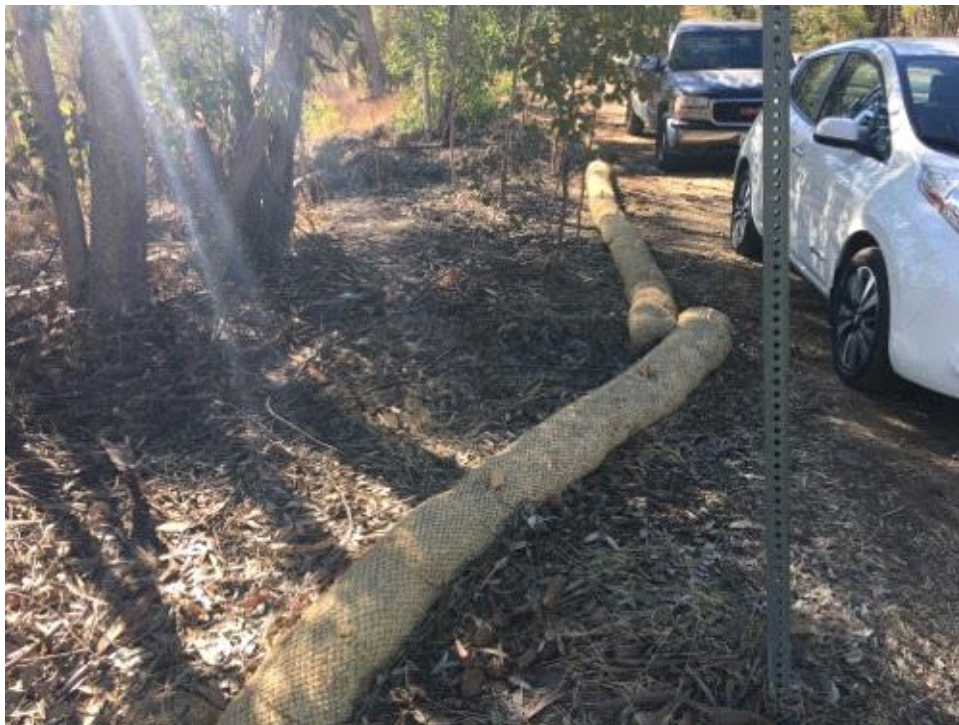
Caption Fiber roll staked now south of Pomerado and east of Scripps Ranch Blvd.

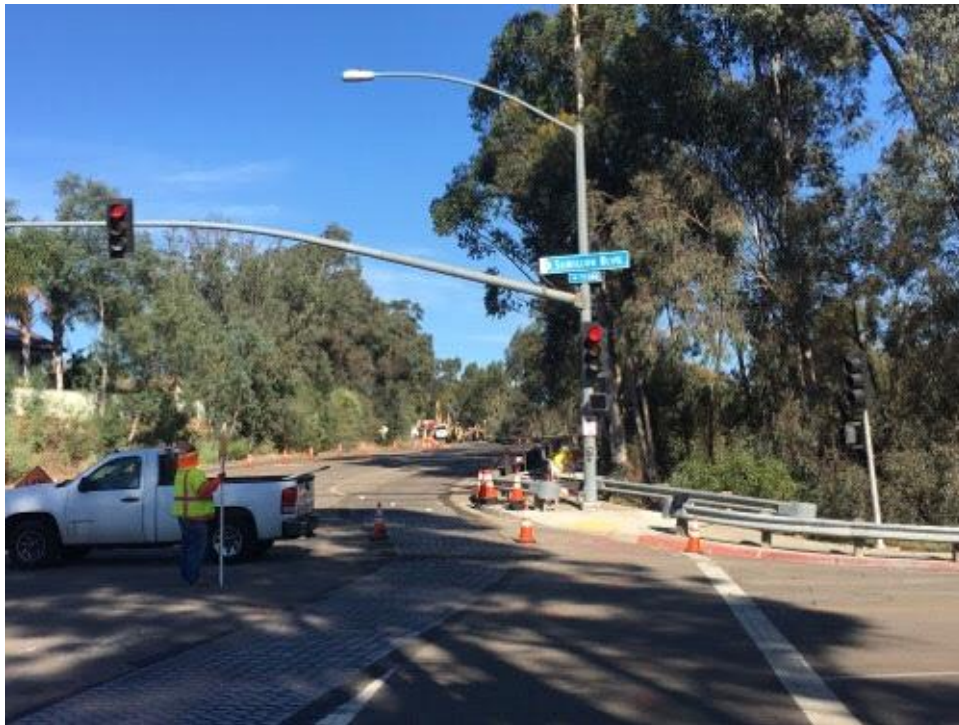
Caption Work on Pomerado Road at intersection with Semillon Blvd.
