PROJECT MEMORANDUM SYCAMORE-PEÑASQUITOS 230-KV TRANSMISSION LINE PROJECT

Date: November 27, 2017
To: Billie Blanchard, CPUC Project Manager
From: Sheila Hoyer, CPUC Monitoring Supervisor
Subject: Weekly Report #46 – November 12 to November 18, 2017

SDG&E Sycamore-Peñasquitos 230-kV Transmission Line Project: Daily Inspection Report

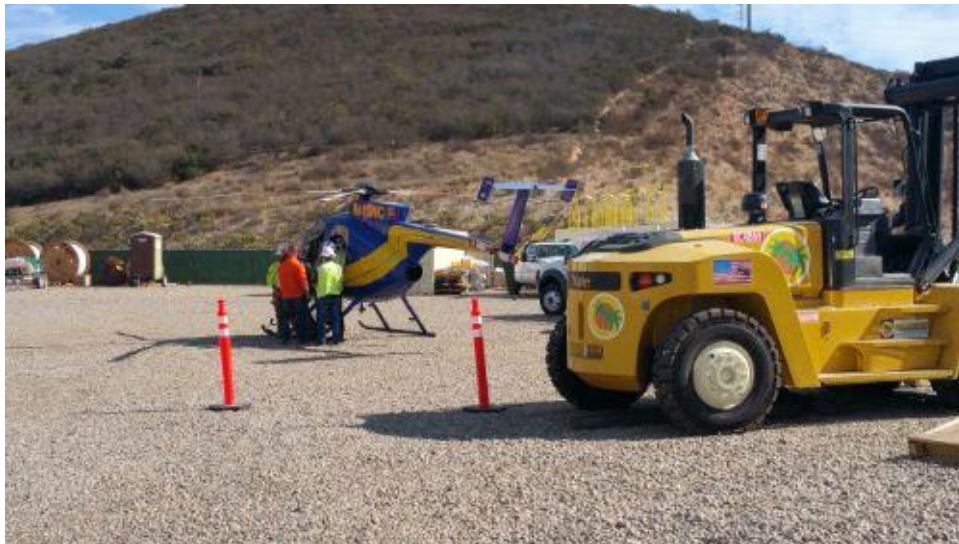
Caption Helicopter parked at Stonebridge Staging Yard.

| Q15 Notes | Helicopter parked at Stonebridge Yard. |

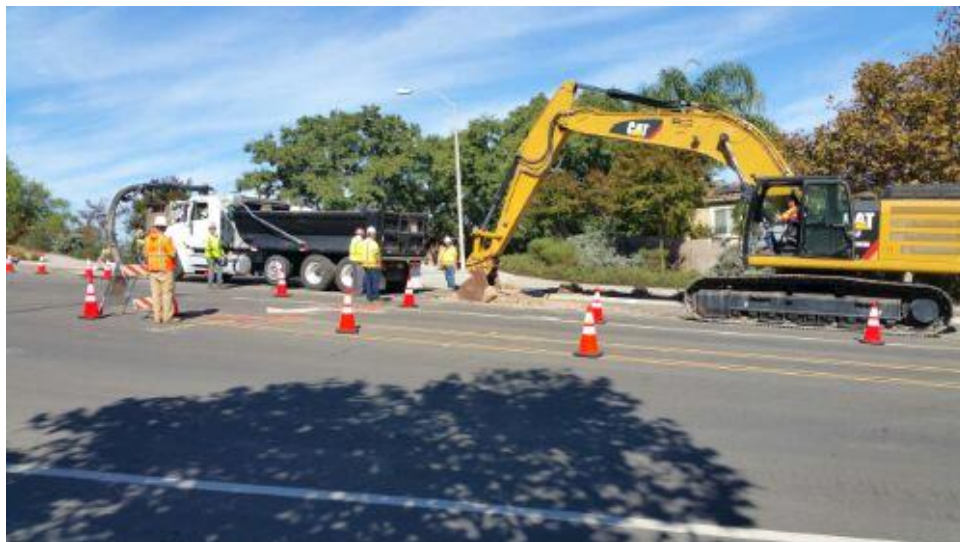
Caption Removing asphalt on Stonebridge Parkway.

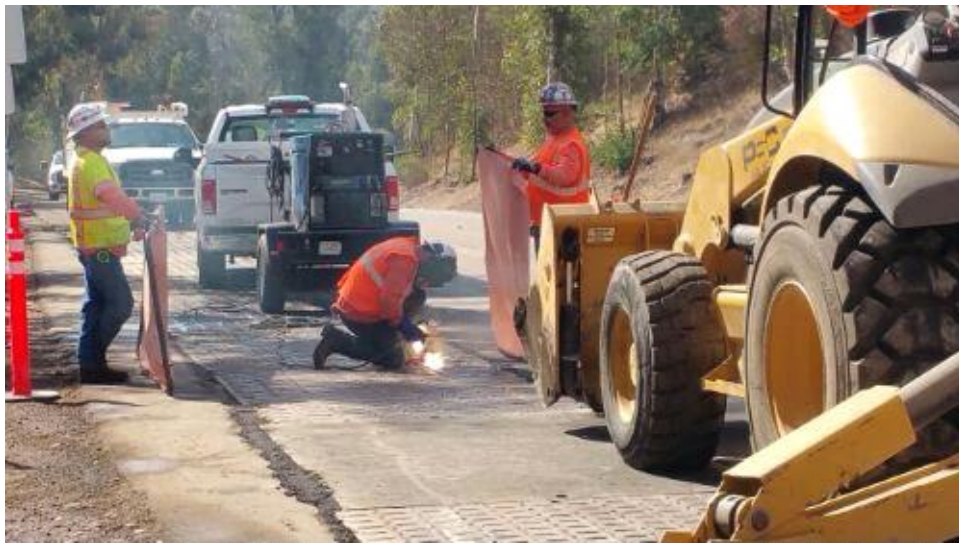
Caption Fire protection in place during trench cutting on Pomerado Road.

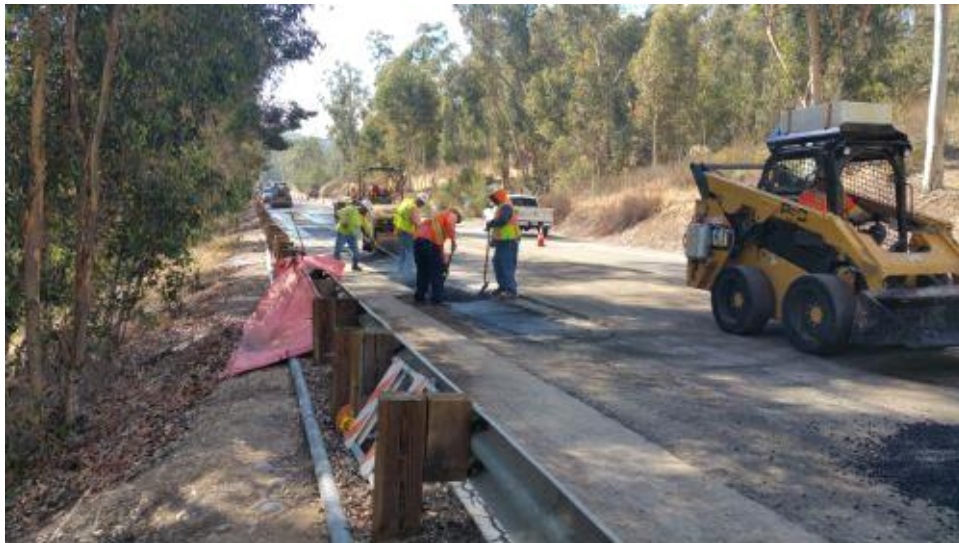
Caption Repaving on Pomerado Road.

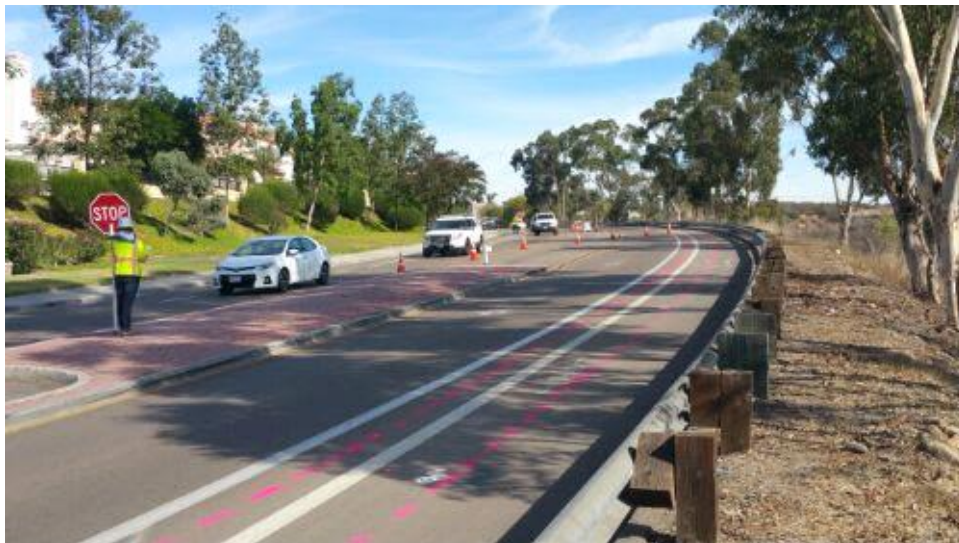
Caption Traffic control for eastbound traffic on Pomerado Road.

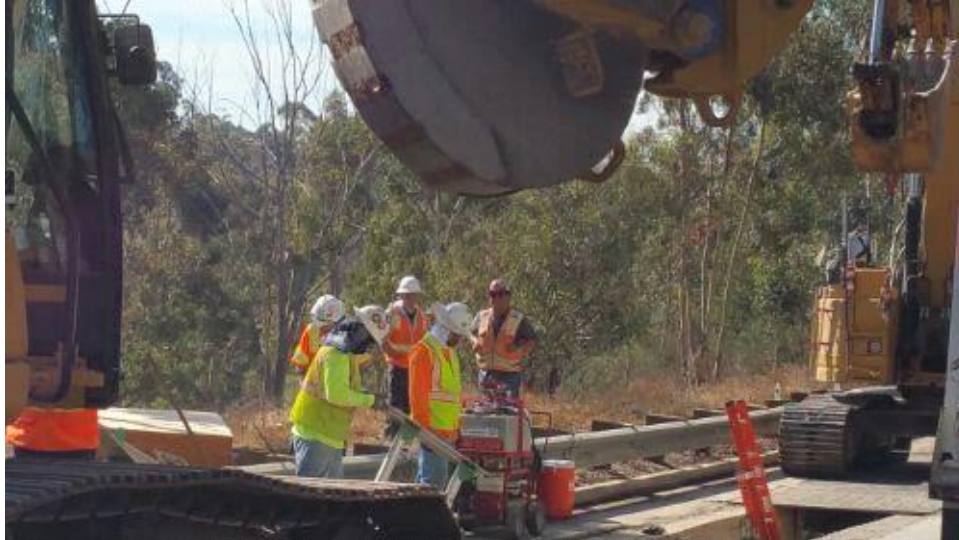
Caption Trenching on Pomerado Road. Three resource monitors observing work.

| Q11 Notes | Three monitors observing excavation on Pomerado Road. |

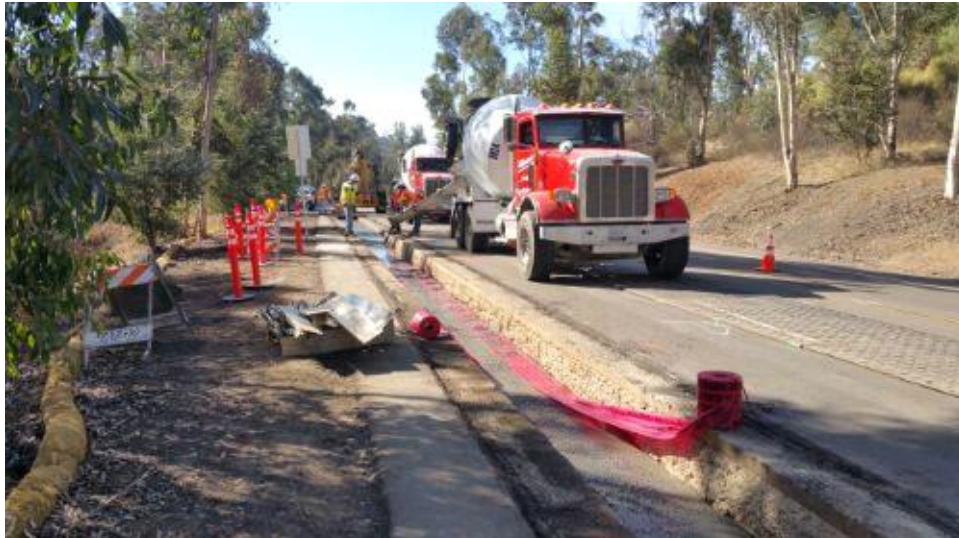
Caption Concrete pour on Pomerado Road.

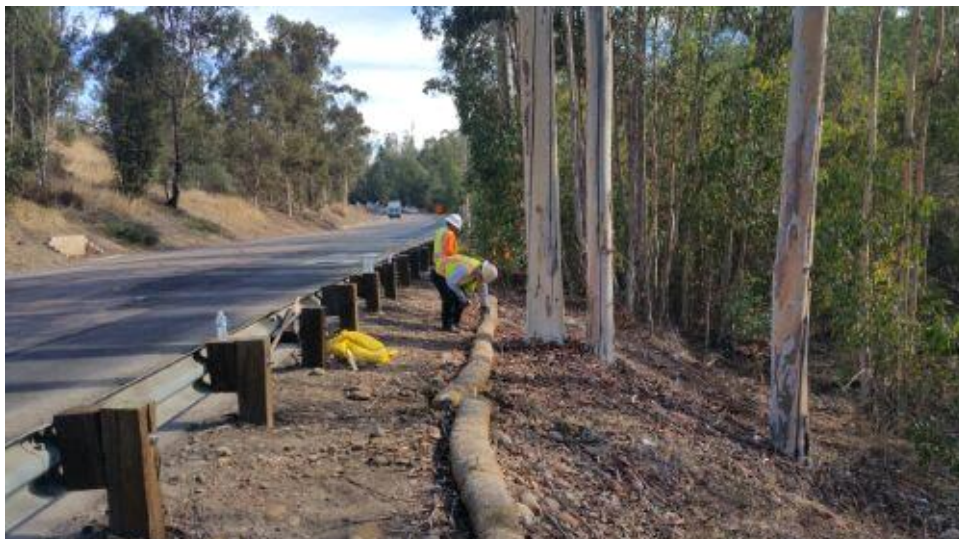
Caption Crew upgrading erosion control BMPs on Pomerado Road, east of Avenida Magnifica.
 Photo Attributes Capture Date/Time: Tue Nov 14 2017 10:07:00 GMT-0600 (CST)
 Coordinates: 0, 0
 View Direction: East

| Q7 Notes | Installation of erosion control BMPS in progress. |

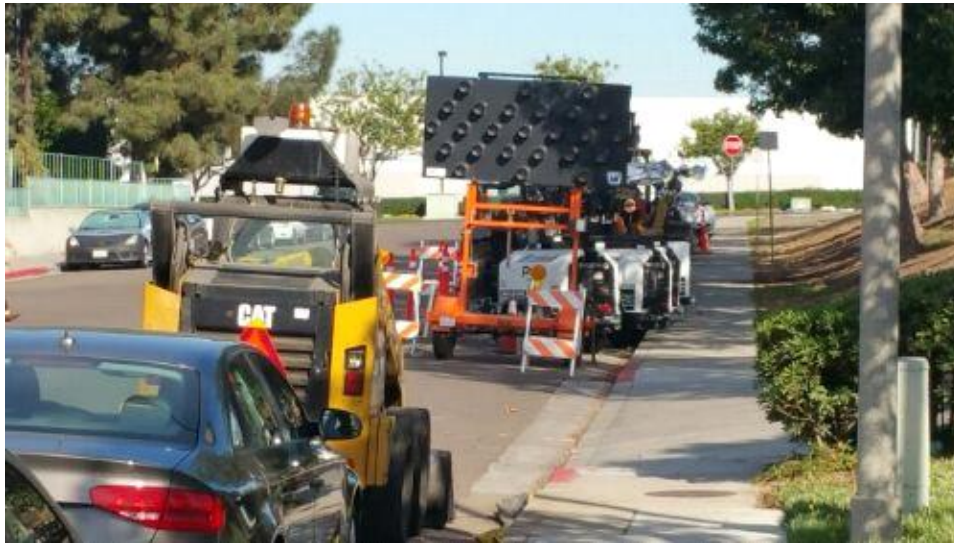
Caption Clayton Drive staging area with flashing directional sign.
 Photo Attributes Capture Date/Time: Tue Nov 14 2017 09:47:15 GMT-0600 (CST)
 Coordinates: 0, 0
 View Direction: North

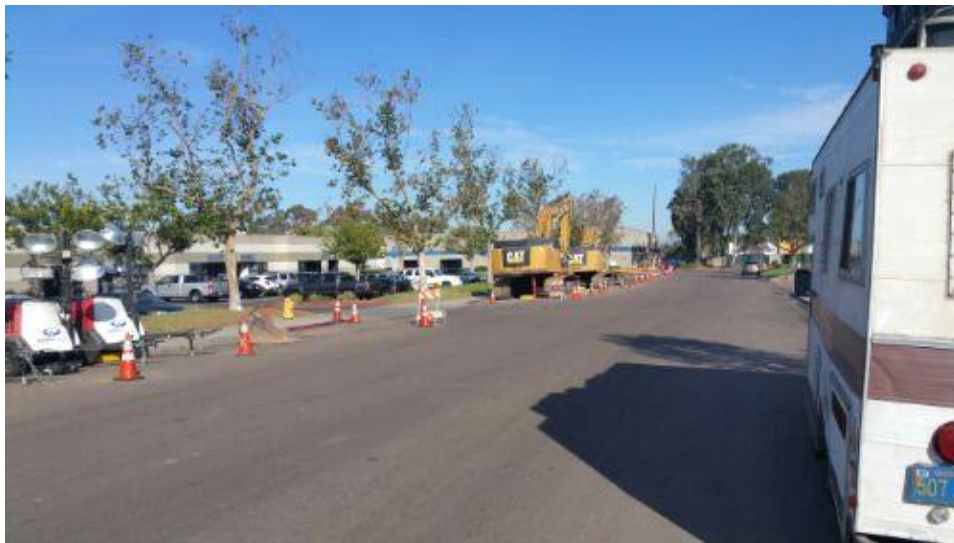
Caption Padgett Street staging area in good order.
 Photo Attributes Capture Date/Time: Tue Nov 14 2017 09:33:00 GMT-0600 (CST)
 Coordinates: 0, 0
 View Direction: Northwest

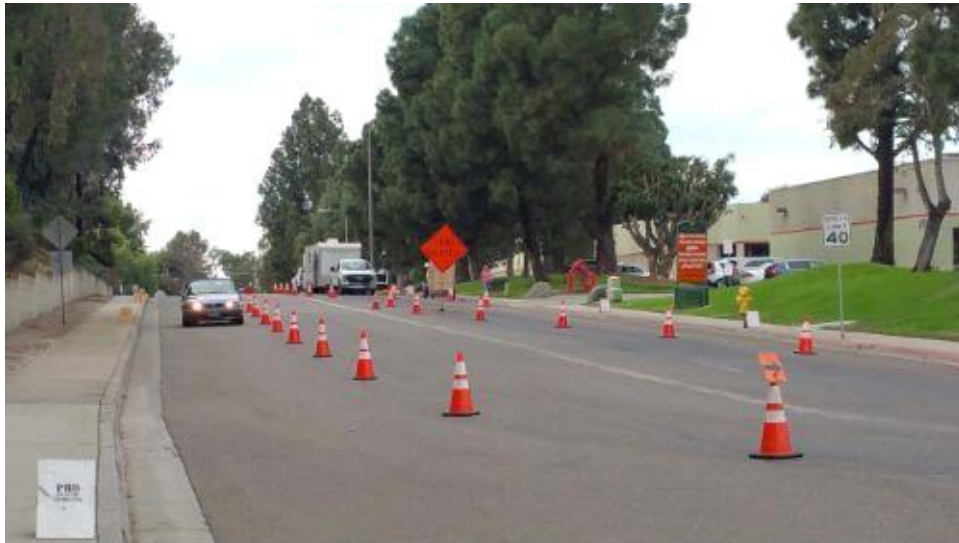
Caption Traffic control in place for underground work on Trade Street. (also Trade Place).

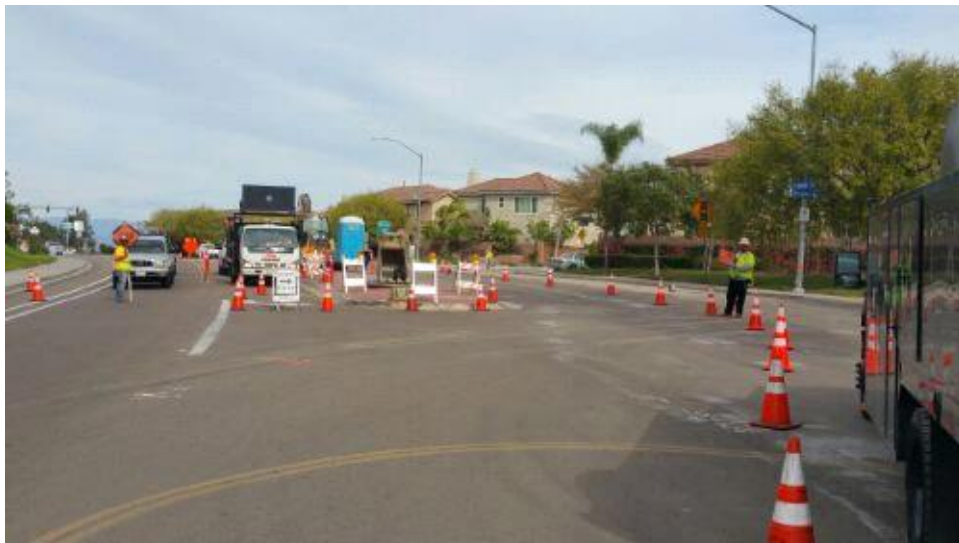
Caption Traffic control on side streets to Pomerado Road.

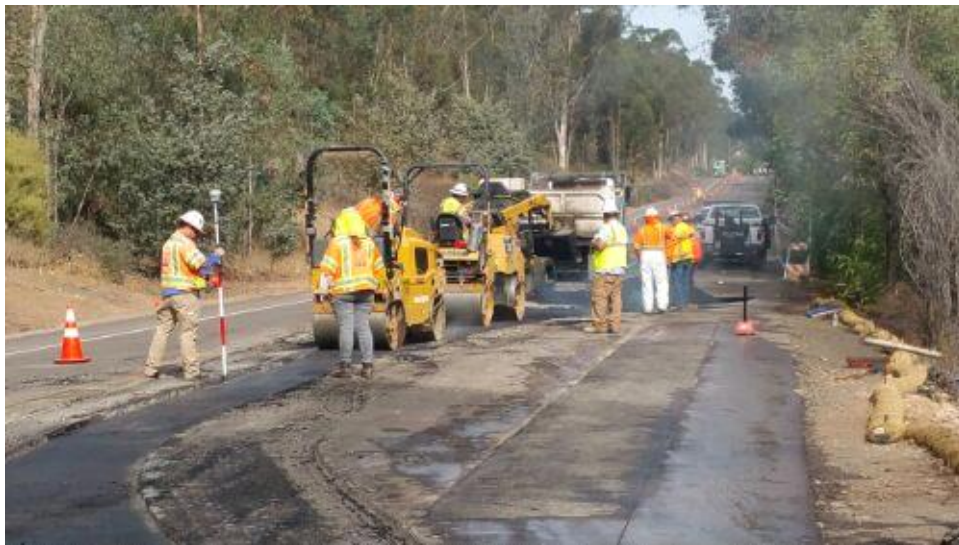
Caption Repaving Pomerado Road.

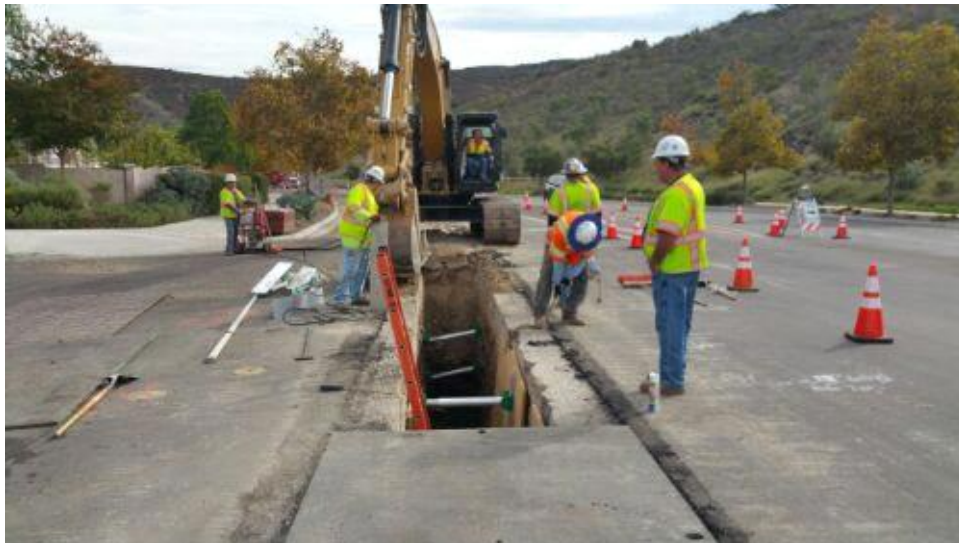
Caption Excavation on Stonebridge Parkway, monitors present.

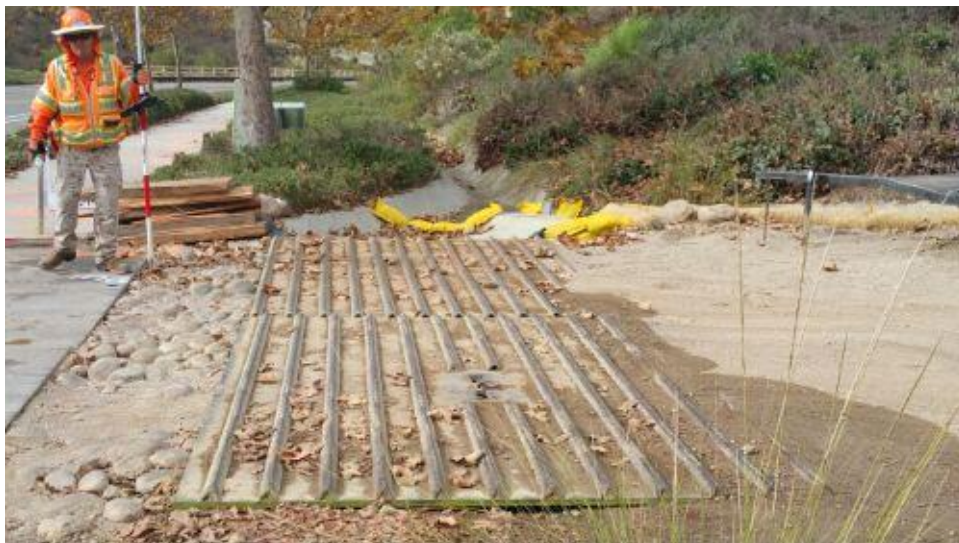
Caption Rumble plates and gravel bags installed on road to pole sites.

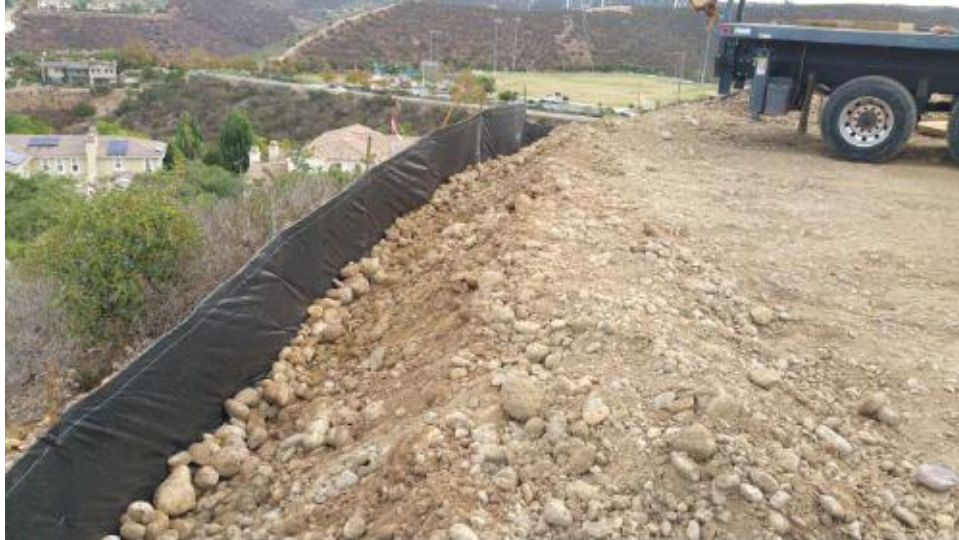
Caption Silt fencing installed along north end of PO5.

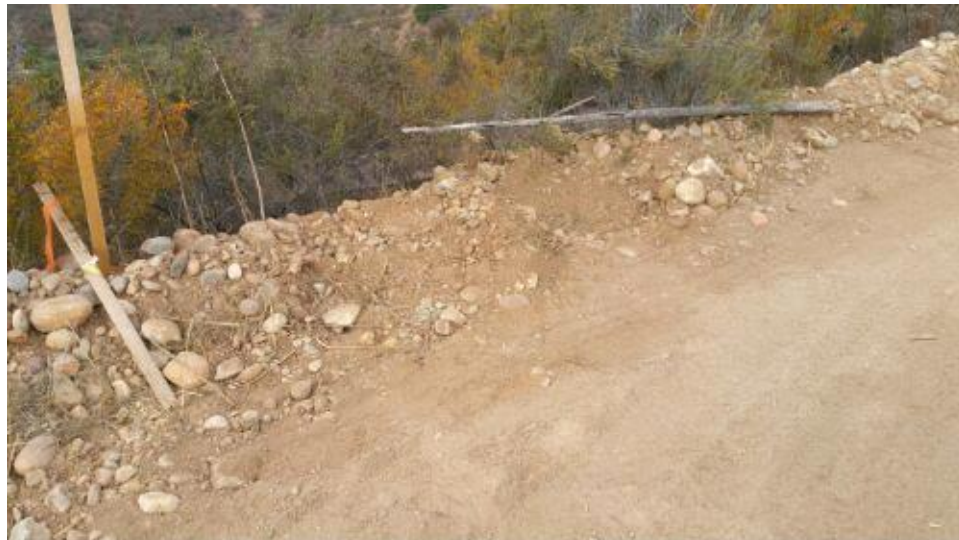
Caption Gravel berm in west establishing side of PO6 site appears damaged from being backed over. It should be repaired or upgraded.

| Q7 – Stormwater, Erosion, and Sediment Control: (a) Were erosion and sediment control BMPs in place and functioning properly? (b) Were inactive or completed work areas stabilized and/or restored adequately? | Corrections Required |
| Q7 Notes | Erosion control BMPs at PO6 site are fiber rolls and a berm (on west side where site slopes north). Vehicles have backed onto the berm creating weak points that could be compromised in a storm. LEI will ask SWPPP to check site and suggest correction. |

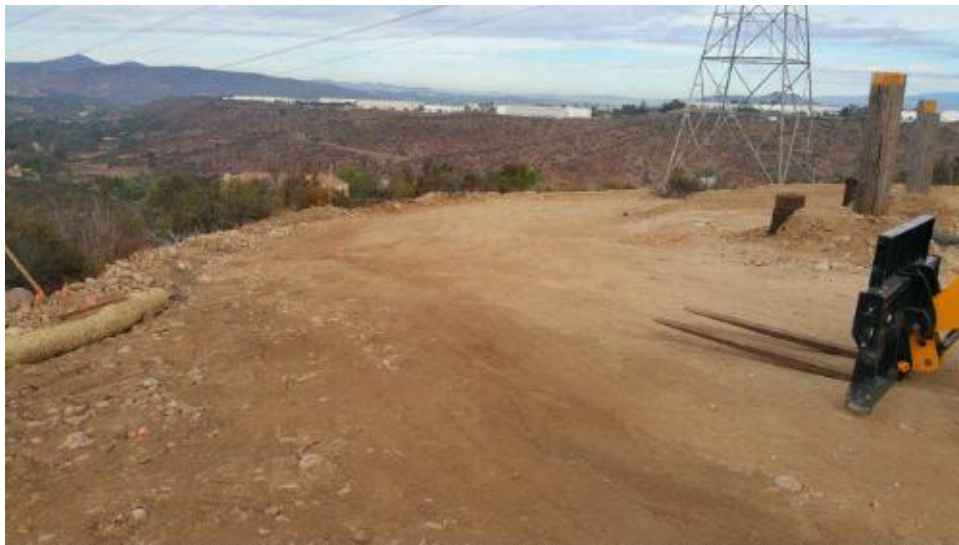
Caption Erosion control BMPs at PO6 site: fiber rolls and gravel berm.

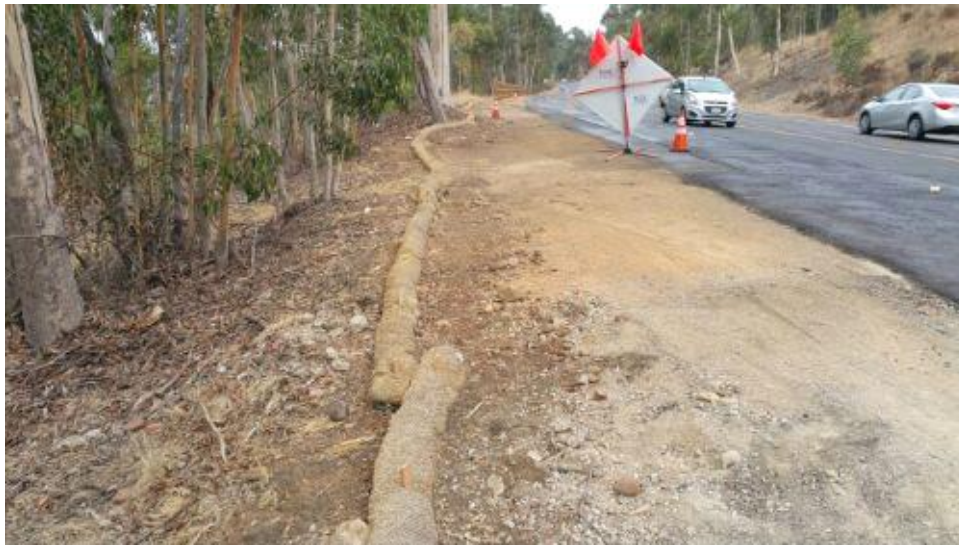
Caption Fiber roll installation on Pomerado Road.

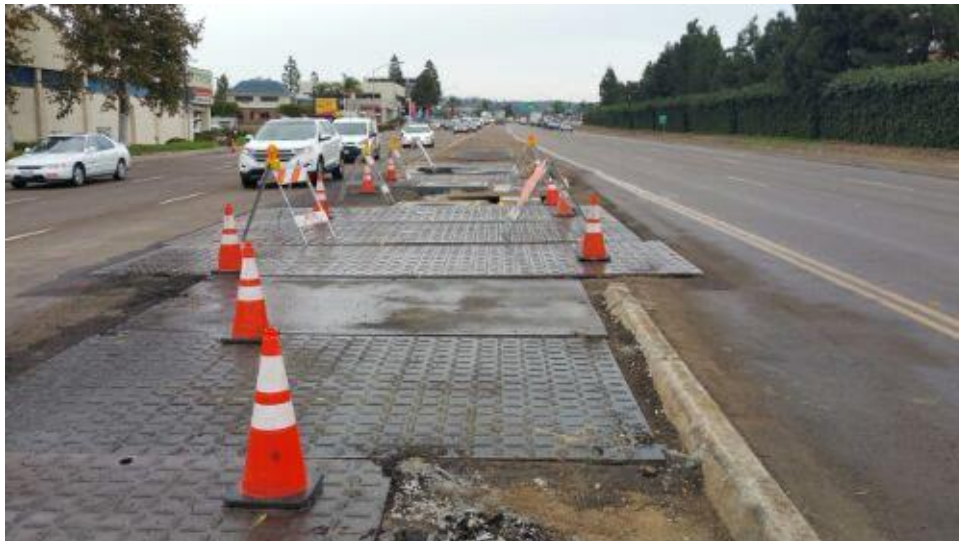
Caption Well-marked work zone on Miramar Road.

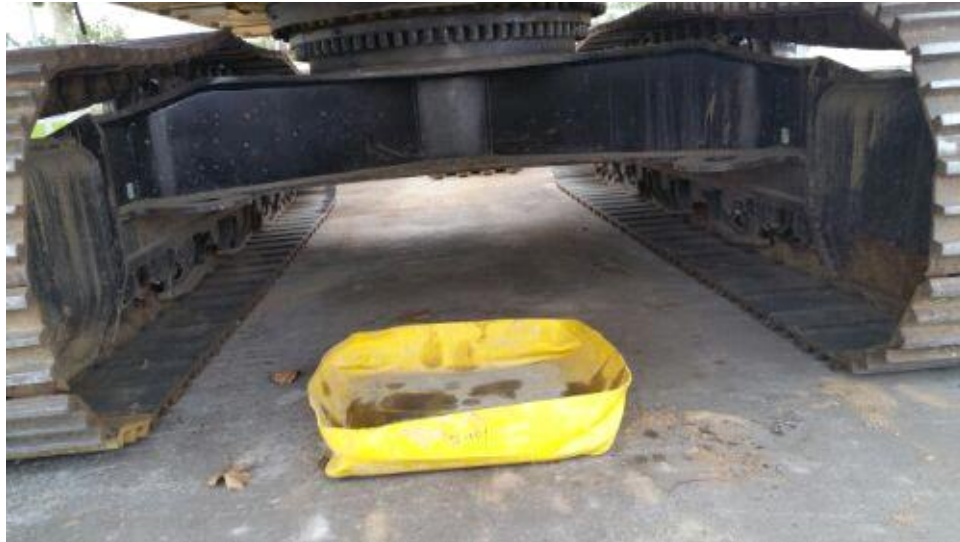
Caption Properly placed drip pan at Padgett Street 'staging area.
