PROJECT MEMORANDUM SYCAMORE-PEÑASQUITOS 230-KV TRANSMISSION LINE PROJECT

Date: December 1, 2017
To: Billie Blanchard, CPUC Project Manager
From: Sheila Hoyer, CPUC Monitoring Supervisor
Subject: Weekly Report #47 – November 20 to November 22, 2017

2017-11-20 AM Inspection Report

2017-11-22 AM Inspection Report

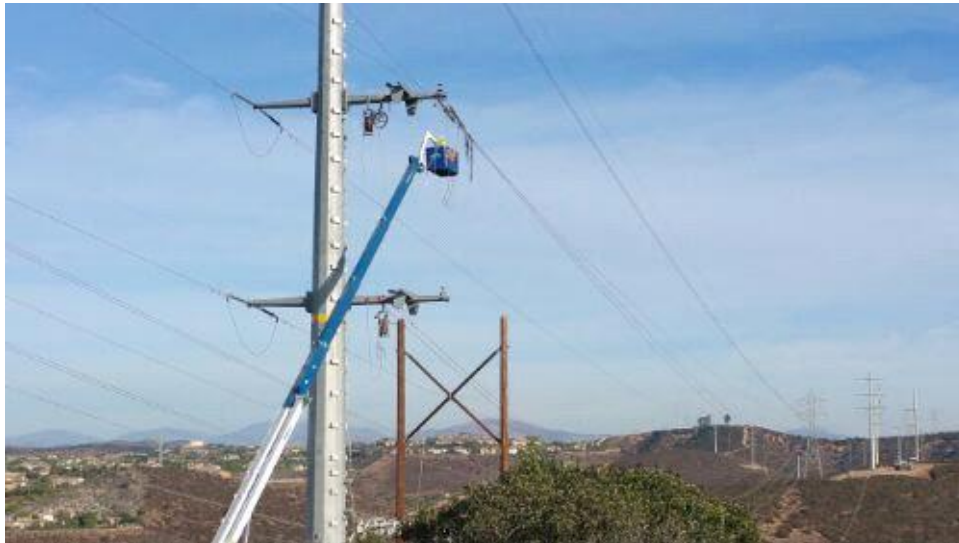
Caption Crew dead-ending wire at PO5.

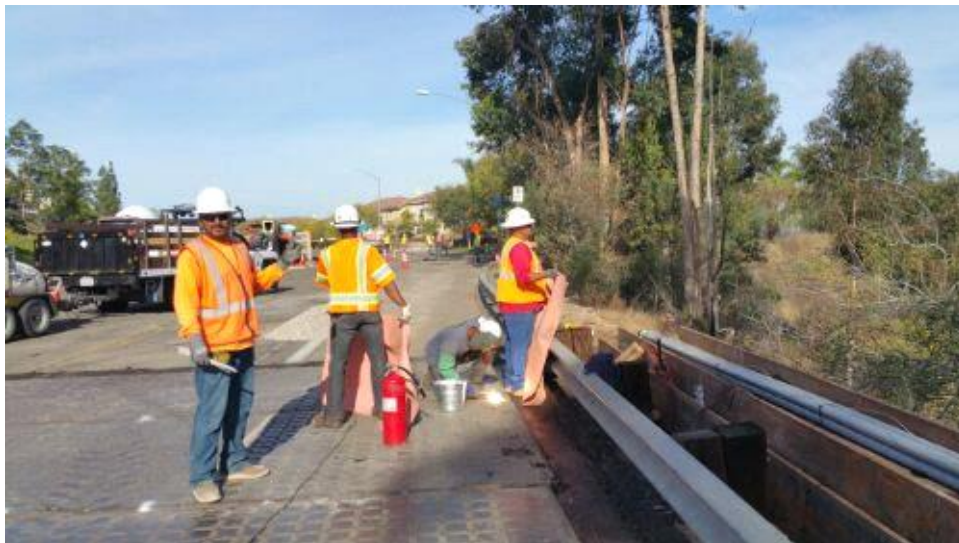
Caption Welding trench plates with fire protection.

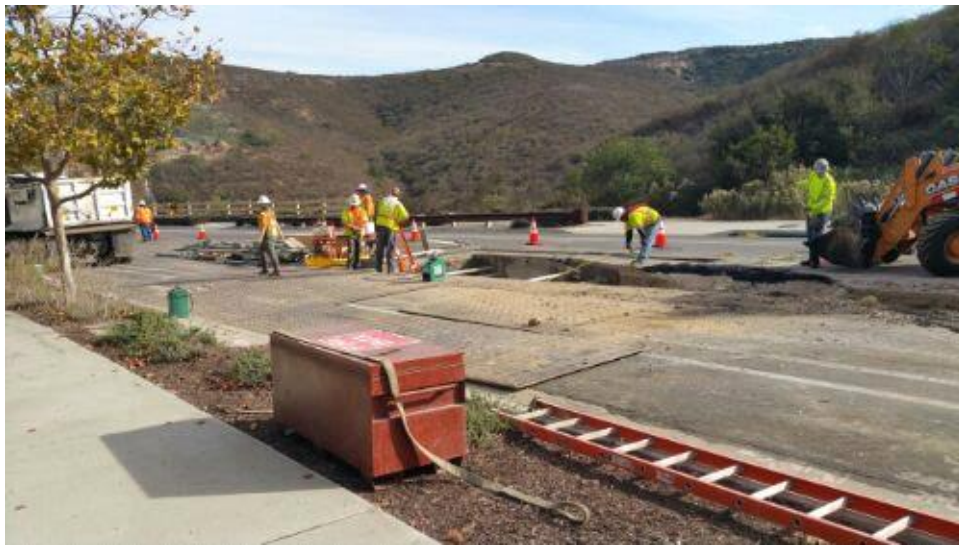
Caption Fire box at Stonebridge Parkway excavation site. Archeology monitor in background.

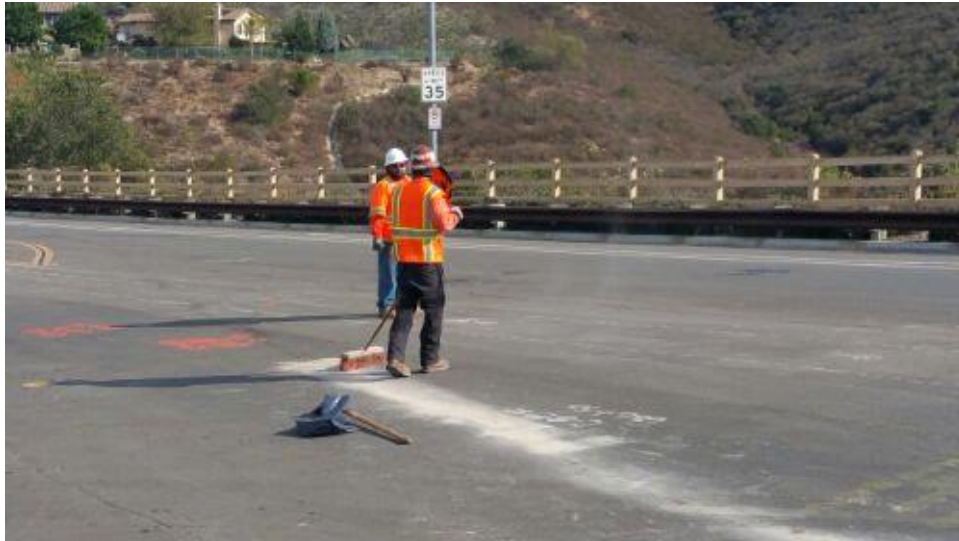
Caption Cleaned-up fuel spill site at Stonebridge Parkway and Rose Garden.

Q9 Notes	Spill during refueling (less than 1/2 gallon per EI) occurred and was promptly cleaned up on Stonebridge Parkway.
Q10 – Fire Management: (a) Were fire prevention procedures in place? (b) Was firefighting equipment available on site?	Met Requirements
Q11 – Cultural, Paleontological, and Tribal Resources: (a) Were cultural, paleontological, and tribal resources monitoring and impact avoidance occurring as required? (b) If potential resources or human remains were inadvertently discovered, were response procedures and protocols implemented as required?	Met Requirements
Q12 – Construction Noise: (a) Were noise minimization measures in place, as required? (b) If noise complaints were received, were they documented and addressed, as required?	Met Requirements
Q13 – Maintain Access: (a) Was access to driveways (e.g., businesses, schools, residences) maintained as required? (b) Was access to recreational areas maintained and appropriate signage installed? (c) Was pedestrian and bicycle access maintained, or were detours clearly defined?	Met Requirements

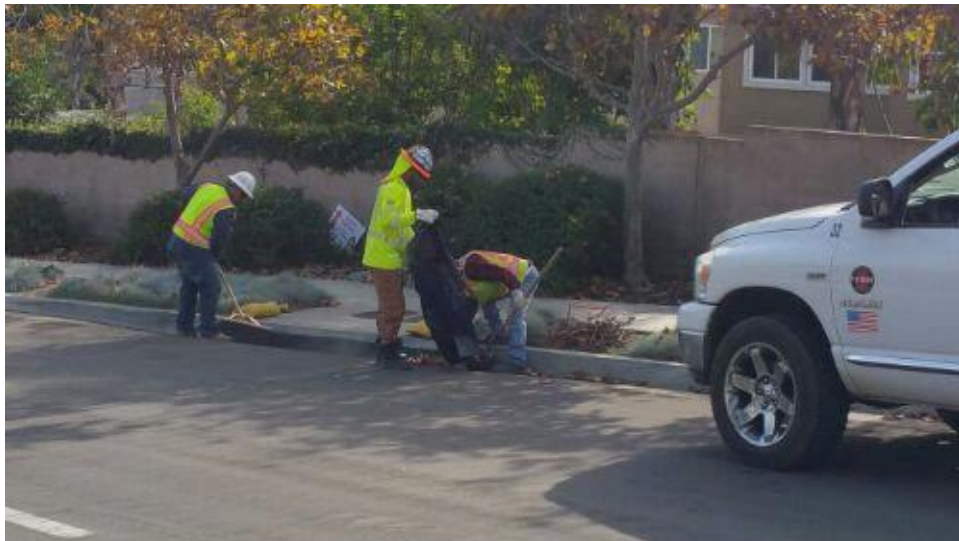
Caption Crew maintaining sediment traps on Stonebridge Parkway.

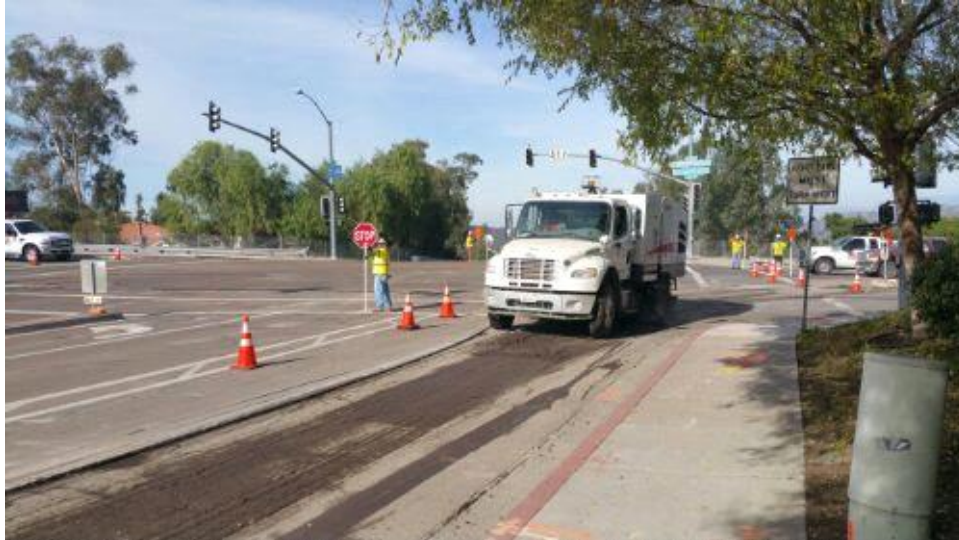
Caption Street sweeping and five flaggers at Pomerado Road corner.

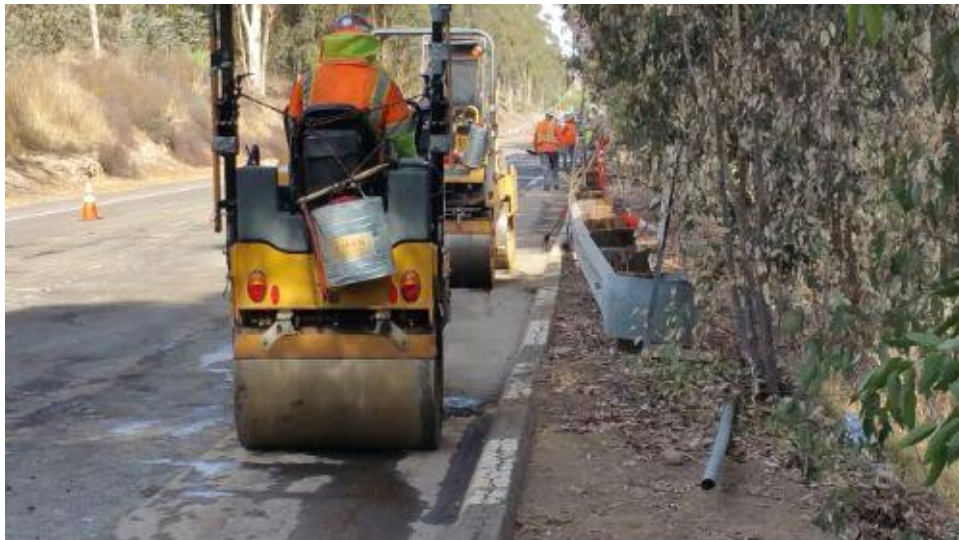
Caption Fire control gear on vehicles and available at paving crew work site on Pomerado Road.

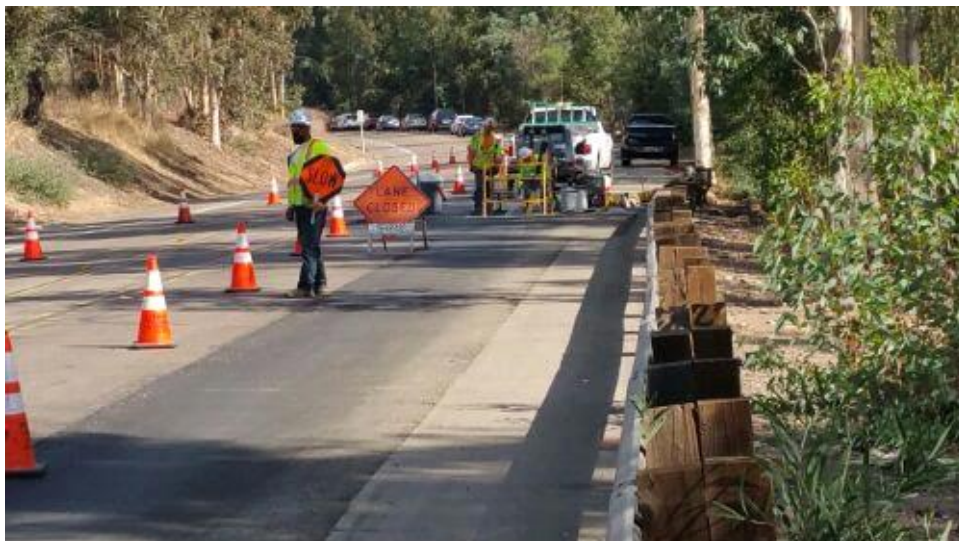
Caption Mandreling on Pomerado Road.
 Photo Attributes Capture Date/Time: Mon Nov 20 2017 12:17:33 GMT-0600 (CST)
 Coordinates: 32.906063, -117.081315
 View Direction: East

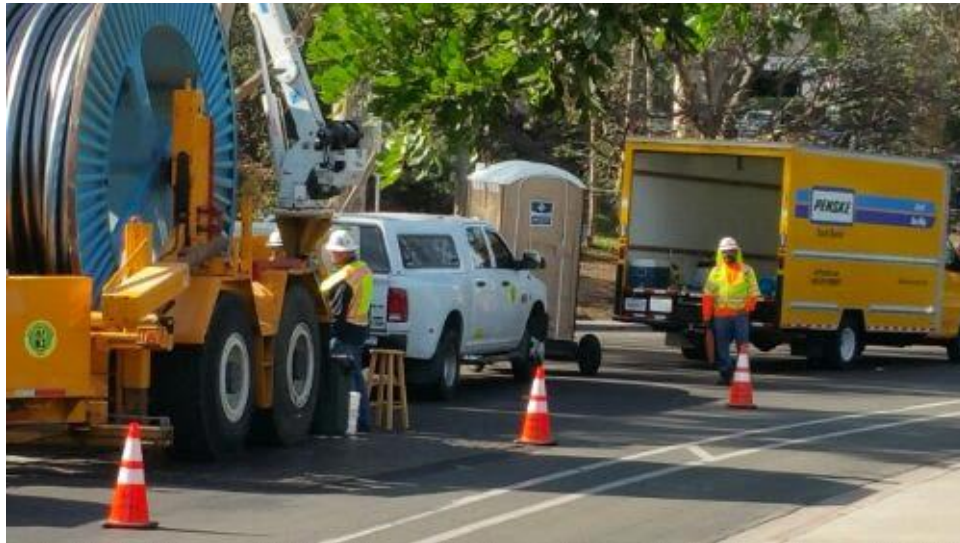
Caption Flagger present at Carroll Canon Road work area.
 Photo Attributes Capture Date/Time: Mon Nov 20 2017 11:51:26 GMT-0600 (CST)
 Coordinates: 32.88514, -117.172295
 View Direction: Northeast

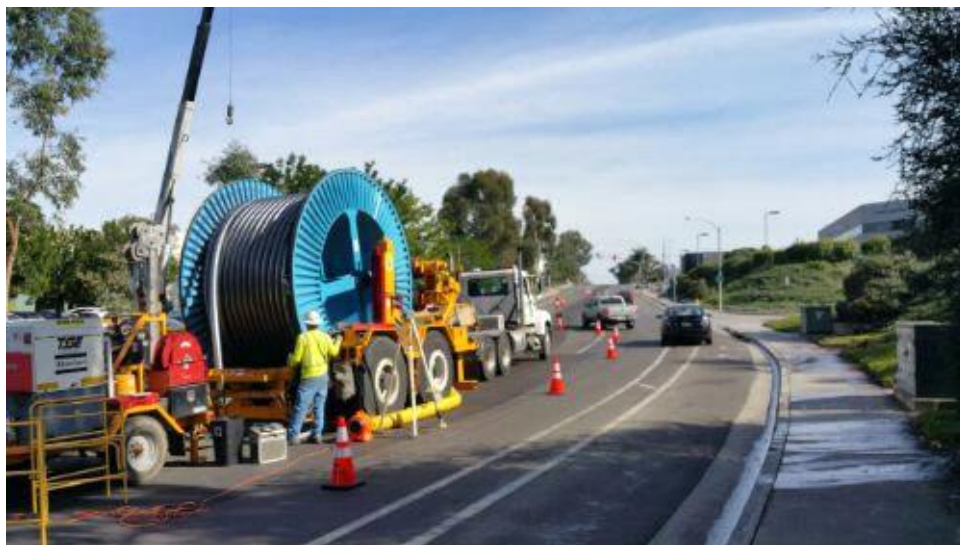
Caption Stringing cable on Carroll Canyon Road.
 Photo Attributes Capture Date/Time: Mon Nov 20 2017 11:48:25 GMT-0600 (CST)
 Coordinates: 32.884957, -117.172958
 View Direction: Northwest

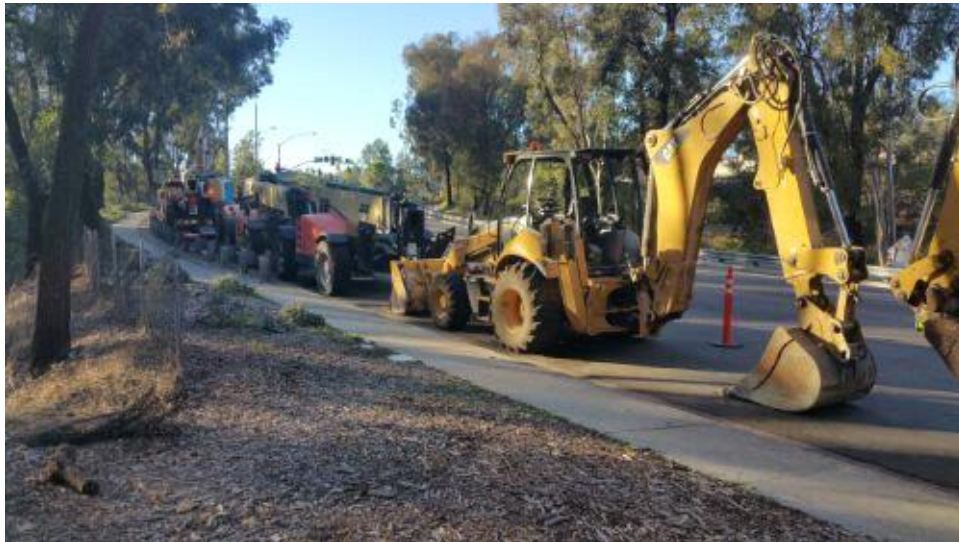
Caption Semillon Boulevard storage area in good condition.

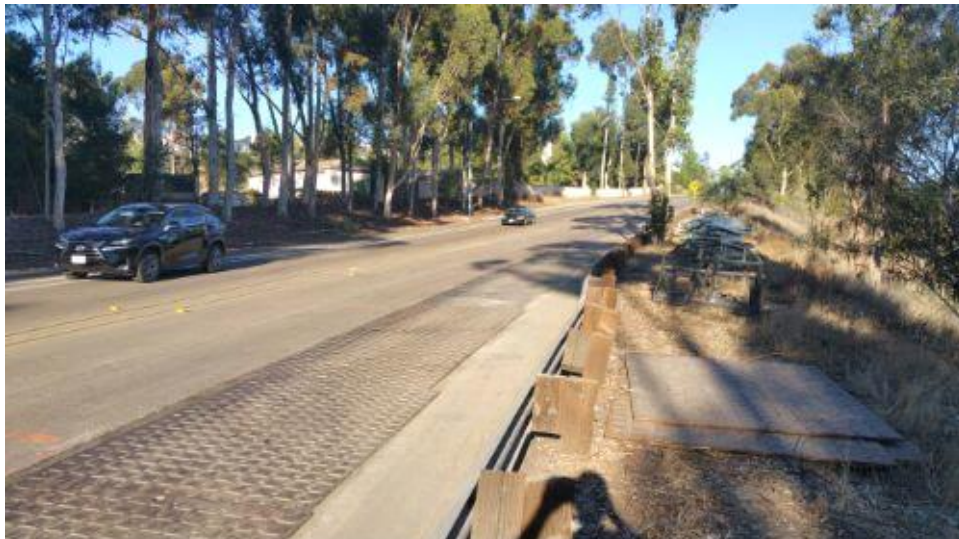
Caption Normal traffic pattern restored at 3 pm on Pomerado Road.

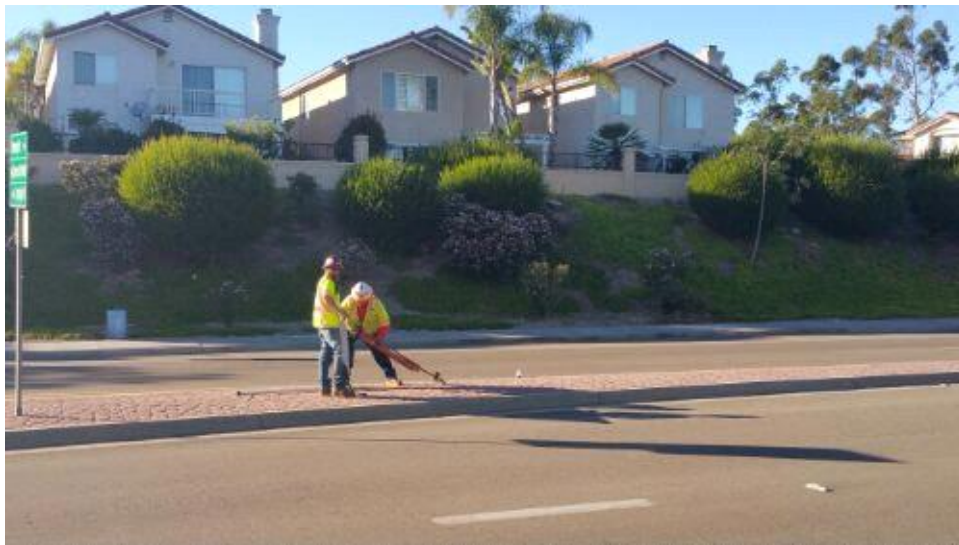
Caption Taking down traffic control signs on upper Pomerado Road.

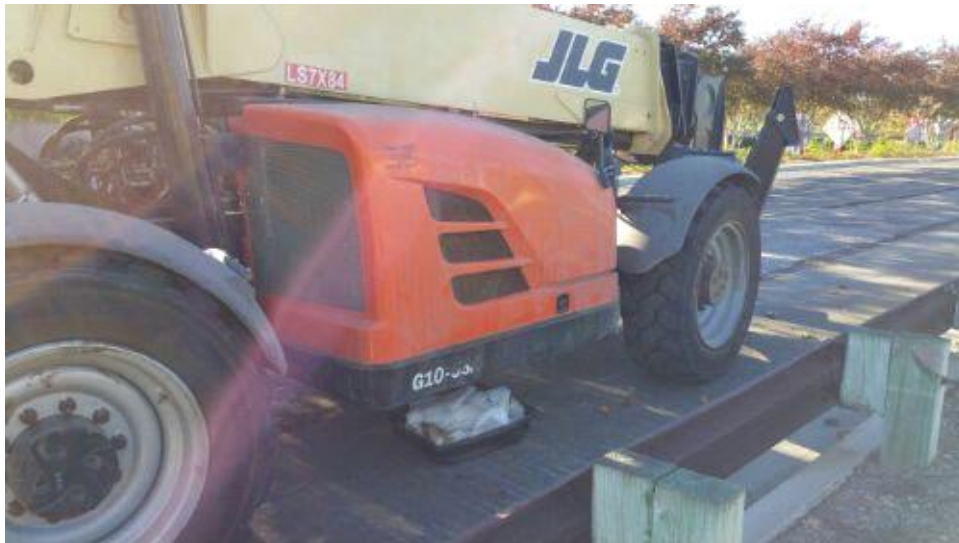
Caption Proper placement of drip pan on Stonebridge Parkway.

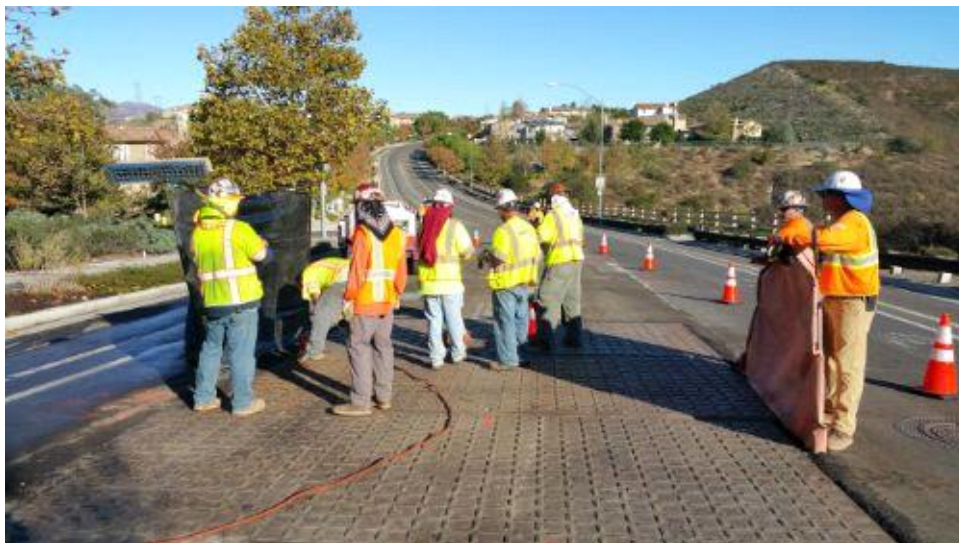
Caption Welding trench plates with excellent fire protection on Stonebridge Parkway.

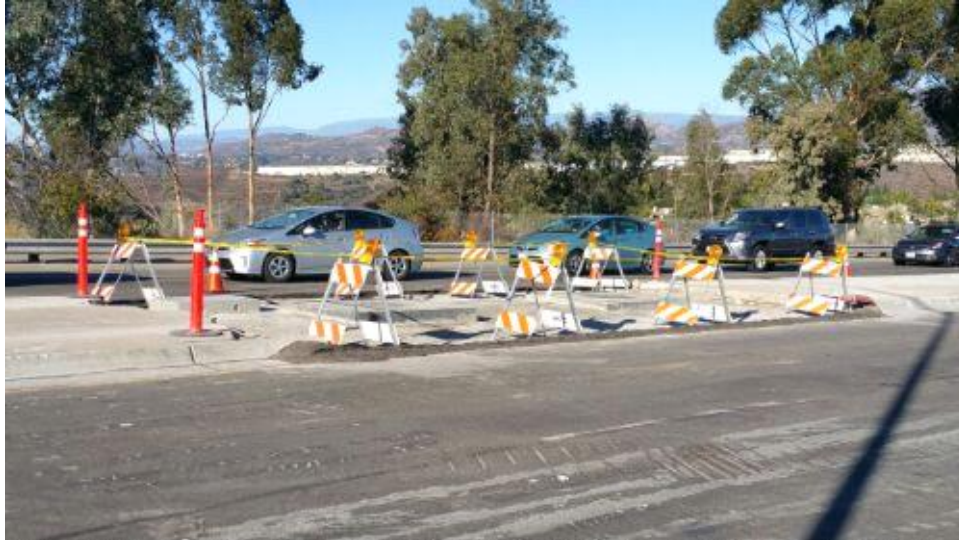
Caption Barrier around vault on Pomerado Road.

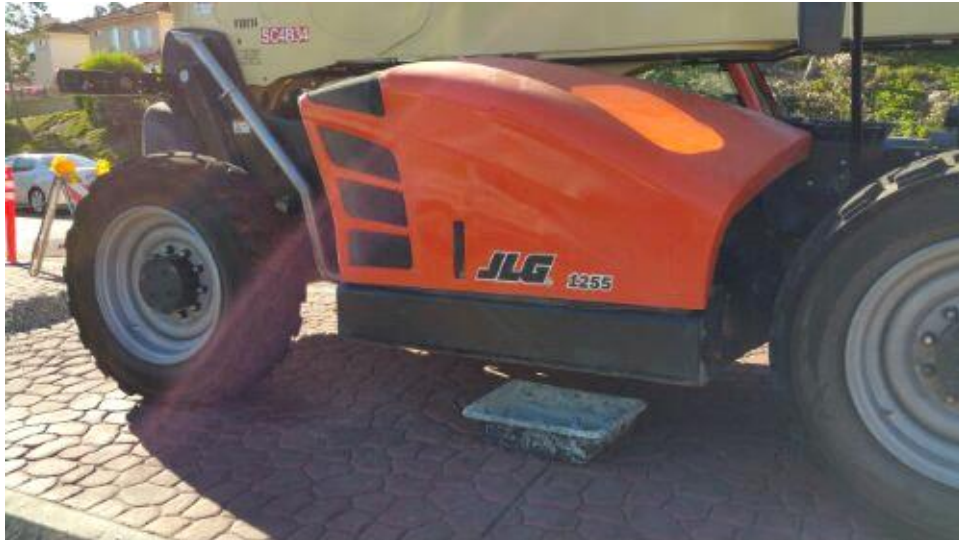
Caption Questionably placed drip pan on Pomerado Road at Vista Elevada.

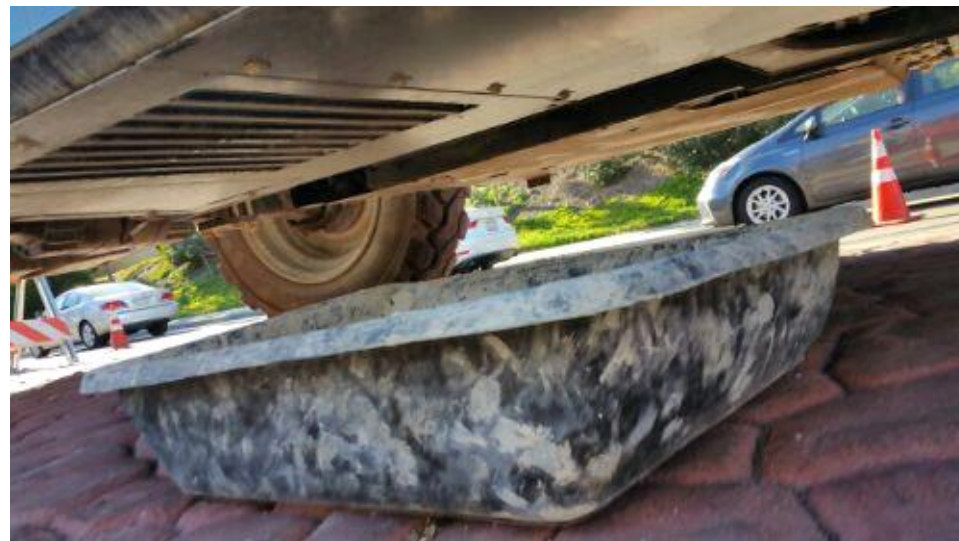
Caption Drip pan placed beneath a smooth (non-leaky) surface on SX4V34 on median at Pomerado Road and Vista Elevada.
Photo Attributes Capture Date/Time: Wed Nov 22 2017 14:07:54 GMT-0600 (CST)
Coordinates: 32.920527, -117.062967
View Direction: West

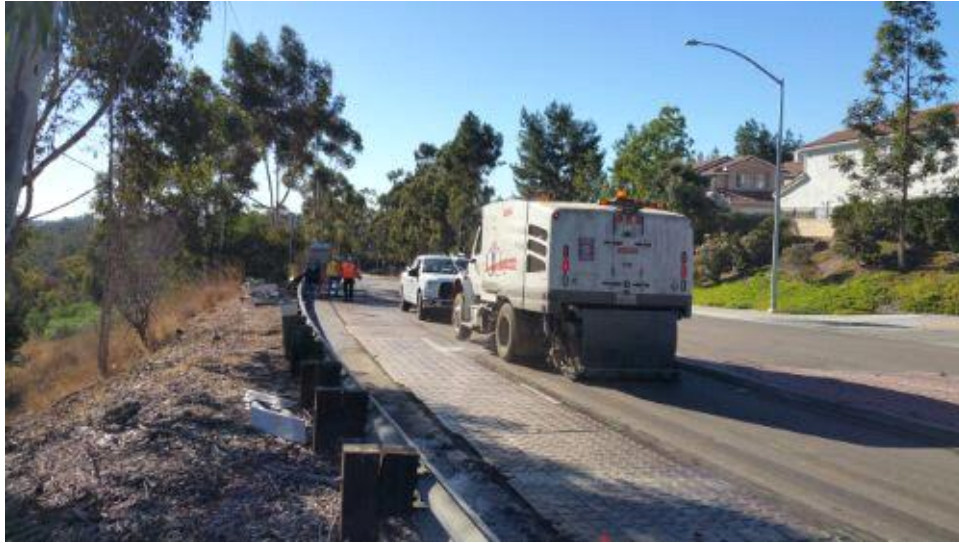
Caption Street sweeping with trench plate welders in background.

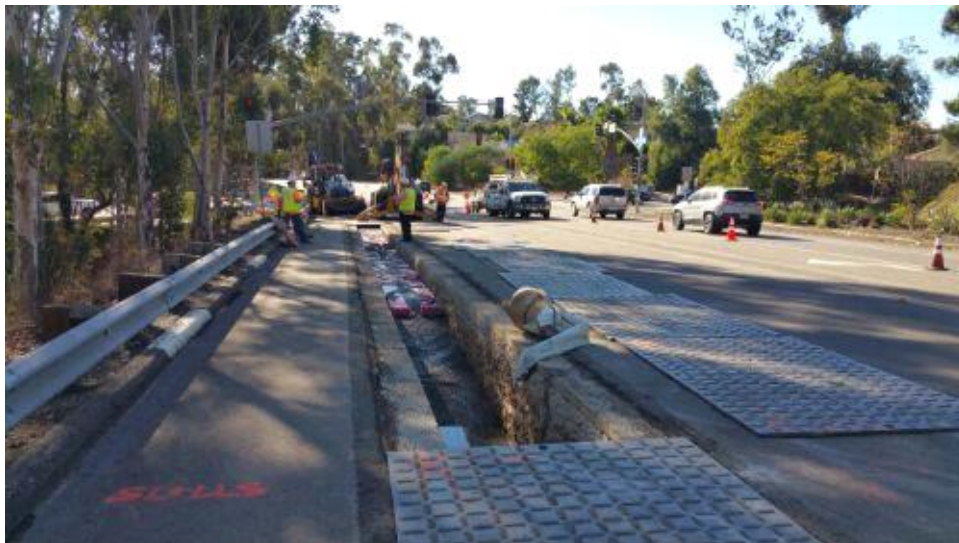
Caption Trenching on Pomerado Road.

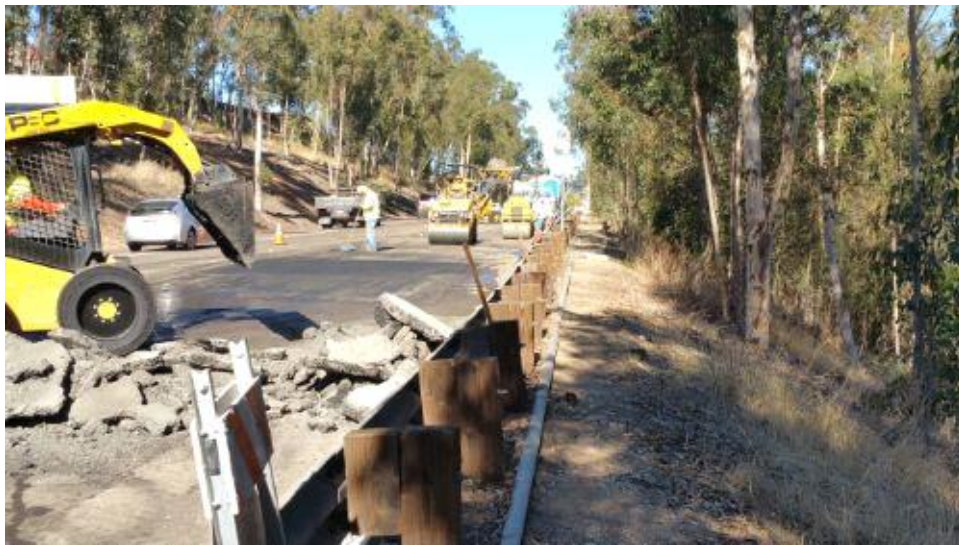
Caption Asphalt removal on Pomerado Road.

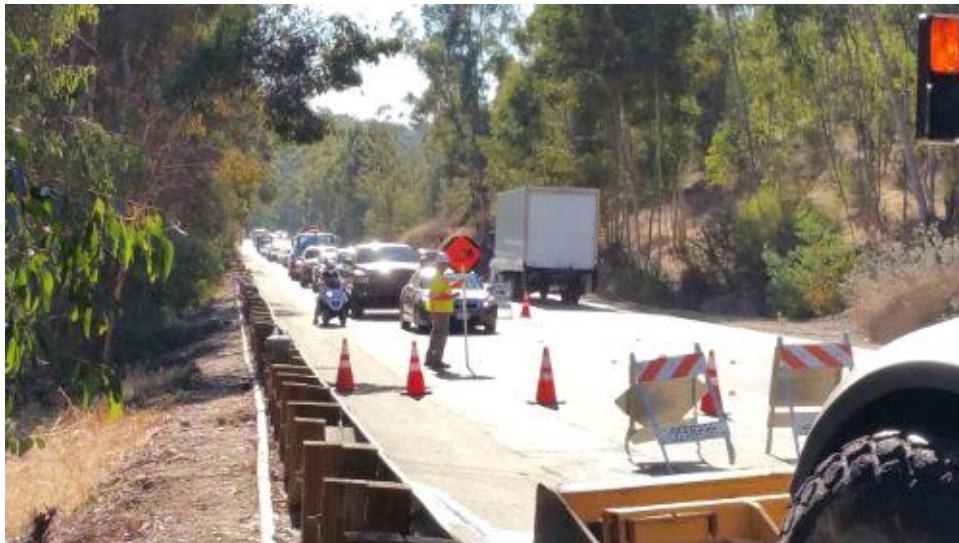
Caption Traffic control at west end of main work area on Pomerado Road.
