## PROJECT MEMORANDUM SYCAMORE-PEÑASQUITOS 230-KV TRANSMISSION LINE PROJECT

Date: December 11, 2017  
To: Billie Blanchard, CPUC Project Manager  
From: Sheila Hoyer, CPUC Monitoring Supervisor  
Subject: Weekly Report #48 – November 26 to December 02, 2017

# 2017-11-28 AM Inspection Report

# 2017-11-30 AM Inspection Report

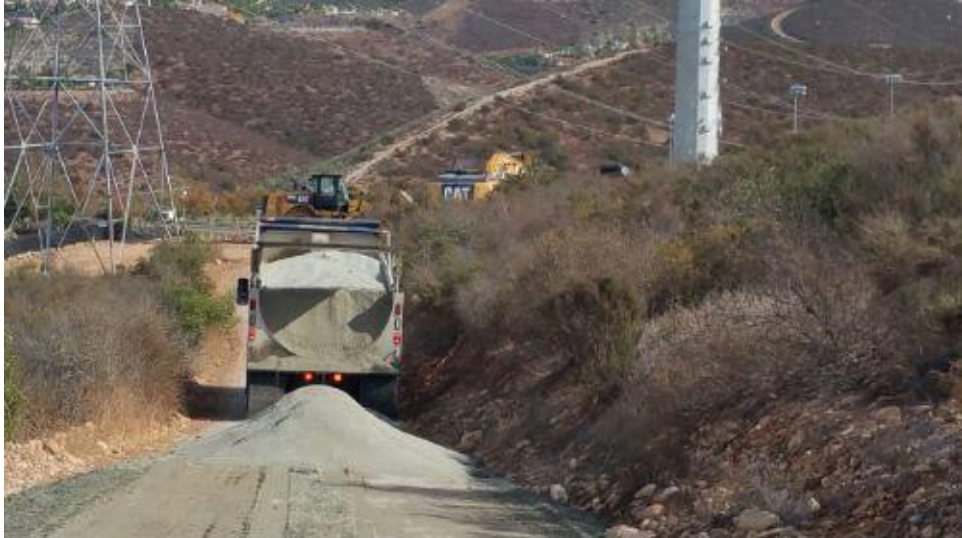
Caption Depositing fill for wall at PO5. This is temporary, no storms anticipated. Per LEI, if storm anticipated, sedimentation from piles will be prevented.

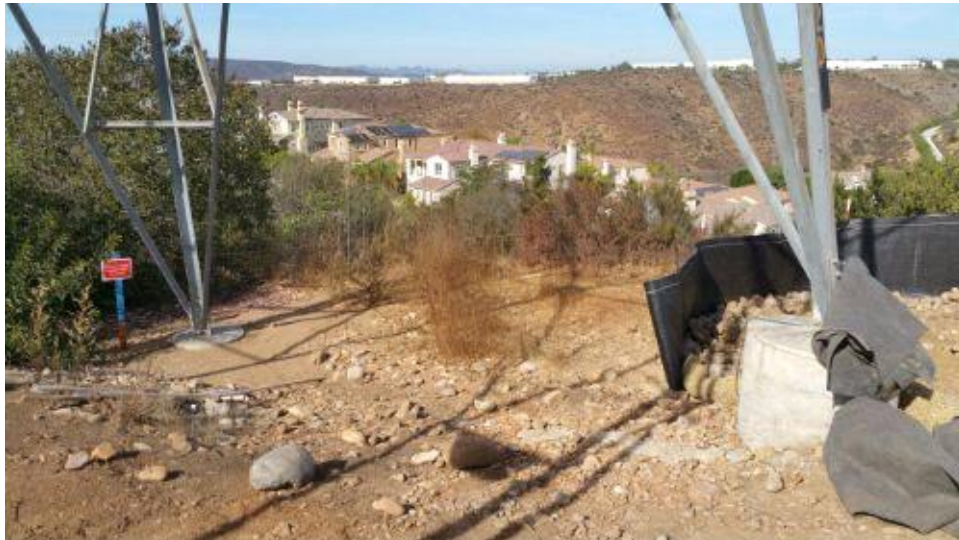
Caption Site conditions at low point on PO5 (before storms).

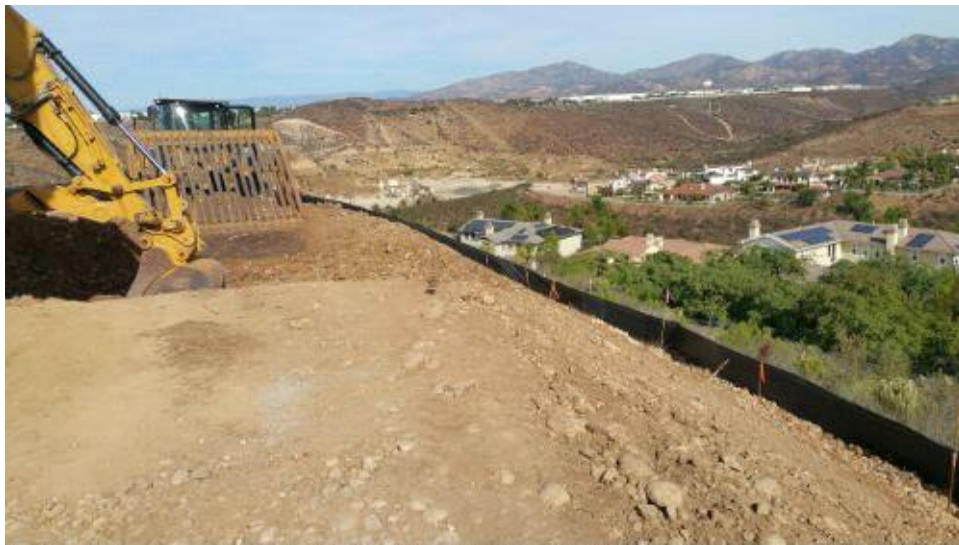
Caption Excavation for retaining wall at PO5.  
Photo Attributes Capture Date/Time: Tue Nov 28 2017 12:12:18 GMT-0800 (PST)  
Coordinates: 32.922523, -117.042395  
View Direction: North

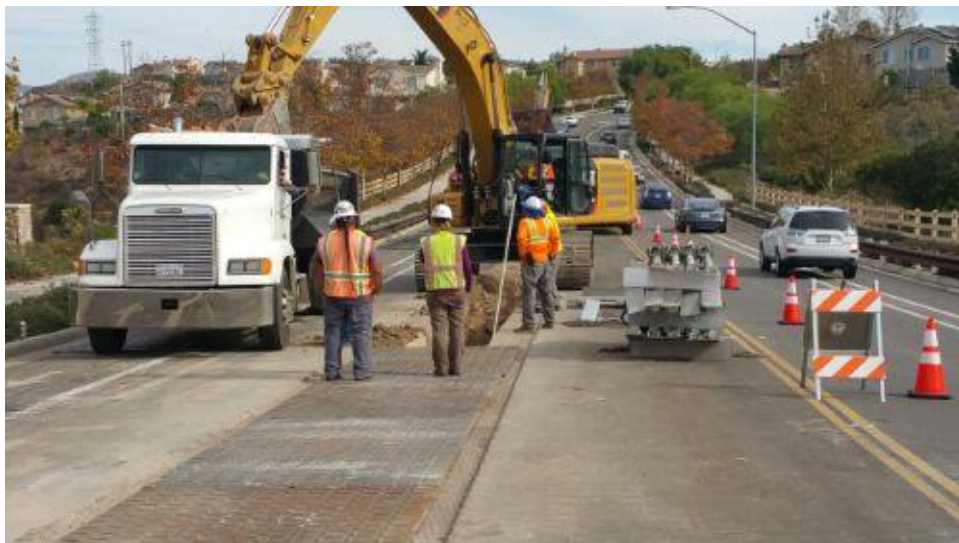
Caption Excavation in Stonebridge Parkway, 2 monitors present.  
Photo Attributes Capture Date/Time: Tue Nov 28 2017 11:32:46 GMT-0800 (PST)

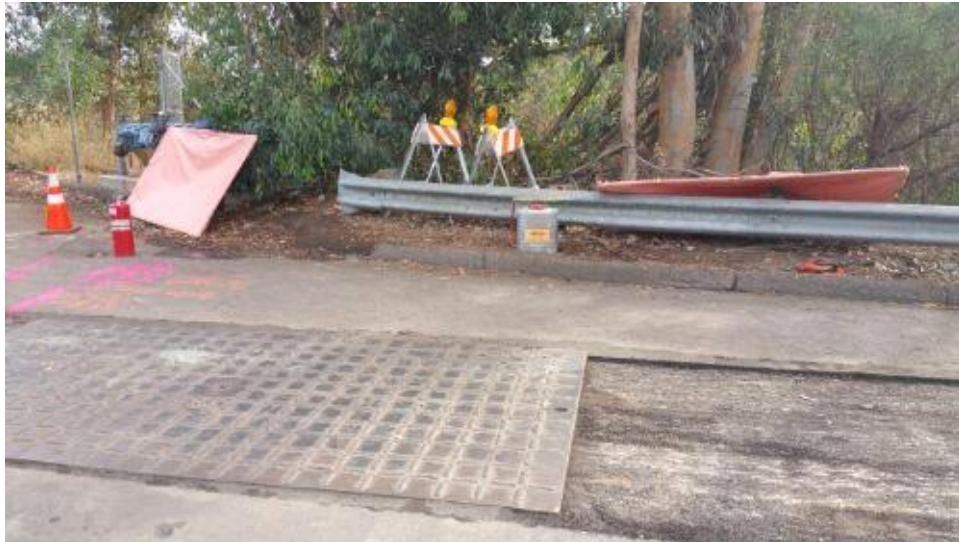
Caption Fire protection equipment, Pomerado Road at Sycamore Test.

Q10 – Fire Management: (a) Were fire prevention procedures in place? (b) Was firefighting equipment available on site?	Met Requirements
Q10 Notes	New fire protection blankets on frames were observed at work site.
Q11 – Cultural, Paleontological, and Tribal Resources: (a) Were cultural, paleontological, and tribal resources monitoring and impact avoidance occurring as required? (b) If potential resources or human remains were inadvertently discovered, were response procedures and protocols implemented as required?	Met Requirements
Q11 Notes	Two teams of monitors were present at excavation work on Pomerado Road and Stonebridge Parkway.
Q12 – Construction Noise: (a) Were noise minimization measures in place, as required? (b) If noise complaints were received, were they documented and addressed, as required?	Met Requirements
Q13 – Maintain Access: (a) Was access to driveways (e.g., businesses, schools, residences) maintained as required? (b) Was access to recreational areas maintained and appropriate signage installed? (c) Was pedestrian and bicycle access maintained, or were detours clearly defined?	Met Requirements

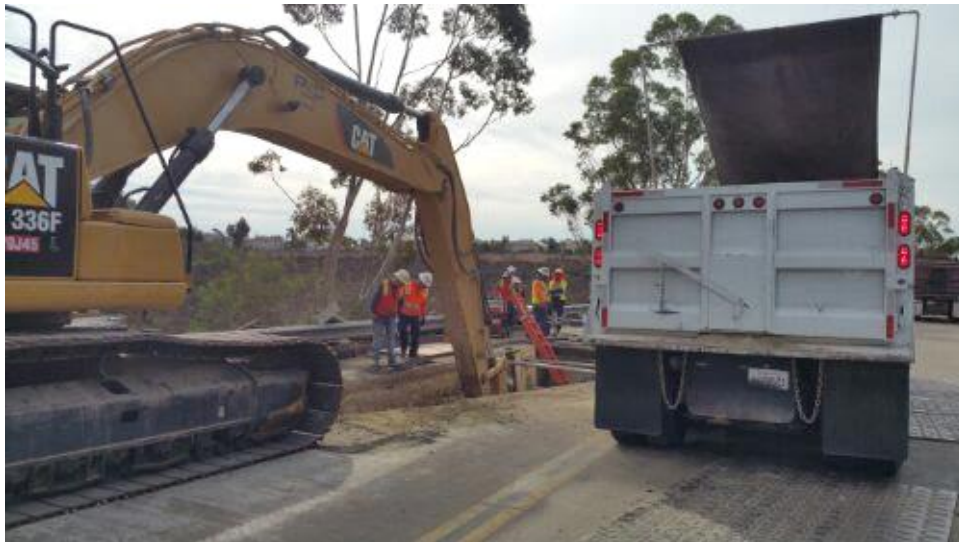
Caption Excavation, Pomerado Road. Monitors present.

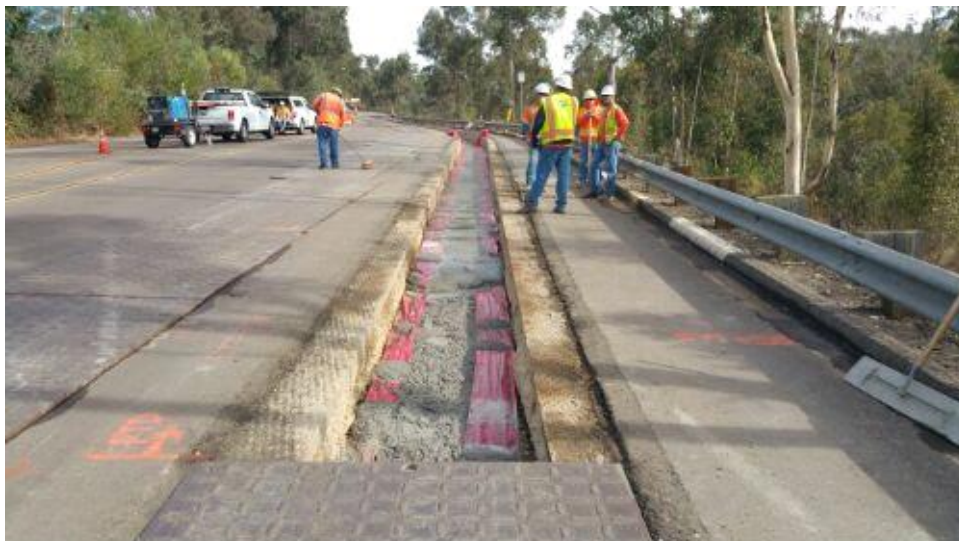
Caption Poured concrete on Pomerado Road.  
 Photo Attributes Capture Date/Time: Tue Nov 28 2017 10:40:56 GMT-0800 (PST)  
 Coordinates: 32.915536, -117.06998  
 View Direction: East

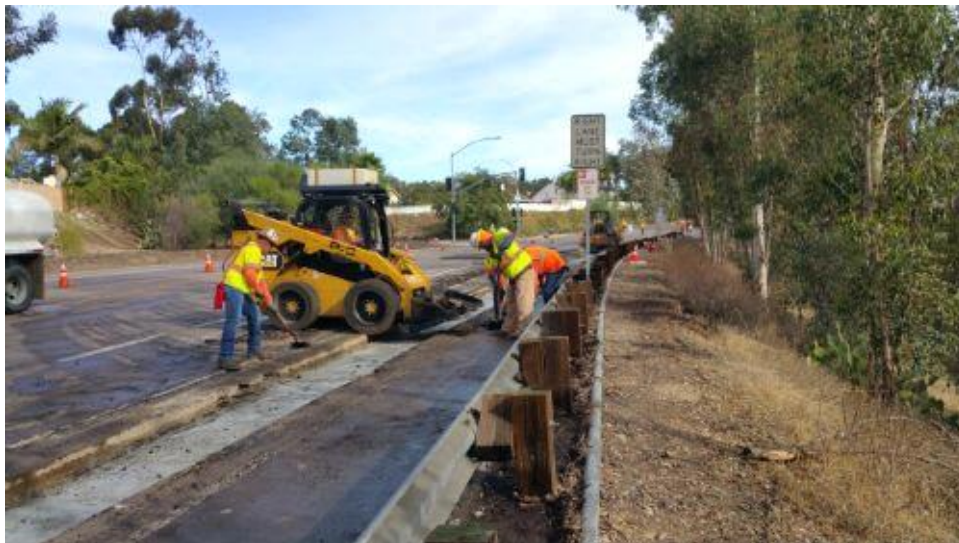
Caption Removing asphalt for trench plates on Pomerado Road.

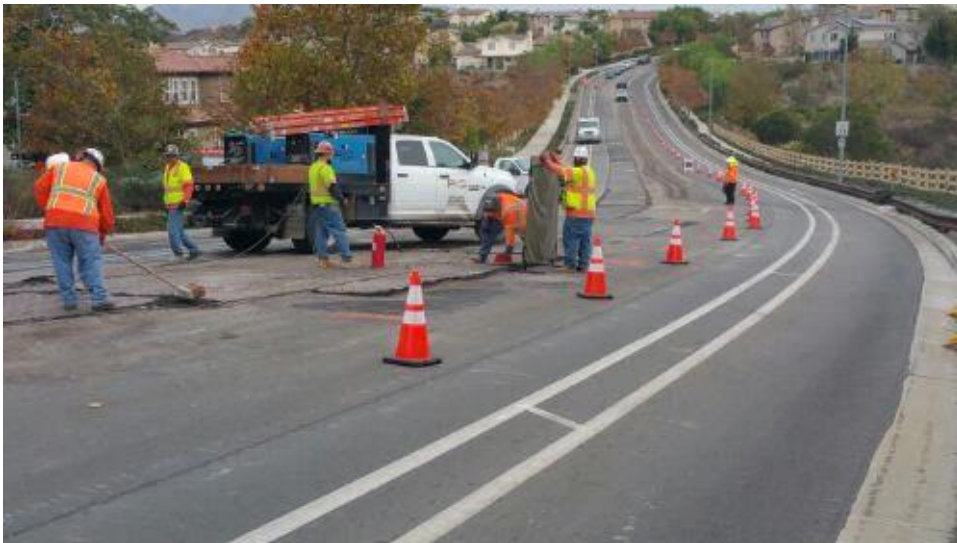
Caption Welding trench plates on Stonebridge Parkway.

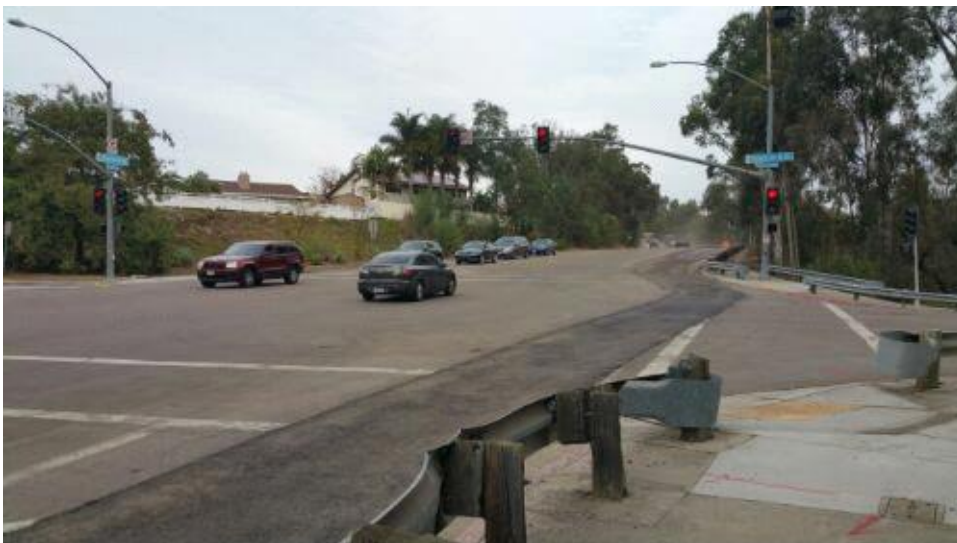
Caption Traffic control removed, Semillon Blvd. and Pomerado Road. Work on Pomerado Road done for day.

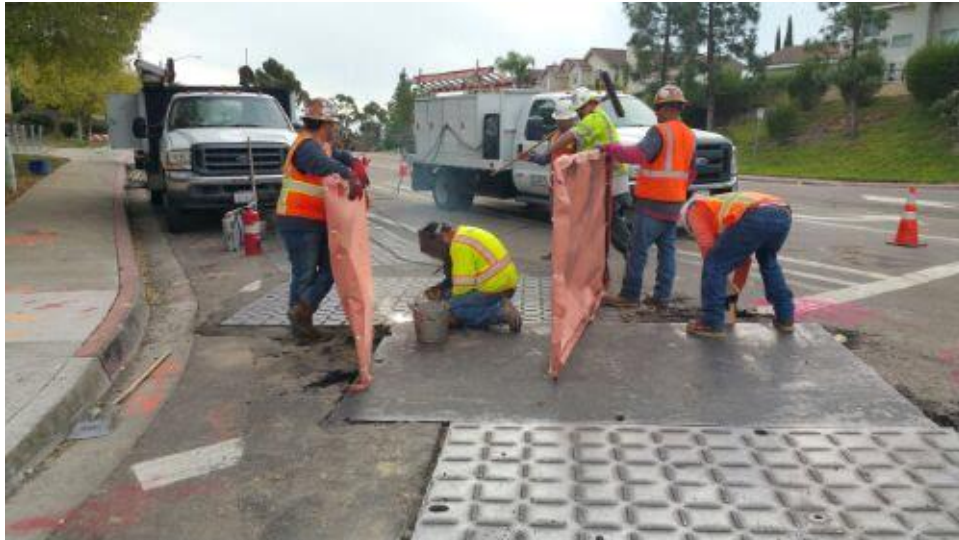
Caption Welding trench plates shut on Pomerado Road.

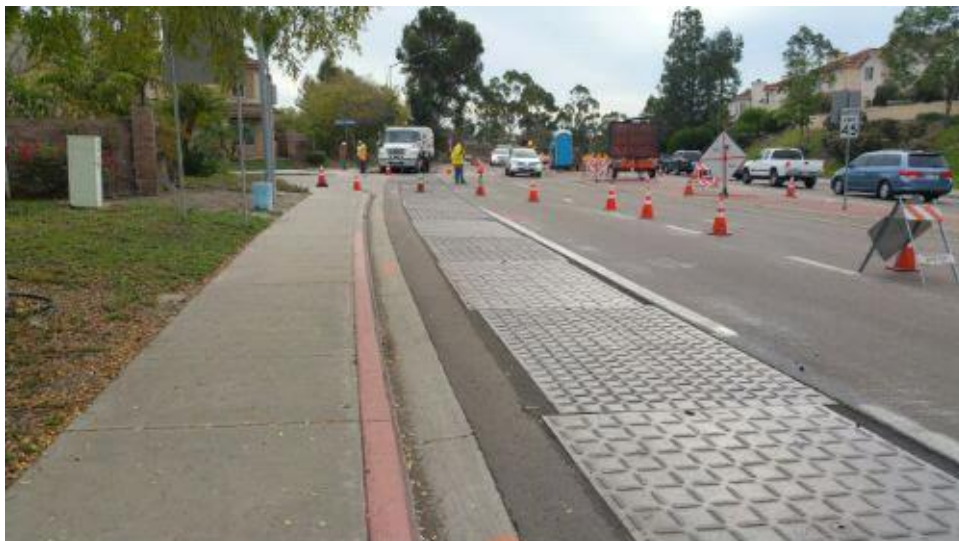
Caption Trench plates swept at end of shift on Pomerado Road.  
Photo Attributes Capture Date/Time: Thu Nov 30 2017 14:33:03 GMT-0800 (PST)  
Coordinates: 32.920906, -117.062705  
View Direction: South

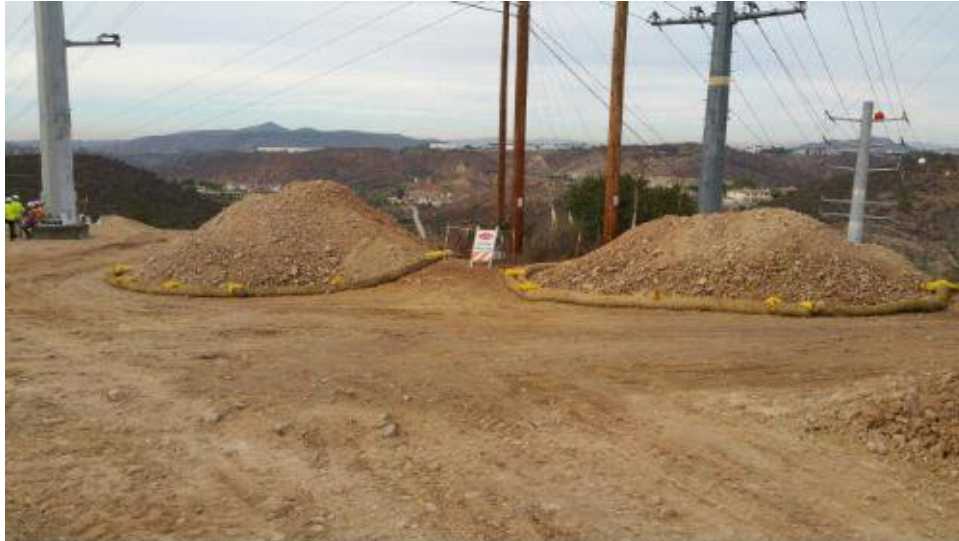
Caption Soil stockpiles at PO3. Not covered to preserve seed viability.  
Photo Attributes Capture Date/Time: Thu Nov 30 2017 14:16:18 GMT-0800 (PST)  
Coordinates: 32.91971, -117.031919  
View Direction: Northwest

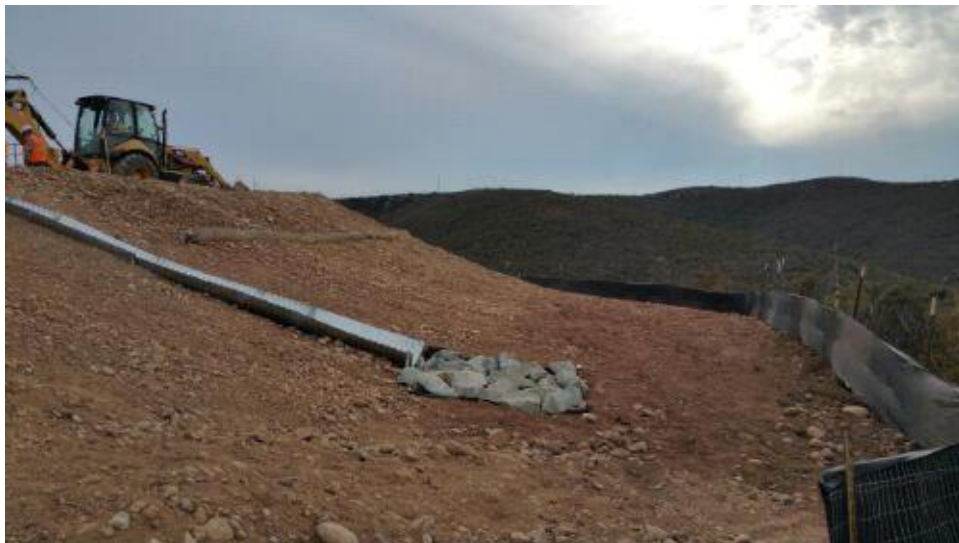
Caption Erosion control BMPs at PO3.  
Photo Attributes Capture Date/Time: Thu Nov 30 2017 14:11:22 GMT-0800 (PST)  
Coordinates: 32.914948, -117.069614  
View Direction: South

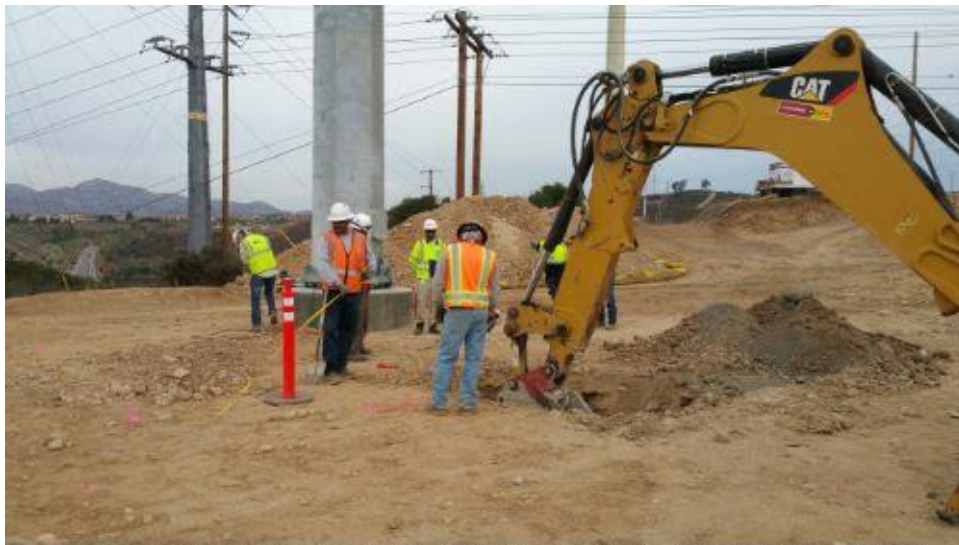
Caption Excavation for risers at PO3. Archaeology monitor present.

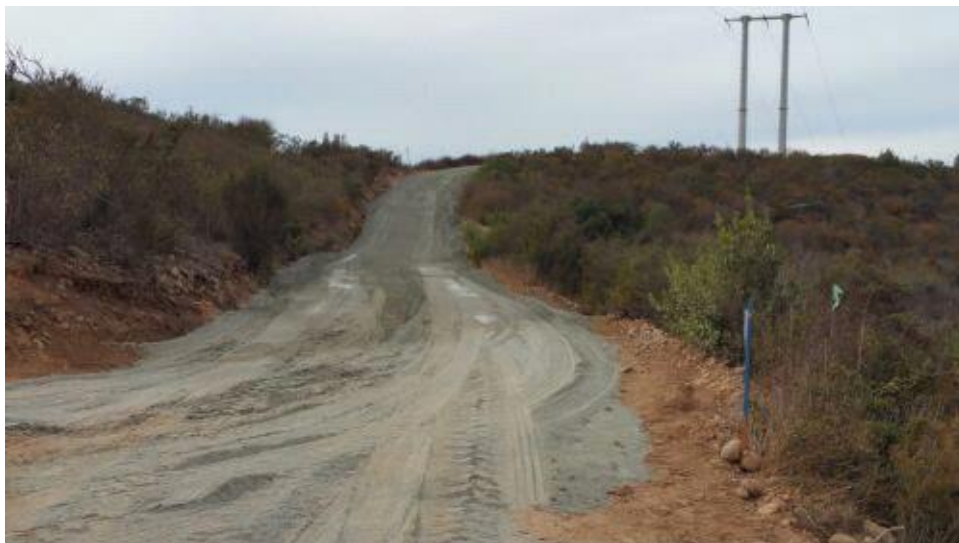
Caption Fill material for PO5 spread out on upper access road still to be watered.

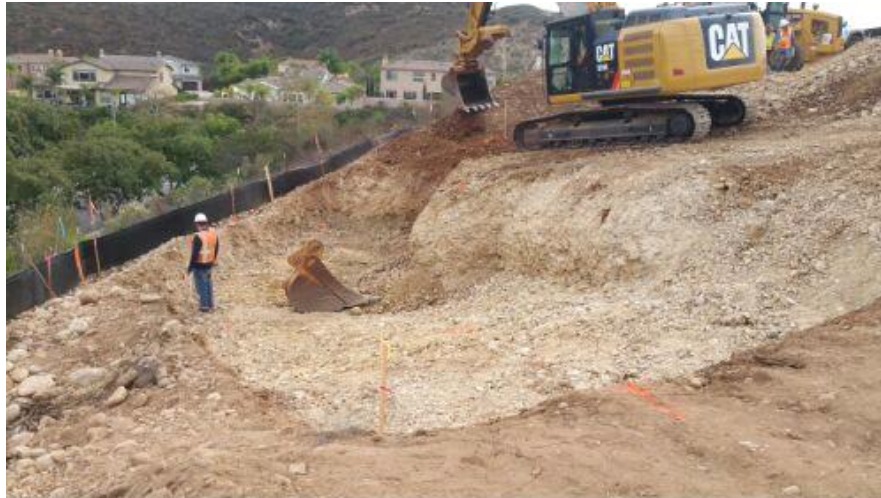
Caption Excavation at PO5 for retaining wall.
