PROJECT MEMORANDUM SYCAMORE-PEÑASQUITOS 230-KV TRANSMISSION LINE PROJECT

Date: December 21, 2017
To: Billie Blanchard, CPUC Project Manager
From: Sheila Hoyer, CPUC Monitoring Supervisor
Subject: Weekly Report #50 – December 11 to December 16, 2017

SDG&E Sycamore-Peñasquitos 230-kV Transmission Line Project: Daily Inspection Report

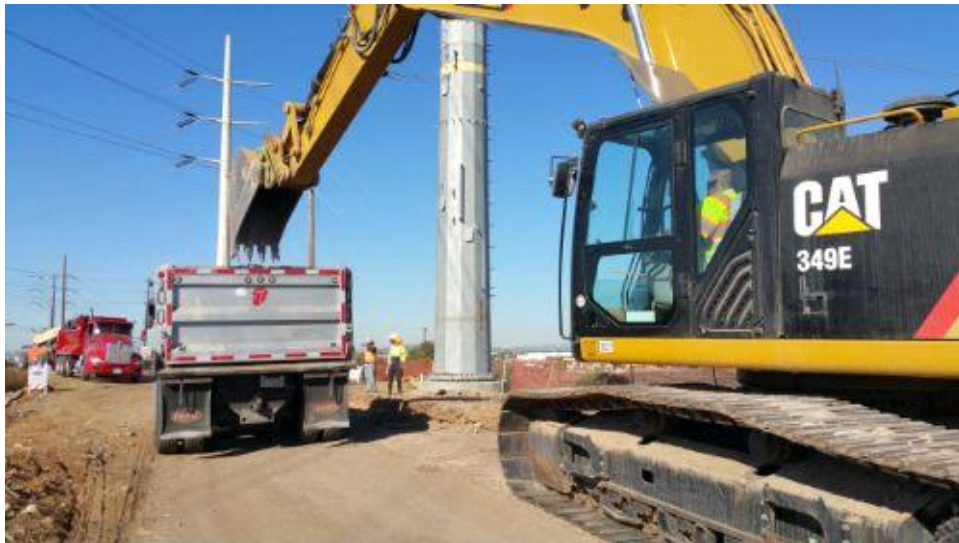
Caption Excavation at PO3 with archaeological monitor present.

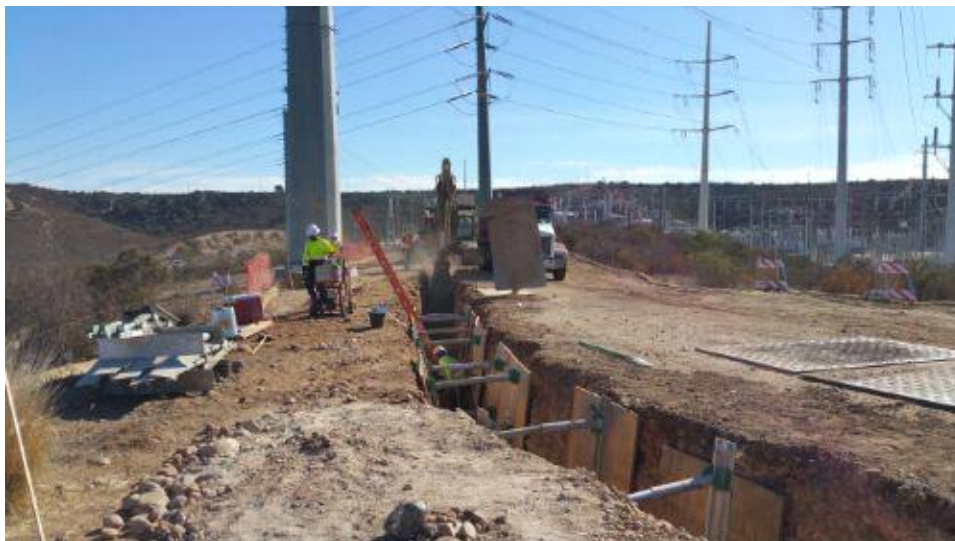
Caption Trenching at PO3.

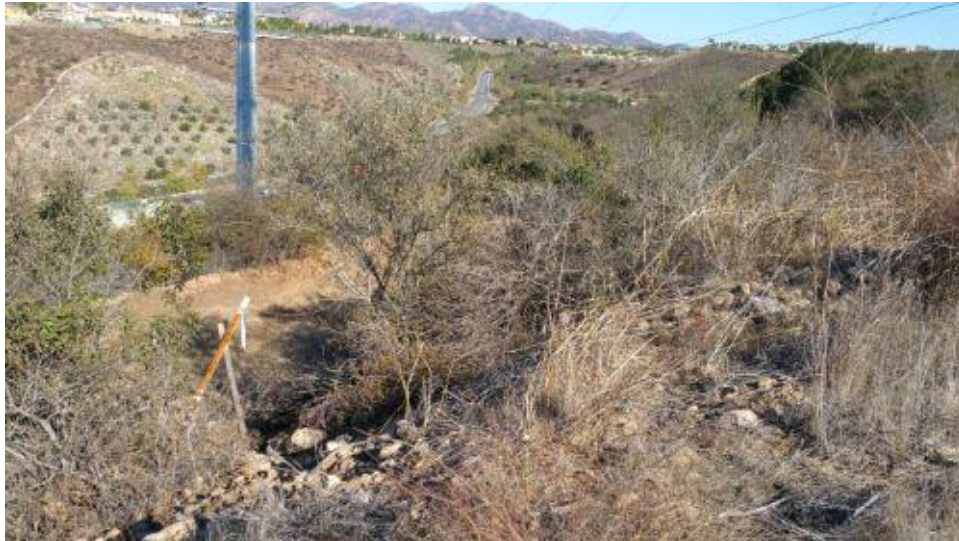
Caption Work limits staking drainage at PO3.

I noted stakes and strings delimiting work area were down in some places at P03 and informed LEI, who will arrange for them to be repaired.

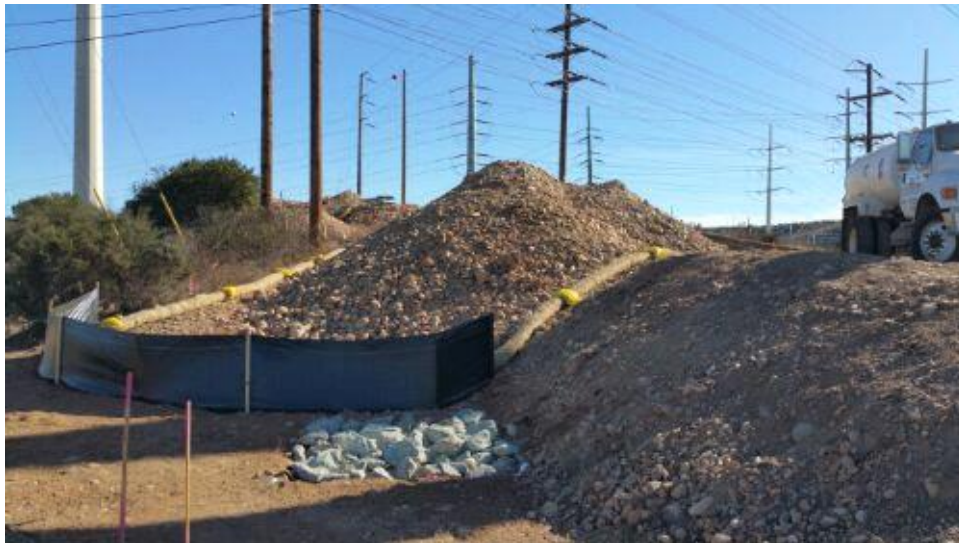
Caption Topsoil storage with erosion control at PO3.

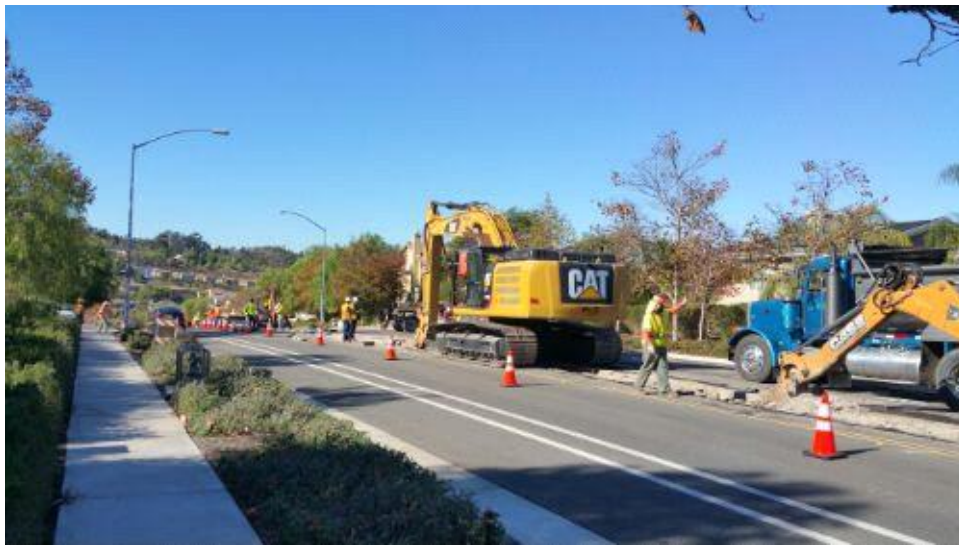
Caption Digging on Stonebridge Parkway. Two monitors on hand.

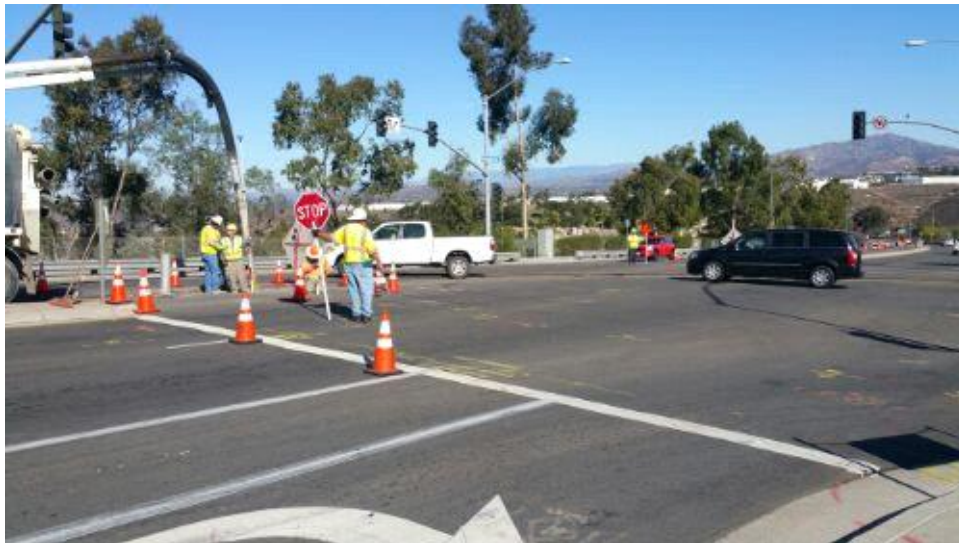
Caption Potholing at Pomerado Road and Stonebridge Parkway.

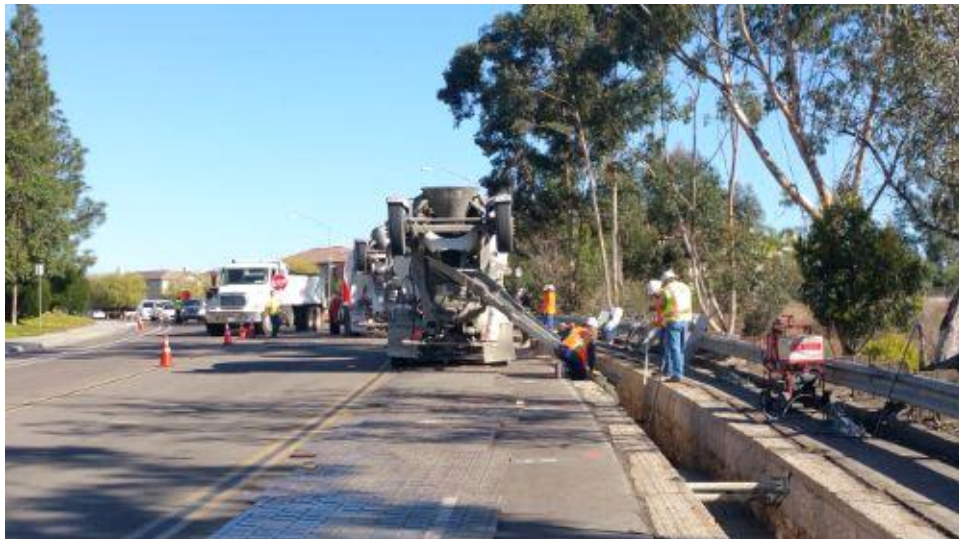
Caption Concrete pour on Pomerado Road.

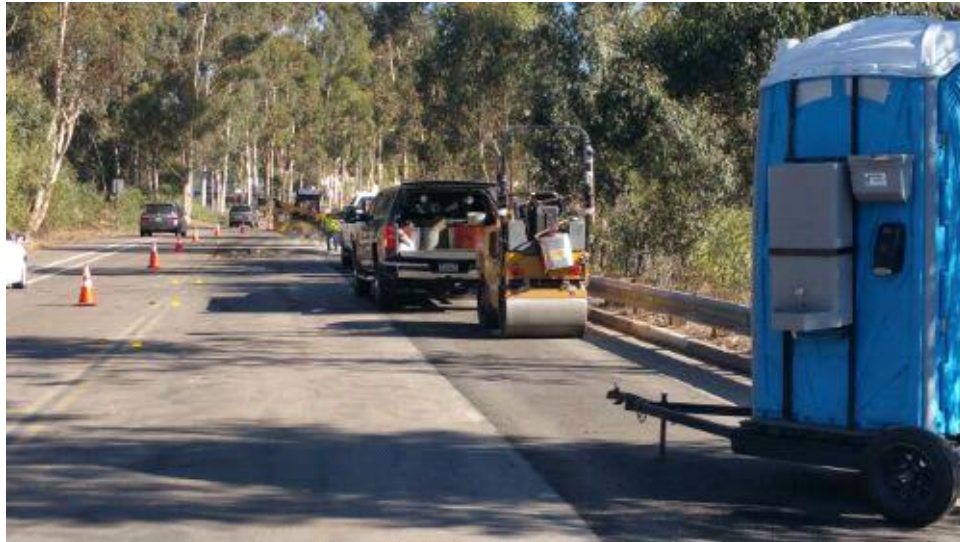
Caption Repaving crew on Pomerado Road.

Q10 – Fire Management: (a) Were fire prevention procedures in place? (b) Was firefighting equipment available on site?	Corrections Required
Q10 Notes	I noted a frayed fire protection blanket with repaving crew and spoke with foreman. He said since they repaved, welding trench plates would not be needed, but that this blanket would be repaired.
Q11 – Cultural, Paleontological, and Tribal Resources: (a) Were cultural, paleontological, and tribal resources monitoring and impact avoidance occurring as required? (b) If potential resources or human remains were inadvertently discovered, were response procedures and protocols implemented as required?	Met Requirements
Q11 Notes	Monitors were working at excavation sites.
Q12 – Construction Noise: (a) Were noise minimization measures in place, as required? (b) If noise complaints were received, were they documented and addressed, as required?	Met Requirements

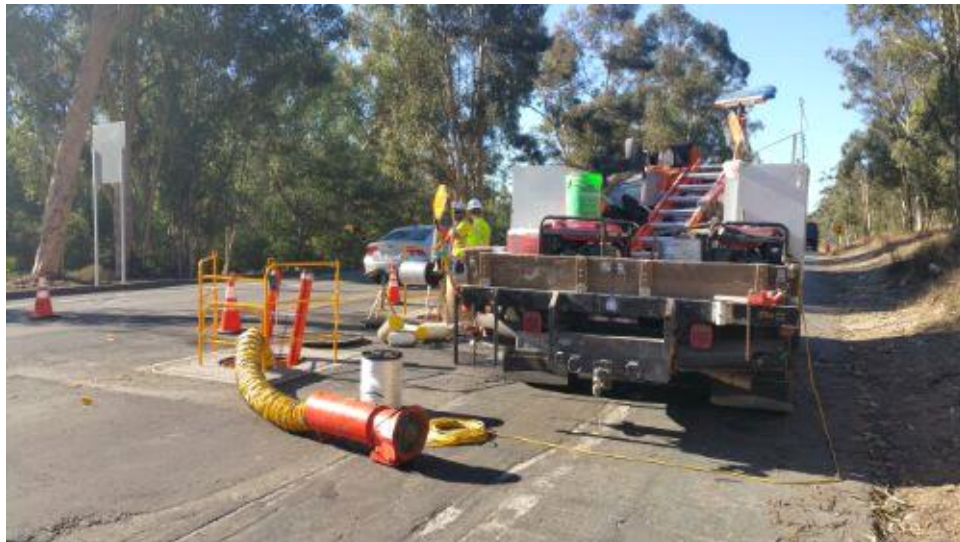
Caption Mandreling crew with traffic control and fire equipment.

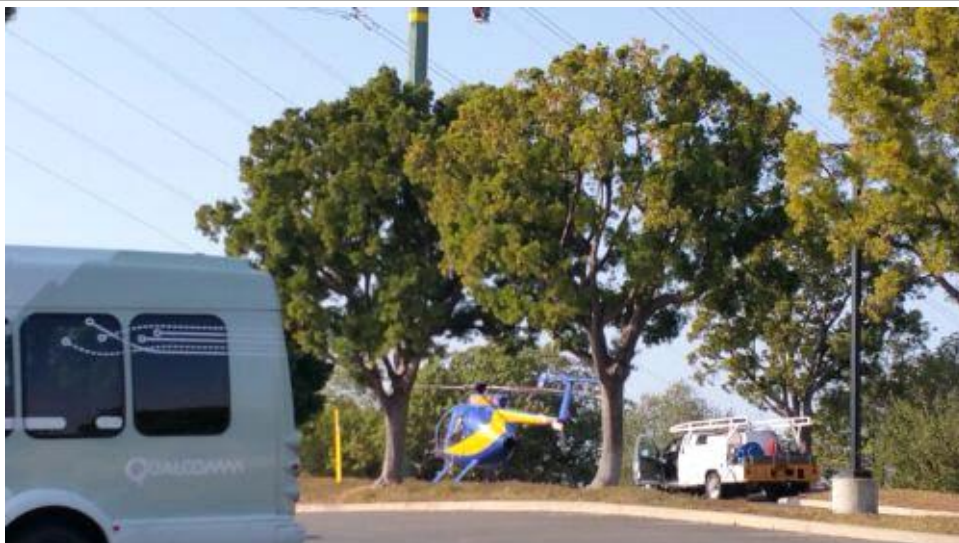
Caption Helicopter parked near E44.

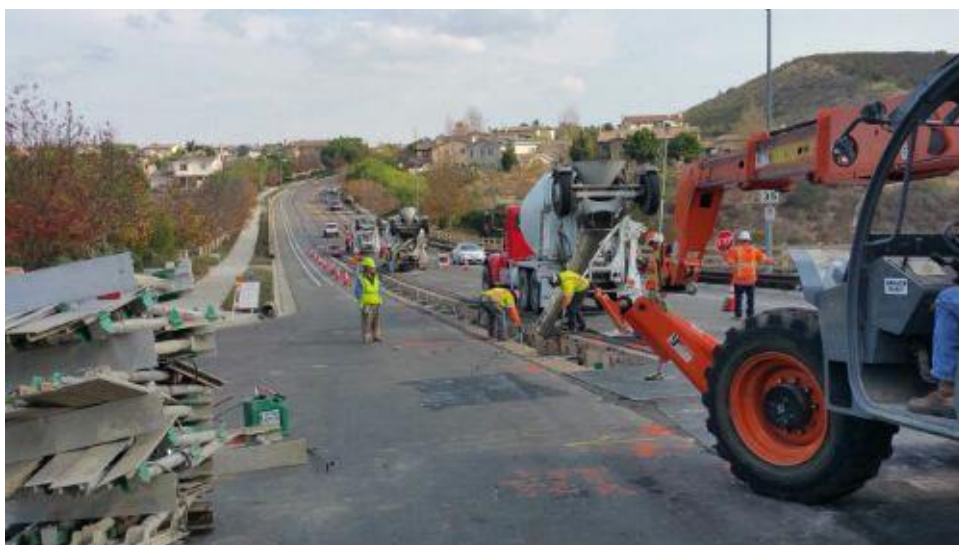
Caption Concrete pour on Stonebridge Pkwy.

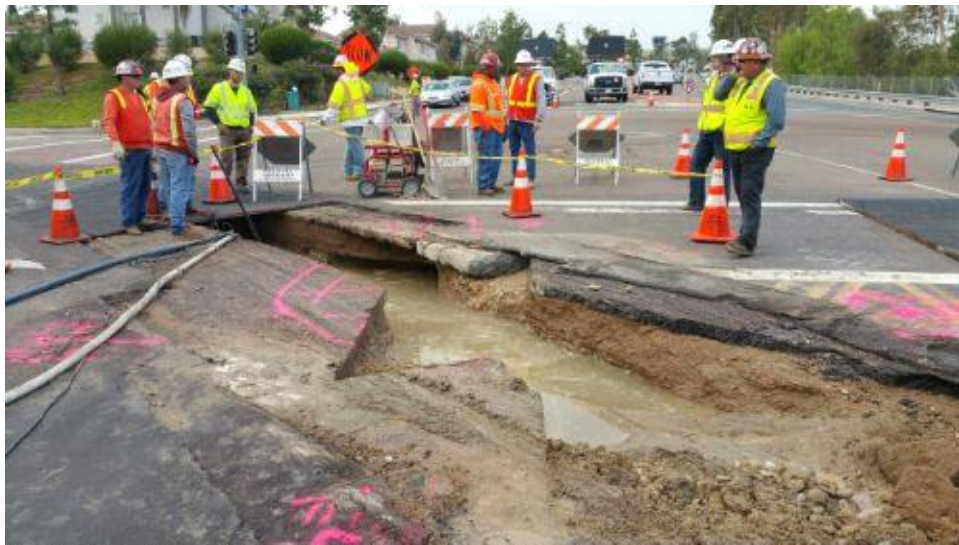
Caption Water line repair in progress on Pomerado Road.

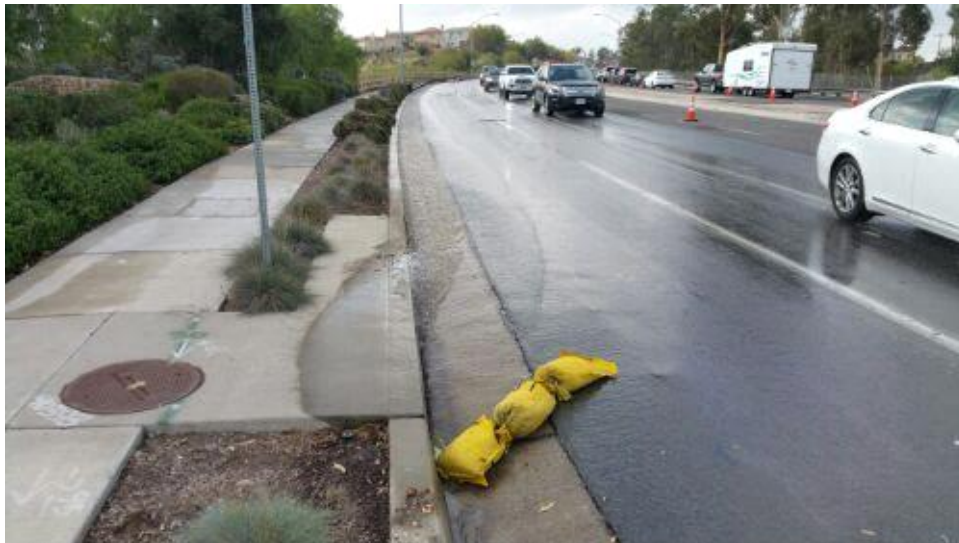
Caption Water flow was directed into storm drain system during busted water line emergency.

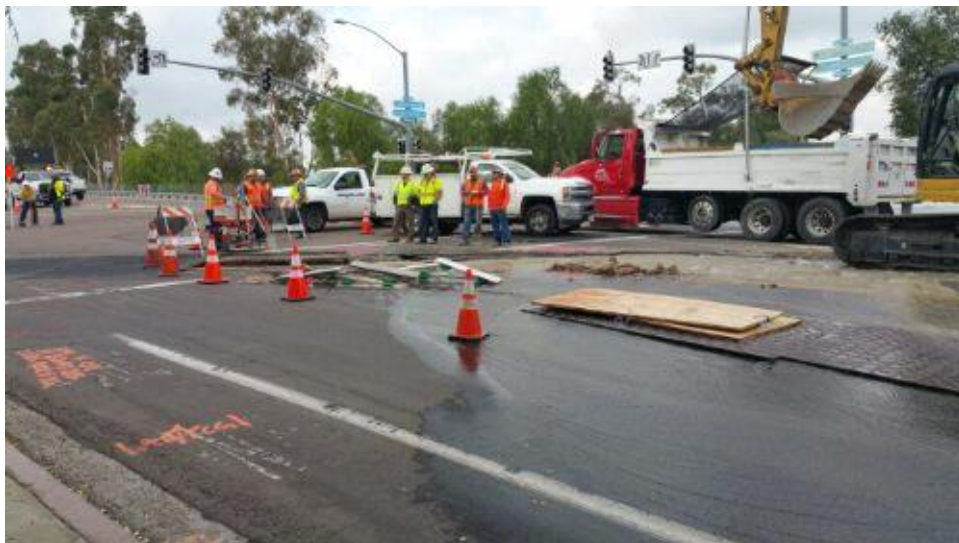
Caption Broken water line with City crew working on repair.

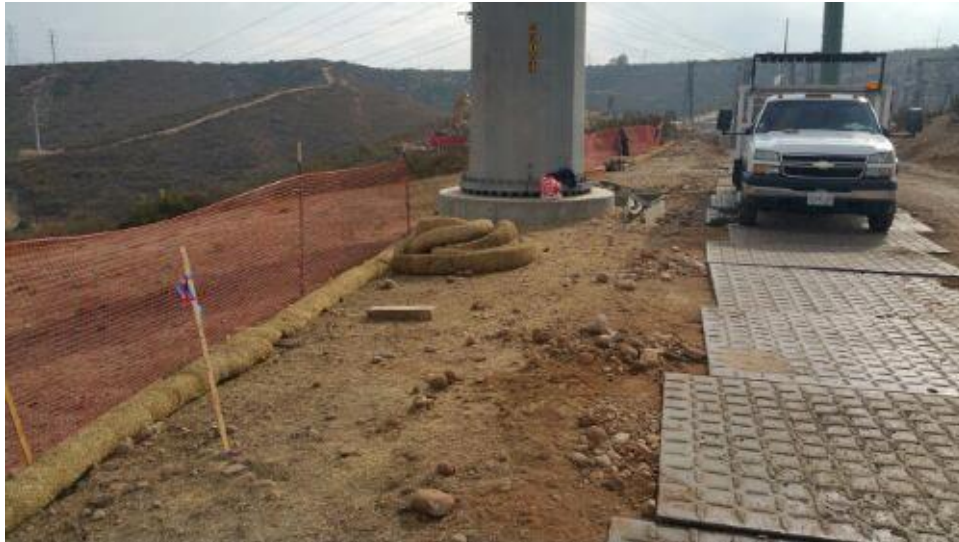
Caption New fencing for PO3 limits.

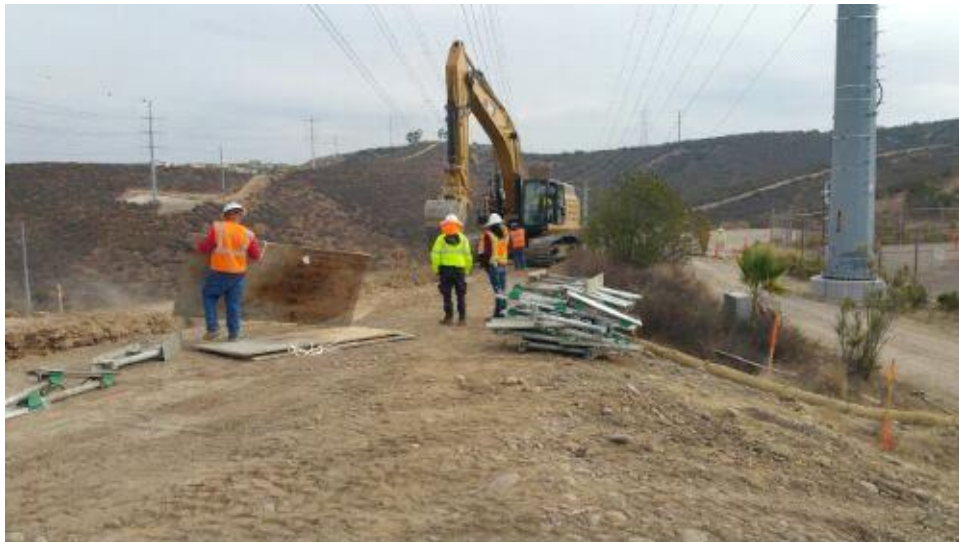
Caption Trenching at PO3 with monitors present.

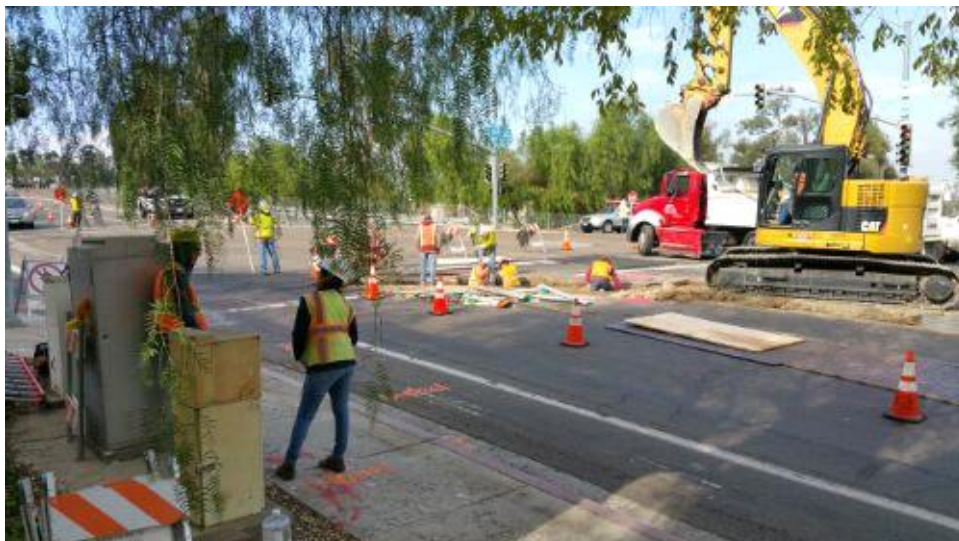
Caption Potholing with monitors present on Pomerado Road.
Photo Attributes Capture Date/Time: Sat Dec 16 2017 10:24:24 GMT-0800 (PST)
Coordinates: 32.921713, -117.062273
View Direction: Northwest

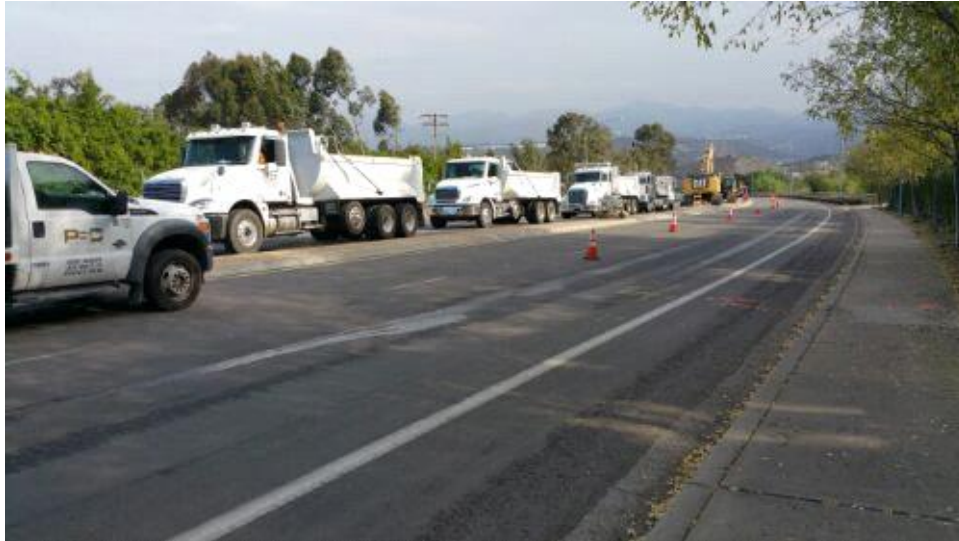
Caption Line of trucks waiting to receive excavated soil at upper Pomerado Road.
Photo Attributes Capture Date/Time: Sat Dec 16 2017 10:22:49 GMT-0800 (PST)
Coordinates: 32.921723, -117.06227
View Direction: North

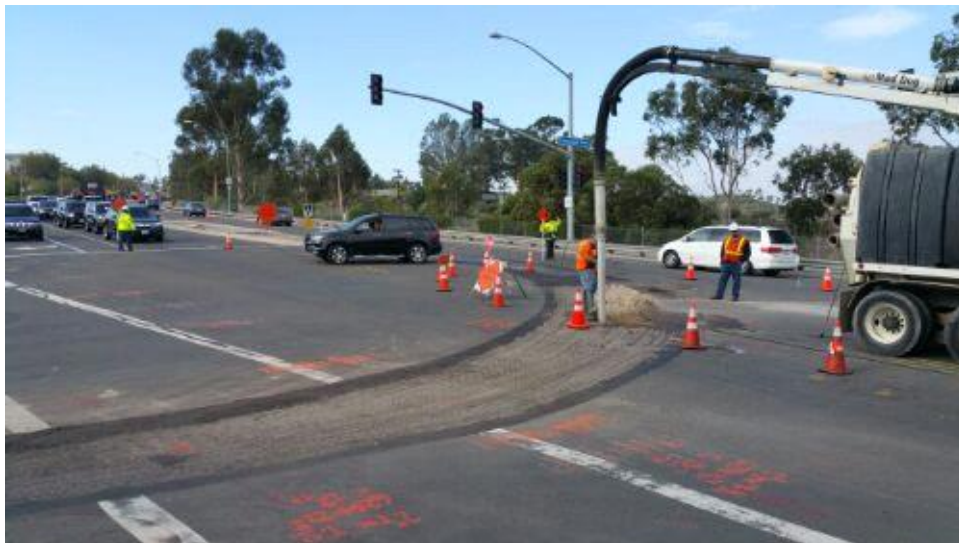
Caption Potholing and traffic control at Pomerado Road and Stonebridge Parkway.
Photo Attributes Capture Date/Time: Sat Dec 16 2017 10:16:13 GMT-0800 (PST)
Coordinates: 32.923065, -117.058891
View Direction: Southwest

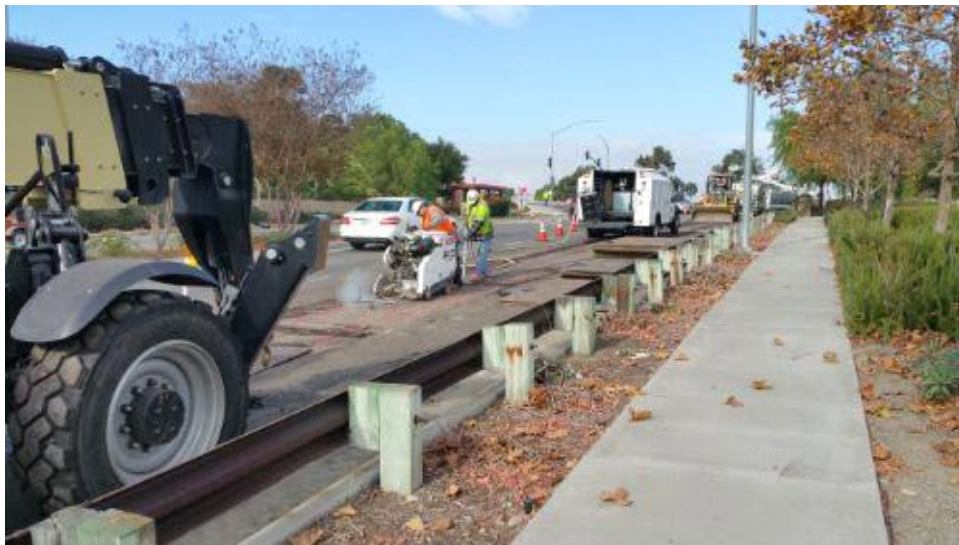
Caption Grinding pavement on Stonebridge Parkway.

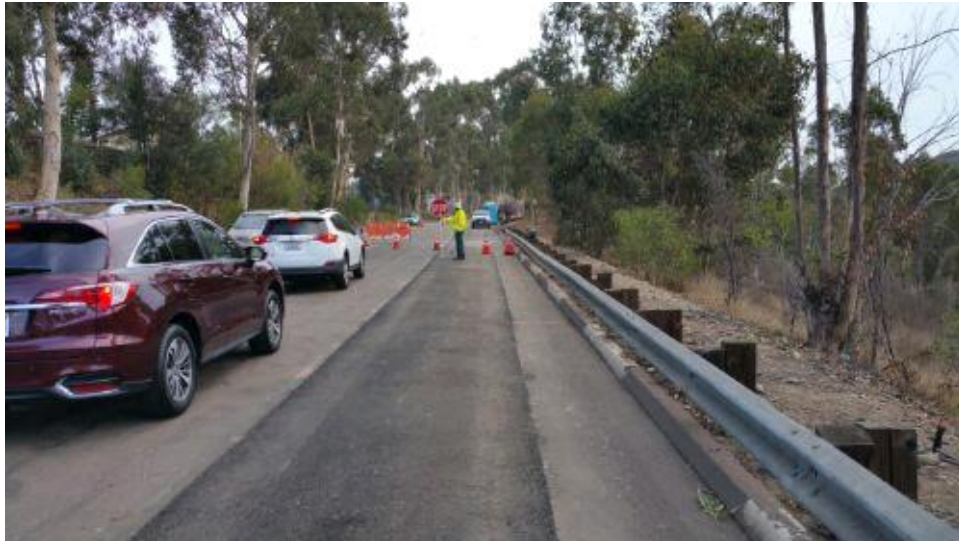
Caption Eastbound traffic control on Pomerado Road.
