## PROJECT MEMORANDUM SYCAMORE-PEÑASQUITOS 230-KV TRANSMISSION LINE PROJECT

Date: January 26, 2018  
To: Billie Blanchard, CPUC Project Manager  
From: Sheila Hoyer, CPUC Monitoring Supervisor  
Subject: Weekly Report #55 – January 15 to January 20, 2018

## SDG&E Sycamore-Peñasquitos 230-kV Transmission Line Project: Daily Inspection Report

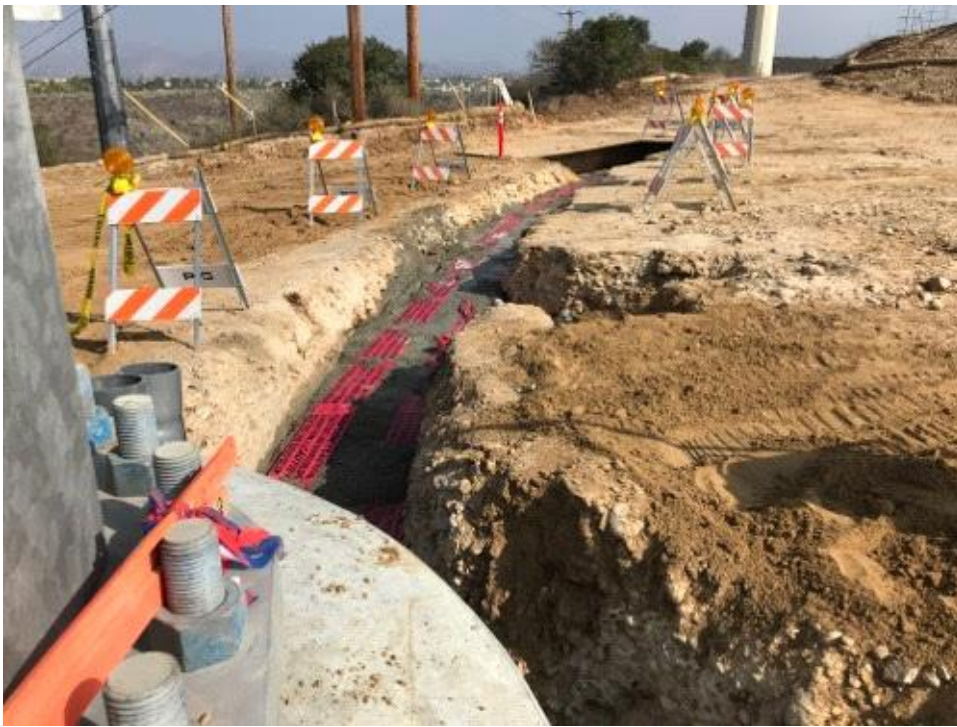
Caption Getaway at P04 with fresh slurry.

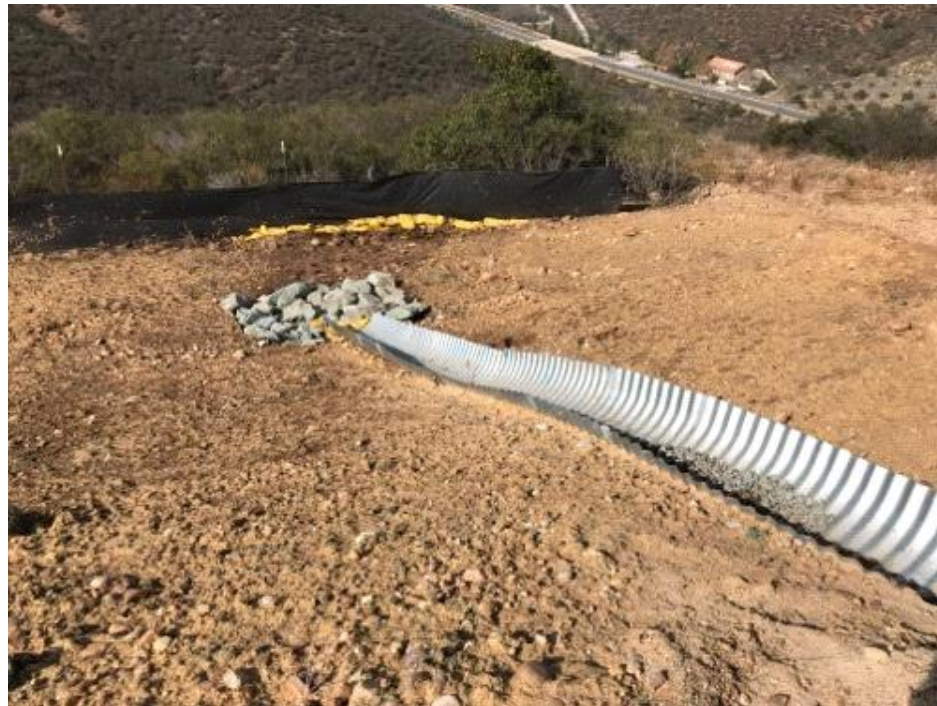
Caption McCarthy drain at P03 working well.

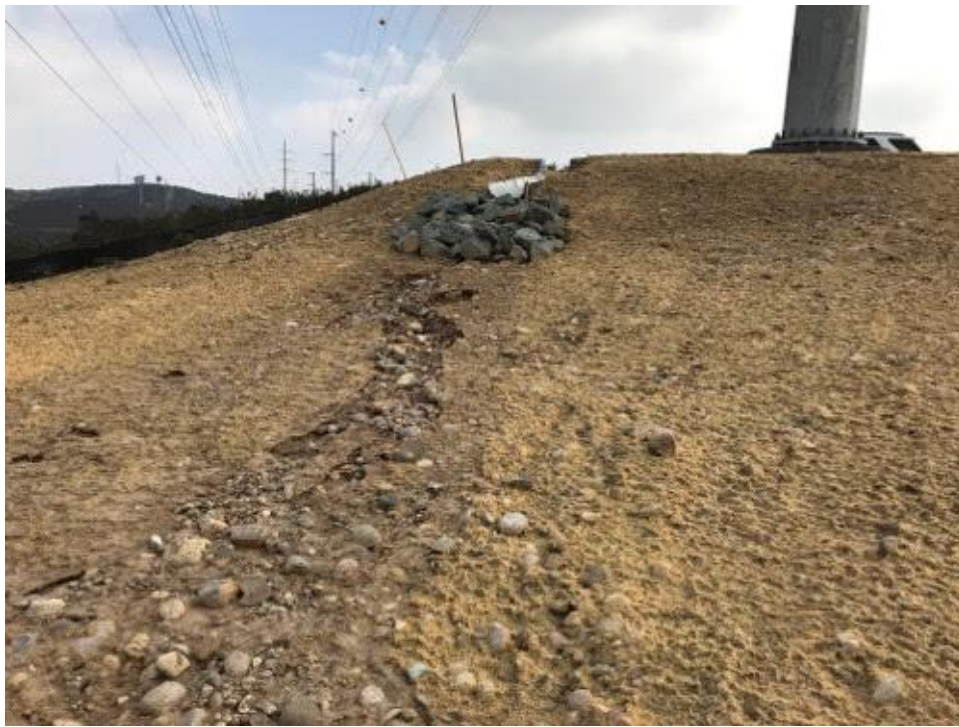
Caption Erosion below rip-rap occurring at P04.

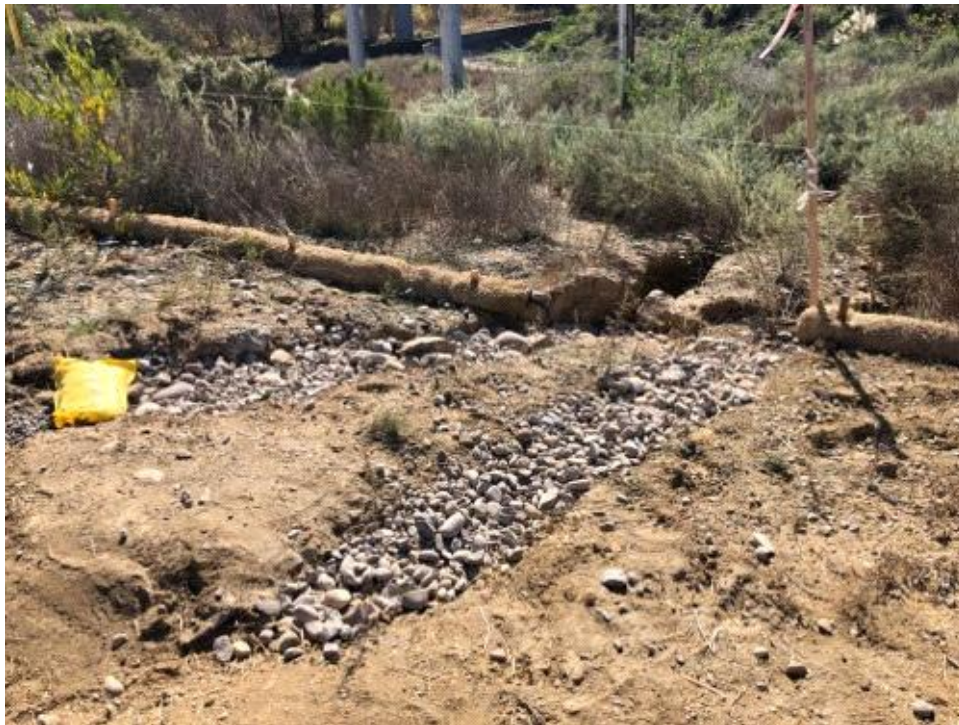
Caption Erosion north of CC MM CP pole adjacent to road.

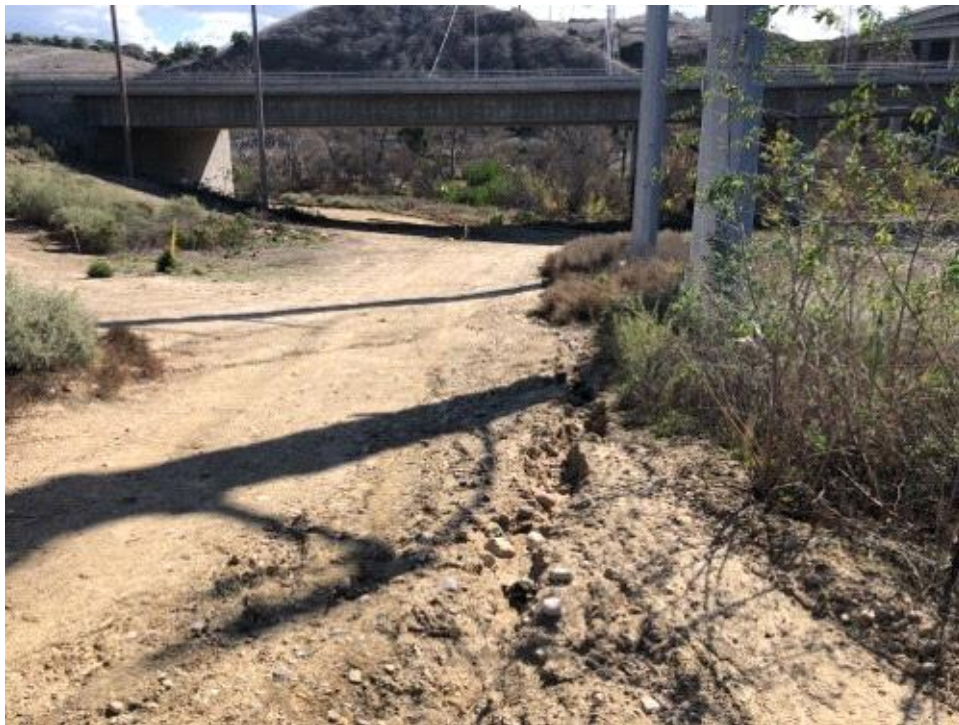
Caption Erosion on road.

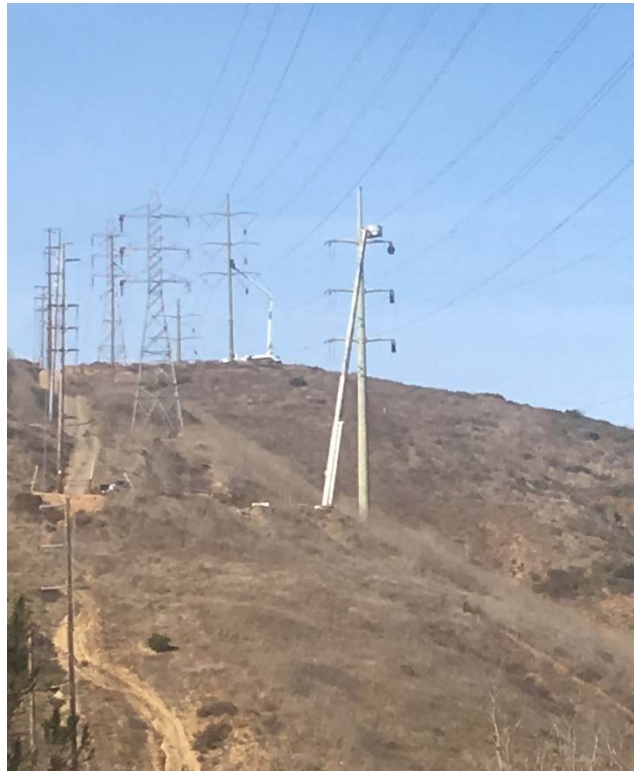
On or about January 14, 2017 the existing conductor at the top phase of a de-energized line that will eventually be replaced by the future TL23071 line fell while being held in a temporary configuration at a traveler (pulley) and steel sling hanging off the cross arm at structure E42 (Z479062). At this time we are still investigating the cause of the break, but it appears that induction on the de-energized line, traveler and steel sling arced and generated enough heat to cause the steel sling to fail, allowing the conductor to fall.

View of E42 (Z479062) where conductor break occurred

- The contractor will make sure all conductor connections are tight and bonded with the appropriate materials that will not burn through due to induced voltage.

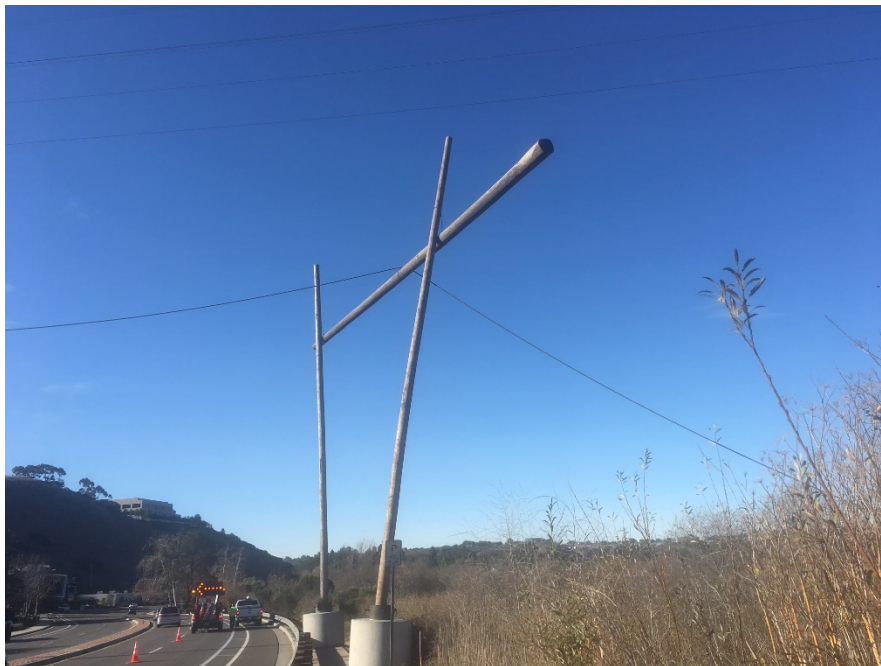
As a result of the break, the de-energized line between Penasquitos Substation and Structure E43 fell (see Attachment 1 for a visual reference). The guard structures installed at Ocean Drive Air and Sorrento Valley Blvd. caught the falling line. No damages to the surrounding streets or properties were reported.

Fallen line on guard structure located on northern side of Sorrento Valley Blvd.

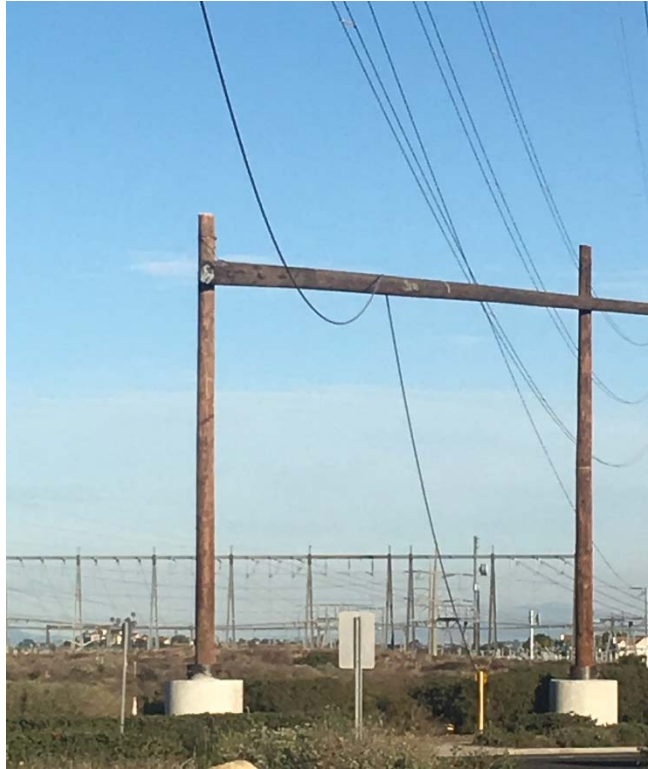
Fallen line on guard structure located on East Ocean Air Drive.

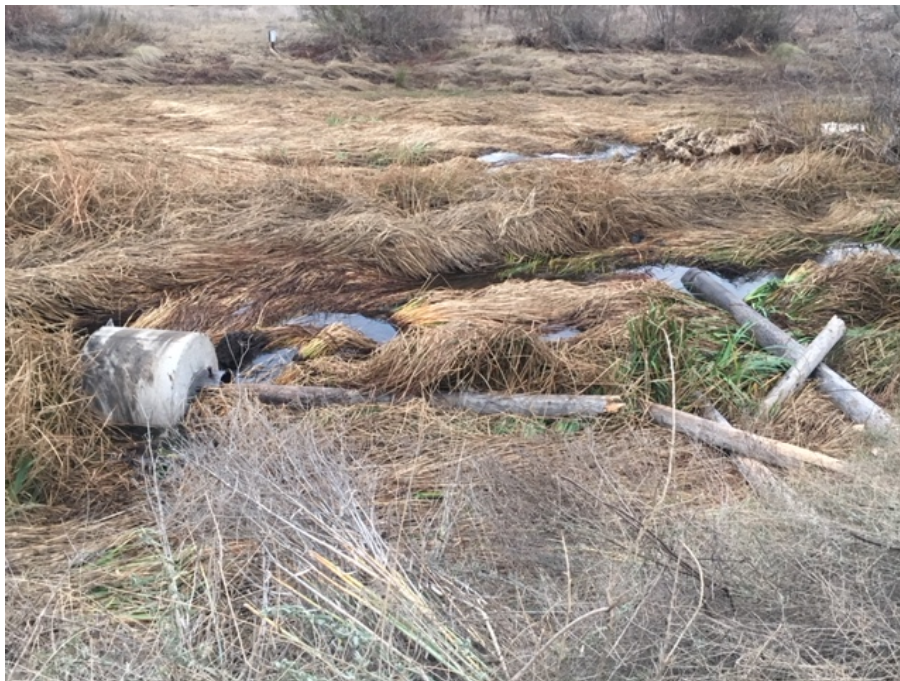
The fallen line was discovered by SDG&E's contractor the morning of January 15, 2017 and emergency crews were dispatched to fix the fallen line. The angle at which the line was pulled off the guard structures located on Sorrento Valley Blvd during repair operations caused the structures to fall over. The guard structure located on the north side of Sorrento Valley Blvd collapsed into the Los Penasquitos Creek bed and the guard structures located on the south side of Sorrento Blvd fell onto surrounding coastal sage scrub/disturbed habitat. These areas are outside of the Project's approved work limits. Efforts to retrieve the collapsed guard structures were scheduled for the following morning since a crane needed to be mobilized to pull the structures out.

North-facing view from Sorrento Valley Blvd of collapsed guard structure in Los Penasquitos Creek (before removal).

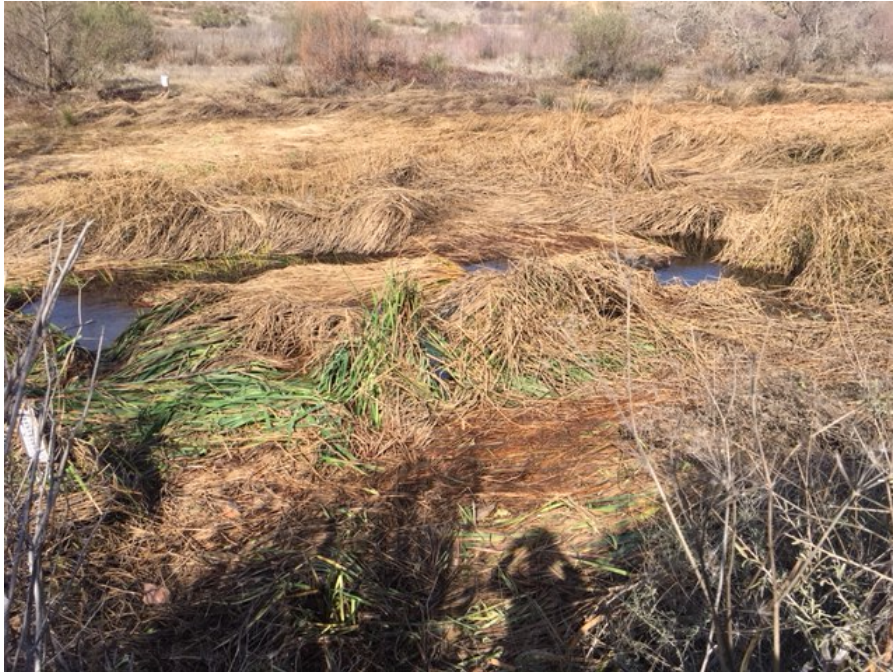
North-facing view from Sorrento Valley Blvd of collapsed guard structure in Los Penasquitos Creek (after removal)

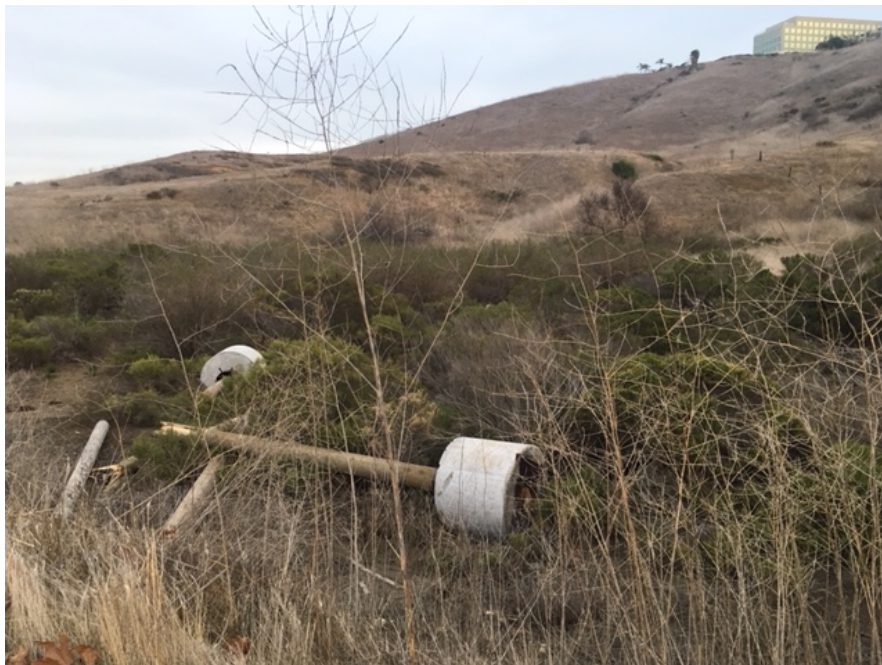
South-facing view from Sorrento Valley Blvd of collapsed guard structure (before removal).

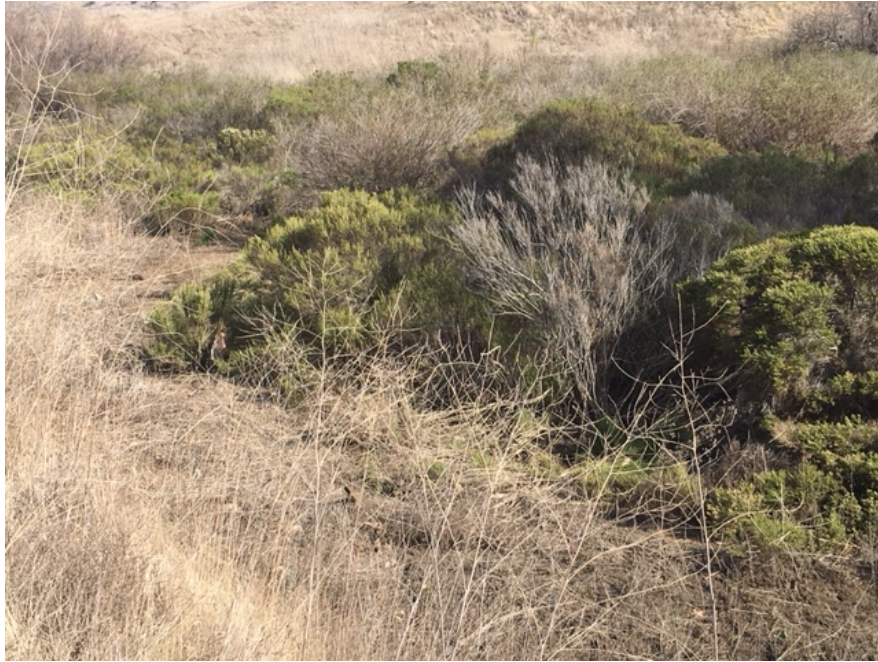
South-facing view from Sorrento Valley Blvd of collapsed guard structure (after removal).
