PROJECT MEMORANDUM SYCAMORE-PEÑASQUITOS 230-KV TRANSMISSION LINE PROJECT

Date: February 2, 2018
To: Billie Blanchard, CPUC Project Manager
From: Sheila Hoyer, CPUC Monitoring Supervisor
Subject: Weekly Report #56 – January 22 to January 27, 2018

SDG&E Sycamore-Peñasquitos 230-kV Transmission Line Project: Daily Inspection Report

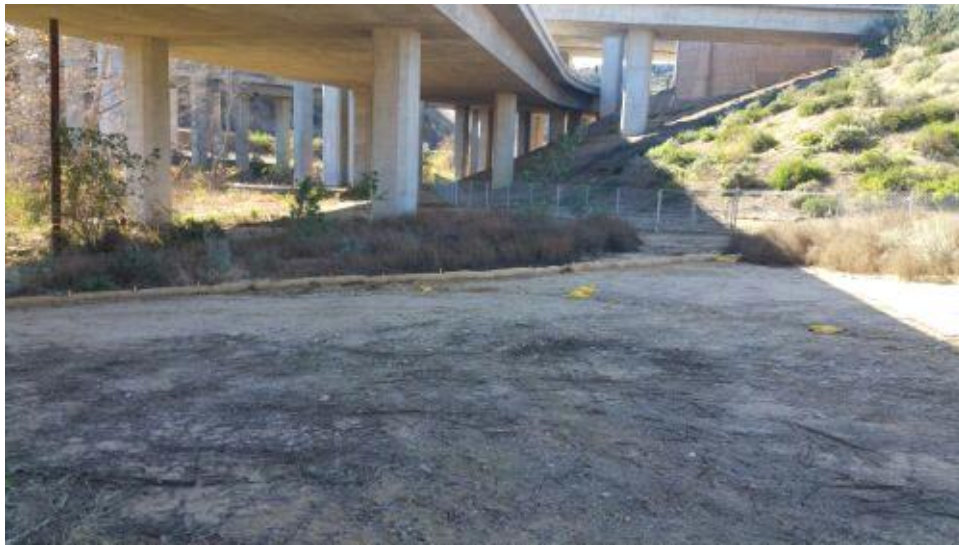
Caption Straw wattles have been extended across entire bottom of road below CC MM CP.

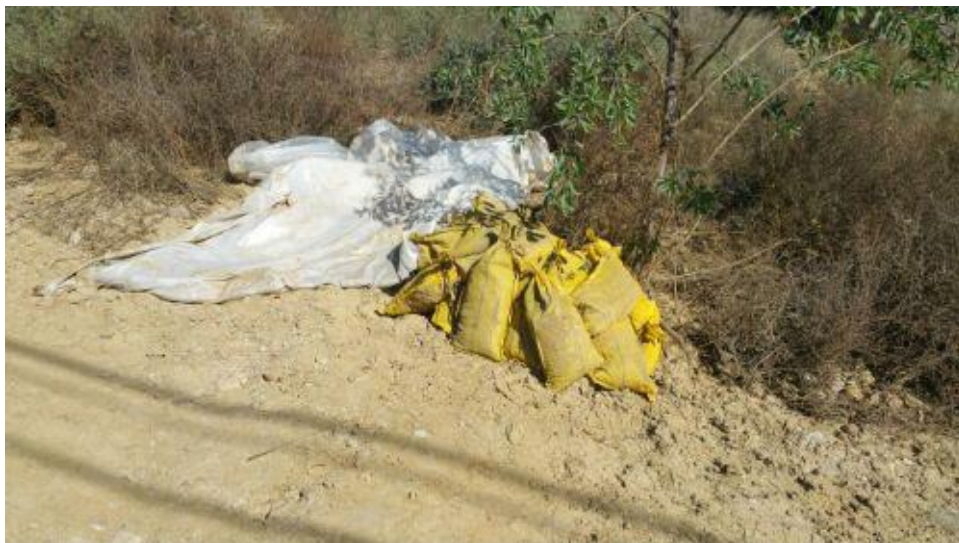
Caption Erosion control devices below CC MM CP will be deployed before next predicted rain event, per LEI.

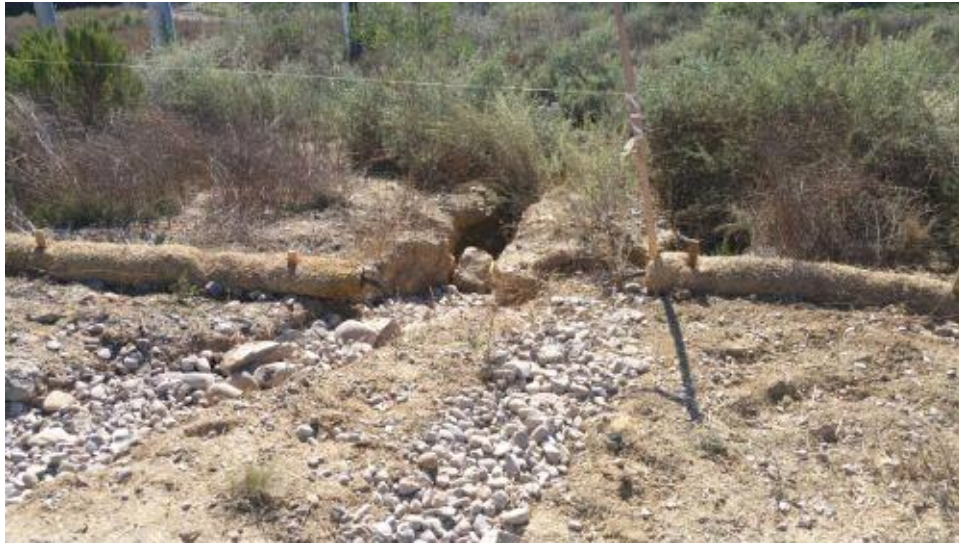
Caption Gap in straw wattles is to allow water from outflow pipe at CC MM CP to flow across work site and downslope, per LEI.

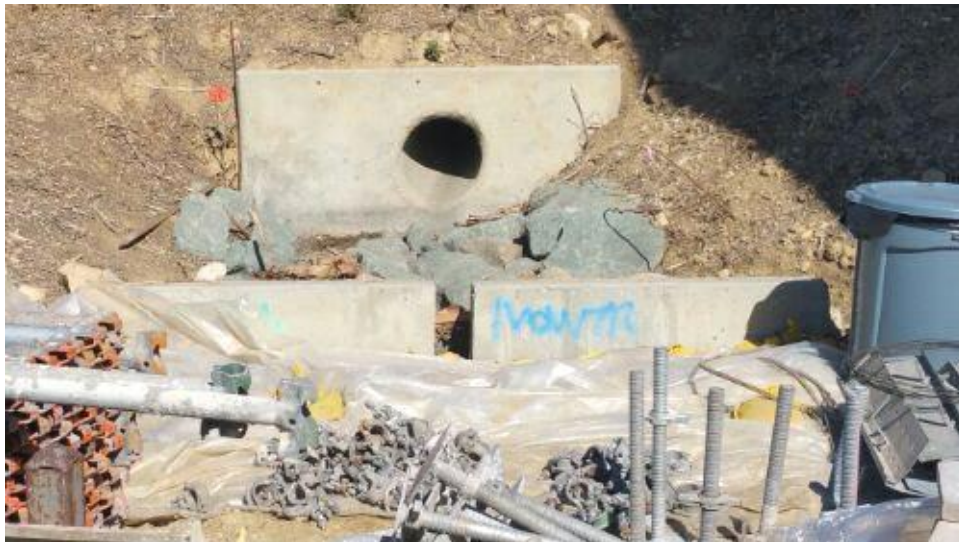
Caption Erosion control below outfall onto CC MM CP.

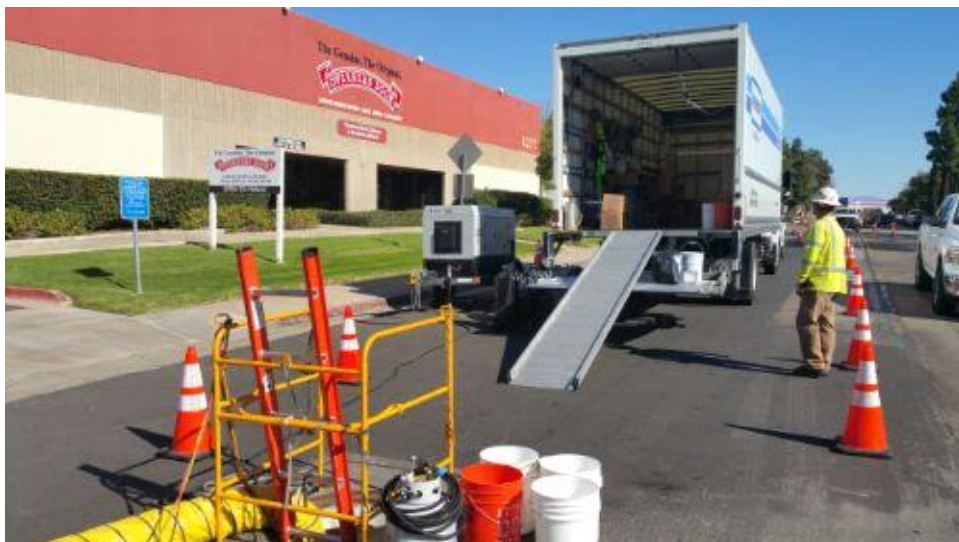
Caption Vault work on Marilani Road. Fire equipment is in back of open truck.

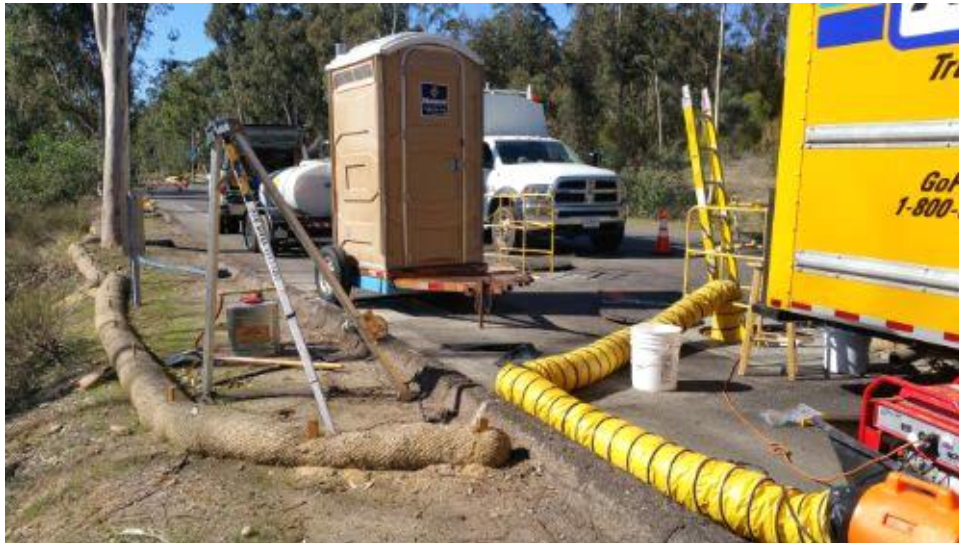
Caption Vault work site on Pomerado Road.

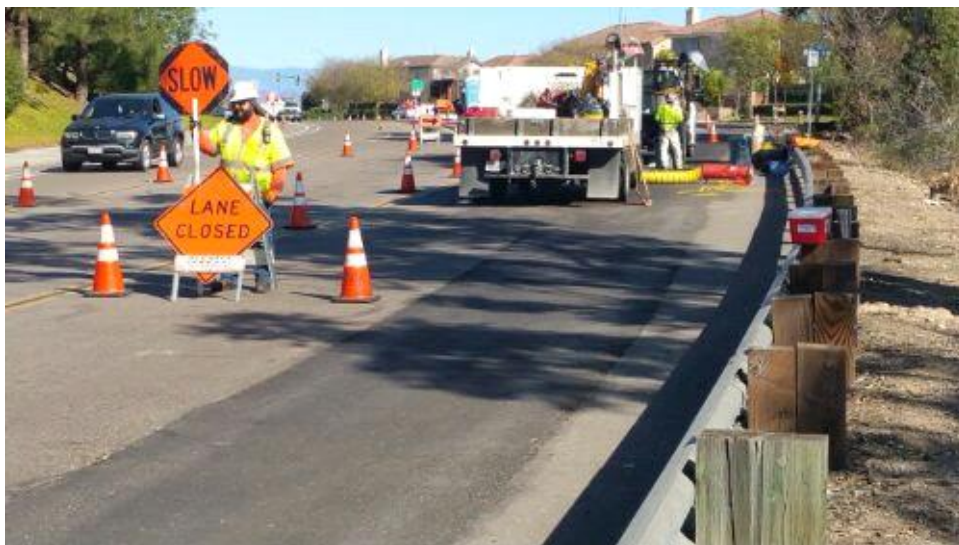
Caption Approach to work zone from west (Pomerado Road). Mandreling in background.

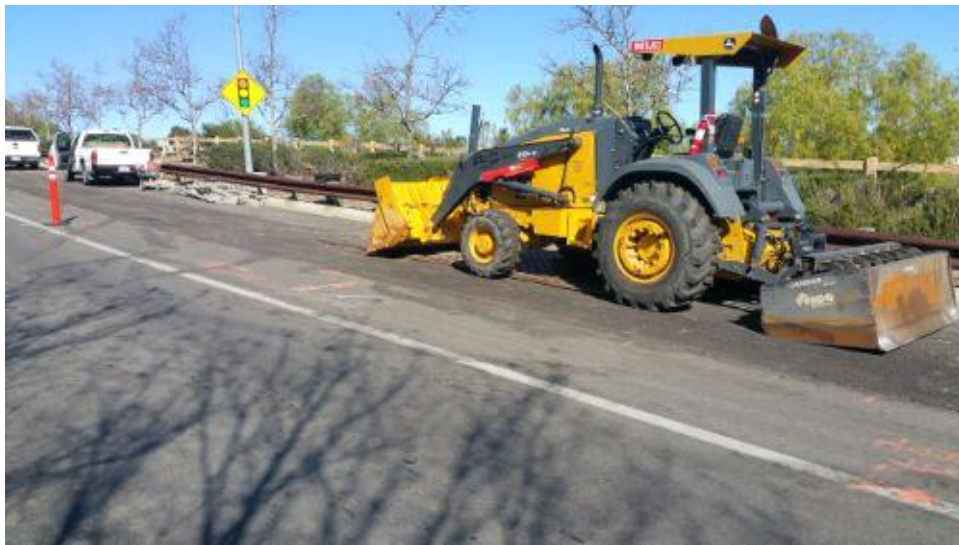
Caption Staging area on Stonebridge Parkway. Drip pan is under equipment.

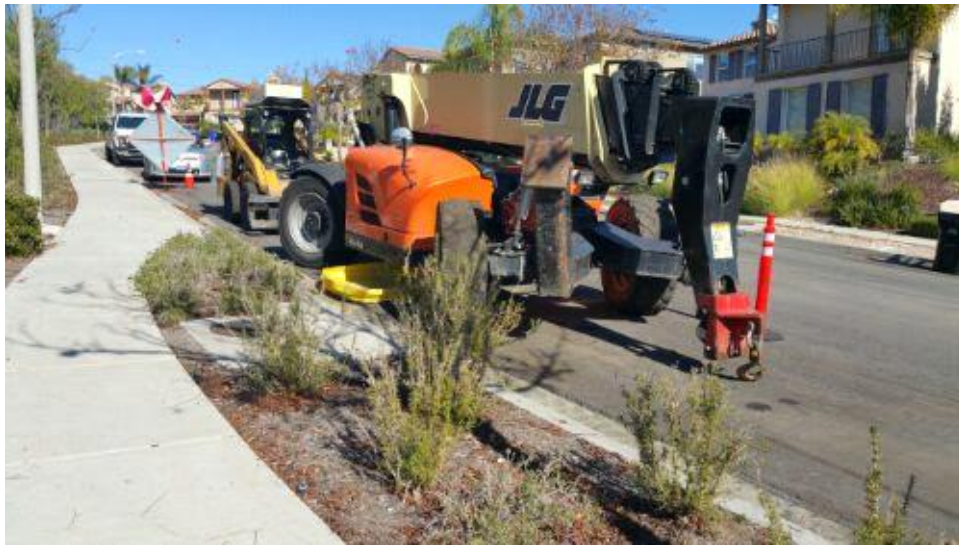
Caption Staging area on Downing Lane. (off Stonebridge Parkway), with drip pan in place.

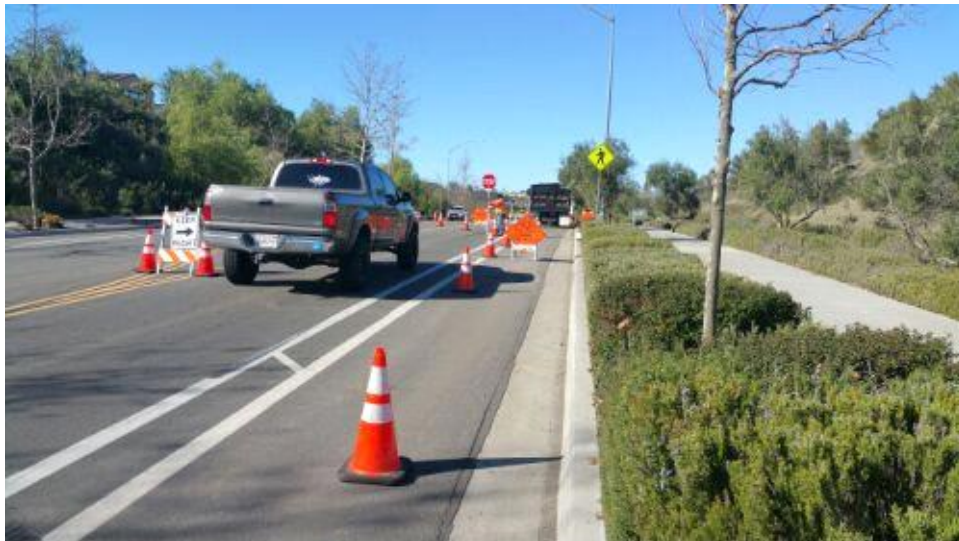
Caption Approach to work zone from east (Stonebridge Parkway).

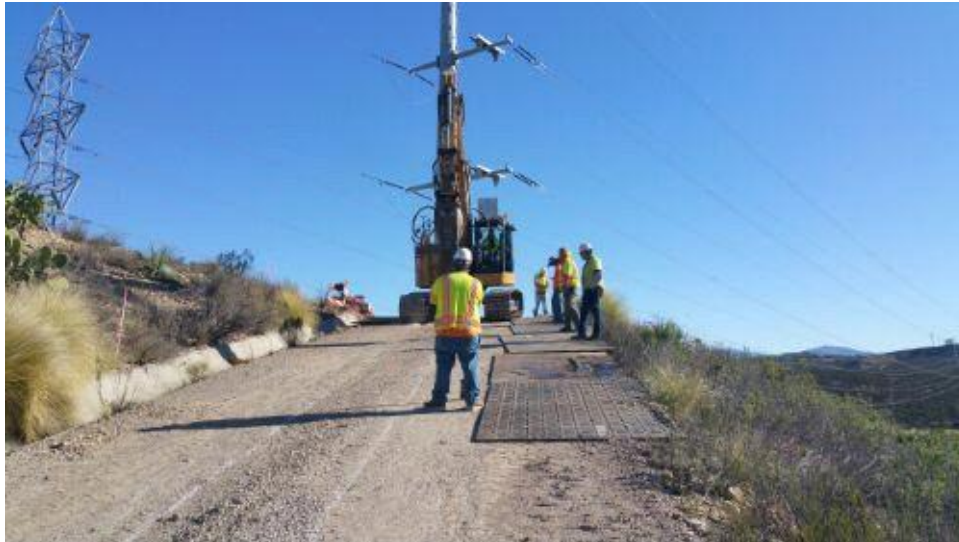
Caption Digging trench in PO5 access road.

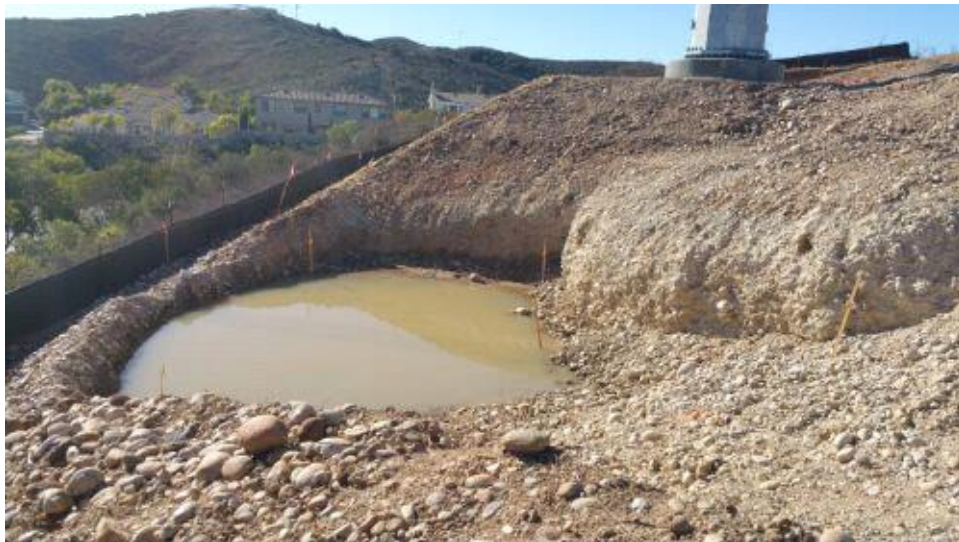
Caption Excavated area around base of PO5 is holding water.

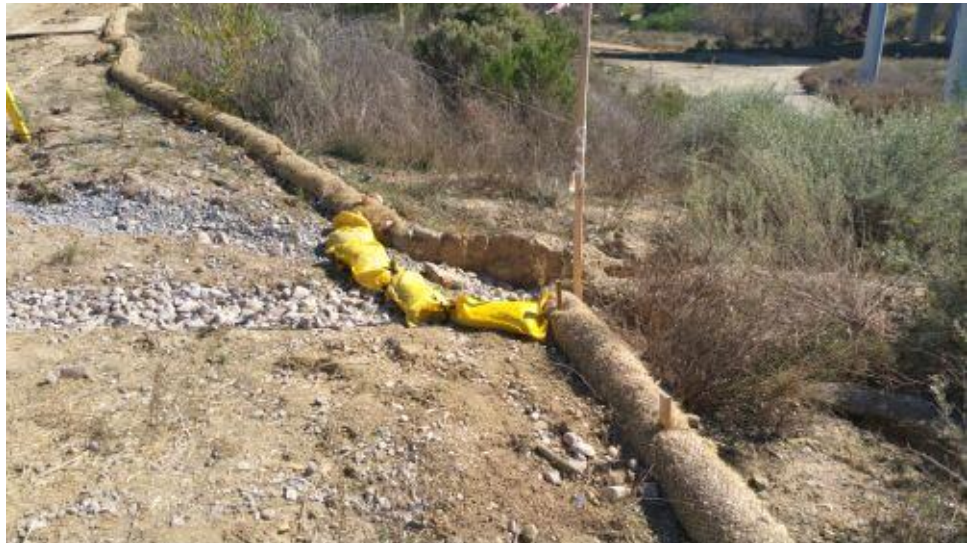
Caption Gravel bag BMP in place at CC MM CP site. See comments regarding erosion control.

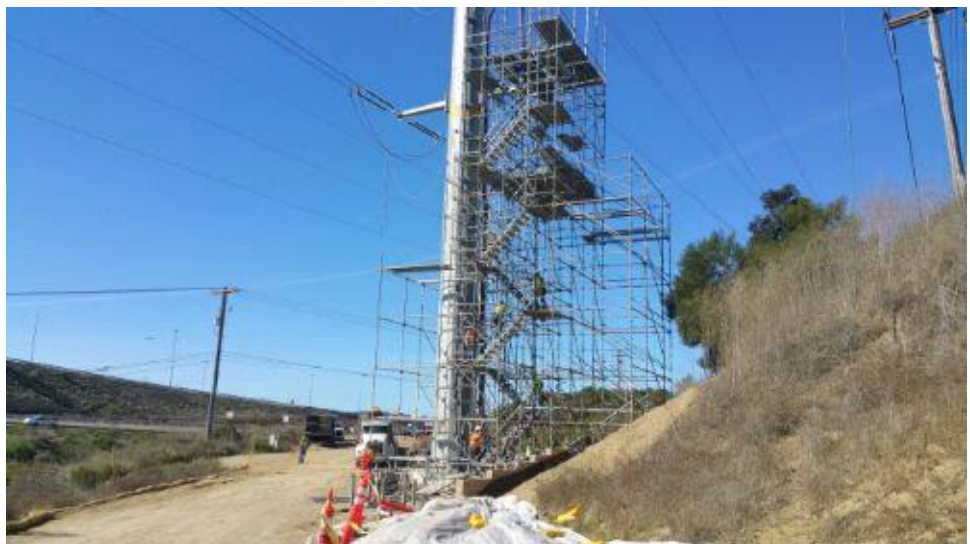
Caption Scaffolding being erected at CC MM CP site.

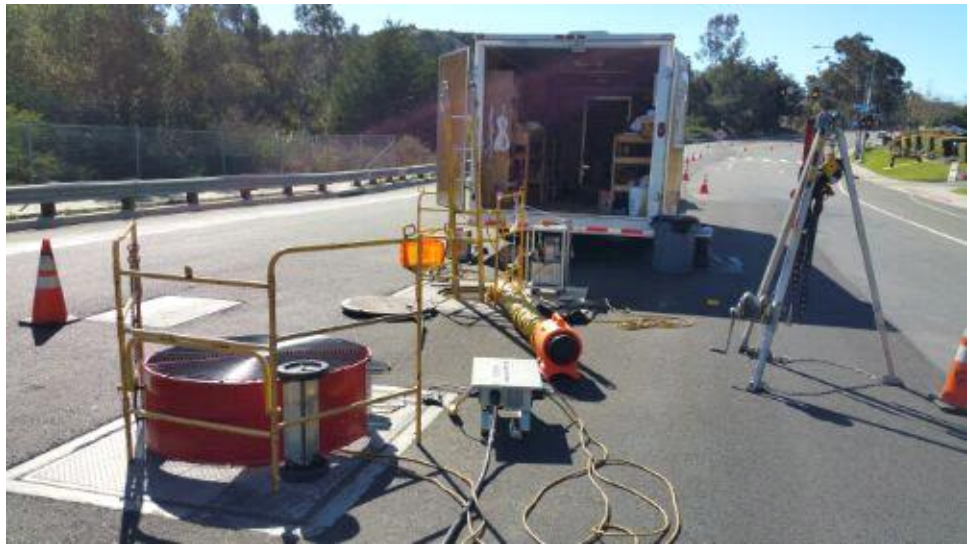
Caption Vault work site, Carroll Canyon Road.

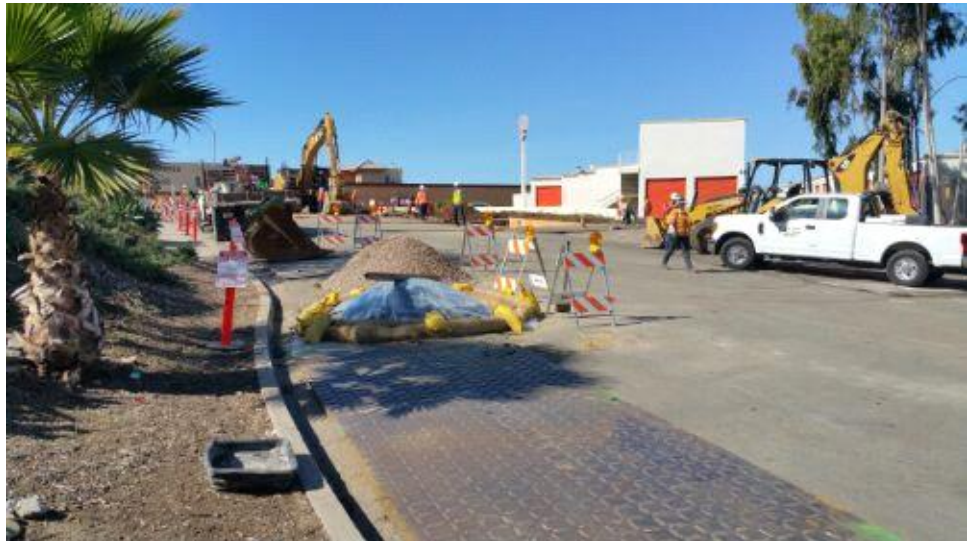
Caption Kearney Mesa Road work site, covered soil stockpile in foreground

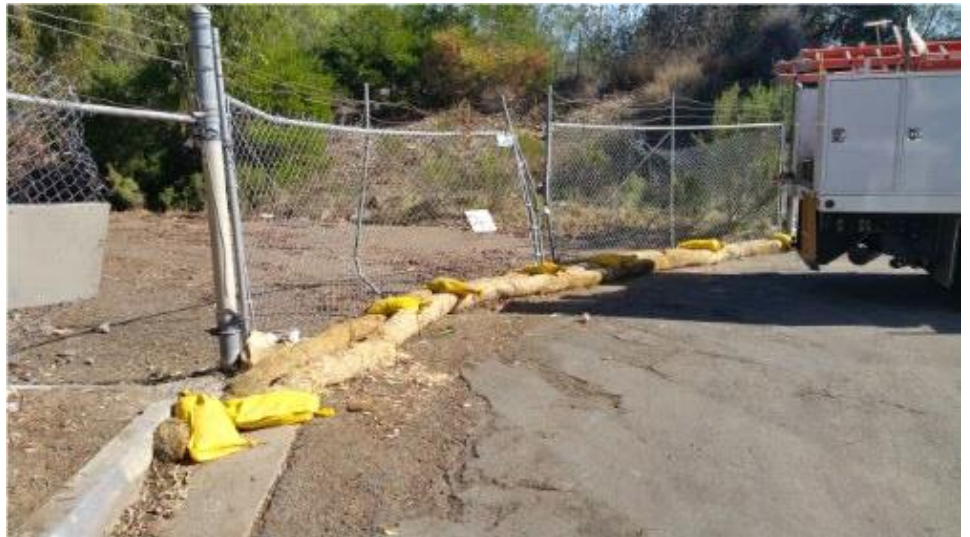
Caption Erosion controls BMPs at bottom of Kearney Mesa Road work area.

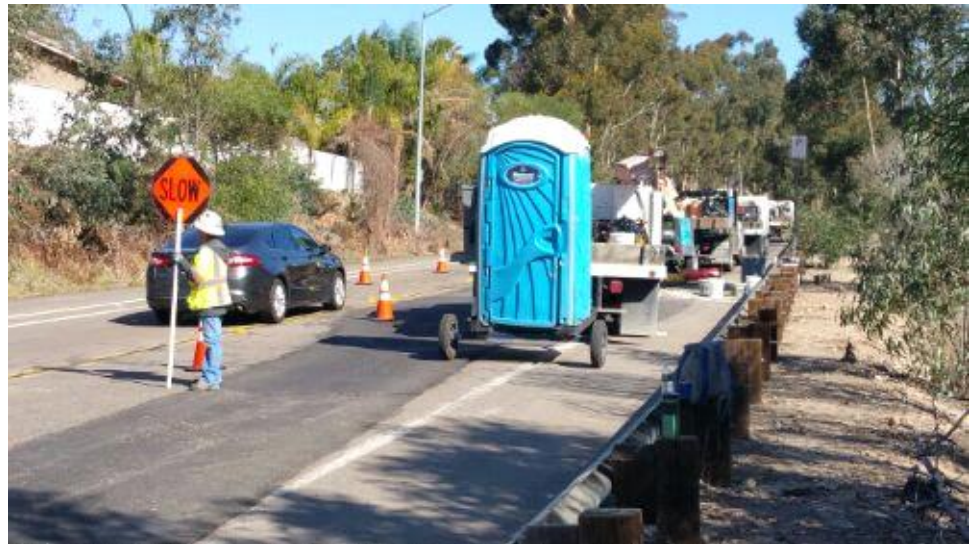
Caption Mandreling site on Pomerado Road.

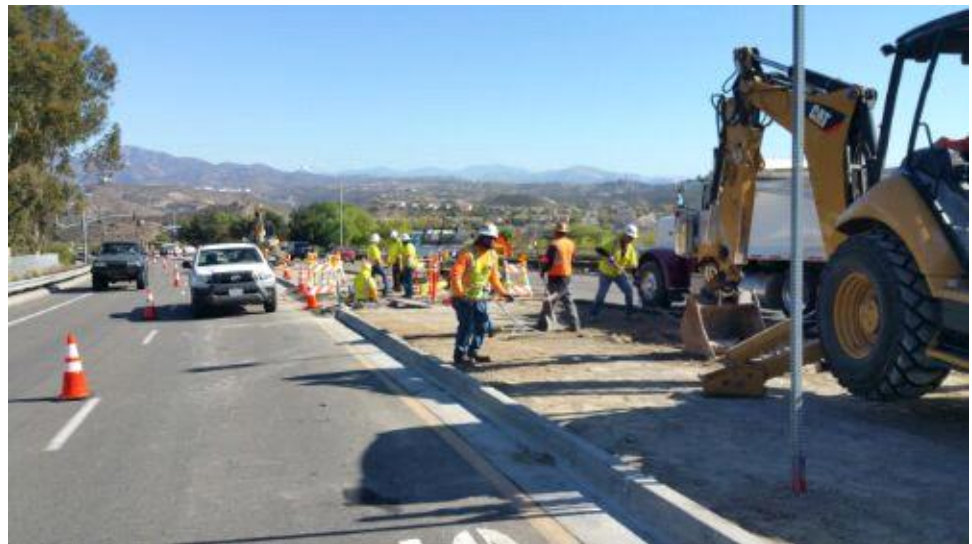
Caption Removing concrete from Pomerado Road median and mandreling.

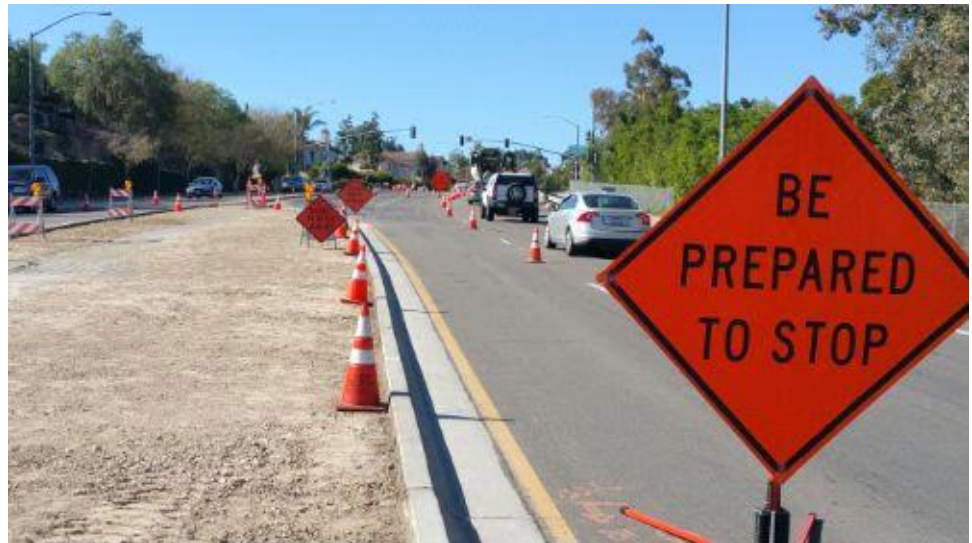
Caption Four warning signs approaching corner of Pomerado Road.

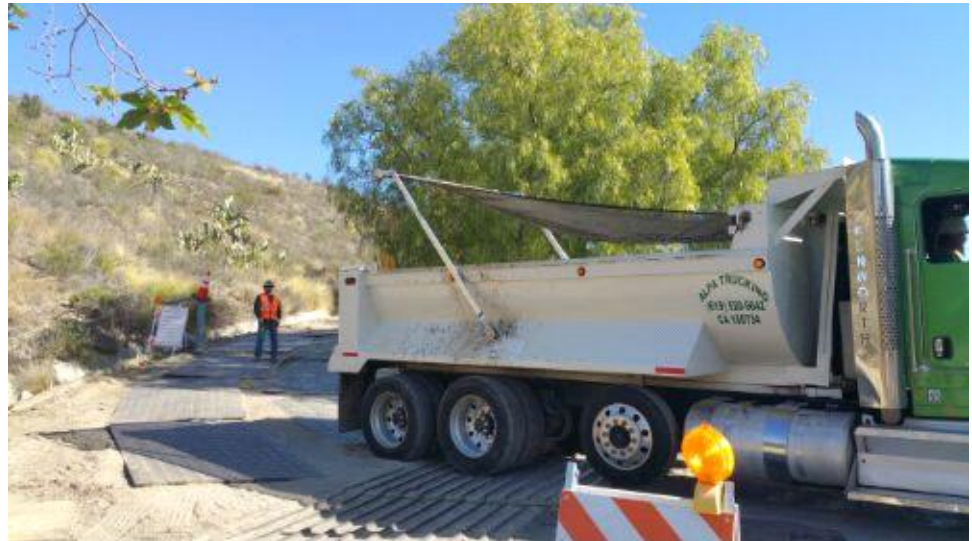
Caption Truck covering over soil being transported from PO5.

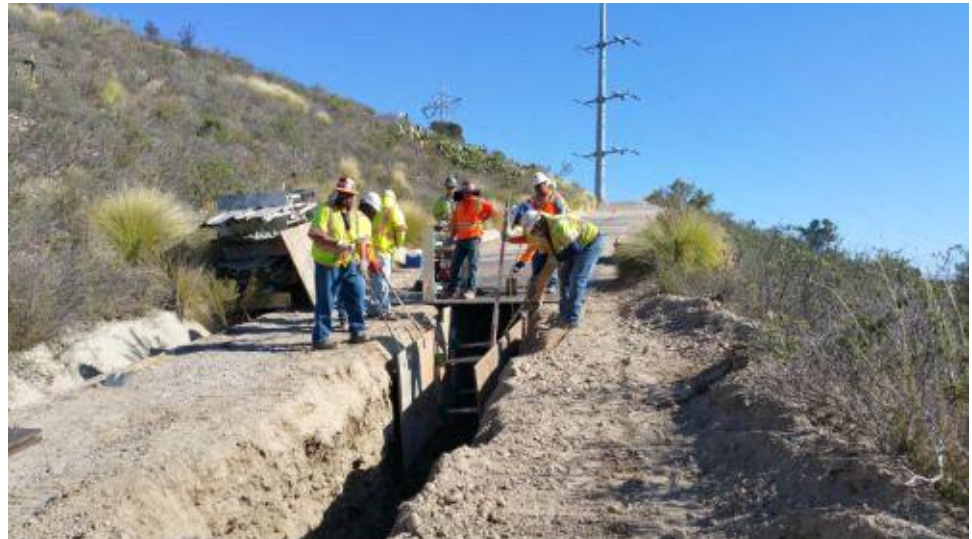
Caption Trenching in PO5 access road, 2 monitors present.
