PROJECT MEMORANDUM SYCAMORE-PEÑASQUITOS 230-KV TRANSMISSION LINE PROJECT

Date: February 9, 2018
To: Billie Blanchard, CPUC Project Manager
From: Sheila Hoyer, CPUC Monitoring Supervisor
Subject: Weekly Report #57 – January 29 to February 3, 2018

SDG&E Sycamore-Peñasquitos 230-kV Transmission Line Project: Daily Inspection Report

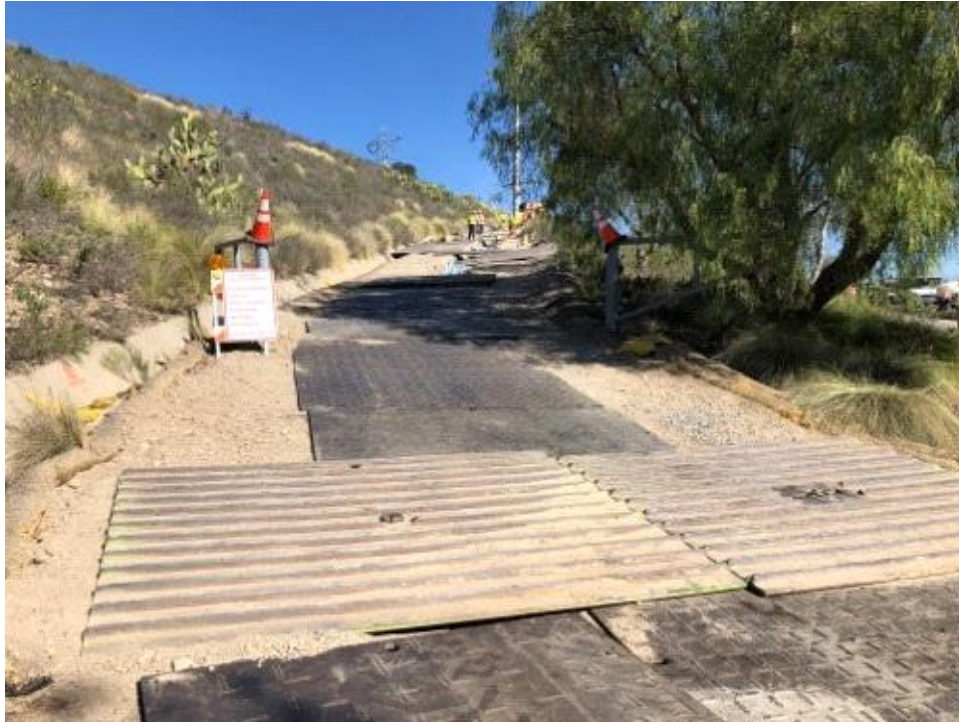
Caption Trench work to P05.

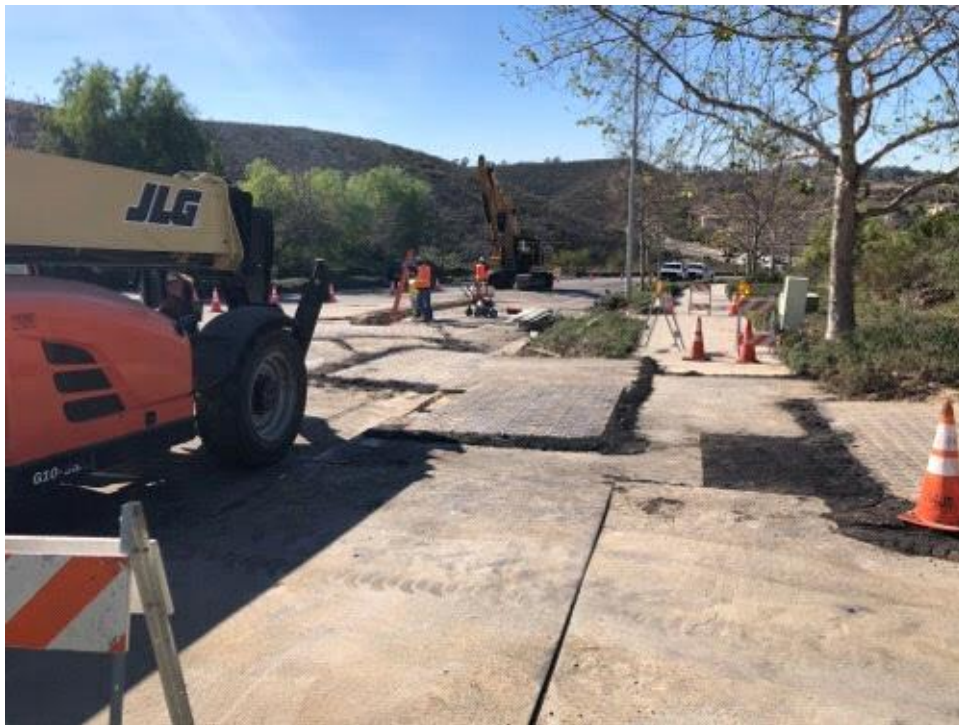
Caption Trench work on Stonebridge Parkway.

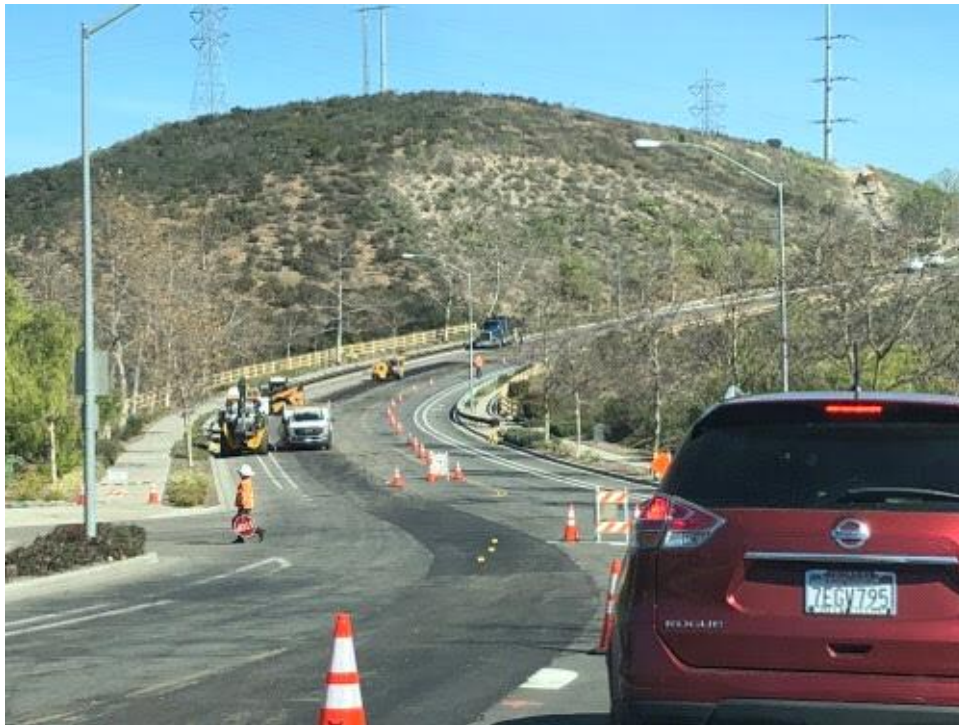
Caption Paving and traffic control on Stonebridge Parkway.

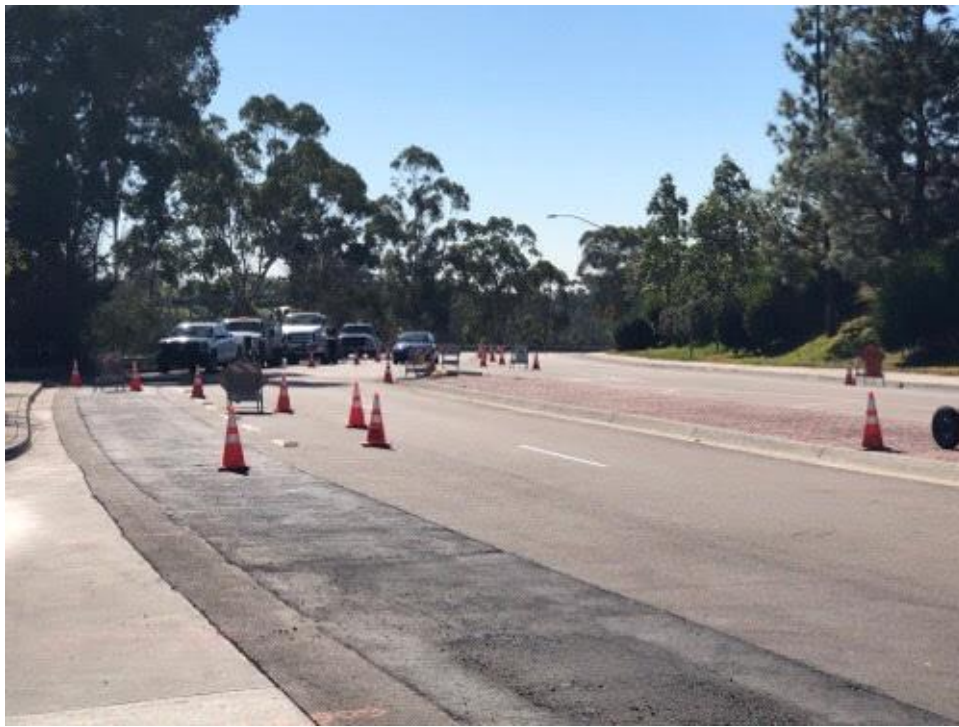
Caption Vault mandreling on Pomerado Road.

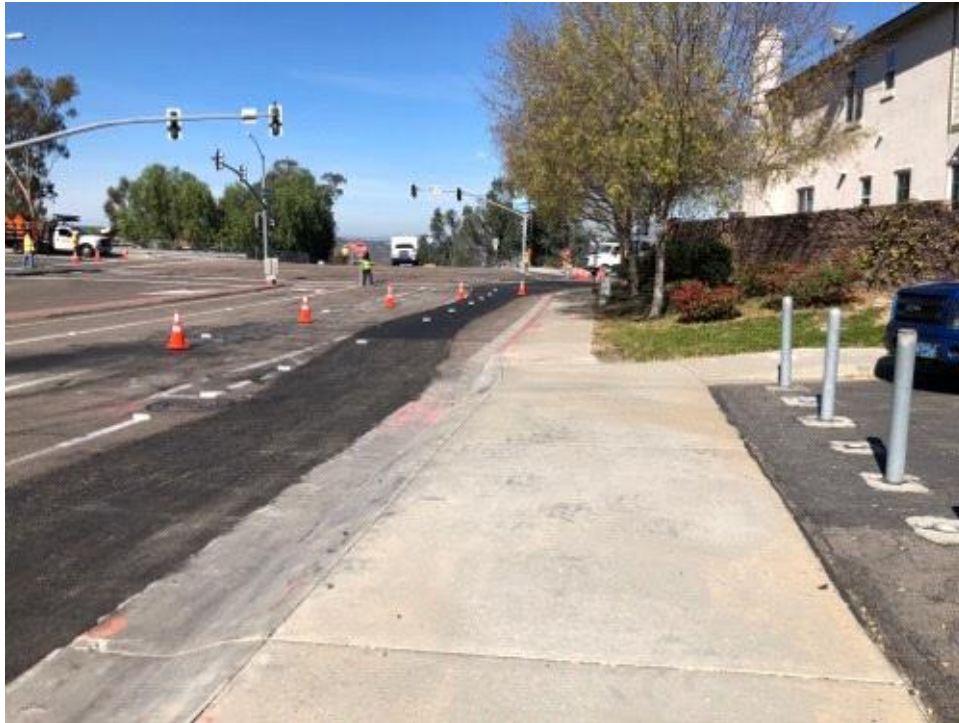
Caption Traffic control at Pomerado Road.

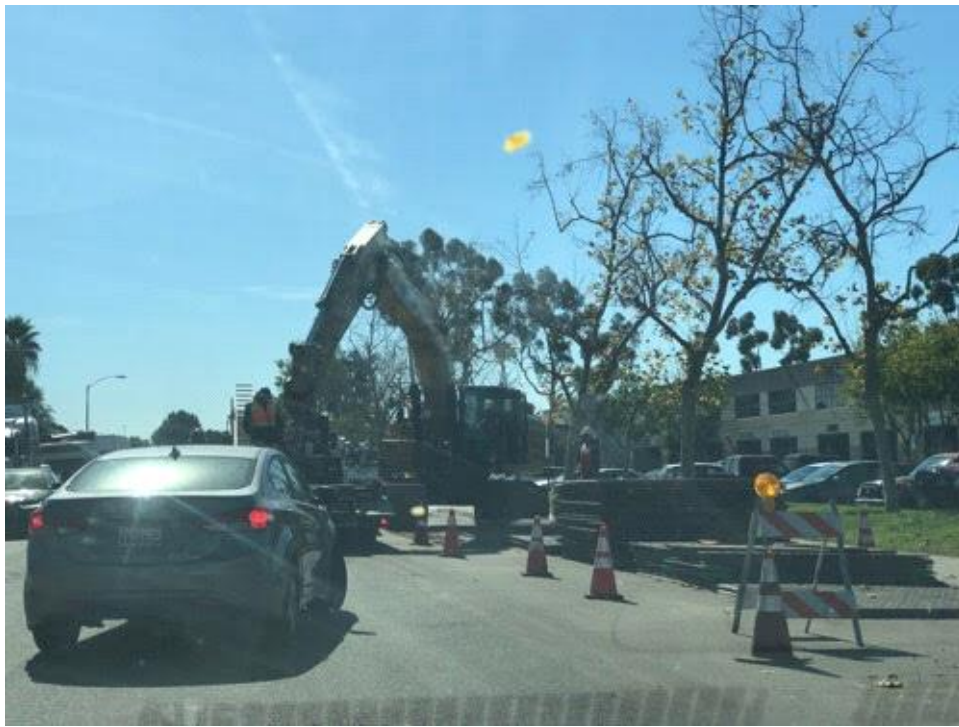
Caption Street plate storage, active traffic control in place on Padgett Street.

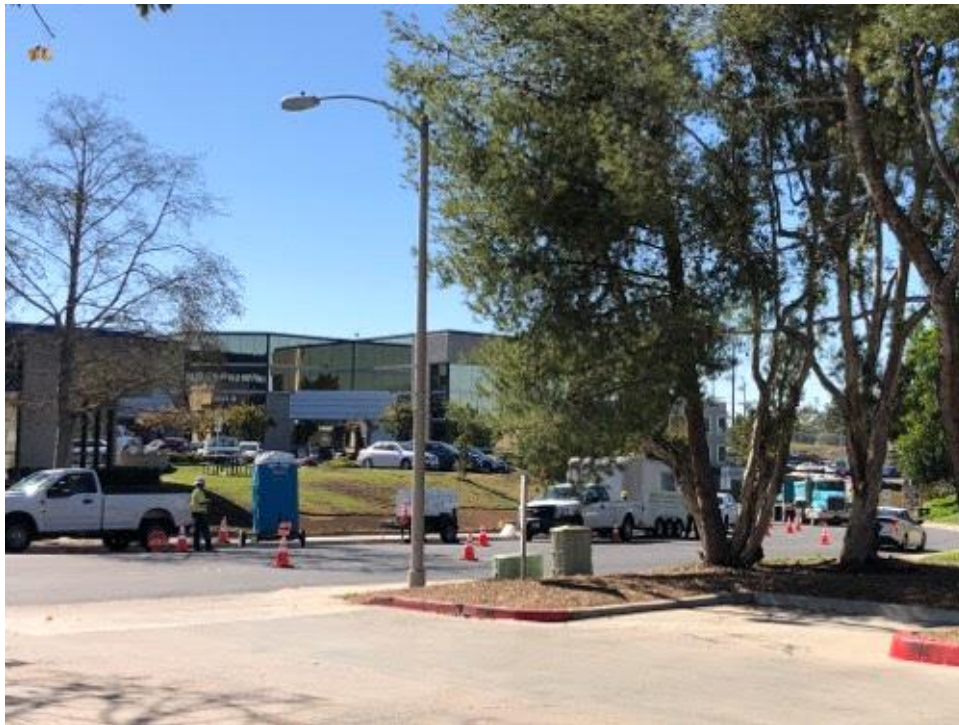
Caption Vault/cable work on Activity Road.

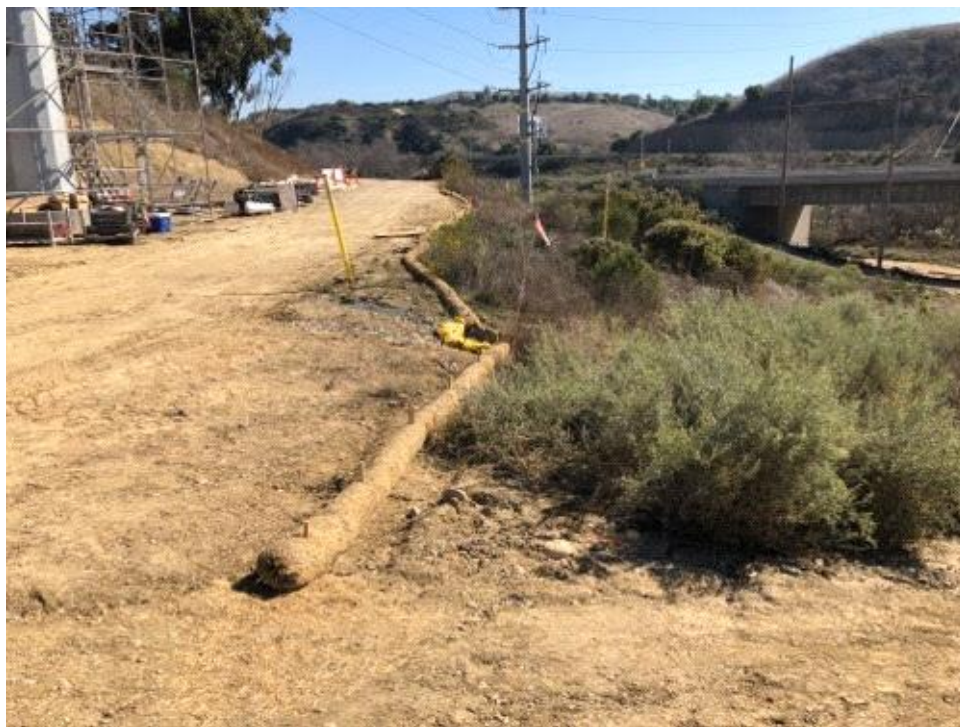
Caption BMPs in place and maintained at CC MM CP.

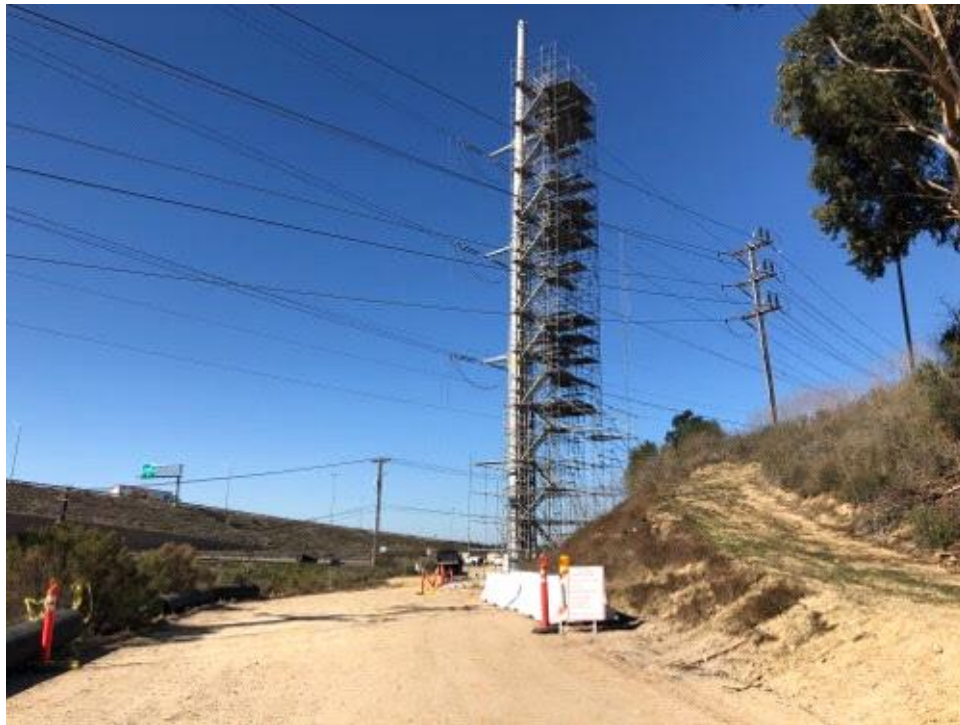
Caption CCM MCP pole and scaffolding.

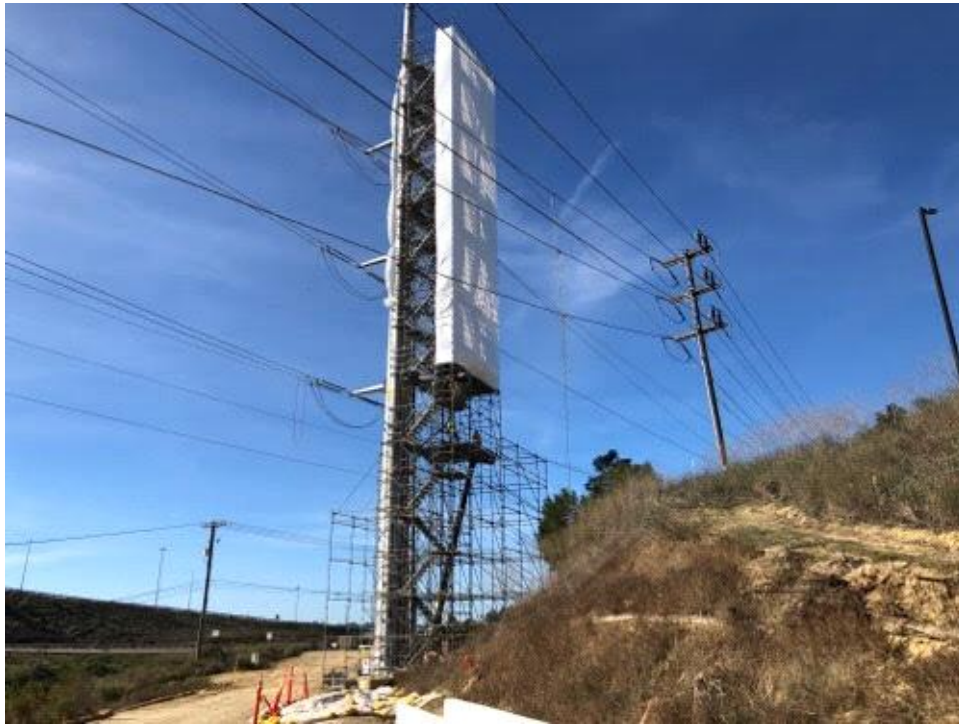
Caption CC MM CP with tarp on east side.

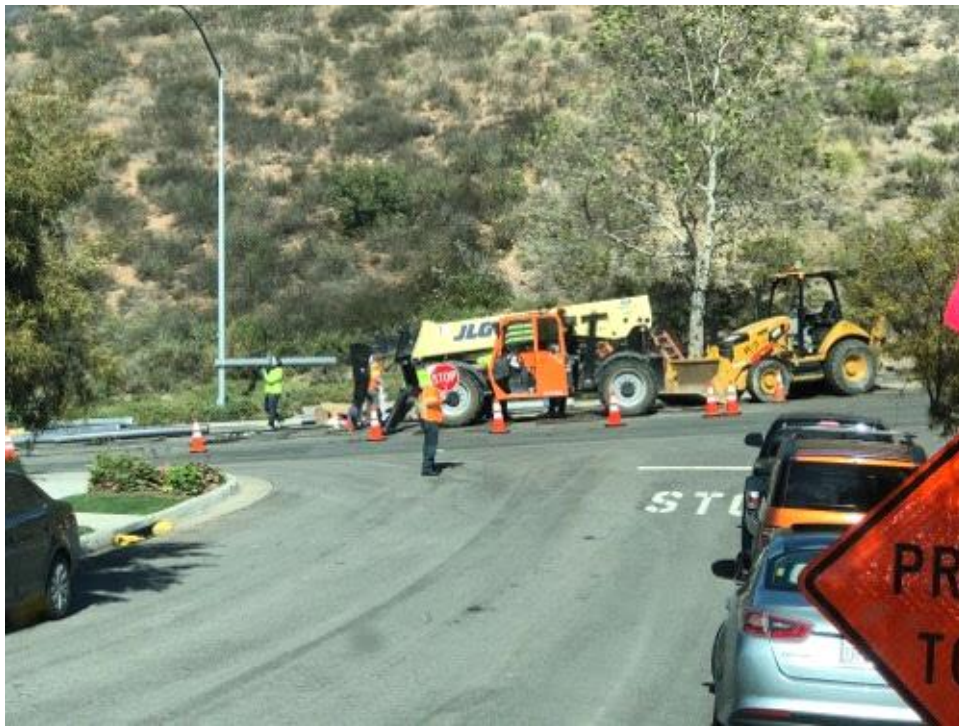
Caption Trench work and traffic control on Stonebridge Parkway.

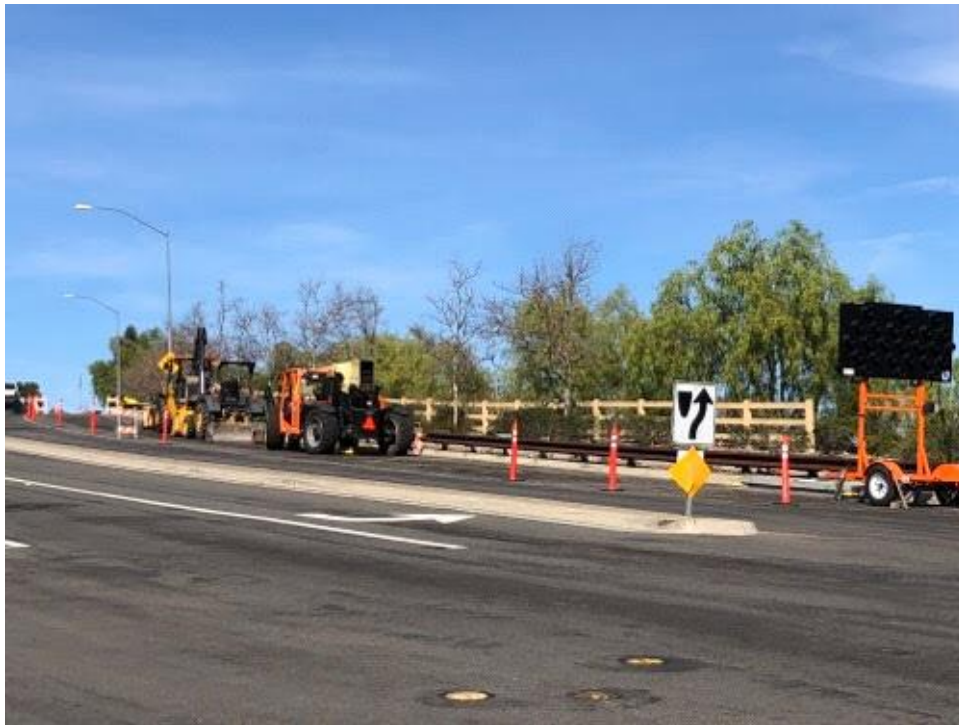
Caption Equipment storage Stonebridge Parkway.

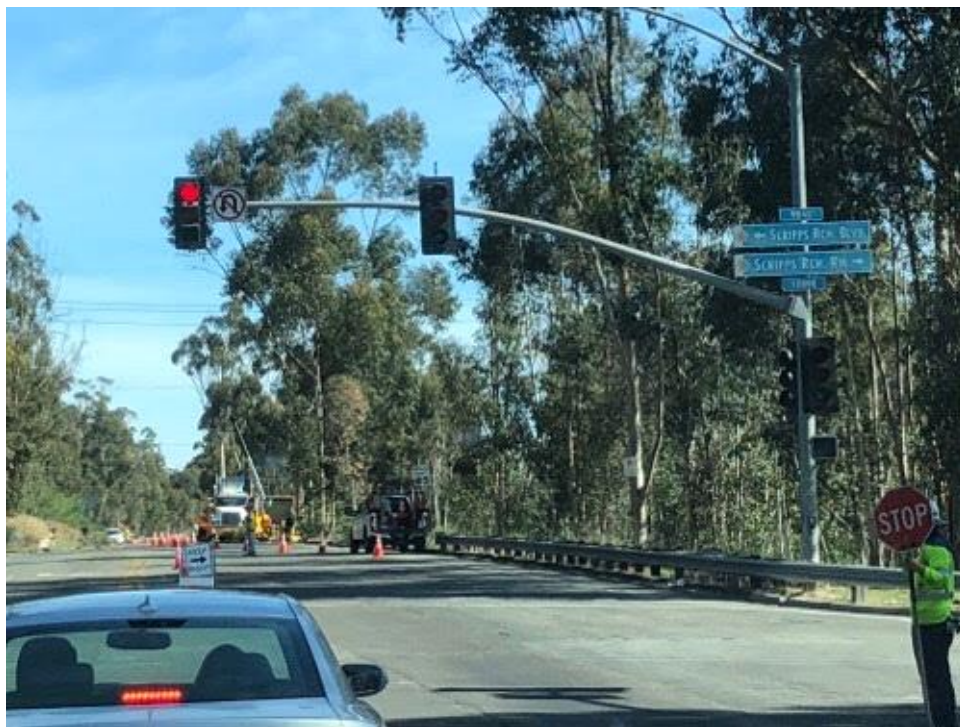
Caption Cable installation on Pomerado Road.
