## PROJECT MEMORANDUM SYCAMORE-PEÑASQUITOS 230-KV TRANSMISSION LINE PROJECT

Date: March 05, 2018  
To: Billie Blanchard, CPUC Project Manager  
From: Sheila Hoyer, CPUC Monitoring Supervisor  
Subject: Weekly Report #60 – February 19 to February 24, 2018

# 2018-02-20 AM Inspection Report

# 2018-02-23 AM Inspection Report

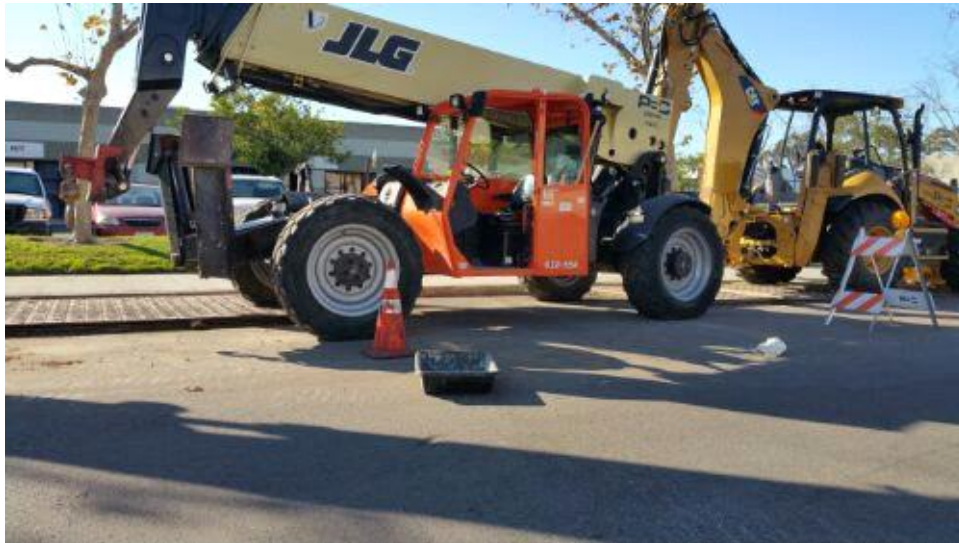
Caption Drip pan not beneath ARB 26501 on Padgett Road.

Q6 – Water Features and Aquatic Habitat: Were water features avoided?	Met Requirements
Q7 – Stormwater, Erosion, and Sediment Control: (a) Were erosion and sediment control BMPs in place and functioning properly? (b) Were inactive or completed work areas stabilized and/or restored adequately?	Corrections Required
Q7 Notes	Two straw wattles appear to have been run over (Pomerado Road at station 439+00). LEI was informed and will have them repaired.
Q8 – Invasive Weed Control: Were procedures to prevent the spread of invasive weeds implemented adequately?	Met Requirements
Q9 – Hazardous Materials and Waste Management: (a) Were hazardous materials stored and labeled properly? (b) Was hazardous material waste disposed of appropriately? (c) Were any spills or leaks addressed adequately? (d) Was solid waste collected and disposed of adequately?	Met Requirements
Q9 Notes	Drip pan not in place beneath one piece of equipment in Padgett Street staging area. More care in placement or something to weigh down pan (it was windy) is needed. No leak. LEI informed.

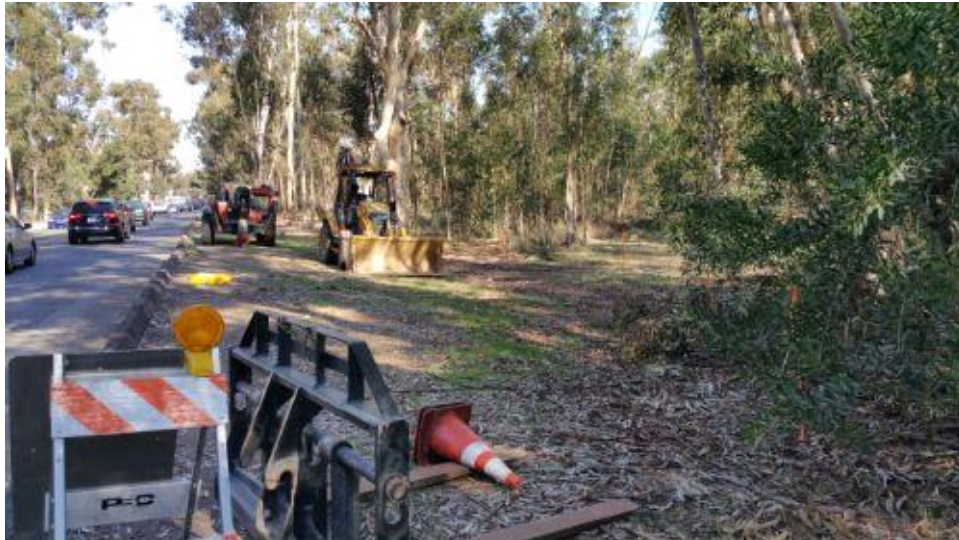
Caption Staging area with limits staked on Pomerado Road.

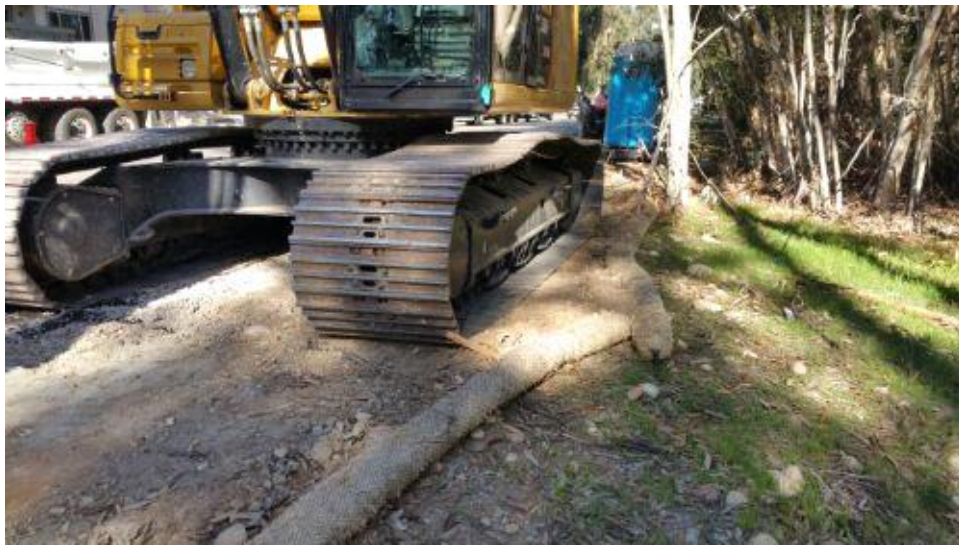
Caption Straw wattles damaged on Pomerado Road, about station 439+00.

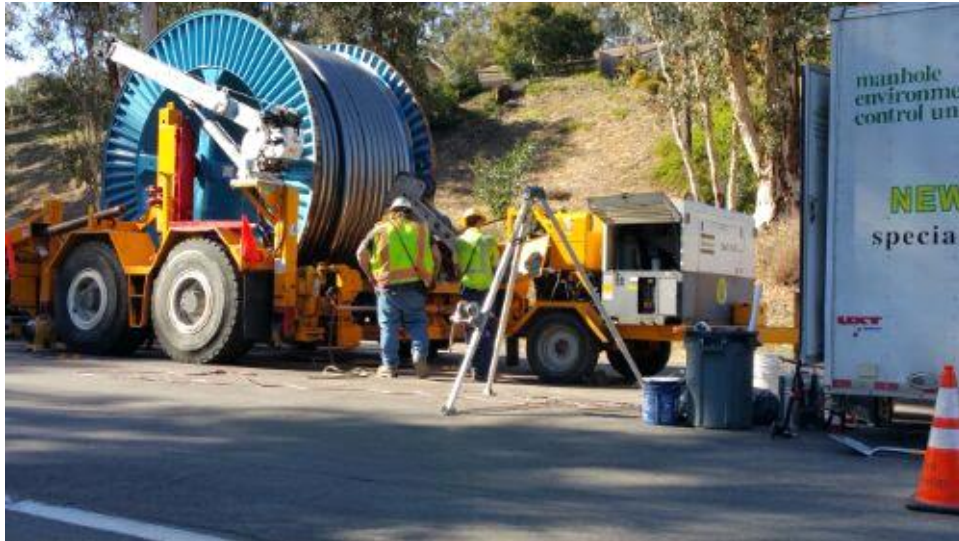
Caption Stringing cable on Pomerado Road.

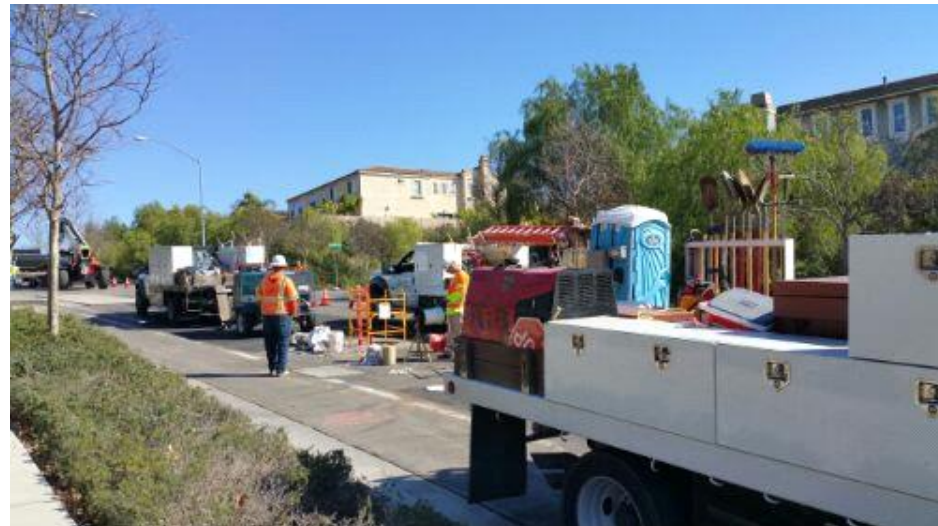
Caption Mandreling site on Stonebridge Parkway.

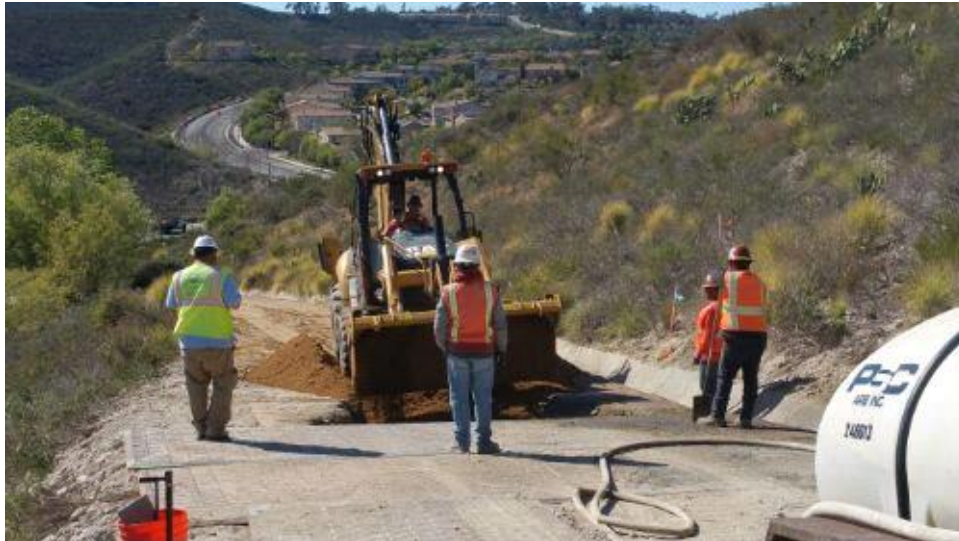
Caption Filling trench at PO5 access road.

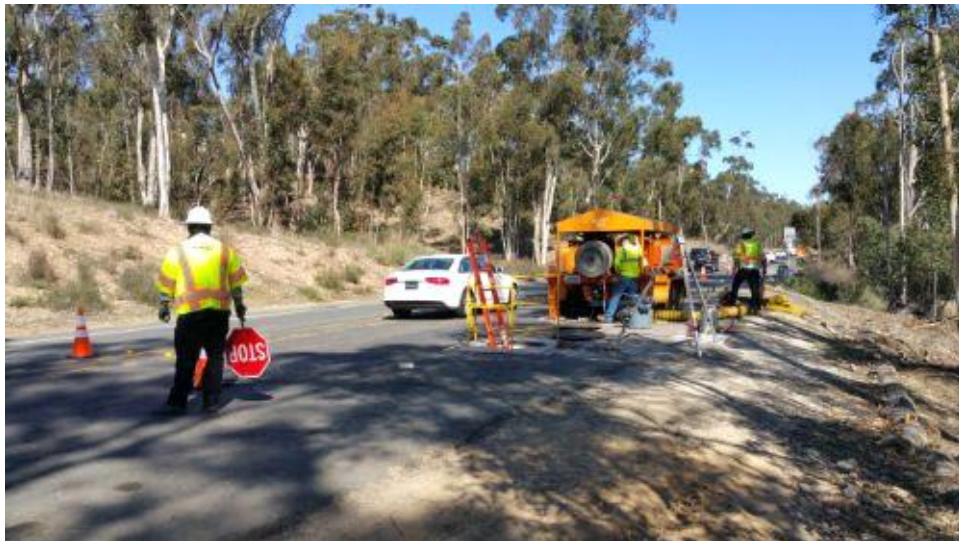
Caption Mandreling and cable pulling on Pomerado Road.

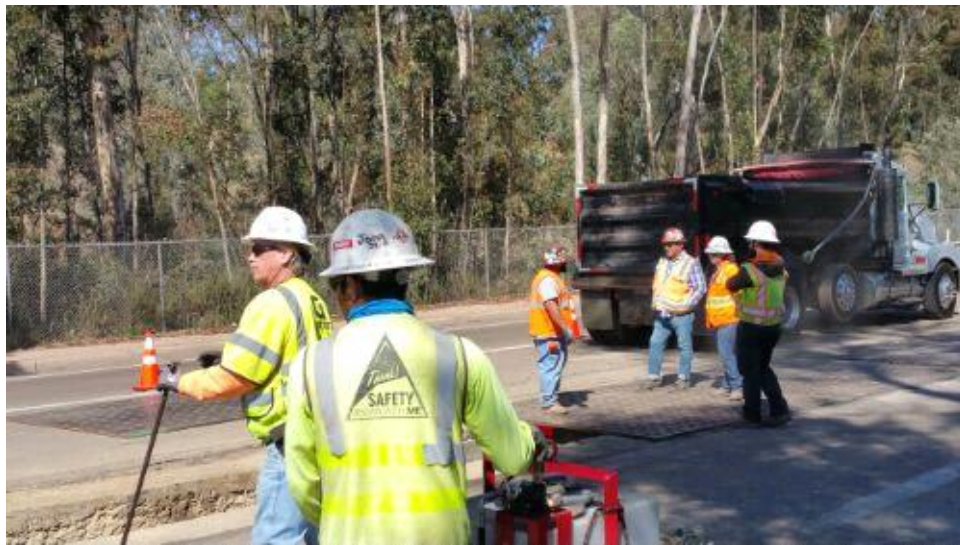
Caption Resource monitors at trenching site on Pomerado Road.

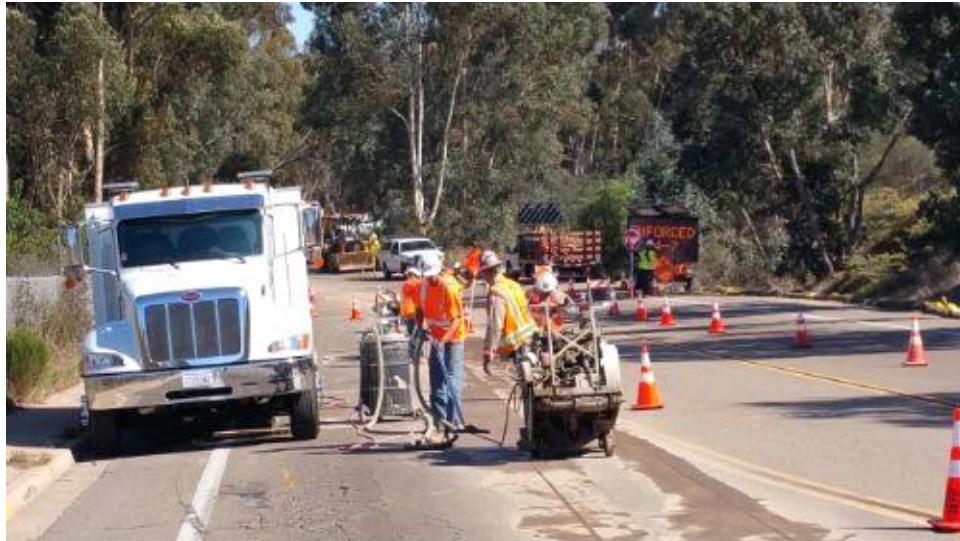
Caption Cutting pavement on Pomerado Road near I-805.

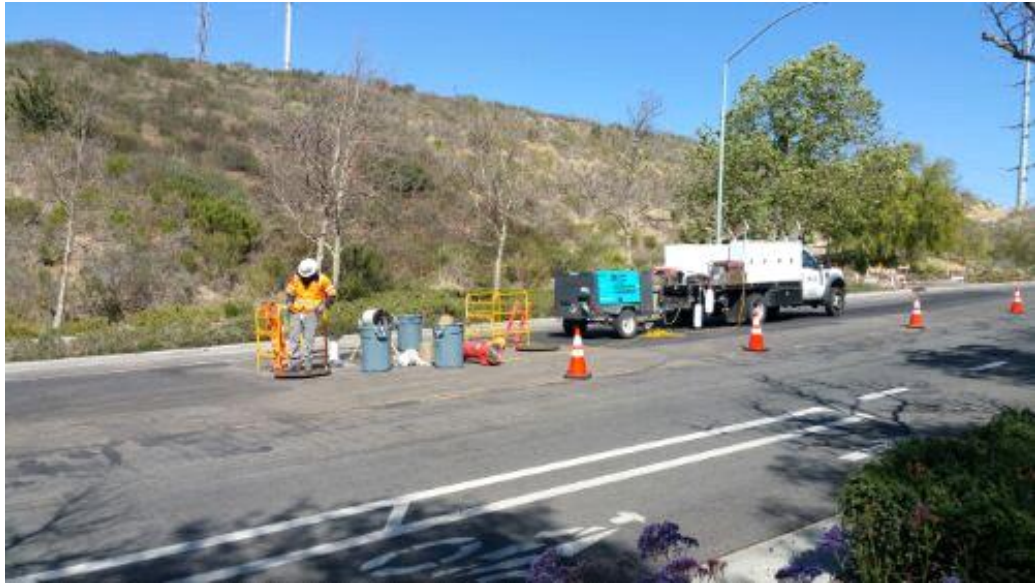
Caption Mandreling on Stonebridge Parkway.

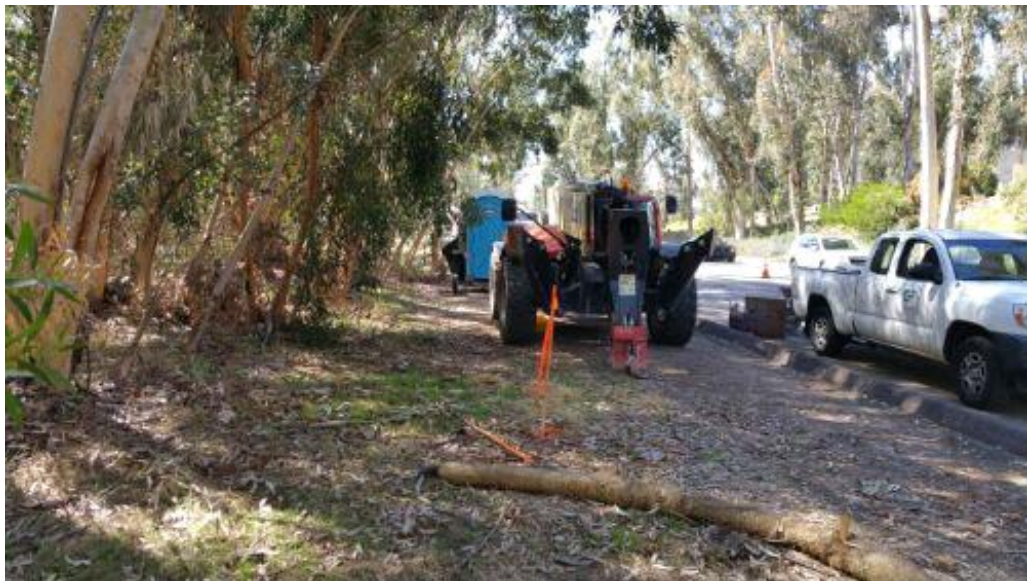
Caption Limit of work stakes placed in immediate response to discussion with EI on Pomerado Road.

<p>Q1 – General Avoidance and Minimization: (a) Were the limits of work areas and access roads clearly marked? (b) Were construction activities limited to CPUC-approved work areas?</p>	<p>Met Requirements</p>
<p>Q1 Notes</p>	<p>Small area (200 ft) lacking clear limits was staked within 1/2 hour of discussion of issue.</p>
<p>Q2 – Air Quality/GHG: (a) Were dust avoidance and minimization requirements implemented and monitored adequately? (b) Was dust generation below required thresholds? (c) Were equipment and vehicles maintained and operated in a manner to limit emissions? (d) Was organic waste collected and separated from non-organic waste for appropriate composting or recycling, as appropriate?</p>	<p>Met Requirements</p>
<p>Q3 – Special-Status Plants: Were impact avoidance and minimization requirements for special-status plants implemented adequately (e.g., avoiding sensitive areas)?</p>	<p>N/A</p>

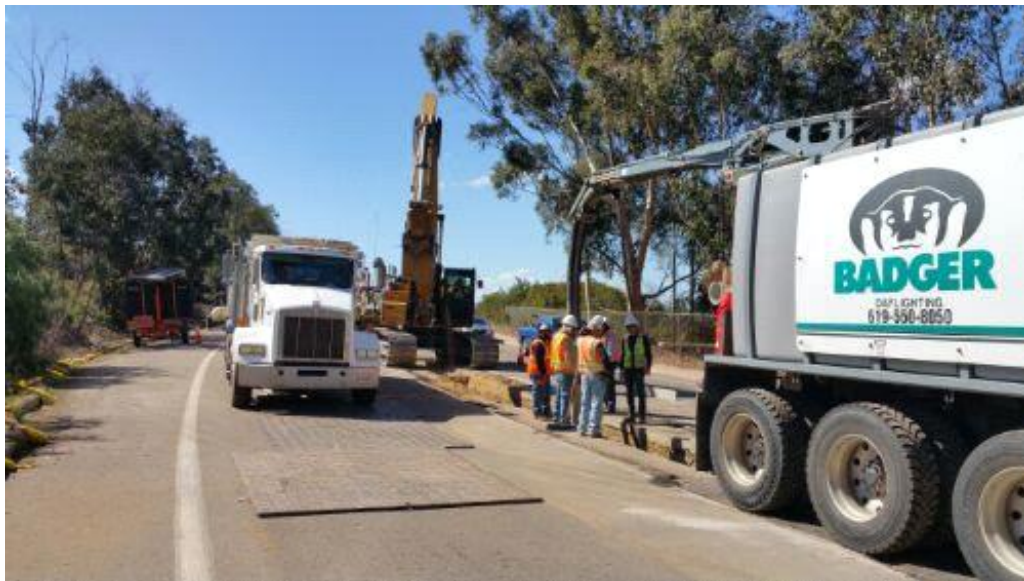
Caption Excavation on Pomerado Road. Cultural resources and Native American monitors on hand.

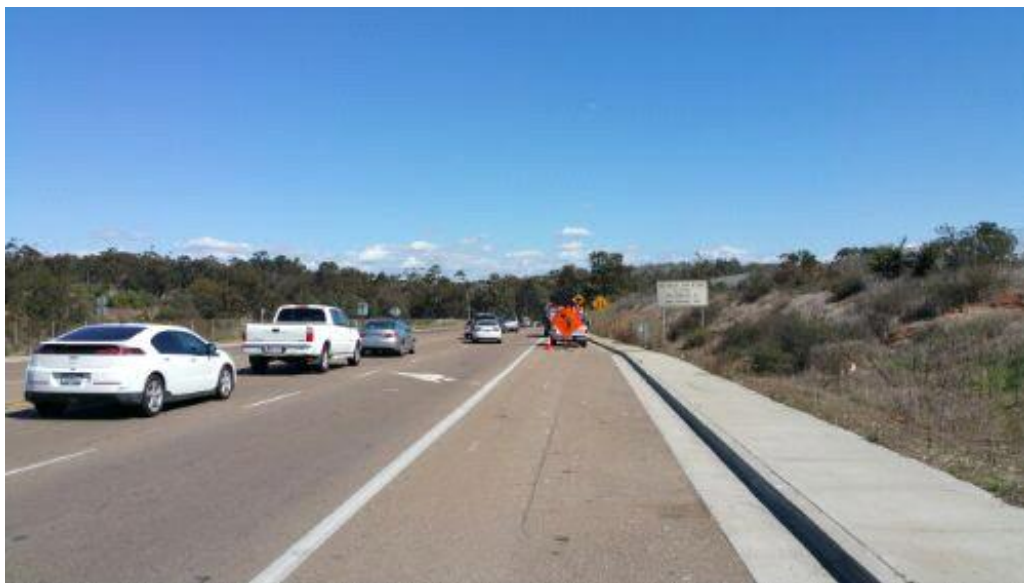
Caption Traffic control at east end of Pomerado Road work area.

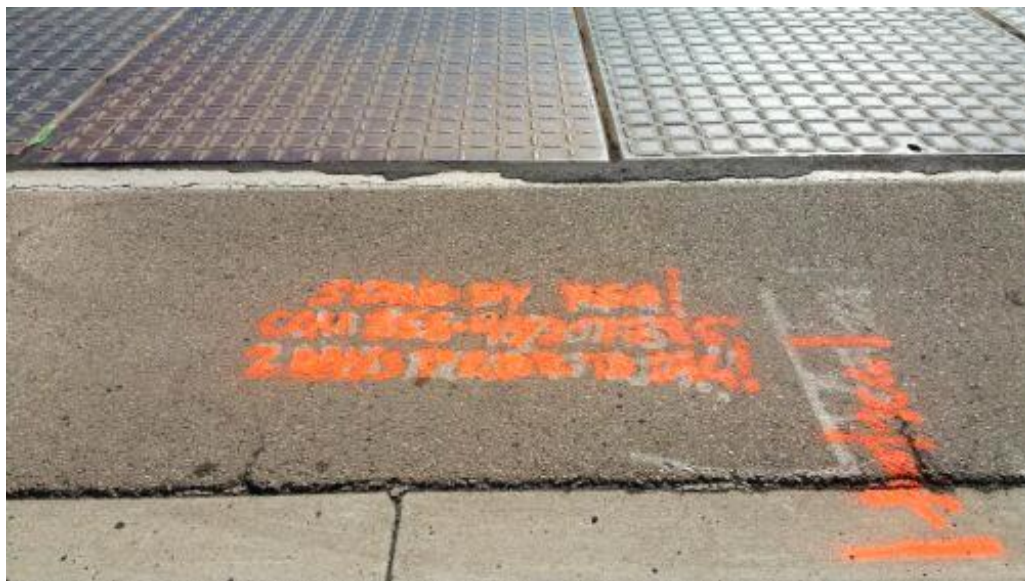
Caption Water line intersecting trenching route on Pomerado Road.

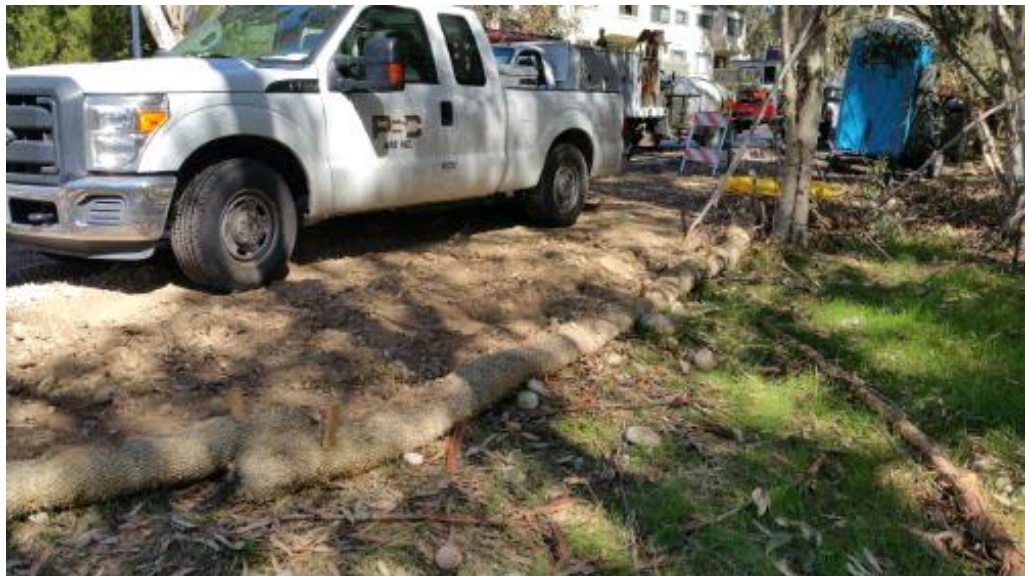
Caption Repaired straw wattles at station139+00 on Pomerado Road.

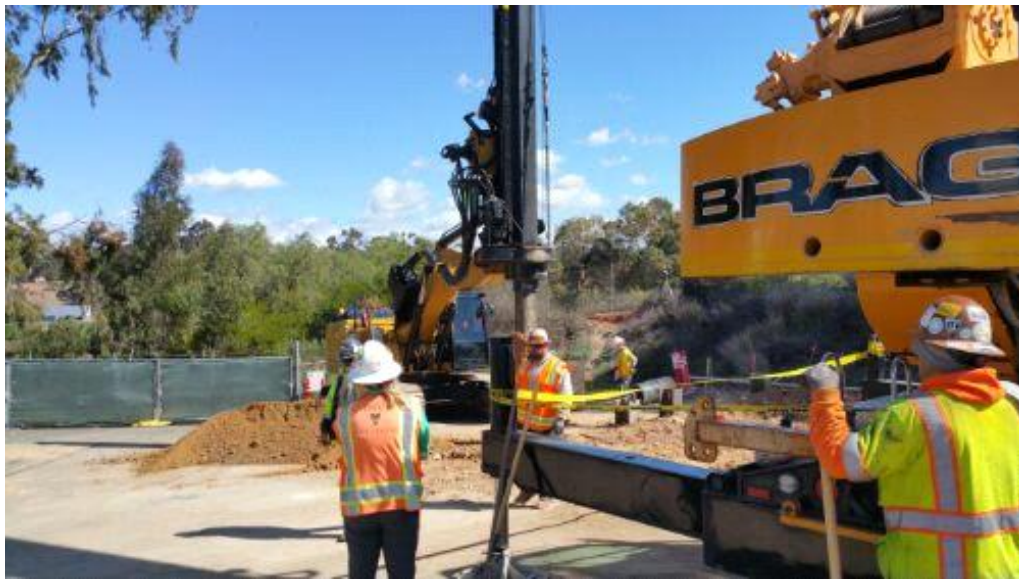
Caption Drilling for placement of supports for pit at Kearney Mesa Road. Paleontology monitor present.

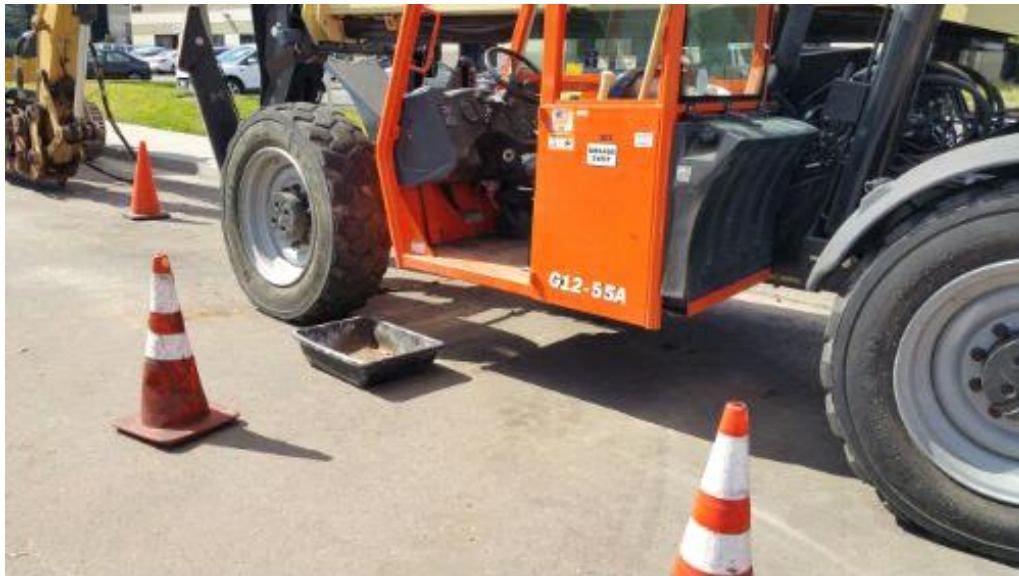
Caption Drip pan is not beneath equipment (265011) at Padgett Road staging area.

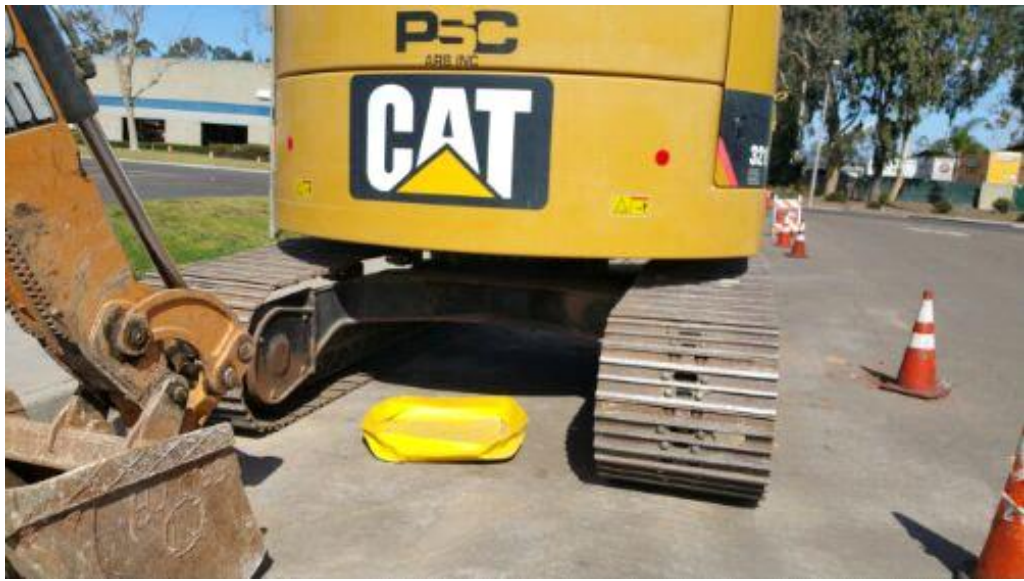
Caption Drip pan is not below point where a leak would occur for Cat 361036 at Padgett Road staging area.

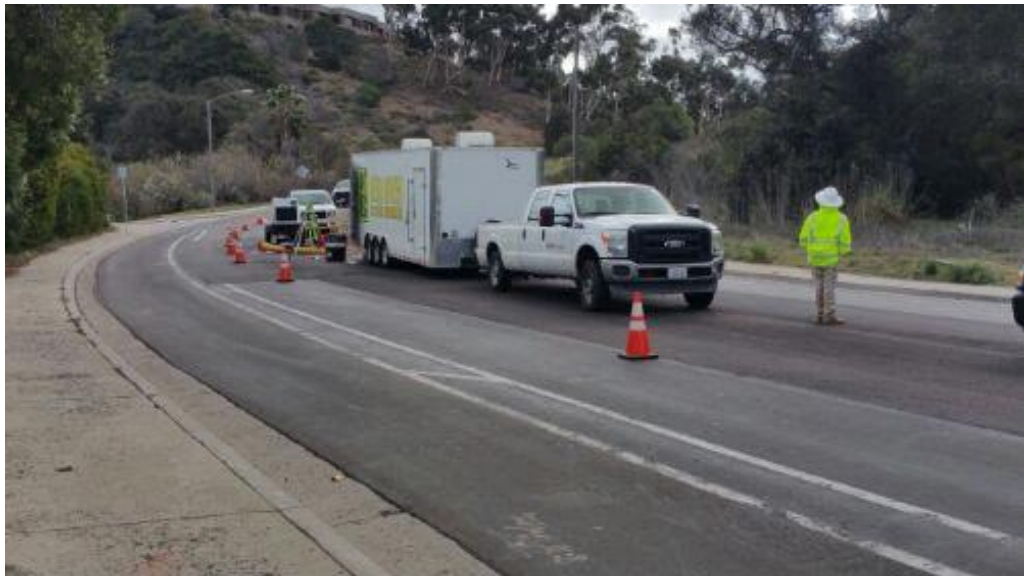
Caption Splicing site on Carroll Canyon Road.

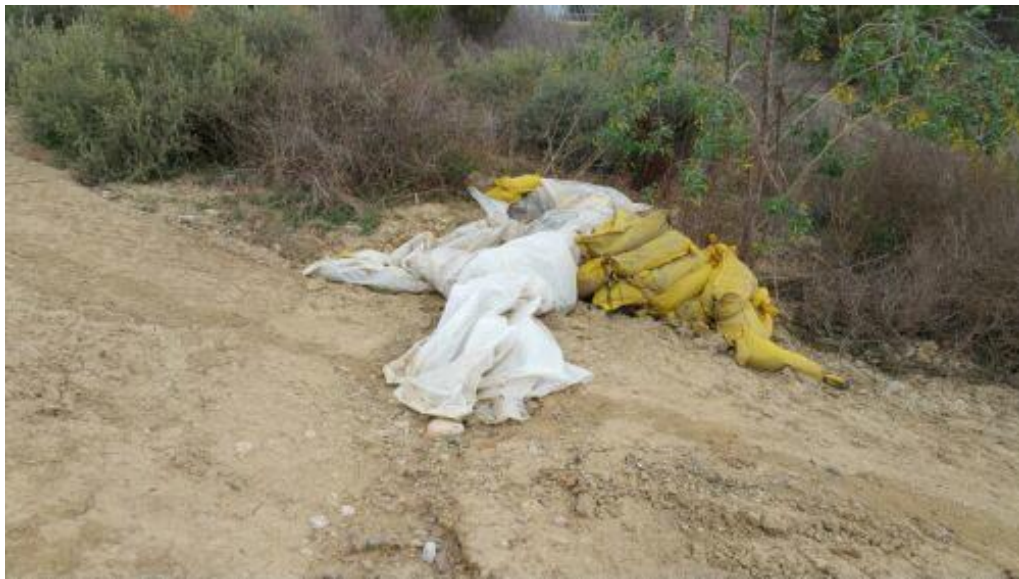
Caption Erosion control BMPs immediately downhill from CC MM CP site.

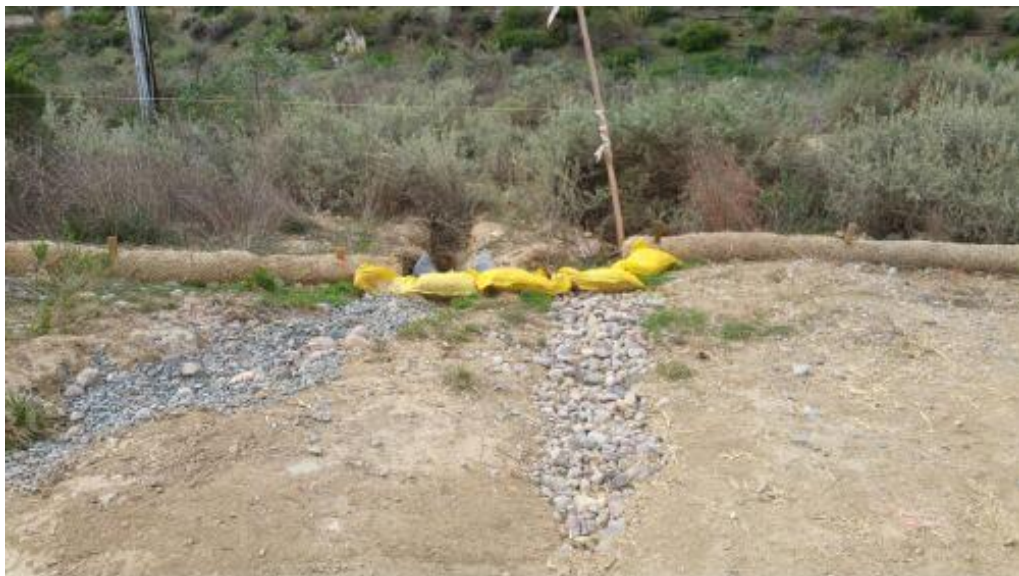
Caption Erosion control BMPs for outflow from CC MM CP site.

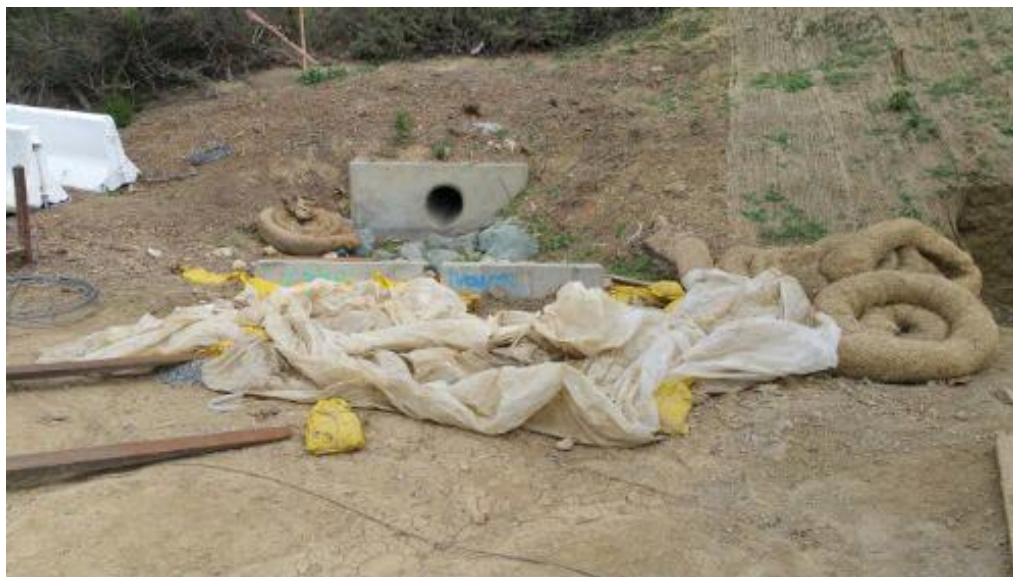
Caption Erosion control BMPs for inflow onto CC MM CP site.
