PROJECT MEMORANDUM SYCAMORE-PEÑASQUITOS 230-KV TRANSMISSION LINE PROJECT

Date: March 30, 2018
To: Billie Blanchard, CPUC Project Manager
From: Sheila Hoyer, CPUC Monitoring Supervisor
Subject: Weekly Report #64 – March 19 to March 24, 2018

2018-03-20 AM Inspection Report

2018-03-23 AM Inspection Report

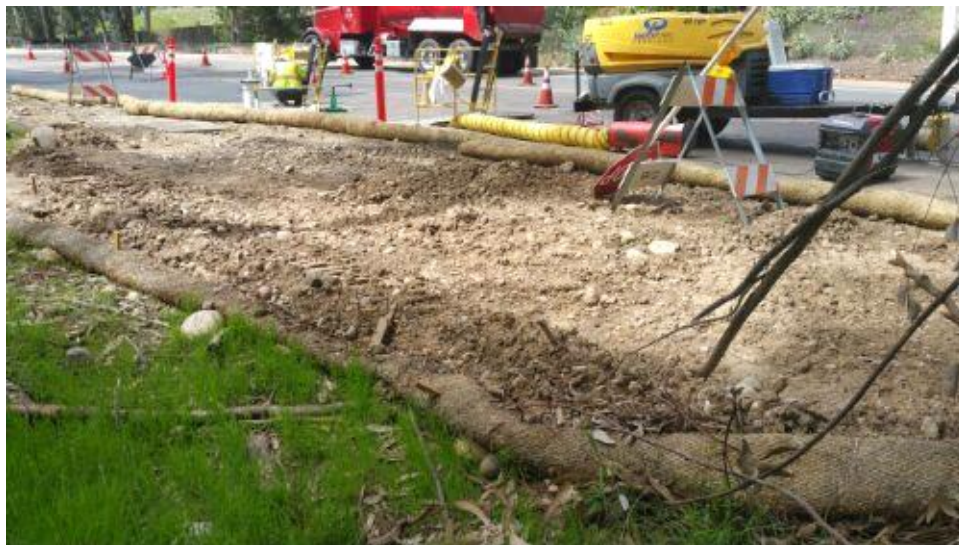
Caption Mandreling site on Pomerado Road.

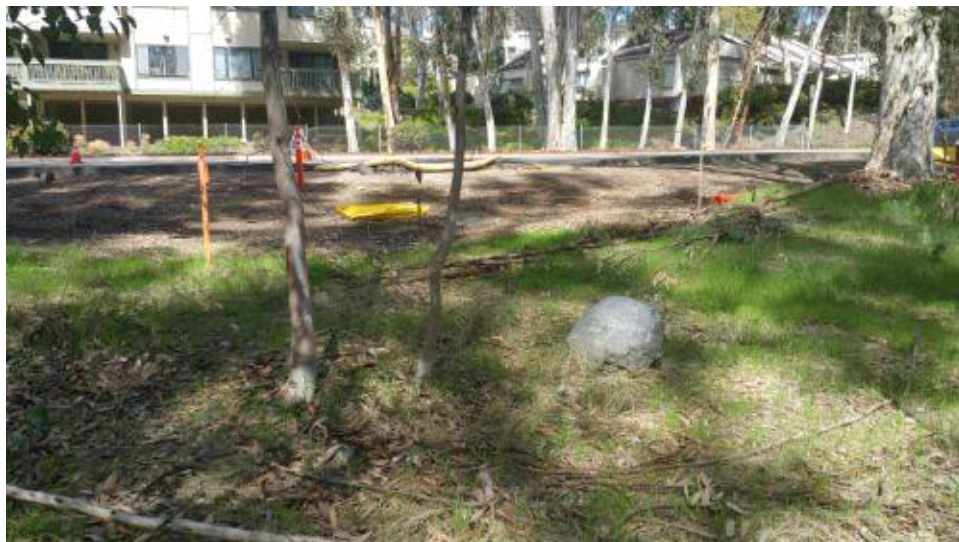
Caption Staging area on Pomerado Road.

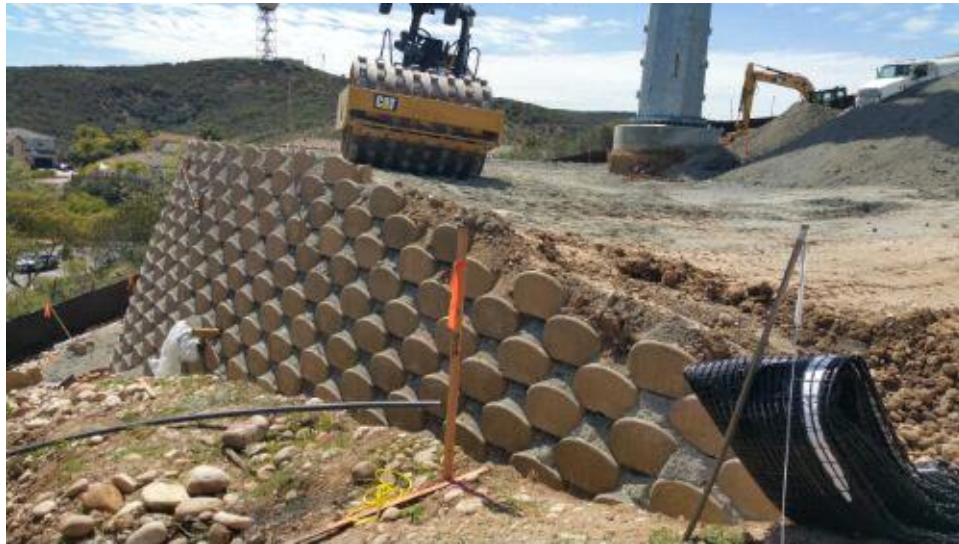
Caption PO5 work site.

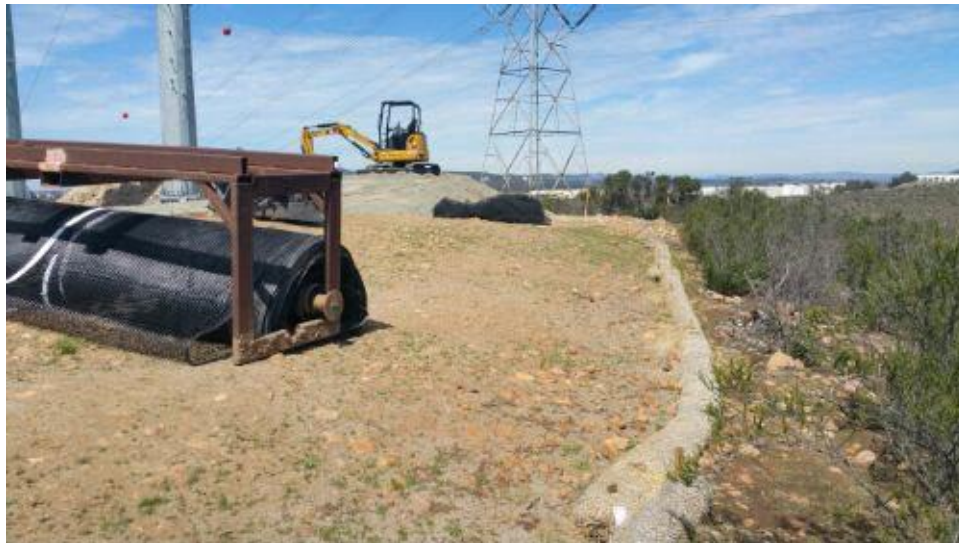
Caption PO6 work site.

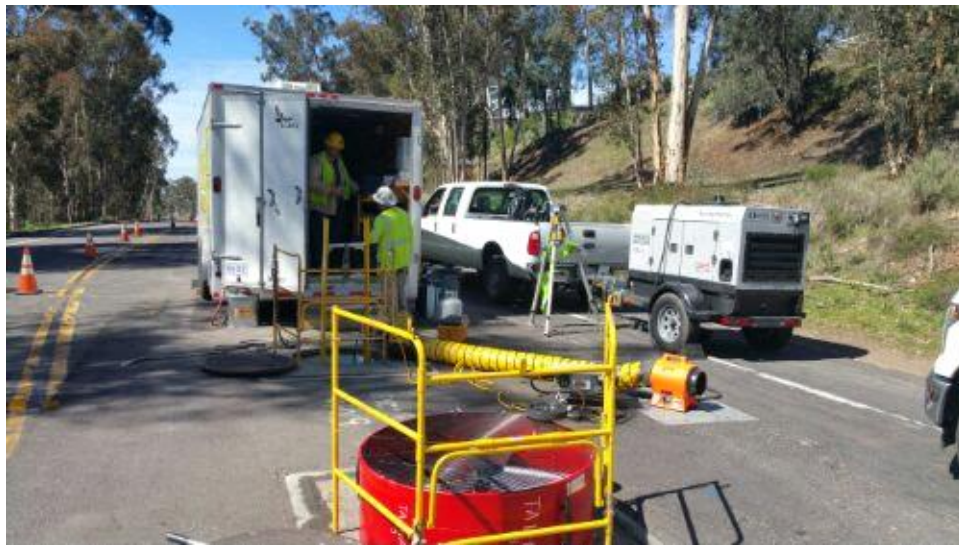
Caption Line splicing site on Pomerado Road.

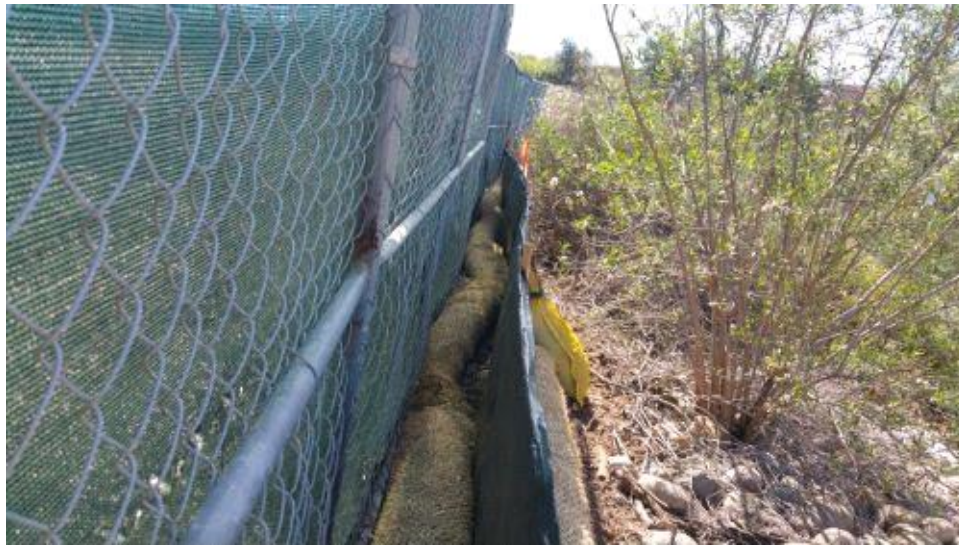
Caption Erosion control BMPs, receiving pit site.

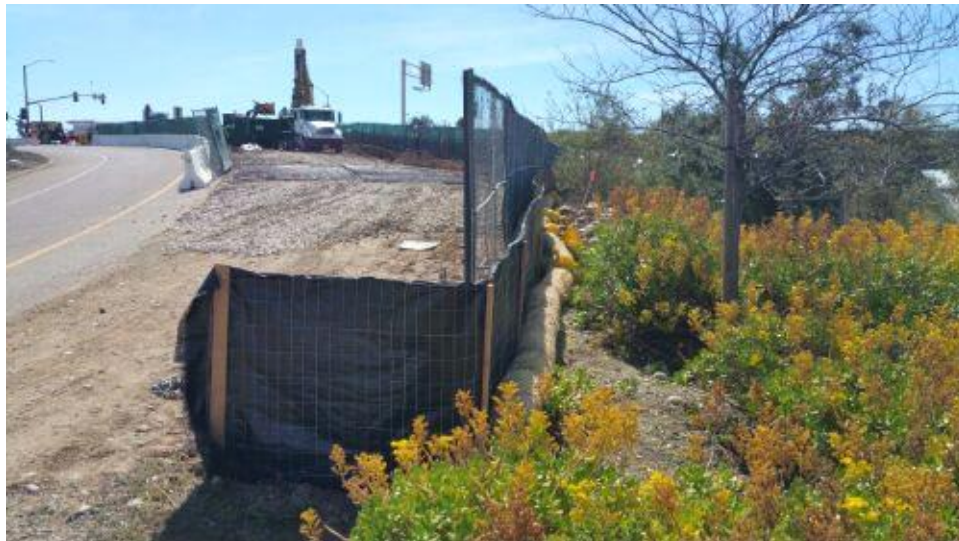
Caption Erosion control BMPs, receiving pit site.

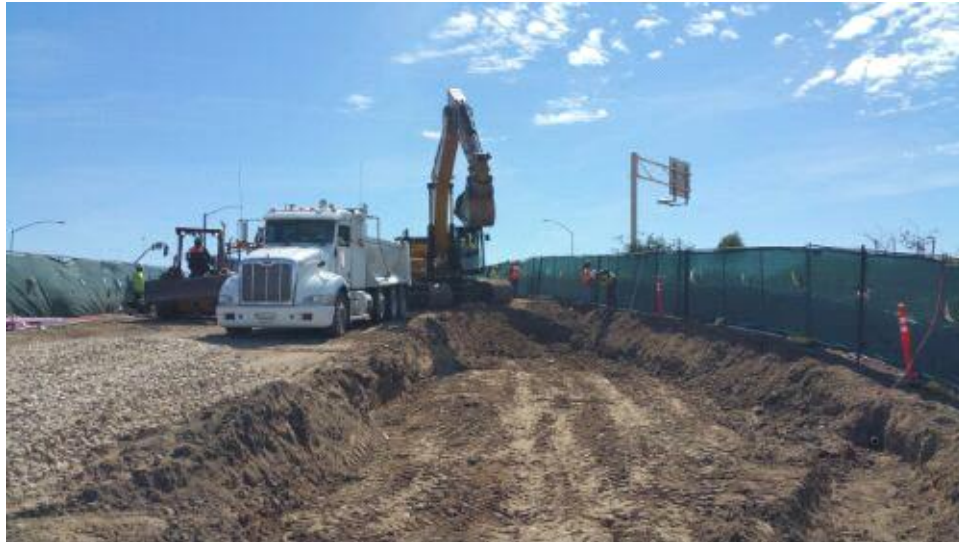
Caption Grading for receiving pit. Native American and archeology monitors on site.

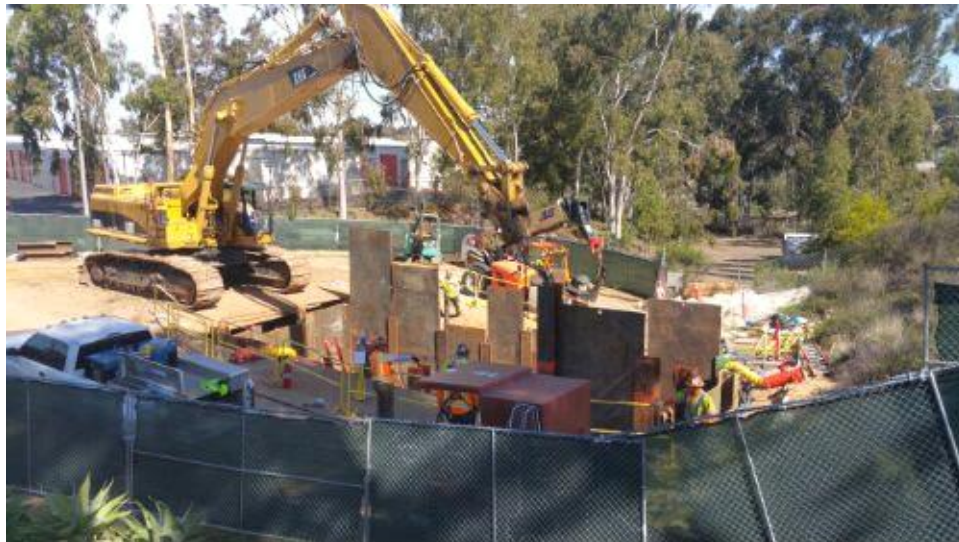
Caption Kearney Mesa Road sending pit site overview.

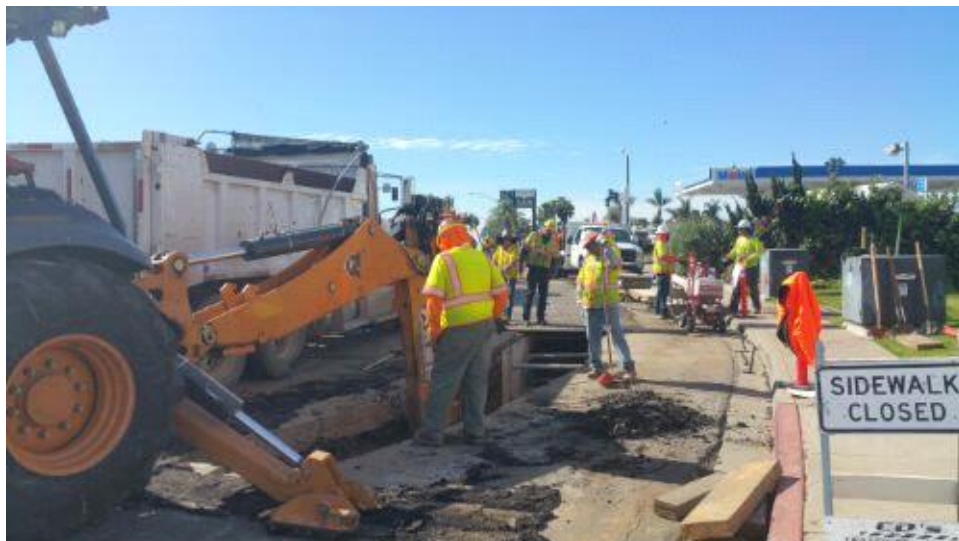
Caption Trench excavation on Kearney Mesa Road.
 Photo Attributes Capture Date/Time: Tue Mar 20 2018 10:02:06 GMT-0700 (PDT)
 Coordinates: 32.894613, -117.118415
 View Direction: South

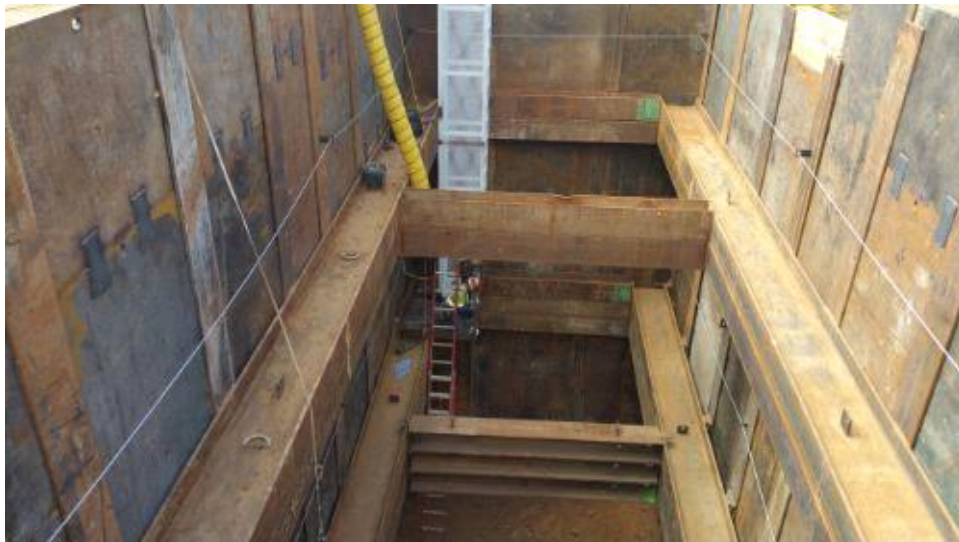
Caption Installing ladder in sending bore pit, Kearney Mesa Road.

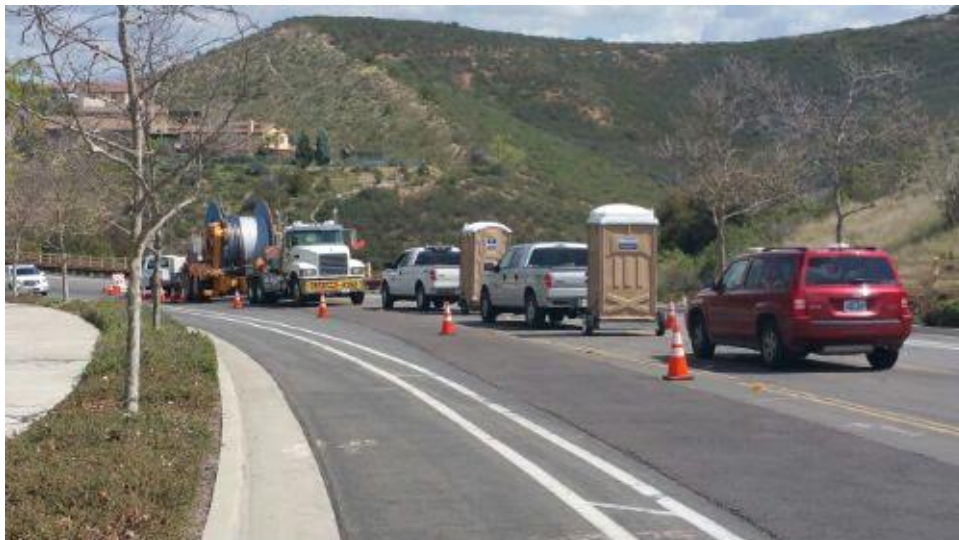
Caption Cable pull site, Stonebridge Parkway.
Photo Attributes Capture Date/Time: Fri Mar 23 2018 13:38:56 GMT-0700 (PDT)
Coordinates: 32.921253, -117.056435
View Direction: East

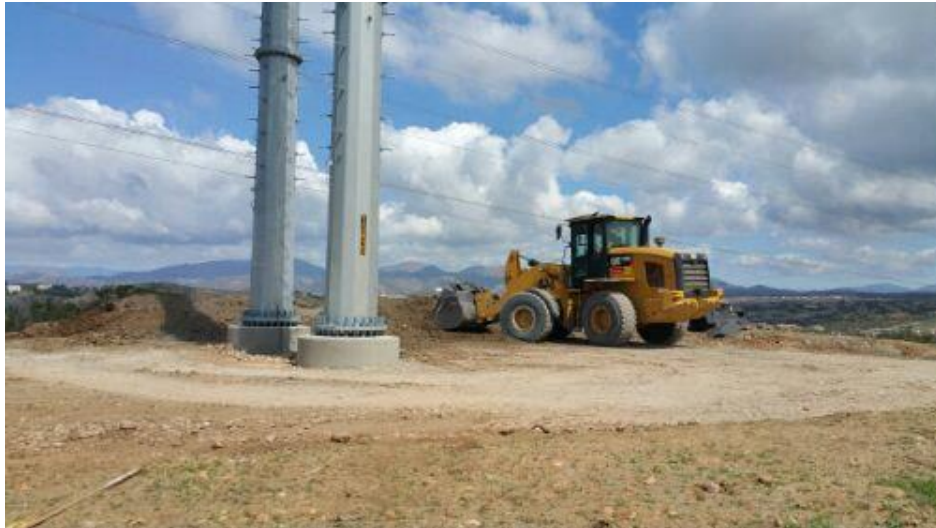
Caption PO6 topsoil donor site.
Photo Attributes Capture Date/Time: Fri Mar 23 2018 13:20:13 GMT-0700 (PDT)
Coordinates: 32.922829, -117.044214
View Direction: Northeast

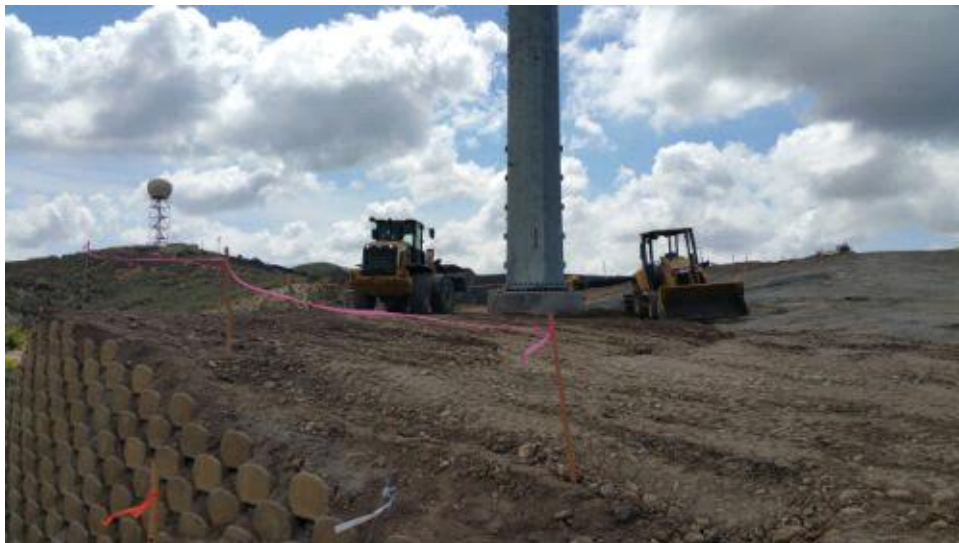
Caption Grading at PO5.
Photo Attributes Capture Date/Time: Fri Mar 23 2018 13:08:56 GMT-0700 (PDT)
Coordinates: 32.922769, -117.042329
View Direction: South

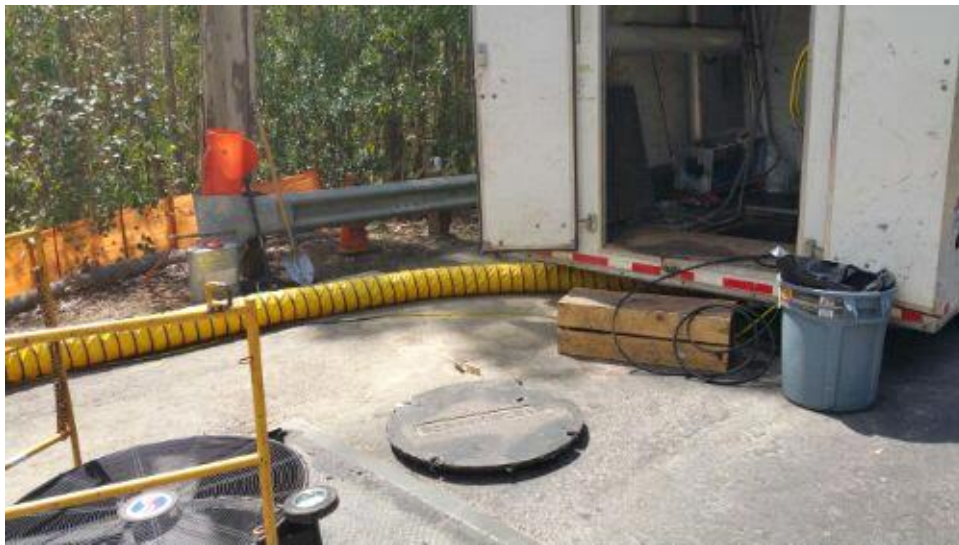
Caption Pre-racking site on Pomerado Road.

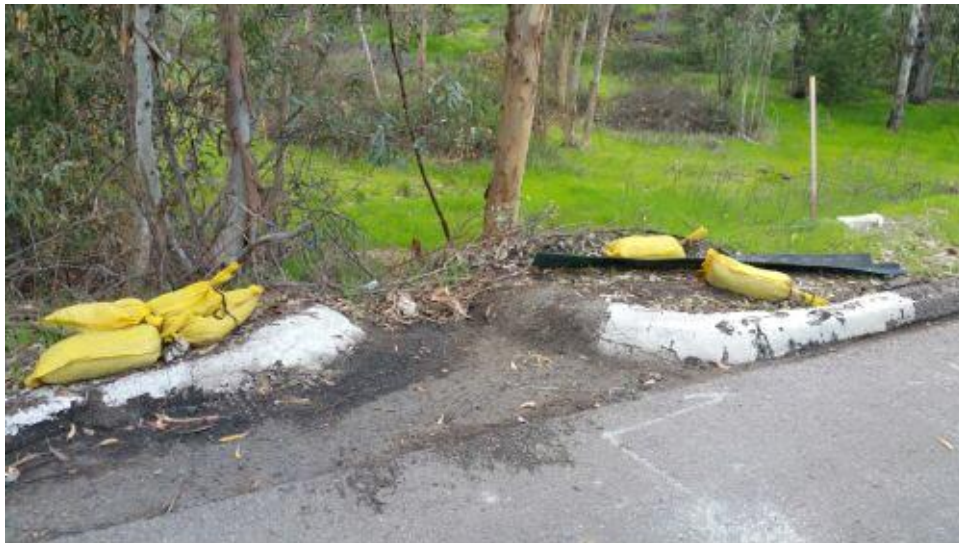
Caption Erosion control BMPs removed at Station 435+00: indicating point is not within active work area.

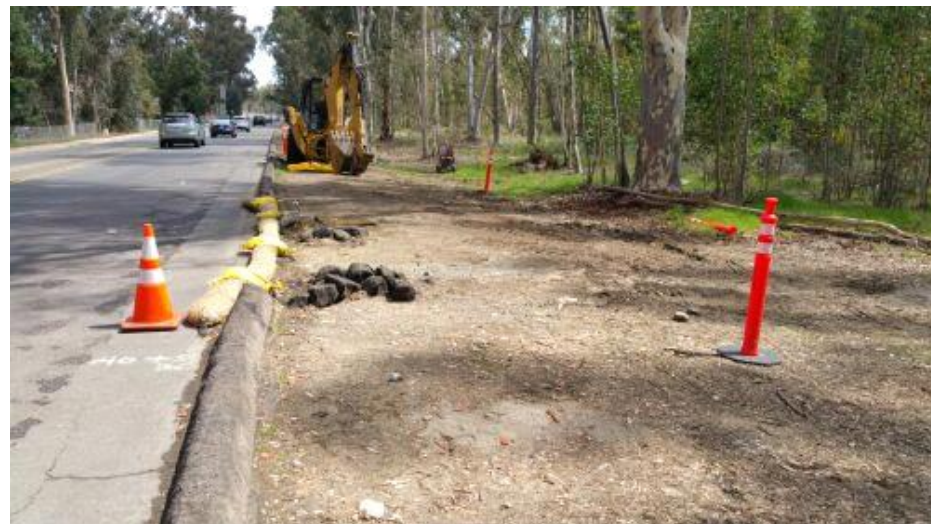
Caption Straw wattles put in place, MPR staging area on Pomerado Road.

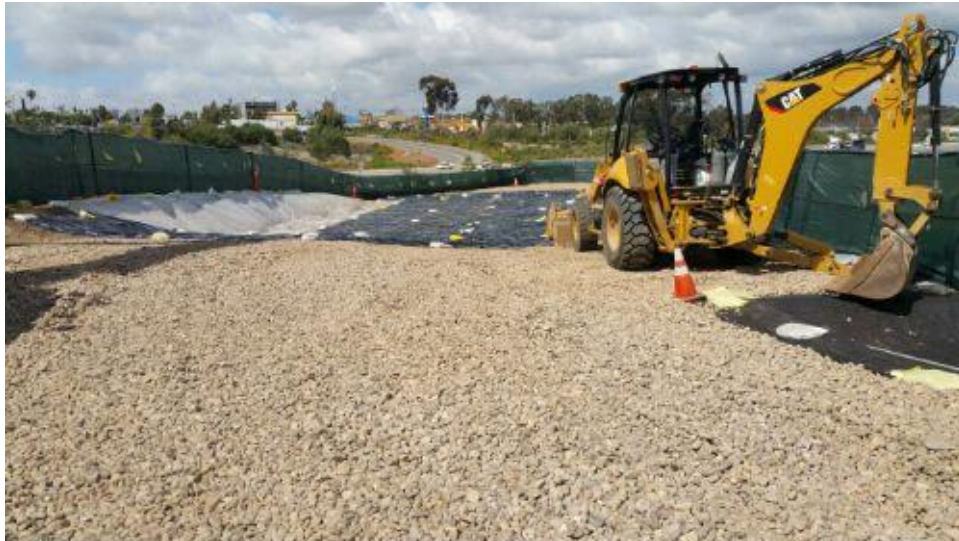
Caption Receiving pit site, near I-15 ramp.

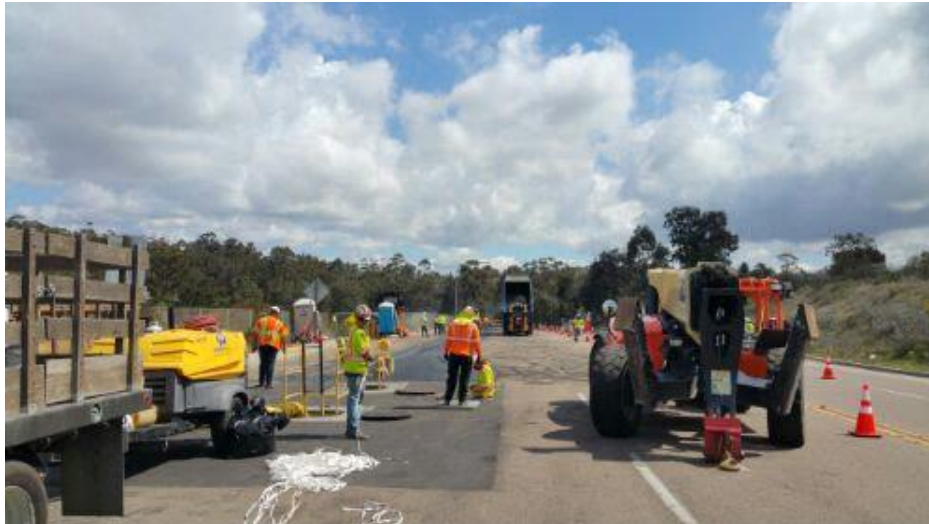
Caption Repaving and mandreling on Pomerado Road.

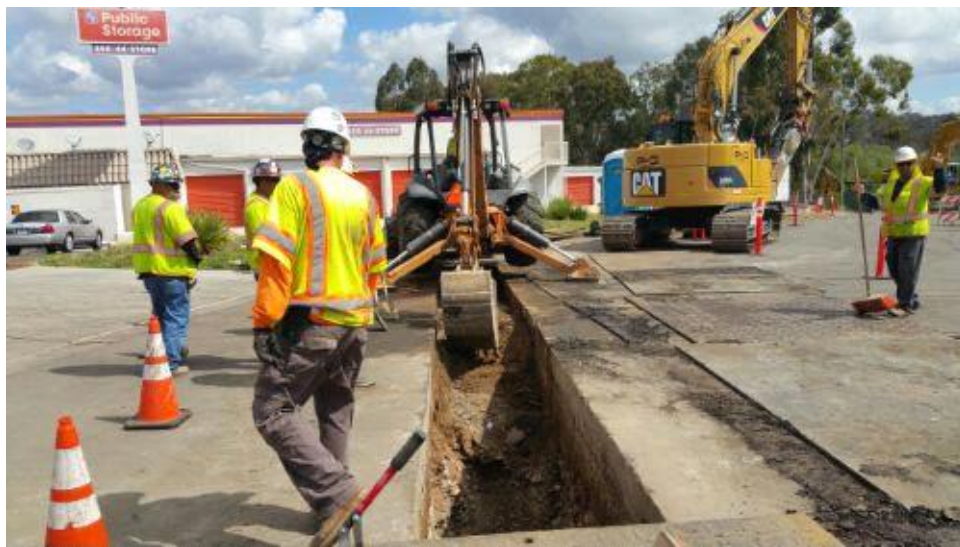
Caption Trenching on Kearney Mesa Road.
