## PROJECT MEMORANDUM SYCAMORE-PEÑASQUITOS 230-KV TRANSMISSION LINE PROJECT

Date: April 13, 2018  
To: Billie Blanchard, CPUC Project Manager  
From: Sheila Hoyer, CPUC Monitoring Supervisor  
Subject: Weekly Report #66 – April 2 to April 7, 2018

## SDG&E Sycamore-Peñasquitos 230-kV Transmission Line Project: Daily Inspection Report

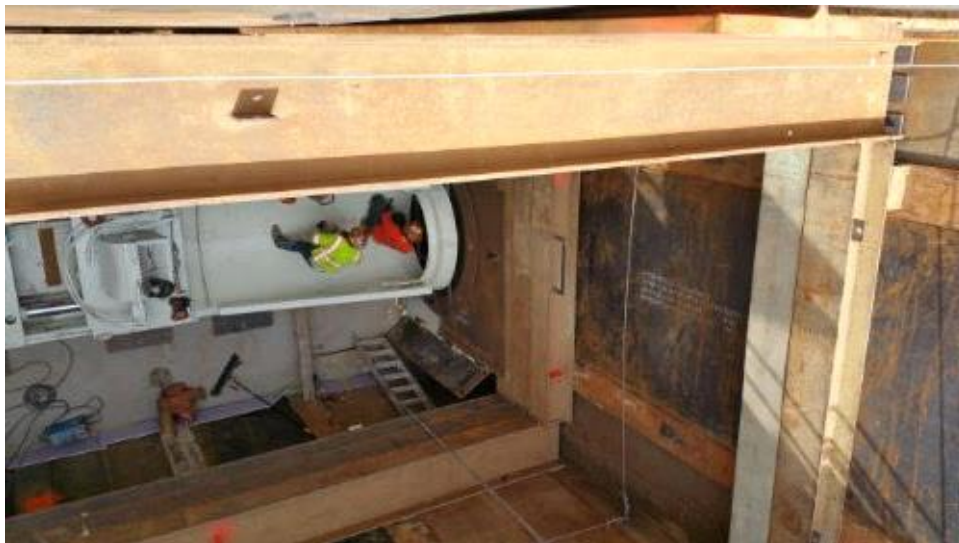
Caption Installing horizontal drill, sending pit site.

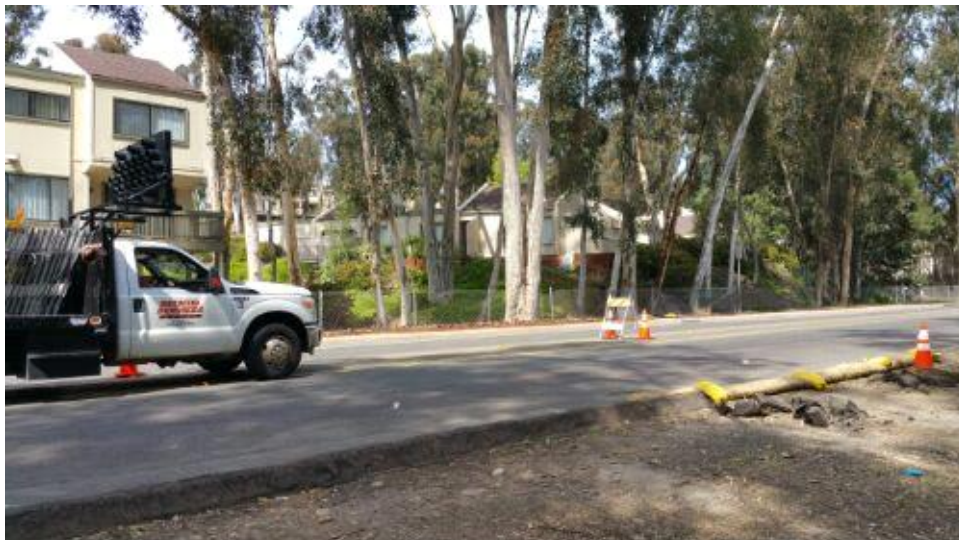
Caption Removing traffic cones on Pomerado Road.

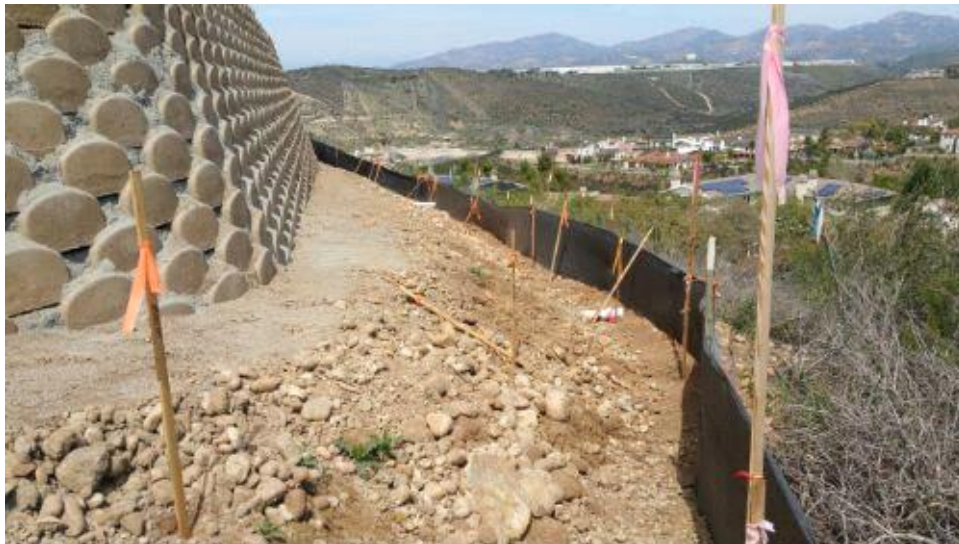
Caption Drains installed below Verdura wall at PO5.

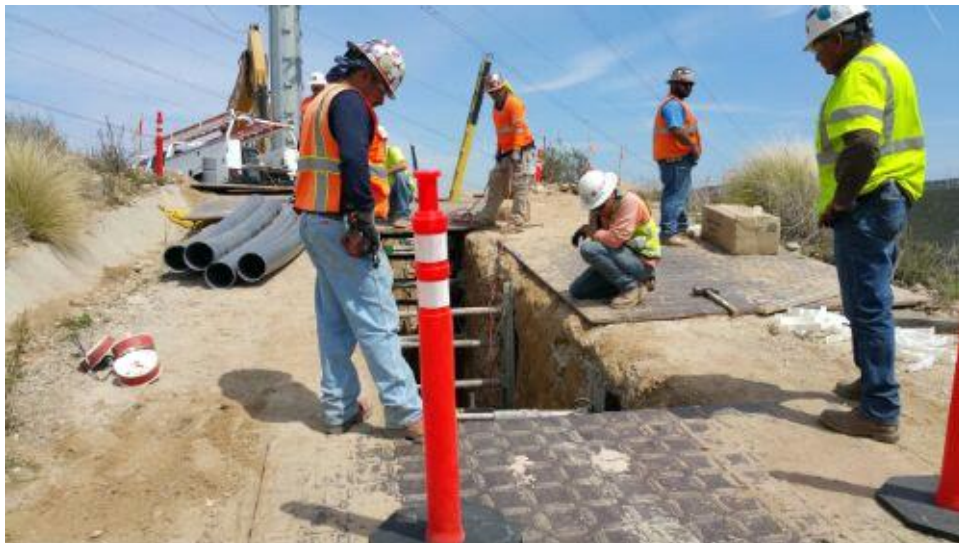
Caption Placing conduit in PO5 access road.

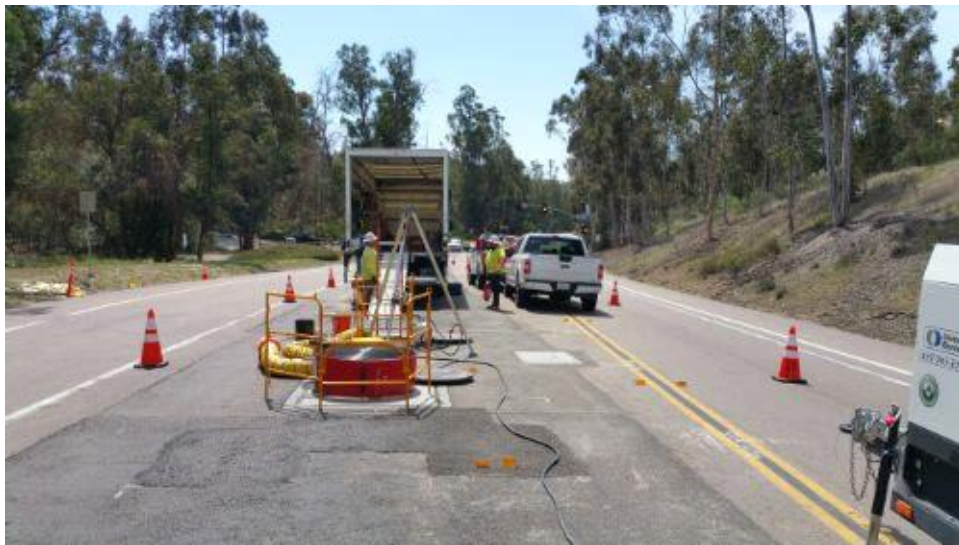
Caption Splicing work site on Pomerado Road.

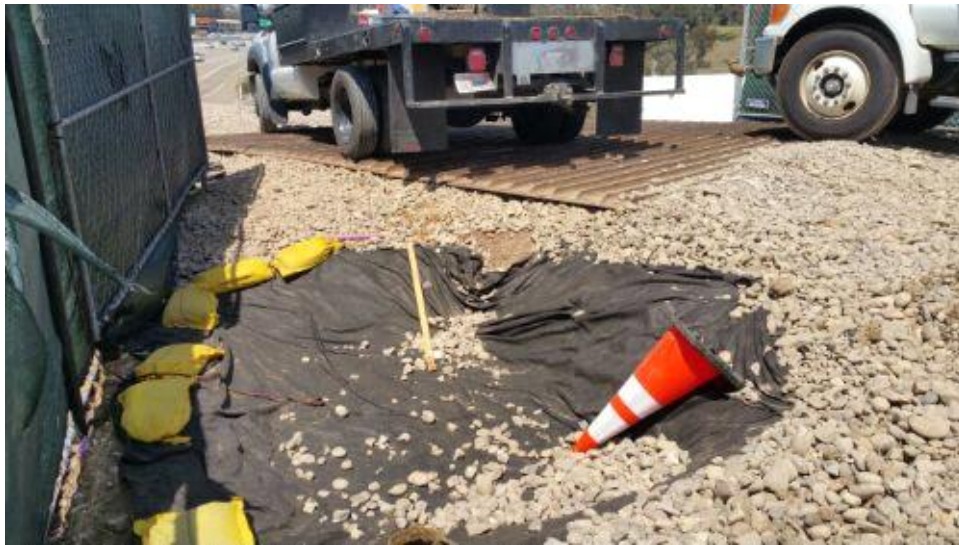
Caption Drain protection and rumble plates at east side I-15 sending pit work site.

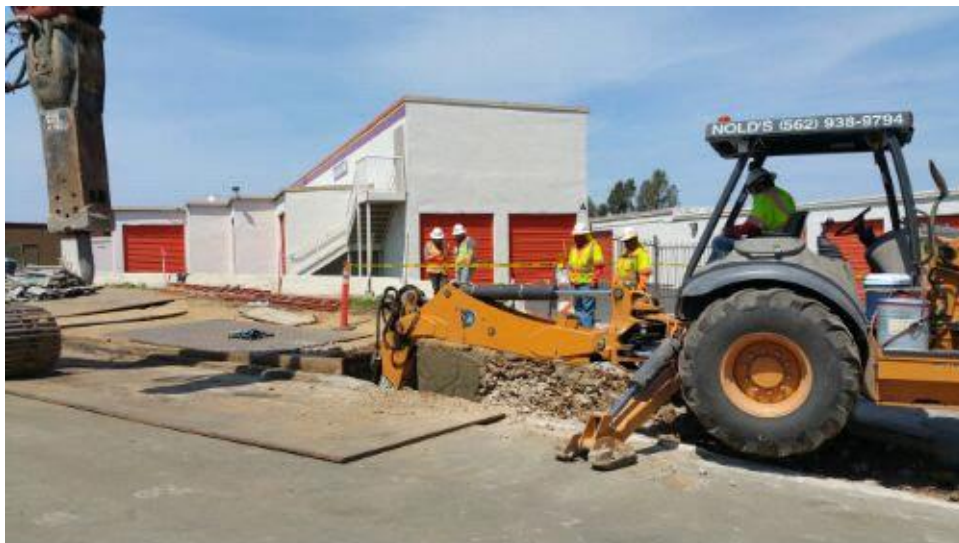
Caption Cultural and paleontology monitors at trench excavation, Kearney Mesa Road.

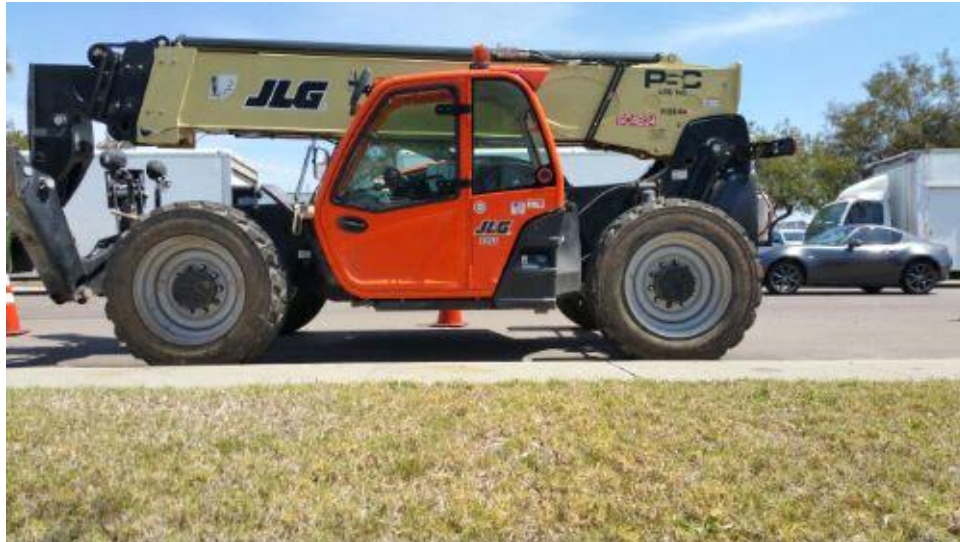
Caption No drip pan beneath SC4B34 at Padgett Road staging area.

Q9 Notes	One piece of equipment at the Padgett Road staging area had no drip pan. No drips observed, but this has been a persistent problem.
Q10 – Fire Management: (a) Were fire prevention procedures in place? (b) Was firefighting equipment available on site?	Met Requirements
Q11 – Cultural, Paleontological, and Tribal Resources: (a) Were cultural, paleontological, and tribal resources monitoring and impact avoidance occurring as required? (b) If potential resources or human remains were inadvertently discovered, were response procedures and protocols implemented as required?	Met Requirements
Q12 – Construction Noise: (a) Were noise minimization measures	Met Requirements

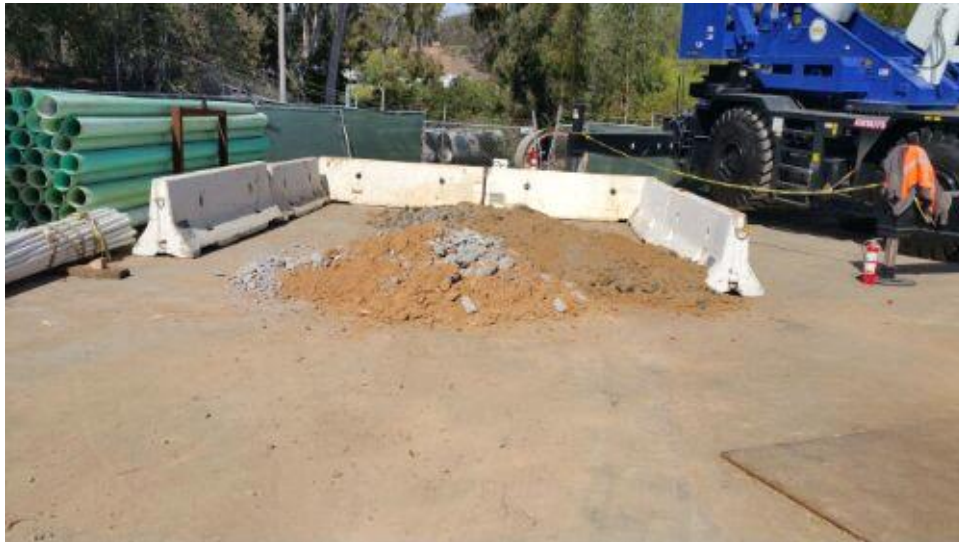
Caption Bored soils at the sending pit bore site.

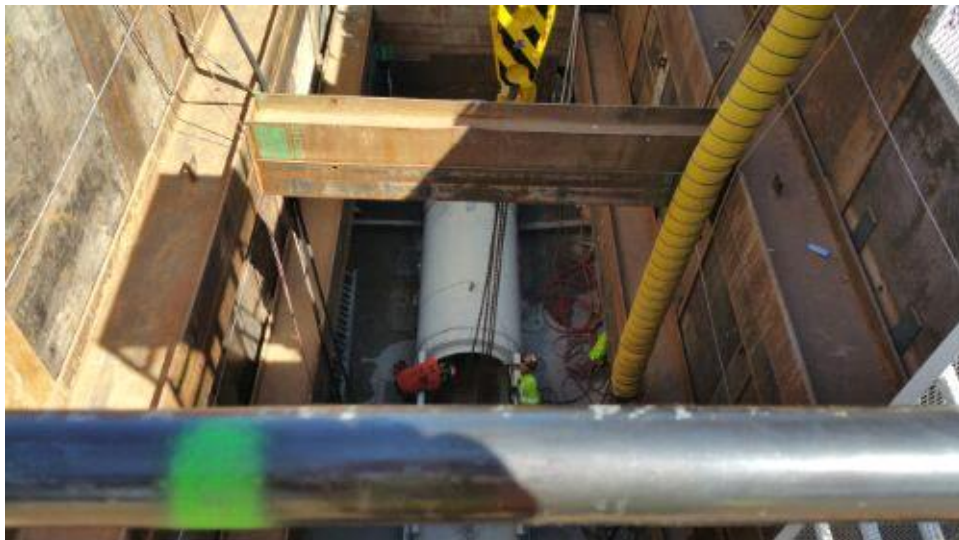
Caption Placing bucket on bore rin the sending bore pit.  
Photo Attributes Capture Date/Time: Thu Apr 05 2018 15:03:58 GMT-0700 (PDT)  
Coordinates: 32.894773, -117.117439  
View Direction: East

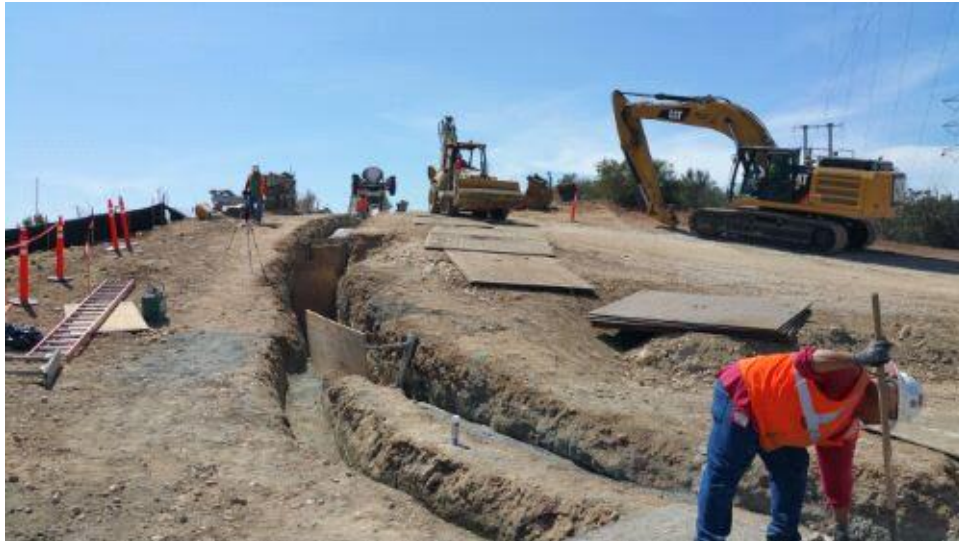
Caption Filling trench at PO5.  
Photo Attributes Capture Date/Time: Thu Apr 05 2018 14:23:12 GMT-0700 (PDT)  
Coordinates: 32.922494, -117.04236  
View Direction: West

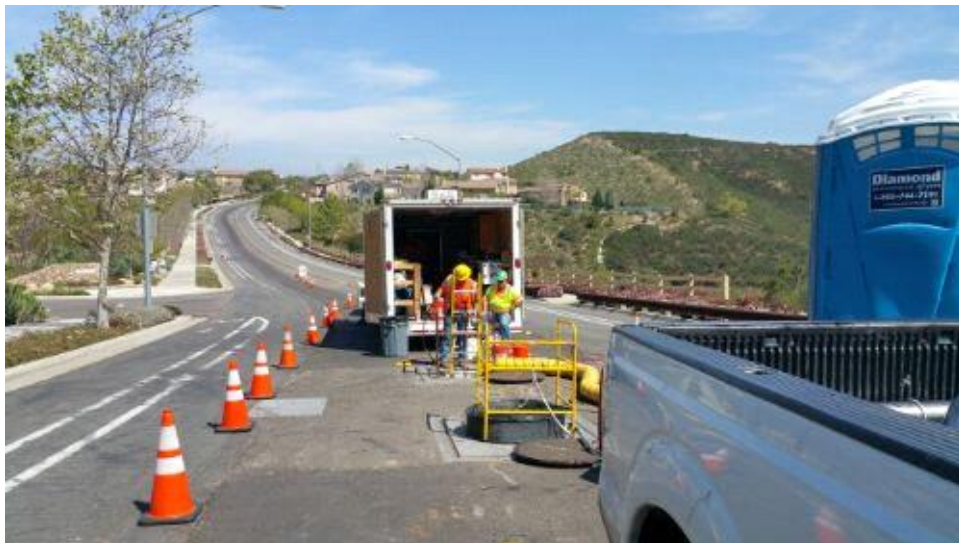
Caption Racking site on Stonebridge Parkway.  
Photo Attributes Capture Date/Time: Thu Apr 05 2018 14:13:04 GMT-0700 (PDT)  
Coordinates: 32.895831, -117.107626  
View Direction: East

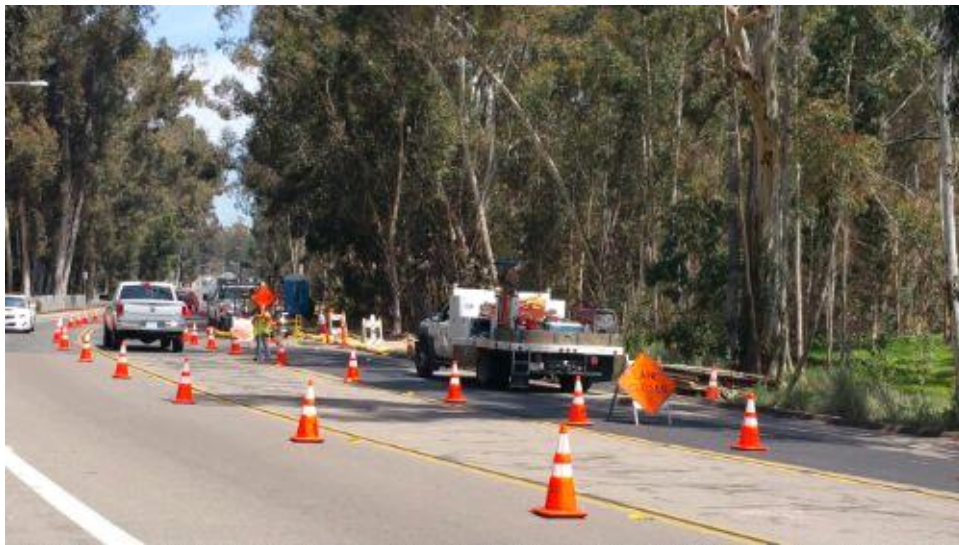
Caption Mandreling site on Pomerado Road.

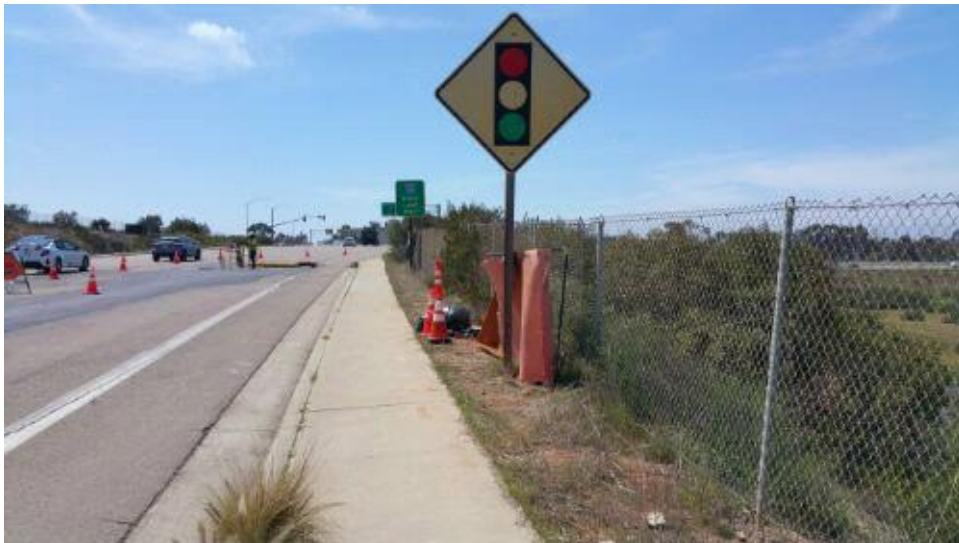
Caption Construction materials no longer in use on Pomerado Road east of I-15. LEI said he would get them picked up.

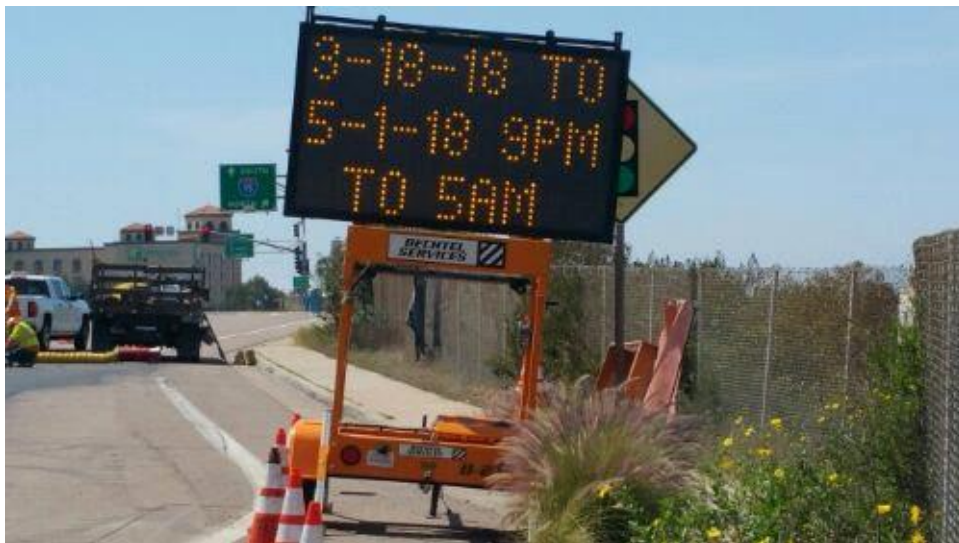
Caption I-15 on-ramp closure sign.

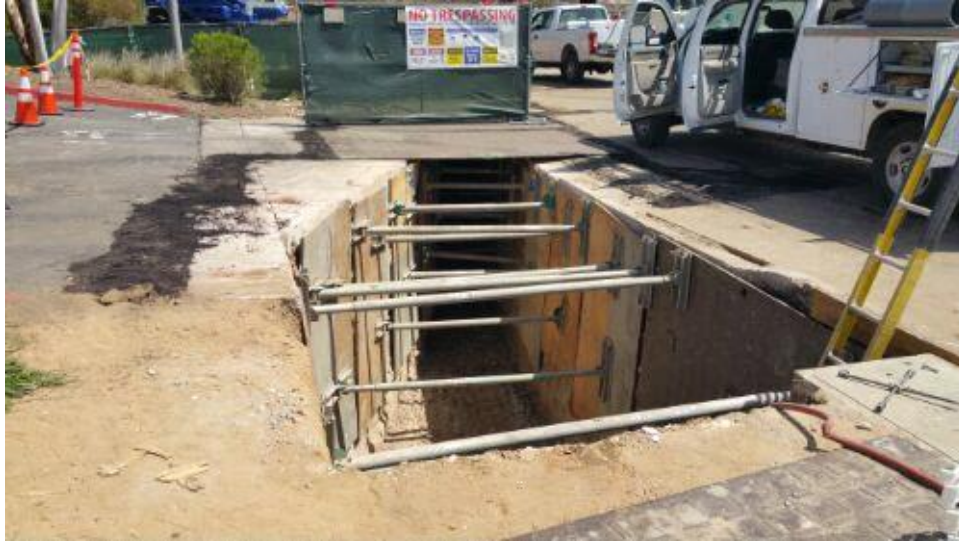
Caption Trench to Kearney Mesa Road sending bore pit.

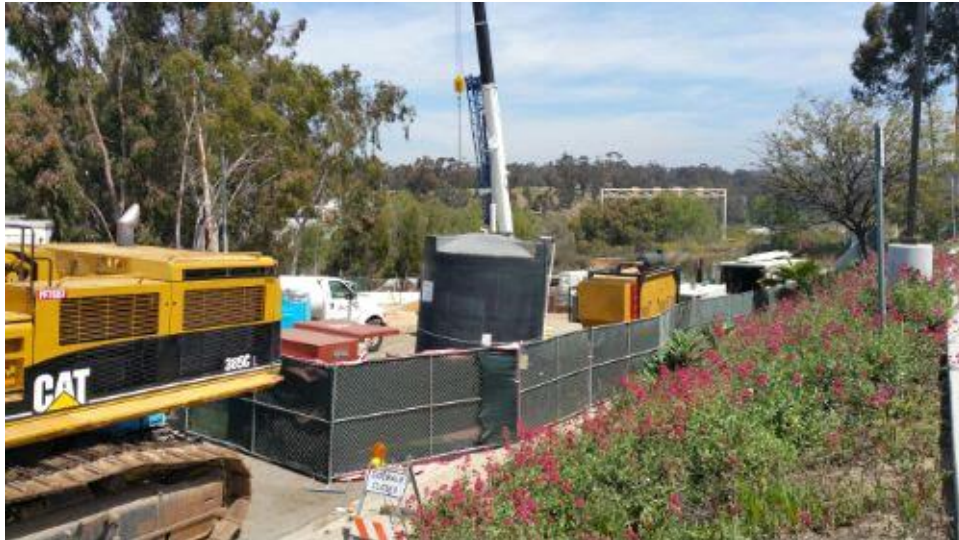
Caption Sending bore pit site west of I-15.

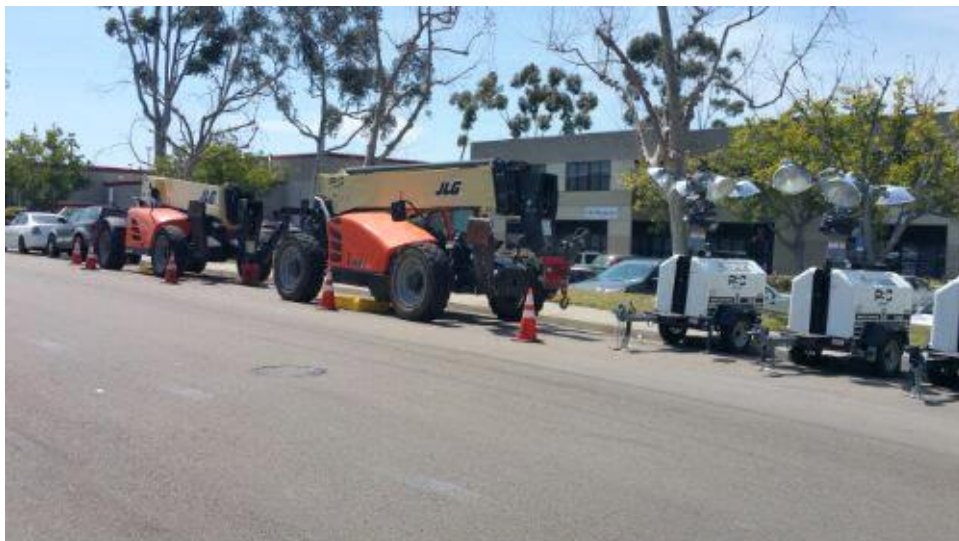
Caption Drip pans beneath equipment at Padgett Road yard.  
 Photo Attributes Capture Date/Time: Thu Apr 05 2018 12:48:03 GMT-0700 (PDT)  
 Coordinates: 32.89585, -117.126922  
 View Direction: Southwest

Q9 Notes	Drip pans in place at Padgett Road site. I noted a small spill (1 oz) of primer from a tipped can at the sending bore pit site and the dirt was immediately picked up for removal to Nancy Ridge Yard.
Q10 – Fire Management: (a) Were fire prevention procedures in place? (b) Was firefighting equipment available on site?	Met Requirements
Q10 Notes	Fire gear at all work sites.
Q11 – Cultural, Paleontological, and Tribal Resources: (a) Were cultural, paleontological, and tribal resources monitoring and impact avoidance occurring as required? (b) If potential resources or human remains were inadvertently discovered, were response procedures and protocols implemented as required?	Met Requirements
Q11 Notes	No monitors needed.
Q12 – Construction Noise: (a) Were noise minimization measures in place, as required? (b) If noise complaints were received, were they documented and addressed, as required?	Met Requirements
