PROJECT MEMORANDUM SYCAMORE-PEÑASQUITOS 230-KV TRANSMISSION LINE PROJECT

Date: May 4, 2018
To: Billie Blanchard, CPUC Project Manager
From: Sheila Hoyer, CPUC Monitoring Supervisor
Subject: Weekly Report #69 – April 23 to April 28, 2018

2018-04-27 AM Inspection Report

APRIL 27, 2018 NON-COMPLIANCE MEMORANDUM

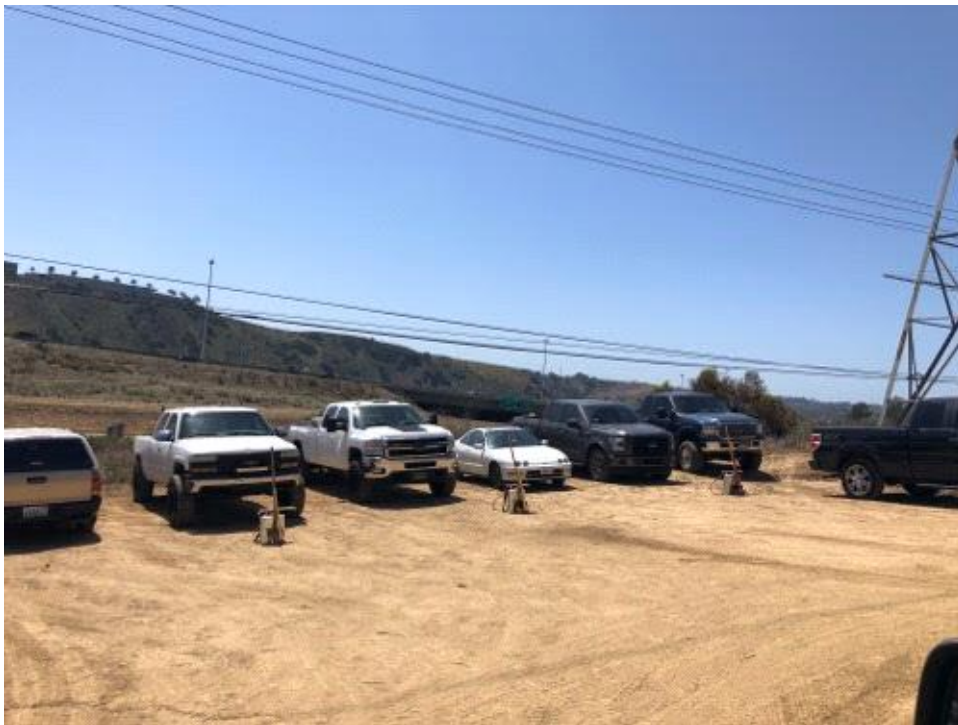
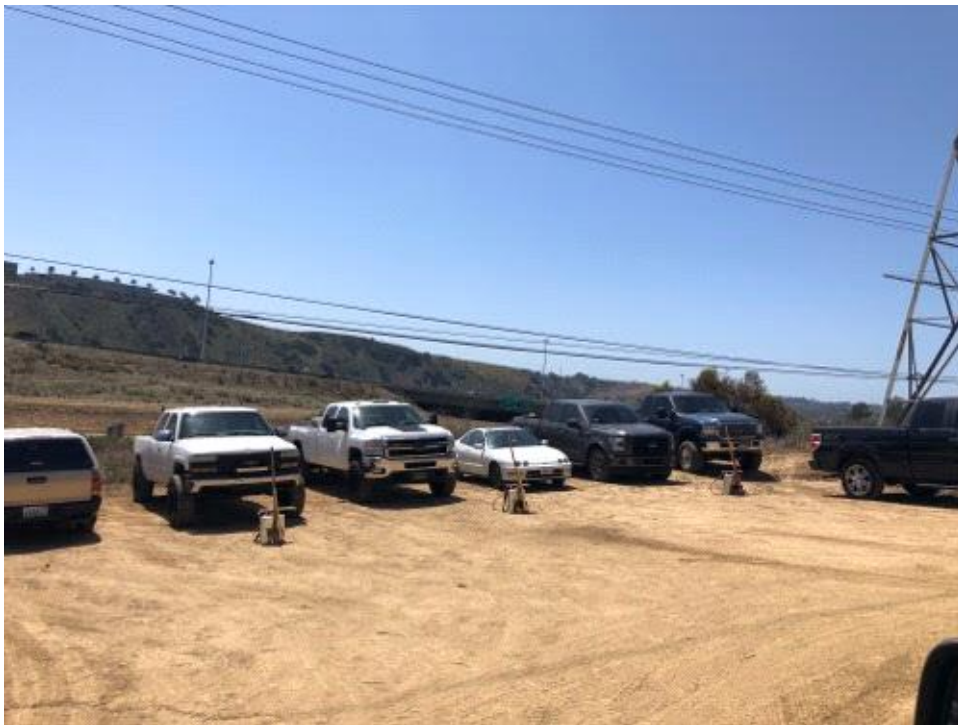
Incident Category	Compliance Level
MMCRP Compliance Level	Level 3: Non-Compliance
Incident Start Date	2018-04-27
Resolution Date	2018-04-27
Summary of Incident	Personal vehicles for the overhead crews were parked without fire tools within the active ROW. These vehicles were parked northeast of the CC MM CP yard. Prior to leaving the site the EI instructed the contractor to place fire tools next to the vehicles. There 4 sets for 9 vehicles. No personnel were on site at the time of the initial observation.

Caption POVs parked northeast of CC MM CP.

Each privately-owned vehicle parked at CC MM CP outside of the Staging Area must have a set of required fire tools at all times.

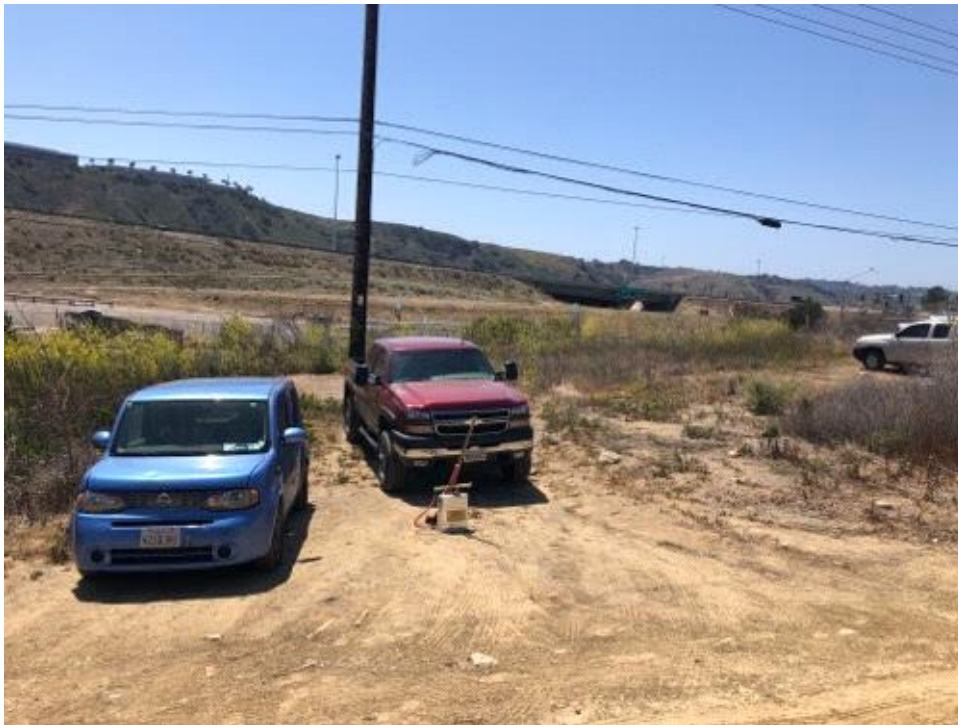
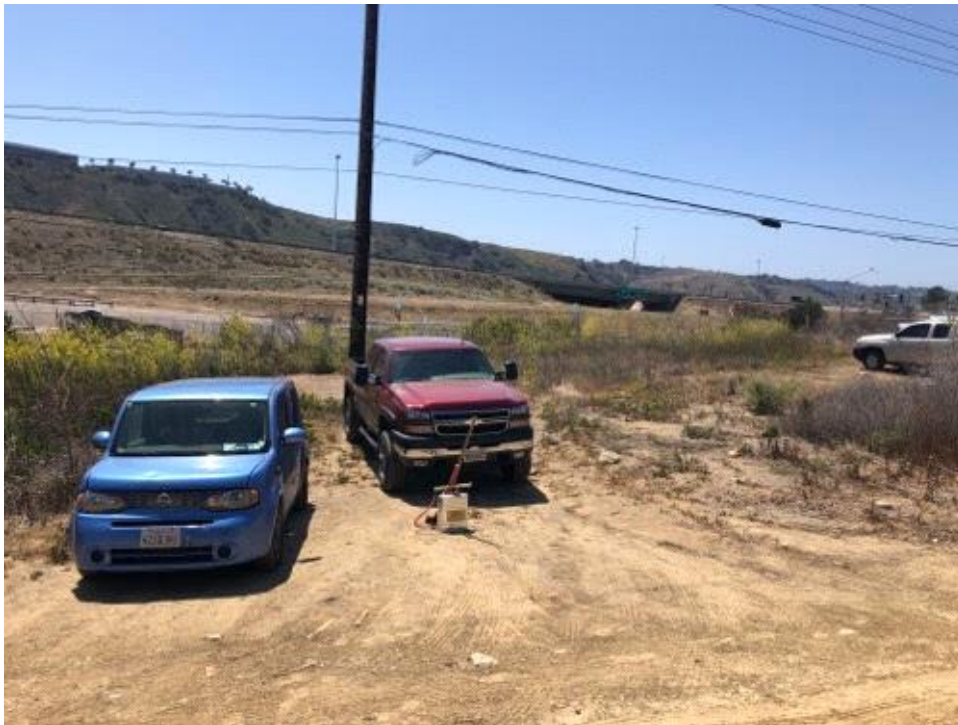
Caption POVs - crew added 4 set of tools to cover the 9 vehicles.

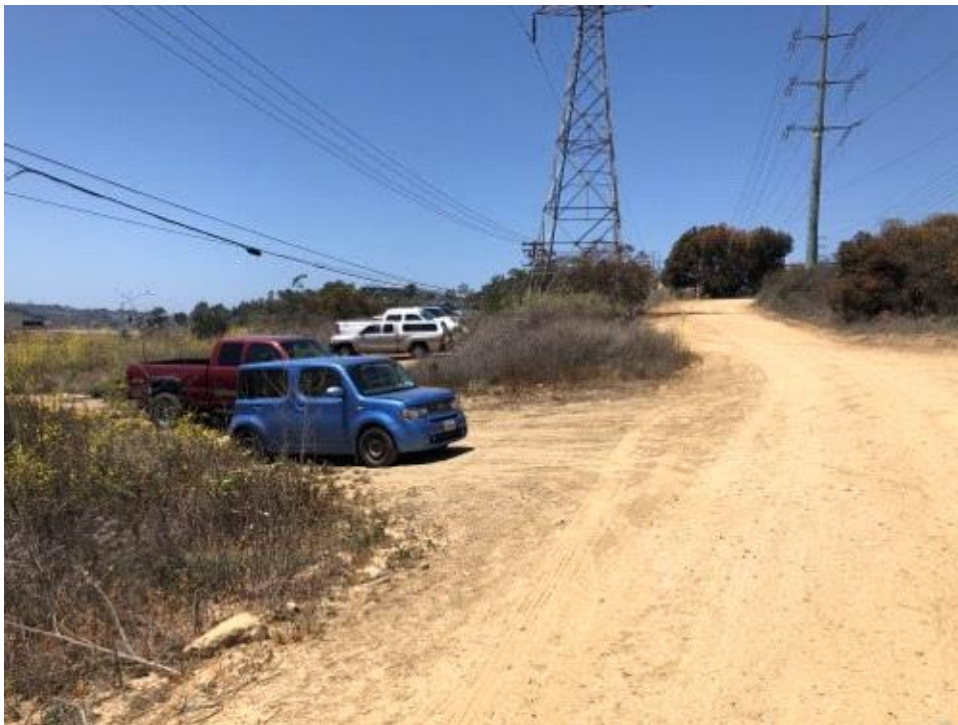
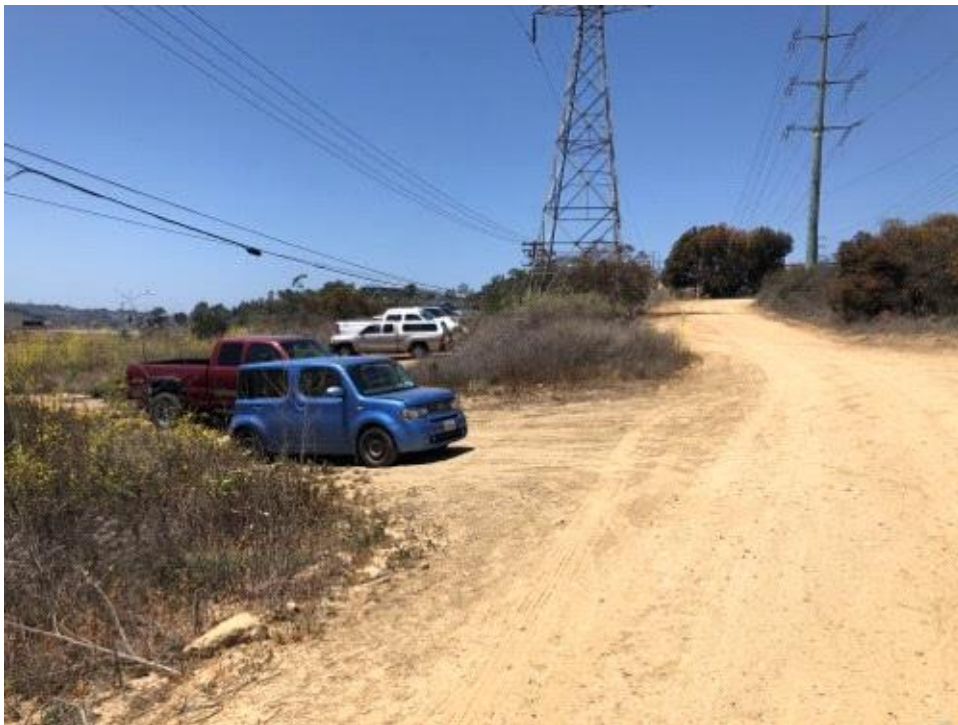
Caption POVs parked beneath lines northeast of CC MM CP.

1. May 18, 2017: Fire tools were missing at several work locations.
2. June 8, 2017: Vehicles, equipment and work areas not equipped with fire tools; pumps were not full of water; and improper fire shovels were in use.
3. June 15, 2017: Vehicles and one work area not equipped with the required fire tools.
4. July 20, 2017: Worker smoking in non-smoking area.
5. August 28, 2017: Equipment parked on grass during elevated fire conditions, and vehicle parked in ROW not equipped with fire tools.
6. April 27, 2018: Privately-owned vehicles parked outside of the MPR #14 Staging Area without the required fire tools.

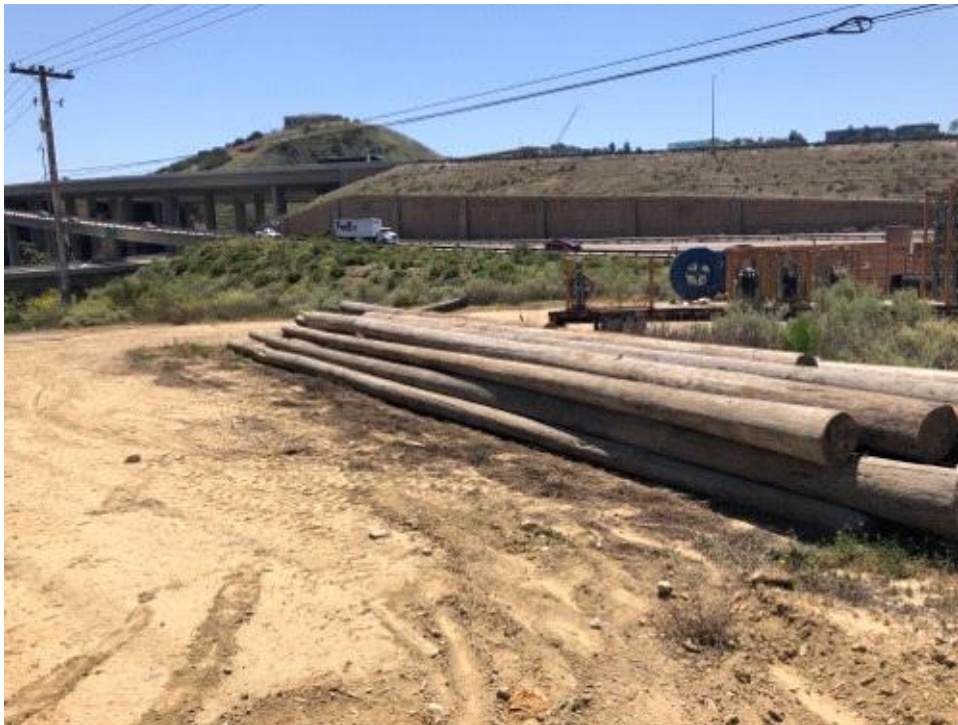
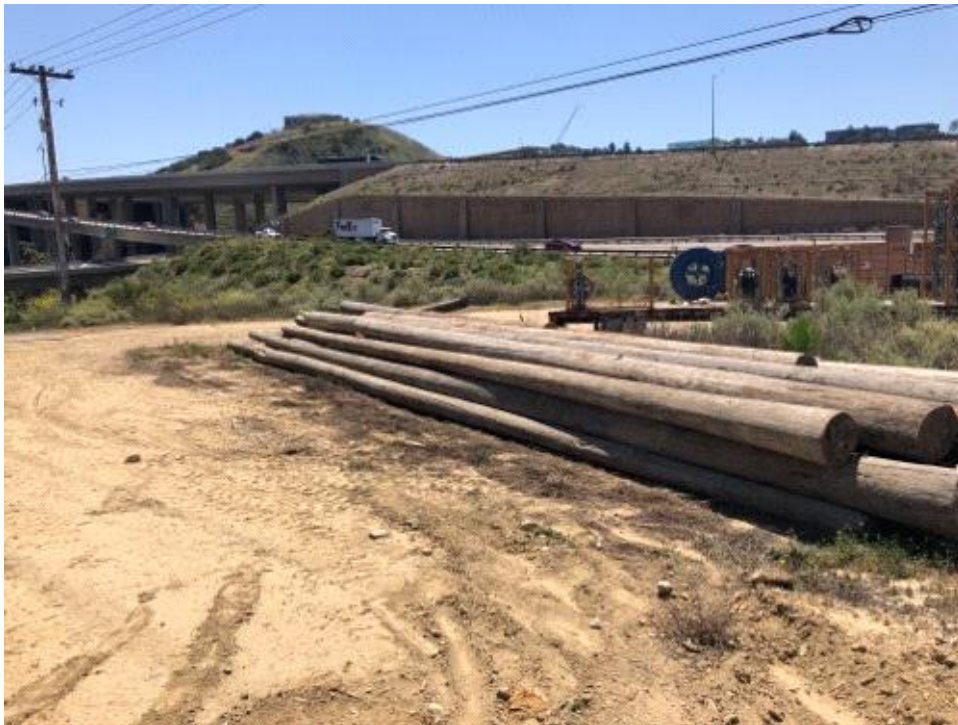
Caption Pole pile east of CC MM CP.

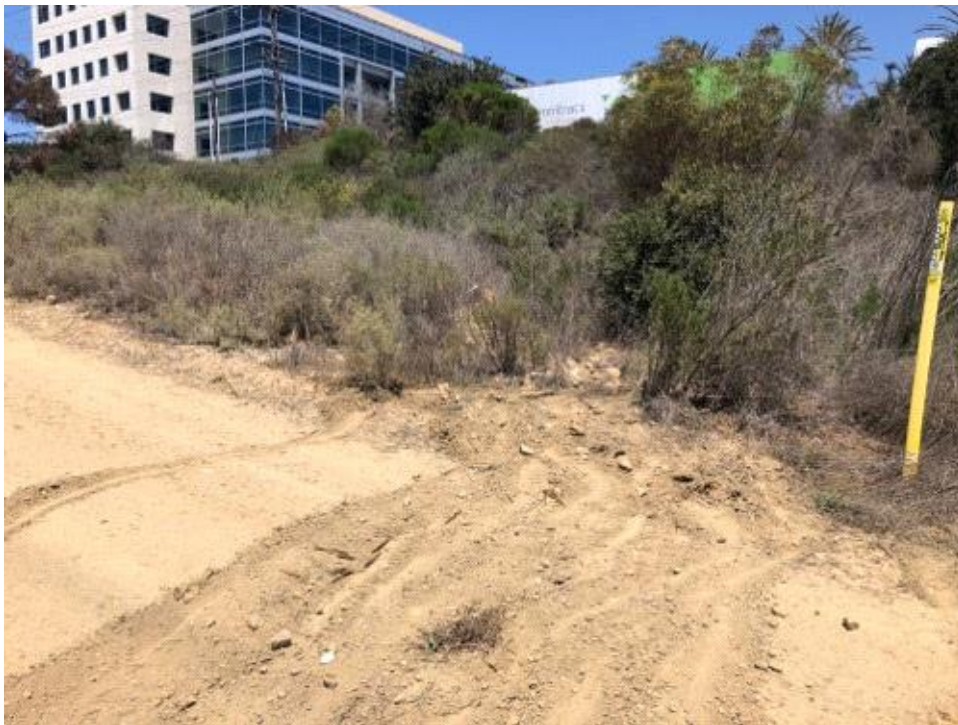
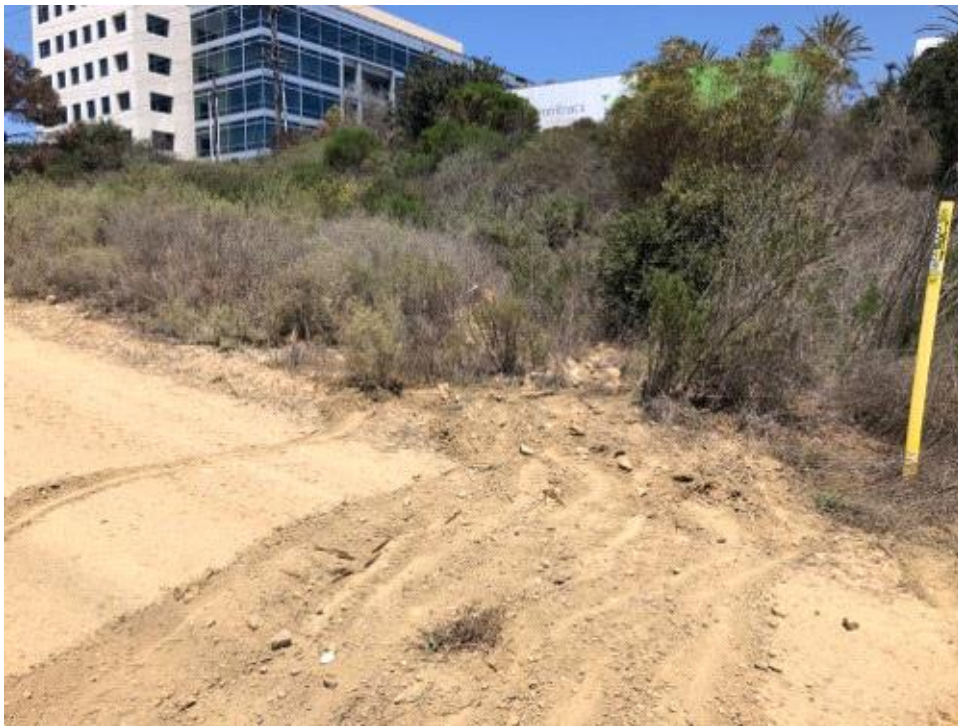
Caption Small ground disturbance and vegetation impact east of CC MM CP.

On April 27, 2018, a Wilson construction crew arrived onsite to remove wooden guard structure poles. During removal, the Wilson crew drove off the access road crushing vegetation. The vegetation impacts occurred within, and just outside of, the northeast corner of the approved temporary work space limits of the stringing site located north of CC MM CP. In addition, a nesting bird survey had not been conducted in that area in accordance with MM Biology-7 as vegetation impacts were not anticipated as a result of this work.

On April 27, 2018 during a routine inspection, the California Public Utilities Commission (CPUC) Environmental Monitor discovered the crushed vegetation and notified the SDG&E Environmental Inspector (EI). Upon notification from the CPUC Environmental Monitor, the EI conducted an impact assessment (see attached) of the area on the same day. During the impact assessment it was observed that two tire tracks, each approximately 2 feet (ft.) wide extended approximately 7 ft. outside of the approved temporary work space limits and resulted in approximately 6 square ft. of crushed vegetation.

As a corrective action, Wilson will be required to provide advanced notice of any activities to be performed on the Project and an EI will accompany Wilson crews to monitor that work occurs within work limits and surveys are performed prior to any vegetation or ground disturbing activities as required.

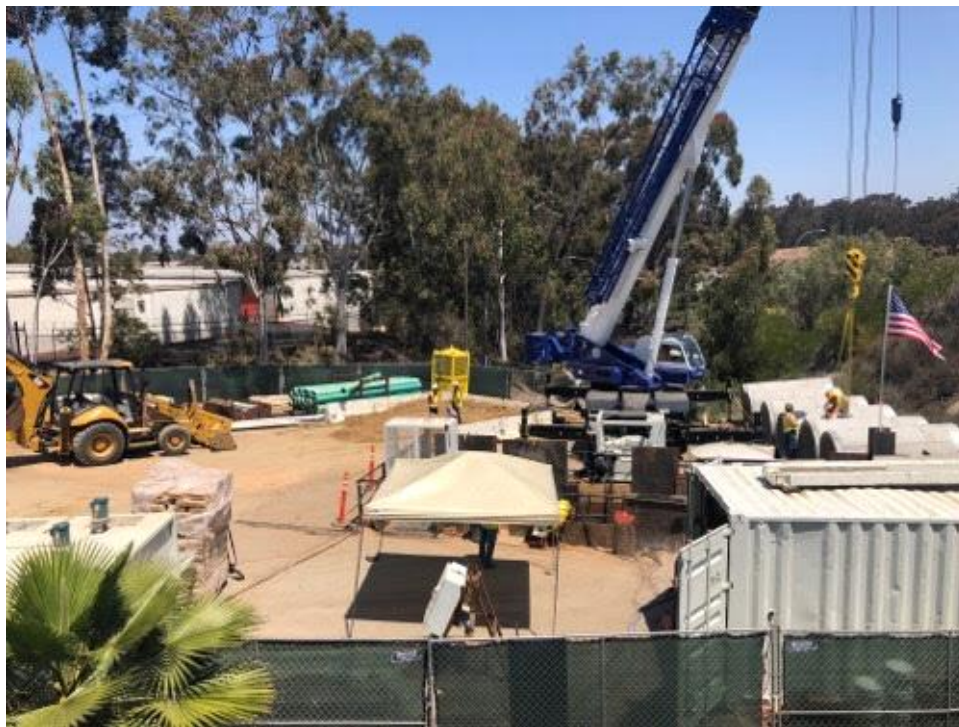
Cultural monitor inspecting spoils at west bore pit site.
