PROJECT MEMORANDUM SYCAMORE-PEÑASQUITOS 230-KV TRANSMISSION LINE PROJECT

Date: July 16, 2018
To: Billie Blanchard, CPUC Project Manager
From: Jessica Hing, CPUC Monitoring Supervisor (back-up)
Subject: Weekly Report #79 – July 2-7, 2018

2018-07-07 AM Inspection Report

SDG&E Sycamore-Peñasquitos 230-kV Transmission Line Project: Daily Inspection Report

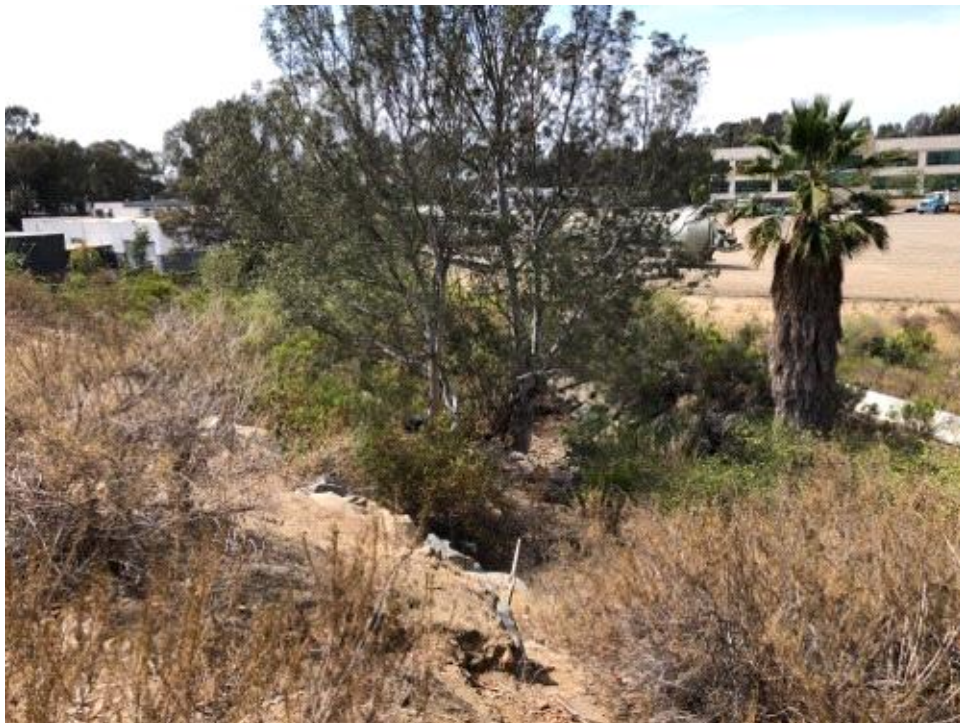
Caption Drainage north of outlet RD.

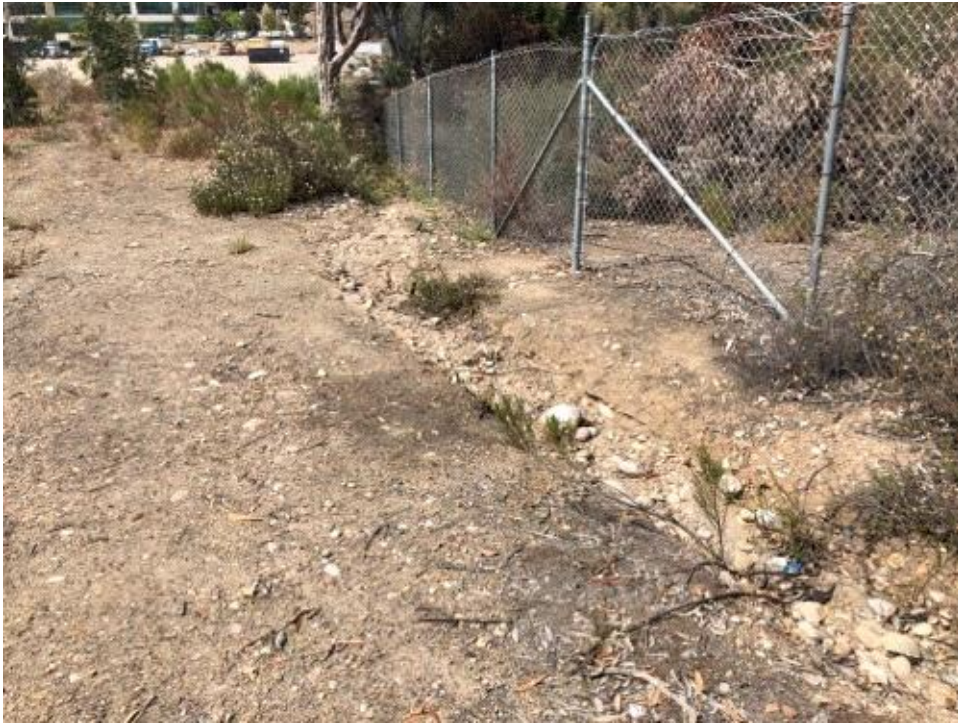
Channel off outlet road.

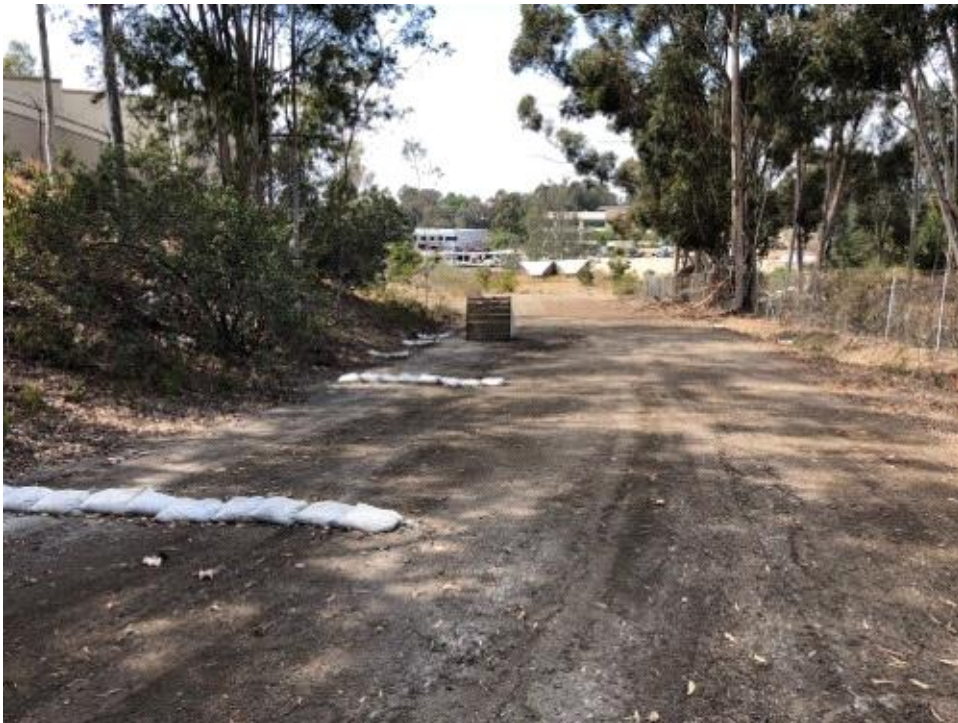
Outlet area.

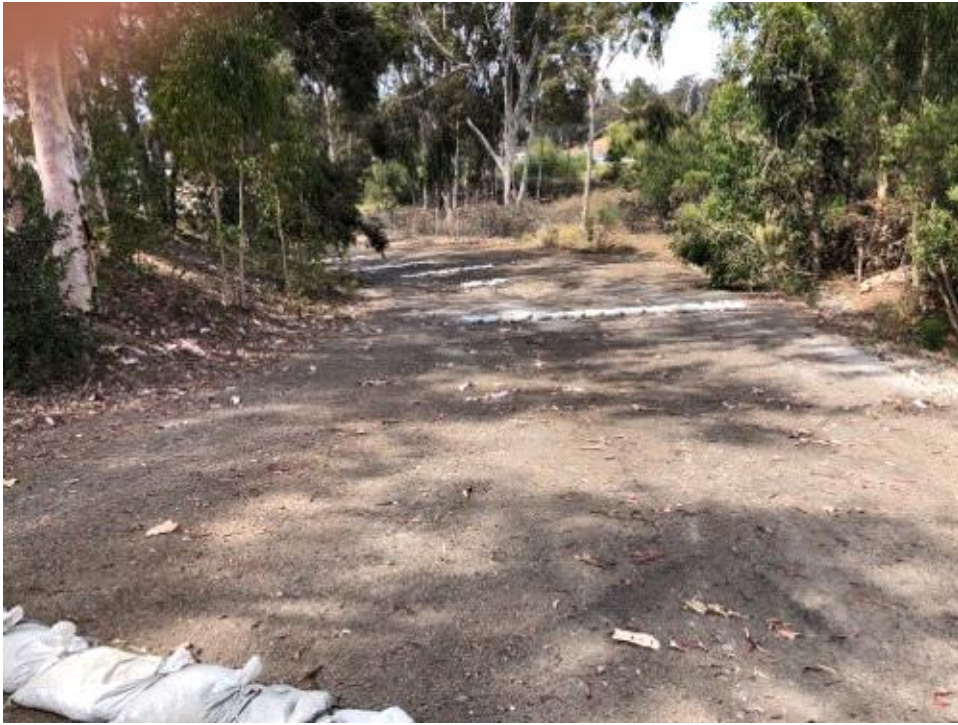
Caption Outlet area north of vault.

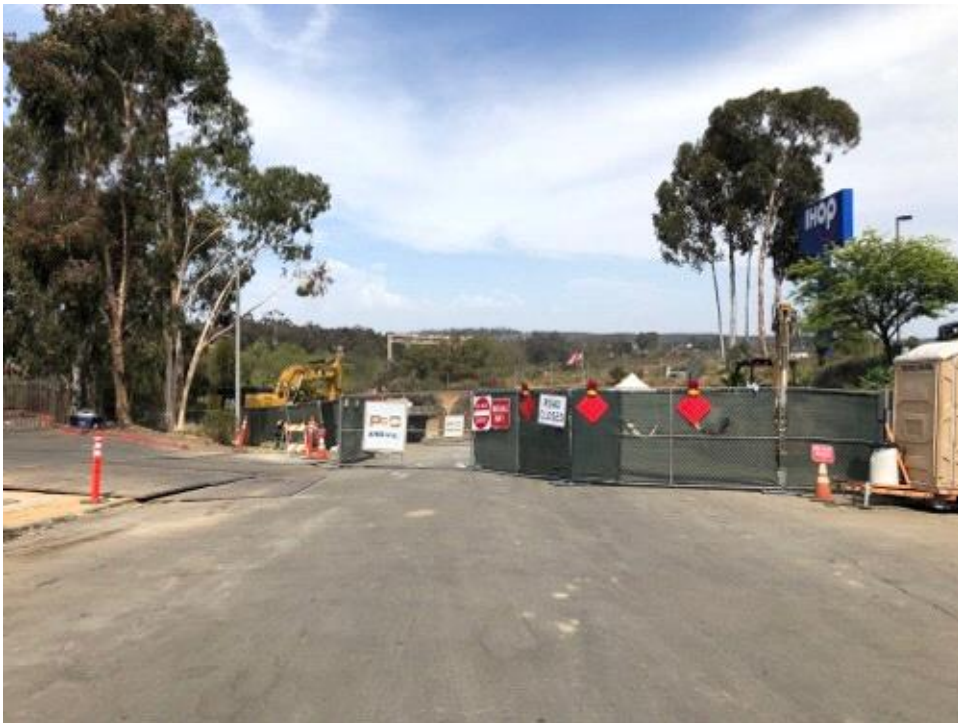
Caption Western vault no work at time of photo.

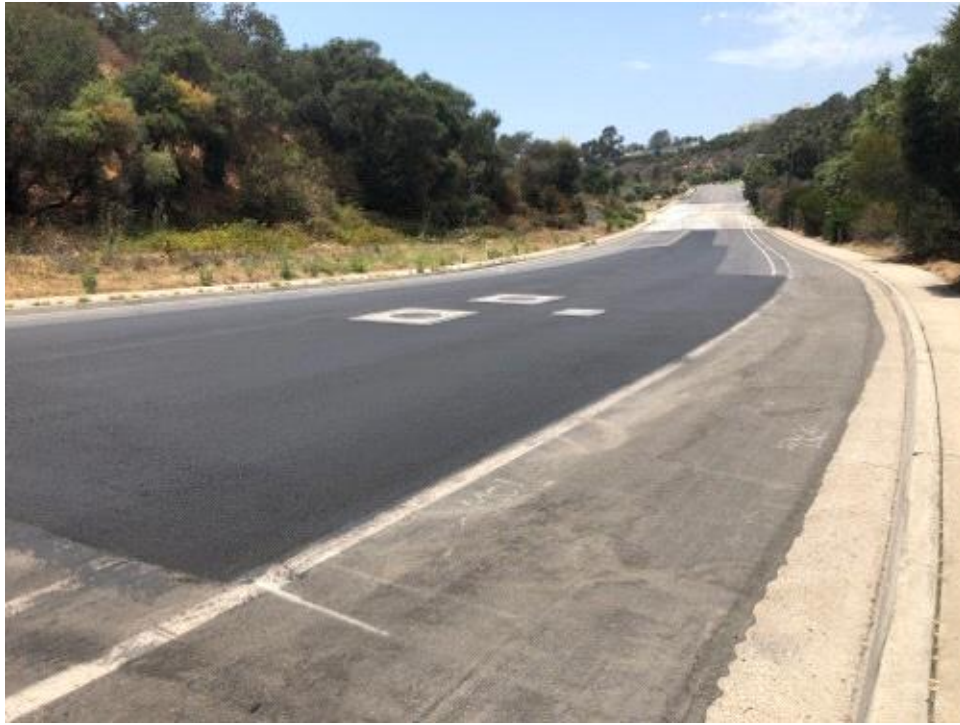
Caption Vault area paved on Carroll.

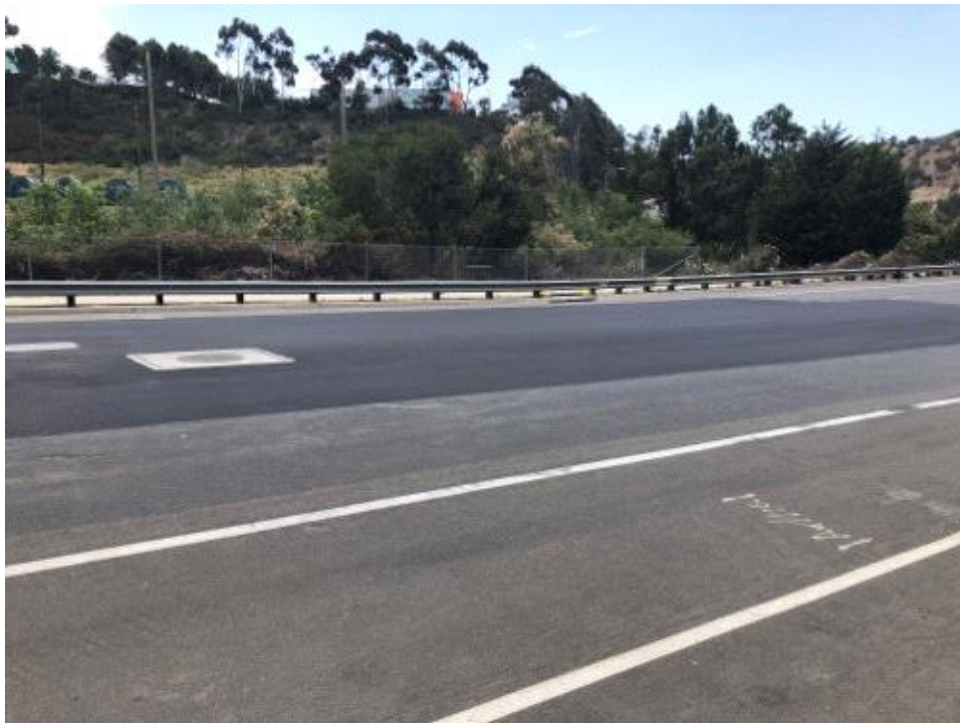
Caption Paved street, vault and storm drain inlet. Note BMPs not actively installed.

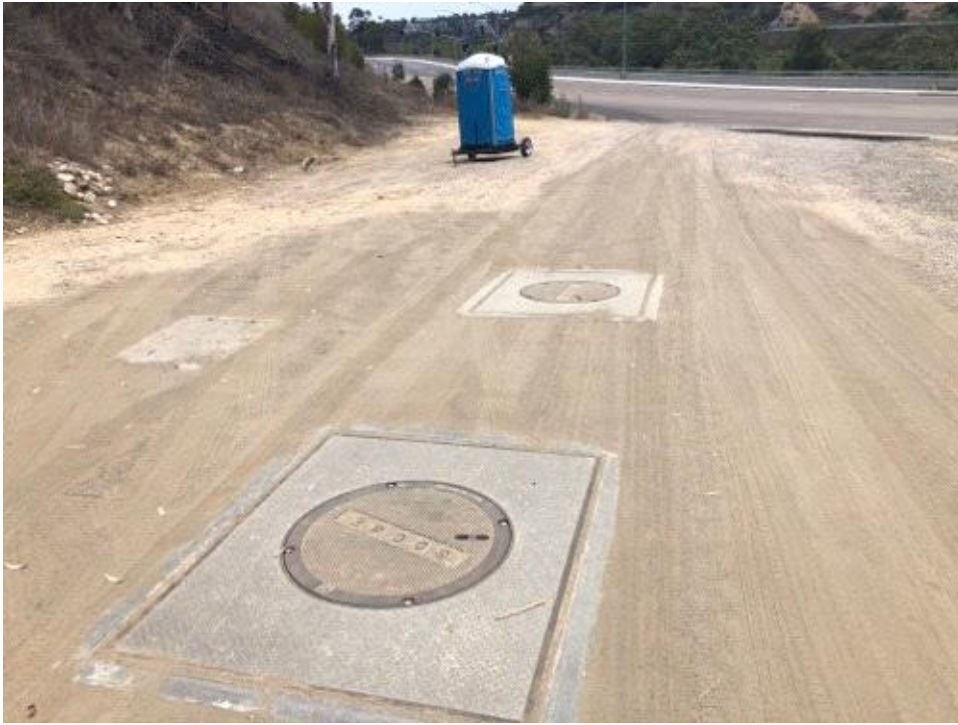
Caption Vaults north of Carroll Canyon Rd and south of CC MM CP.

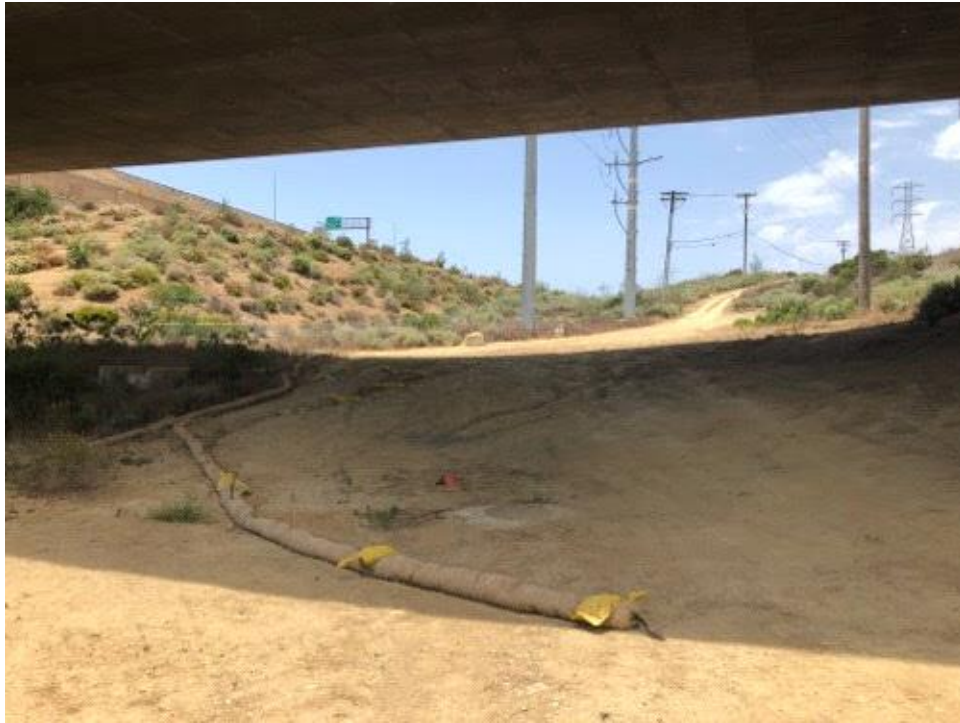
Caption BMPs beneath Carroll Canyon Rd bridge.

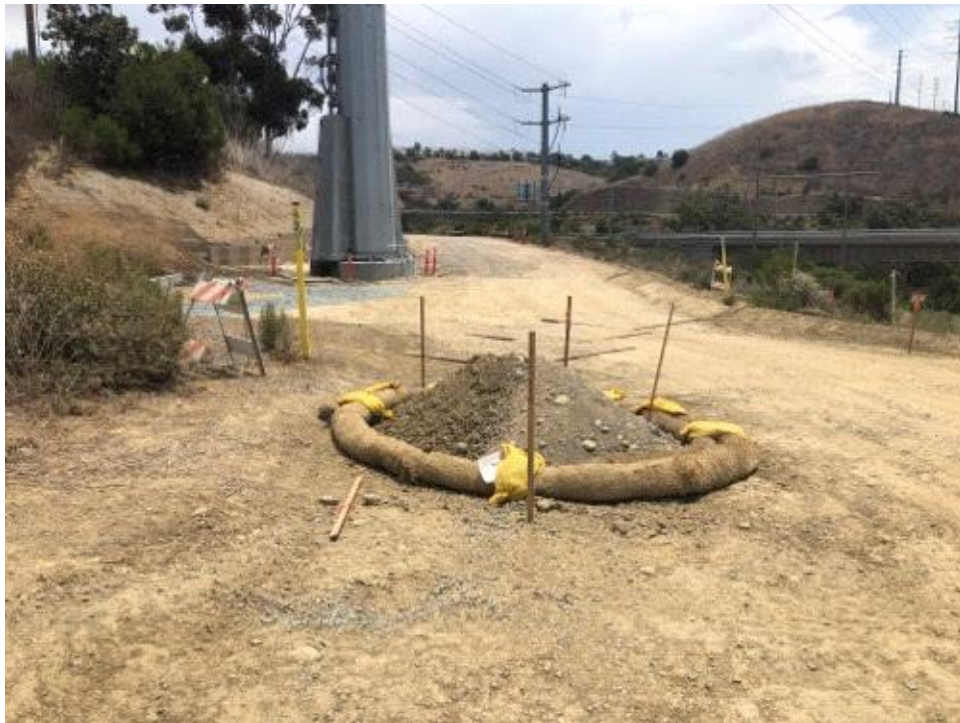
Caption Stockpile CC MM CP with BMP protection.

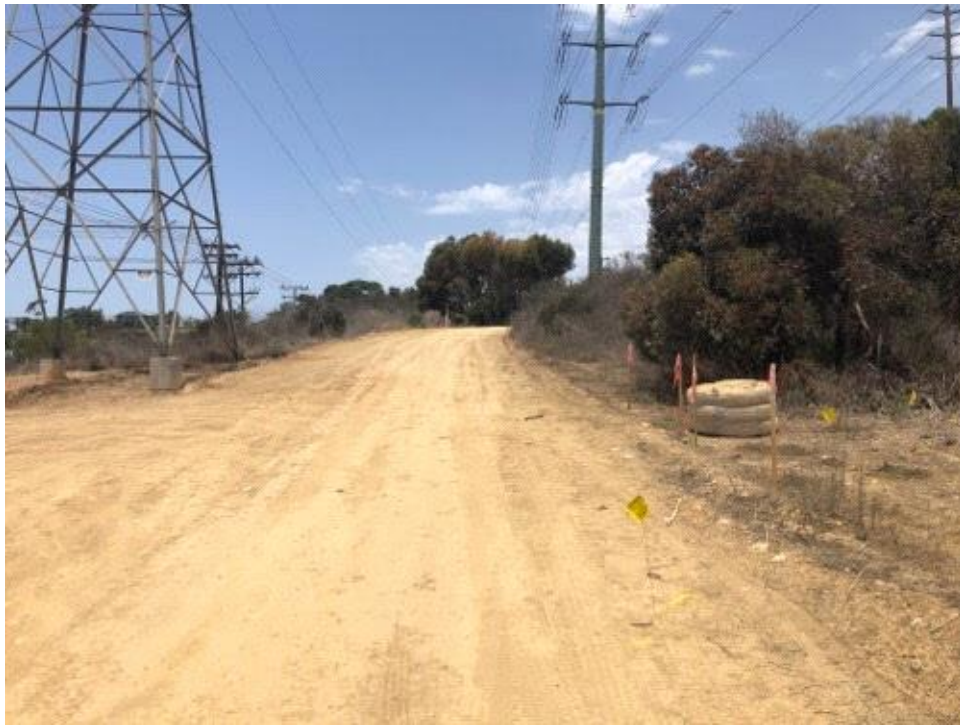
Caption Access road north of CC MM CP.
