PUBLIC UTILITIES COMMISSION

GA2014-04

SUBJECT: General Order 112-E Gas Audit of PG&E's Sierra Division

SUMMARY OF INSPECTION FINDINGS

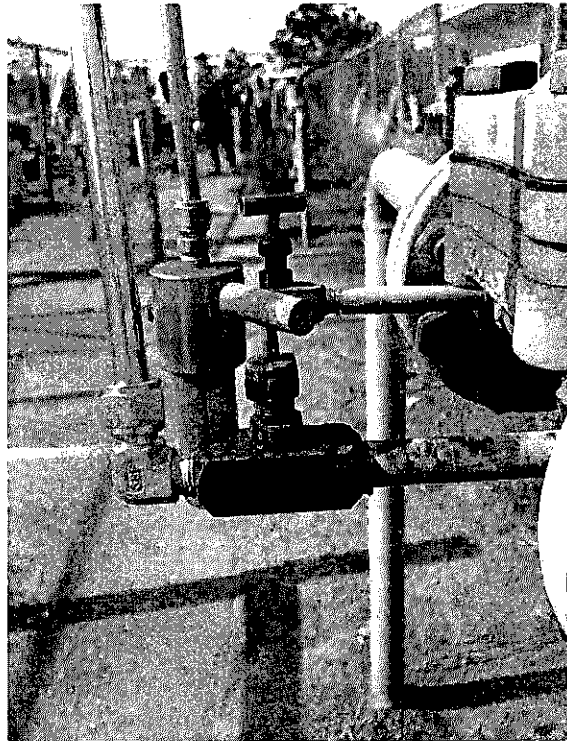
2.3 On 5/1/14, SED and PG&E visited Regulator Station, MRB-99, located on 6th Street and Walnut Street in Marysville to exercise valves. SED observed Atmospheric Corrosion (AC) on bleed sense part of the regulator station.

Photo 2- Atmospheric Corrosion observed on Valve 5 located at Regulator Station MRB-99

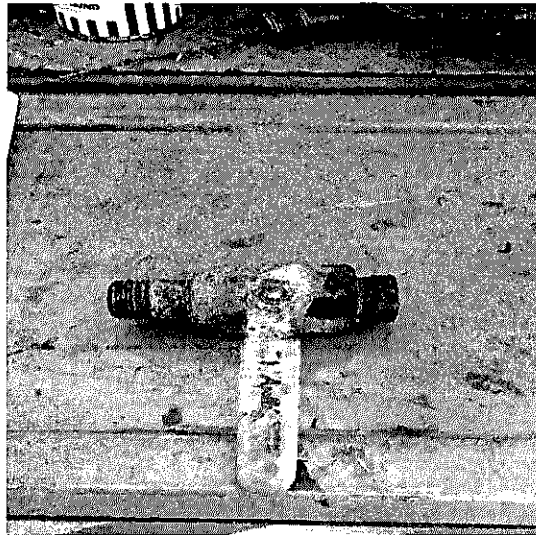
1. On 5/1/14, SED and PG&E visited Regulator Stations, MRB-73A and MRB-73 located on Township & Almandra in Yuba City. SED noted the following deficiencies at these regulator stations:
 - Station diagram for both stations shows Valve 13 which no longer exists since PG&E removed it. Division needs to update the station diagram. Please provide SED with a copy of the revised diagram.
 - During the field check, PG&E crews found a fuzz leak on the stand-by (left) side of the monitor (upstream vault) of the Regulator Station MRB-73A and repaired it by removing the old ball valve, shown in Photo 3, and replaced it with ½" ball valve. After the repair, crew soap tested it and did not find any leaks.

Photo 3- Leaking valve located at the bottom of the filter cylinder that was replaced during field visit on May 1, 2014 at Regulator Station MRB-73A

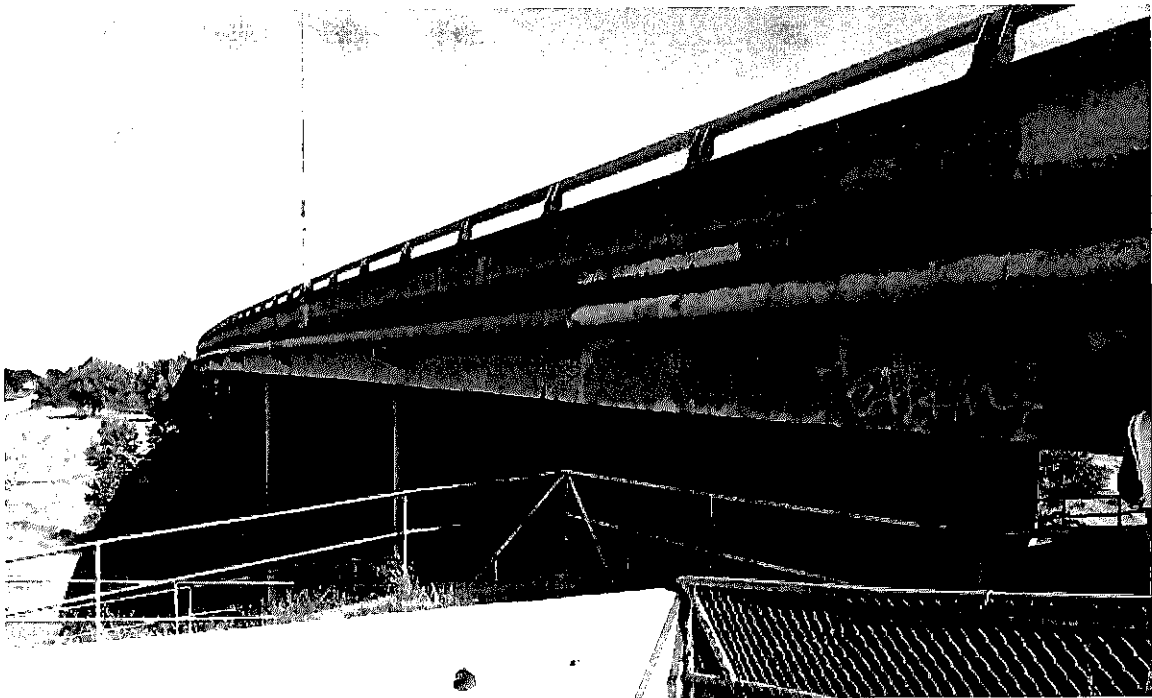
Photo 4- Span L-124B at MP 22.59

- a. Maintenance record of transmission valve V-7 Tap SAP WM NO. 41431641 was incomplete. Division staff didn't check the box on transmission valve type (EMERGENCY or OTHER).
 - b. Maintenance record of transmission valve V - 38.05 SAP WM NO. C-A010 42577652 was incomplete. Division staff didn't fill out the service history completely on 5/28/2013, missing information on columns (OPERATE and VALVE POSITION).
6. On May 2, 2014, during a field visit to a pipe span on Line 124B, SED observed a comprised pipe hanger on the north side of the span, shown in Photo 4. The concrete around the anchor bolts supporting the pipe hanger appeared to be crumbling. Additionally, pipeline markers were not visible at the time of the field visit.

Please provide SED with an update on the Division's follow up actions.
