Date: March 20, 1989  
To: GOLDEN GATE REGION  
From: GAS SYSTEM DESIGN  
Subject: Failure of Longitudinal Weld on  
30-Inch Steel Pipe

**MATERIAL AND/OR EQUIPMENT - PROBLEM OR FAILURE REPORT**

Date March 1, 1989 File # 4152  
To GAS SYSTEM DESIGN  
From TECHNICAL AND ECOLOGICAL SERVICES  
Subject [REDACTED] 30" Transmission Line Failure

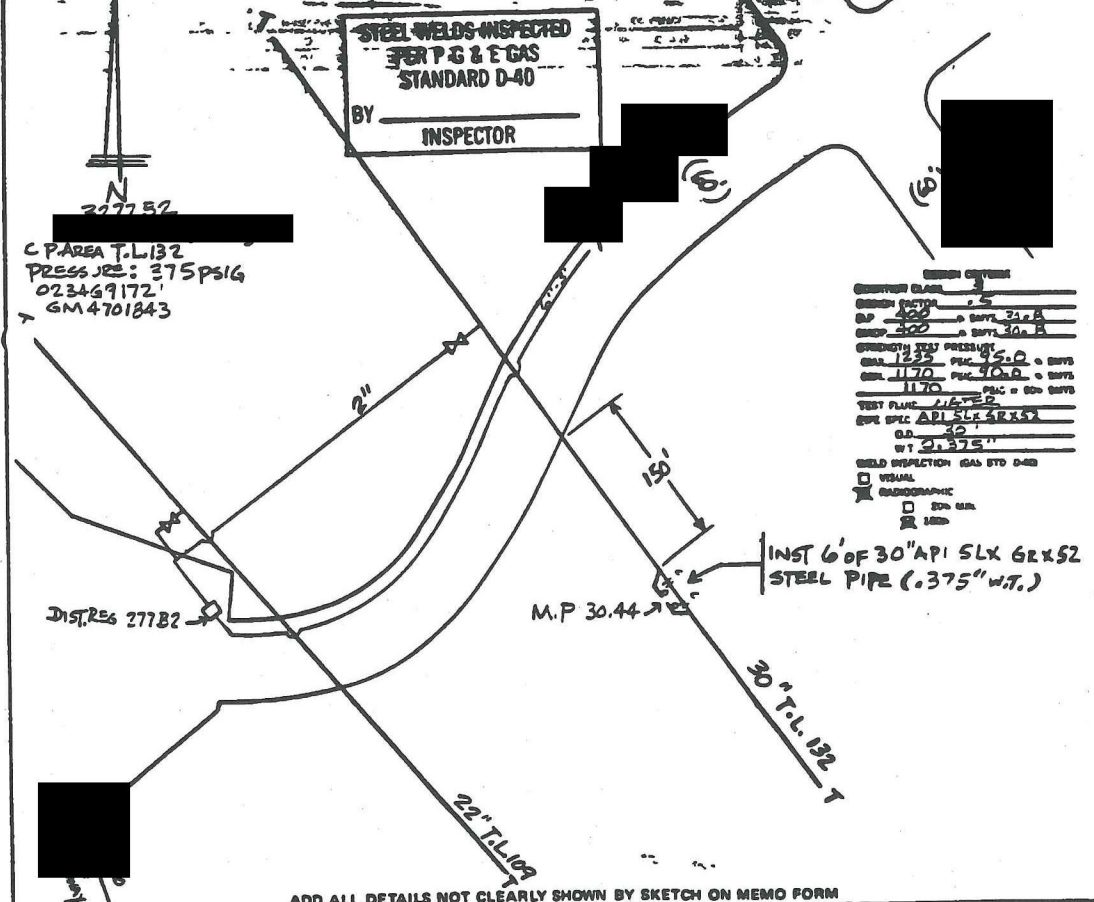
SKETCH OF WORK - Foreman to connect & charge to make - otherwise O.K. by installing

IT IS NECESSARY TO REPLACE A 6' SECTION OF 30" T.L. 132 DUE TO A LONGITUDINAL WELD DEFECT.

Dy	C	ACCOUNT	SUB ACCOUNT	SPECIAL CODE	DESCRIPTION OF DIRECT COST ITEMS (If involved estimate give summary item—detail on other sheets)	WEEKDAYS of UNIT AMOUNT	AMOUNT (Dollars Only)					
							LABOR	MATERIAL	UTILITY RELATED COST	CONTRACT OR OUTSIDE SERVICES	OTHER	
02	132	3475	6034		SHUTDOWN AND RESTORE MAIN	40	5800		75	1000		
02	132	3664	2040		REPAIR LONGITUDINAL WELD DEFECT	22	3190	300		5000
