CALIFORNIA PUBLIC UTILITIES COMMISSION
Safety and Enforcement Division
Electric Safety and Reliability Branch

Incident Investigation Report

Incident Number: E20171010-02

Utility: Pacific Gas and Electric Company (PG&E)

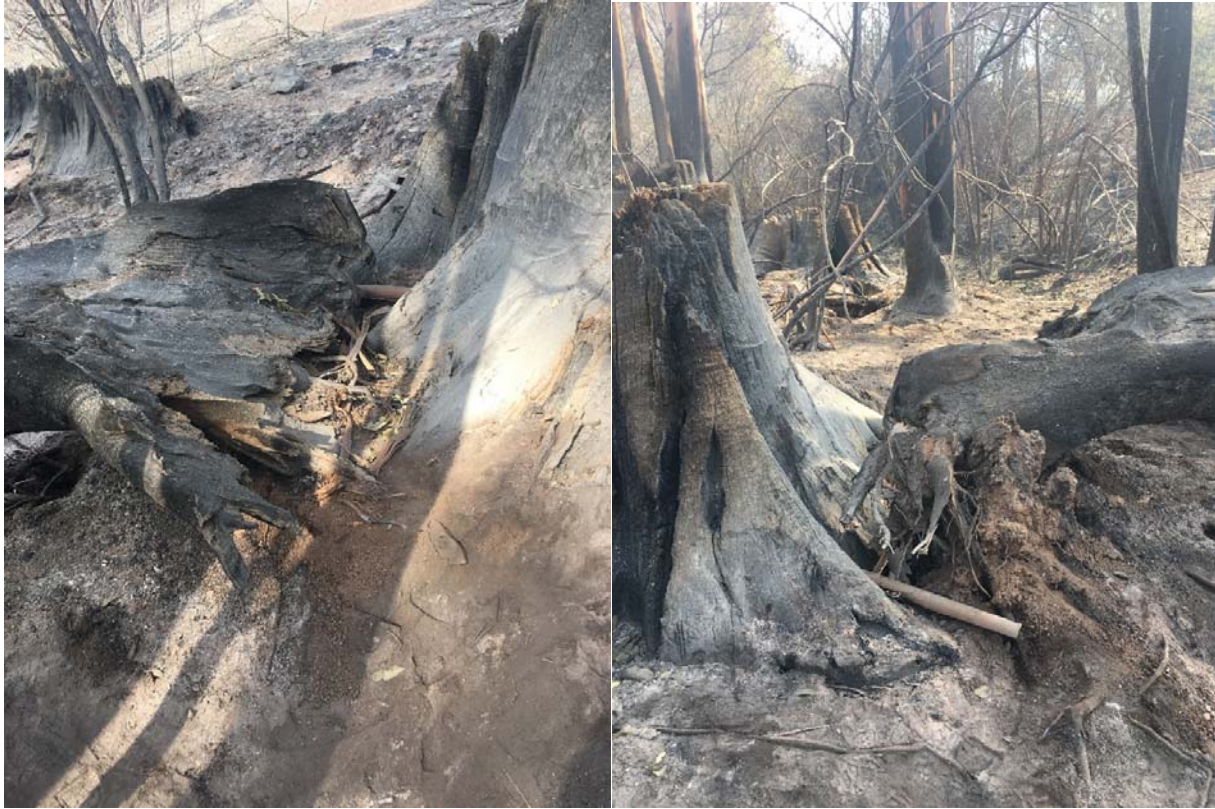
CAL FIRE contracted a Certified Arborist, Mark Porter, to evaluate the subject Eucalyptus tree failure. In Mr. Porter's "Evaluation of Tree Failure" report¹⁷ the subject tree was described as a re-growth from a once mature Eucalyptus that was cut down to a stump. "The stump had decayed over time and was utterly hollow at the time of inspection. The epicormic shoot approximately 109 feet high, was weakly attached to a rotting stump."¹⁸ Epicormics are defined as shoots or branches "growing from a previously dormant bud on the trunk or a limb of a tree."¹⁹ In this case a dormant bud sprouted a tree from the dead Eucalyptus stump. The report also identified that "the epicormics shoot developed with a one-sided buttress root." Buttress roots are the roots at the trunk base that help support the tree and equalize mechanical stress. The report further explains that the roots did not fully develop for stability which created an "unequaled mechanical stress".

Figure 2. Left. Base of Eucalyptus epicormic shoot separated from dead stump (photo facing south). **Right.** Base of Eucalyptus epicormic shoot and dead stump (photo facing north).

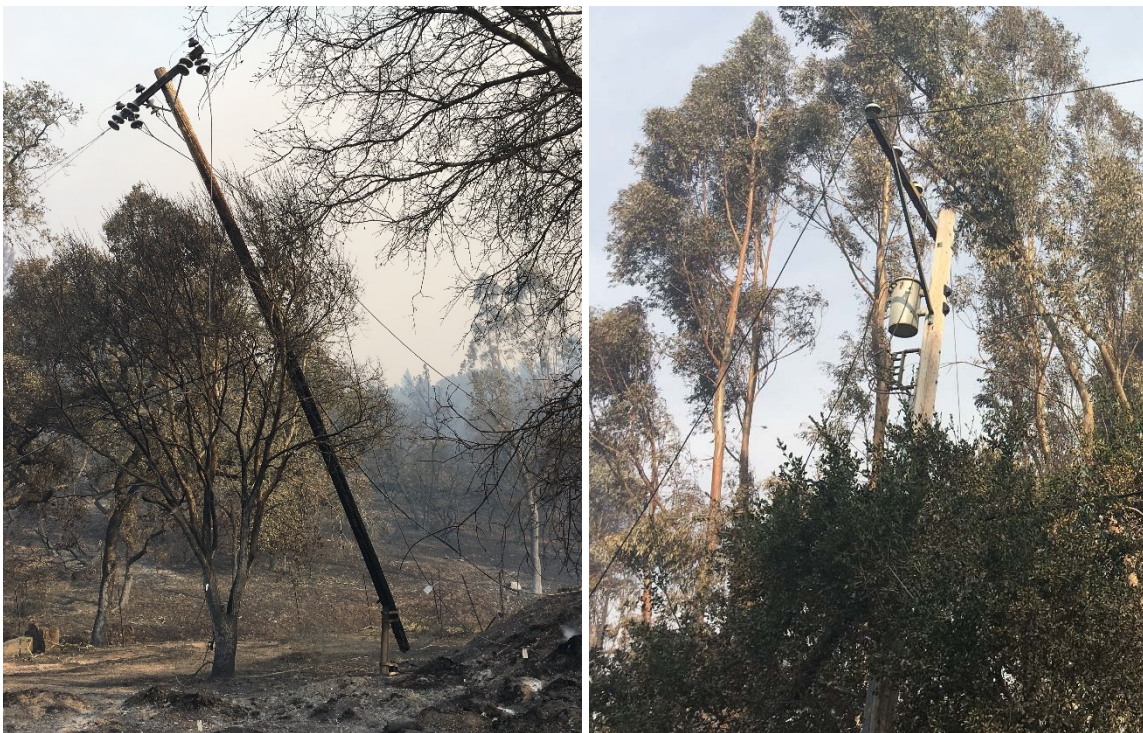
Figure 4. Left: Subject Pole #6 (Coordinates: 38.4283590, -122.5489570). Photo taken from southeast side of pole. **Right:** Subject Pole #5 (Coordinates: 38.4284454, -122.5480649). Photo taken from the southwest side of failed pole.

Pole #6 failed at the ground level with two spans of three phase conductors attached above and running in two opposing directions. Pole #6 also had an anchor guy attached to counter the imbalanced load caused by the spans in two different directions. PG&E had previously installed structural steel reinforcement at the ground level for Pole #6 in February 2002²⁴. This subject pole passed the last intrusive inspection on April 11, 2017²⁵.

Pole #5 did not fail and had an “alley arm” construction with all three primary insulators set on one side of the pole. Also attached to Pole #5 was one 15 KVA transformer with three secondary conductors directly below. The two insulators that were attached to the top of the transformer were pulled out due to the lateral force on the conductors from the subject tree. PG&E also installed structural steel reinforcement at the ground level for Pole #5 in February 2002²⁶. This subject pole required replacement after the last intrusive inspection on April 11, 2017²⁷.

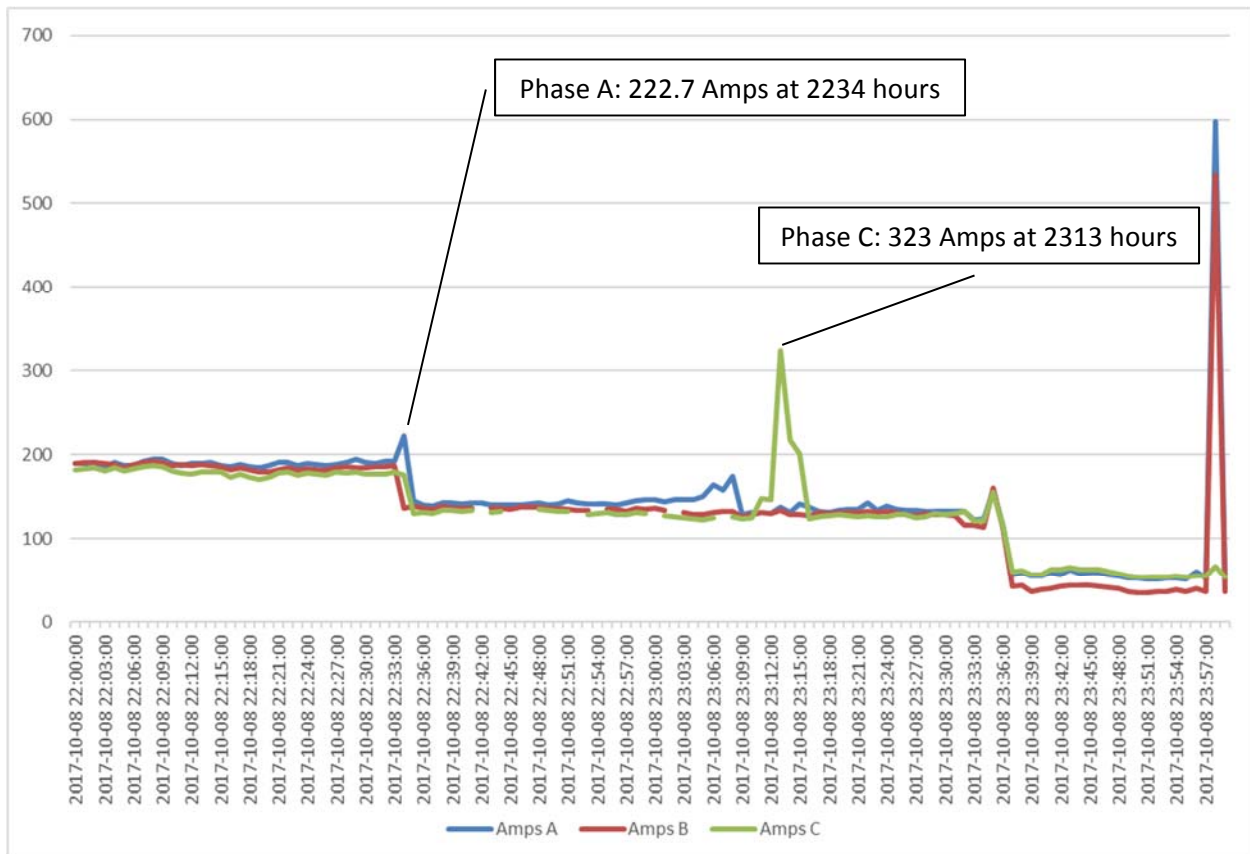
Figure 7. SCADA plot of load data recorded at Dunbar-1101 CB on October 8, 2017, from 2200 hours to 2359 hours. Highlight of load reduction event at 2233 to 2235 hours.

On October 8, 2017, at 2234 hours, SED staff believes the load reduction to be linked to the operation of two fuses that are part of fuse 1261. The subject Eucalyptus tree falling into the overhead lines likely caused a ground fault condition and ultimately the fire.

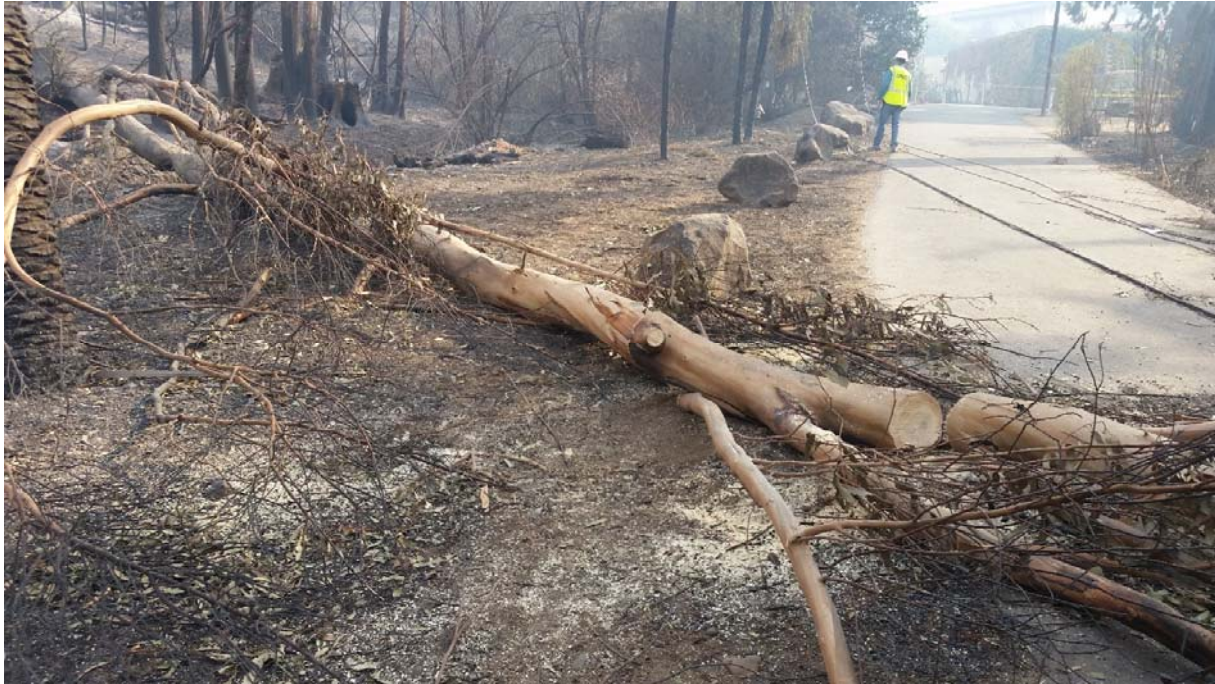
Figure 8. Subject Eucalyptus tree laying across the road and subject conductor spans. The tree was rooted in the top left corner of the image. (October 17, 2017)

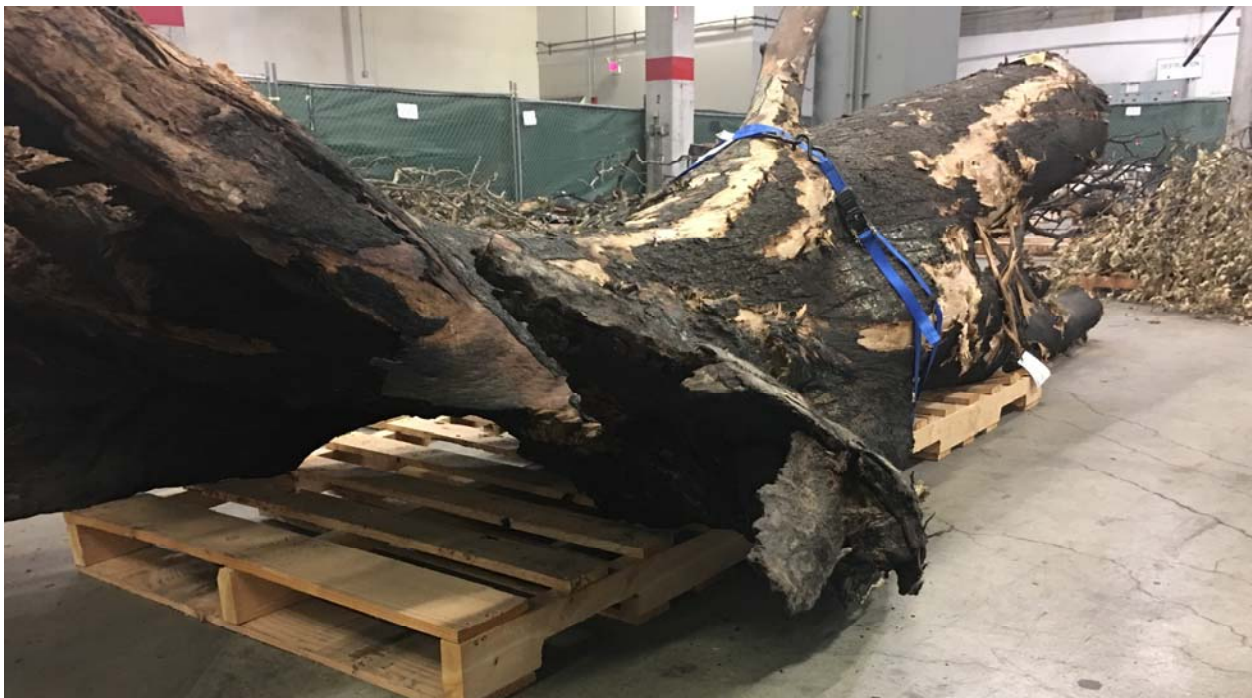
On June 11, 2018, SED staff visited PG&E's evidence storage location in Oakland, California. SED identified the base of the Eucalyptus tree and photographed the unbalanced root system mentioned in Mr. Porter's report.

Figure 9. Subject Eucalyptus tree base with unbalanced root system. (June 11, 2018)

Mr. Porter determined that the tree failure was caused by a weak connection of the epicormic shoot, the height of the epicormic, decay in the stump, a one-sided root system, and unbalanced tree base³⁵.

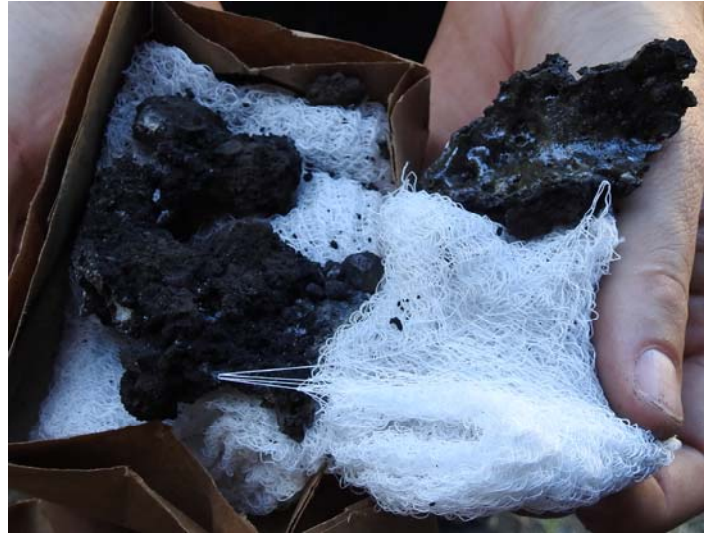
Figure 10. Fulgarite-like mass found in the Adobe incident area.

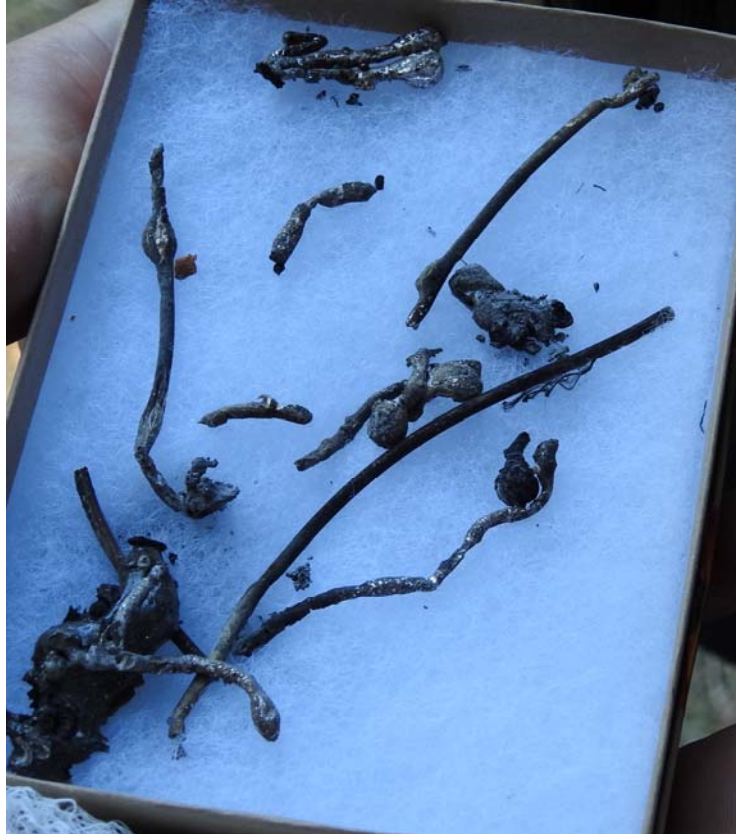
SED staff did not unwind the multiple bundles of conductor wire but reviewed the failure points. The Eucalyptus tree and fire damaged the insulating rubber material around the conductors. SED found evidence of arcing exhibited by molten metal attached to failed pieces of conductor.

Figure 11. Failed pieces of conductor strands and evidence of arcing.

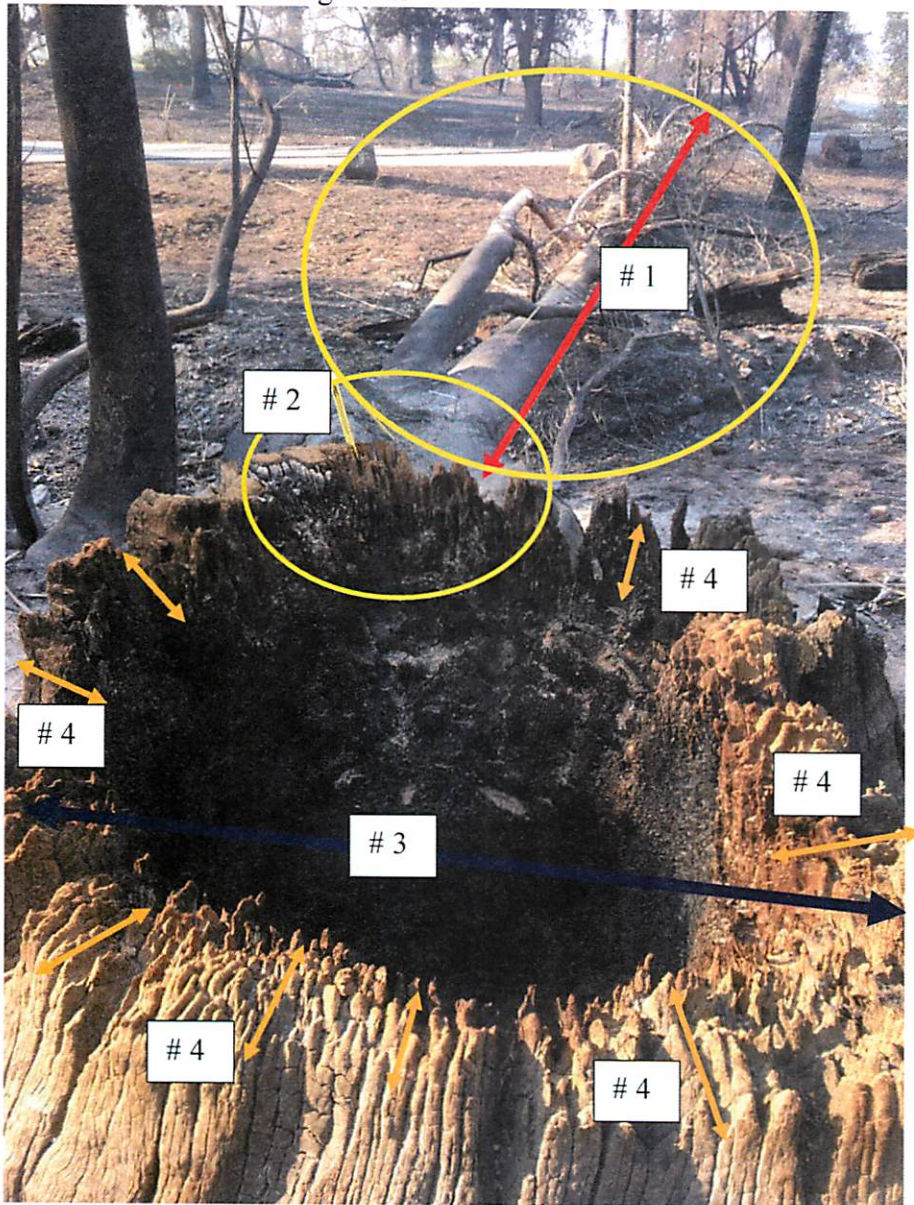
Appendix III Photo 3 Subject Tree

Weakly attached epicormic shoot failure. Technically a trunk failure.

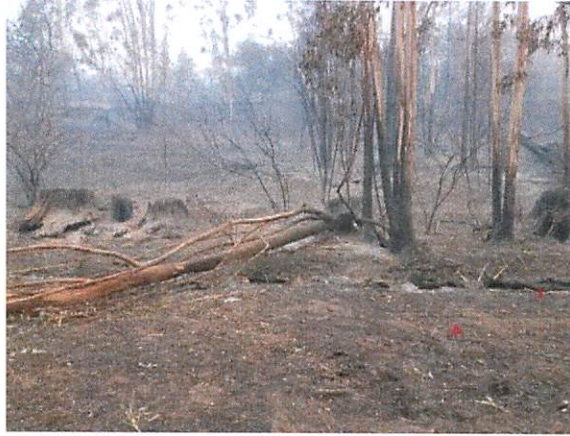
Figure 1: Fallen Eucalyptus stump sprout. Also in the frame are Eucalyptus sprouts growing from other stumps within the stand.

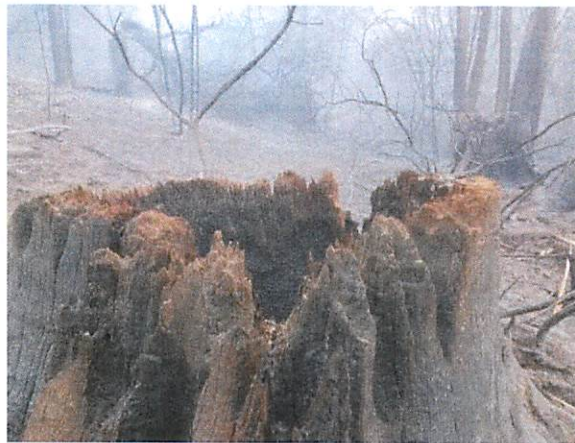
Figure 2: The flat top to this stump indicates that the portion of the tree above it was cut, as opposed to breaking off. The same flattened top can be seen in the stump in the background. The consistent state of decay and similar size of the stump sprouts indicate that these trees were all cut in one entry.

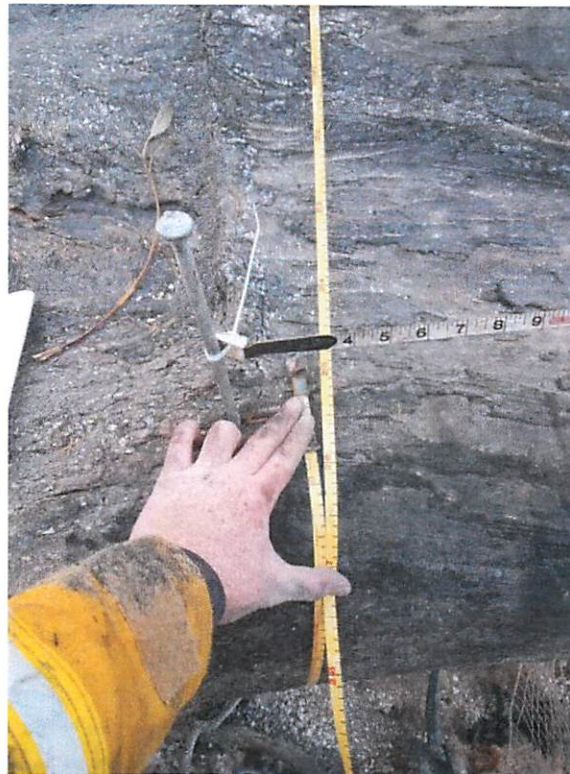
Figure 3: Diameter taken at the point where the sprout was growing over the top of the old stump. The ridge that is visible where the nail is driven in is the edge where the sprout met the top of the old stump.

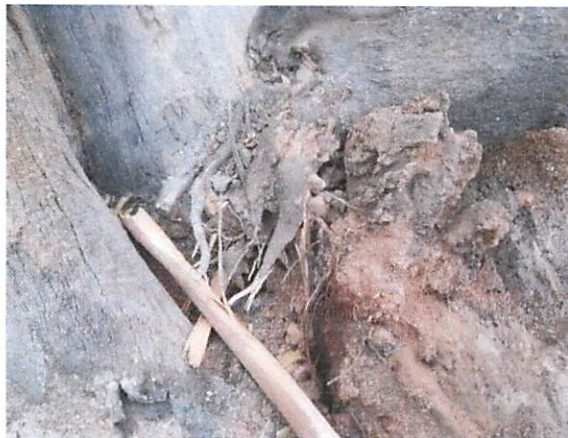
The tree in question is a sprout growing from the still living root system of a tree that was cut down many years previously. The sprout forks into two stems, a secondary and a main stem, 8.2' above the root collar. The sprout was growing up over the top of the stump it was sprouting from, but was only rooted at the base of the tree at the root collar (Figure 8 and Figure 9). The failure of the stump appeared to be due to a structural weakness as opposed to any insects, decay, or other pathogen. The branches on the sprout in question were all weighted to one side, consistent with how the tree fell (Figure 10).

Figure 9: Close up view of the roots of the sprout at the base of the old stump.

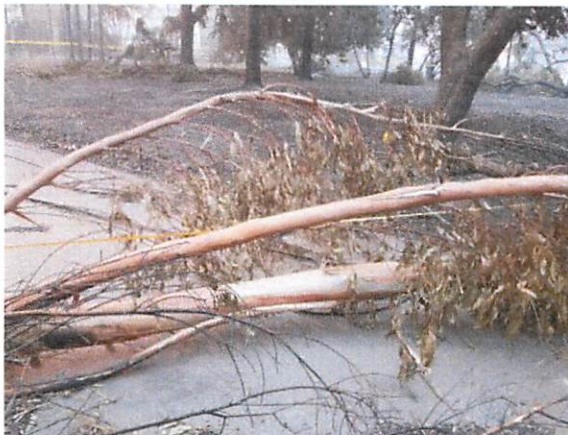
Figure 10: The branches in this image can all be clearly seen growing from the same side of the main stem.
