**CALIFORNIA PUBLIC UTILITIES COMMISSION**  
**Safety and Enforcement Division**  
**Electric Safety and Reliability Branch**

**Incident Investigation Report**

**Incident Number:** E20171011-02

**Utility Facilities Involved:** Redbud 1102, 12 kV Circuit

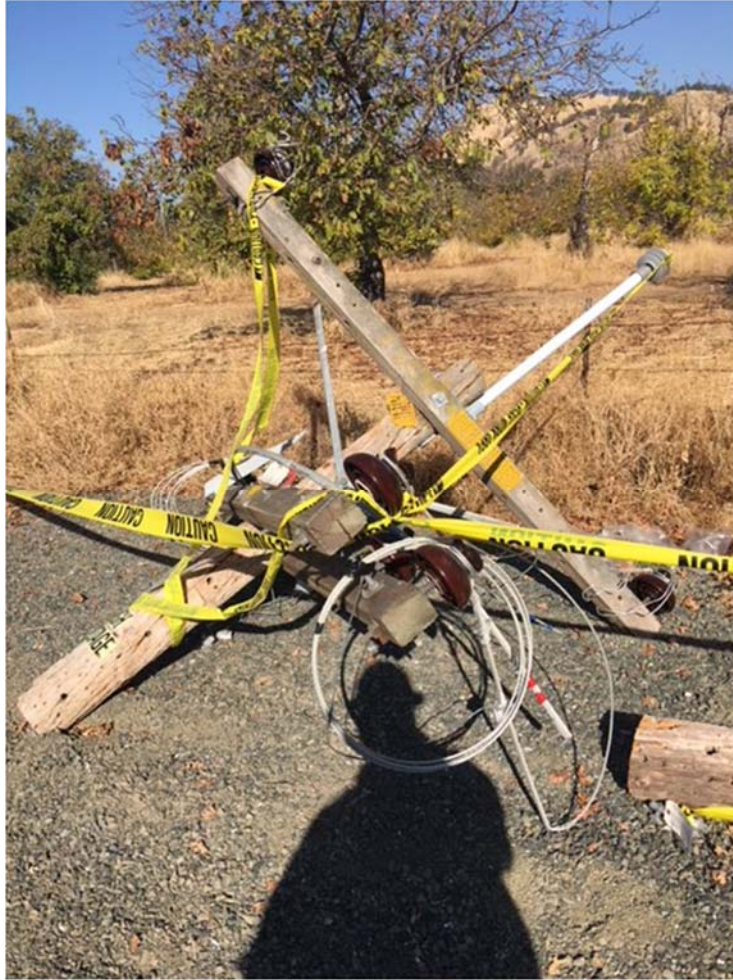
SED observed the pole and equipment that was left by CAL FIRE for PG&E to store for evidence. SED observed the pole and the section of the pole where CAL FIRE removed the 4 to 6-foot pole section. The three fuse cutout brackets and a section of jumper wire that went to the two cross arms were missing from the pole. SED did not observe any burn marks on the pole. SED observed the pole top may have had some type of decay, but could not make a clear assessment. It was later clarified in a PG&E Data Request Response #1 that the top of the pole was not rotten. SED took numerous pictures of the pole and the evidence tags.

**Figure 2.** Fuse Cutout pole at PG&E's Clearlake Service Center

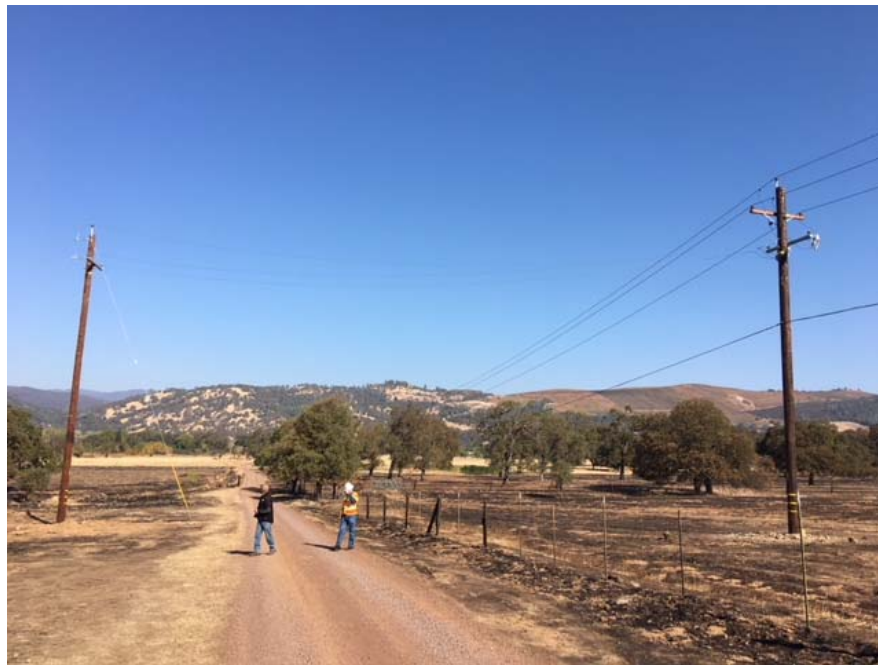
Furthermore, SED reviewed the work orders for replacement of both poles. PG&E work orders #113702903<sup>11</sup> and #113723126<sup>12</sup> were completed on October 13, 2017.

**Figure 3.** New Fuse Cutout Pole 1447 (left) and new second pole to the west #120143559 (right).

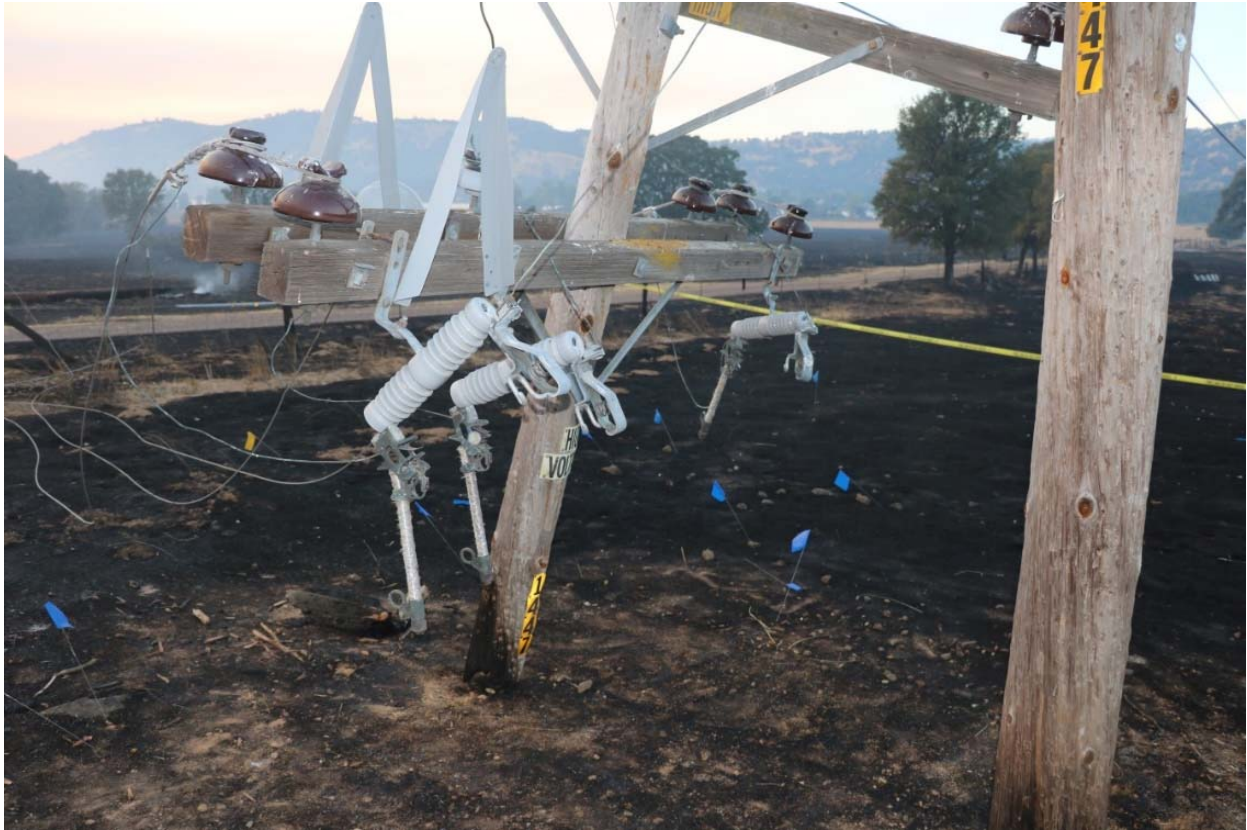
On July 6, 2018 SED met with CAL FIRE Battalion Chief Joseph Baldwin in Middletown to view the evidence CAL FIRE retained from the Sulphur Fire incident site. Chief Baldwin stated the broken portion (top section) of the Fuse Cutout Pole 1447 was found standing upright from its broken point with burn marks found at the bottom. (Figure 6)

**Figure 6.** The subject pole (Fuse Cutout Pole 1447) found after arrival. (Source: CAL FIRE)

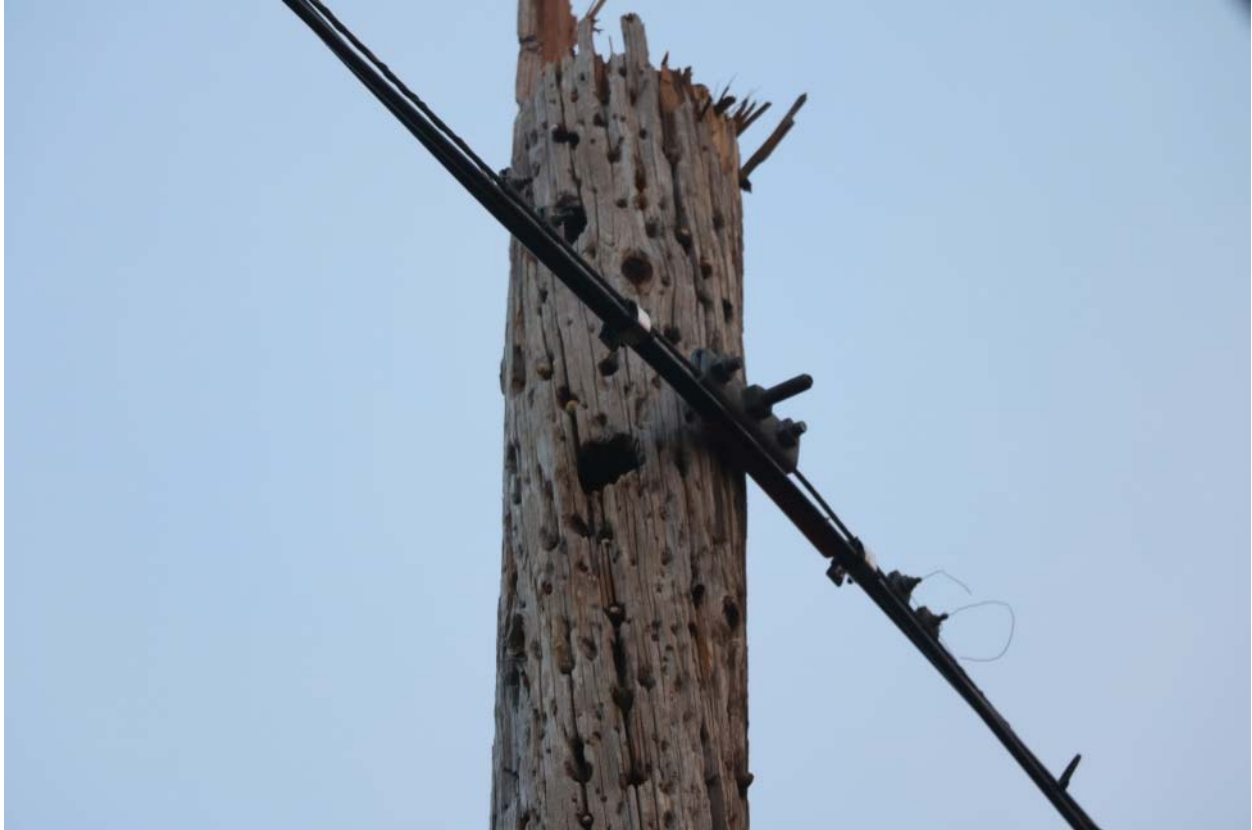
The bottom section of the pole was broken off at approximately 18 inches above the communication cable attachment. There were various woodpecker holes in this broken section of the pole. (Figure 7)

**Figure 7.** Break 18 inches above the communication conductor attachment on Fuse Cutout Pole 1447 with woodpecker holes (Source: CAL FIRE)

The section of pole that had been cut by CAL FIRE was covered in woodpecker holes. Chief Baldwin stated that the amount of woodpecker holes severely weakened the pole and contributed to its failure.

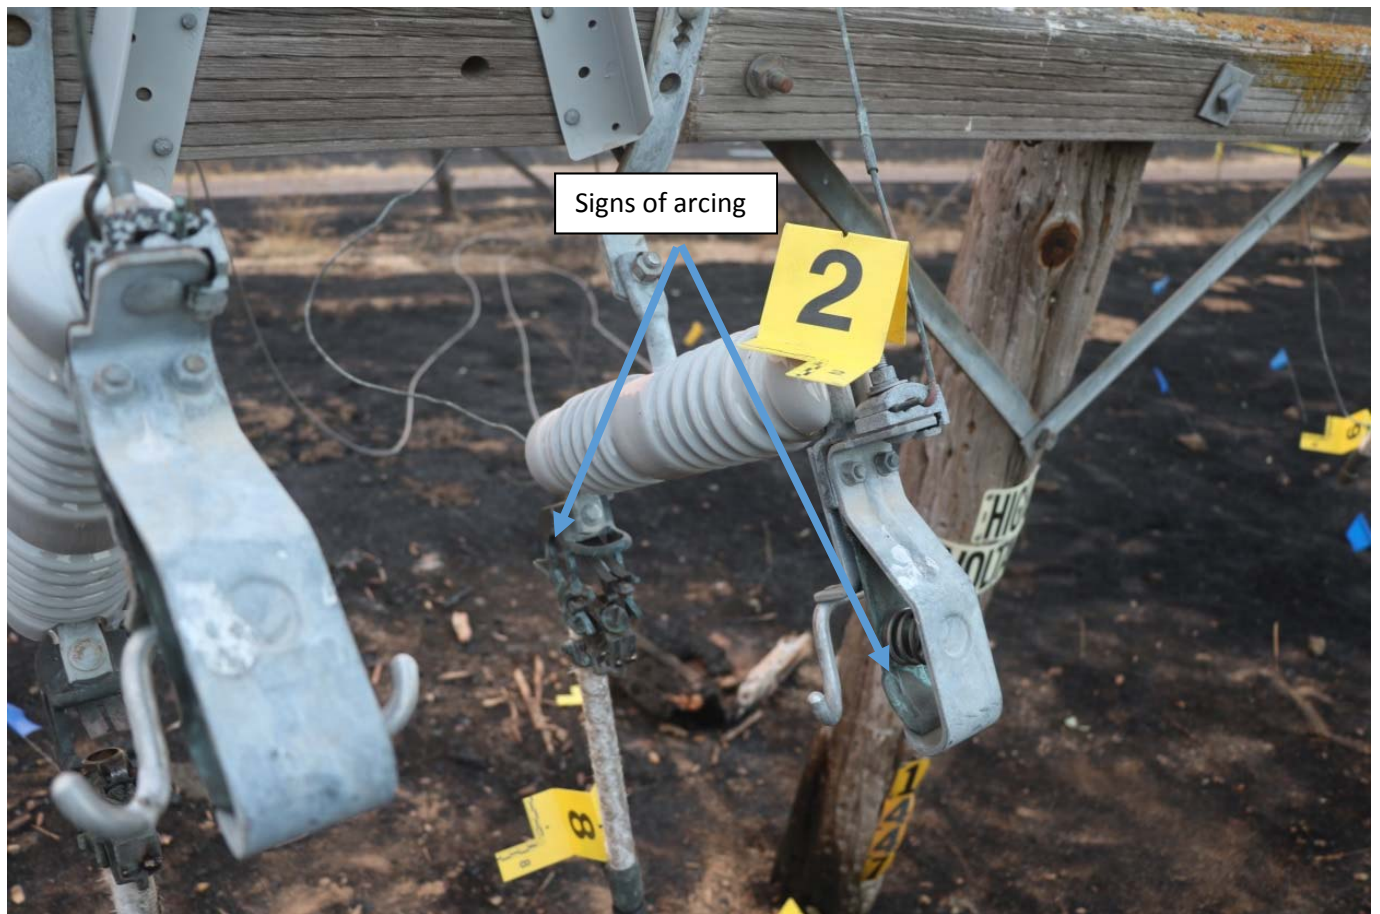
Chief Baldwin stated that he believes that the force of impact from the broken portion of the pole caused all three fuses to open and arc. SED viewed the three fuse insulators, three fuses and the section of the pole CAL FIRE had cut from Fuse Cutout Pole 1447. All three fuses were opened, and SED observed signs of arcing (greenish coloring) on all three fuse insulators.

**Figure 8.** Signs of arcing on the fuses (Source: CAL FIRE)

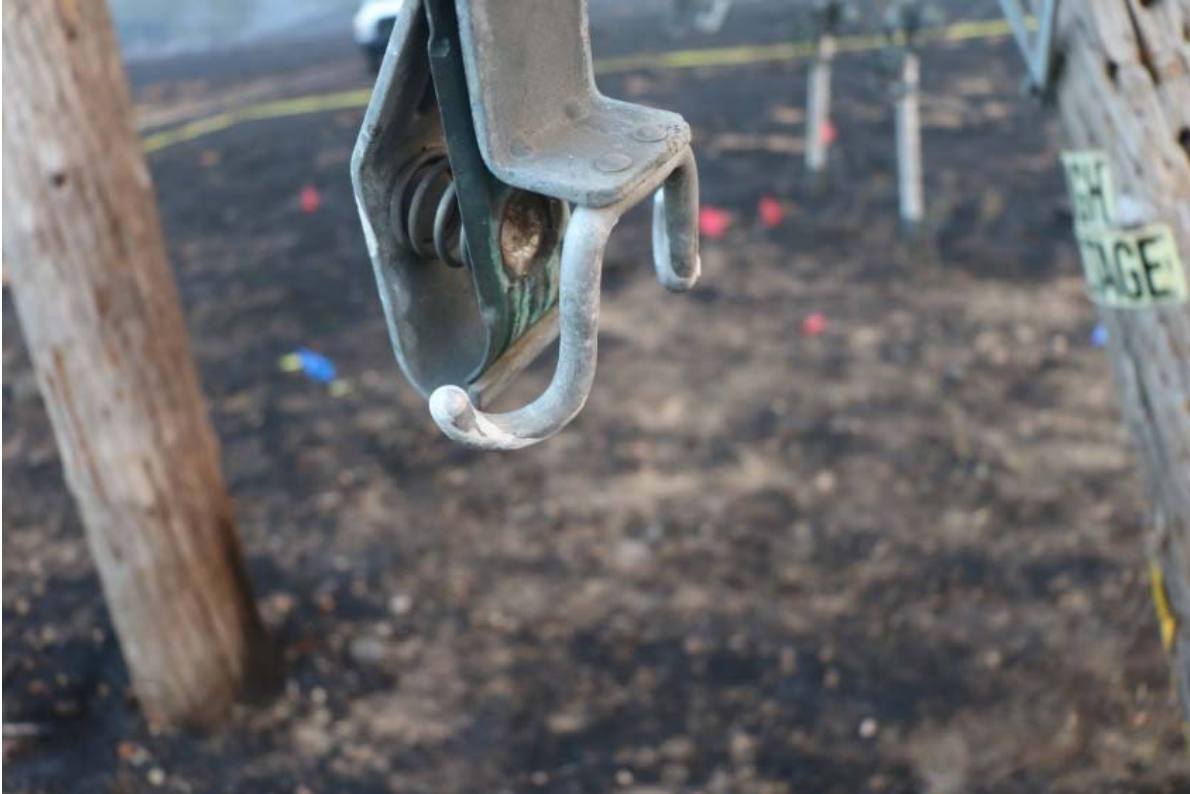
**Figure 9.** More signs of arcing (greenish coloring) on the fuses (Source: CAL FIRE)

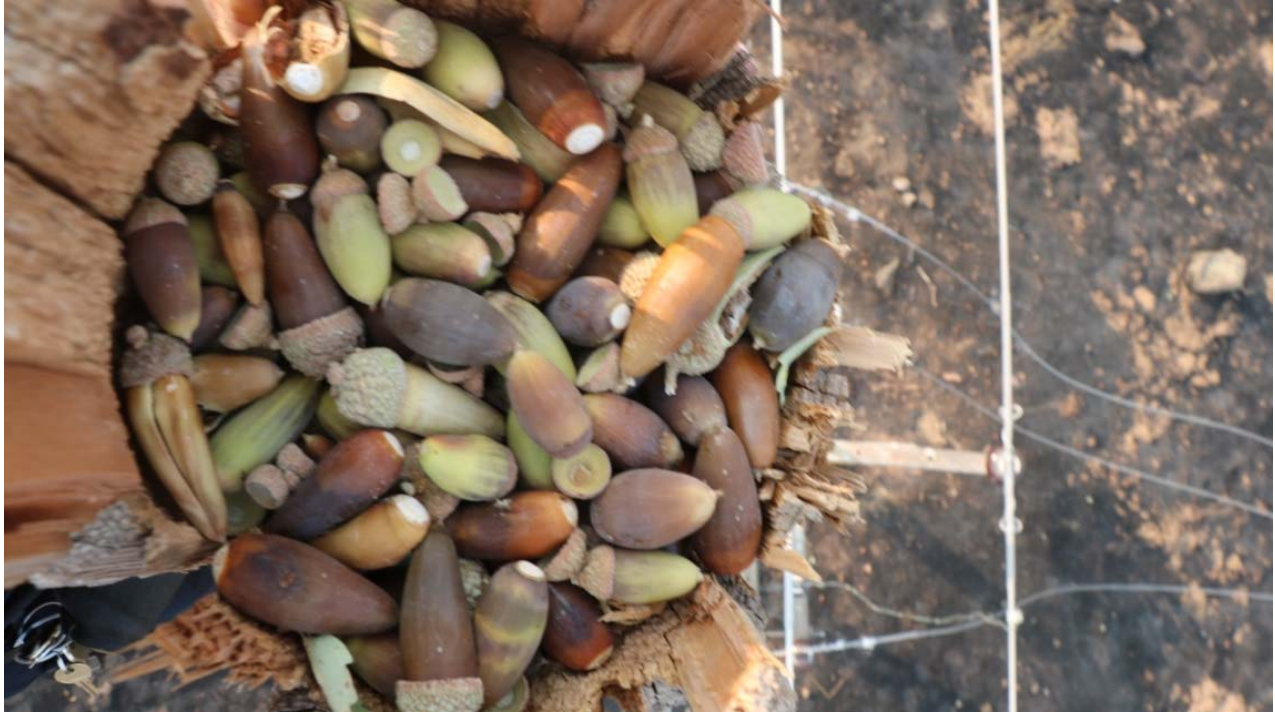
During his investigation, he observed that at the top of the broken pole was a dead woodpecker. The top of the pole was hollowed out with an exterior wall thickness of approximately one inch or less around the perimeter and was full of acorns. (Figure 10)

**Figure 10.** Top view of break on Fuse Cutout Pole 1447 full of acorns (Source CAL FIRE)

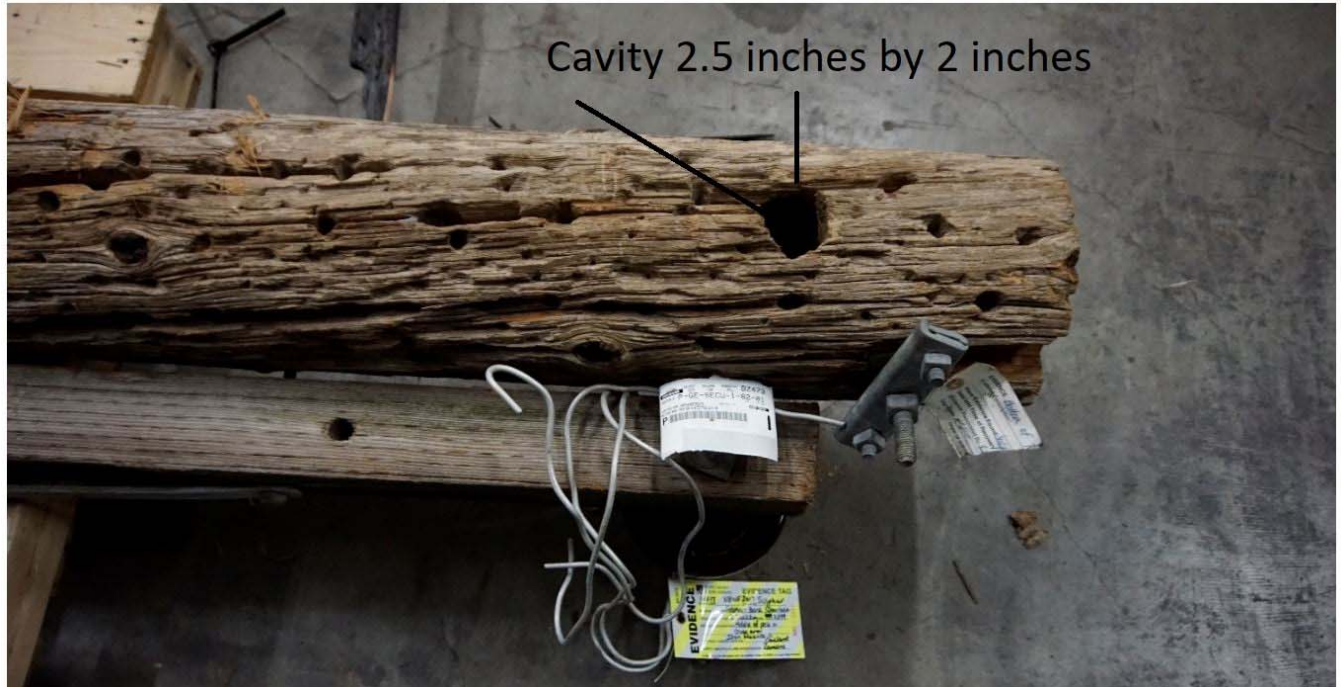
PG&E did report in Data Response Request #1 that there was a cavity located in the vicinity of the communication level attachment, approximately 8 inches below the point of failure of the pole still in the ground. The cavity measured approximately 7 inches deep and 5 inches in diameter at the base of the cavity. The entrance to the cavity is approximately 2.5 inches wide and 2 inches tall.

**Figure 11.** Cavity found on incident pole (2.5 inches wide and 2 inches tall)

According to PG&E's EDPM for assessing woodpecker damaged poles, poles are suitable for restoration and can remain in service if they have an outside hole diameter that is less than 4 inches wide. Since the outside hole diameter of the cavity was measured at approximately 2.5 inches, PG&E could allow the pole to be restored and remain in service.
