CALIFORNIA PUBLIC UTILITIES COMMISSION
Safety and Enforcement Division
Electric Safety and Reliability Branch

Incident Investigation Report

Incident Number: E20171020-06

Utility Facilities Involved: Bangor 1101, 12 kV Circuit

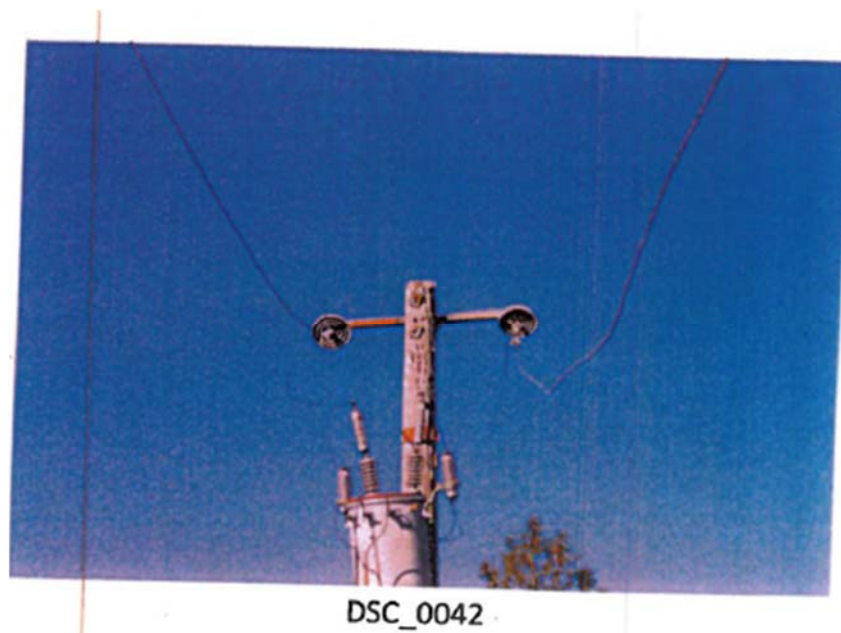
Figure 2. Northern Subject Transformer Pole and Sagging Conductors (Source: CALFIRE)

The two subject conductors involved in the incident were insulated, size 4 American Wire Gauge (AWG), Aluminum Conductor, Steel Reinforced (ACSR) and were part of PG&E's Bangor 1101 12 kV circuit. They spanned approximately 102 feet, seven inches between poles, and were installed in 1980. The northernmost pole has a 25-kVA transformer installed which services to a customer owned pole, and then to the home at 13916 Cascade Way. The next pole to the south is where the main line circuit runs through. The picture in Figure 2 below shows the two sagging subject conductors facing north as found by CAL FIRE on October 9, 2017.

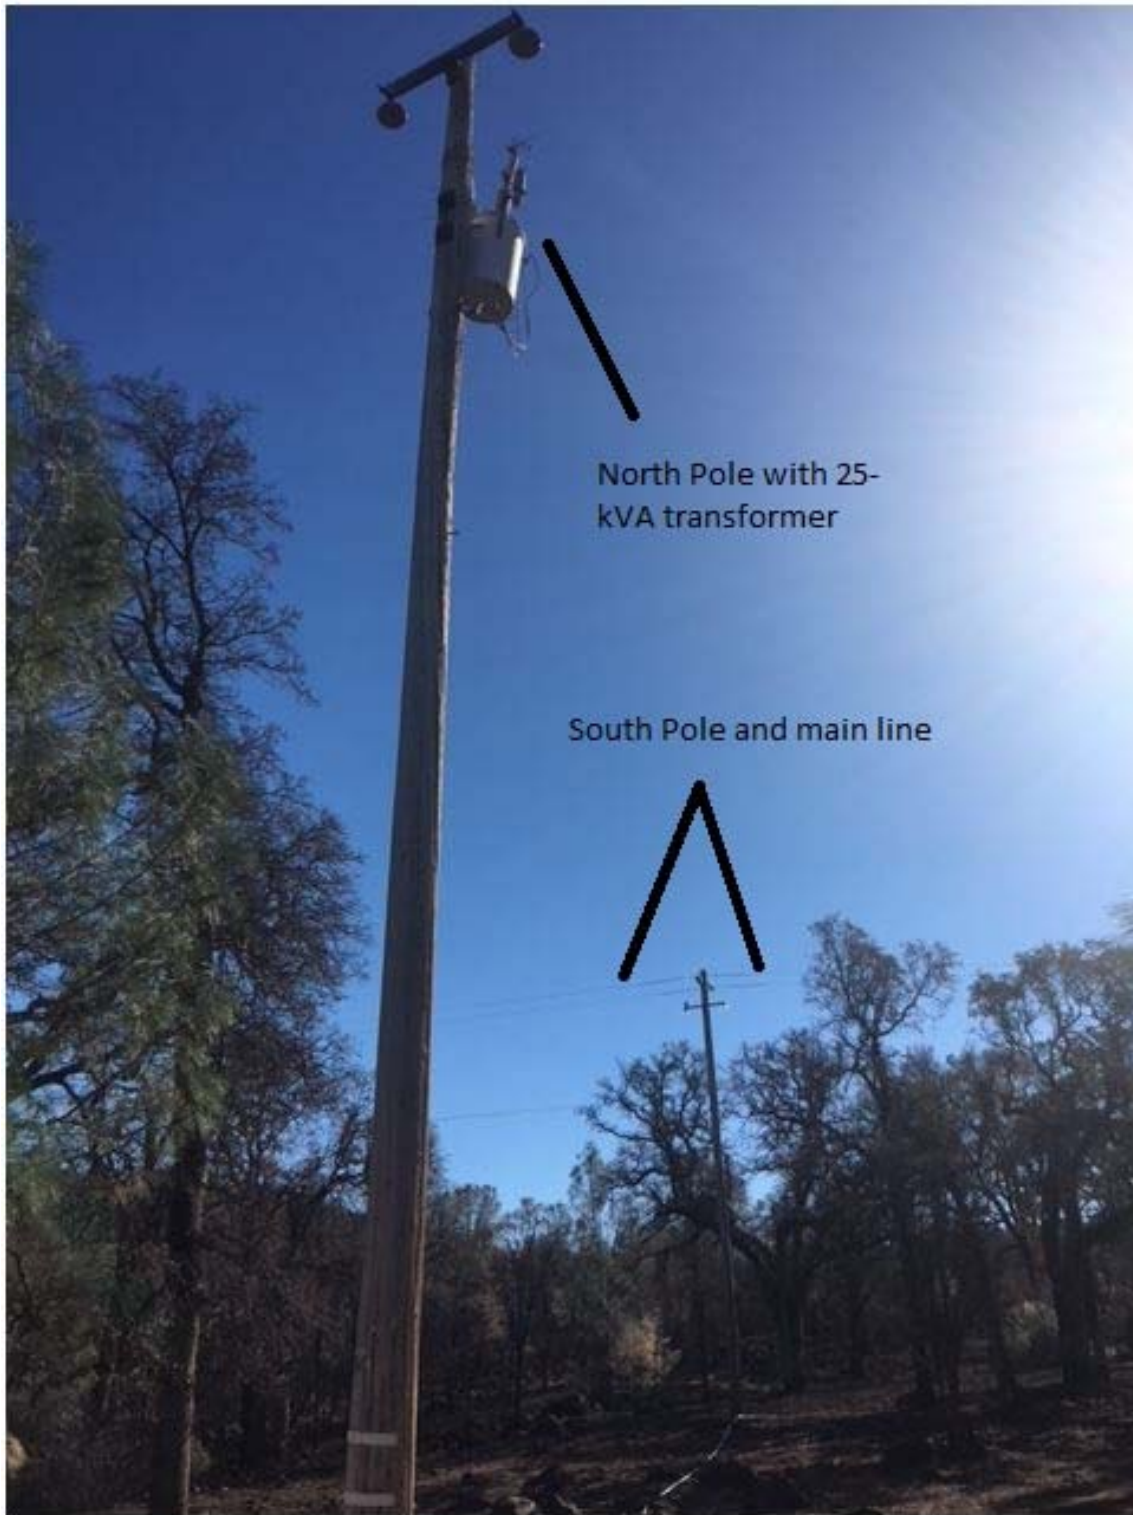
Figure 3. North and South Poles at 13916 Cascade Way, with two primary conductors missing.

SED walked the primary main line starting from the south pole at the incident site and did not see any clearance issues with the trees or vegetation. SED observed the northern transformer pole, for which the two primary conductors were missing. (Figure 3)

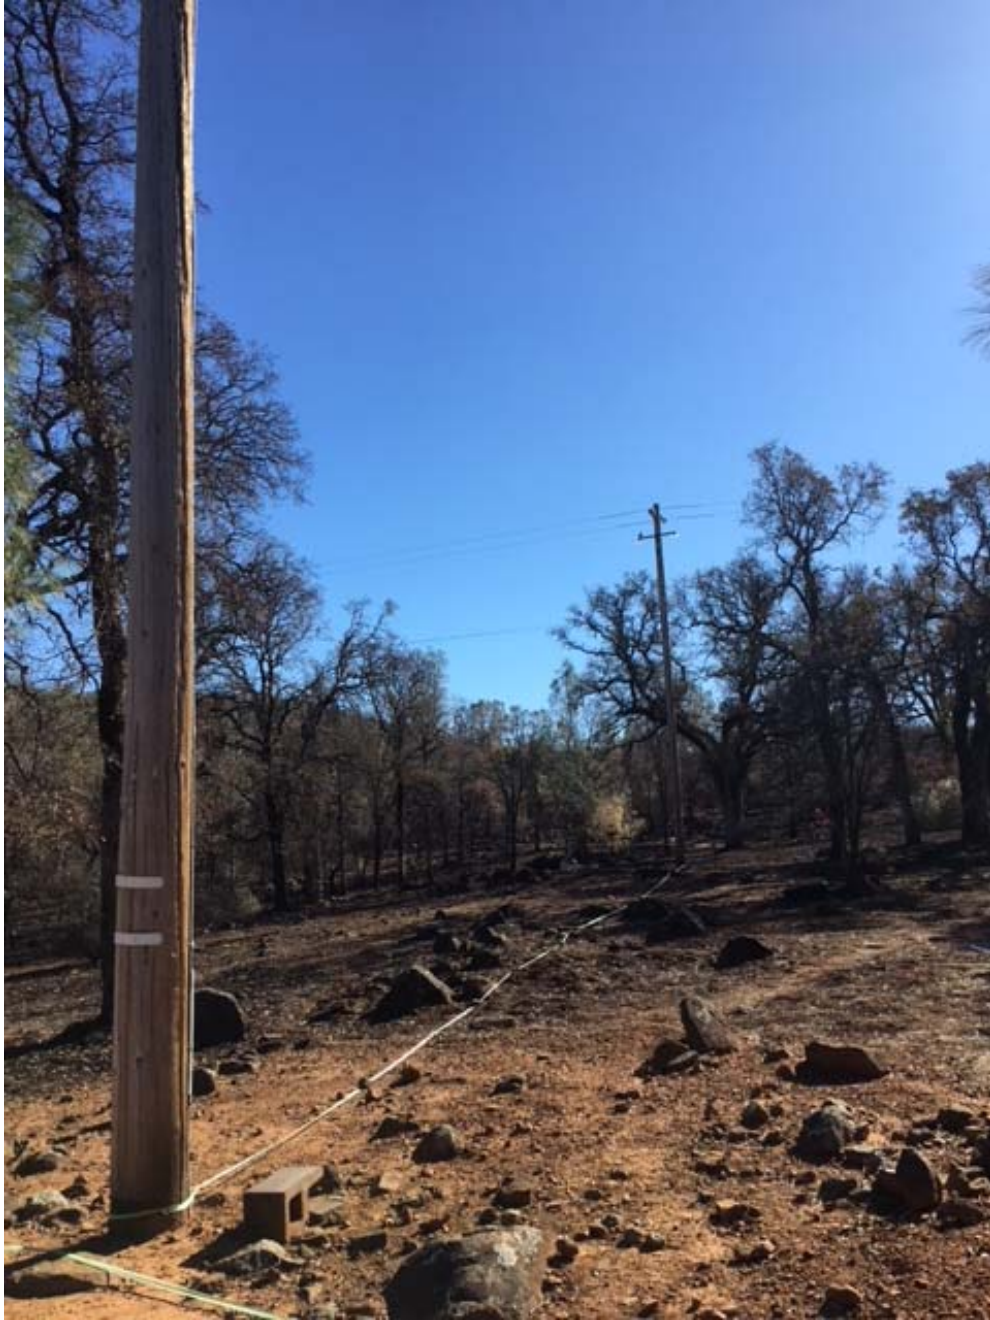
Figure 4. The two subject poles cleared of vegetation.

SED observed that there was no vegetation near where the conductor span was taken by CALFIRE. (Figure 4) SED believes that this fire was not vegetation related.

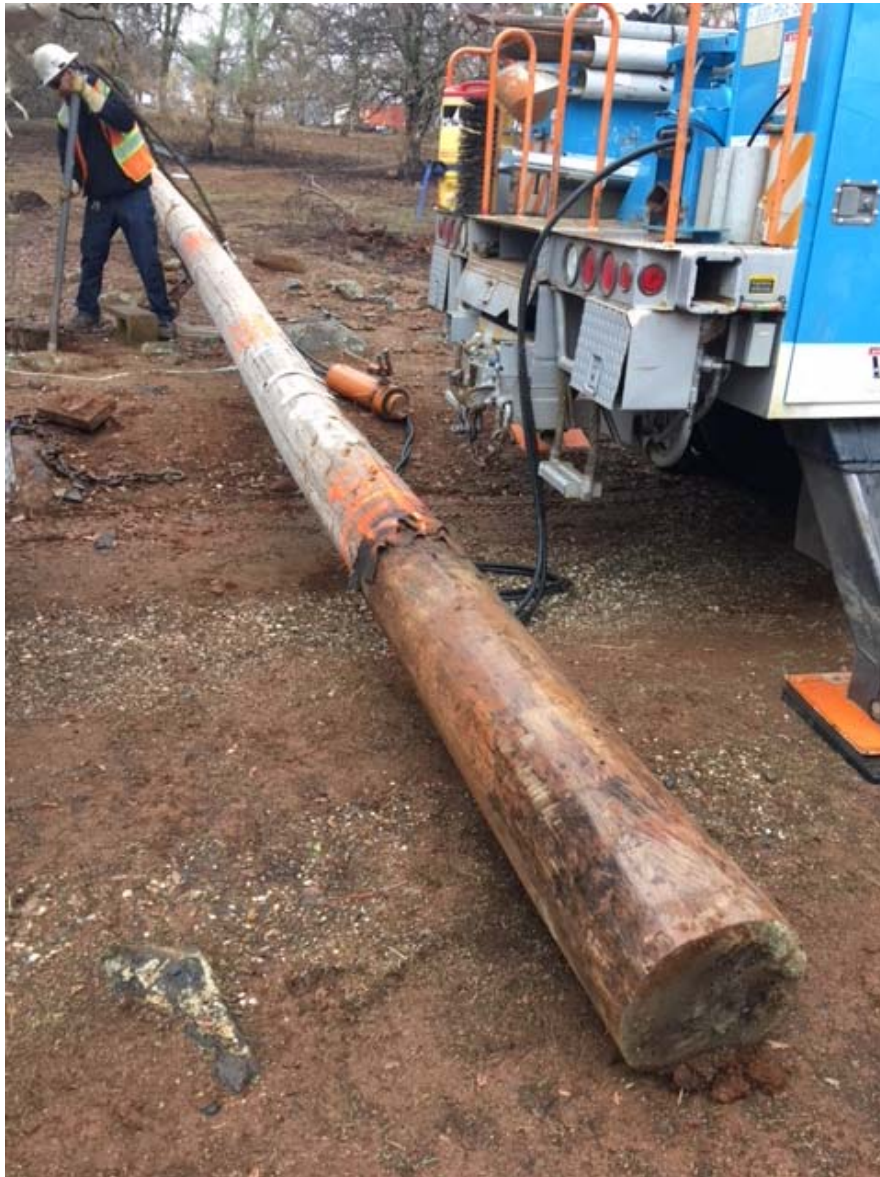
Figure 5. The subject 40-foot, Class 4 wooden pole.

of 2007. SED observed the pole top did have some minor damage but nothing to suggest it was hollow or rotten on the inside.

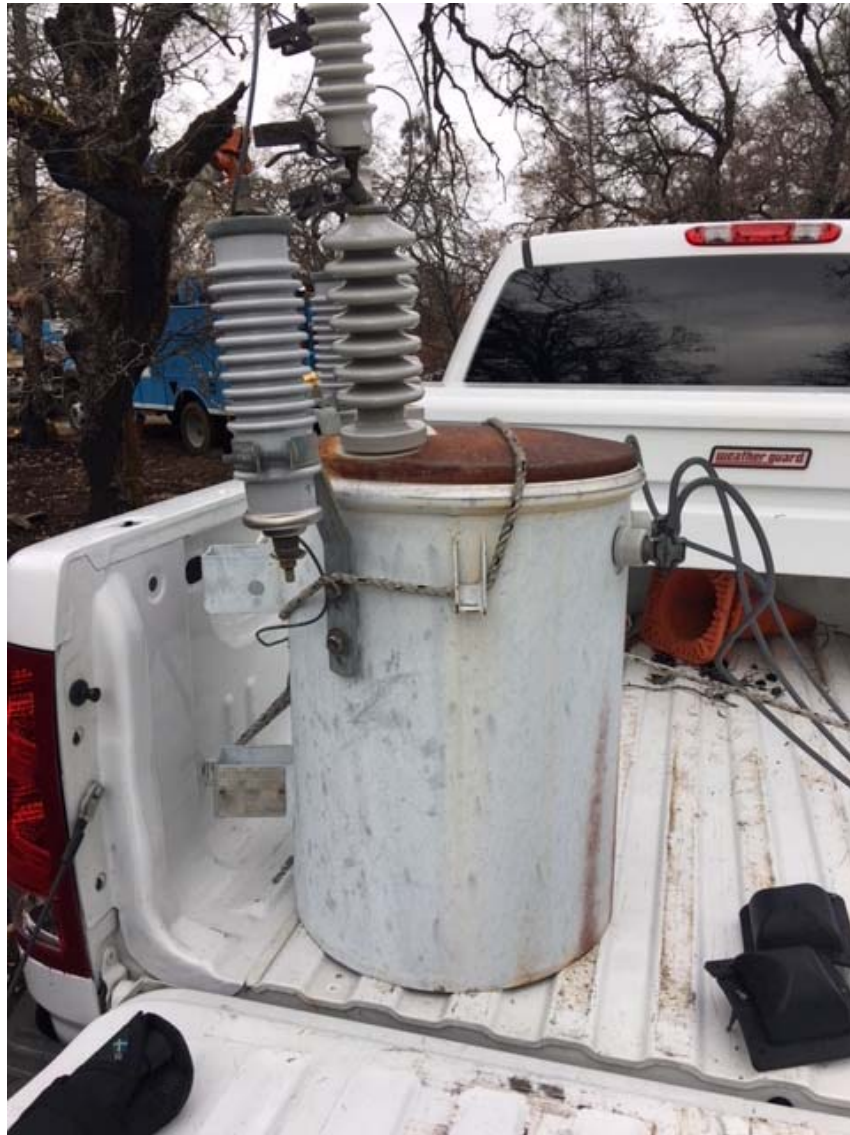
Figure 6. The subject 25-kVA transformer.

On November 10, 2017, at approximately 0900 hours, SED met with PG&E's Law Claims representative, Jon Dailey, for an evidence collection at the site of the Cascade Fire. PG&E took down a 25-kVA transformer and removed a 40-foot, Class 4 wooden pole for evidence. (Figure 5). After the transformer was brought down, SED did a visual inspection and found no oil leaks or excessive corrosion on it. (Figure 6)

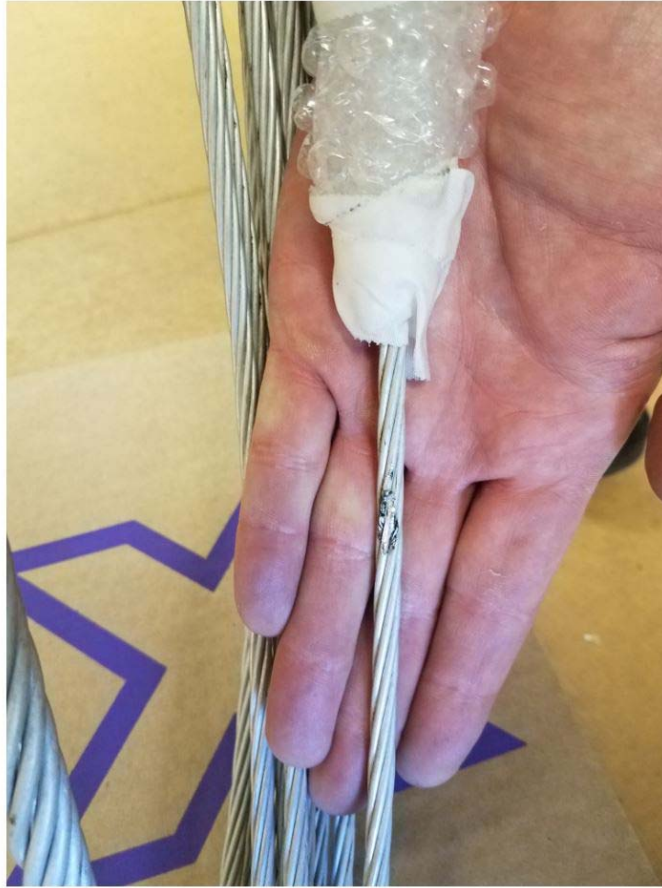
Figure 10. East conductor with burn mark.

SED took pictures of the burnt east and west conductors at CAL FIRE's Auburn Fire Station. The burn marks on each conductor are evident of a contact. (Figure 7, Figure 8) Chief Rufenacht stated the contact occurred at about half distance between the poles, which would have been an approximate distance of 51 feet from each pole.

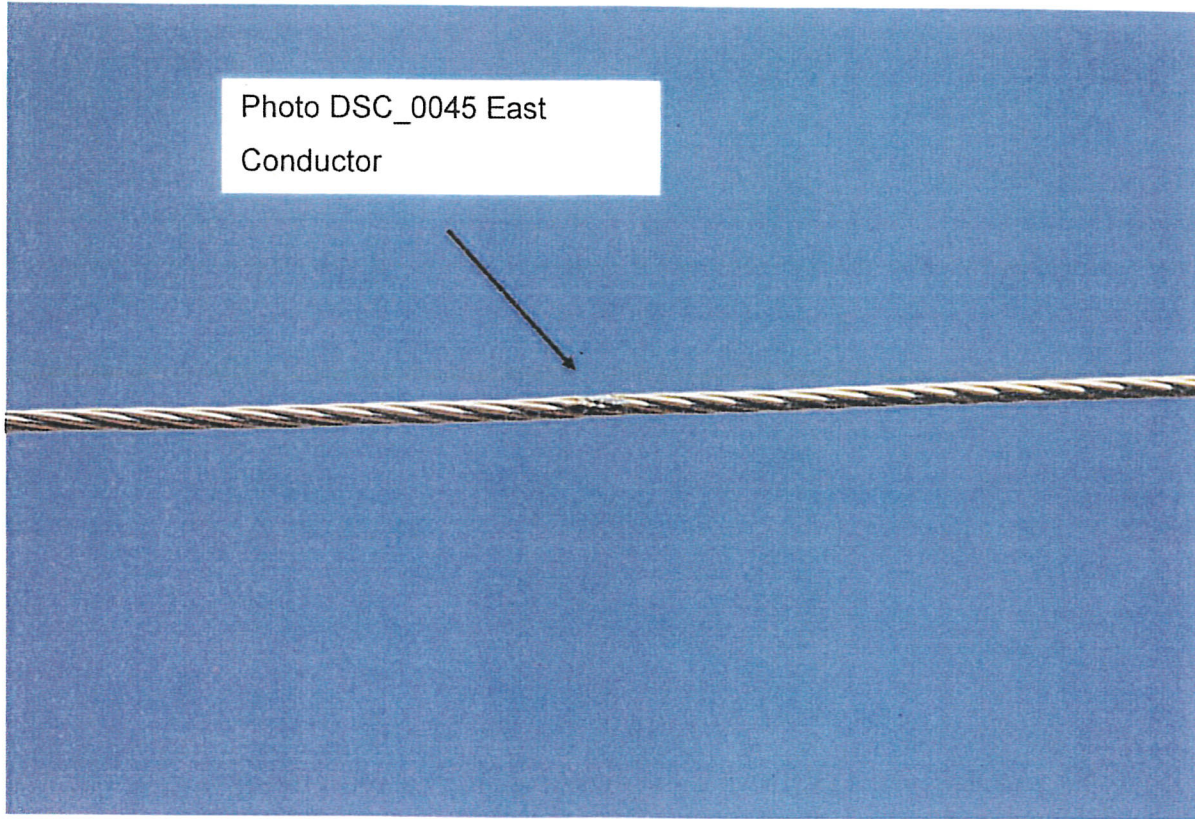
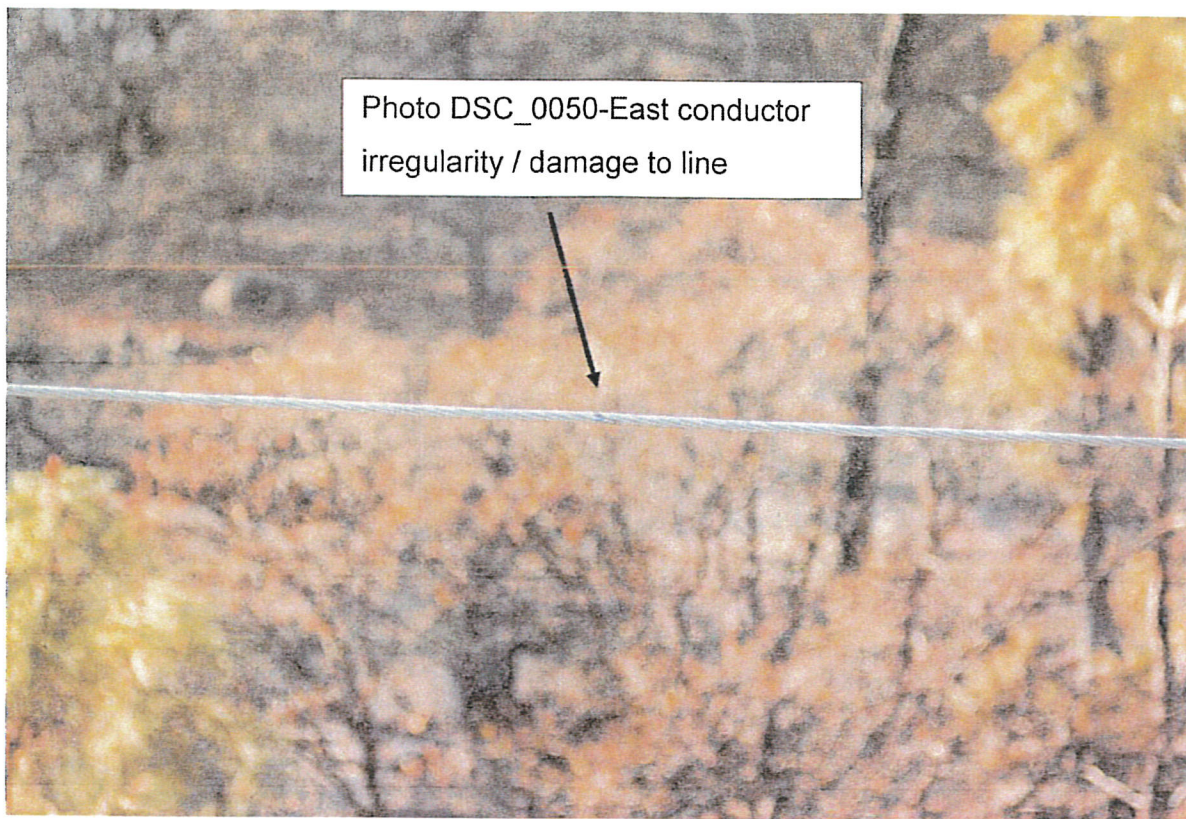
1 From the bucket truck, I observed and photographed an irregularity on both the east
2 and west conductors. The irregularities appeared to be damage to the lines. The
3 damage appeared to be close to the same distance between the north and south utility
4 poles. Jim NOLT completed an independent report of the electrical equipment at the
5 scene (Attachment -7).

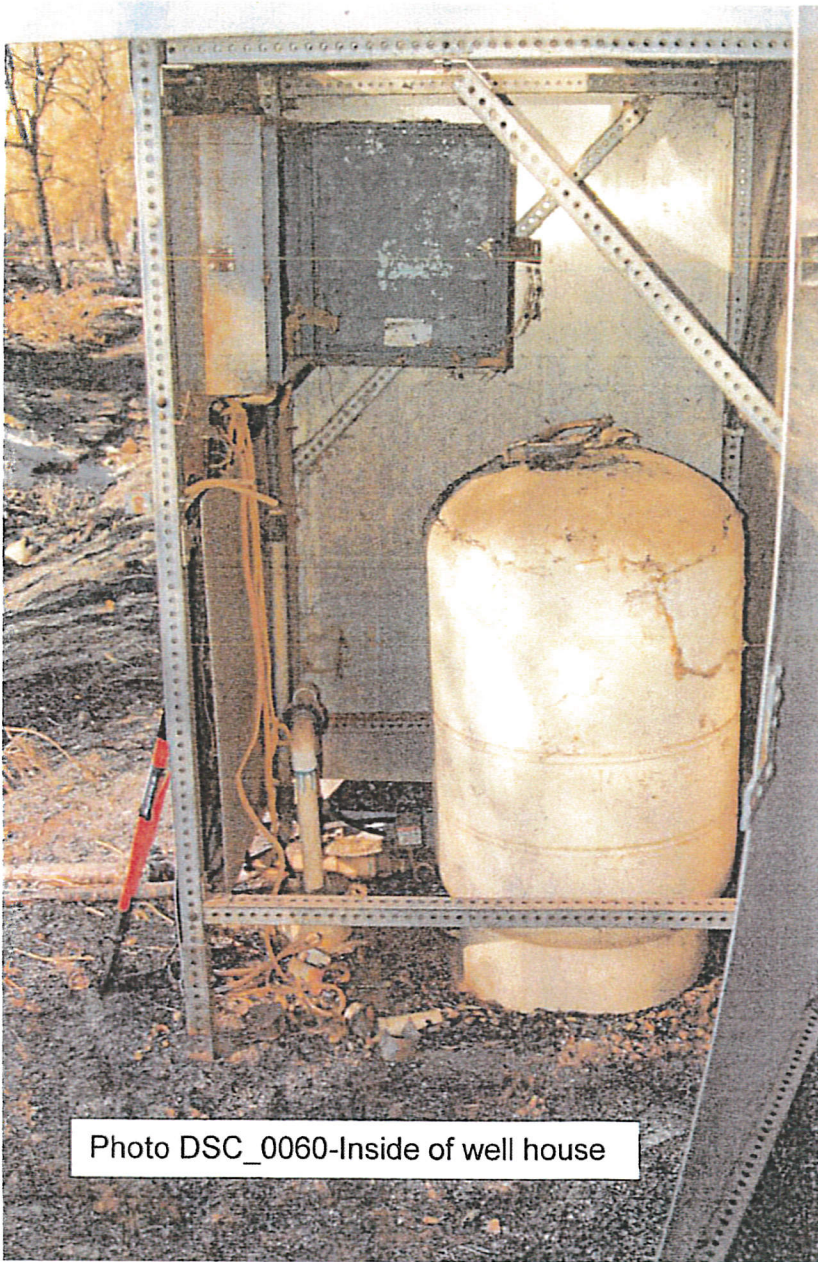
Photo DSC_0060-Inside of well house

1
2 NOLT and I examined the well house to the RIDDLE property. Fire pattern indicators
3 showed the fire moving toward the well house from the area of the north and south
4 utility poles on the RIDDLE property. NOLT examined the well house electrical to rule
5 the well house out as the cause of the fire (See Attachment 7 – NOLT Report). The well
6 house was locked, and we cut the lock to gain access to the small metal enclosure.
7 The inside of the well house was not consumed by fire (See photo DSC_0060).

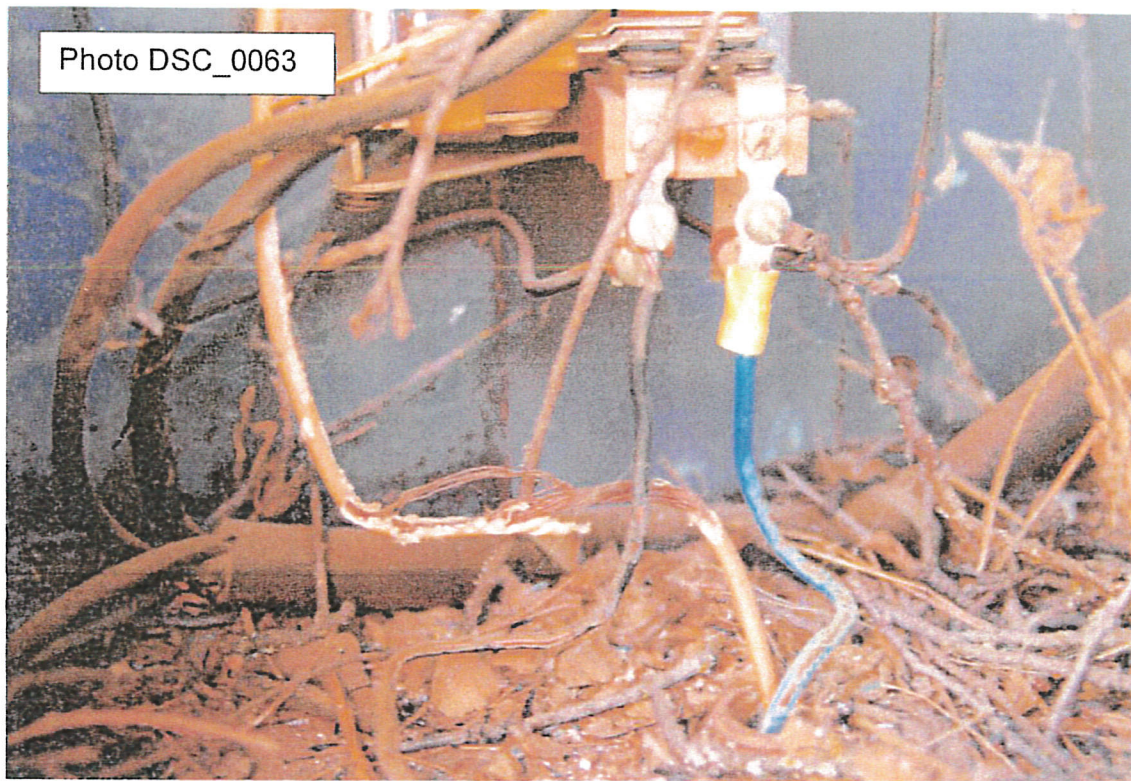
1
2 The electrical panel inside of the well house appeared to be weathered and damaged
3 by rodents (see photo DSC_0063).

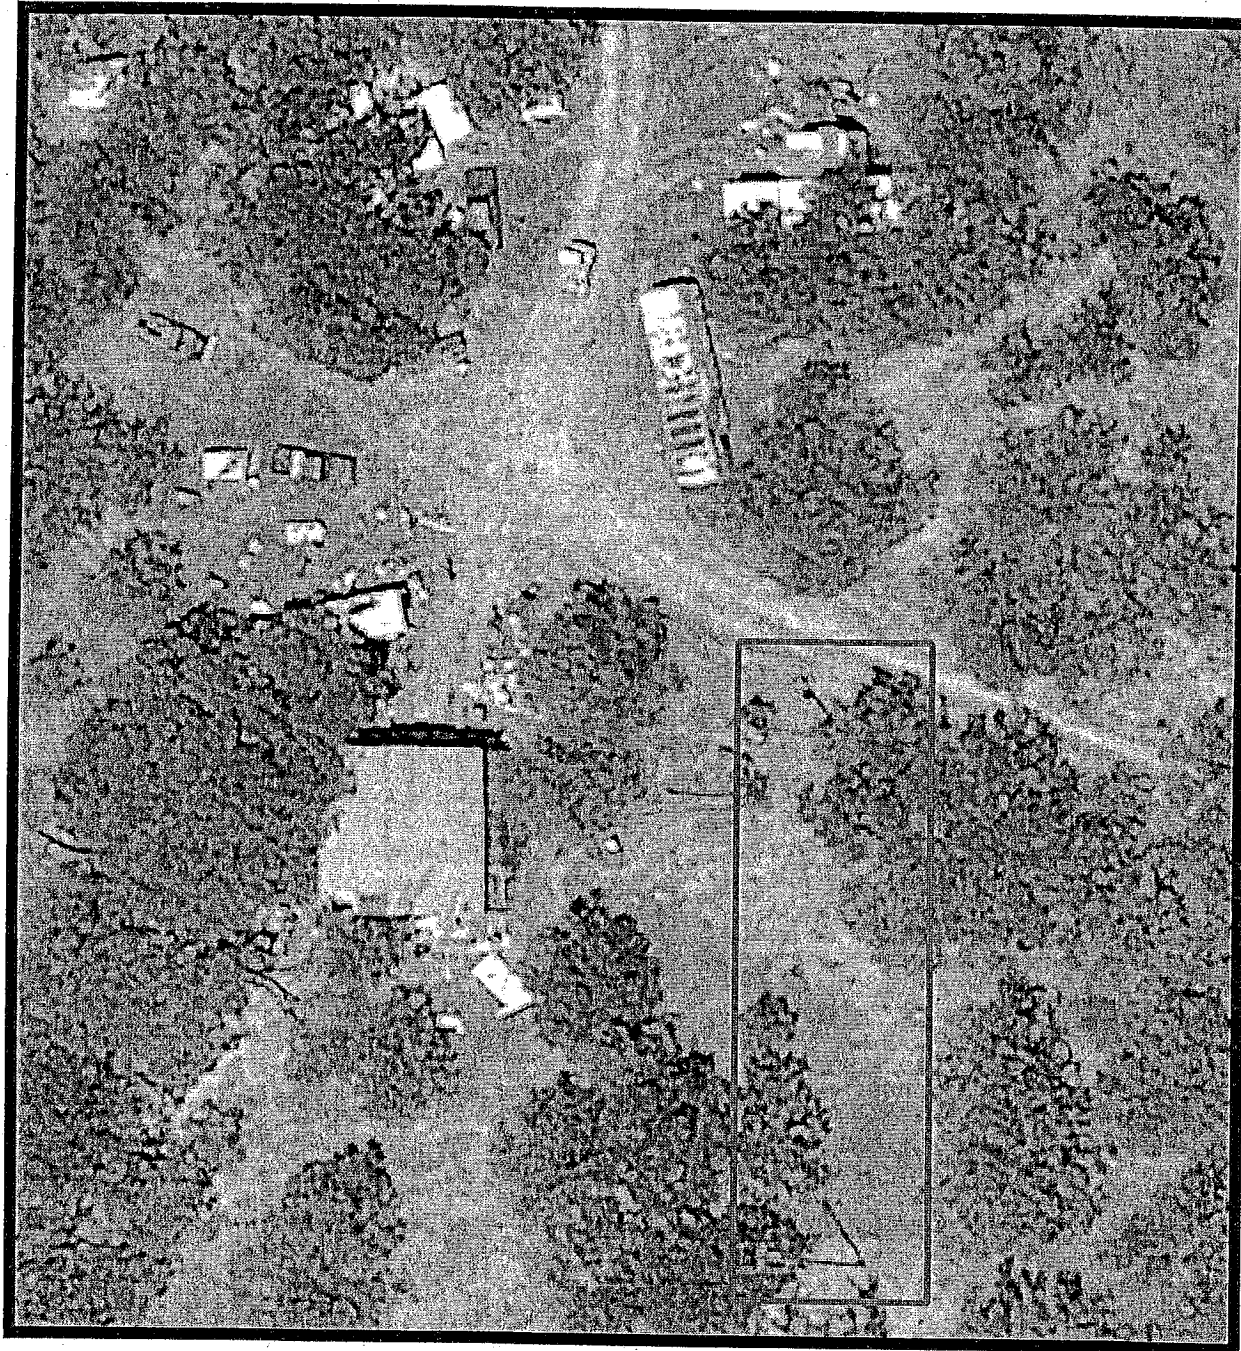
Attachment 1

Distribution conductor line-slap area was between pole at North (# 13897B3)
and pole at South (# ?3????2) ends of indicated area.
