**CALIFORNIA PUBLIC UTILITIES COMMISSION**  
**Safety and Enforcement Division**  
**Electric Safety and Reliability Branch**

**Incident Investigation Report**

**Incident Number:** E20171016-01

**Utility:** Pacific Gas and Electric Company (PG&E)

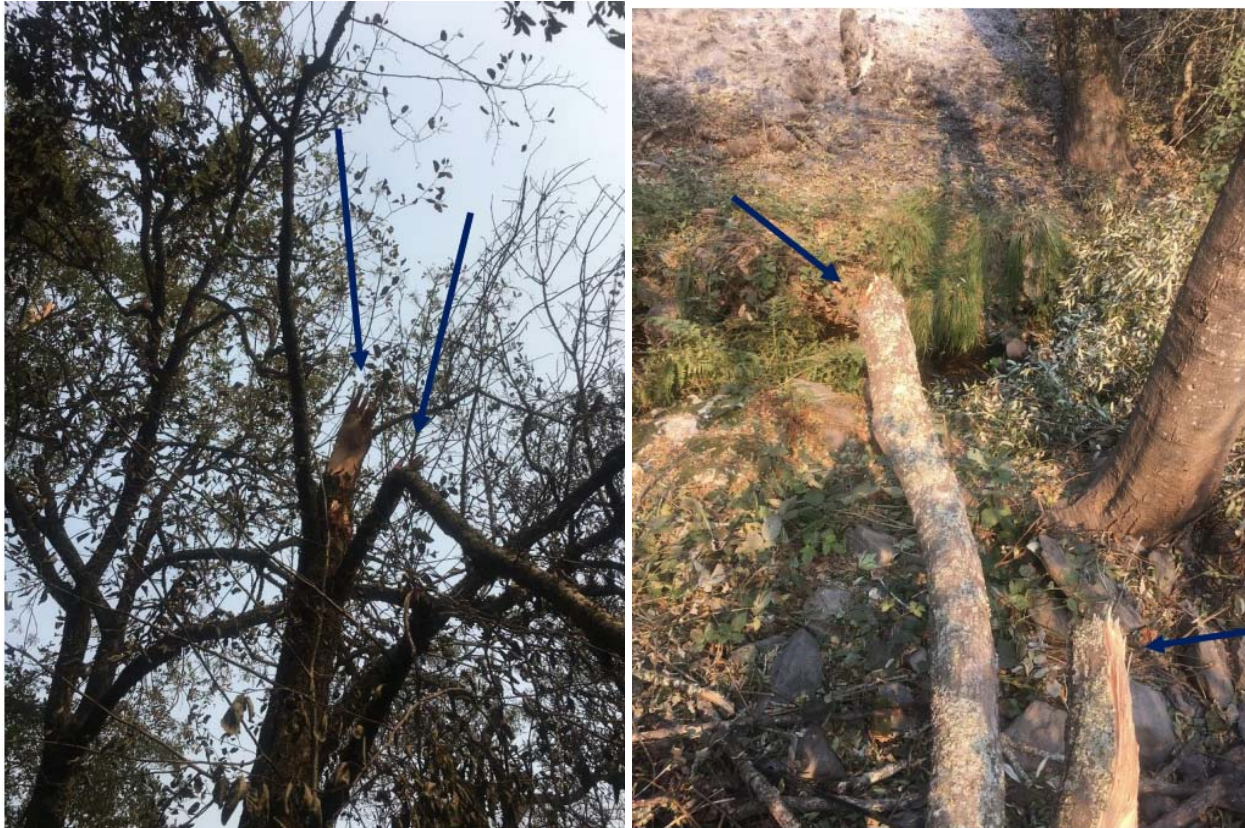
CAL FIRE contracted a Certified Arborist, Mark Porter, to evaluate the subject Alder tree failure. In Mr. Porter’s “Evaluation of Alder Tree Failure” report<sup>19</sup>, Mr. Porter found that the subject Alder tree branch failed due to “excess load exceeding material strength of wood”. Also, diagnostic test results reported fungal decay that may have weakened the branch’s strength. Abrasion marks were also noted on broken branches found on the ground next to the Alder tree. Mr. Porter did not note any obvious visual signs of decay on the Alder tree. Figure 2 below shows the tree failure documented by Mr. Porter.

**Figure 2.** Alder tree branch failure at Location #1. **Left:** Alder tree failure points. **Right:** Failed Alder tree branches on the ground. (Source: Evaluation of Alder Tree Failure by Mark Porter)

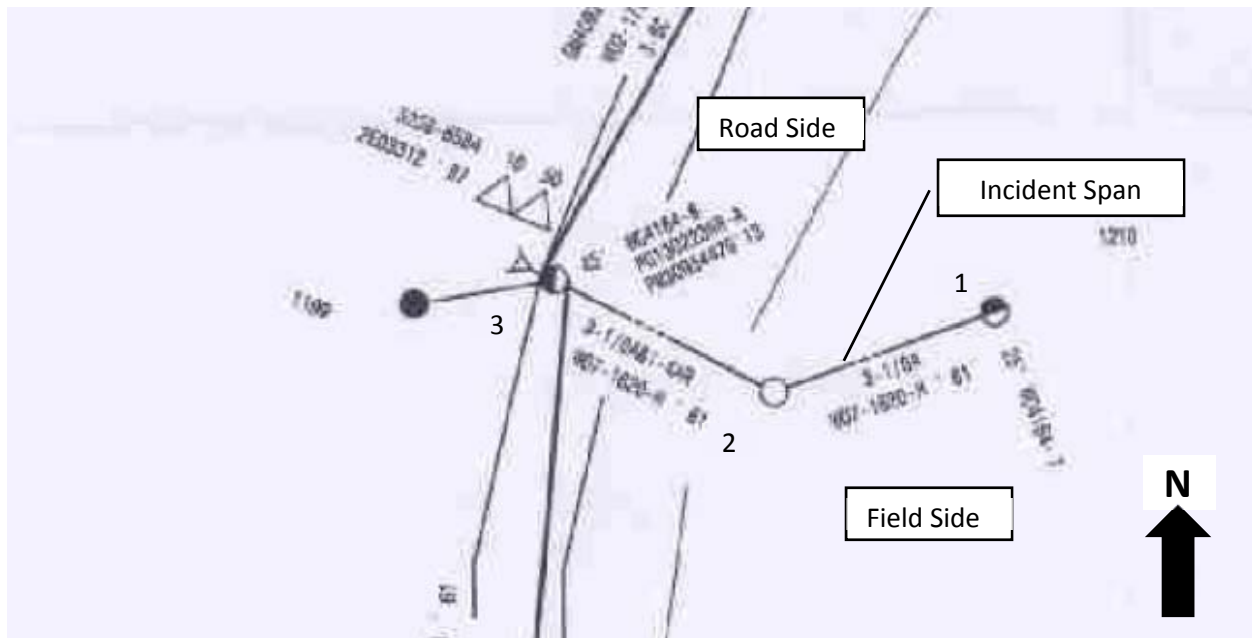
On October 16, 2017, SED staff, Raymond Cho, Ryan Yamamoto and Wilson Tsai, examined the Nuns 1 site and met with the lead CAL FIRE investigator, Captain Kyle Steis. Several PG&E representatives also investigated the site and aided in evidence collection. At the incident span, SED staff encountered the suspect tree, which was later identified as an Alder tree, located across the creek to the west. A large branch from the subject tree, about six inches in diameter, had broken off and fallen into the secondary voltage (120/240 V) road-side conductor. SED staff found one conductor on the ground while the center and field-side phases were still intact and attached to the poles. However, on Pole #2 toward the south, the center phase's insulator pin had broken and the insulator rested on the cross arm. The road-side conductor separated about 4-6 feet from the insulator pin. While taking a closer look at Pole #2, SED staff discovered a slack anchor guy which is a potential violation of GO 95, Rule 56.2. However, it is unknown whether or not this condition was caused by the tree branch failure or if it was an existing condition prior to the fire.

**Figure 3.** Schematic of pole locations and incident span between Pole #1 and #2.  
(Source: PG&E with added notes)

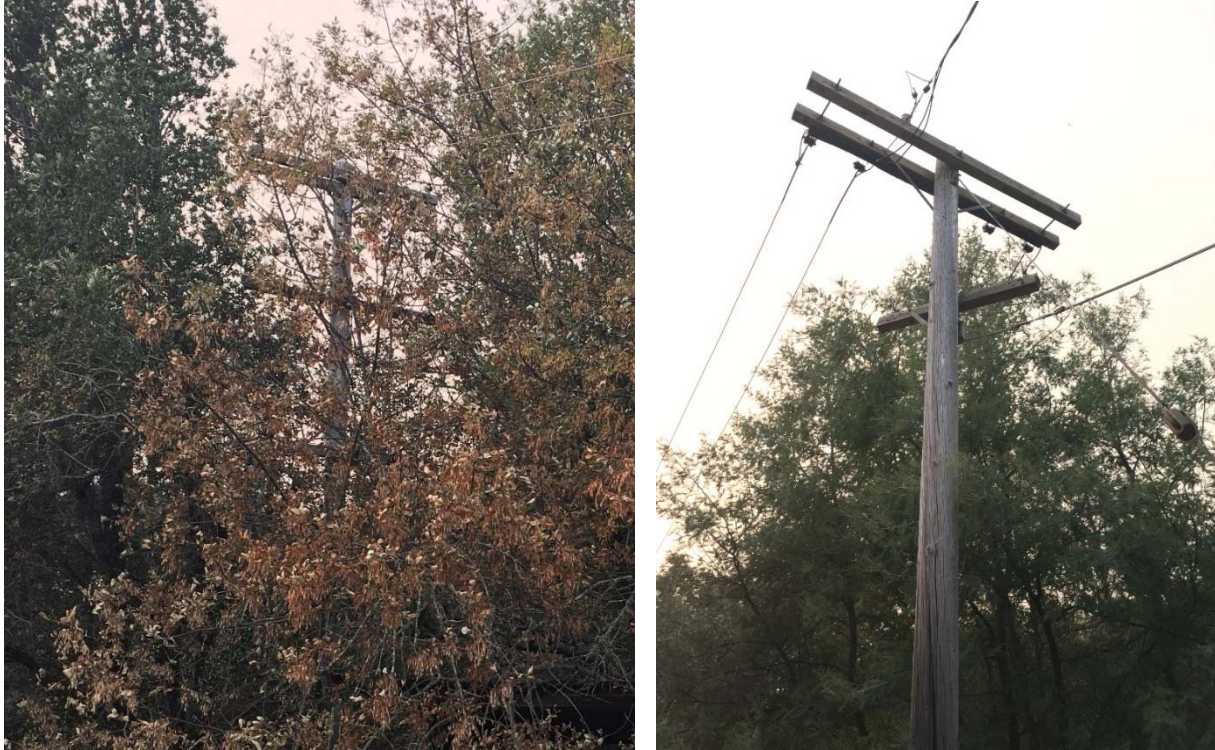
**Figure 4. Left.** Photo of pole #2 behind trees closest to road taken from the east. **Right.** Photo of pole #1 (approximate GPS coordinates 38.3940925, -122.5159884) immediately downstream, northeast of pole #2 taken from the east.

In reference to the subject span, PG&E identified the upstream class 4, 35-foot wood pole (PG&E pole #101993035, GPS coordinates 38.396168, -122.515159) was located to the west of the next downstream pole. The downstream pole to the east that PG&E identified was a class 6, 35-foot pole (PG&E pole #102036545, GPS coordinates 38.396261, -122.514809). SED noted approximate GPS coordinates for pole #1: 38.3940925, -122.5159884. Therefore, SED does not believe that PG&E provided the correct pole intrusive inspection information<sup>21</sup>. Regardless, the poles carrying the subject span did not fail and therefore did not contribute to the fire.

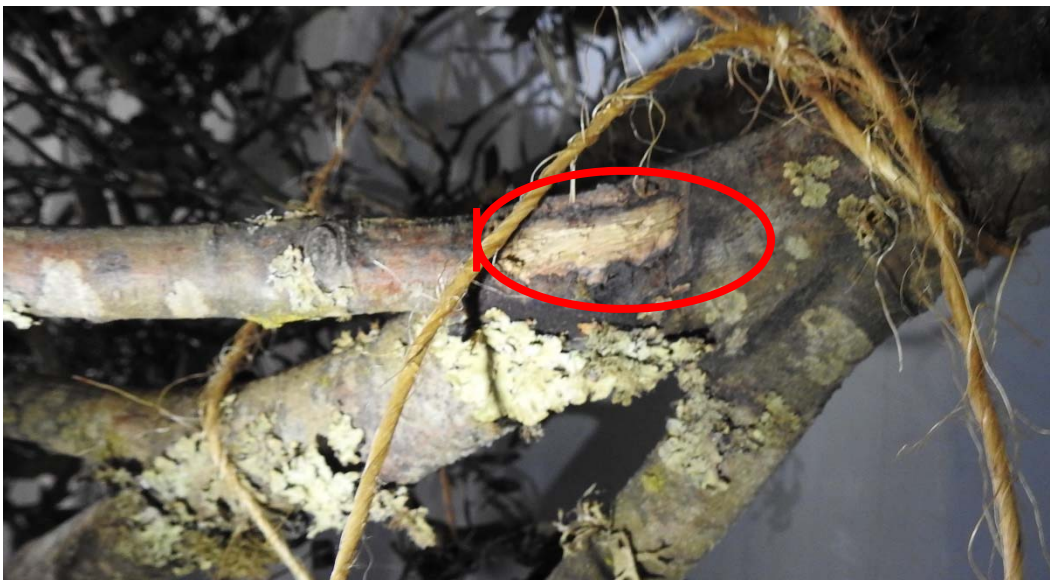
On October 12, 2018, SED staff met with CAL FIRE investigators in Santa Rosa and reviewed evidence retained by CAL FIRE for the Nuns 1 location involving the Alder tree branch. Of the evidence reviewed, SED found metal transfer on a tree limb, abrasion on a tree limb and pitting on all conductor phases. SED could not determine the cause of pitting on the conductors since there were no obvious signs of charring or arcing associated with the pitting.

**Figure 9.** Abrasion circled in red on Alder tree limb. CAL FIRE evidence item number E-1.

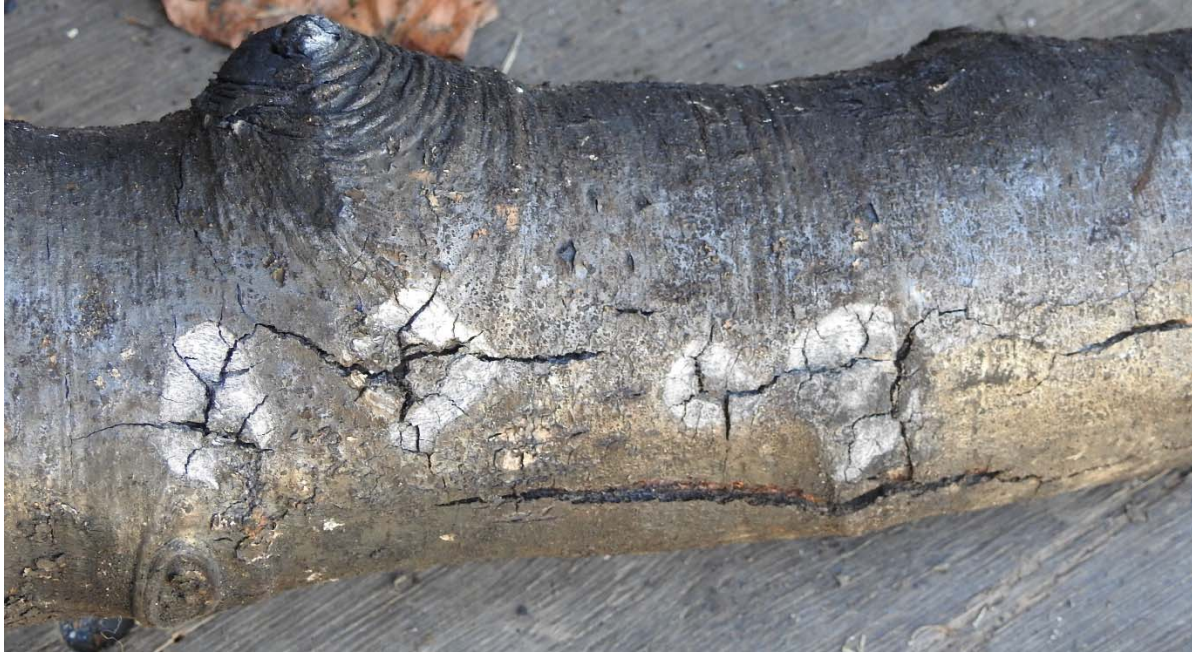
**Figure 10.** Metallic transfer on Alder tree limb. CAL FIRE evidence item number E-3.

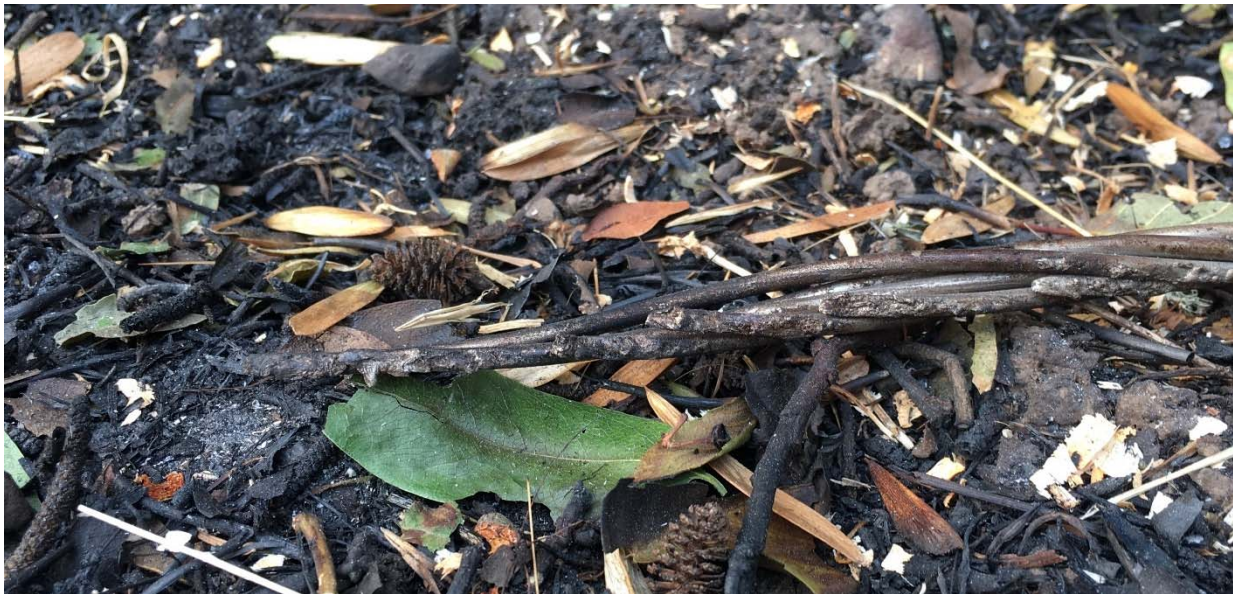
**Figure 11.** One end of the downed roadside conductor near the Alder tree.

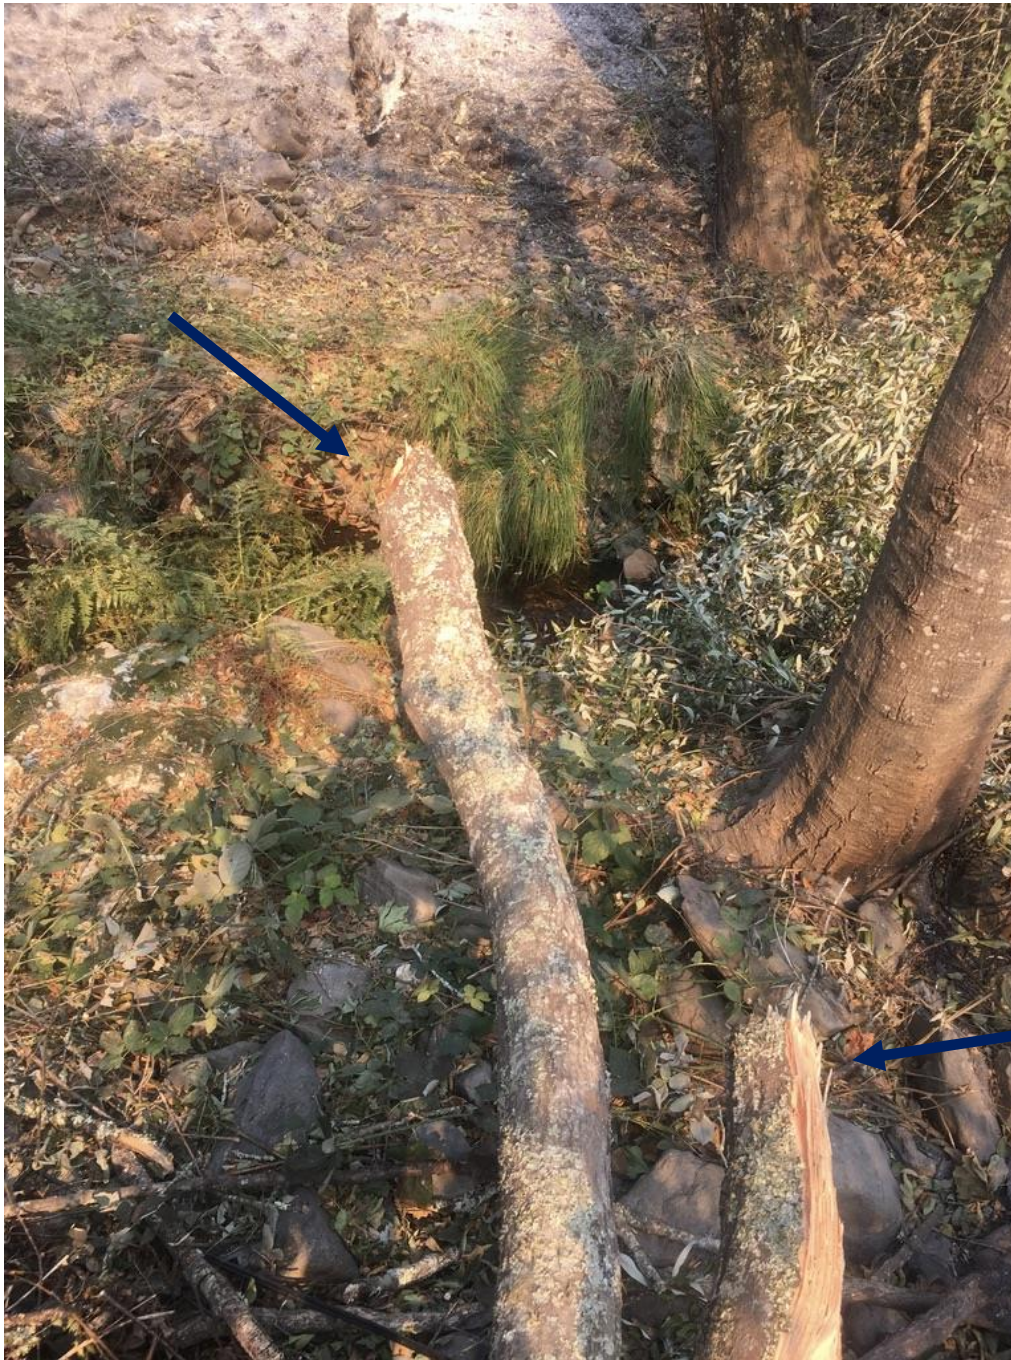
**Photo 2** - fractured branches from subject tree

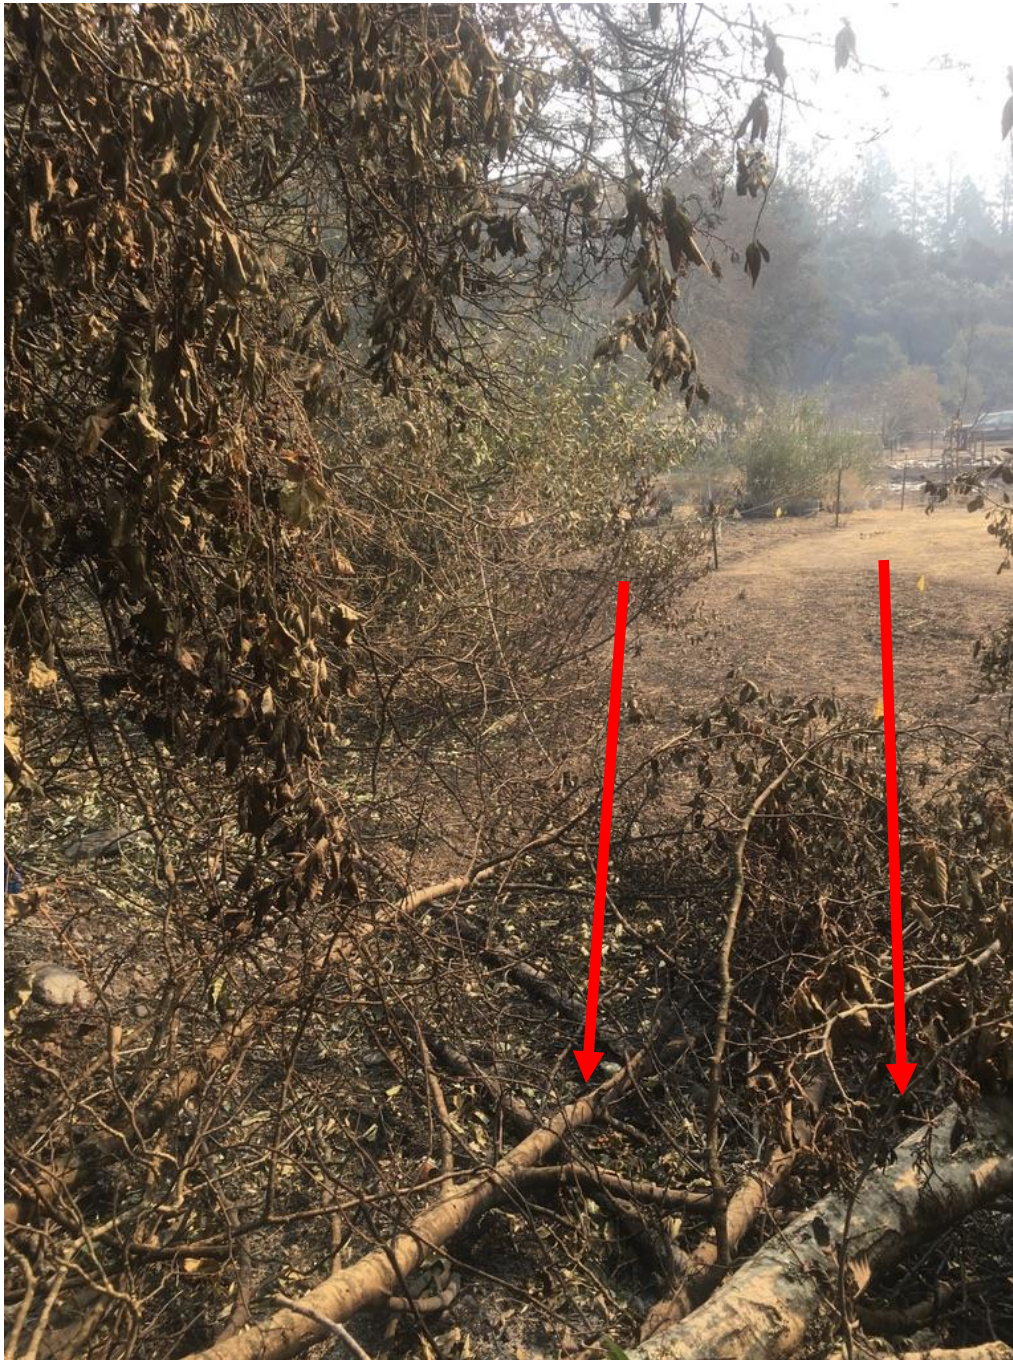
**Photo 3** - fractured branches from subject tree

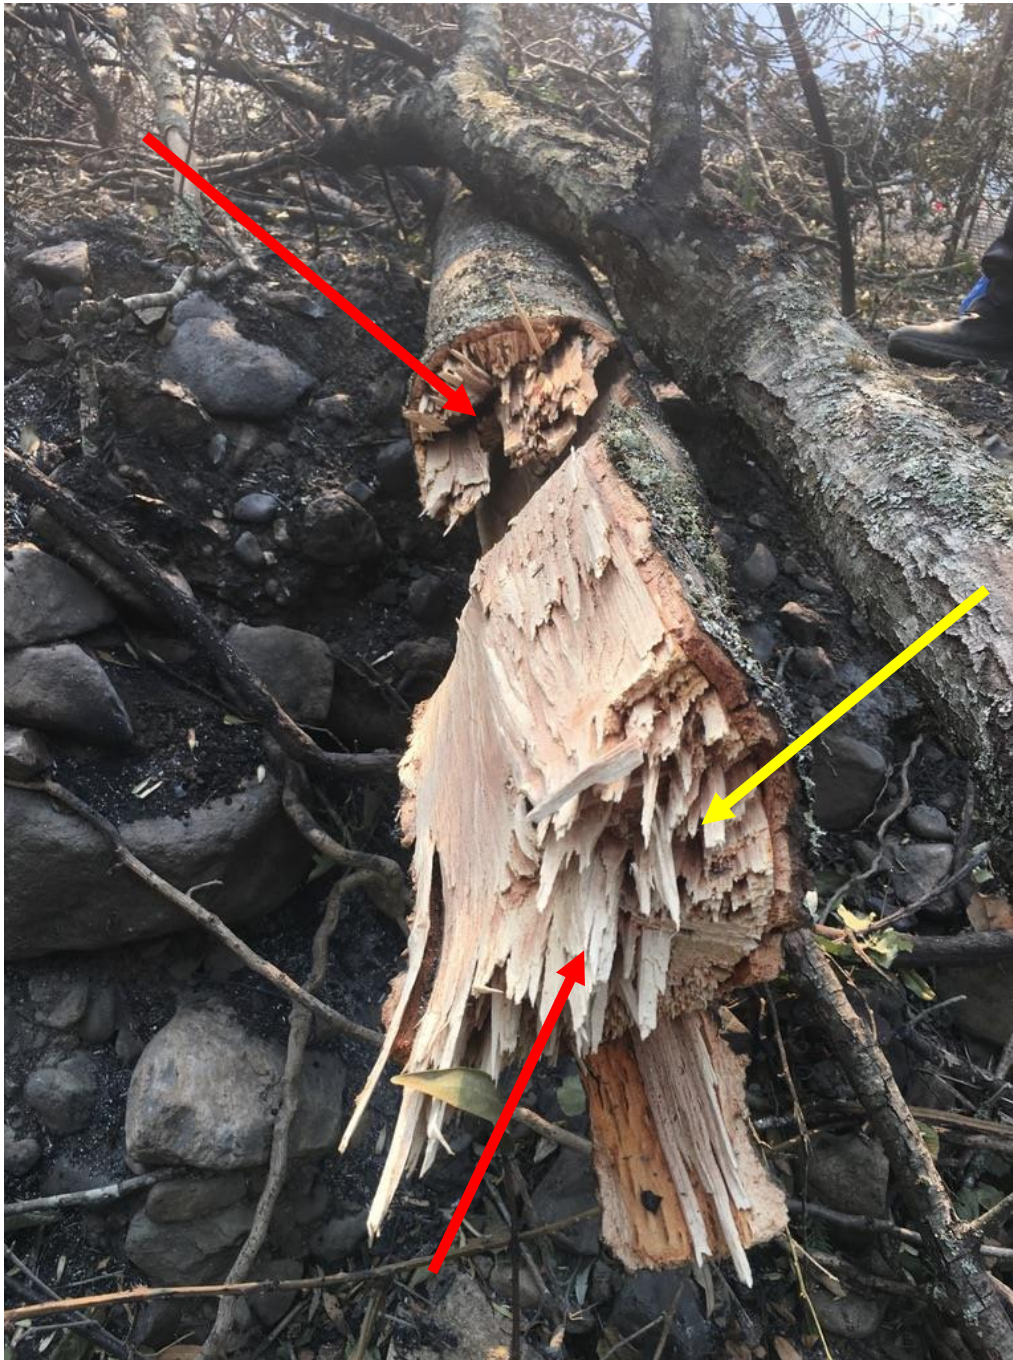
**Photo 4** – close up of fractured branches. Splintered wood in area of fracture. .

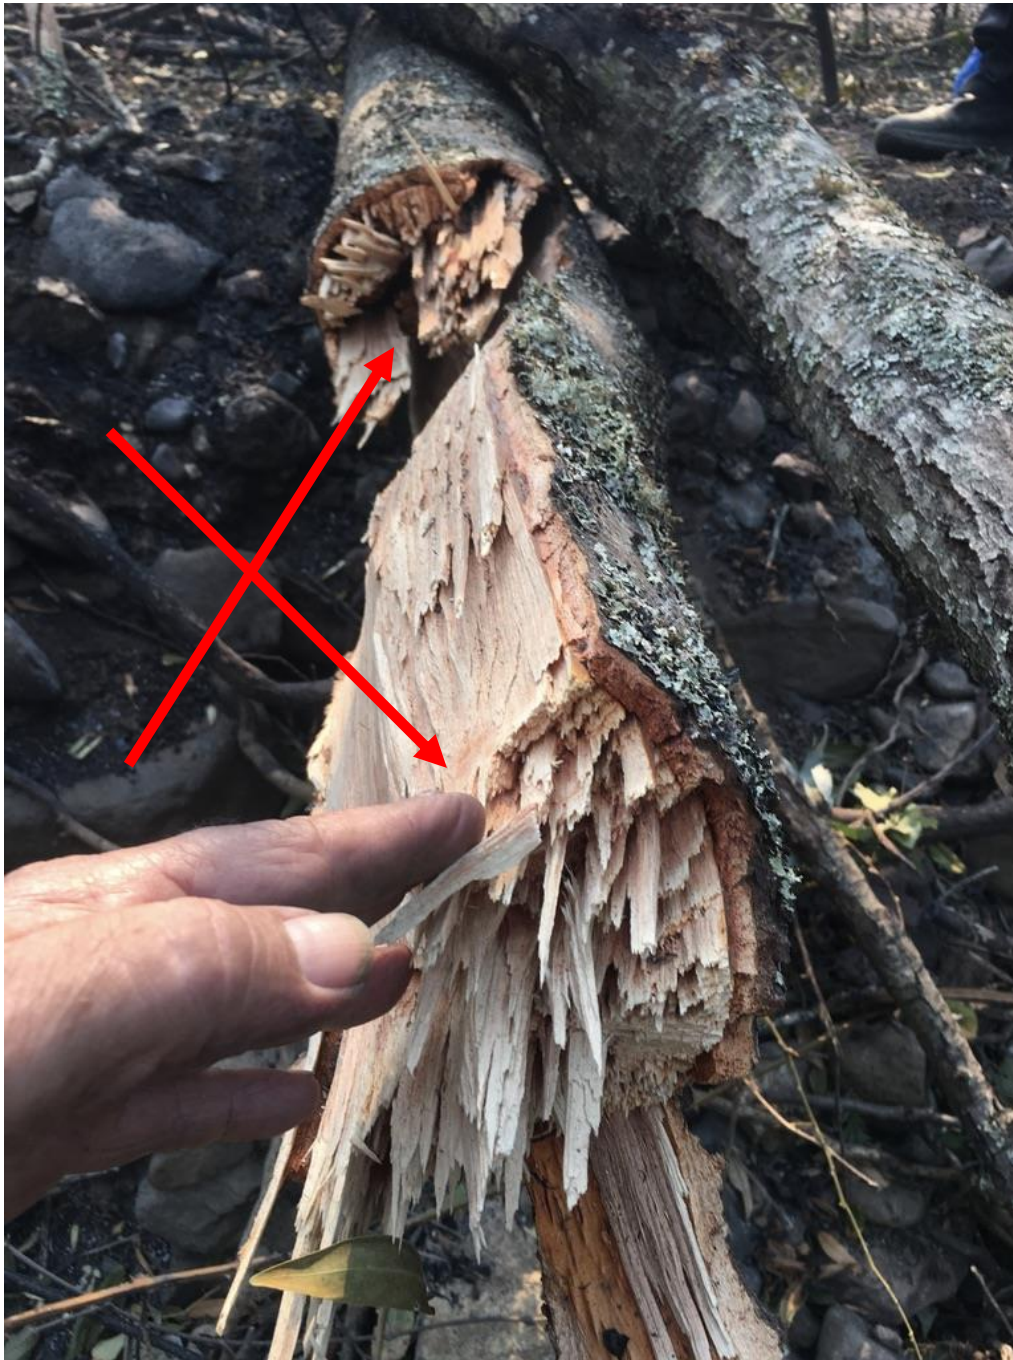
**Photo 5** – closer view of splintered wood.

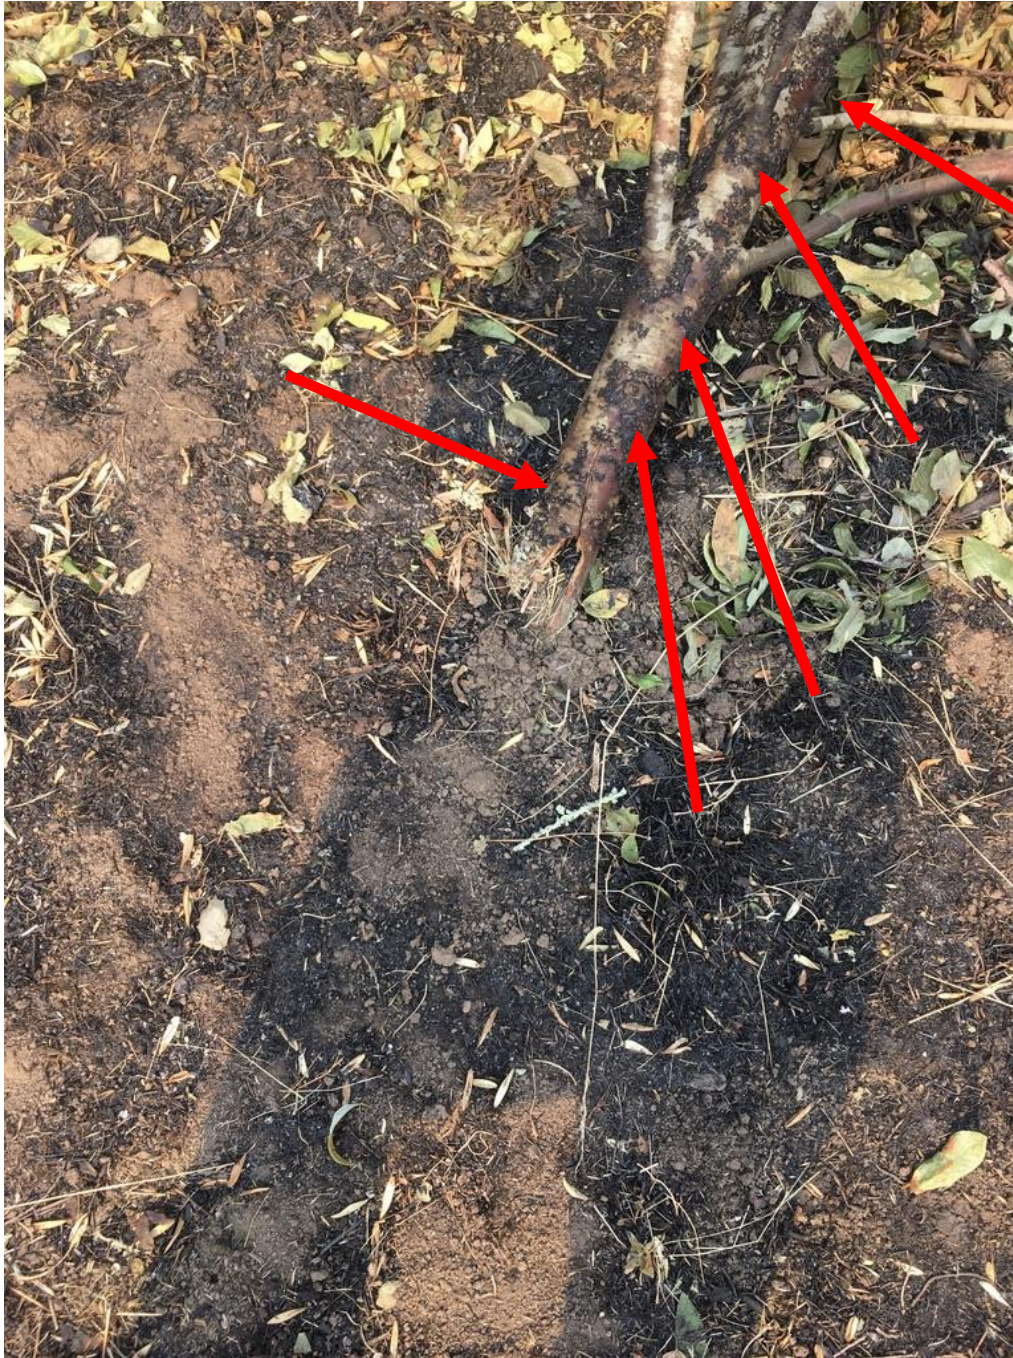
**Photo 6** – discolored broken branch

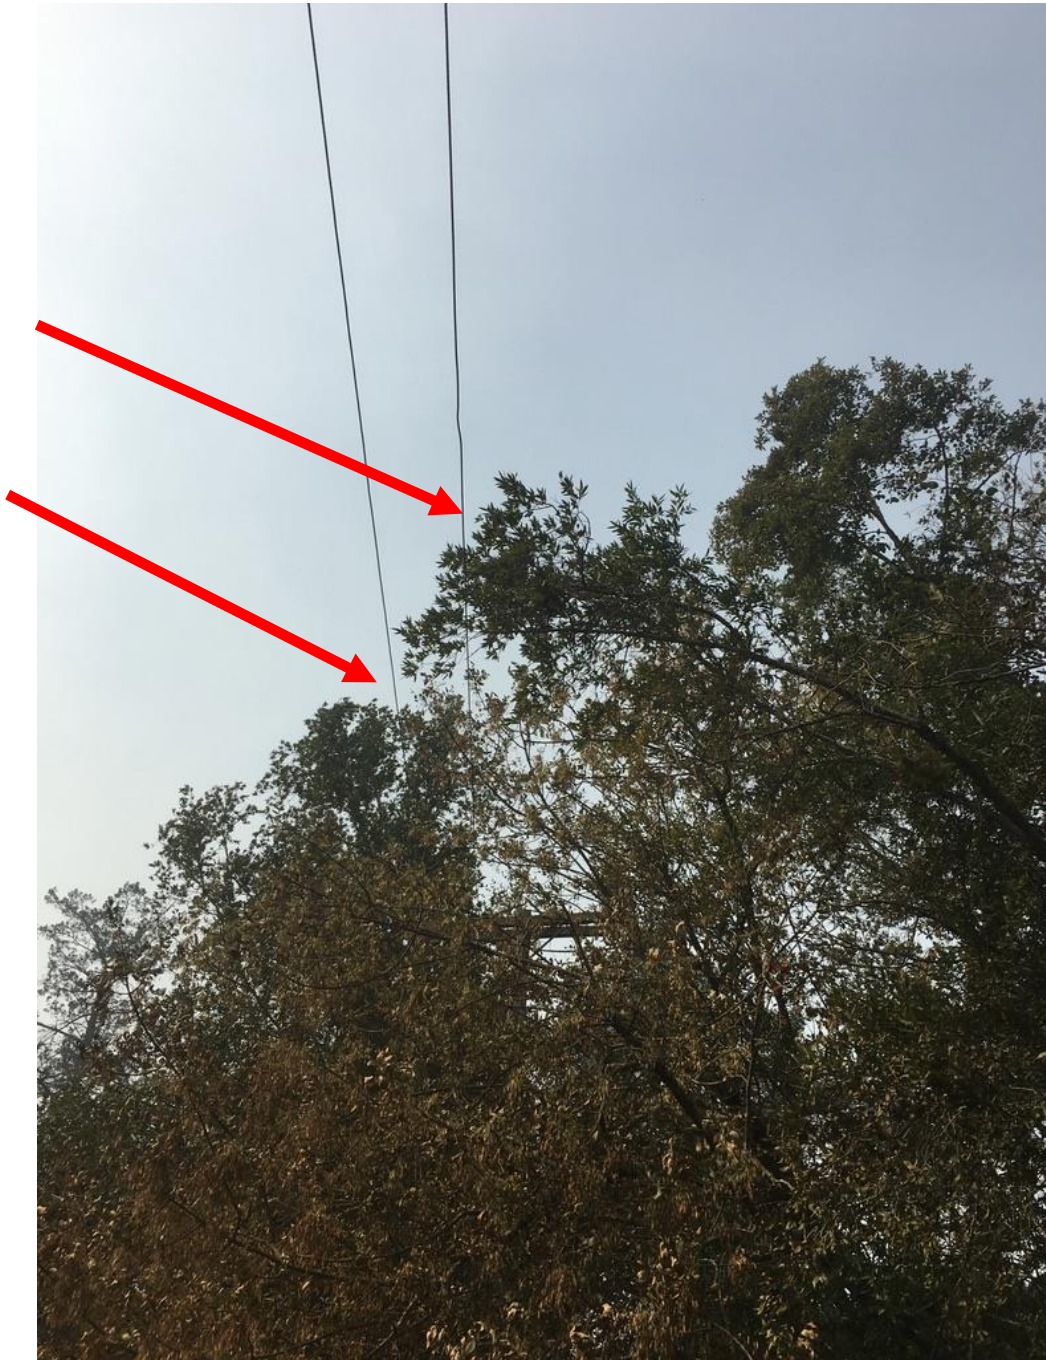
**Photo 7** existing conditions of clearance

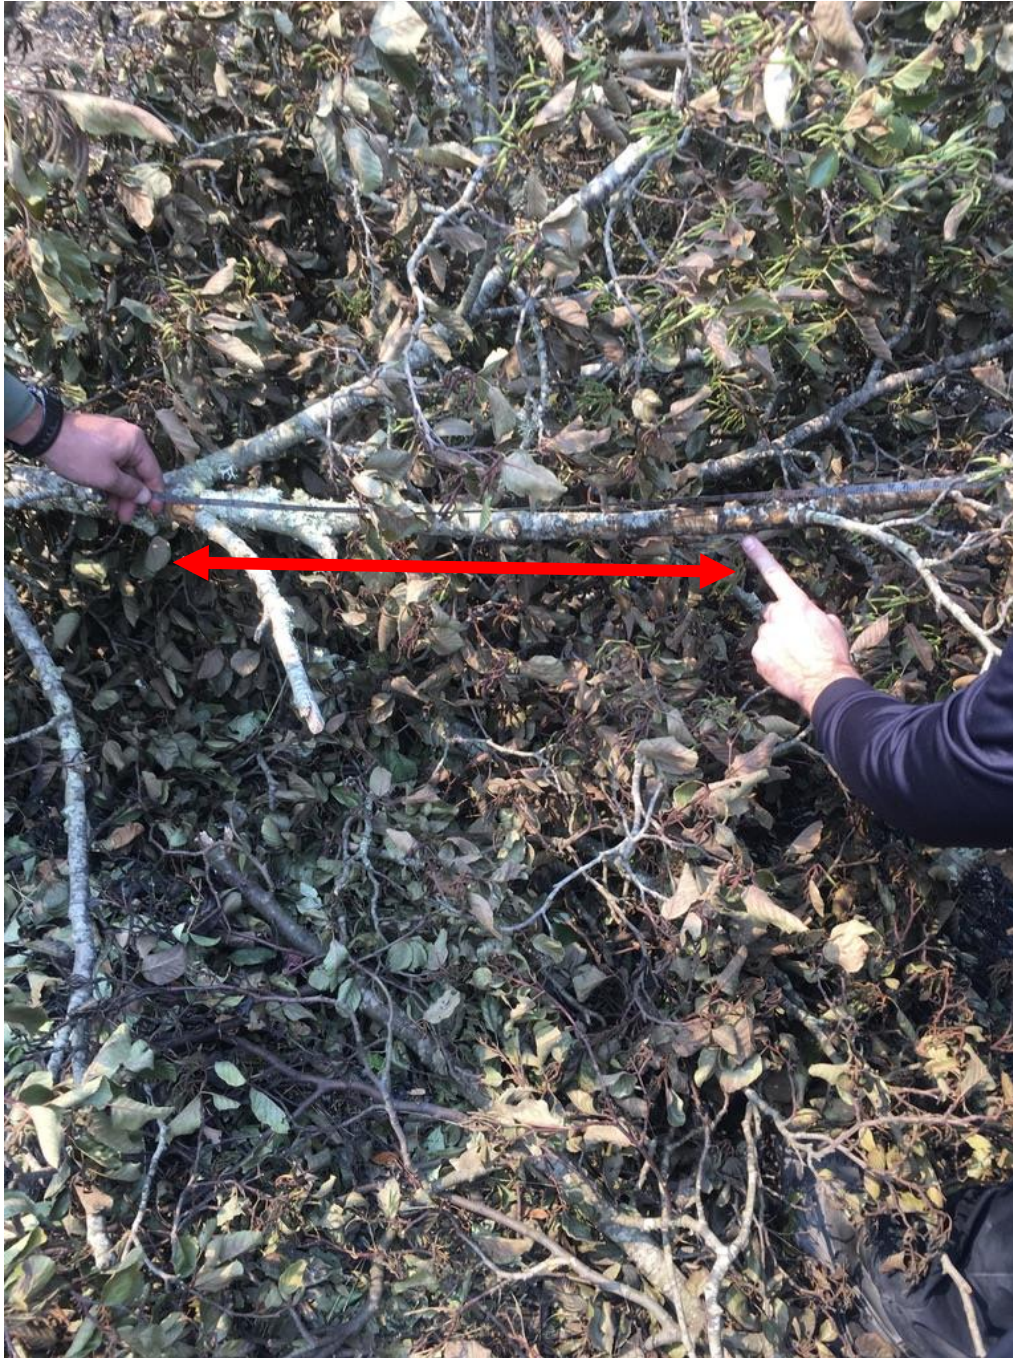
**Photo 8** – abrasion marks on fallen branch approximately 2 feet apart

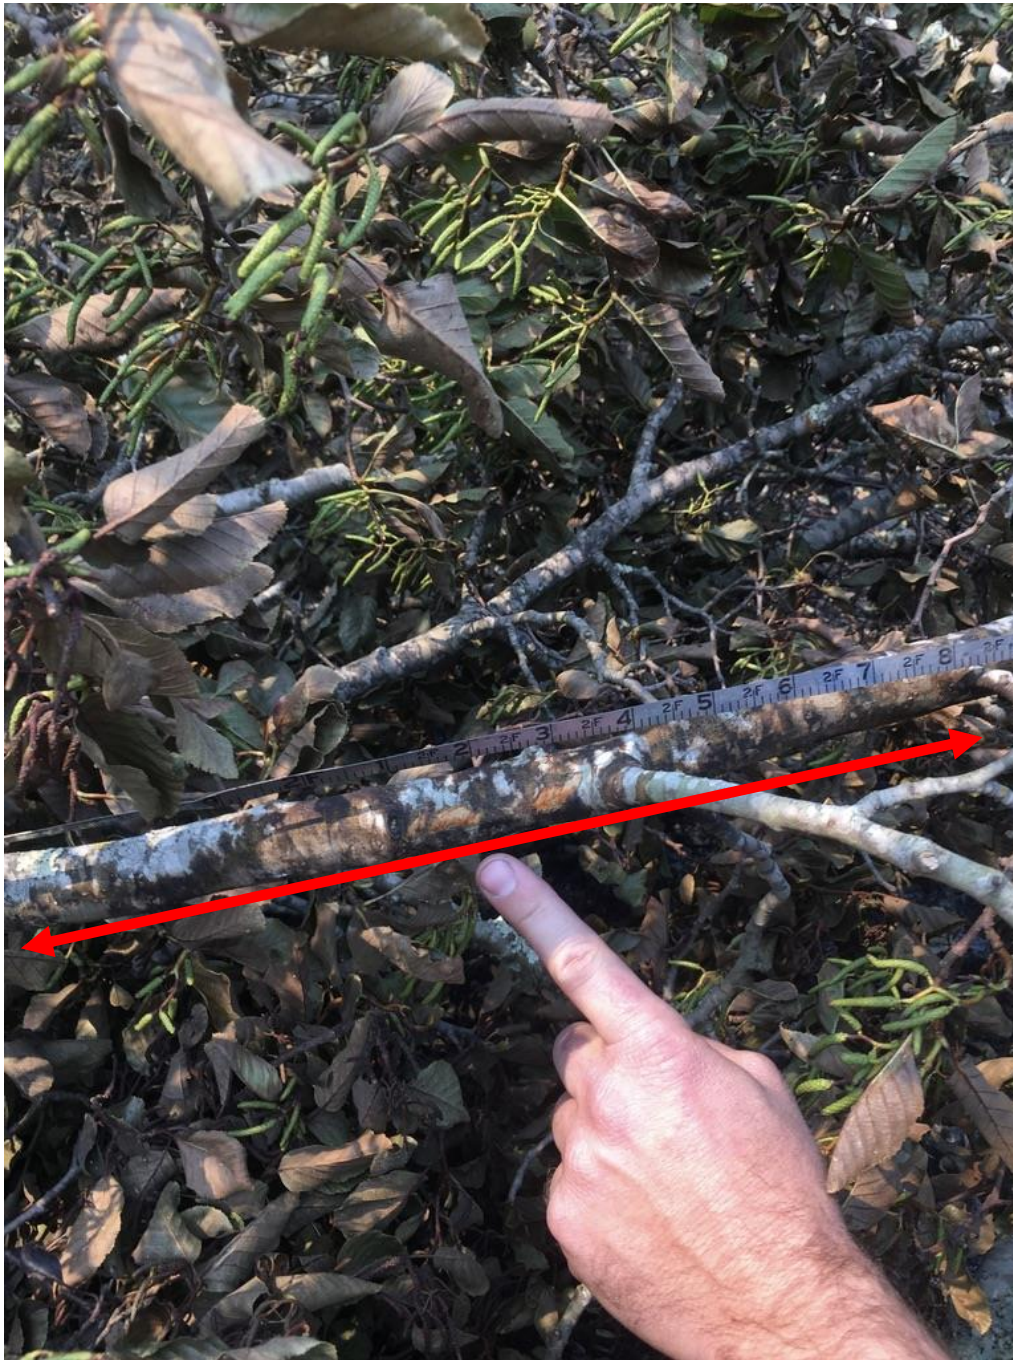
**Photo 9** – close-up of abrasion marks on fallen branch observed from subject tree

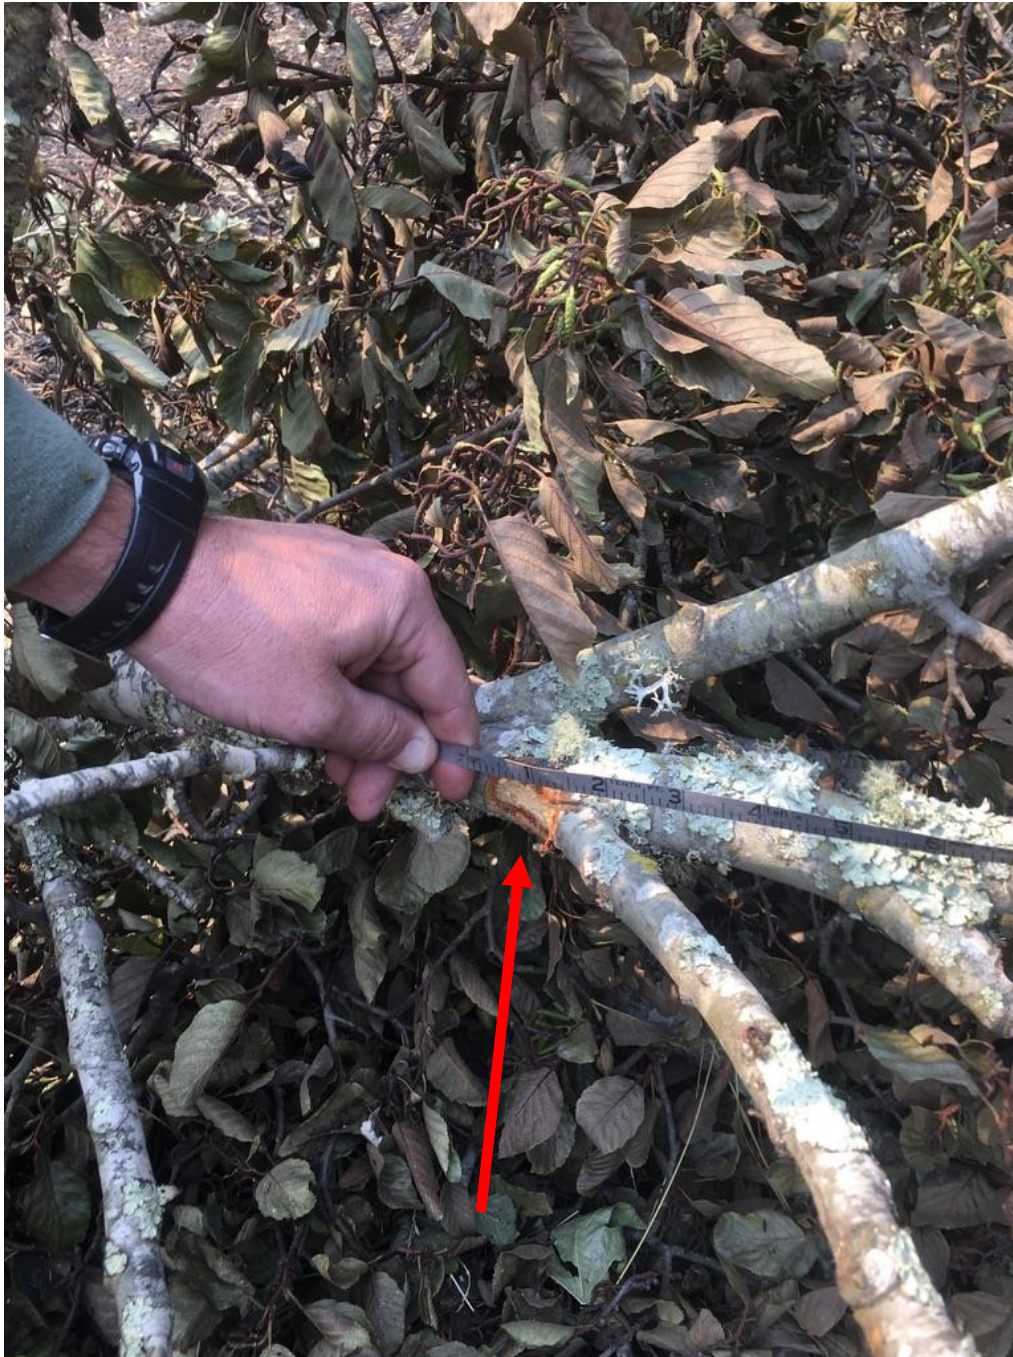
**Photo 10-** abrasion mark on fallen branch point of contact

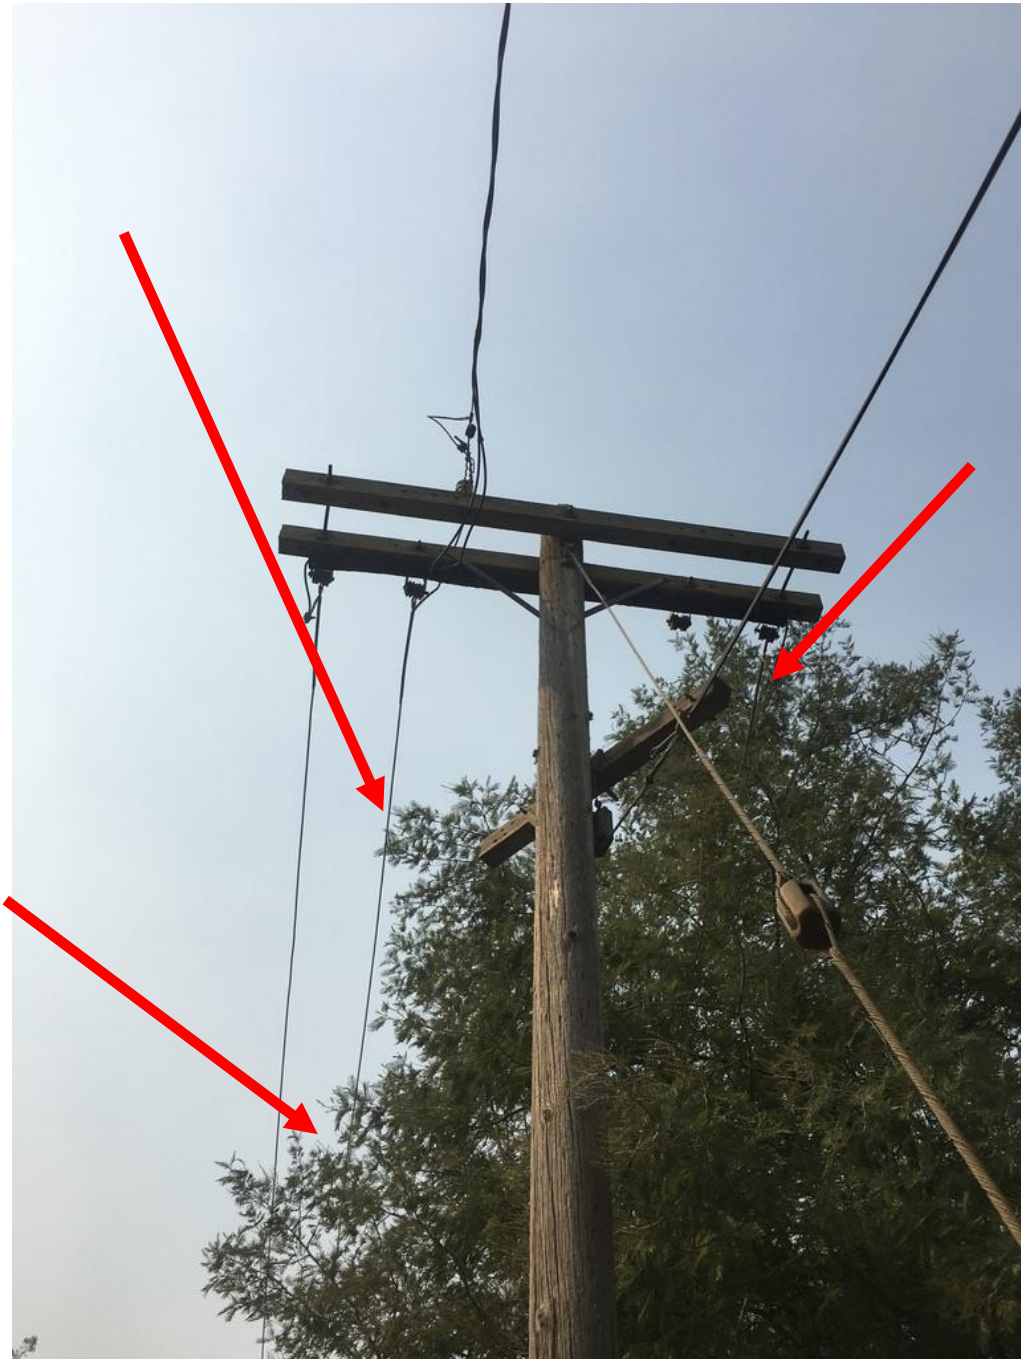
**Photo 11** - existing conditions of clearance. Trees along span in contact with wire and overhanging.

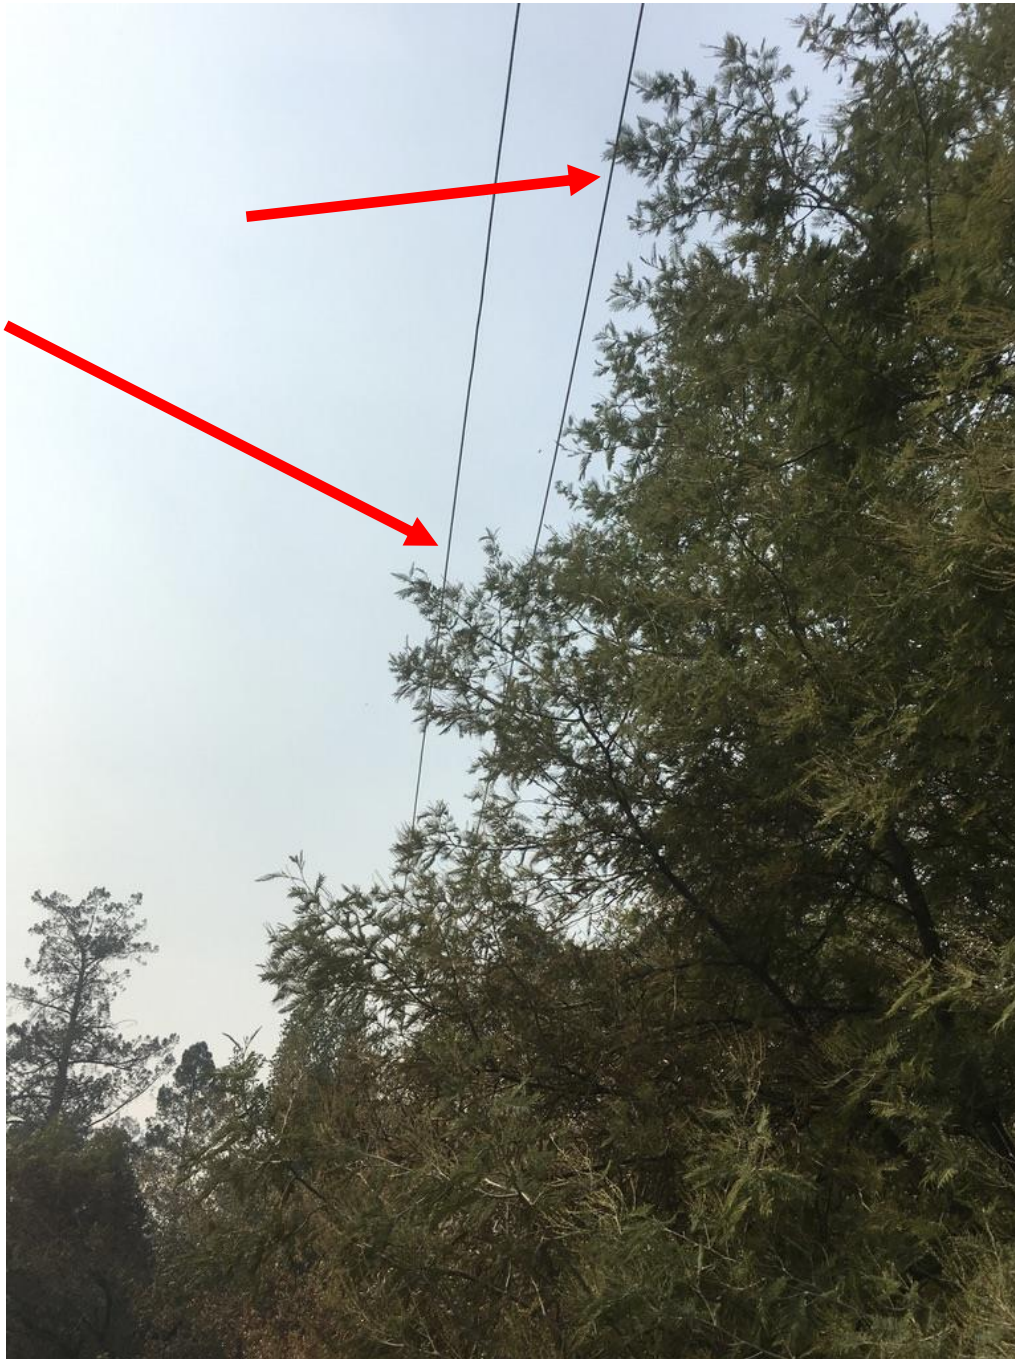
**Photo 12** - existing conditions of clearance. Trees along span in contact with wire and overhanging.

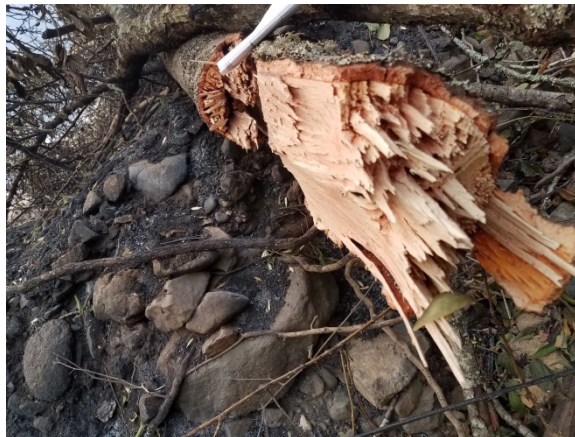
No evidence of rot or loss of structural integrity.

**Figure 5: Close up of the broken end of the tree top. No decay or insect activity observed.**

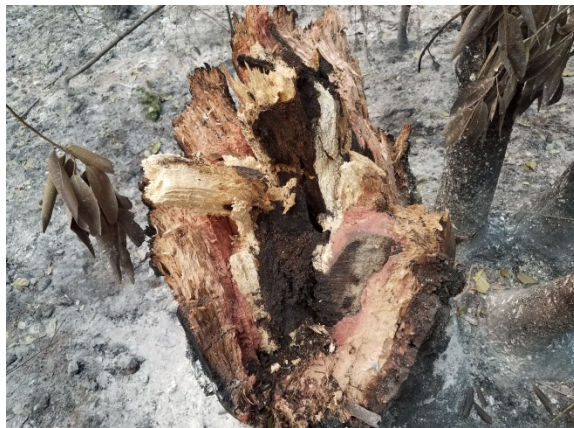
**Figure 11: Horizontal cracks visible at base of tree. The width of the cracks and the depth they extend into the sapwood are possible indicators of saw marks, however the upward curve at the margin and diminishing width suggest that may not be the case.**

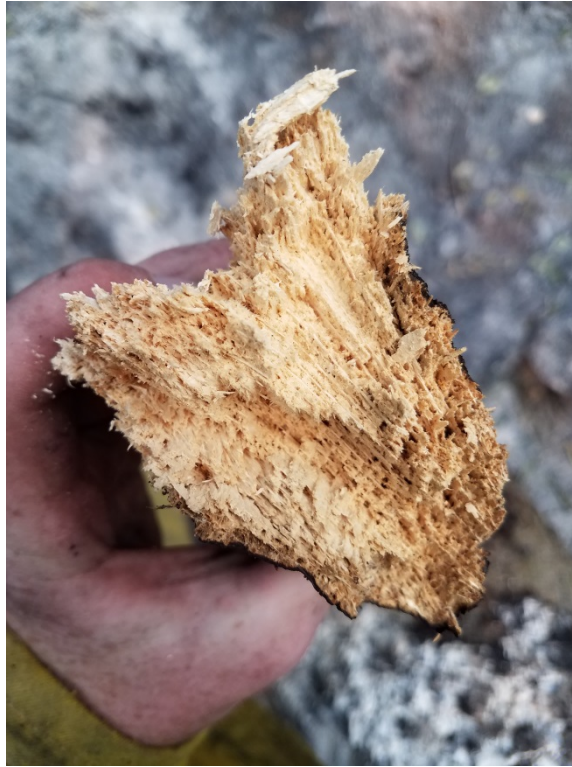
**Figure 12: Heart rot clearly visible in the bole of the tree.**

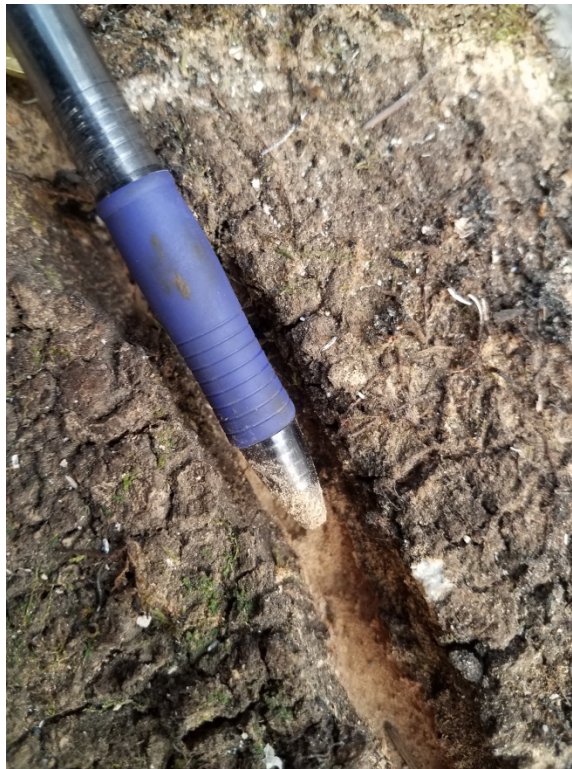
**Figure 13: Spongy, light weight sapwood clearly indicates spread of the fungal infection beyond the heartwood.**
