**CALIFORNIA PUBLIC UTILITIES COMMISSION**  
**Safety and Enforcement Division**  
**Electric Safety and Reliability Branch**

**Incident Investigation Report**

**Incident Number:** E20171016-01

**Utility:** Pacific Gas and Electric Company (PG&E)

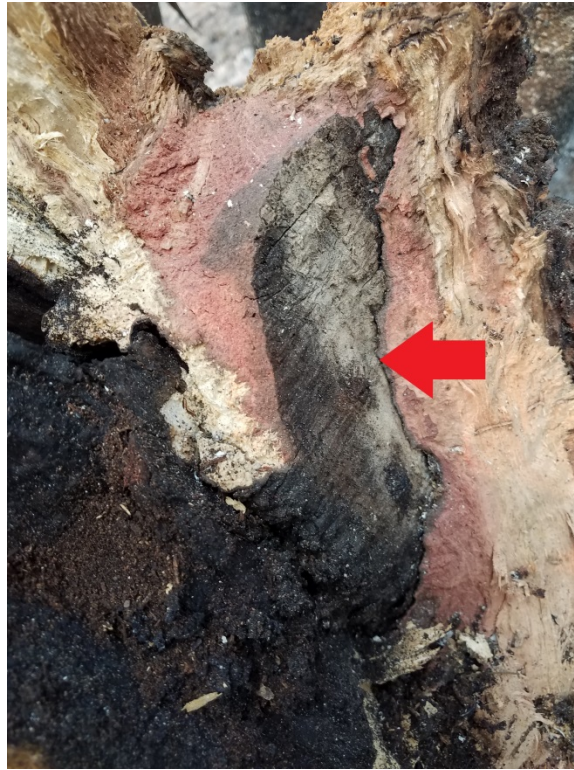
**Figure 14: Fine, powdery, decayed wood visible in cracks in the bark of the tree clearly indicates advanced stages of decay.**
