**CALIFORNIA PUBLIC UTILITIES COMMISSION
Safety and Enforcement Division
Electric Safety and Reliability Branch**

Incident Investigation Report

Incident Number: E20171020-05

Utility Facilities Involved: Sonoma 1103, 12 kV Circuit

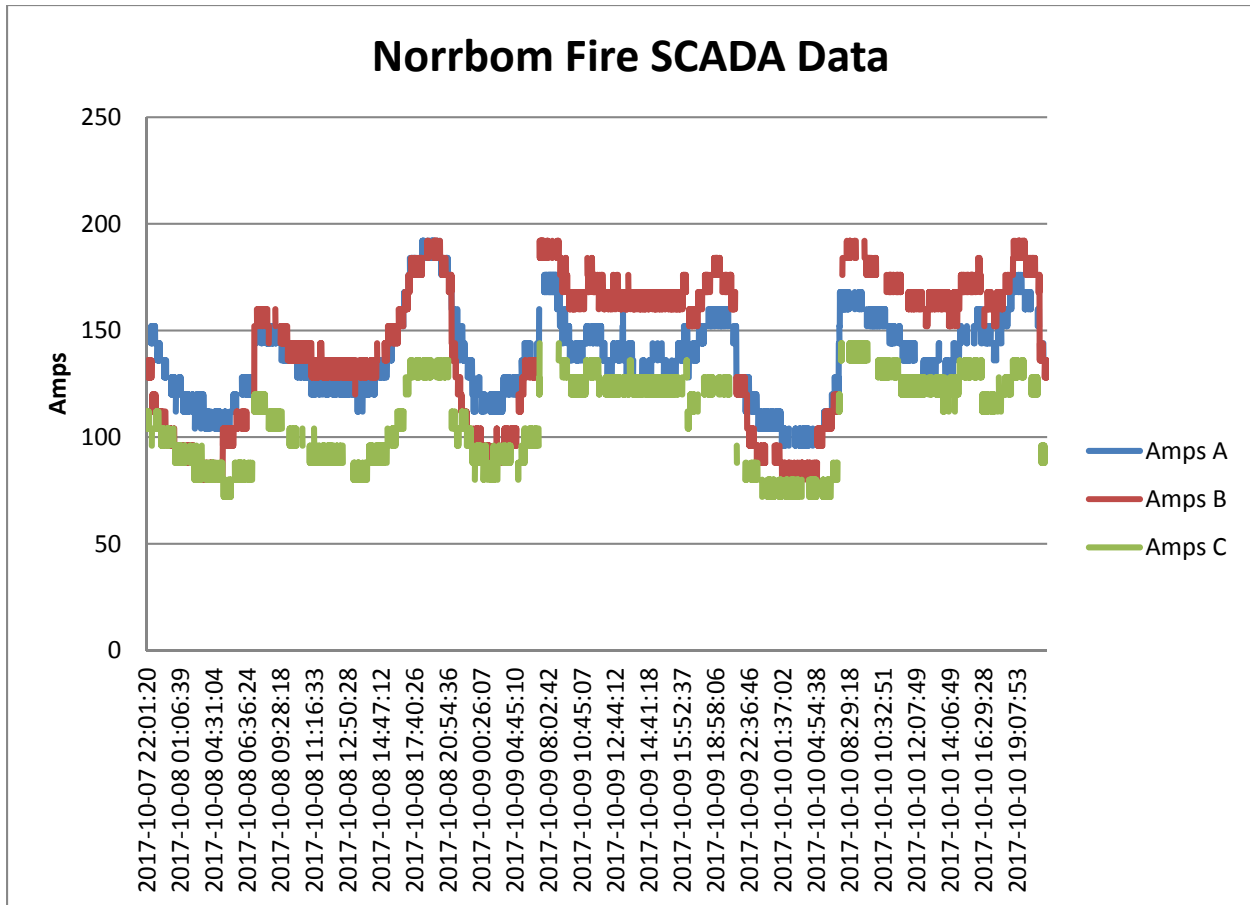
Figure 5: Plot of SCADA data from Sonoma 1103 CB for each phase from 24 hours prior to 48 hours after the CAL FIRE designated start time.

The start time for the Norrbom Fire according to CAL FIRE was 2200 hours on October 8, 2017. Based on Figure 5, on the day of the incident, the circuit experienced an outage between 17:40 and 20:54 hours. The decline in circuit amperage from then on indicates interruption in service either affected by the fire or by protection devices tripping.

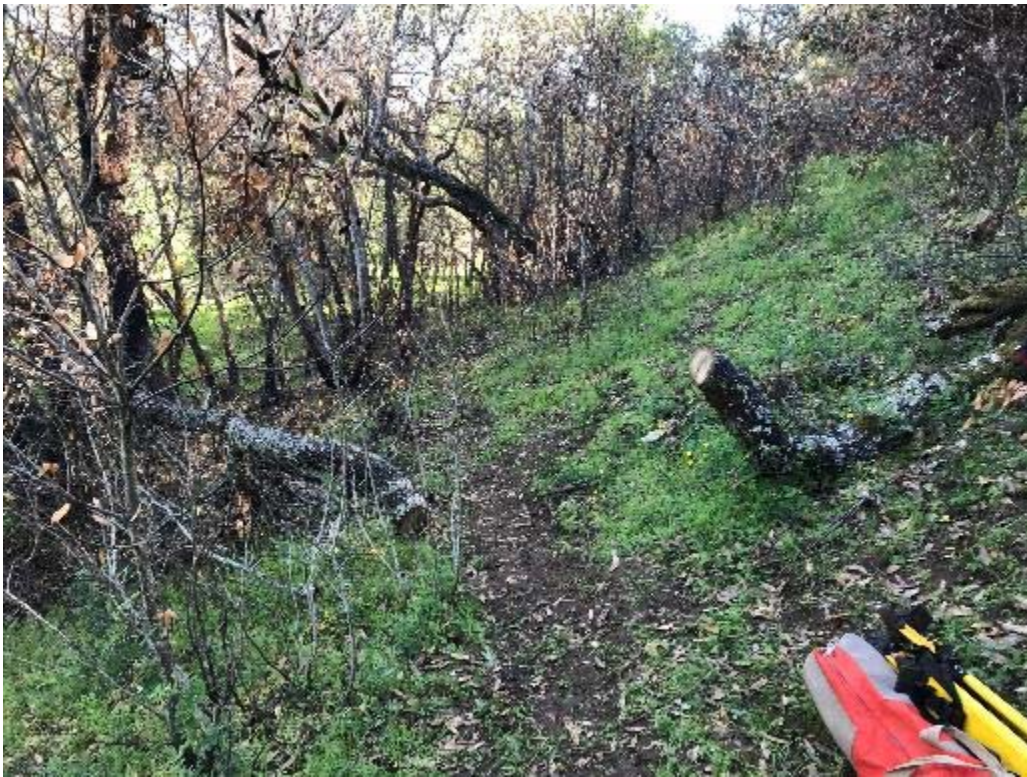
On March 29, 2018, SED attended a PG&E evidence collection located at 16700 Gehricke Road in the city of Sonoma. A tree approximately six to seven feet uphill from the conductor span had fallen. CAL FIRE took a three to four foot section of the tree while PG&E collected the rest. This location is most likely the Norrbom 2 Fire SOA.

Figure 6: Two sections of the fallen tree. CAL FIRE took possession of the approximate 3-4' section of the tree that is missing.

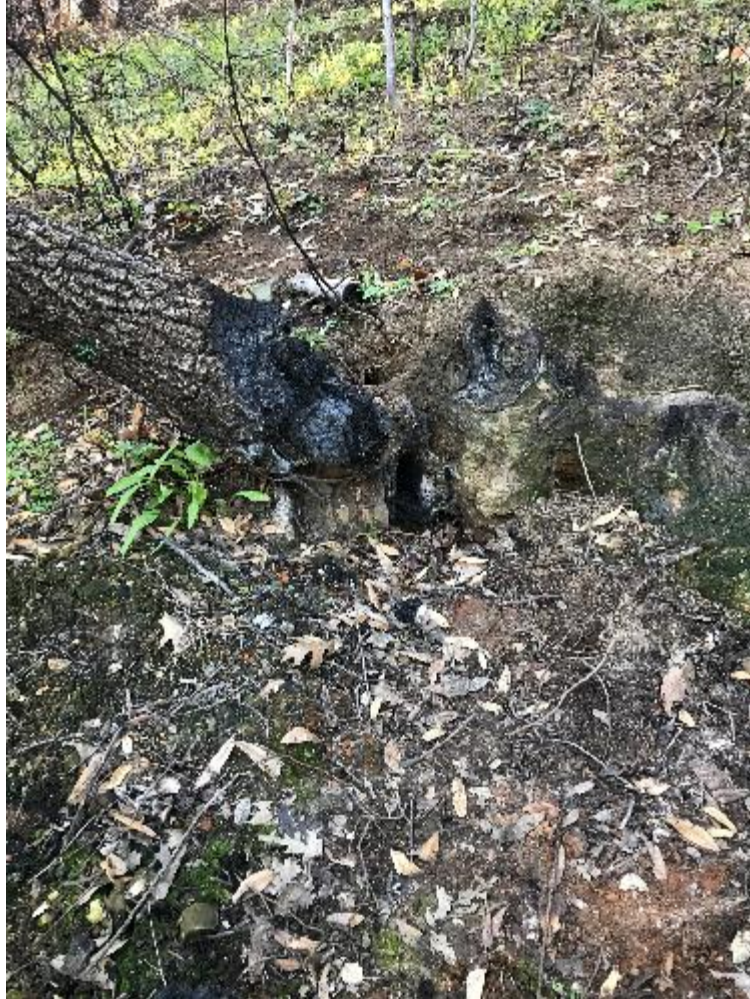
Figure 7: Burned base of the fallen tree.

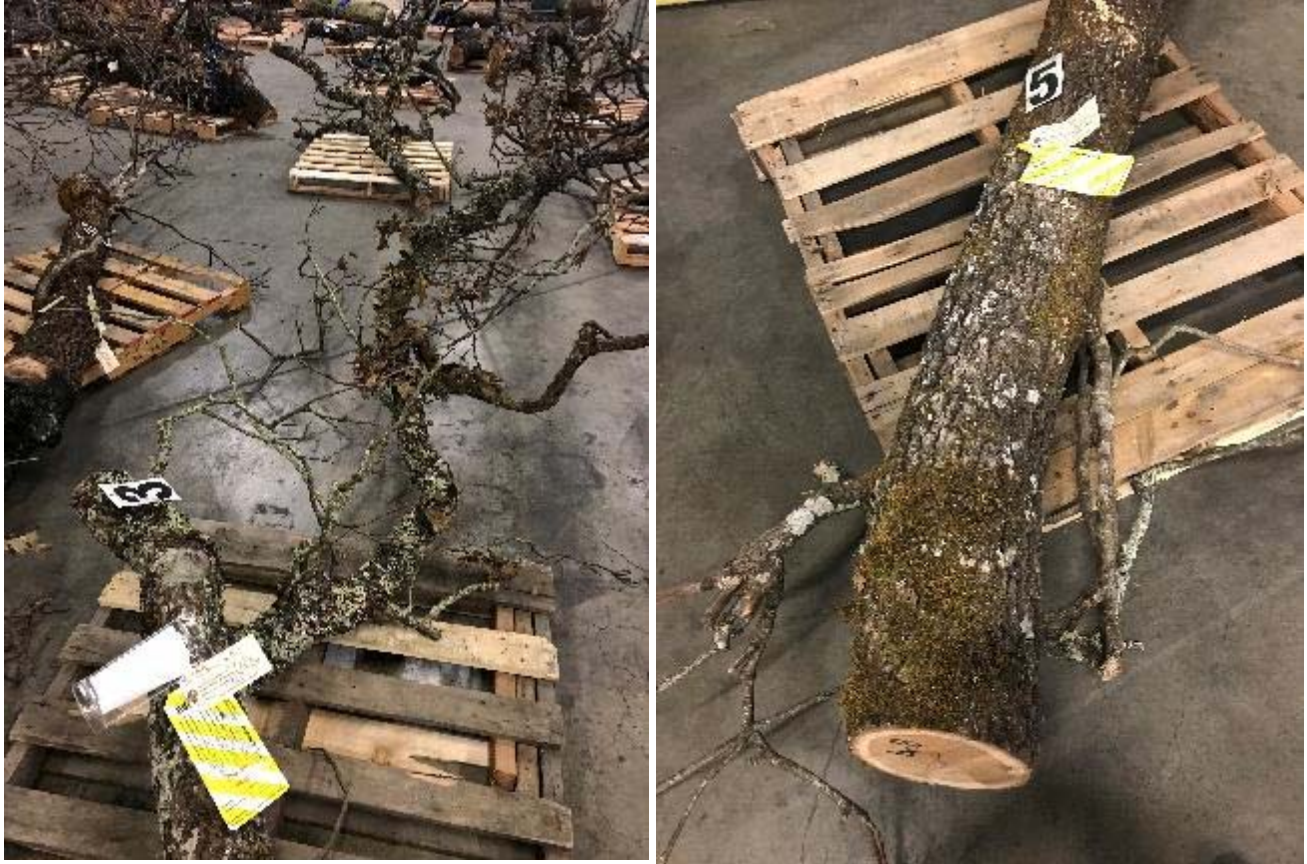
On June 11, 2018, SED conducted an evidence viewing of evidence PG&E obtained for all October fires. According to PG&E, for the Norrbom Fire, PG&E collected “a downed tree three spans to the source side of the incident location on March 29, 2018.” This coincides with the fallen tree mentioned in the March 29, 2018 PG&E evidence collection.

Figures 8 & 9: The fallen tree PG&E took in possession on March 29, 2018.

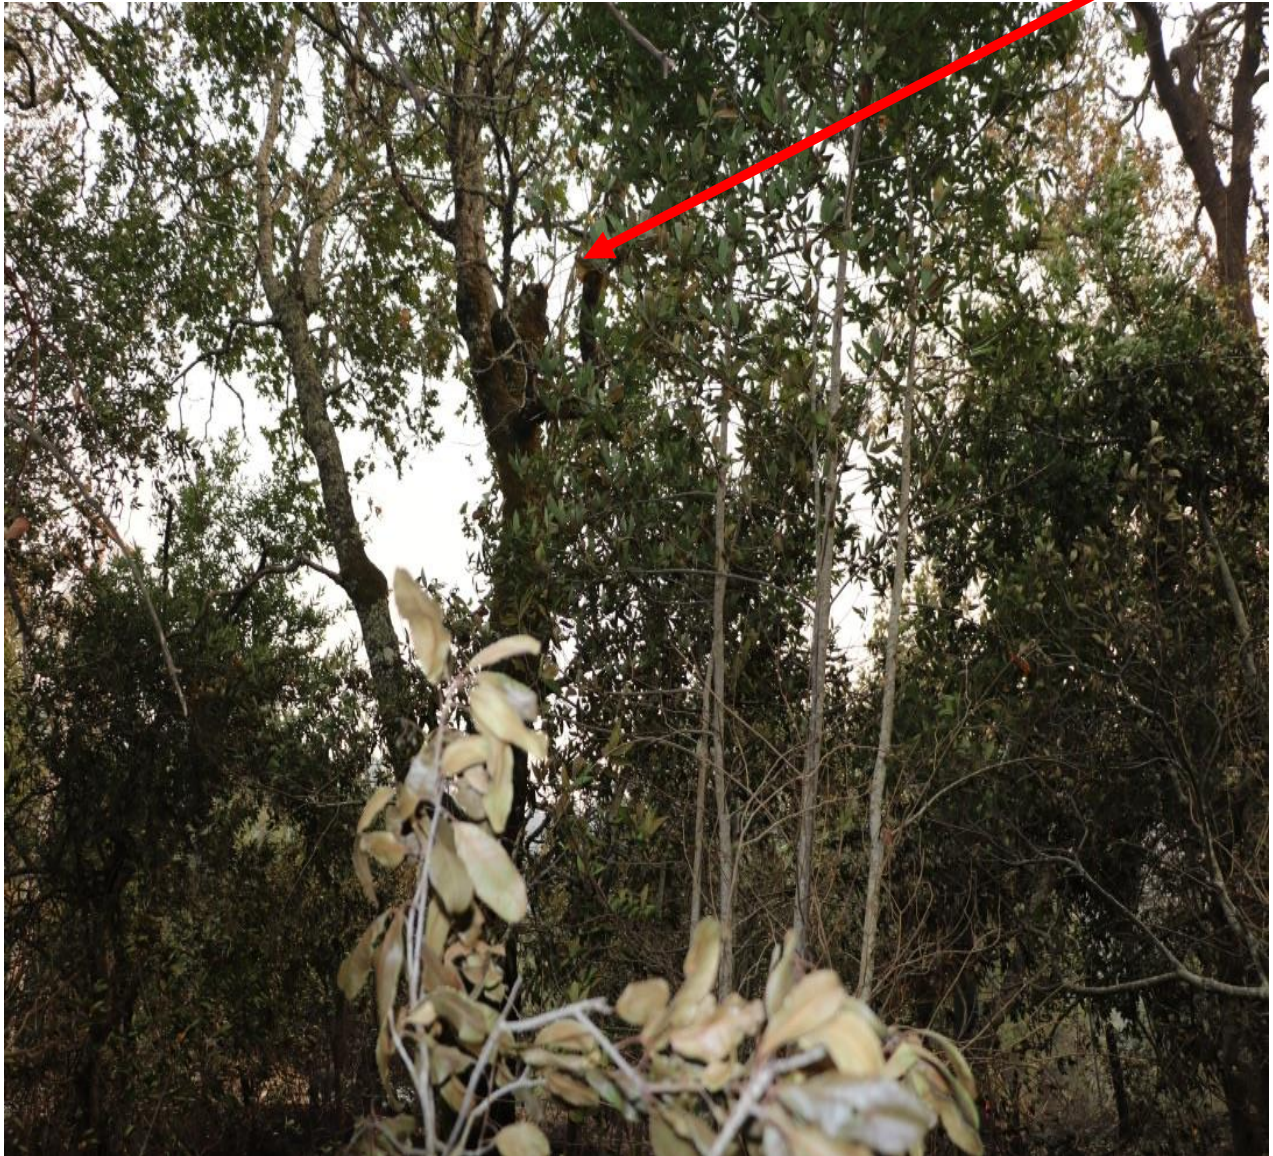
Subject tree Photo 1

Pre-existing decay pocket is a positive indicator of decay (Smiley et al.). The branch failure in Photo 2 was connected here at the arrow prior to failure.

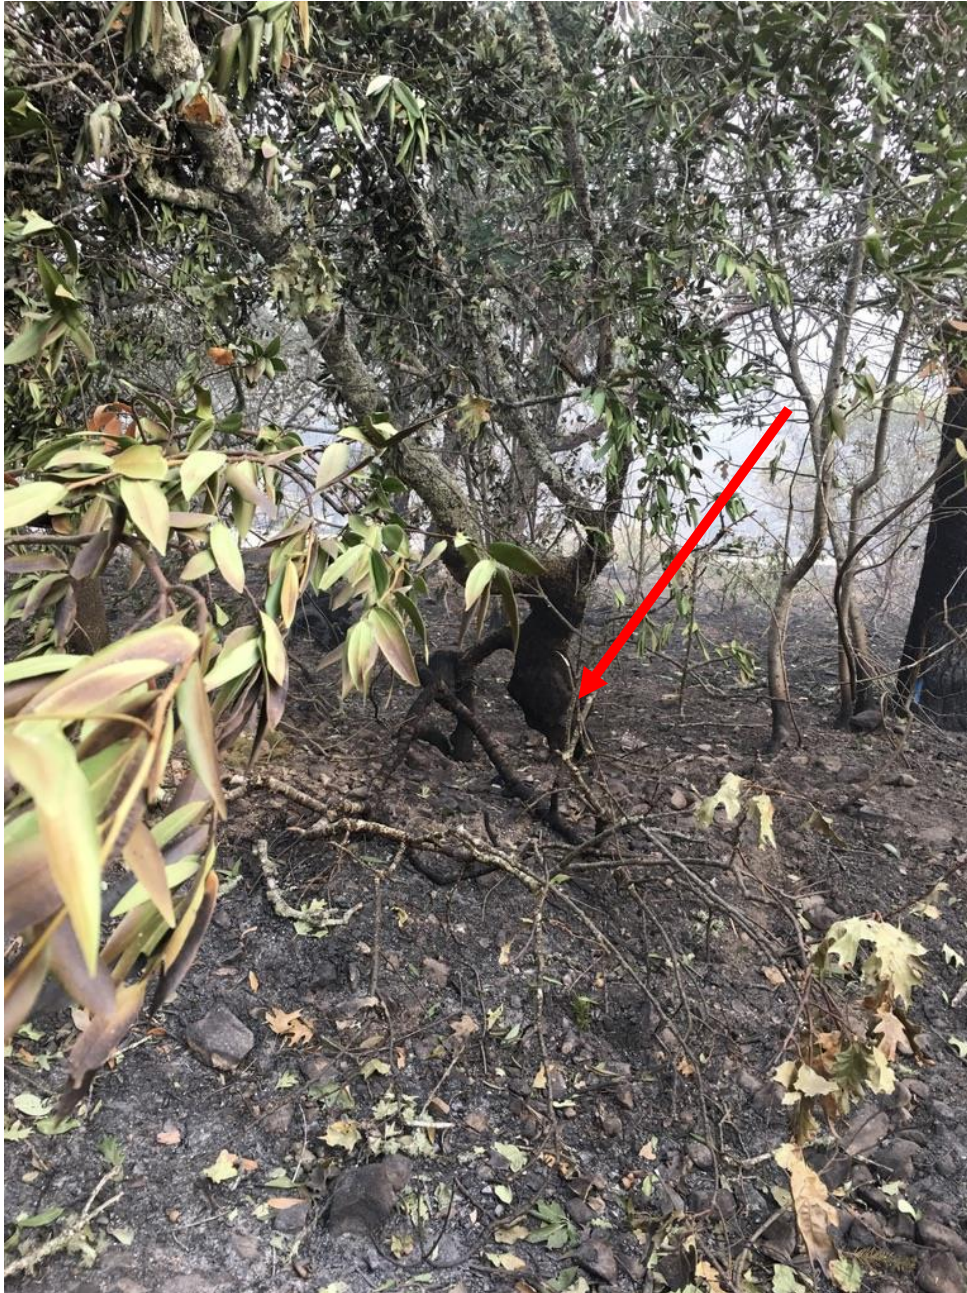
Subject tree Photo 2

Fractured branch decay observed at failure point.

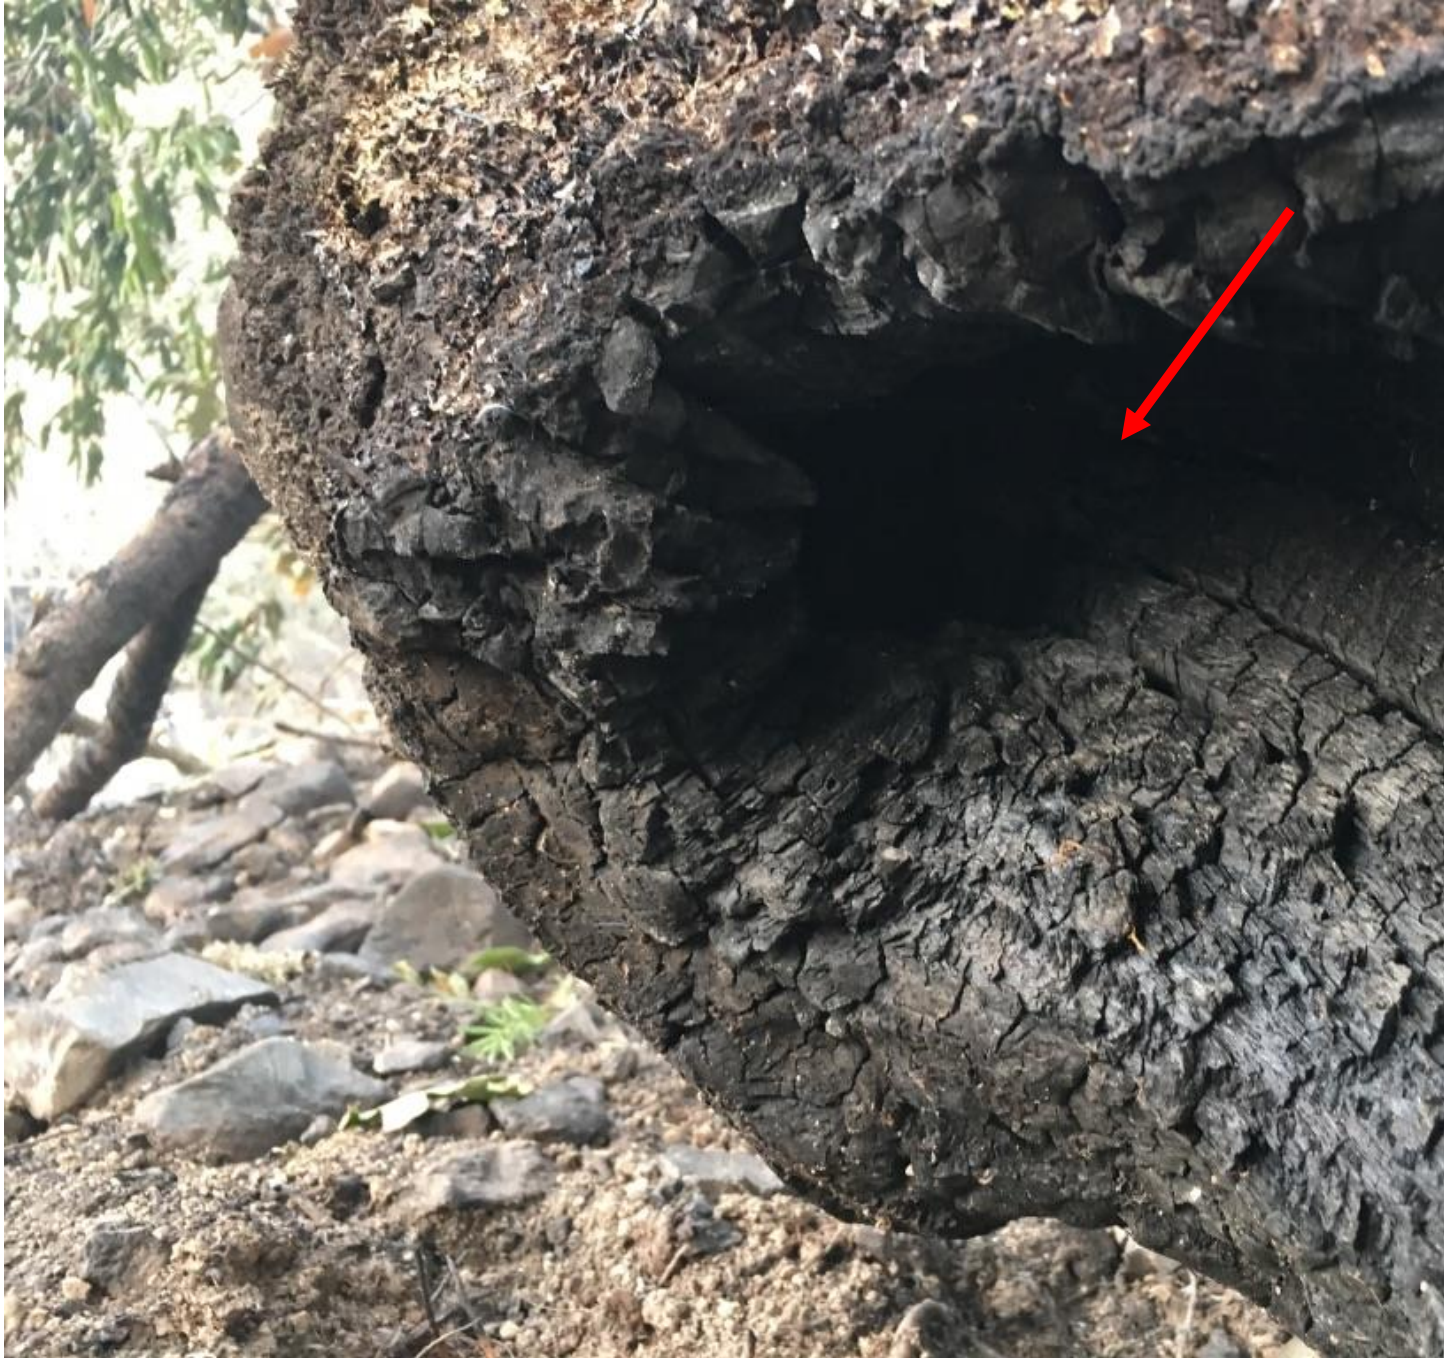
Subject tree Photo 3

Pre-existing decay pocket is a positive indicator of decay (Smiley et al.). Butt end of broken branch as seen in Photo 2.

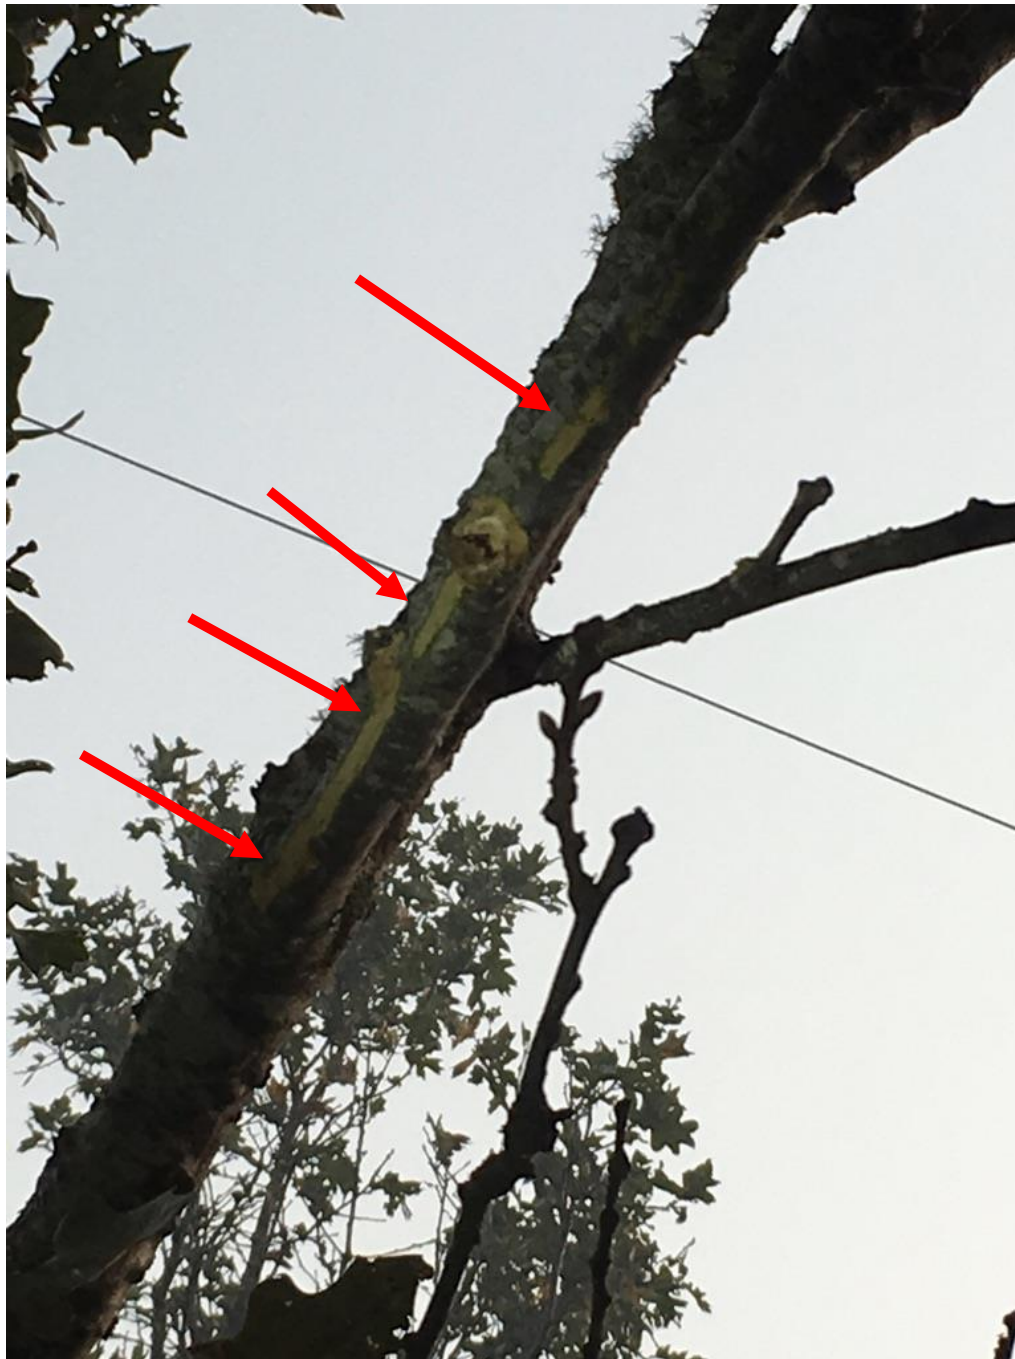
Subject tree Photo 4

Scrape marks believed to be caused by contact with distribution lines

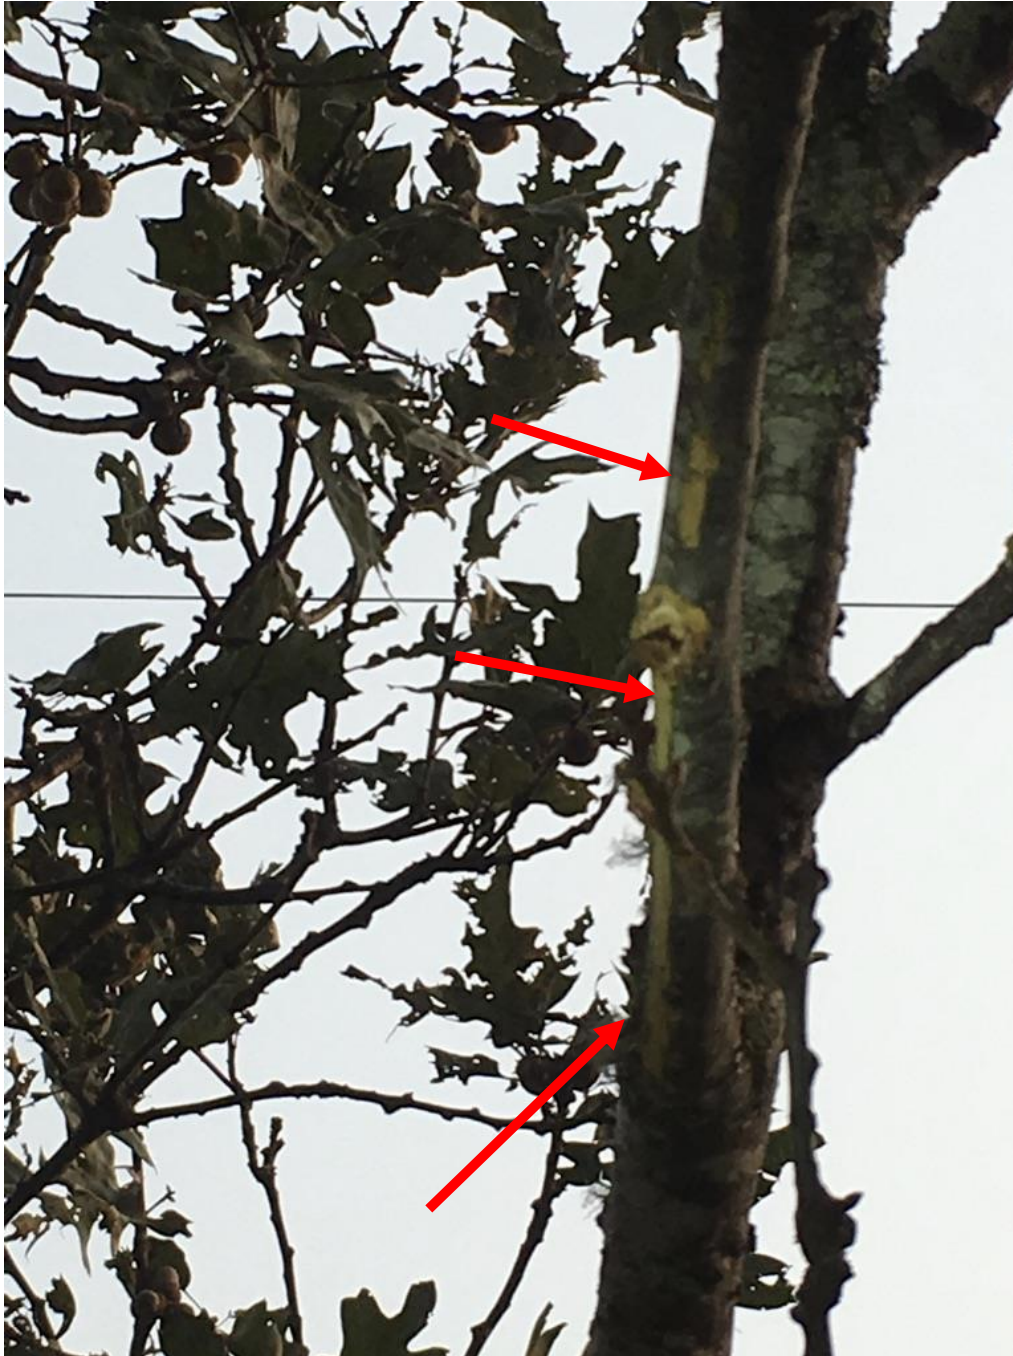
Subject tree Photo 5

Scrape marks believed to be caused by contact with distribution lines

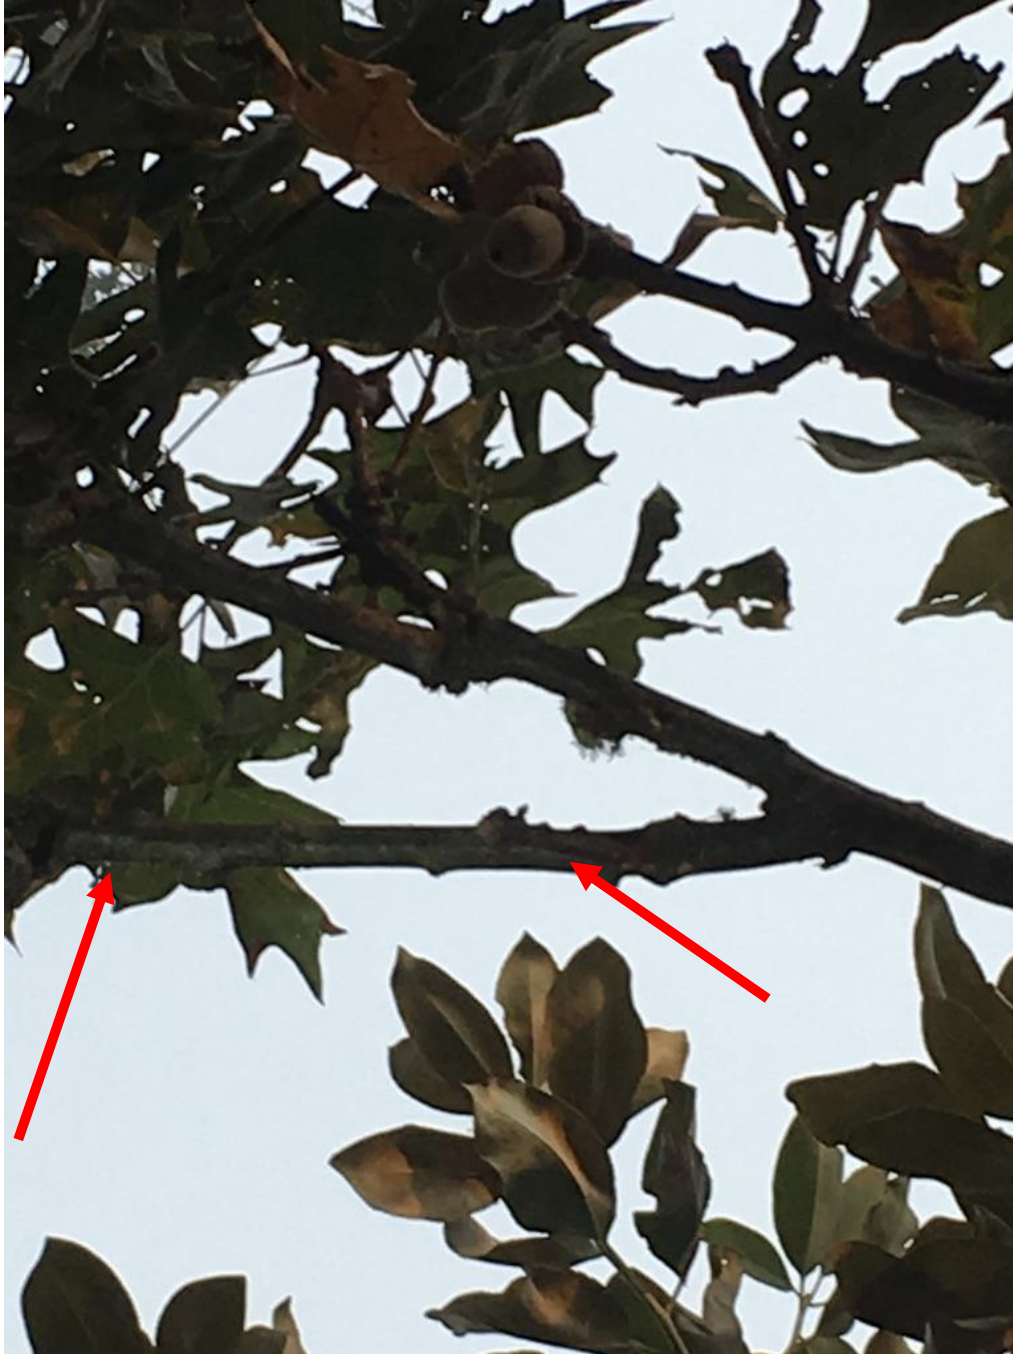
Subject Tree Photo 6

Scrape marks believed to be caused by contact with distribution lines

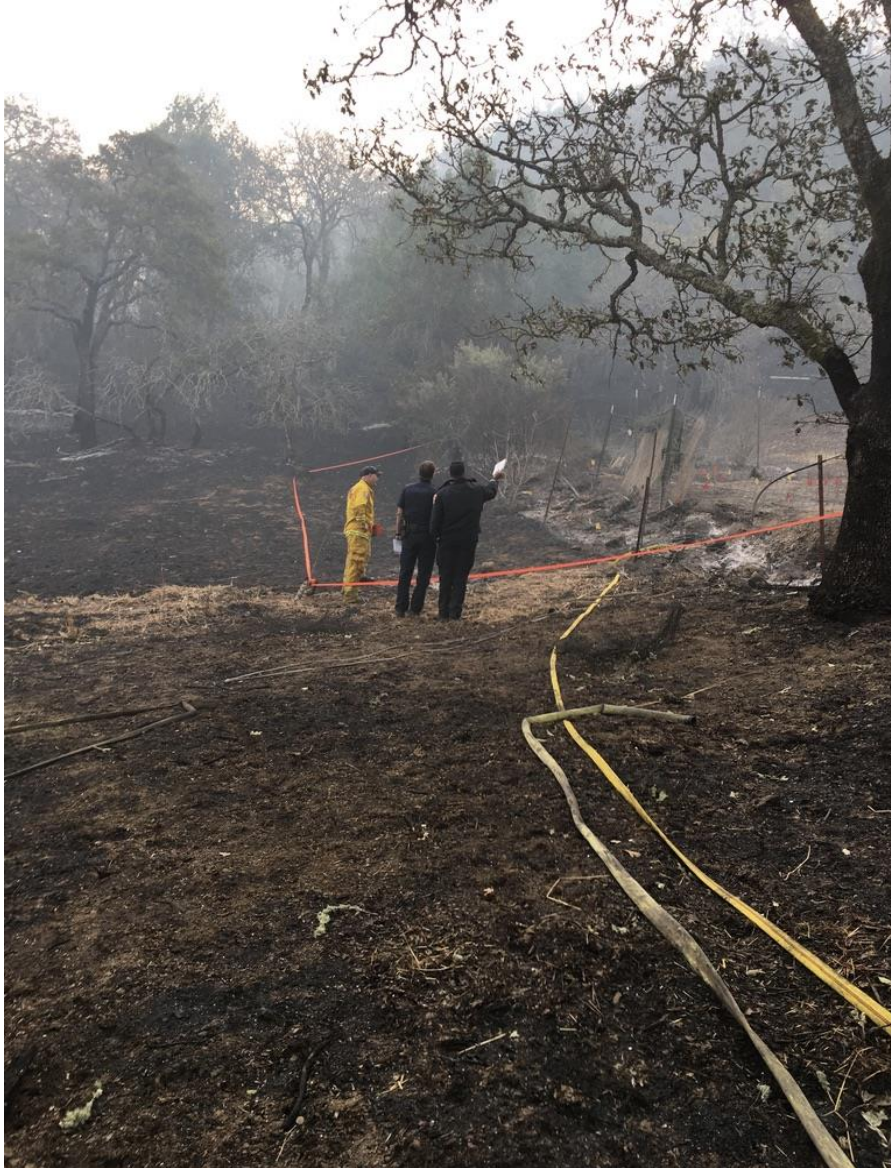
Neighboring tree Photo 7

Area of interest in close proximity to tree failure. Solid trees without visible evidence of decay fared much better in the area of this property and surrounding rural communities.

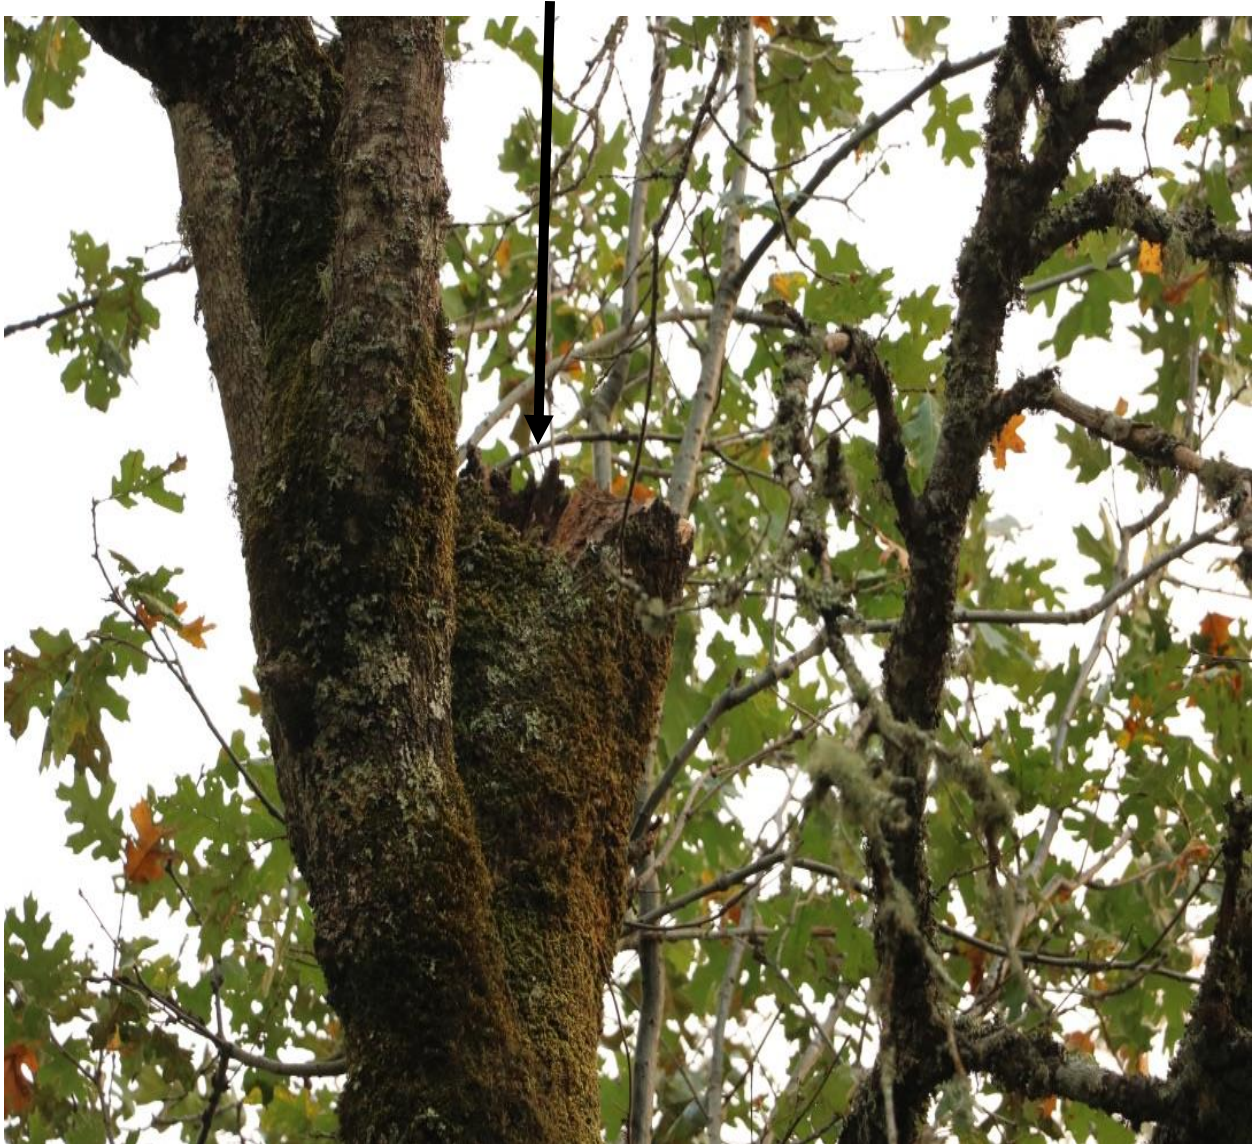
Photo 8

Subject Tree. Close up of the fracture point as seen in Photo 1.

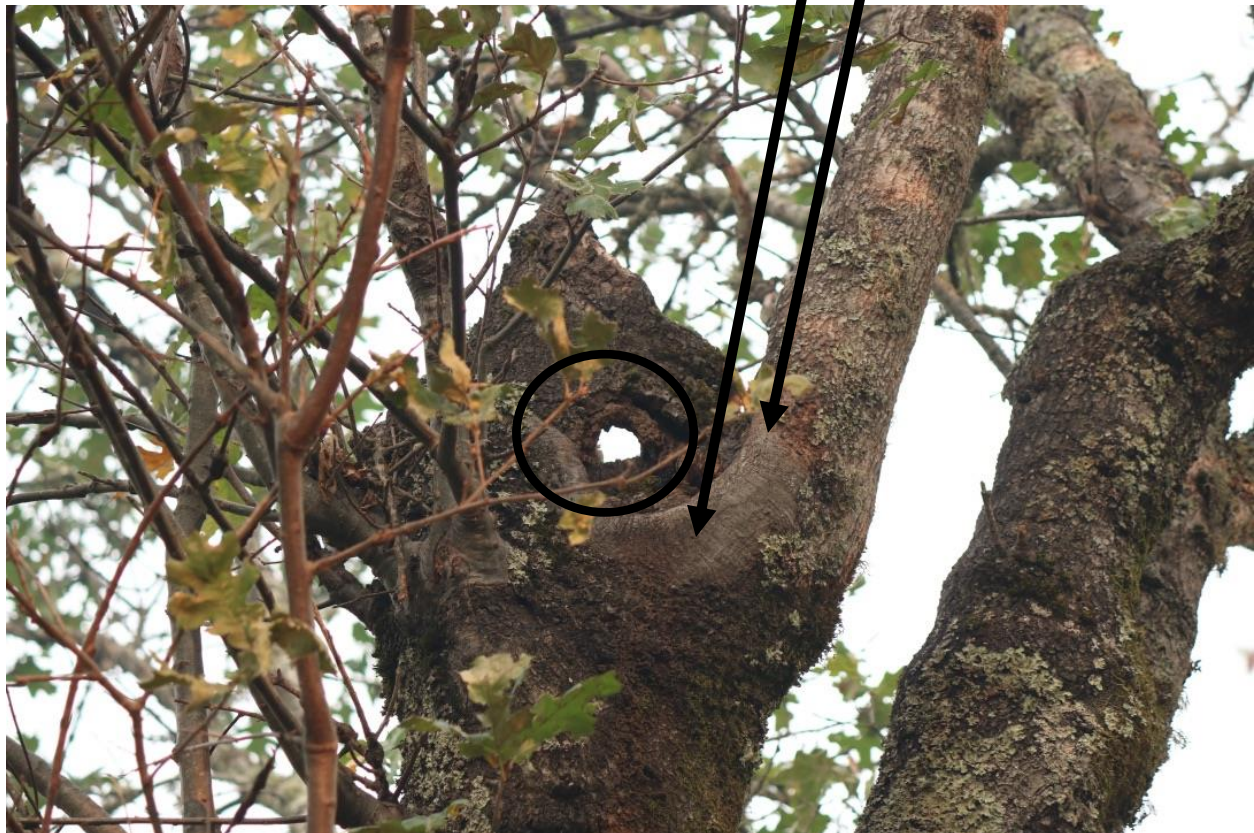
Photo 9

Subject Tree. The opposite side of the failure point in Photo 8. The woundwood (smoother bark texture) suggests that a wound was made several years ago. A large cut creates an easier entry point for decay organisms. The tree responds with epicormic shoots (sprouts near the cut). The leaves from the smaller epicormic shoots near the wound create photosynthate (energy or food for the tree) to assist with woundwood formation.

When decay fungi can grow faster than woundwood the attachment becomes weaker than the load created by branch weight and wind loads. Another old pruning wound (circled area) attempting to close up and hide cavity. The weak area was pre-existing for several years.

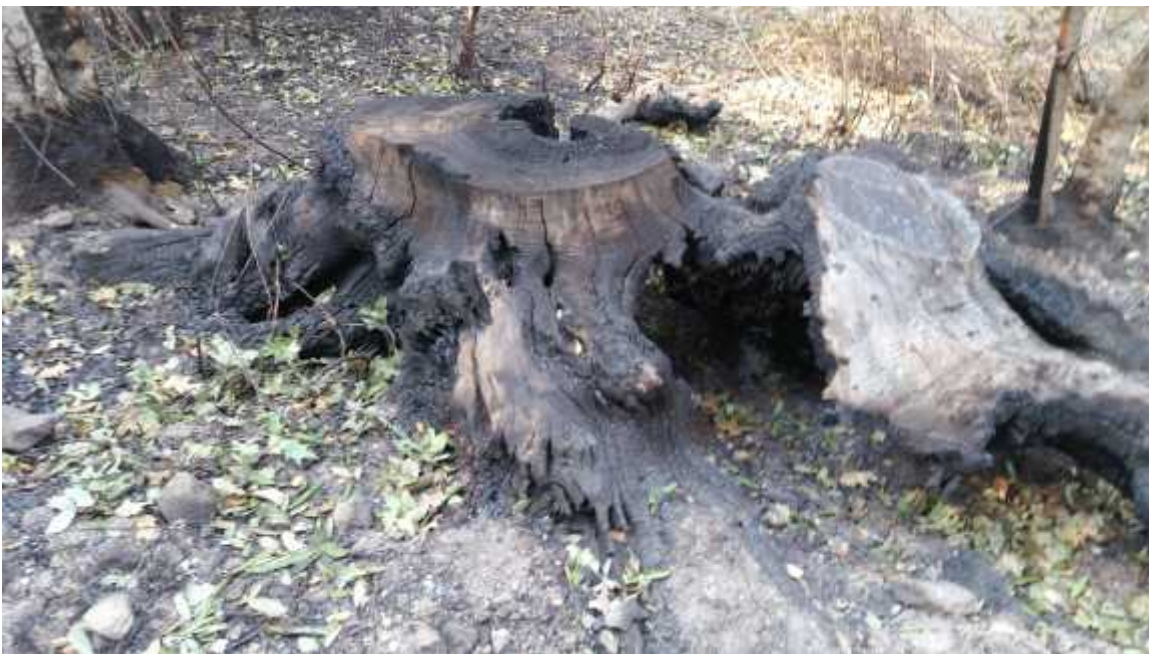
Surveying the area under the span, there was a burnt tree stump six feet from the field phase. Another burnt tree stump was found 10-15 feet from the road phase (Figure 3). The hill dips down into the vineyard which runs

Figure 3: One of the burnt trees identified near the incident span.
