**CALIFORNIA PUBLIC UTILITIES COMMISSION
Safety and Enforcement Division
Electric Safety and Reliability Branch**

Incident Investigation Report

Incident Number: E20171021-01

Utility Facilities Involved: Cloverdale 1102, 12 kV Circuit

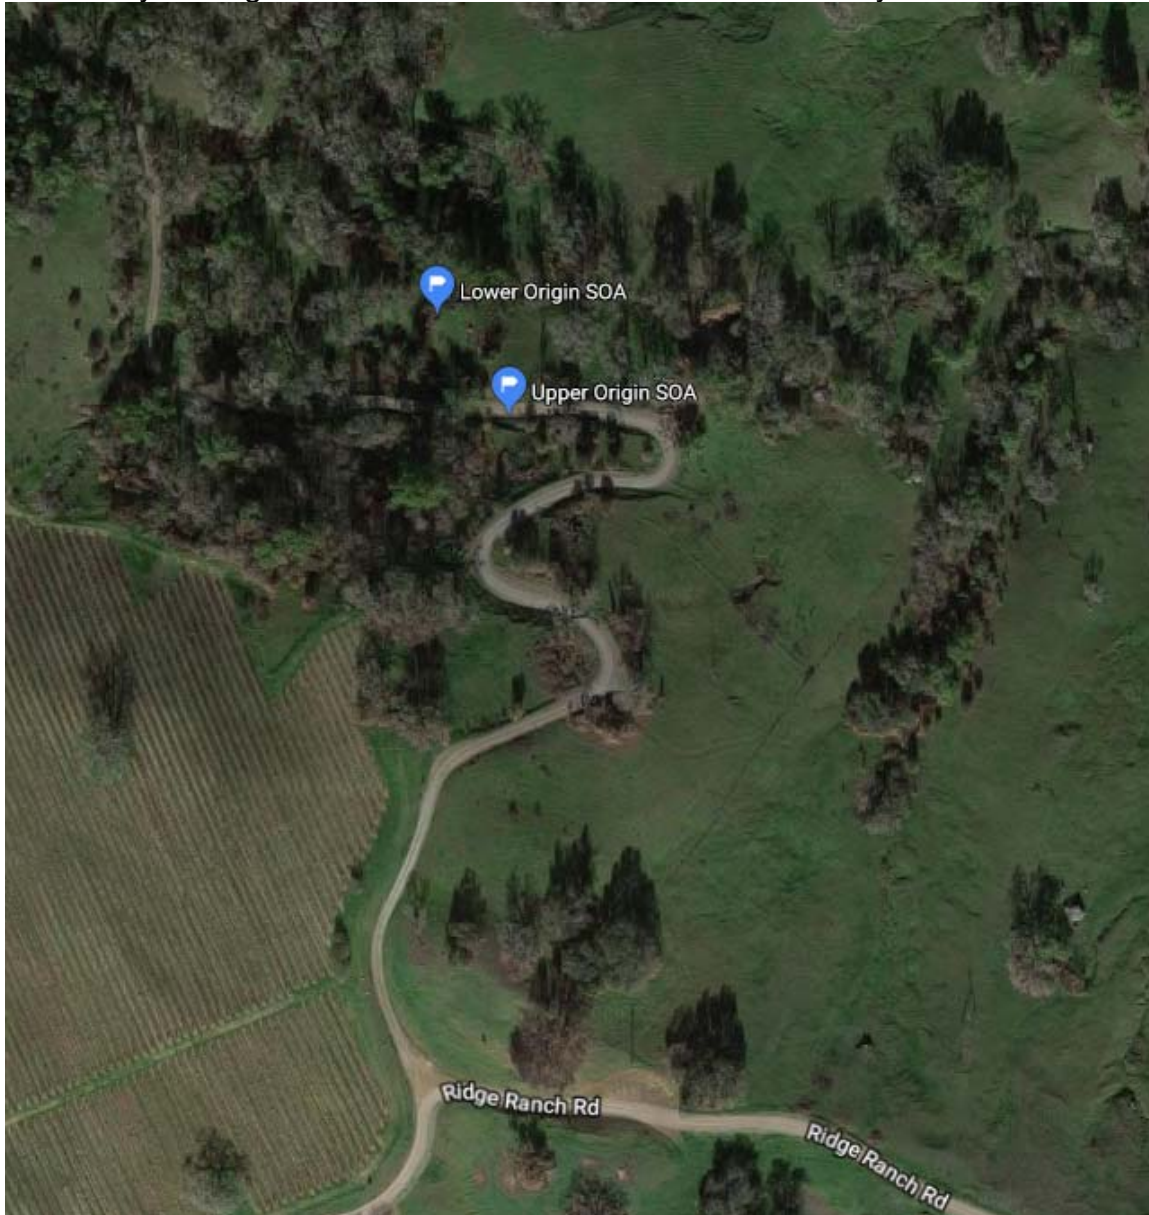
On October 8, 2017, at approximately 0000 hours, the branch of an approximately 40-foot mature Valley Oak tree failed, fell, and contacted overhead conductors of PG&E's Cloverdale 1102 12 kV circuit located near the intersection of Ridge Ranch Road and Ridge Oaks Road in Sonoma. One of the 12 kV conductors fell to the ground and ignited the fire. CAL FIRE identified the Specific Origin Area (SOA) for the Pocket Fire as shown

in Figure 1. The SOA is defined as the immediate area surrounding the ignition area¹. The Upper and Lower Origins establish the boundaries that define the SOA².

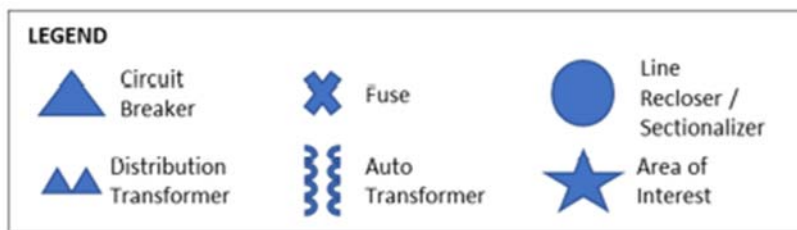
Figure 2: PG&E single-line diagram from the substation to the incident location. The diagram includes all protective devices in-between. Not to scale.

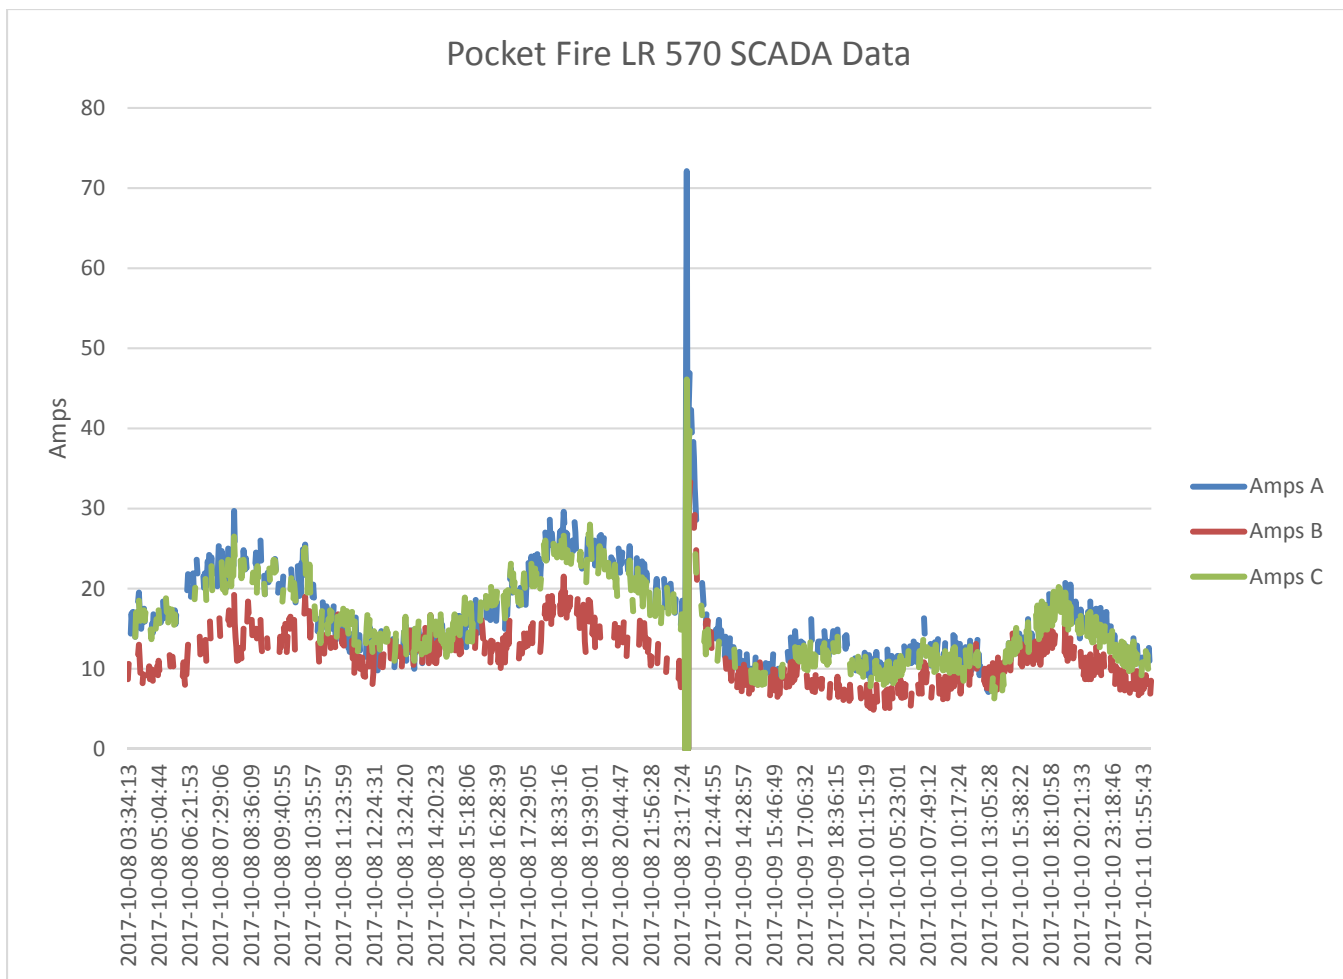
Figure 4: Plot of SCADA data from LR 570 for each phase from 24 hours prior to and 48 hours after the CAL FIRE designated start time.

The load on all three phases is fairly consistent across the entire period, approximately 0-30A. However, there is a spike in amperage around the CAL FIRE designated start time of October 9, 2017 0330 hours. The highest spike occurs on the A phase reaching approximately 72A. Both the B and C phases also experience a spike in current at this point. The spike in current is indicative of a fault downstream as current is back fed to the source side until any of the upstream protection devices trip and isolate the fault.

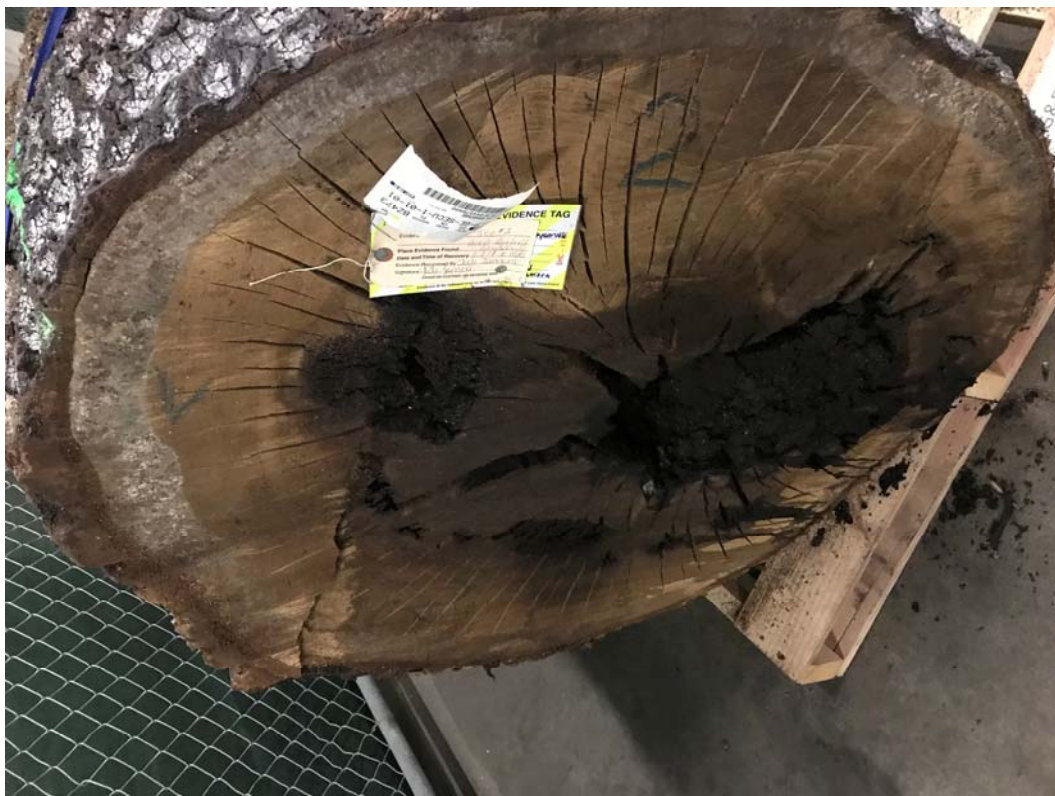
Based on Mr. Porter’s report, the incident tree showed signs of advanced decay as indicated by the large hole on the trunk. The decay persisted to the subject branch which resulted in the failure. The decay and rot on the tree were visually evident. Under PG&E’s Vegetation Management Program, the certified contractors should have identified the tree for removal during the pre-inspection. Records show that from 2014-2017, PG&E did not identify any Facility Protect trees in the incident area.

Figure 5: The trunk of the incident tree.

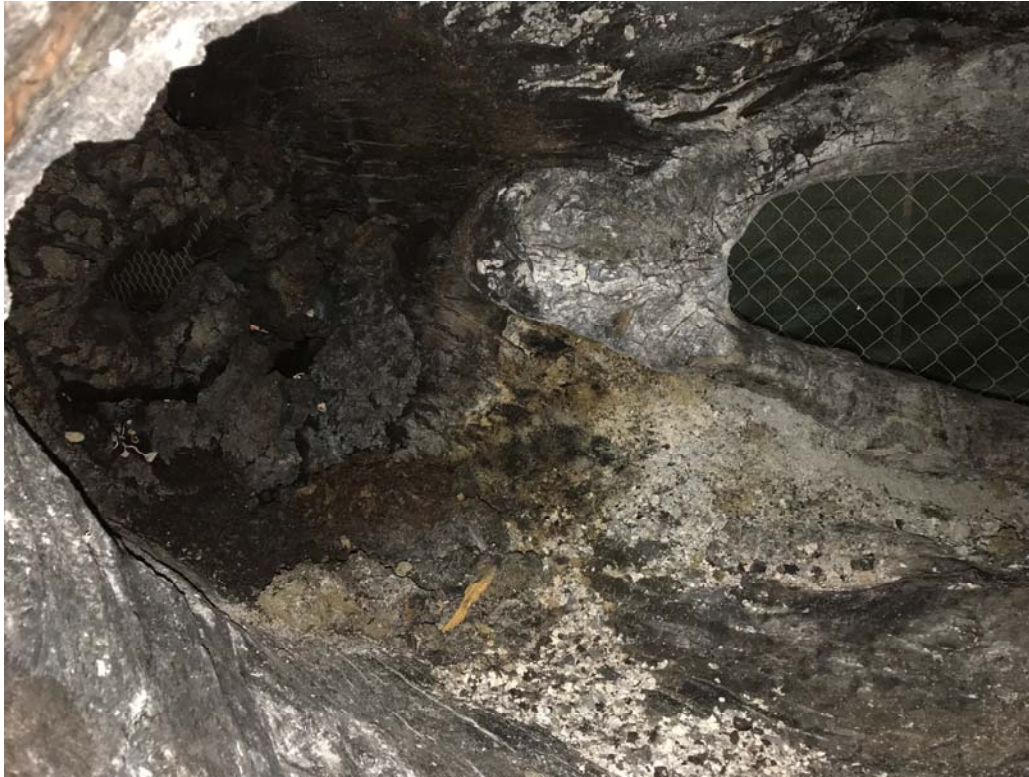
Figure 6: Hollowed out interior of the incident tree trunk.

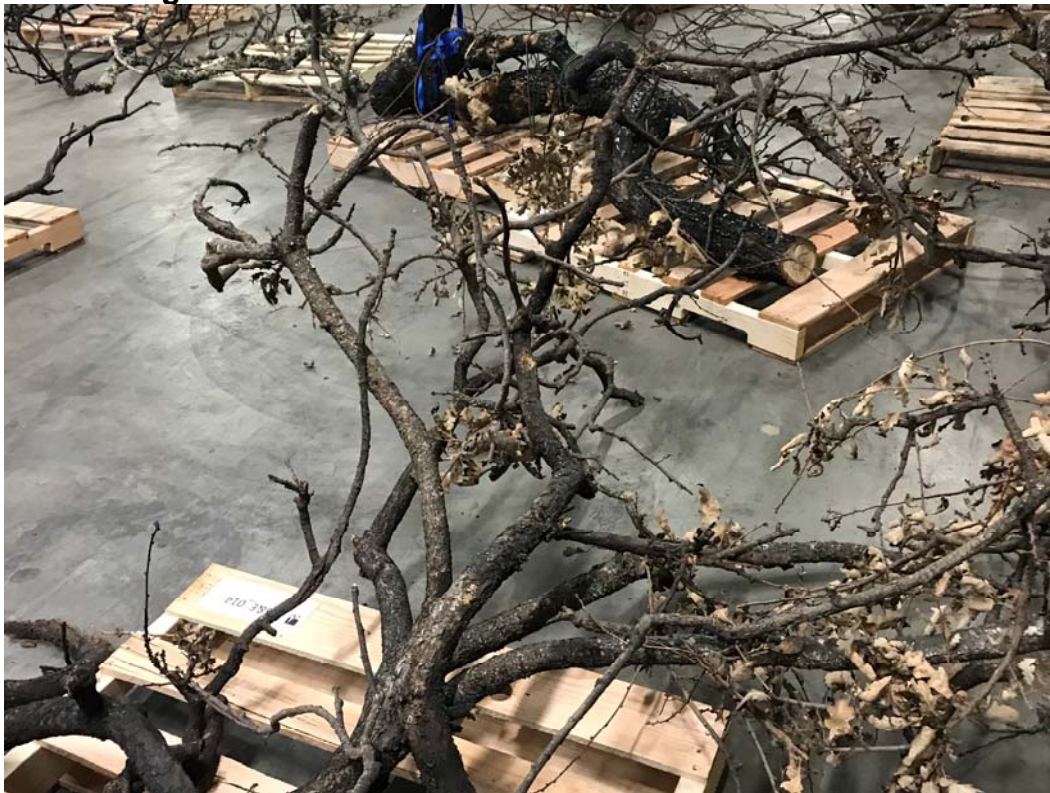
Figure 7: Broken top section of the incident tree as seen in Figure 5.

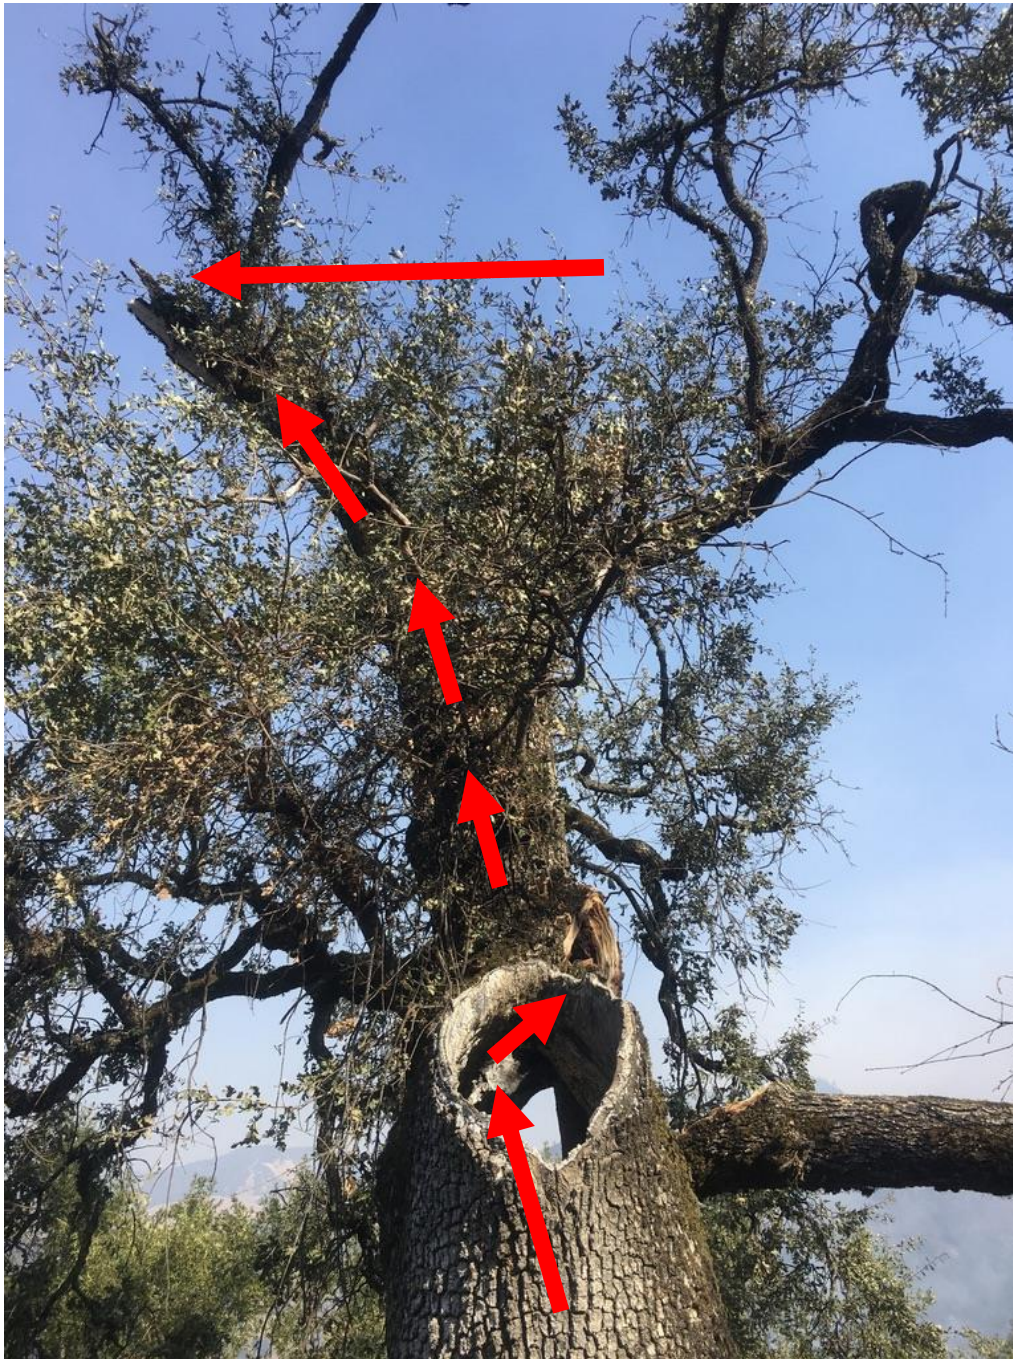
Photo 1

Subject Tree fracture point (horizontal arrow). Breakdown of compartmentalization barriers allowing decay to move (smaller arrows). Trees that are healthy can resist decay better than trees that are stressed or in a state of decline.

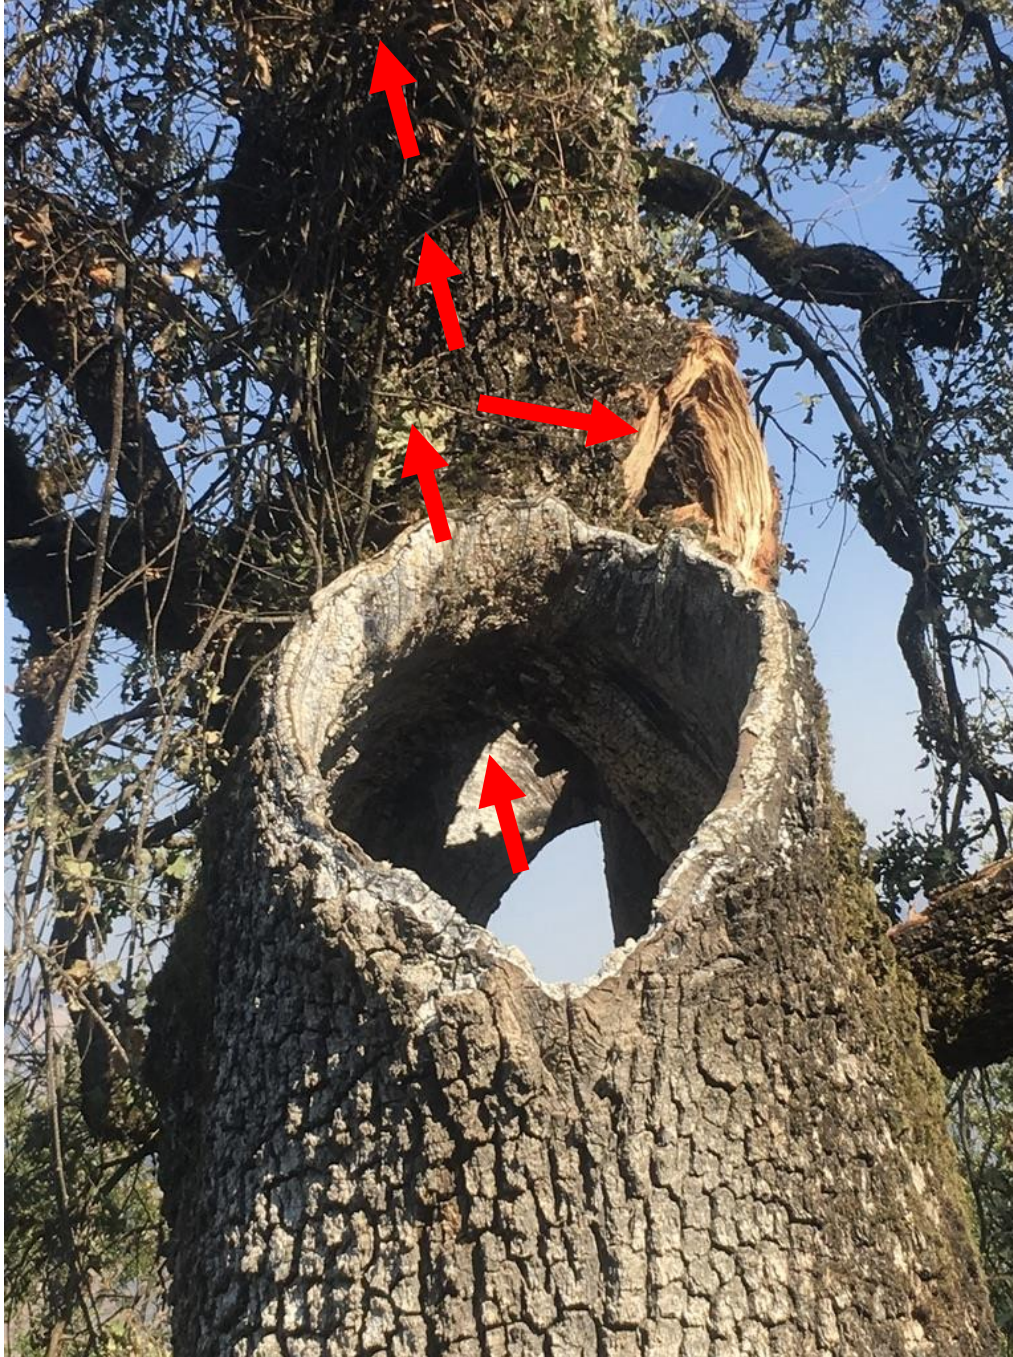
Photo 2

Subject tree trunk – decay at cavity extends through the tree and up the trunk

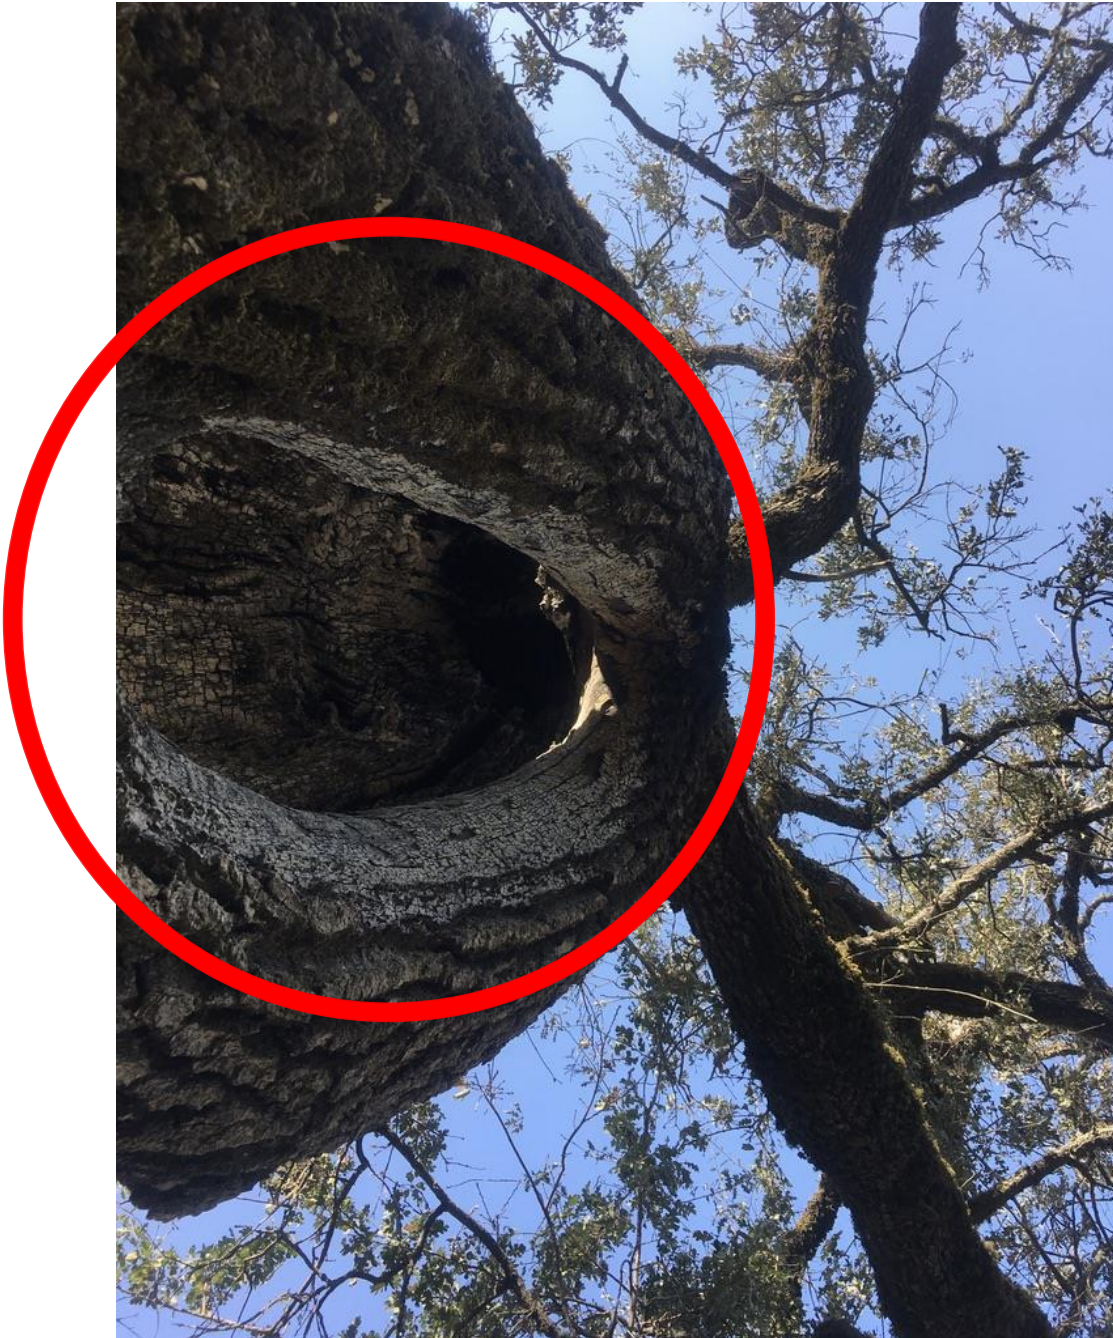
Photo 3

Subject Tree – hollow cavity extends through the tree opposite side of trunk as shown in Photo 2

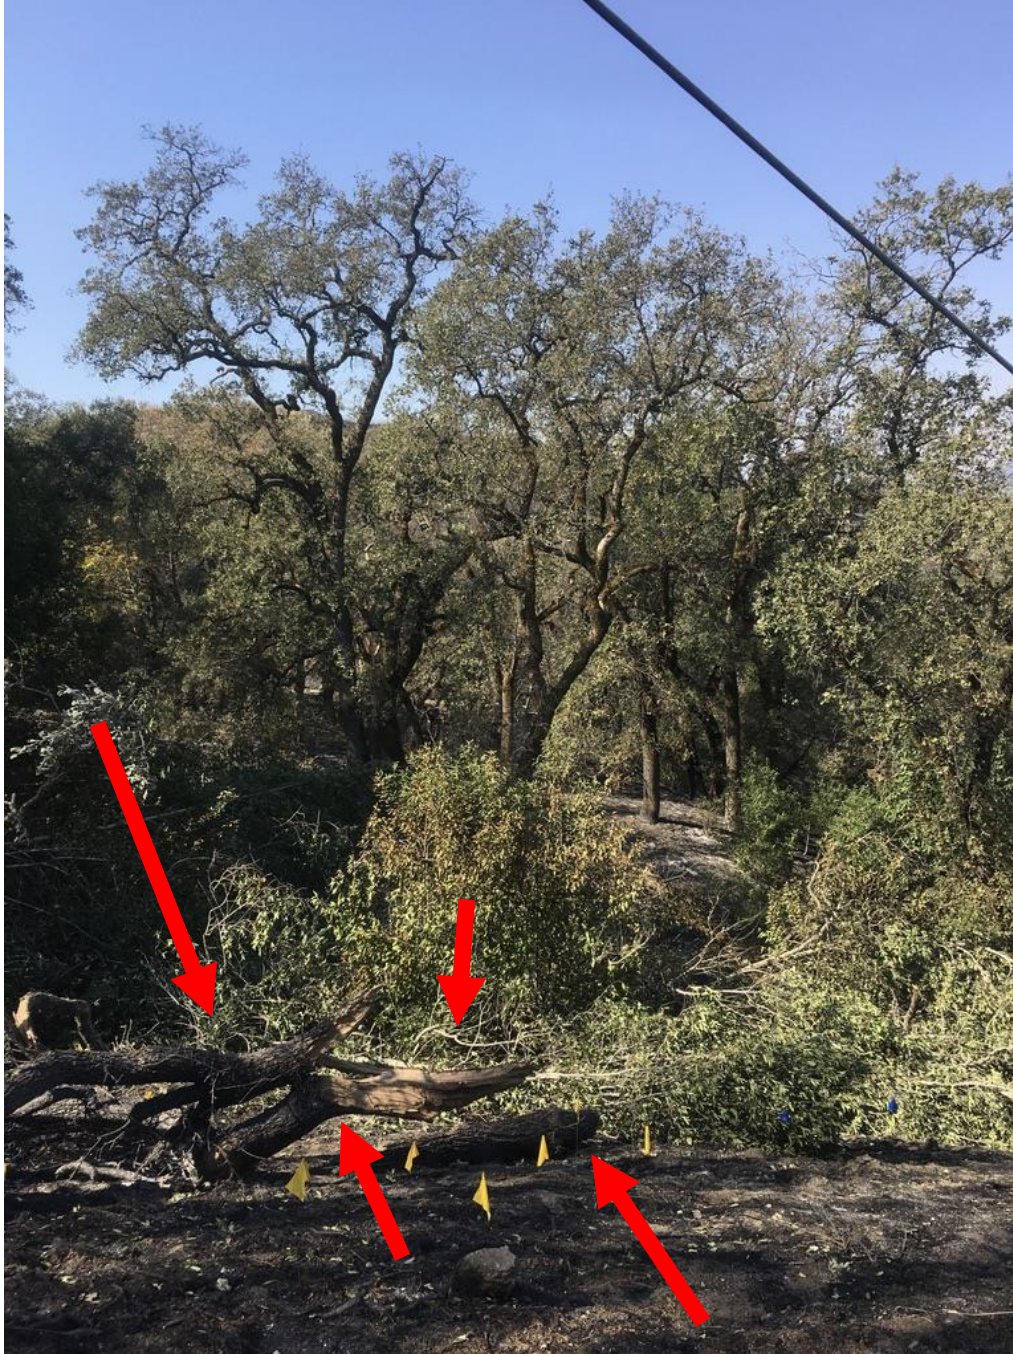
Photo 4

Subject Tree -Fractured branch. Note the trees in the background are free of visible decay and survived the wind event without significant branch fractures.

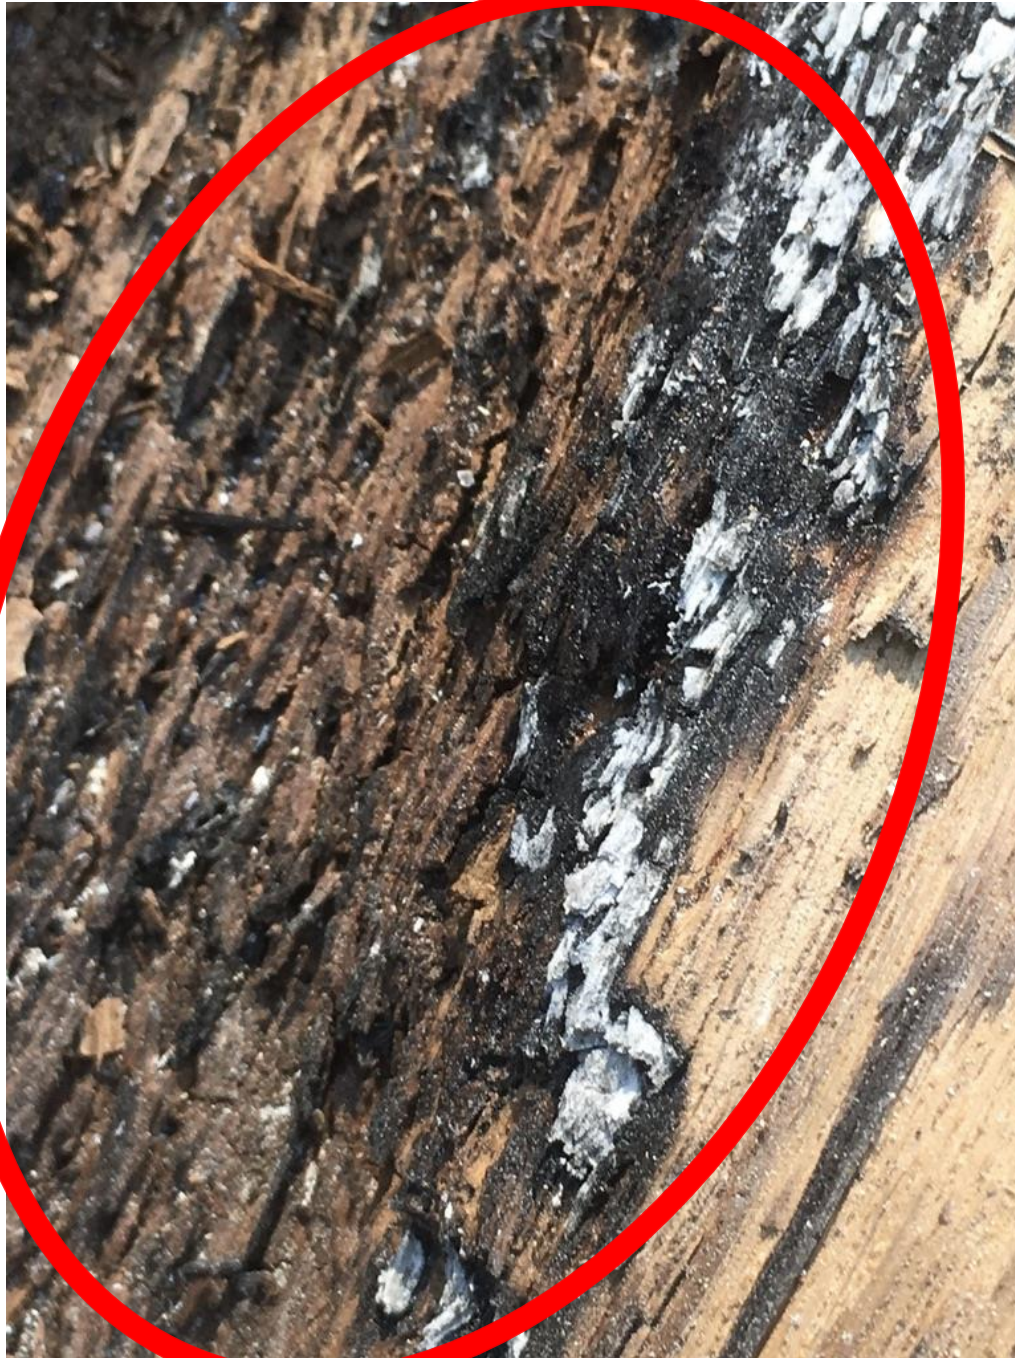
Photo 5

Subject Tree

Decay at fracture point of the fallen branch. Note: the appearance of rot

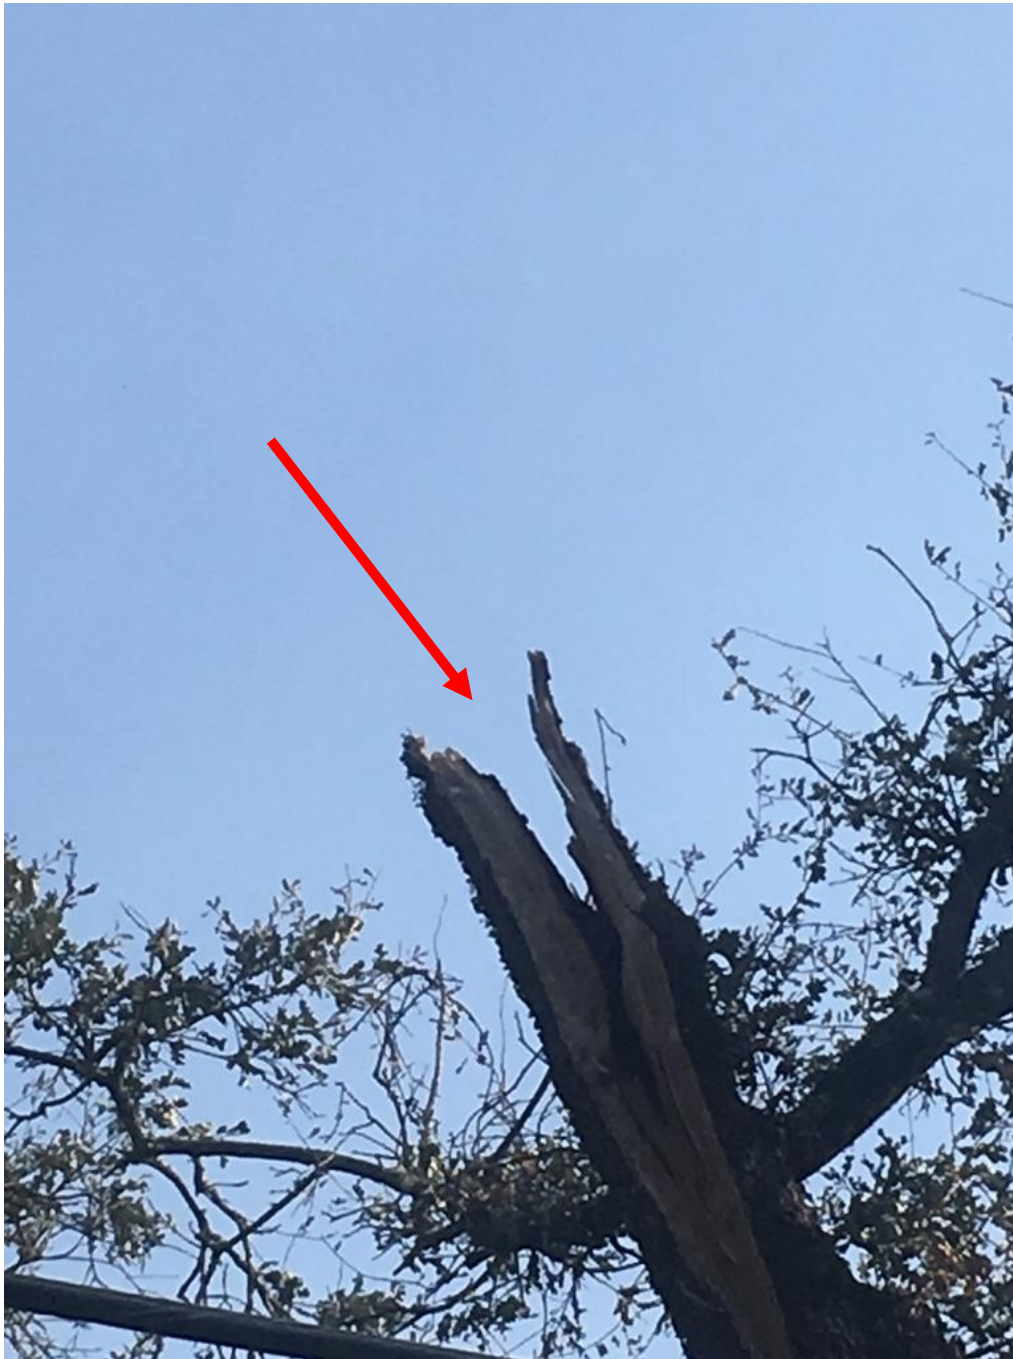
Photo 6

Subject Tree – fracture point

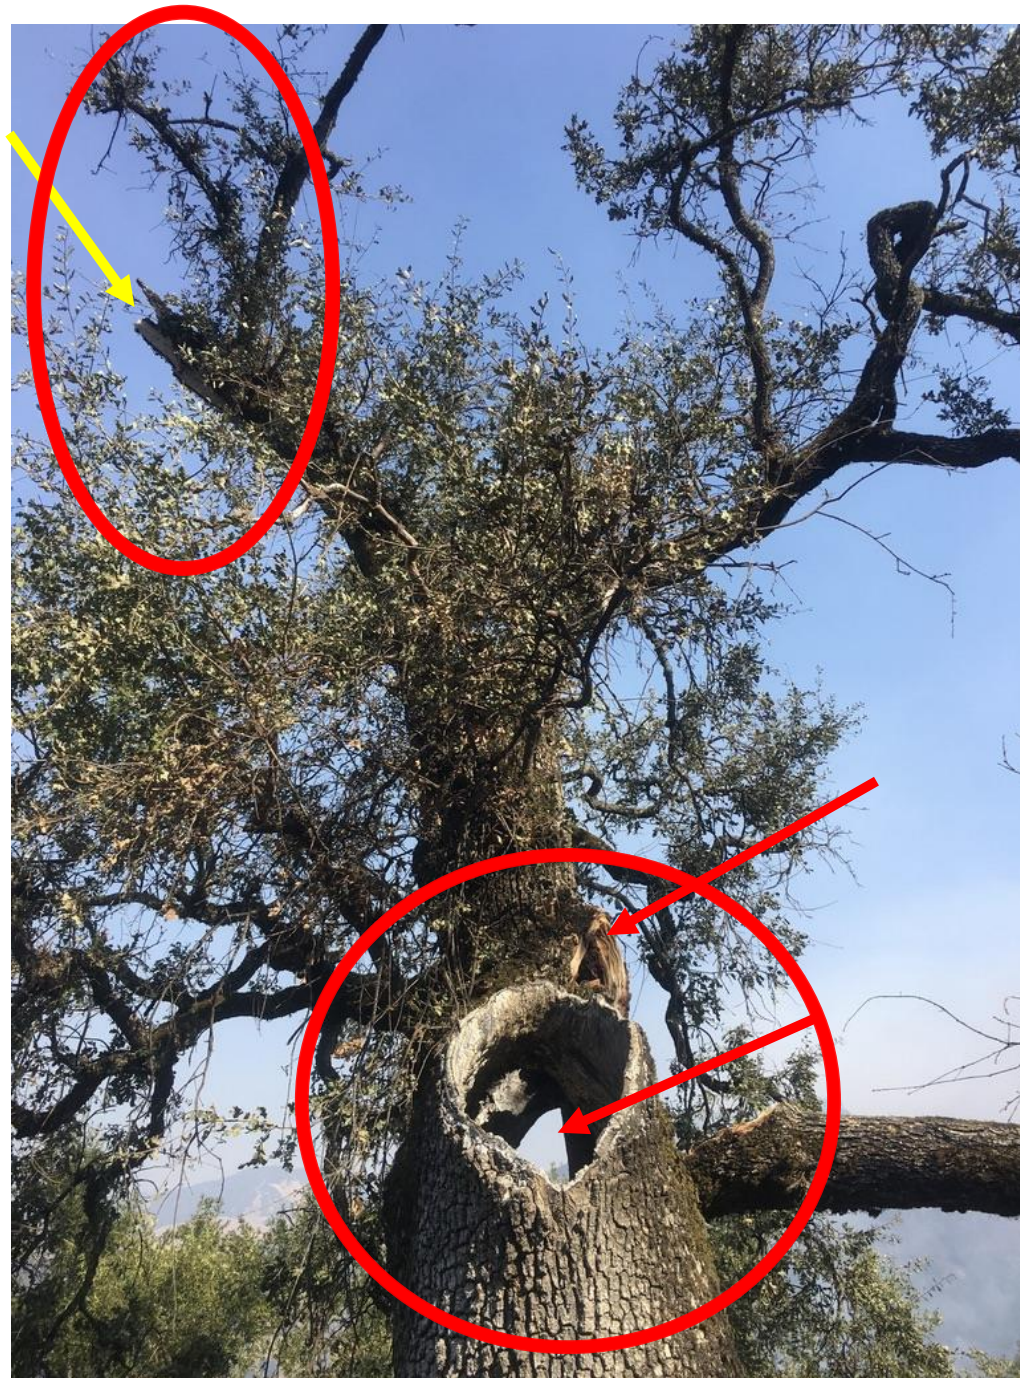
Photo 7

Subject Tree - decay from the open cavity (red arrows) in trunk spread to fractured branch (yellow arrow). Regardless of the trunk surviving the wind event, under normal conditions, the amount of decay is too much to retain a tree of this size with a target nearby. The tree is under stress, shown by the limited amount of foliage and under-sized leaves, thereby reducing the CODIT potential. Decay can consume wood faster than the tree can produce more wood. The **mass to energy ratio** (photosynthate production) is not in balance.

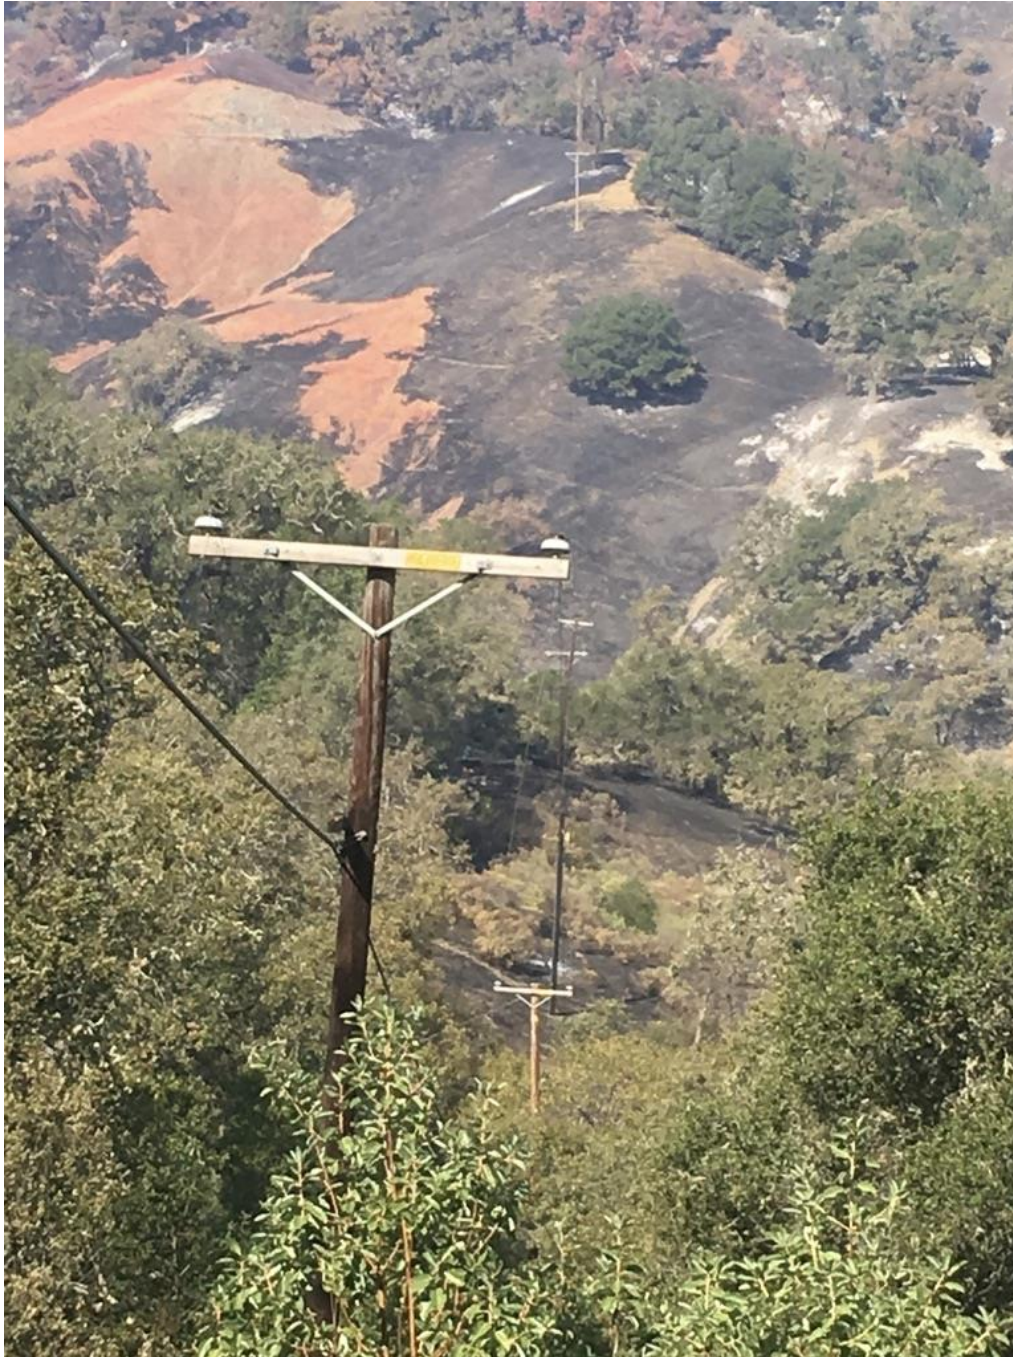
Photo 8

Rural site is adjacent to and below tree failure. Typically, native trees in rural areas survive wind events better than those trees with decay.

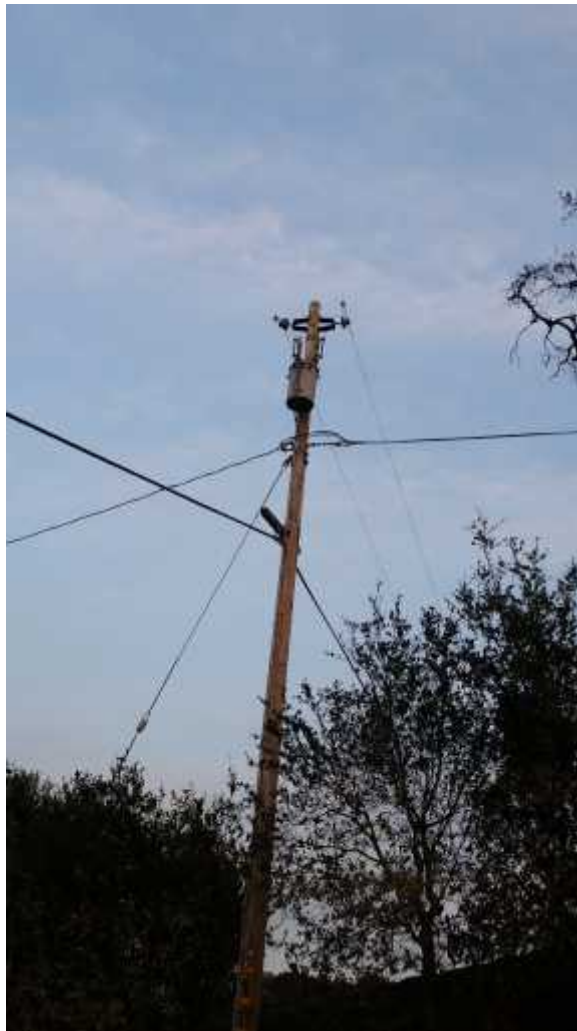
Figure 1: The first incident pole located uphill. CalFire had already removed and taken the incident span as evidence.

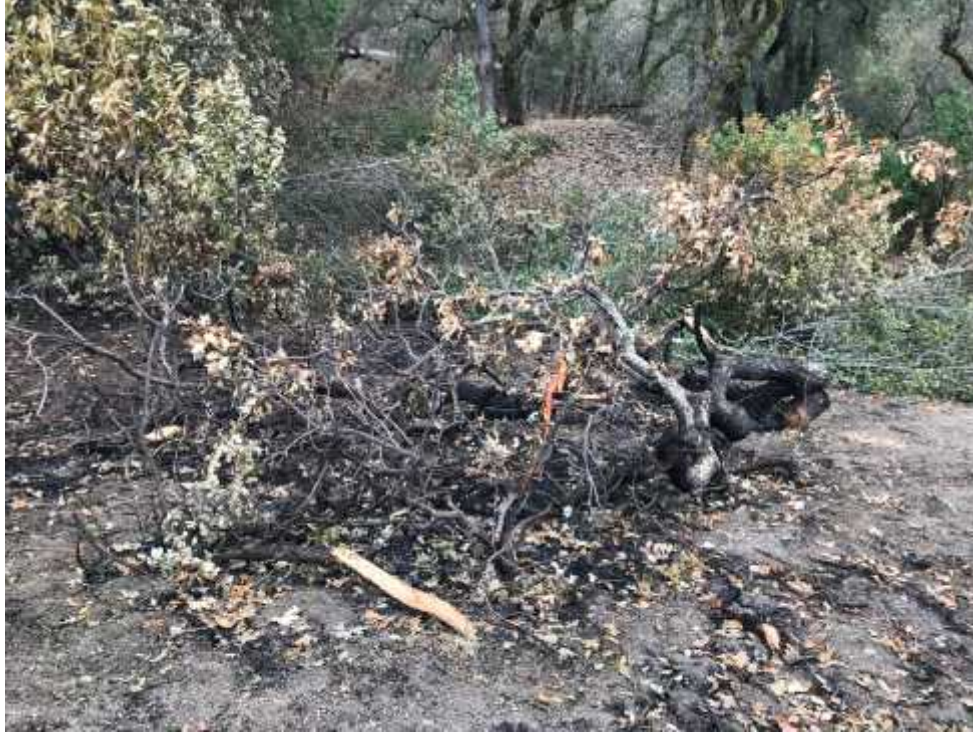
Figure 2: The broken section of tree on the ground by the incident span.

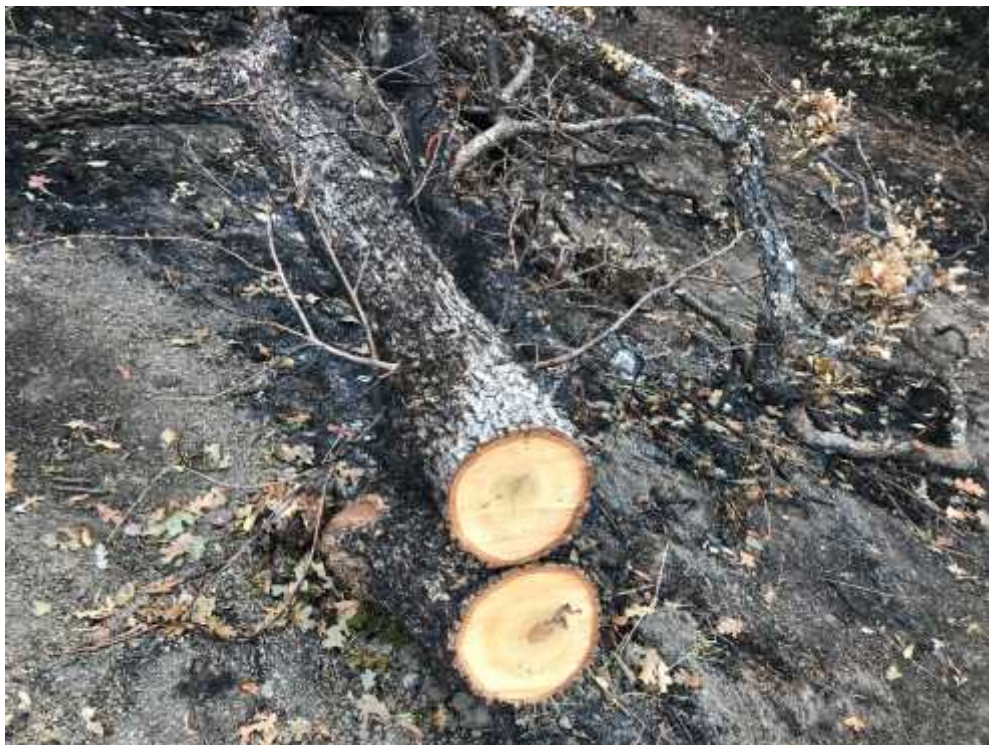
Figure 3: Part of the broken section that was removed by CalFire for evidence.

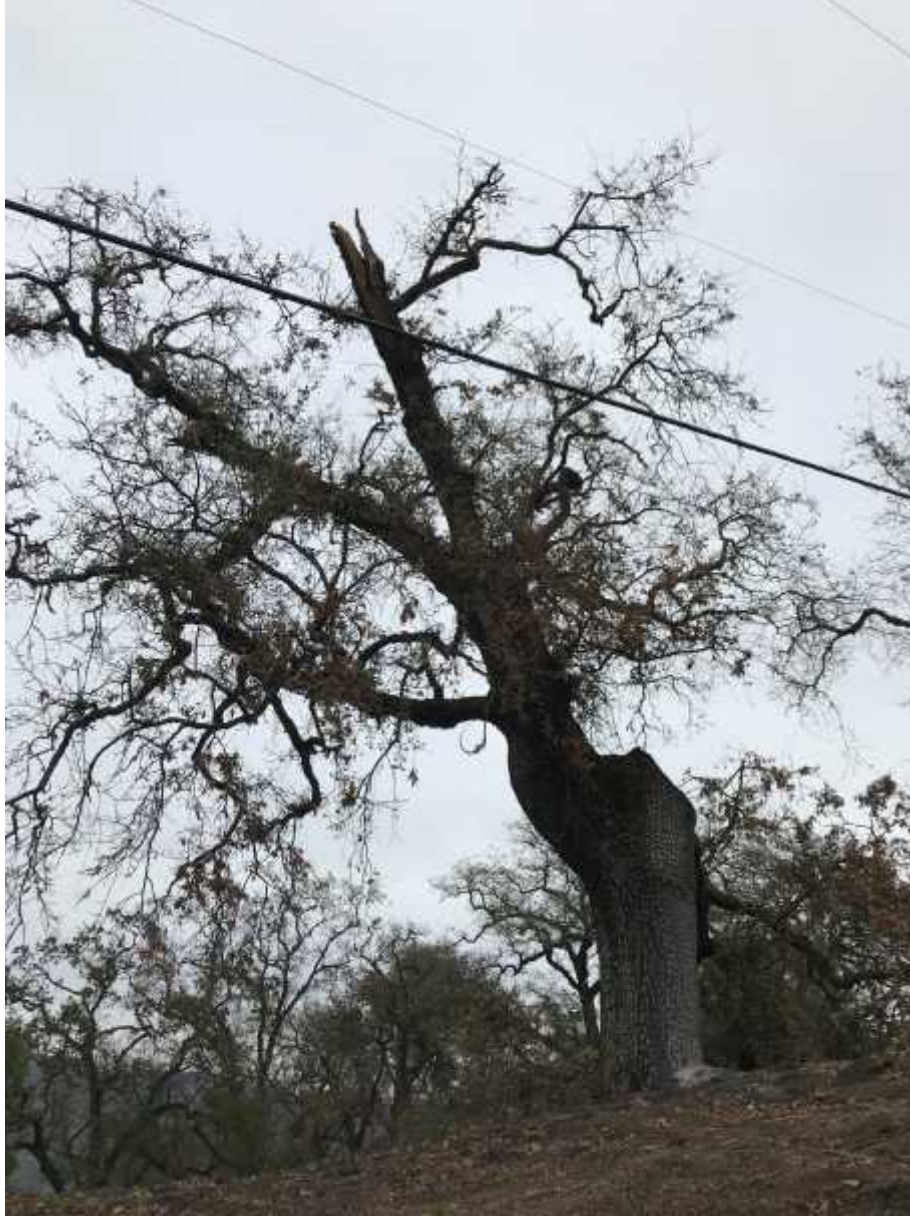
Figure 4: Photo of the burned out hollow tree that may have been the origin of the fire.
