CALIFORNIA PUBLIC UTILITIES COMMISSION
Safety and Enforcement Division
Electric Safety and Reliability Branch

Incident Investigation Report

Incident Number: Atlas 1: 171023-8596 & Atlas 2: 171020-8589

Utility Facilities Involved: Pueblo-1104, 12 kV Circuit

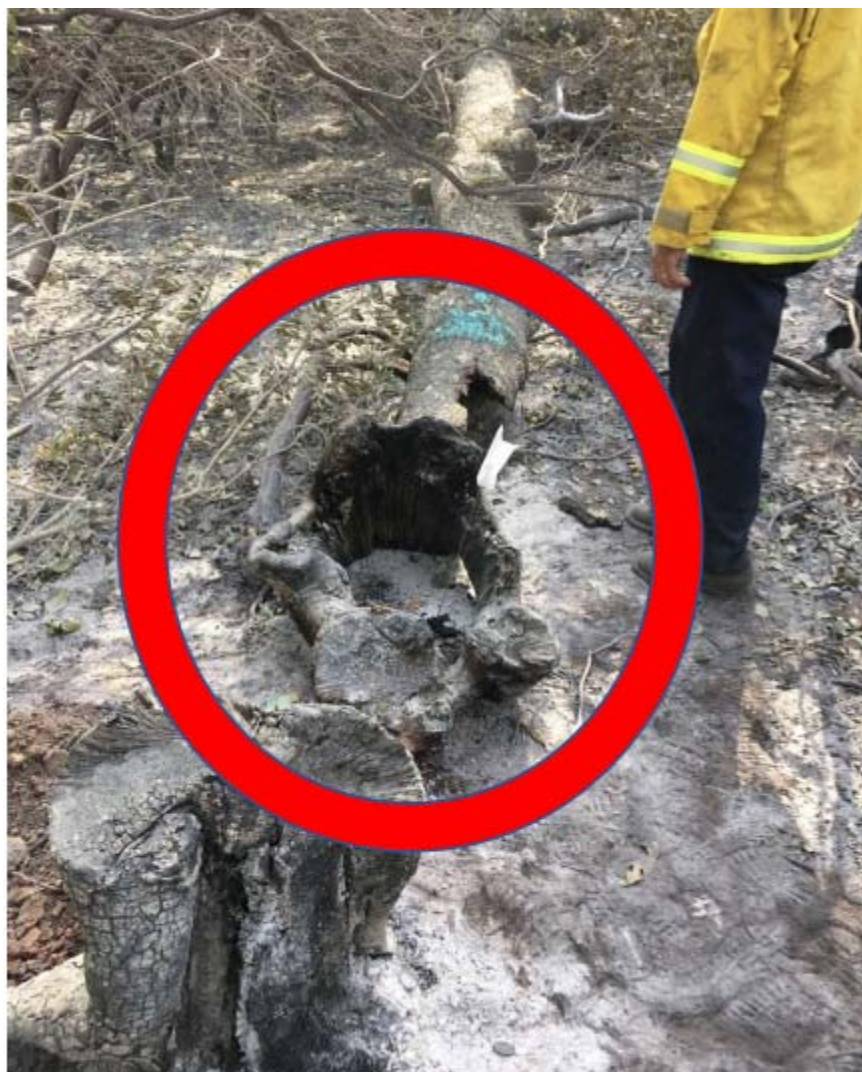
CAL FIRE contracted Certified Arborist, Mark Porter, to evaluate the subject tree failures. In Mr. Porter's "Evaluation of Oak Failure" report¹³ prepared for CAL FIRE, the subject Black Oak tree in the Atlas 1 fire area displayed "extensive decay in the trunk as well as the buttress roots". Mr. Porter also concluded that "(s)ince the black oak had such dangerous conditions close to high voltage lines, it should have been condemned years ago, due to the severity of the consequences."

Figure 2. Atlas 1 - Failed Black Oak displaying decay, trunk rot and butt rot.¹⁴

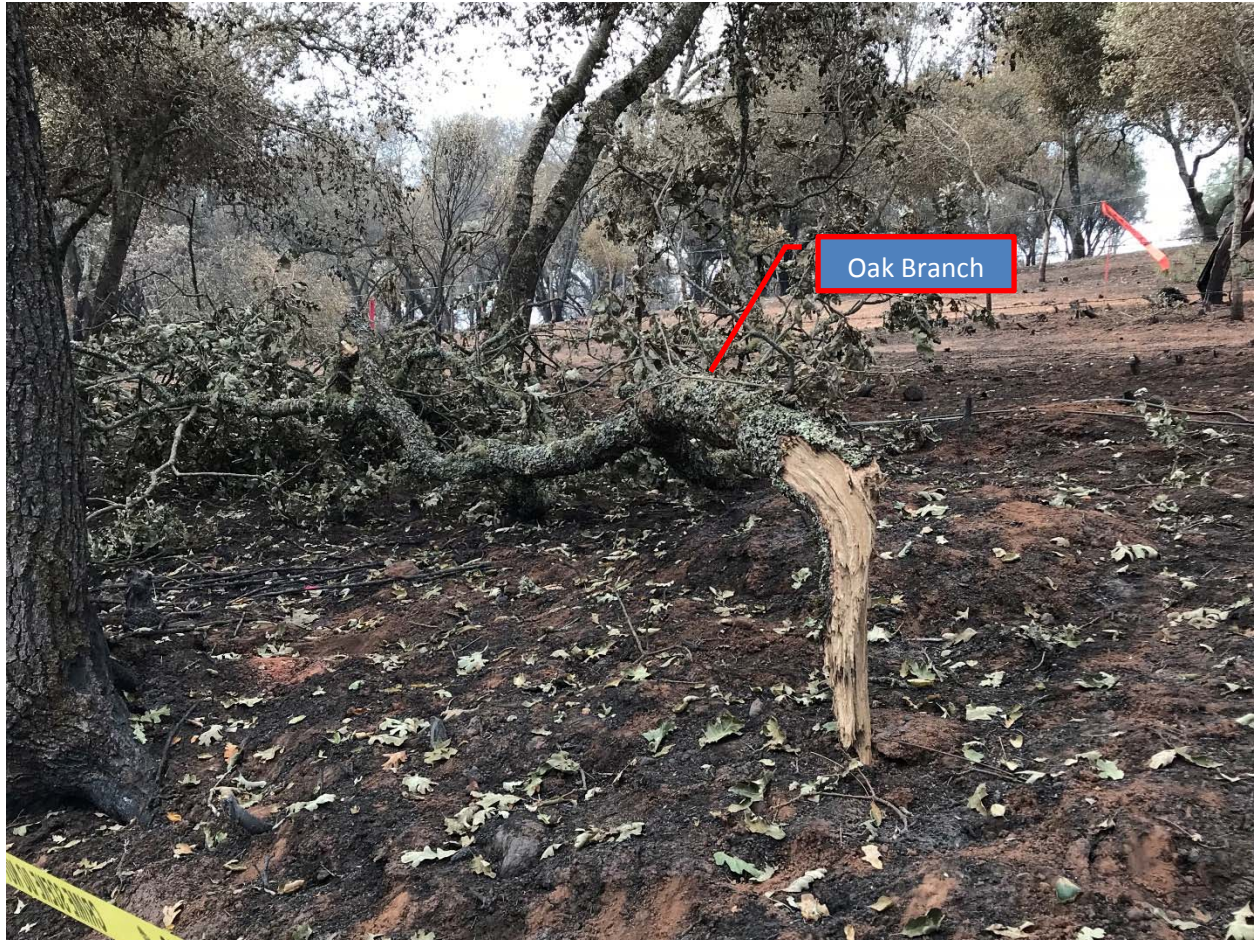
In the same report¹⁵ prepared by Mark Porter for CAL FIRE, Mr. Porter “observed a structural branch defect on a 19-inch diameter valley oak tree...” in the Atlas 2 fire area. Mr. Porter also noted that “[t]he branch of the valley oak broke at a codominant stem” and that the “lab results for the valley oak report fungal DNA and a root disease”. Mr. Porter “concluded that the valley oak codominant branch failure (a defect) could have been avoided if correctional pruning had been employed years earlier. Both tree failures have visible defects.”

Figure 3. Atlas 2 - Failed Valley Oak branch removed from conductors.

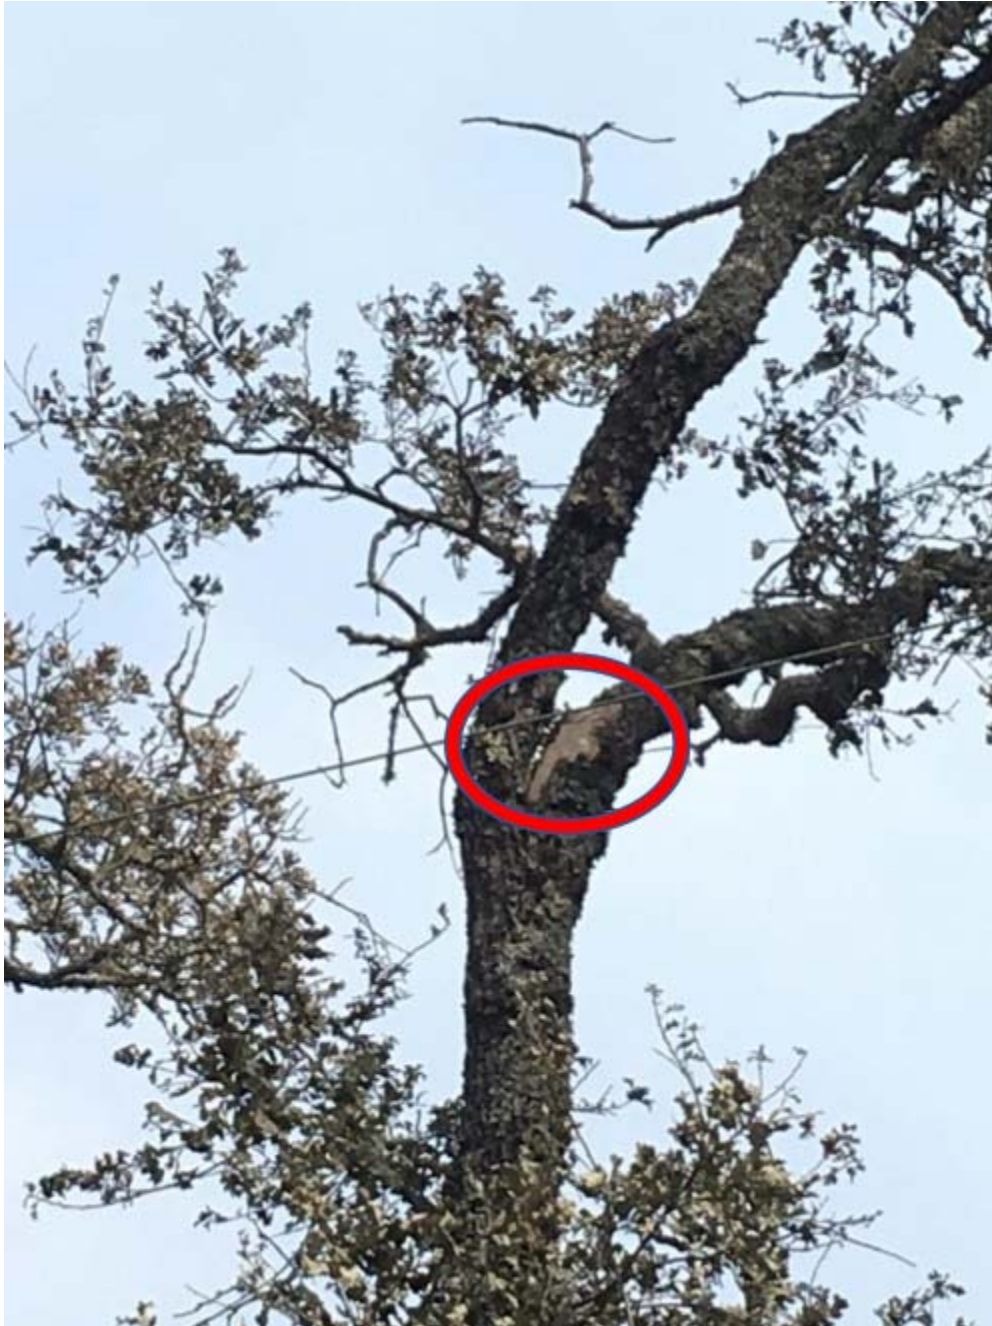
Figure 4. Atlas 2 - Opposite end of Valley Oak codominant stem where the failure occurred.¹⁶

2. PG&E TC personnel failed to identify and perform a correctional prune for the hazardous Valley Oak codominant branch in Atlas 2 prior to the fire.

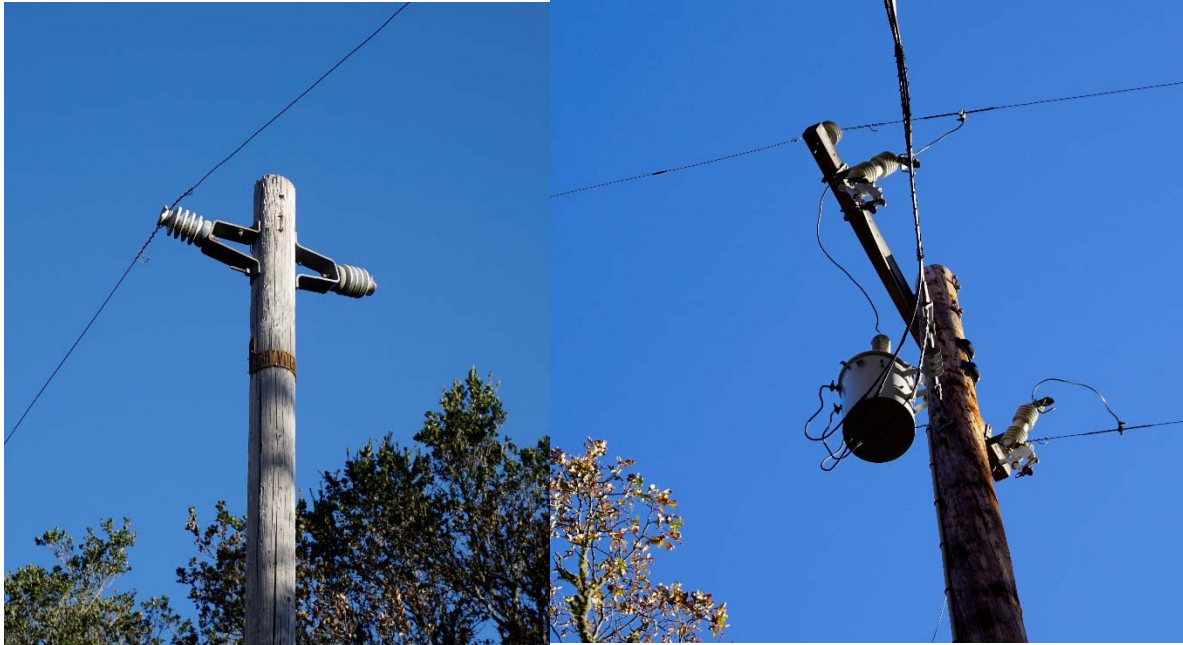
Figure 6. Atlas 1 **Left:** Subject pole #1, 40-foot pole (PG&E pole #102292423, coordinates: 38.409797, -122.246232). Photo taken from the southeast side of pole, looking north. **Right:** Subject pole #2, 45-foot pole with transformer attached (PG&E pole #102292420, coordinates: 38.409435, -122.245904). Photo taken from southwest side of pole, looking northeast.

For Atlas 1, the subject poles (#1 through 3) did not fail; however, the road-side conductor failed mid-span between the poles #2 and #3. The field-side span did not fail and was still attached to the insulators. Attached to pole #2 was a transformer with service conductors in the southwest direction, a crossarm with two fuse assemblies mounted near the ends of the crossarm, and one span attached to the field-side insulator in the south direction.

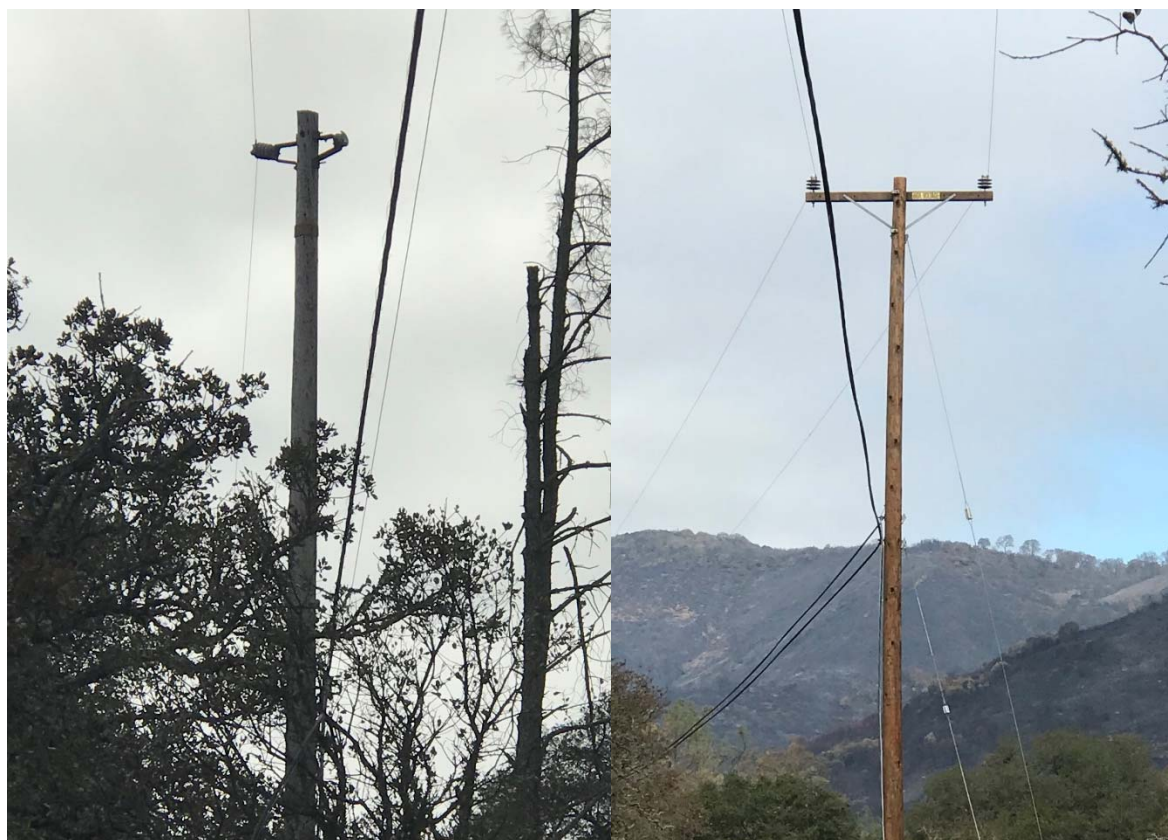
Figure 7. Atlas 2 **Left:** Subject pole #5 (PG&E #102292430, coordinates: 38.414424, -122.248689). Photo taken from the north side of pole. **Right:** Subject pole #6 (PG&E #103770852, coordinates: 38.415058, -122.24888). Photo taken from south side of pole.

For Atlas 2, subject poles #5 and #6 did not fail; however, the field-side conductor detached from pole #5 when a Valley Oak branch failed and fell onto the conductor causing the field-side insulator attached to pole #5 to mechanically fail. Also, as noted previously, pole #4 burned through at the base but still stood in the ground. The failed insulator and conductor at pole #5 did not touch the ground and were still supported by the poles upstream and downstream.

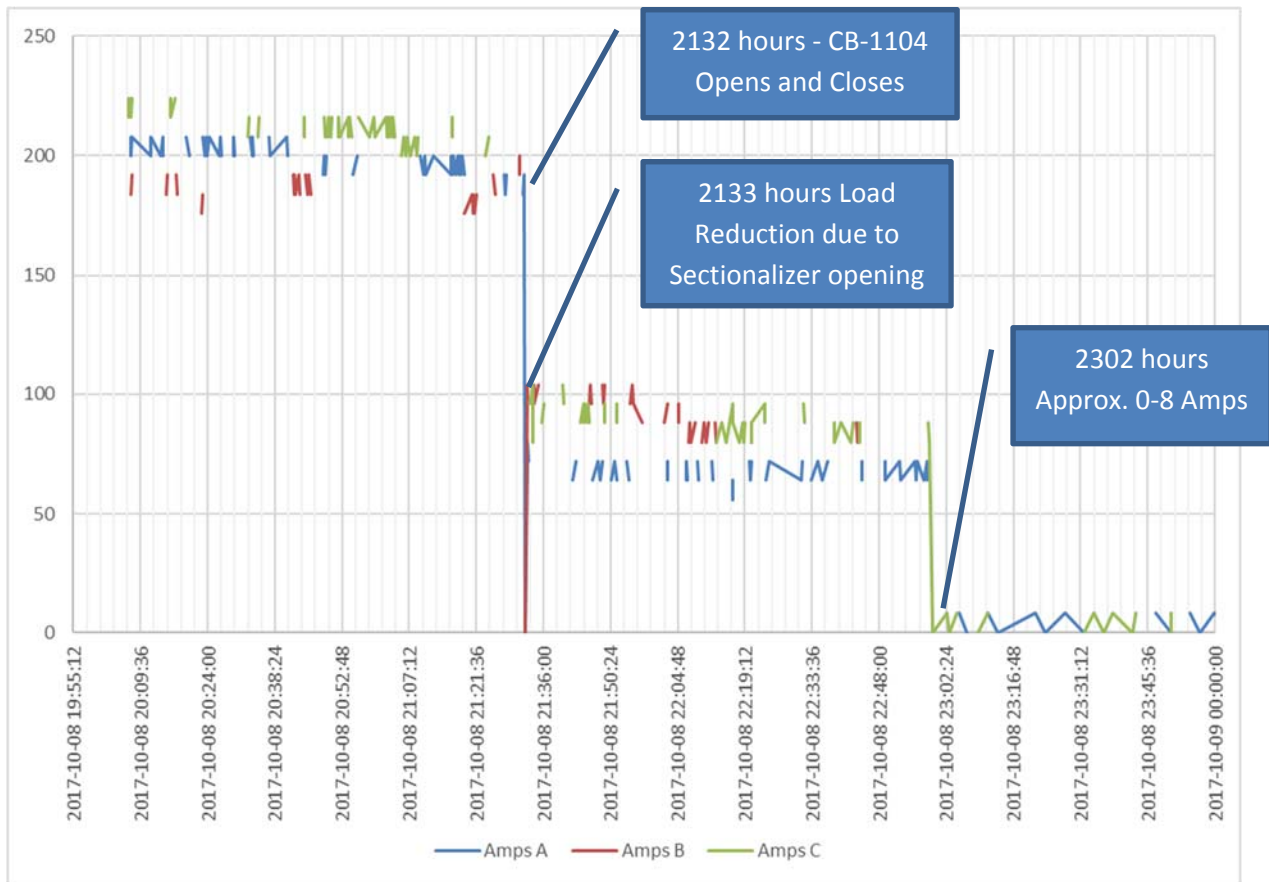
Figure 9. Plot of SCADA load data recorded at Pueblo-1104 CB on October 8, 2017, from 2006 hours to 0146 hours on October 9, 2017.

On October 8, 2017, the Pueblo-1104 CB performed two automatic reclose attempts at 2132 hours. The first was unsuccessful but the second succeeded because Sectionalizer-47912 automatically opened to clear a fault at 1597 Estee Avenue.³⁸ PG&E set the CB to automatically lock out in the open position after two unsuccessful automatic reclose attempts; however the CB did not lock out after successfully reclosing on the second attempt.³⁹

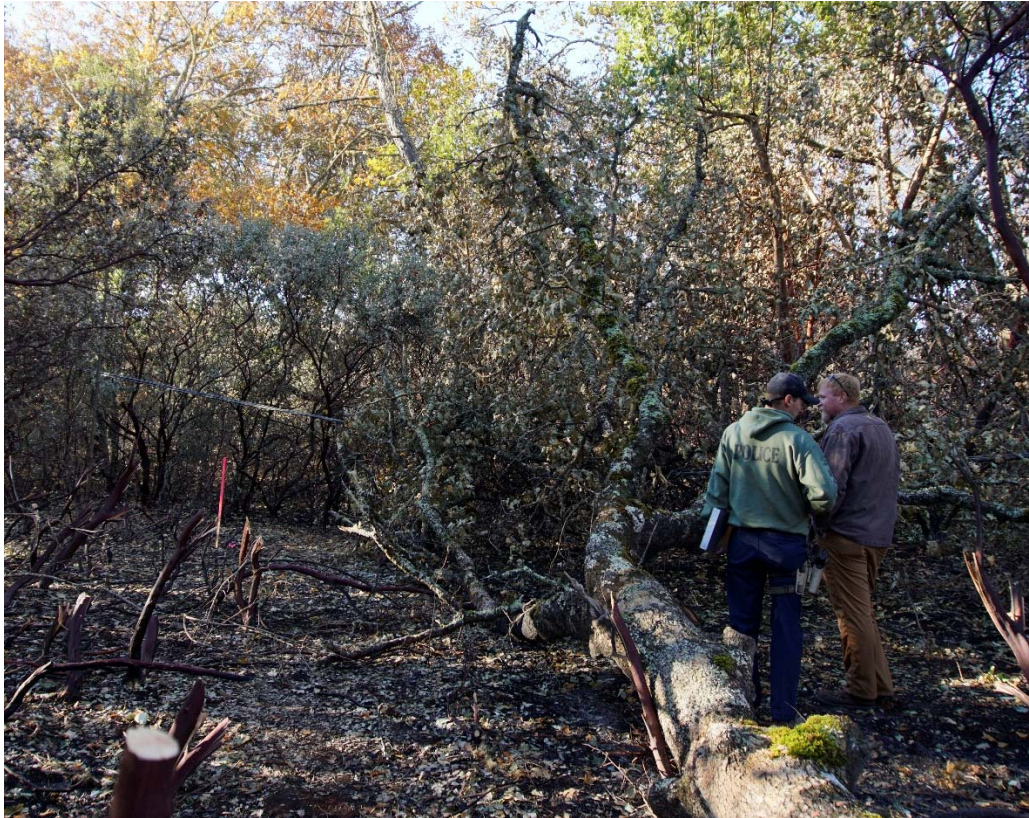
Figure 11. Subject Black Oak tree laying perpendicular to the road. Photo taken from road-side facing the field.

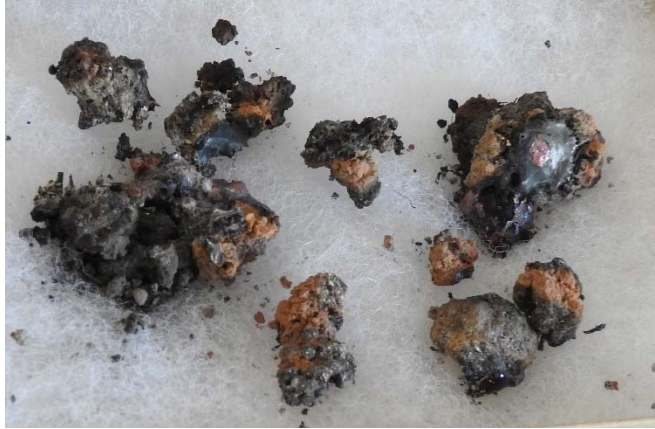
On October 12, 2018, SED staff, Raymond Cho and Wilson Tsai, traveled to Santa Rosa to meet with CAL FIRE investigators and review evidence that they retained from the incident scenes. Of the evidence reviewed and photographed for Atlas 1, SED found charred Madrone tree branches with what appeared to be signs of electric arcing, fulgurite-like masses with what seemed to be copper in the center and also a rock with what seemed to be molten copper in the center. Fulgarites⁴³ are naturally occurring masses of fused soil and/or other debris that can form when lightning discharges into the ground. In this case, a fulgurite-like mass was formed when conductors fell to the ground and discharged enough energy to fuse some of the ground material together.

Figure 12. Fulgarite-like masses found in the Atlas 1 incident area. CAL FIRE Evidence Log items 5A through 5C.

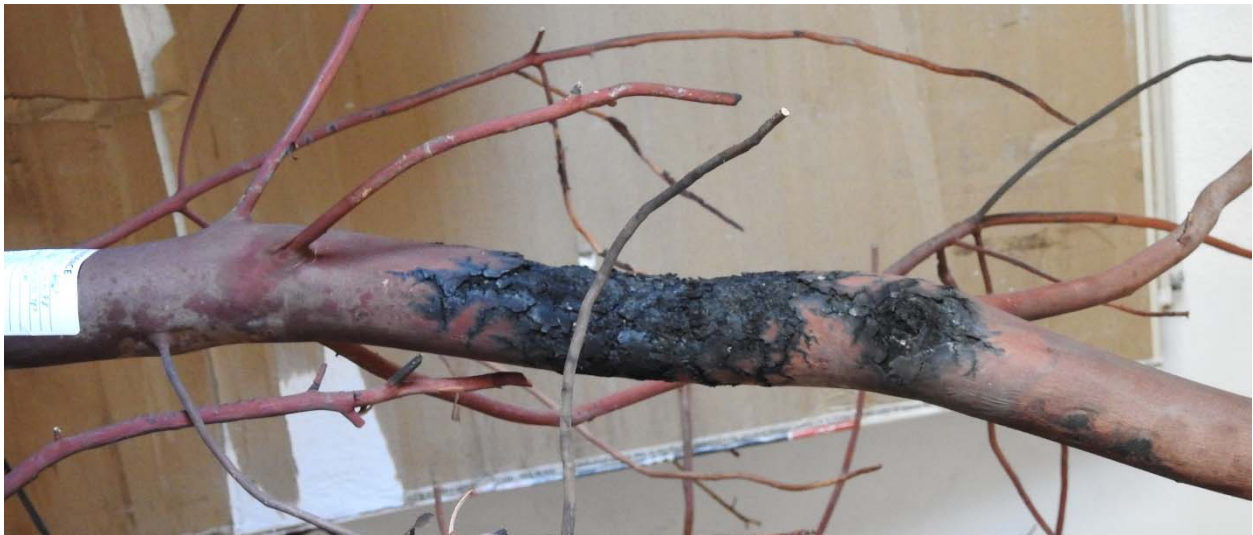
Figure 13. Charring on a Madrone tree branch that appears to be arcing in the Atlas 1 incident area. CAL FIRE evidence item 9B.

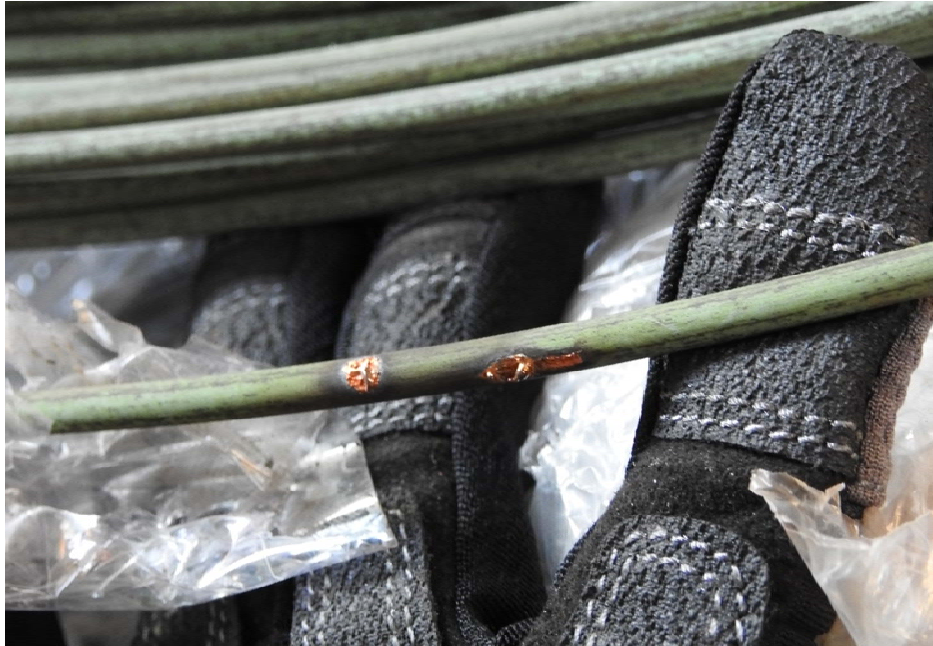
Figure 14. Beading on the subject copper span in the Atlas 2 incident area. CAL FIRE evidence item 3A.

For Atlas 2, SED found beading on the subject PG&E copper conductor which indicated electric arcing on another object. The evidence shows that the conductor was energized when it contacted another object.

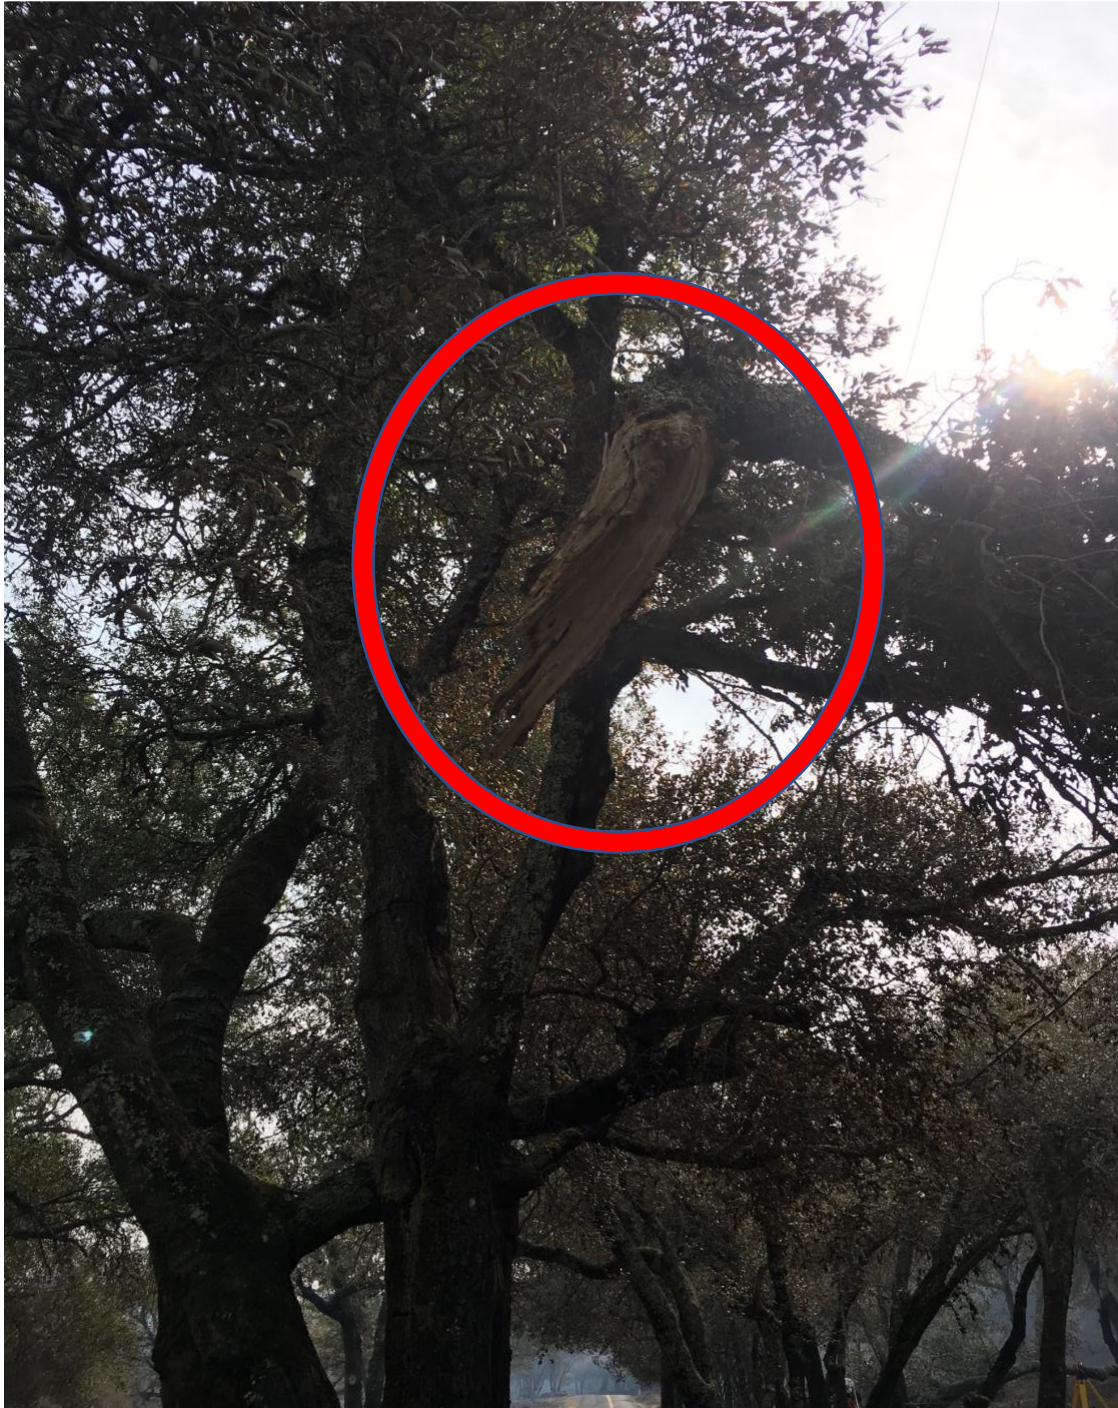
Photo 1

Subject branch failure (codominant)

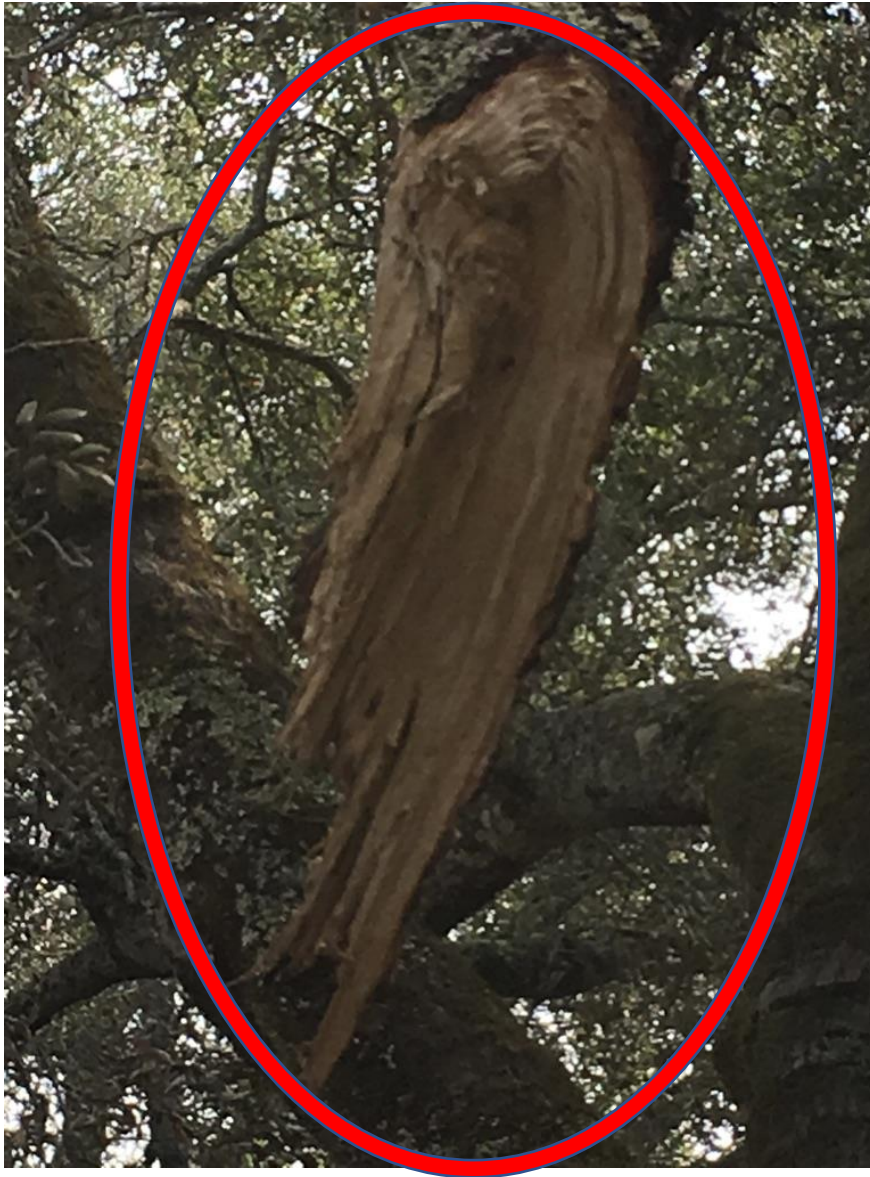
Photo 2

Part of a codominant stem (forked branch union)

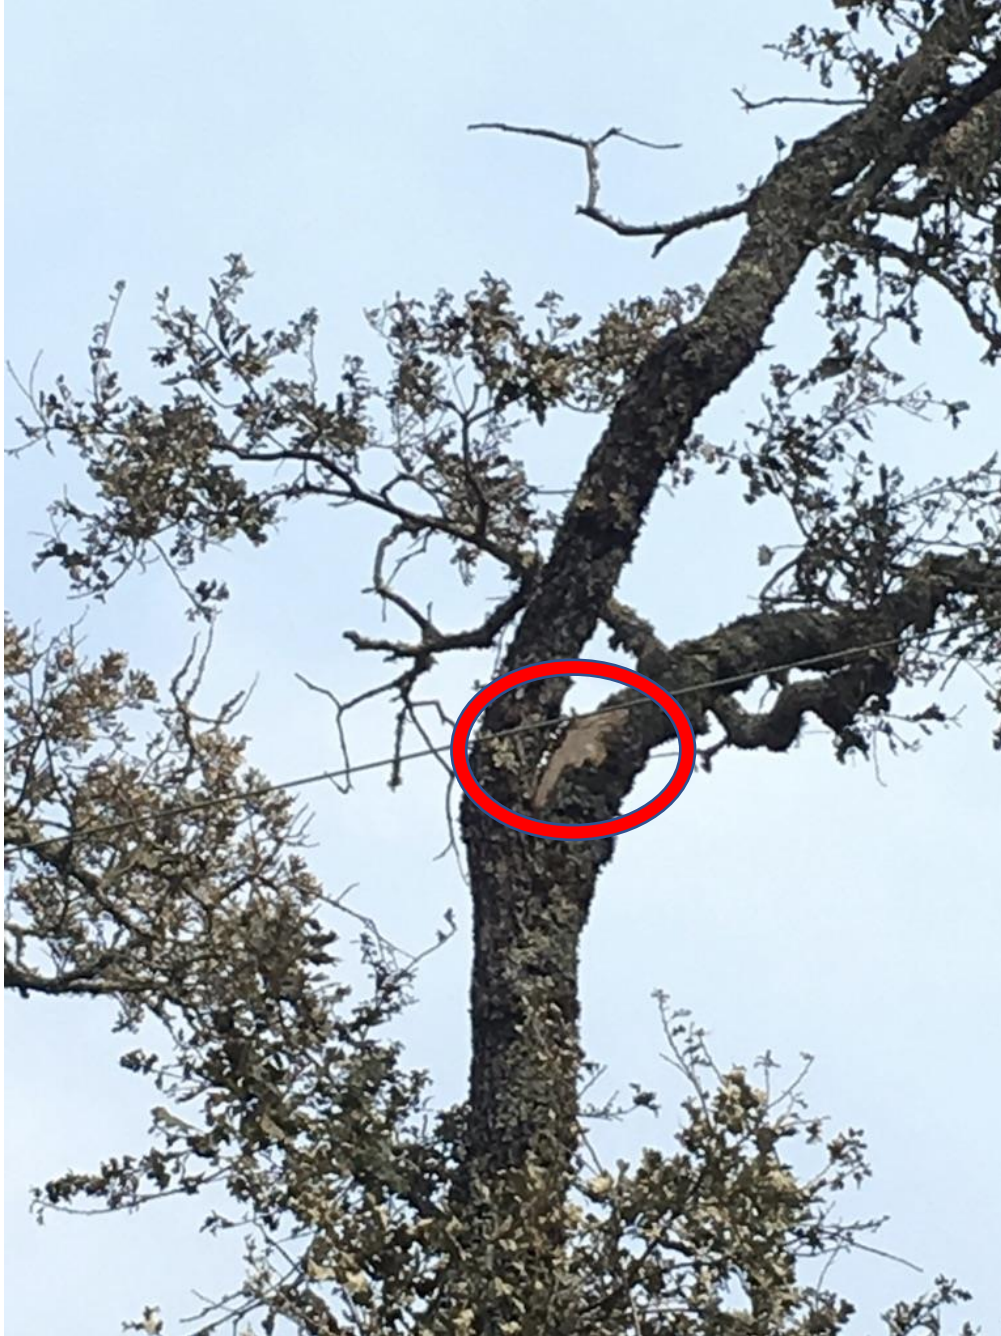
Photo 3

Opposite end of the codominant stem where the failure occurred.

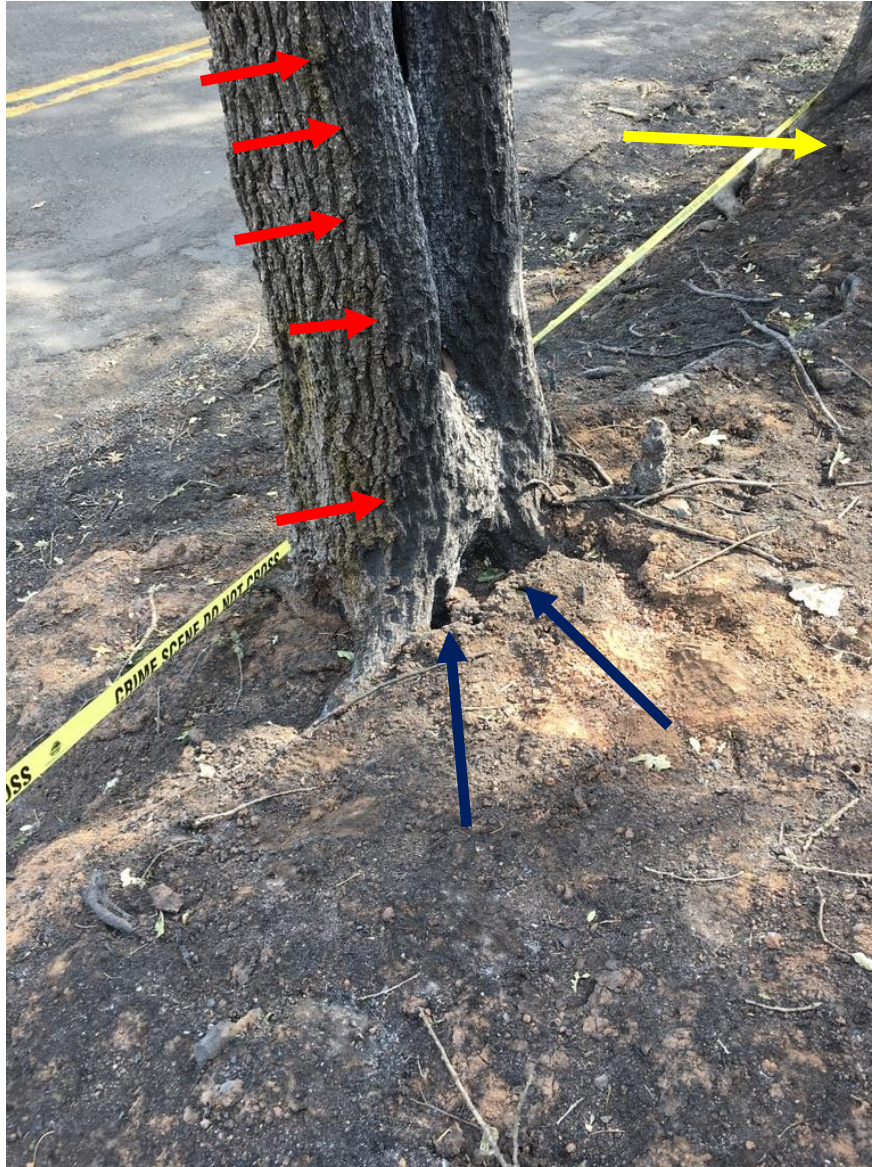
Photo 4

Red arrows: burn edge of trunk

Blue arrows: open cavity below codominant trunk

Yellow arrow: power line side of trunk

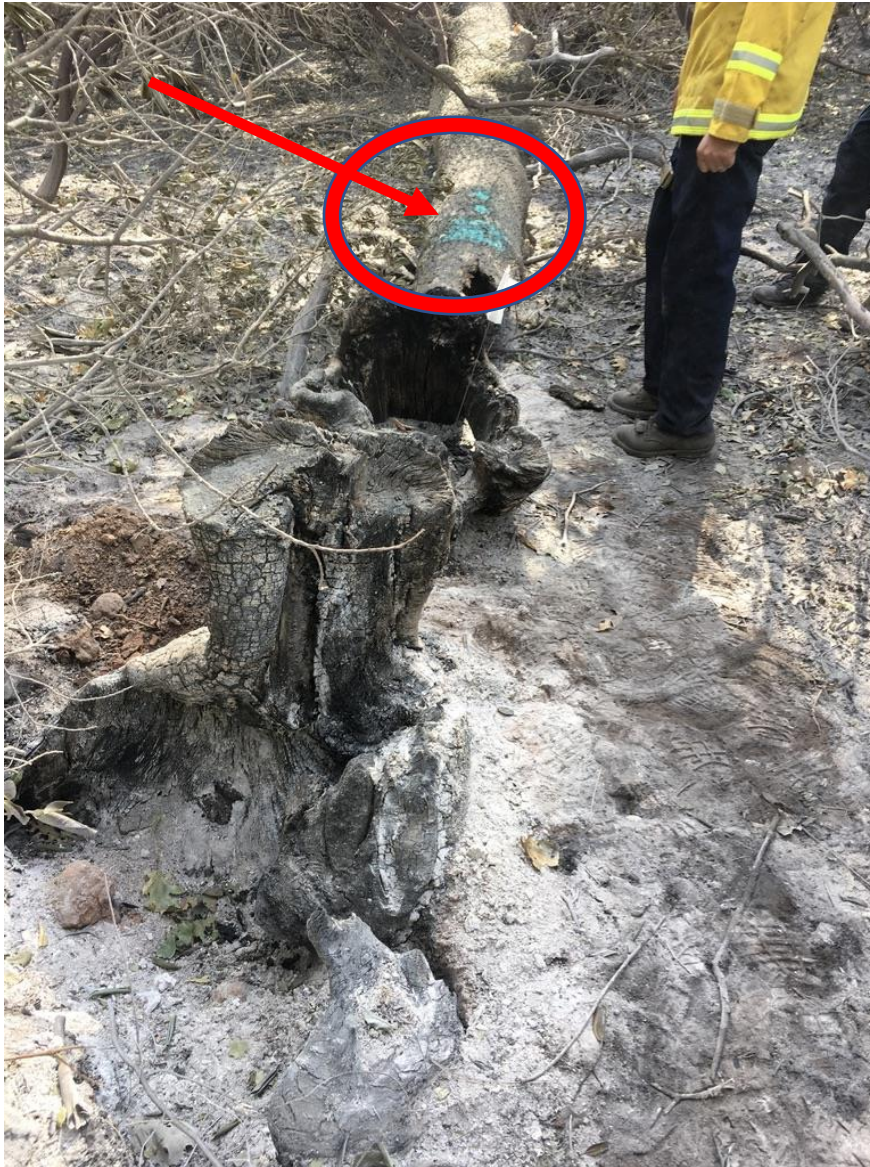
Photo 5

Black oak. Paint mark on trunk

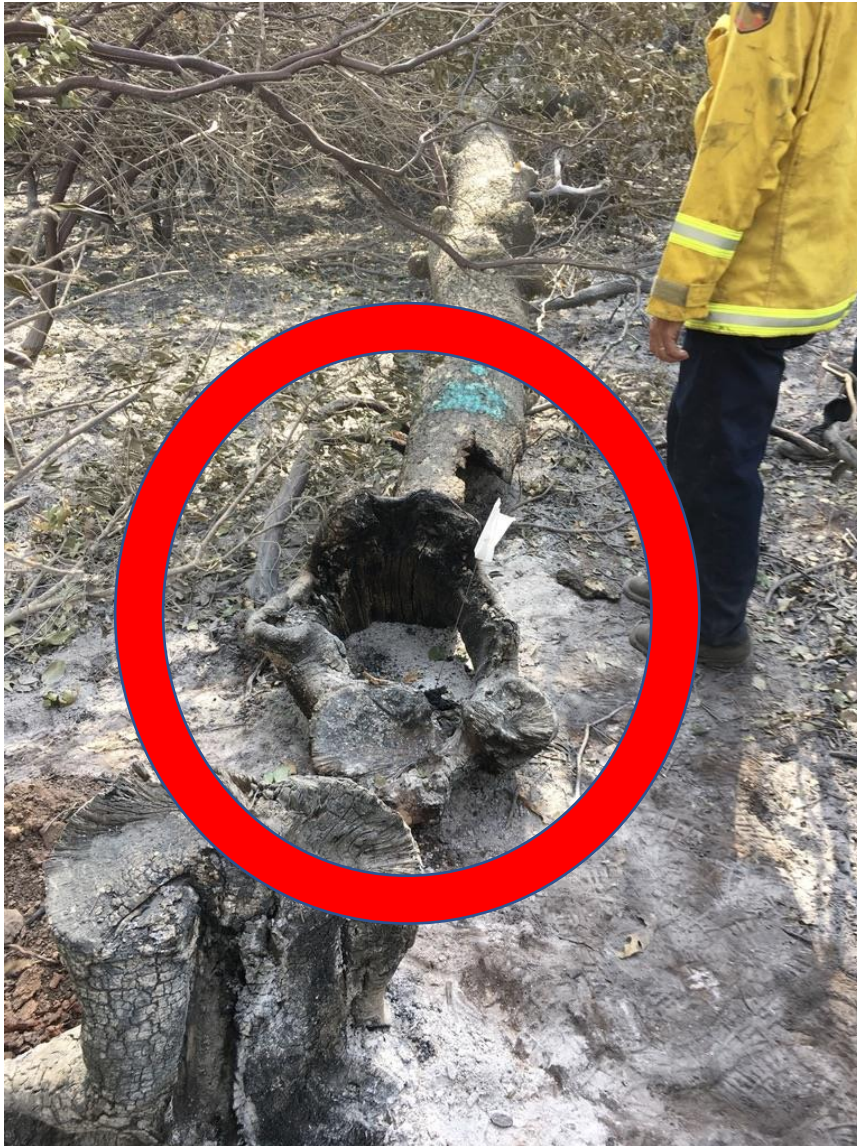
Photo 6

Black oak. Advanced decay. Trunk rot and butt rot

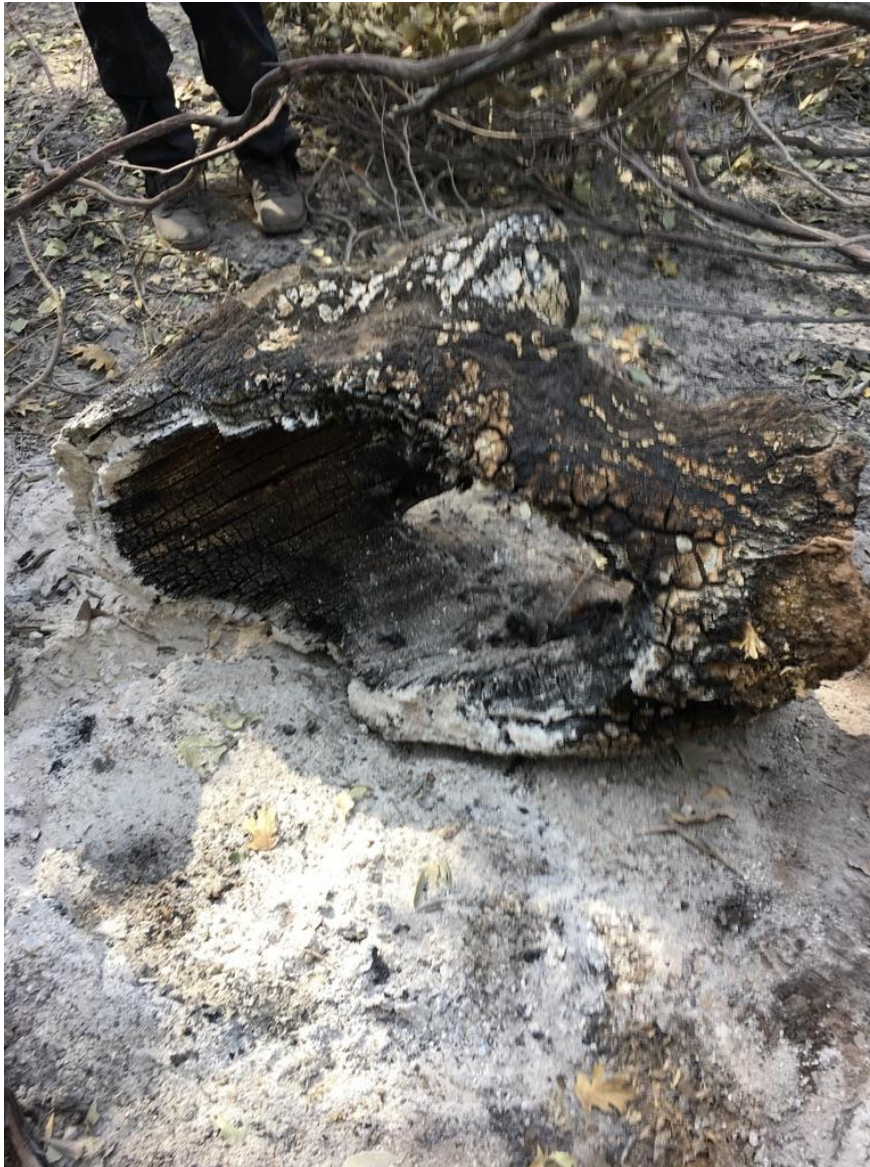
Photo 7

Black oak. Hollow area of buttress roots and trunk. Area of failure.

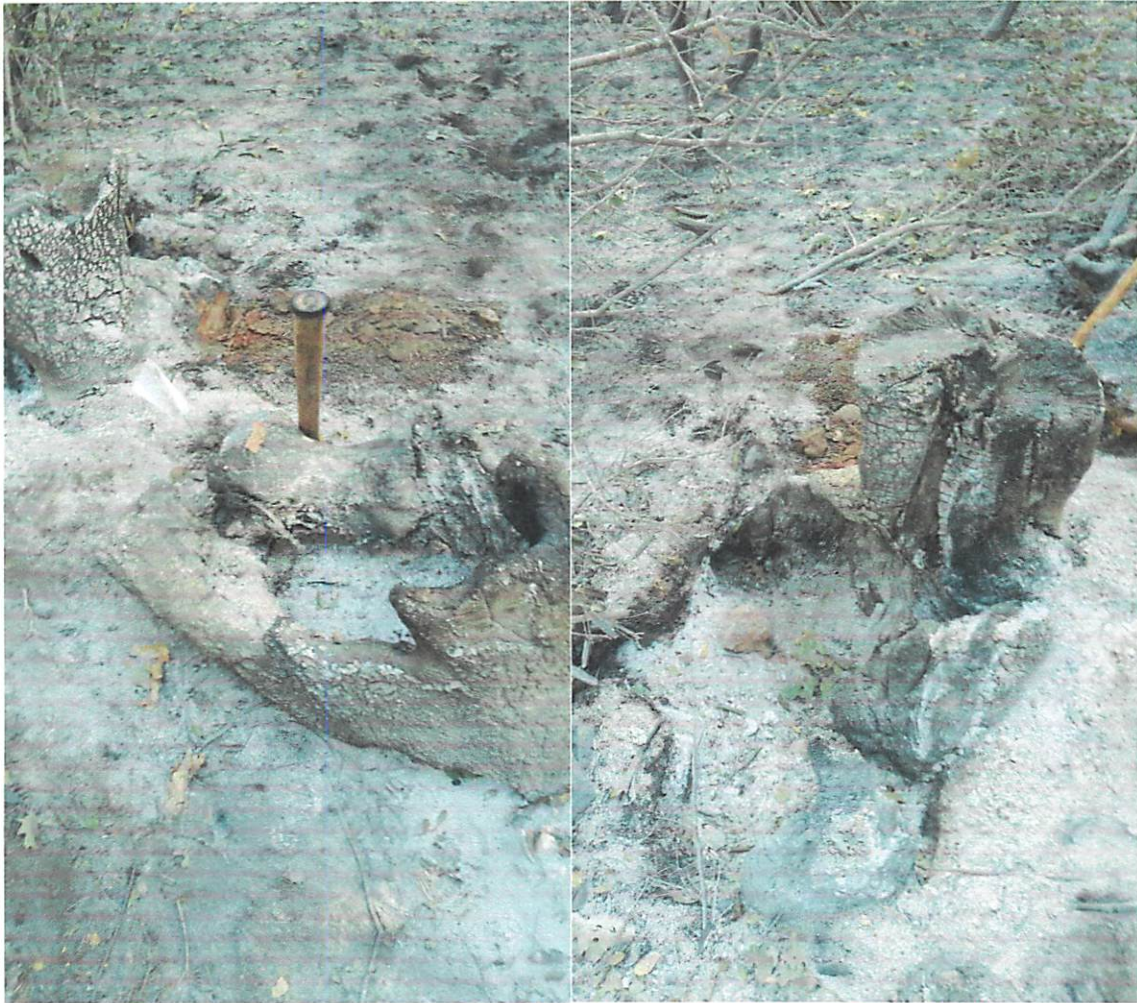
Figure 1 – showing the base of the failed oak tree and indications of a basal hollow

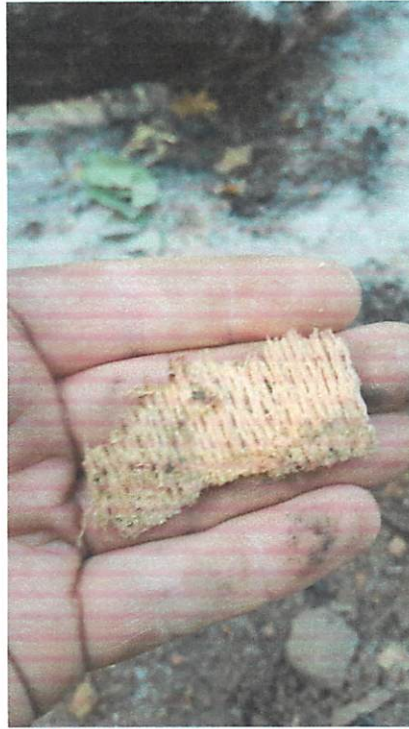
Figure 2 – showing the wood sample collected from beneath the soil profile. Note the delaminated annual rings

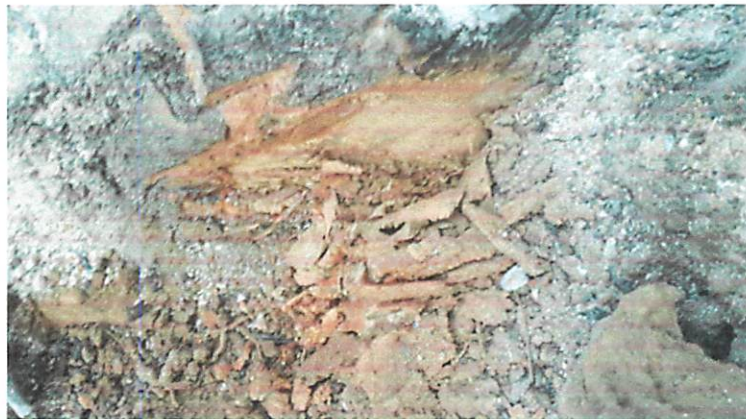
Figure 3 – showing the location where the wood sample was taken beneath the soil surface

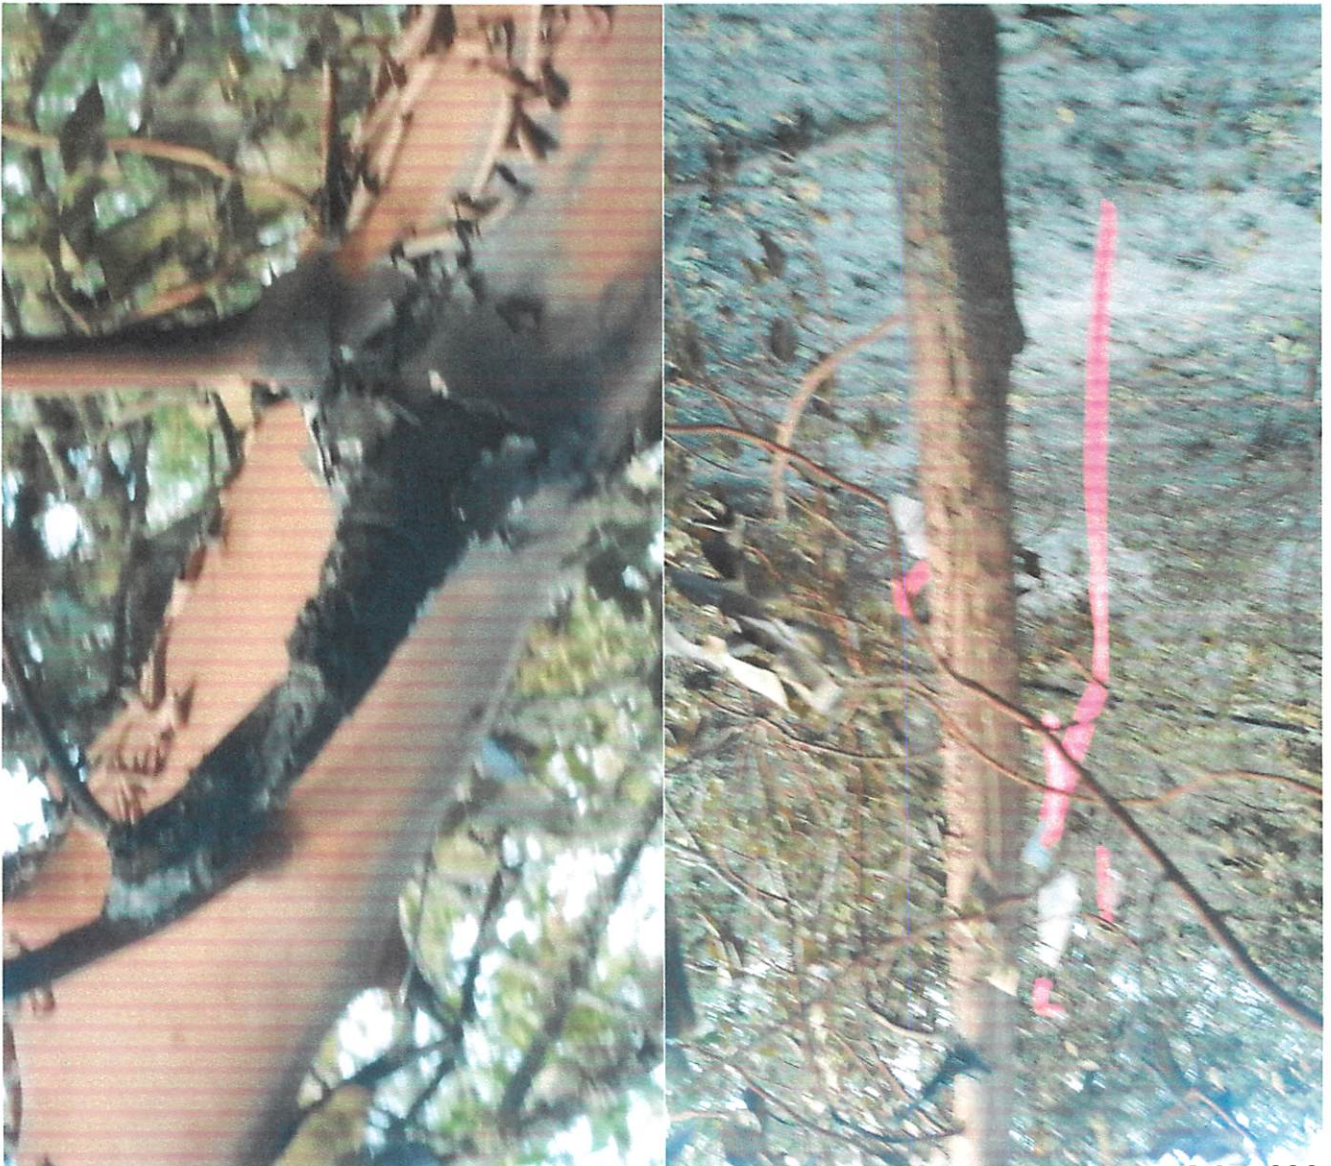
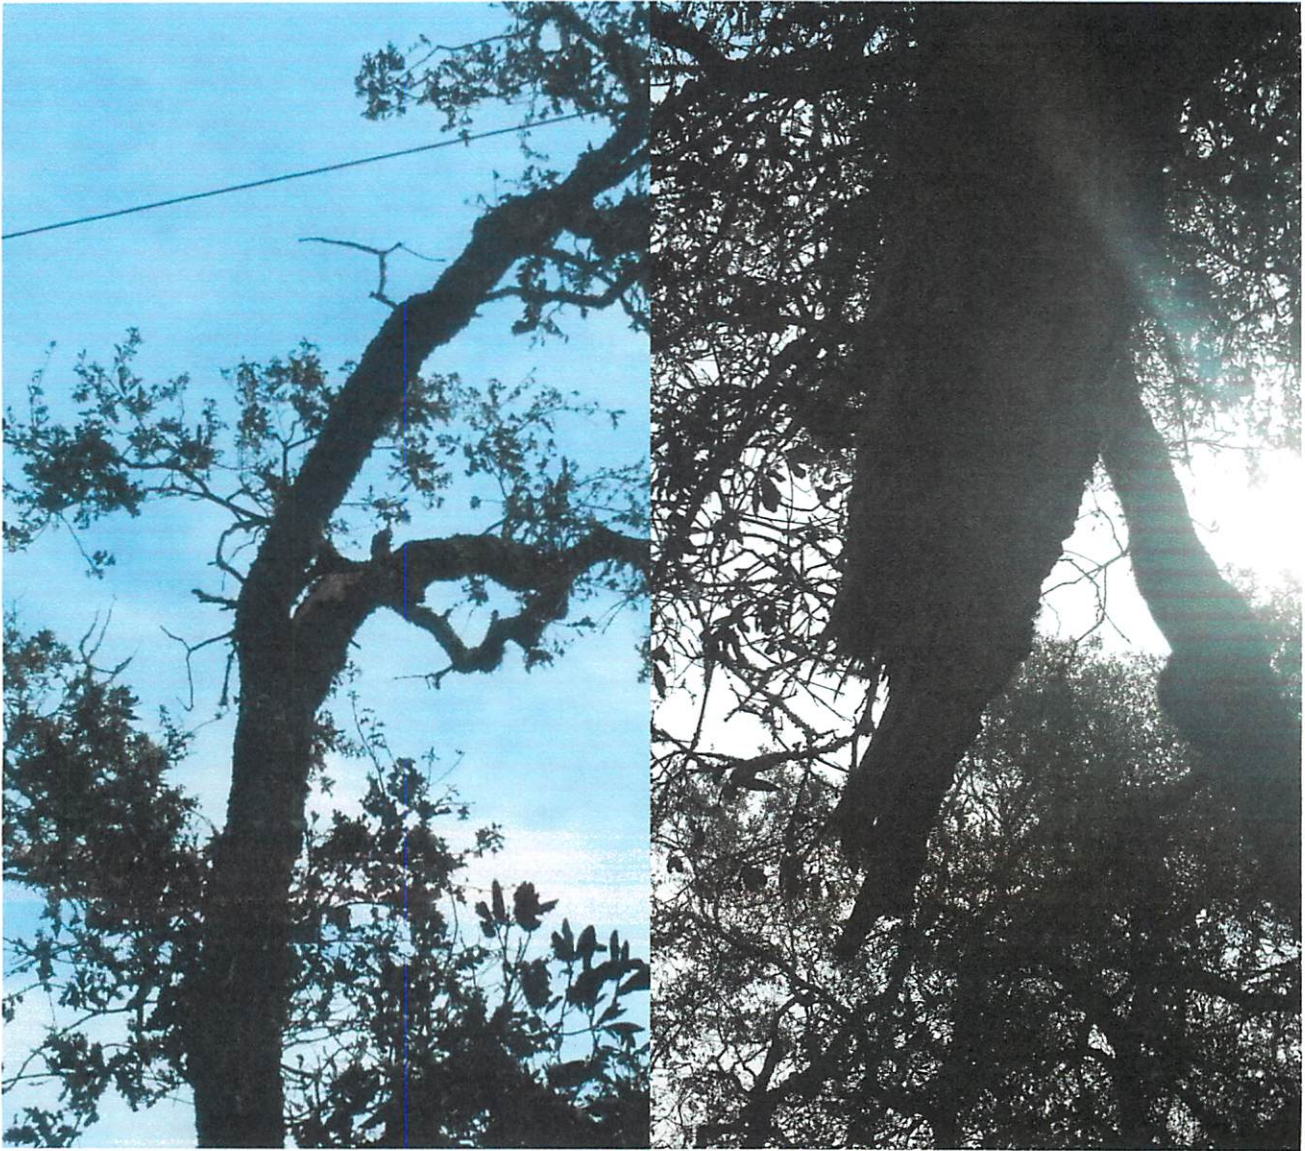
Figures 4 and 5 – showing the madrone damage from electricity from the powerline
