#### CALIFORNIA PUBLIC UTILITIES COMMISSION Safety and Enforcement Division Electric Safety and Reliability Branch

#### **Incident Investigation Report**

Incident Number: E20171026-01

**Utility:** Pacific Gas and Electric Company (PG&E)

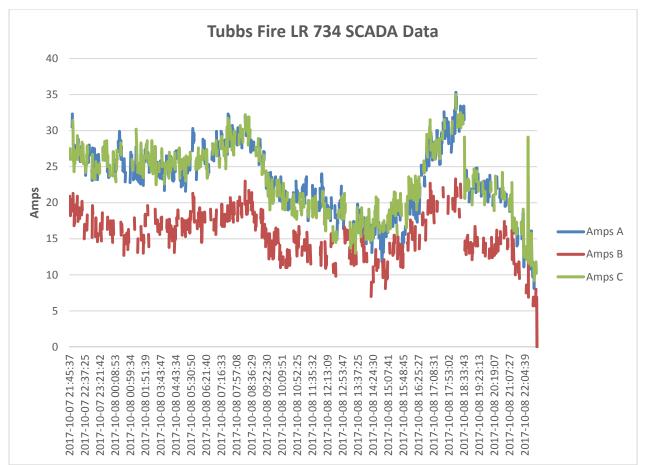
Figure 5: Plot of SCADA data from LR 734 for 24 hours to around the start time of the fire.

The load on all three phases is fairly consistent across the entire period, approximately 0-35A. However, there is a spike in amperage around the CAL FIRE designated start time of October 8, 2017, 2145 hours. The current drops to zero or near zero shortly after the incident start time.

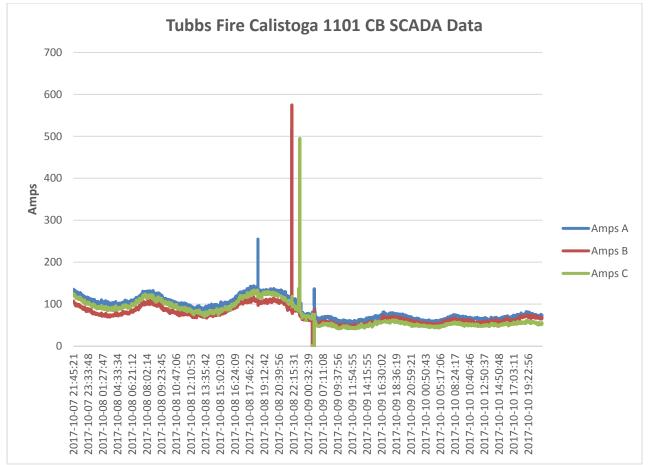
Figure 6: Plot of SCADA data for Calistoga 1101 substation circuit breaker. The plot covers between 24 hours prior to and 48 hours after the incident start time.

As the circuit breaker sees the load for the entire Calistoga 1101 circuit, the amperage is significantly higher ranging from 0-600A. The peak load spikes around the start time of the fire with the B phase peaking at approximately 580A. The C phase also spikes shortly after with a peak of approximately 500A. These spikes are indicative of faults occurring downstream of the circuit breaker such as those caused by vegetation contact with conductor or conductors.

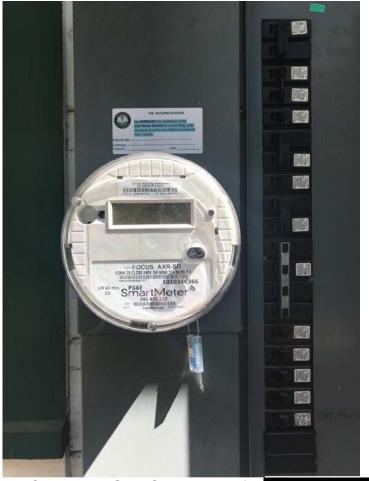
Figure 7: Collected PG&E Smart Meter for

On August 16, 2018, SED attended a PG&E evidence collection at the incident location. PG&E removed a conductor span, service meter, and tree limb from the neighboring residence down the hill at Both the conductor and meter were fed from the same PG&E facilities as 1128 Bennett Lane.
