BEFORE THE RAILROAD COMMISSION
OF THE STATE OF CALIFORNIA.

In the Matter of the Investigation
of the Failure of the Bridge of
the NORTHERN ELECTRIC across the
American River, occurring September
9, 1913.

Case No. 473.

REPORT ON ACCIDENT

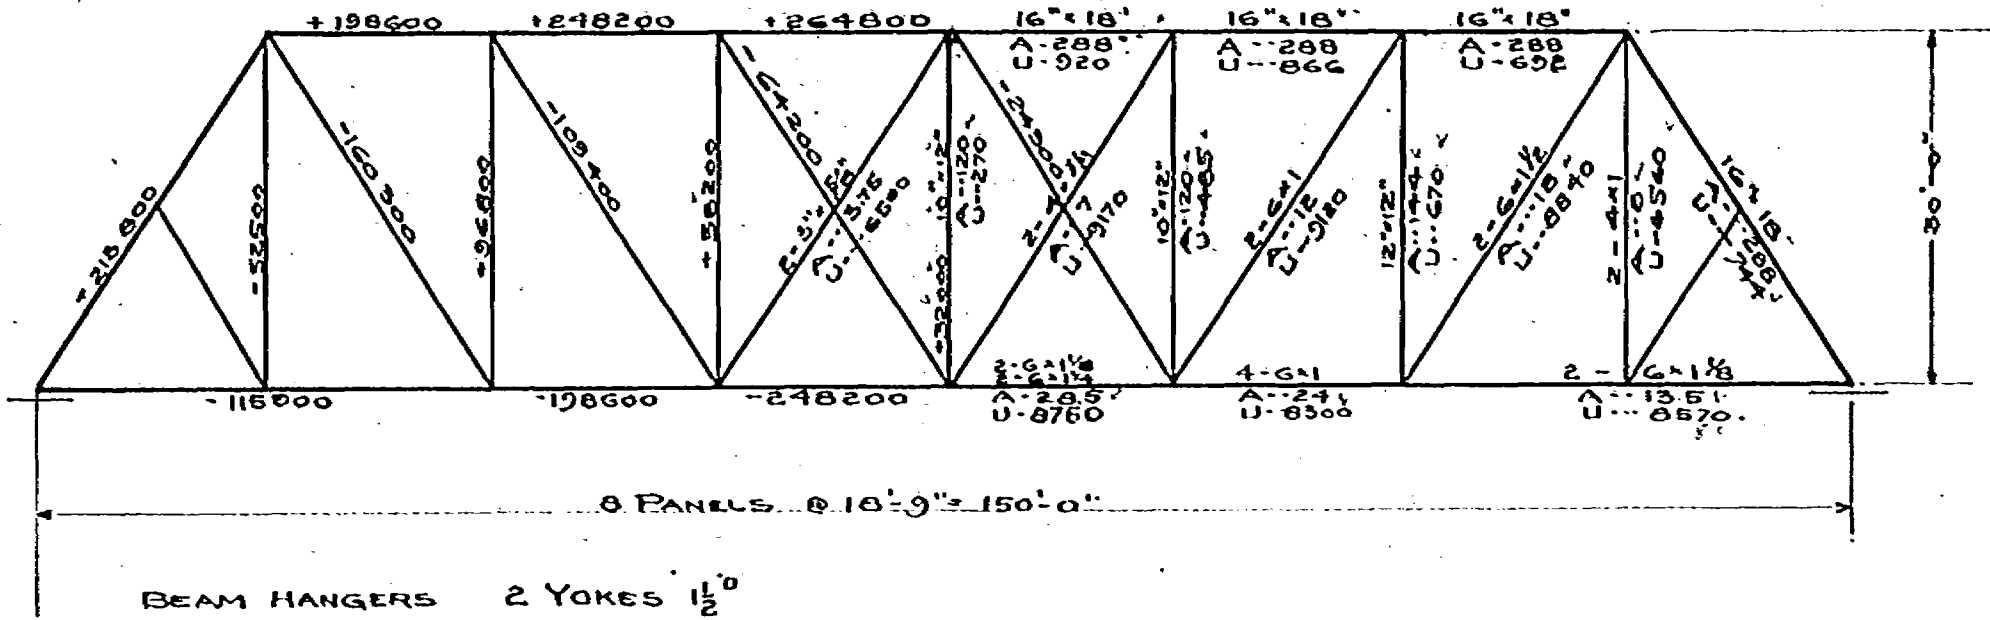
STRESS SHEET
150 FT. COMB. SPAN.

L.L. 4000* LIN FT
D.L. 1600* " "

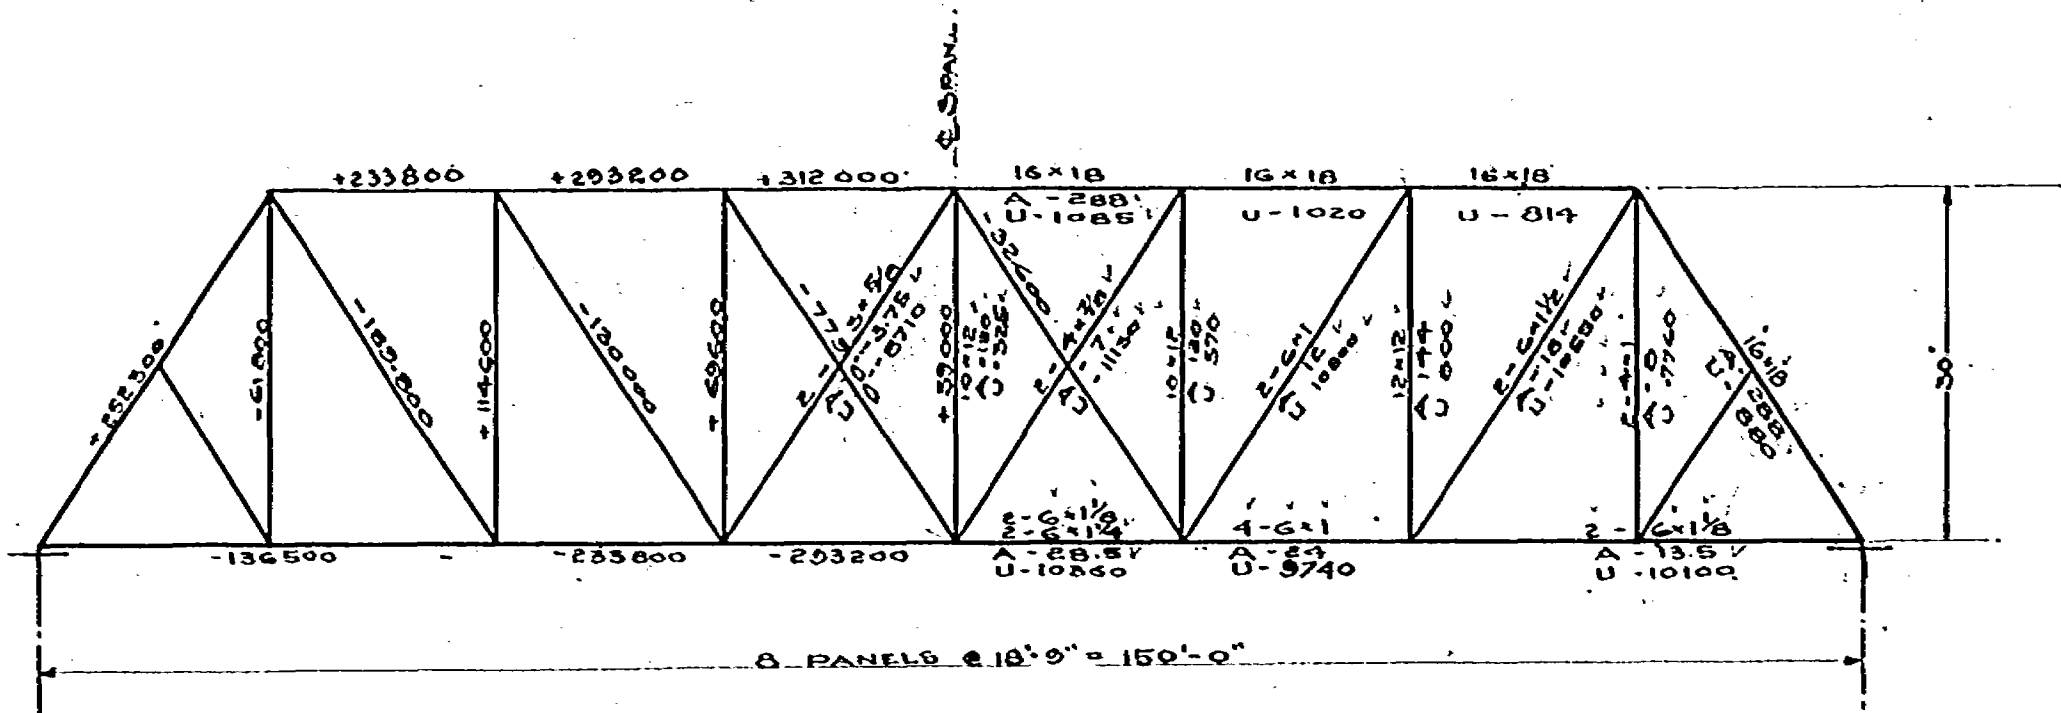
Stress Sheet.
150' Comb. Span.

L.L. 5000* LIN. FT.
D.L 1600*
