Decision 95-12-034 December 18, 1995

BEFORE THE PUBLIC UTILITIES COMMISSION OF THE STATE OF CALIFORNIA

Investigation on the Commission's (BART) (A85) through the A85 interlocking on the own motion into the safety appliances and procedures of the San Francisco Bay Area Rapid Transit District (BART) (Filed February 4, 1995) Case 9867

OPINION

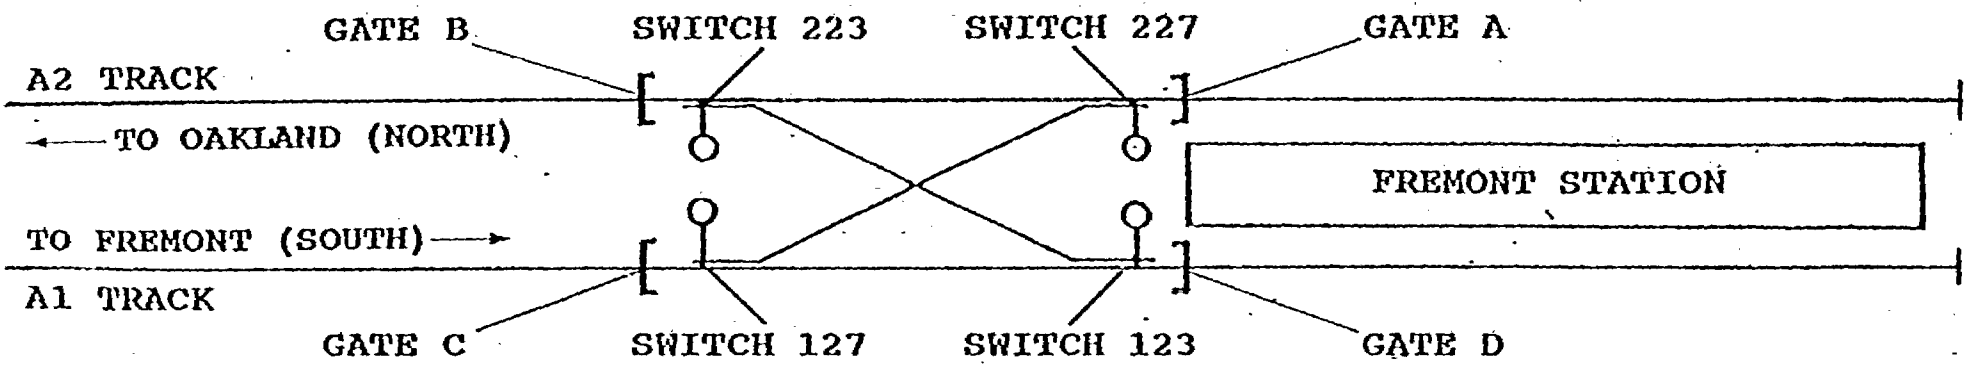
On January 9, 1995 at 3:21 p.m. southbound BART Train 230 derailed the first two of five cars when switch number 127 at the A85 interlocking<sup>1</sup> Fremont changed position under the first car. Three of the 19 passengers on board reported and were treated for injuries and damage.

1 "Interlocking" is defined in BART's Operations Rules & Procedures Manual as "An arrangement of gates and control apparatus so interconnected that functions must succeed each other in proper sequence, permitting train movements over controlled routes only as safe conditions exist." See Appendix A for a diagram of the A85 interlocking, together with the switches involved in the derailment.

The operator of Train 230 was issued manual orders by the trainee to operate through the A85 interlocking on the A1 Track to Fremont Station. The A85 interlocking was in the central automatic mode. The route through Gates C and D was verified for the train operator by the trainee confirming the alternate route alignment, Gate A to Gate B, on the central room display.

At the same time, the instructor, working as a train controller, was trying to clear a false occupancy on the A1 Track at Fremont station by resetting the sequential Occupancy Release System (SORS). As Train 230 was about to enter the A85 interlocking, the SORS Queue behind departing train 111 was deleted as a result of the instructor's actions. The A85 interlocking equipment then found that the A2 Track at Fremont Station was unoccupied, and that the Gate A to Gate B route was clear and therefore ready to receive a route request. With the A85 interlocking in the Central automatic mode, Train 230 was detected and presumed held in the approach zone by the automatic train control system as it requested a Gate C to Gate A route. Switch 127 at Gate C was in the process of aligning for that route as the first car of Train 230 passed over it. The first two cars of the five car train were derailed before the train came to a stop at the interlocking.
