# Root Cause Analysis of the Uncontrolled Hydrocarbon Release from Aliso Canyon SS-25

May 16, 2019

Root Cause Analysis Report

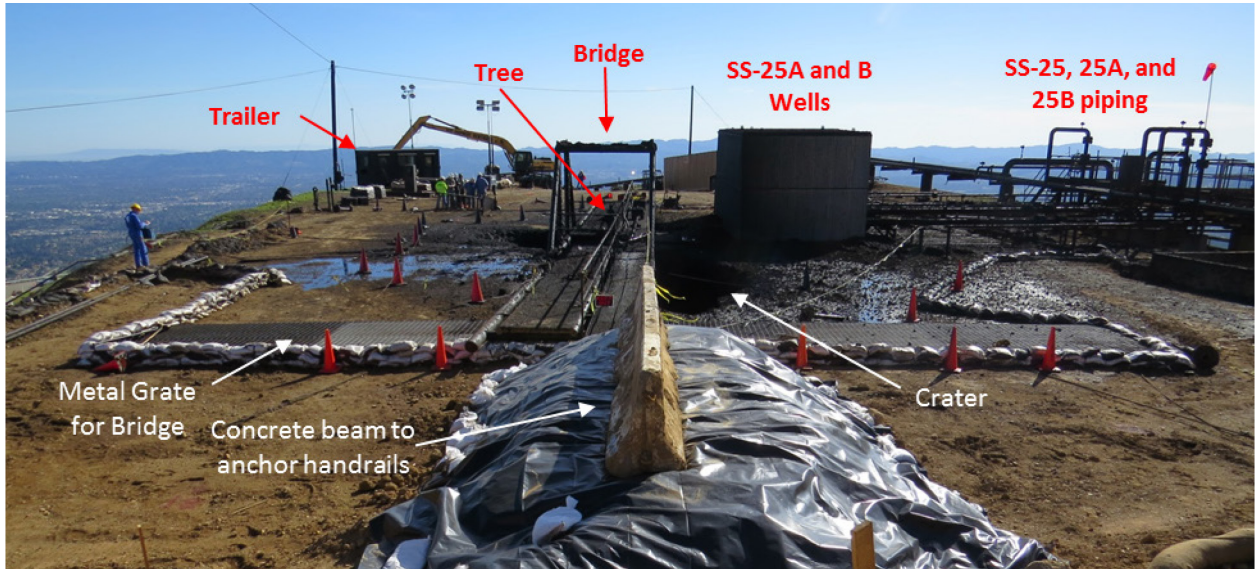
Phase 1 was the first opportunity for the Blade team to observe and document the SS-25 well site. Figure 15 shows one of the initial images taken after the well site was opened to the Blade team. The image shows the SS-25 tree, crater, bridge spanning the crater, SS-25A and SS-25B heat shields, and piping for SS-25, SS-25A, and SS-25B. The majority of the non-permanent items shown in the image were removed throughout Phase 1 or during Phase 2. These items included the trailer, bridge, heat shields, sand bags, cones, and concrete beam.

**Figure 15: SS-25 Well Site Condition on February 25, 2016**

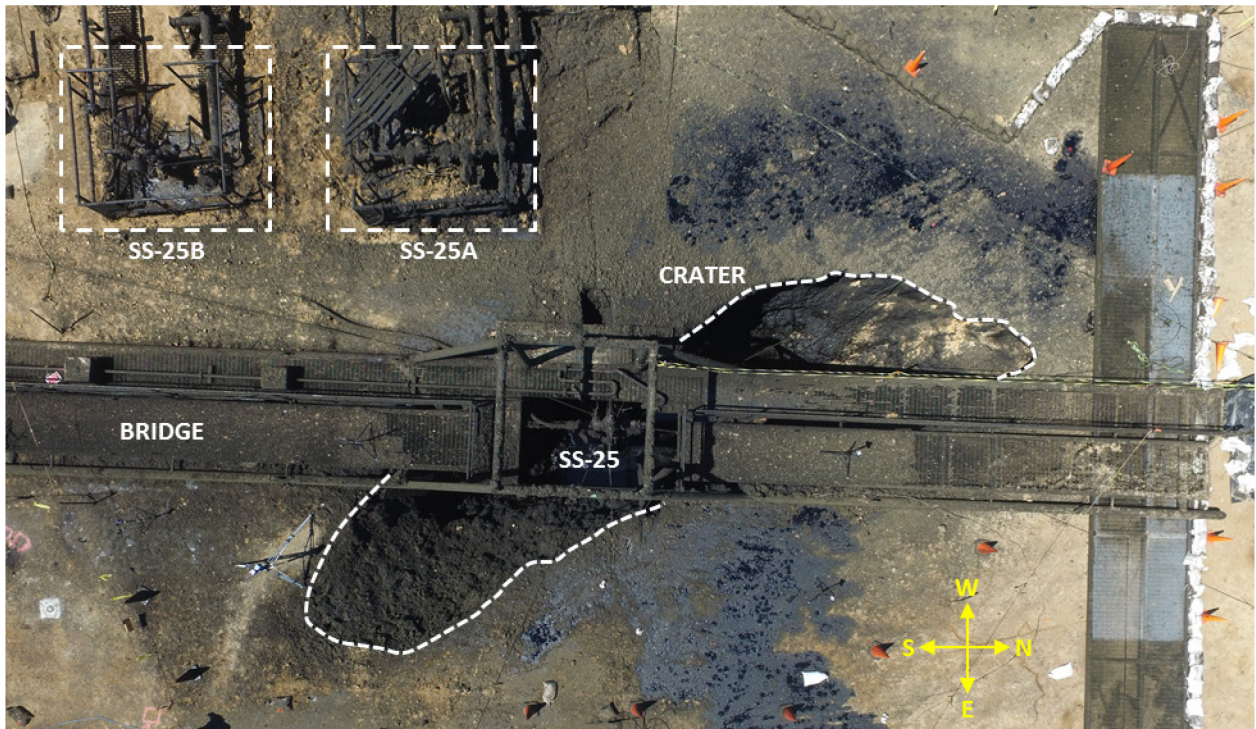
Formation of the crater occurred during various periods of the blowout. Figure 16 and Figure 17 show aerial photographs of the crater looking down and west, respectively. The images also show the SS-25A and SS-25B wellheads after removing the heat shields. The bridge and concrete beam were installed during the kill operations to provide access to the wellhead. The bridge provided a platform for personnel to connect lines and operate valves. The concrete beam was used to anchor a steel cable handrail.

**Figure 16: SS-25 Well Site Top View Aerial Photograph Post Blowout Taken on April 01, 2016**

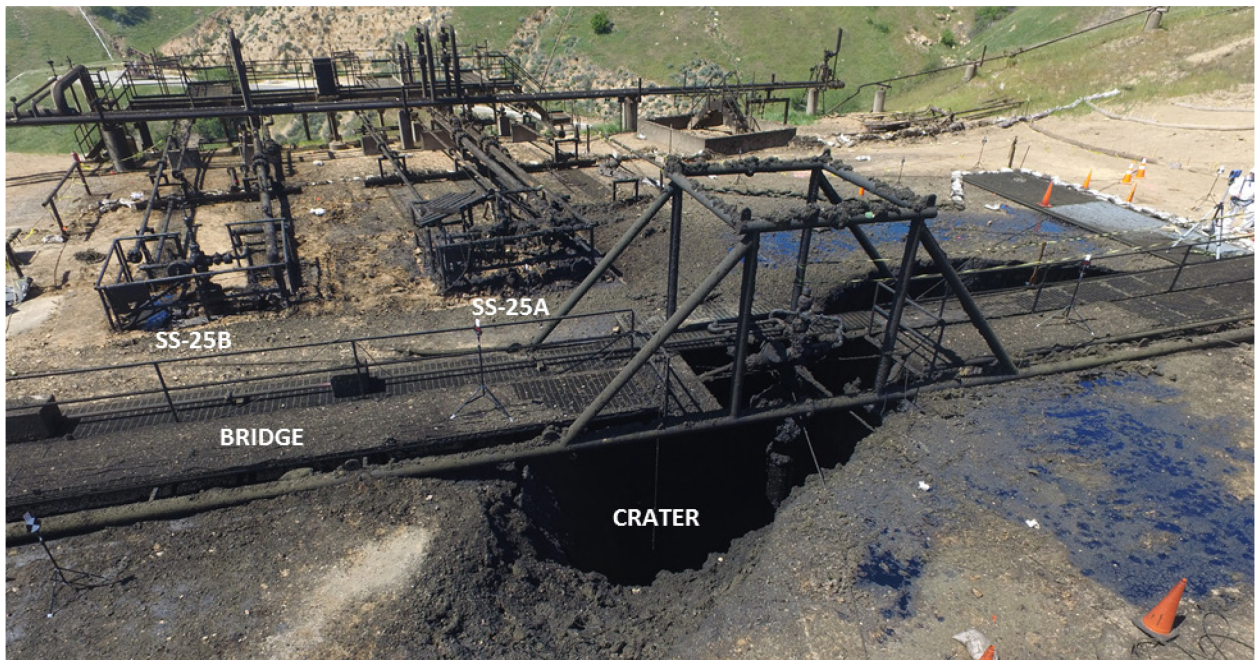
**Figure 17: SS-25 Well Site West View Aerial Photograph Post Blowout Taken on April 01, 2016**

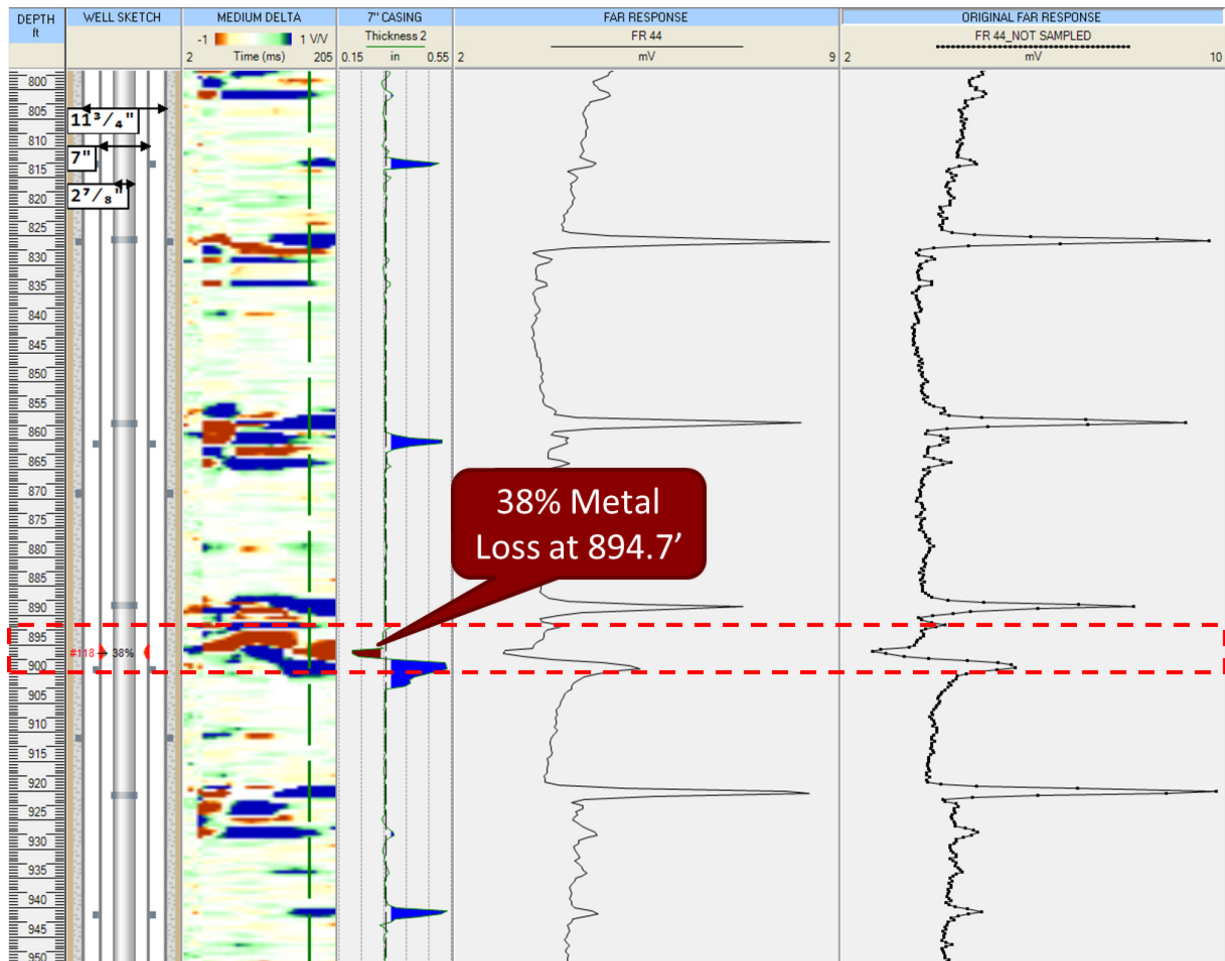
During Phase 1, a Magnetic Imaging Defectoscope (MID) logging tool was used. This tool is designed to record the time response to electromagnetic pulses to detect metal loss or gain in up to three barriers. The MID tool was run within the 2 7/8 in. tubing (first barrier) to identify anomalies in the 7 in. casing (second barrier) and 11 3/4 in. casing (third barrier). The MID detected metal loss at several locations along the length of the 7 in. casing—the most notable one at 895ft MID log depth. Figure 19 shows the MID results at a depth of 895 ft. The well schematic in Figure 19 shows a 38% metal loss feature on the 7 in. casing, suggesting significant metal loss at that depth.

**Figure 19: MID Results Showing 38% Metal Loss at Approximately 895 ft**

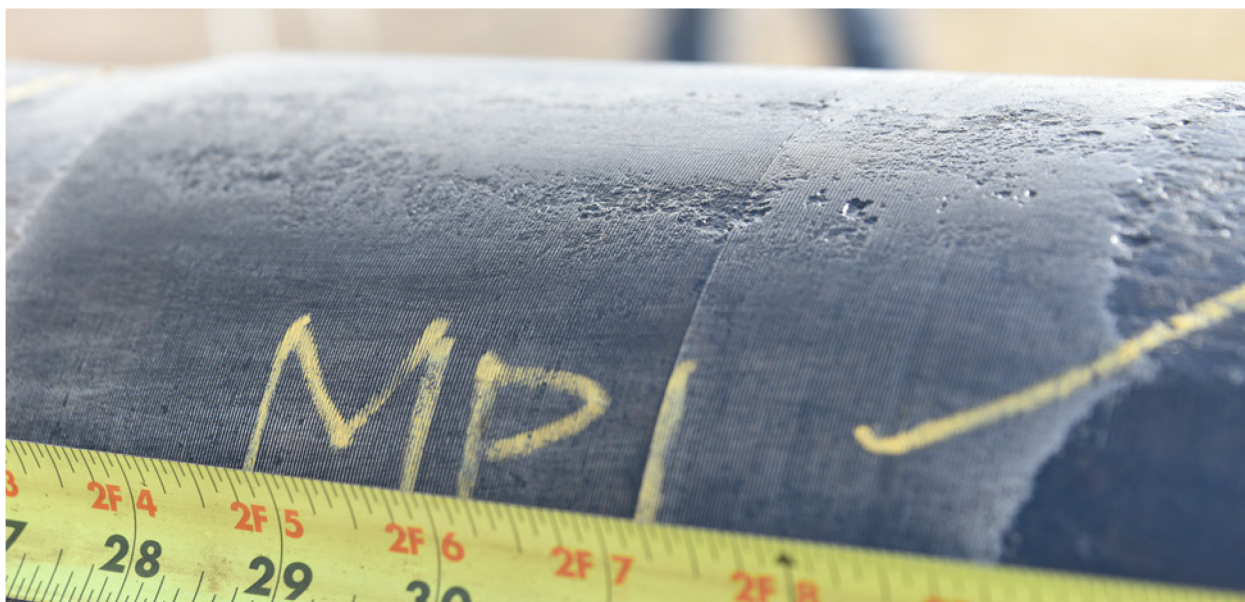
Shallow metal loss was first identified on the C014 connection and was present on the remainder of the extracted casing pipe bodies and connections. Corrosion was identified on many of the connections below C014 with increasing severity. Figure 28 shows the shallow corrosion on the C014 connection. Figure 29 shows corrosion on the connections for (a) C019 and (b) C020. The corrosion is similar to C014's but more severe.

**Figure 28: Shallow Metal Loss on Connection C014**

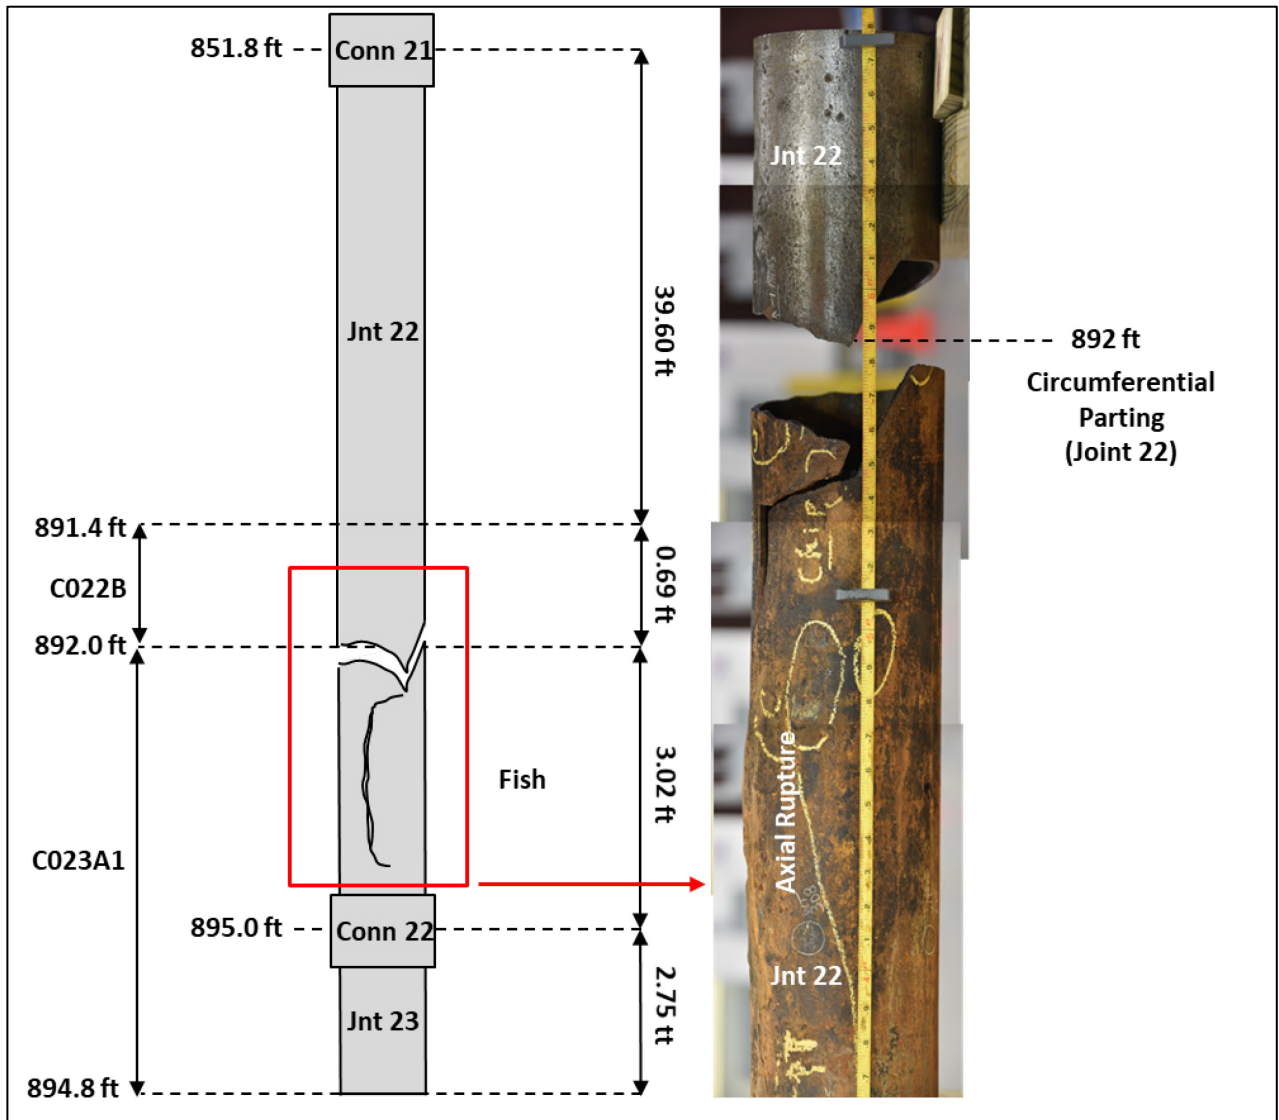
**Figure 44: Schematic and Photo of the Axial Rupture and Circumferential Parting (Joint 22)**

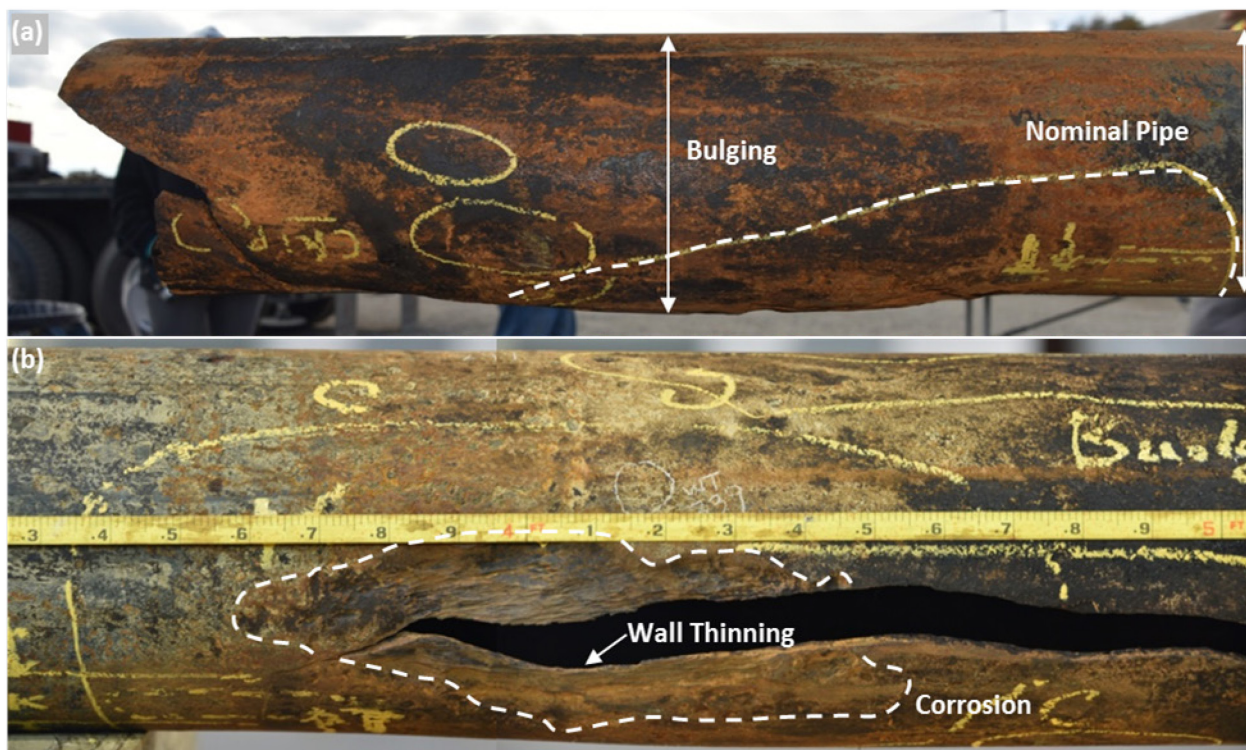
**Figure 45: Images of Axial Rupture Showing (a) Bulging and (b) Corrosion Associated with the Axial Rupture**

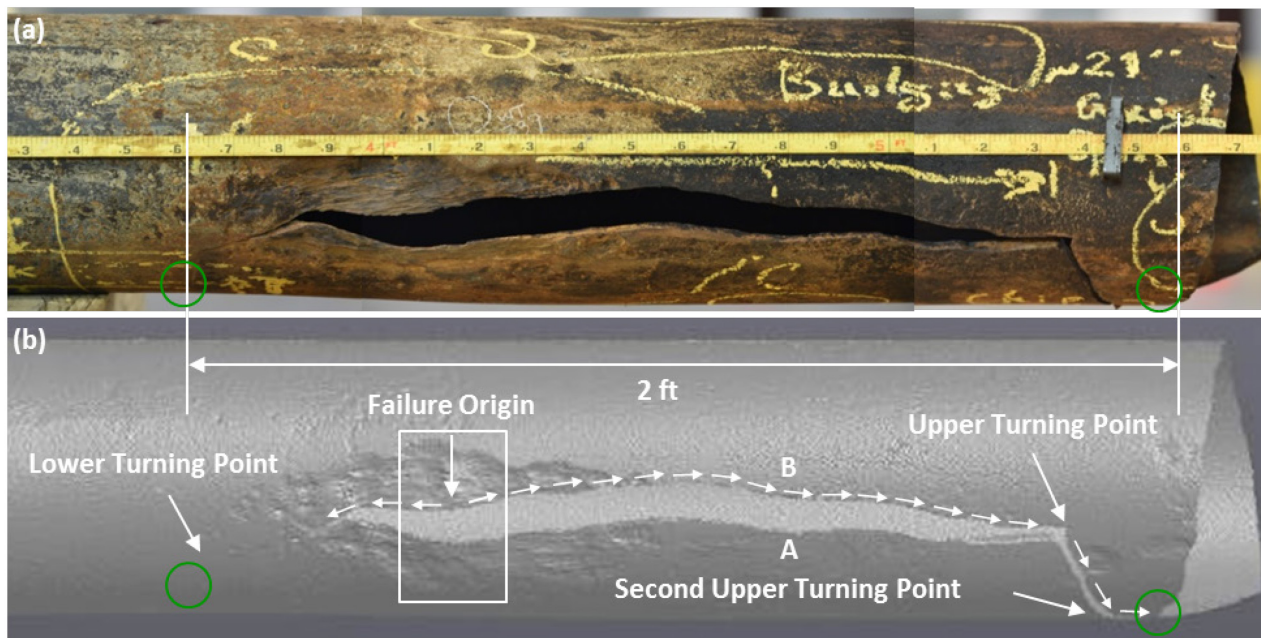
Figure 46 (a) and (b) show a close-up and laser scan image of the axial rupture. The failure origin is indicated by the white box. The direction of crack propagation is indicated on both sides of the origin by white arrows. The upper and lower crack arrest points are indicated by the green circles.

**Figure 46: (a) Field Photo and (b) Laser Scan Indicating the Origin, Lower and Upper Turning Points, and Lower and Upper Arrest Points**

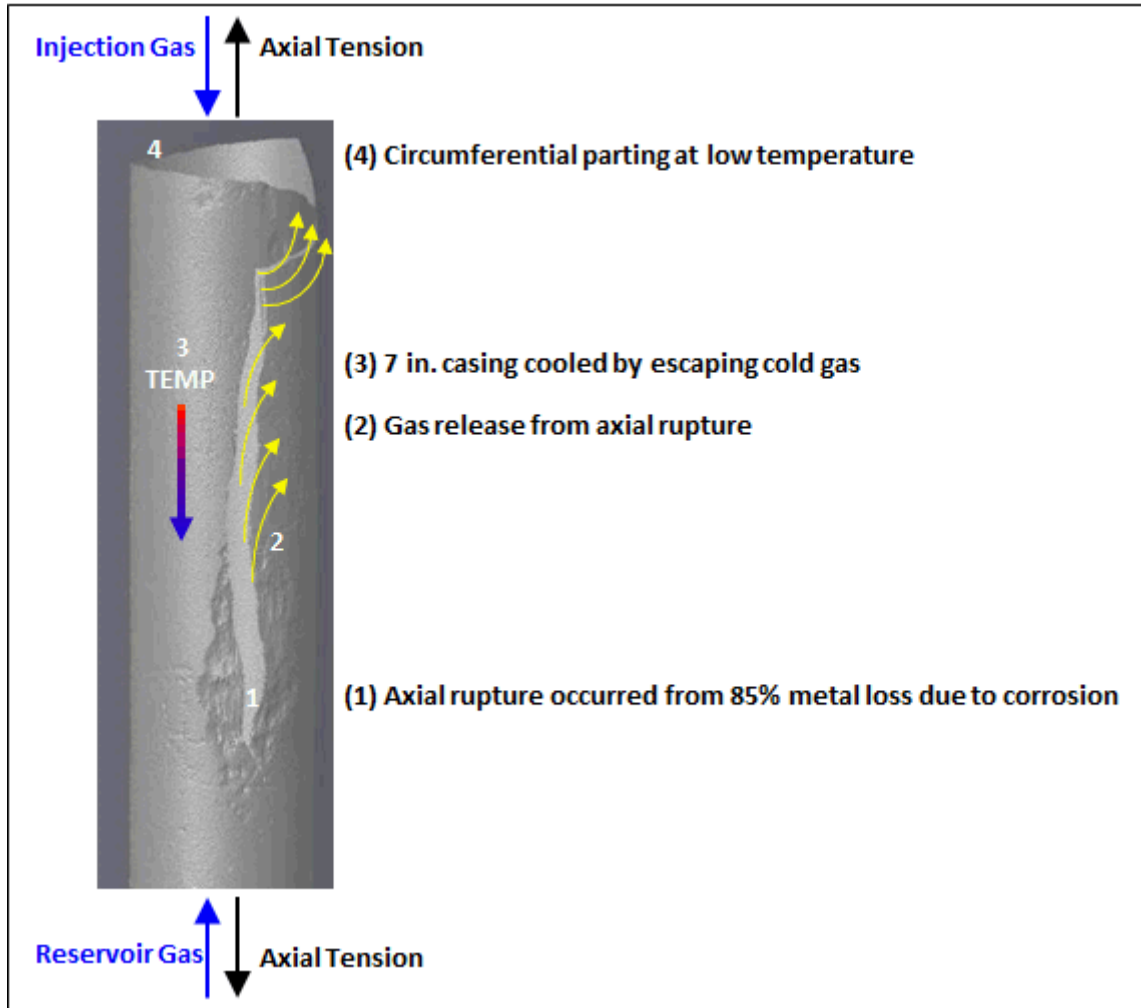
Figure 49 is a schematic based on the laser scan data of C023A1, which illustrates the failure sequence for the axial rupture and circumferential parting. The full cleavage fracture mode was examined, and a temperature for the circumferential parting was estimated to be in the range of  $-76^{\circ}\text{F}$  to  $-38^{\circ}\text{F}$  ( $-60^{\circ}\text{C}$  to  $-39^{\circ}\text{C}$ ).

Figure 49: 7 in. Casing Failure Sequence Schematic

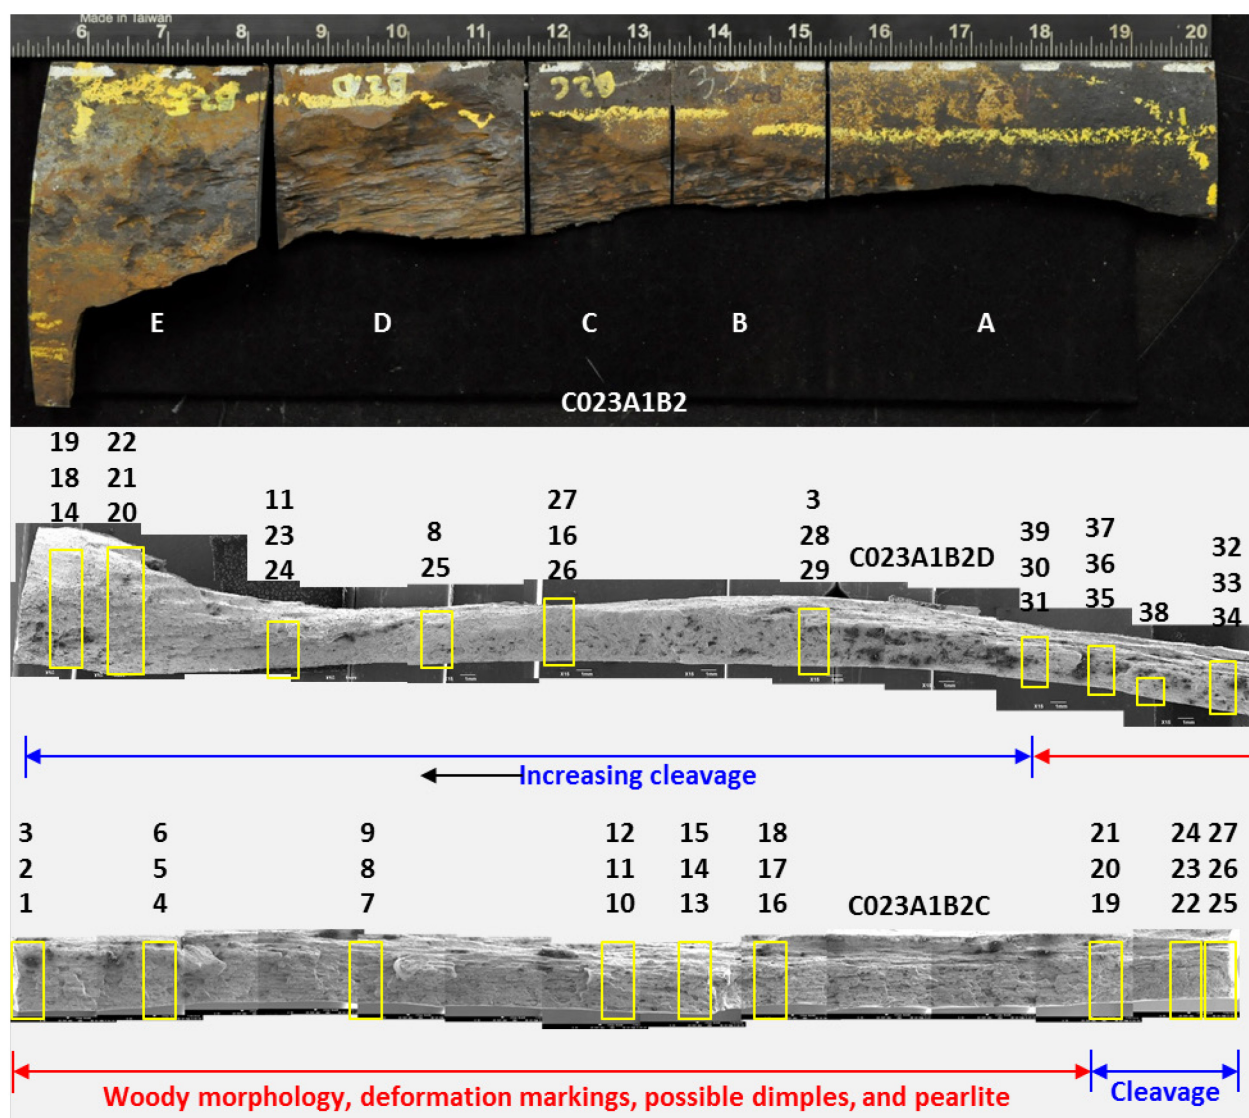
A transition from ductile to a ductile–brittle mix was observed beginning at A19 (Figure 53). The transition showed a shift from a woody-type morphology to a mix of woody-type morphology and cleavage. The amount of cleavage facets appeared to increase from location A19 to A27. The observations implied that the speed of the axial rupture was increasing through the transition zone until the crack became fully unstable. Figure 56 is a SEM image from A19 showing the ductile–brittle mixed fracture mode. The images show areas of cleavage facets and deformation markings.

Figure 53: SEM Examination of the Cleaned Fracture Surfaces of C02A1B2C and B2D

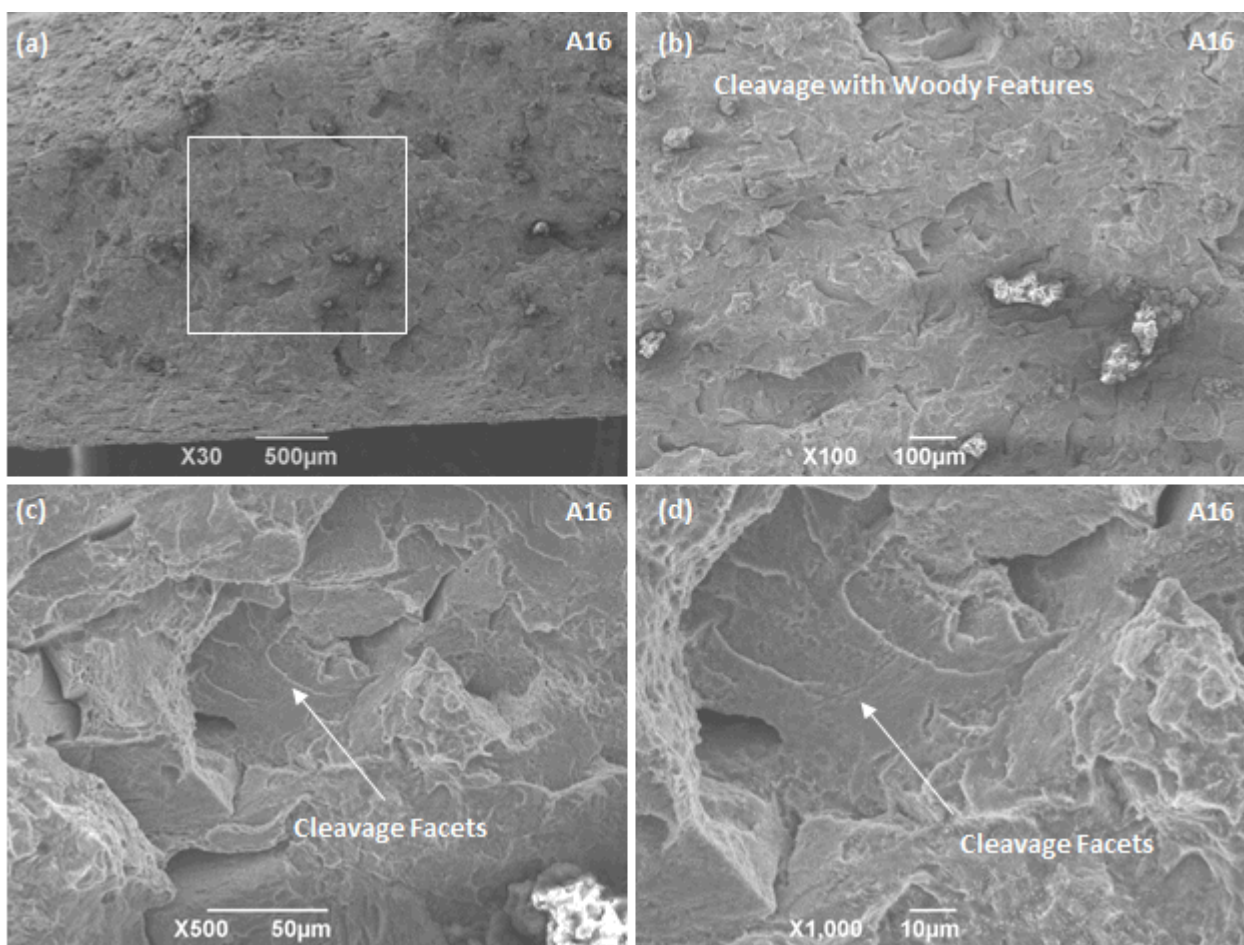
The SEM examination showed a mixed fracture mode that consisted of cleavage (brittle) and micro-void-coalescence and dimples (ductile). The amount of cleavage increased with distance from the origin, but decreased as the crack approached the lower turning point. Figure 61 shows typical SEM images taken from locations in Zone 2.

**Figure 61: SEM Images from Locations A16 and A26 Showing Mixed Fracture Mode**

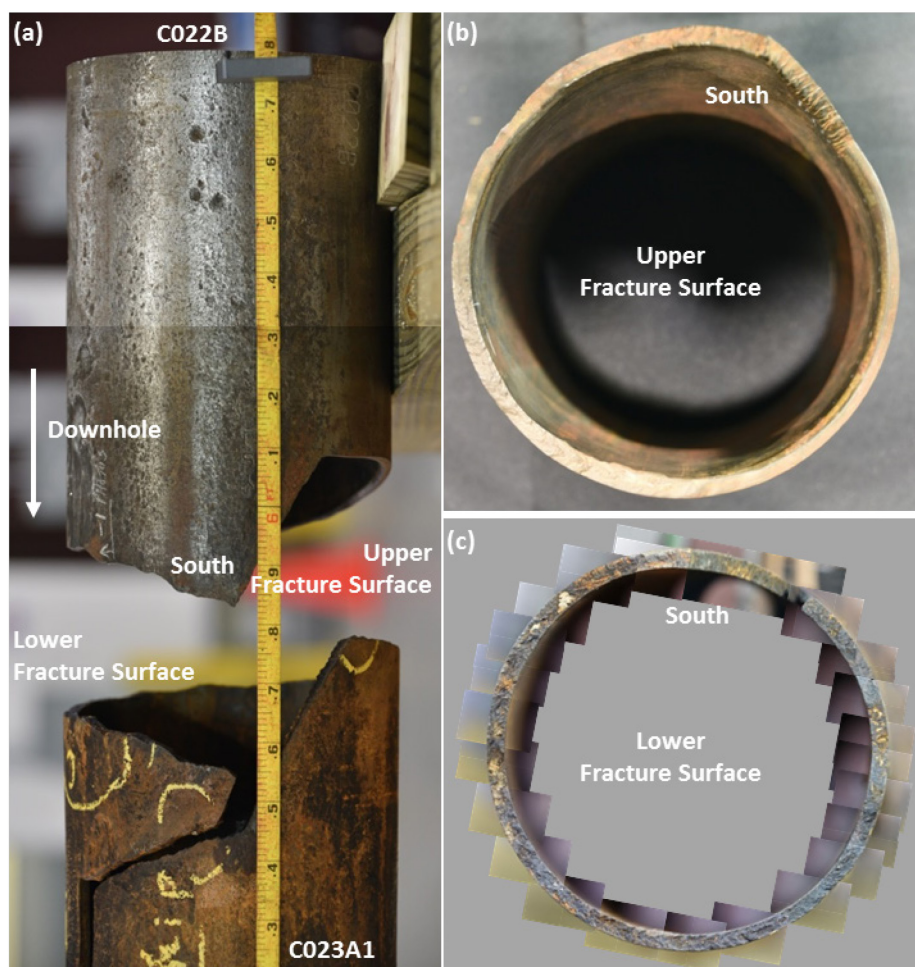
Figure 66: (a) Circumferential Parting Showing the (b) Upper and (c) Lower Fracture Surfaces

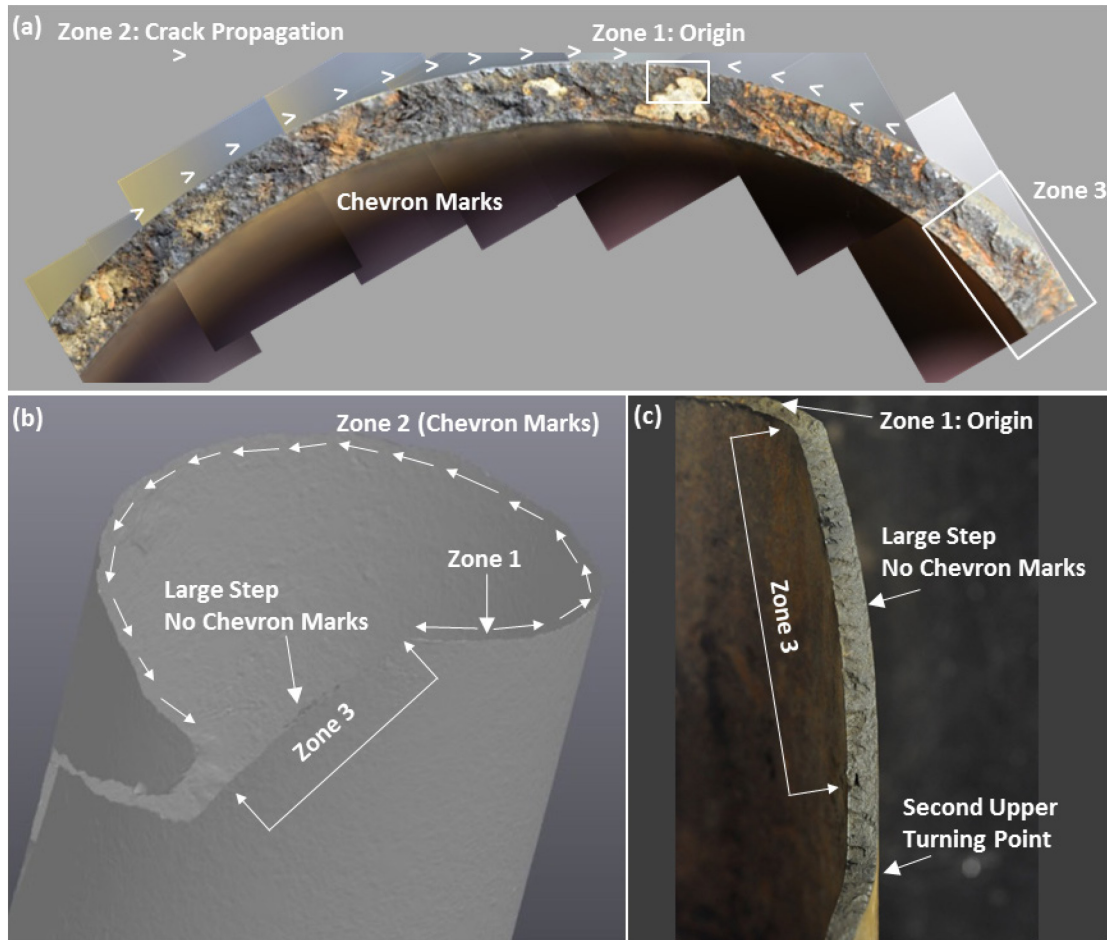
Figure 67 illustrates the three zones of the circumferential parting. Figure 67 (a) is a stereo image showing the three zones, origin, and the direction of the crack propagation. Figure 67 (b) is a 3D schematic showing the overall circumferential parting steps. Figure 67 (c) is a close-up of the Zone 3 fracture surface.

**Figure 67: (a) Stereo Image (b) 3D Schematic of Zones (c) Macro Image of Three Zones**

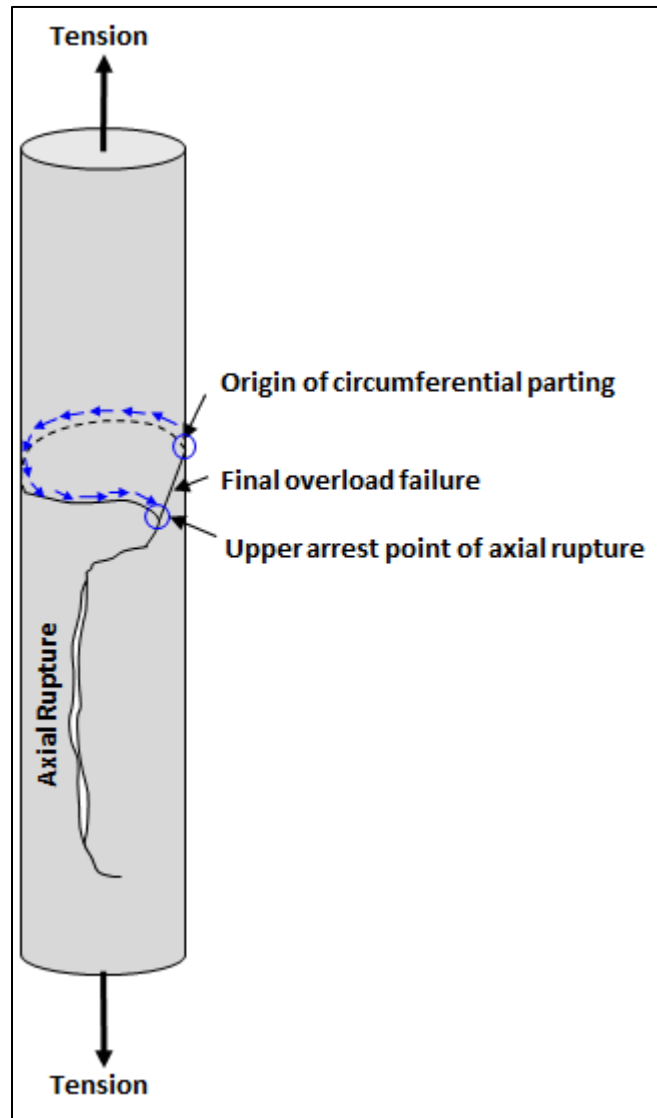
the chevron marks produced by the axial rupture. The initiation site and chevron marks produced by the circumferential parting were located approximately 3.7 in. (94 mm) from the upper arrest point of the axial rupture. Figure 70 is a schematic of the crack path for the axial rupture and circumferential parting. The schematic shows how the circumferential parting initiated above the arrest point of the axial rupture. The crack propagated circumferentially until it reached the axial rupture arrest point. The final ligament failed due to the axial load generated by the weight and tension of the 7 in. casing string. The axial rupture and circumferential parting are thought to be two separate events because there was no evidence that the chevron marks from the axial rupture continued into the circumferential parting. The close proximity of the two failures suggests that they are related despite being two separate events.

**Figure 70: Schematic of the Axial Rupture and Circumferential Parting**

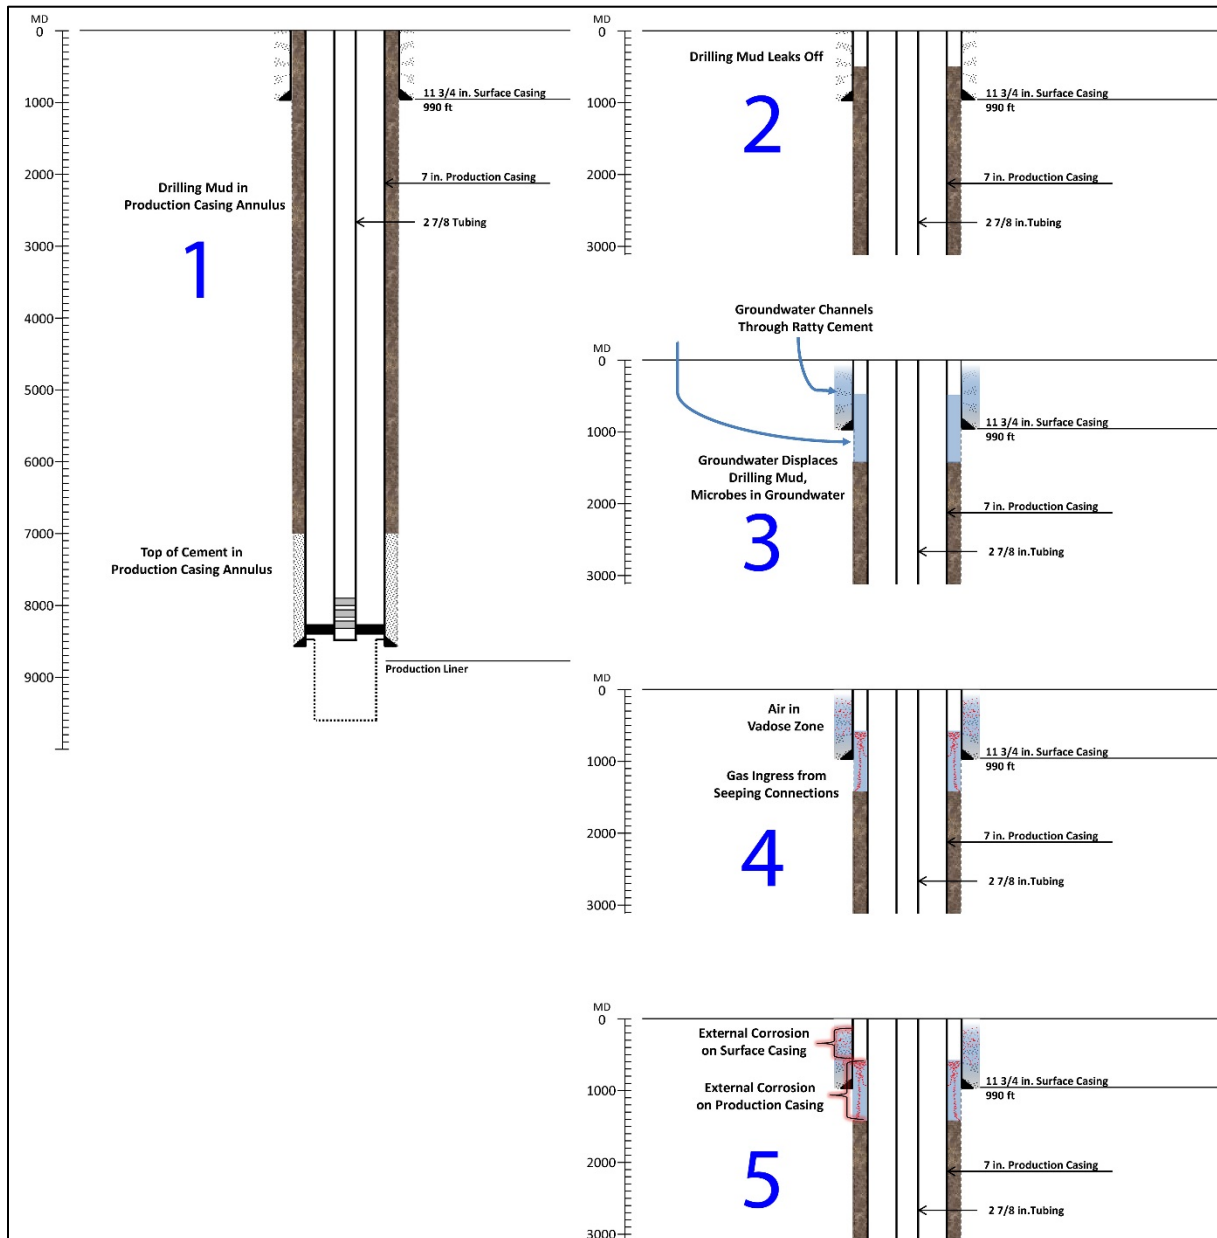
The possible mechanism of the groundwater and drilling fluid interplay is depicted in Figure 85 that includes five steps. The first step, as shown in Figure 85, is the as is well completed condition with the drilling fluid in the 11 3/4 in. × 7 in. annulus. The second step is that over a period of time the drilling fluid would have leaked off into the formation. Over time in step 3, groundwater accesses the surface casing annulus and the OD of the 11 3/4 in. surface casing. The corrosion process would have initiated at this stage, especially as gas is seeping through connections. This finally results in external corrosion on the OD of the surface casing and the OD of the production casing. The fluid level in the surface casing annulus would have fluctuated with time and precipitation; however as discussed in the next section extensive 7 in. OD corrosion is observed from 700 feet and deeper.

**Figure 85: Likely Mechanism of Groundwater Ingress into the Surface Casing and Production Casing Annuli**

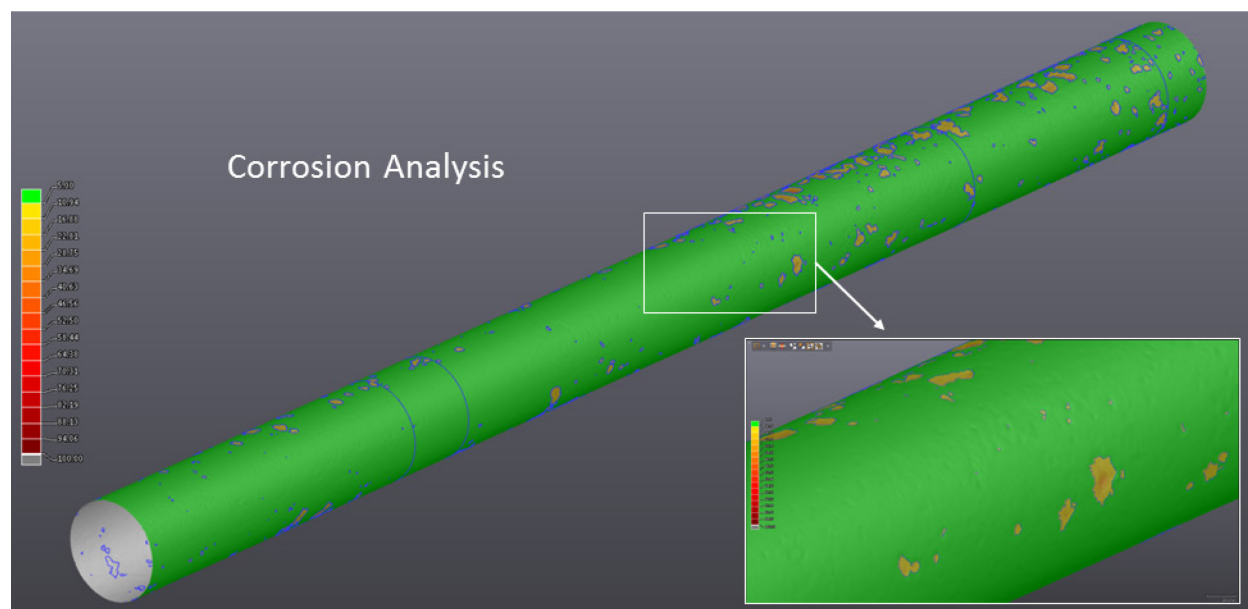
**Figure 87: 3D Color Map of Corrosion Analysis Results for C018A**

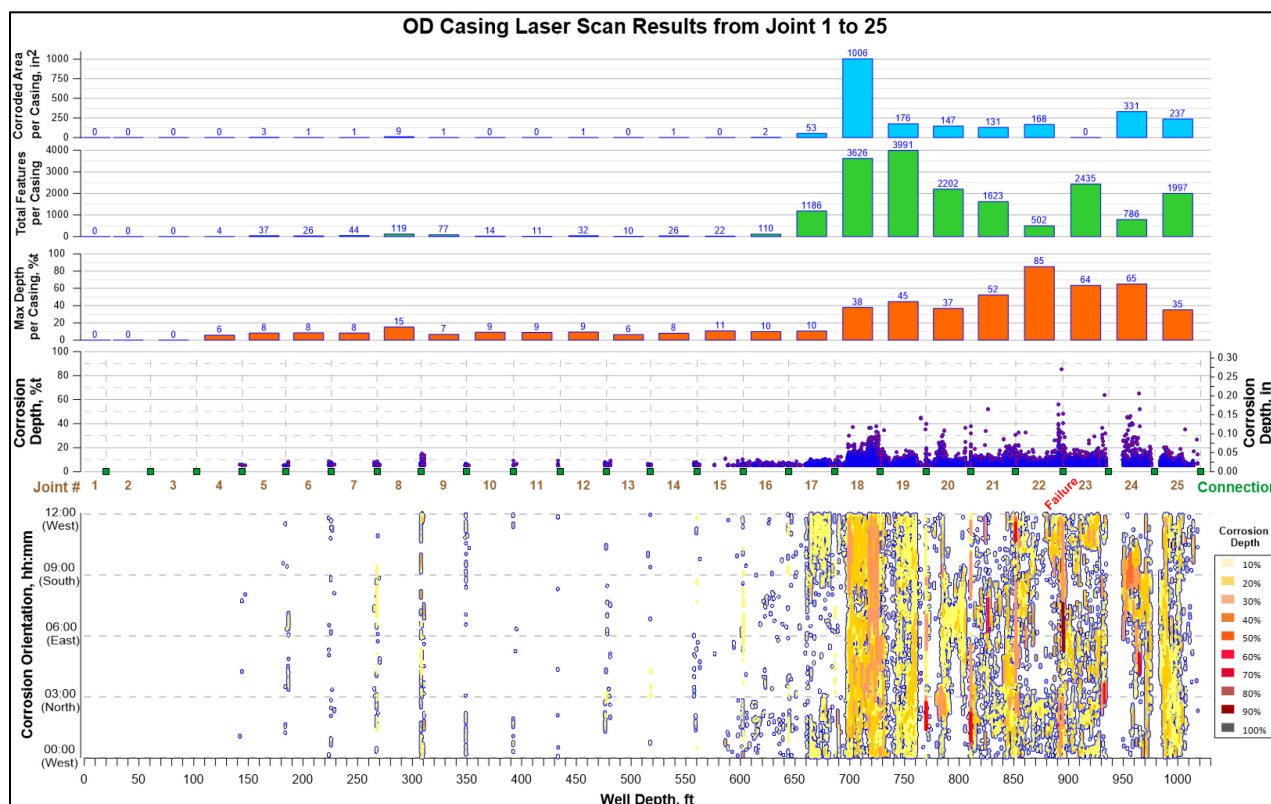
**Figure 88: 7 in. Casing Outside Diameter Corrosion Distribution for Joints 1 through 25**

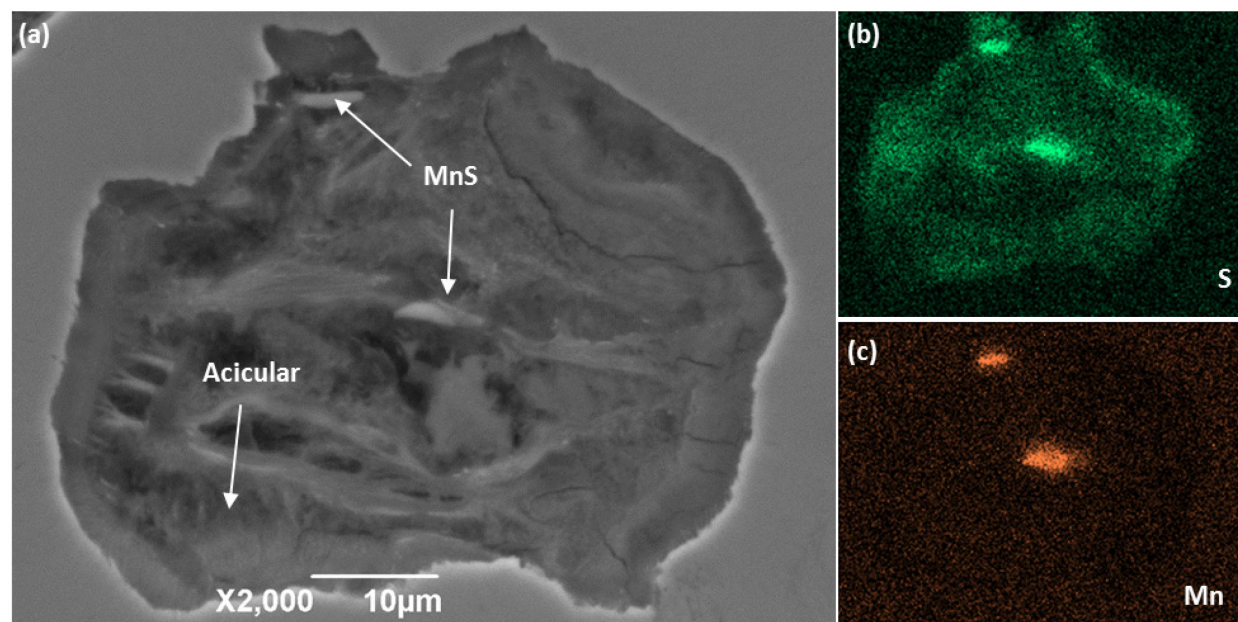
Figure 101: (a) SEM image of Tunnel with Acicular Deposit and EDS Color Maps for (b) S and (c) Mn  
Corrosion Adjacent to the Circumferential Parting (C022B1)

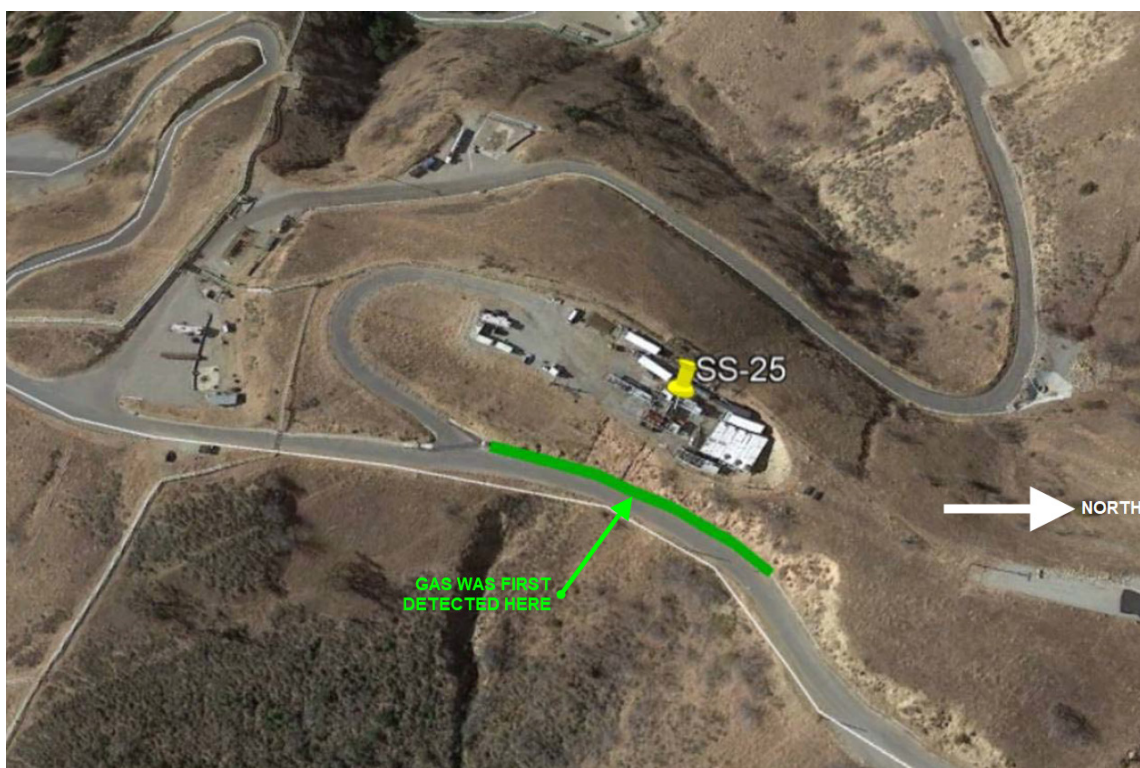
**Figure 110: Location Where Gas was First Detected on October 23, 2015 [39]**
