**Pacific Gas and
Electric Company**

Electric T&D Bulletin

Title: Howard PM Transformer Special Inspection – Energized

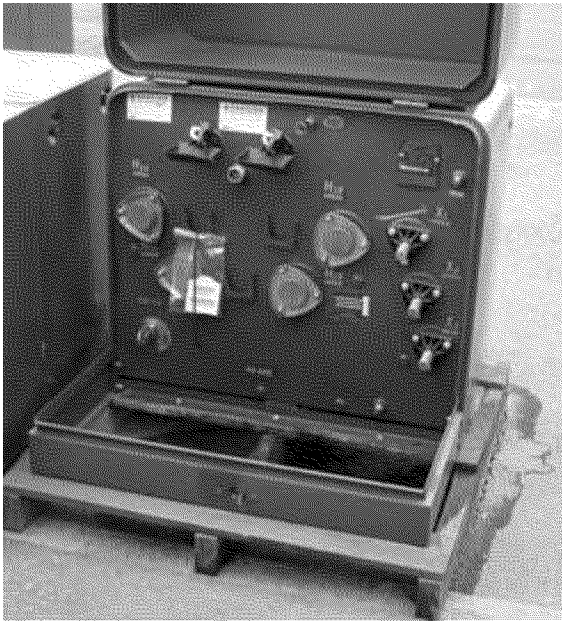
Figure 01

Puddle of oil from bushing well leak on a Style DF in materials stock

1. Verify the following information provided in the Spreadsheet is correct. If not, document the correct information on the Spreadsheet.
 - Serial number
 - Address
2. Check for signs of oil leaking
 - Puddle of oil, see Figure 01:
Check the appropriate box on the Spreadsheet. Complete an MPR requesting Emeryville field personnel complete an in-service repair. Generate at the local headquarters an EC notification with required end date as per local procedure. Notification is a Priority G and work type code is 541. Use Object Part TRPM; Condition Found LEAK; Activity Code REPA. The following details should be provided in the comments: Howard Industries Transformer, a brief description of findings, Emeryville field personnel requested and the MPR number.

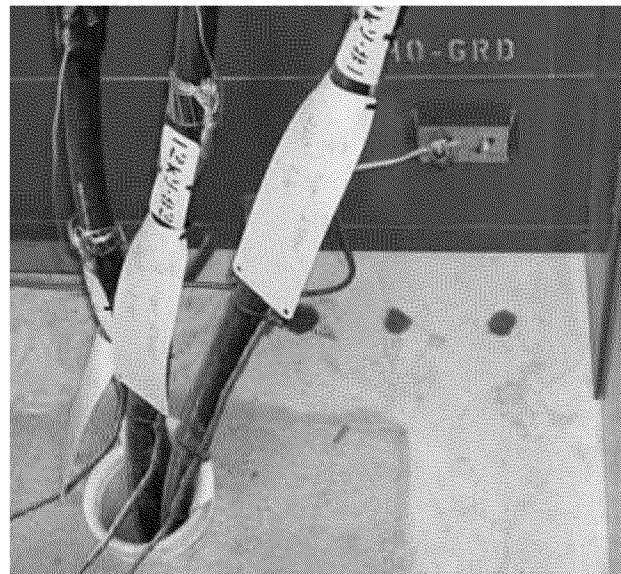
Figure 02

Oil drops on pad from seeping bushing well

- Seeping from around bushings, see Figure 02:
Check the appropriate box on the Spreadsheet. Complete an MPR requesting Emeryville field personnel complete an in-service repair. Generate at the local headquarter an EC notification with required end date as per local procedure. Notification is a Priority G and work type code is 541. Use Object Part TRPM; Condition Found LEAK; Activity Code REPA. The following details should be provided in the comments: Howard Industries Transformer, a brief description of findings, Emeryville field personnel requested and the MPR number.
