Re: PG&E's Accelerated Gas Transmission System Aerial and Ground Leak Survey Trends Report

# **Accelerated Natural Gas Transmission System Aerial and Ground Leak Survey Trends Report**

**Pacific Gas and Electric Company**

February 1, 2011

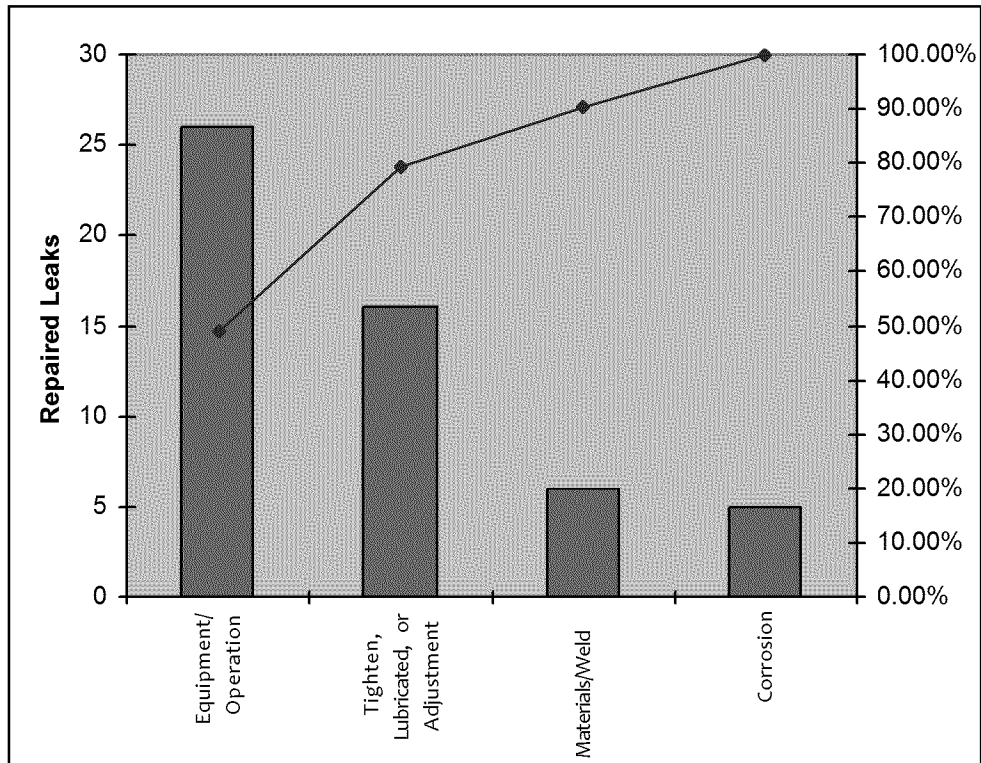
Figure 1 - Leaks by Cause

Figure 1 below conveys the same data in chart form. The chart displays the 53 leaks from the category with the highest number of leaks to the category with the lowest number of leaks. The y-axis to the left of the chart identifies the number of leaks per category. The y-axis to the right of the chart identifies the cumulative percentage of total leaks.

- \* Equipment-related leaks were the leading cause of leaks repaired as part of this Accelerated Leak Survey. Equipment leaks occur on transmission appurtenances and include failures at threaded components, gaskets, valve packing, etc. PG&E found that most of these equipment leaks were associated with PG&E high pressure regulator (HPR) sets serving one to two customers and on facilities generally less than 1 inch in diameter.

- \* The next highest cause of leaks fell within the category “Other.” These are leaks where PG&E performed an immediate response and repaired the leak by tightening, lubricating, or adjusting. The 16 leaks identified in this category could have been considered equipment leaks as they are associated with thread and lubrication components failure. These leaks are also ones that, as discussed below and in the attached expert consultant’s report, may not even have been reportable in the first place.<sup>13</sup>

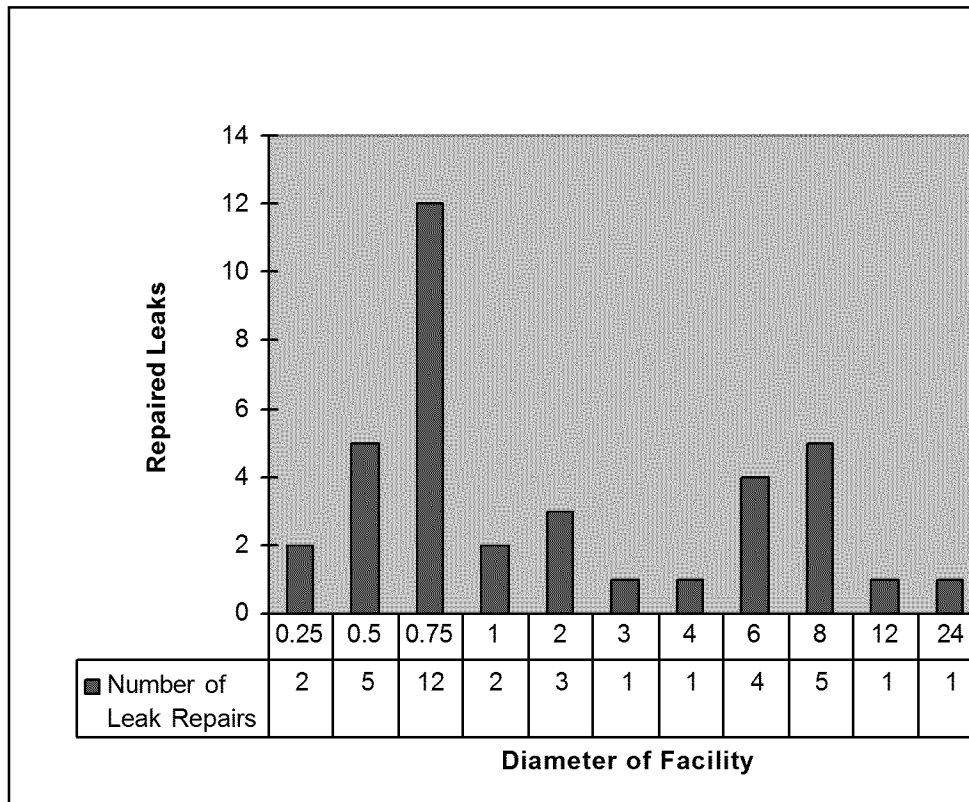
Figure 2 - Size of Facility

Reviewing the size of the facility where the leak occurs can provide insight on leaks where additional focus may be needed. Figure 2, below, includes all transmission/gathering leaks with the exception of leaks repaired by tightening, lubrication, or adjustment.

Note: Excludes the 16 leaks designated as leaks repaired by tightening, lubrication, or adjustment.

As shown by Figure 2 above, ninety-five percent of the leaks found and repaired (excluding the 16 leaks repaired by tightening, lubrication or adjustment) were on facilities less than 12 inches in diameter. Two leaks were found on facilities equal to or greater than 12 inches in diameter, as follows:

- \* On October 6, 2010, an indication of a potential leak was identified via the Accelerated Leak Survey on Line 153 in the City of Oakland. The leak was caused by external corrosion along a welded seam of pipe. A 25-foot section of 24 inch diameter pipeline was removed and replaced to complete the repair.

- 
- \* On October 11, 2010, an indication of a potential leak was identified via the Accelerated Leak Survey on Line 177A near PG&E's Cumming Creek Pressure Limiting Station near Fortuna in Humboldt County. The leak was found to be caused by a pin-hole within a girth weld. A sleeve was welded into place to complete the repair.
