Re: PG&E's Accelerated Gas Transmission System Aerial and Ground Leak Survey Trends Report

Accelerated Natural Gas Transmission System Aerial and Ground Leak Survey Trends Report

Pacific Gas and Electric Company

February 1, 2011

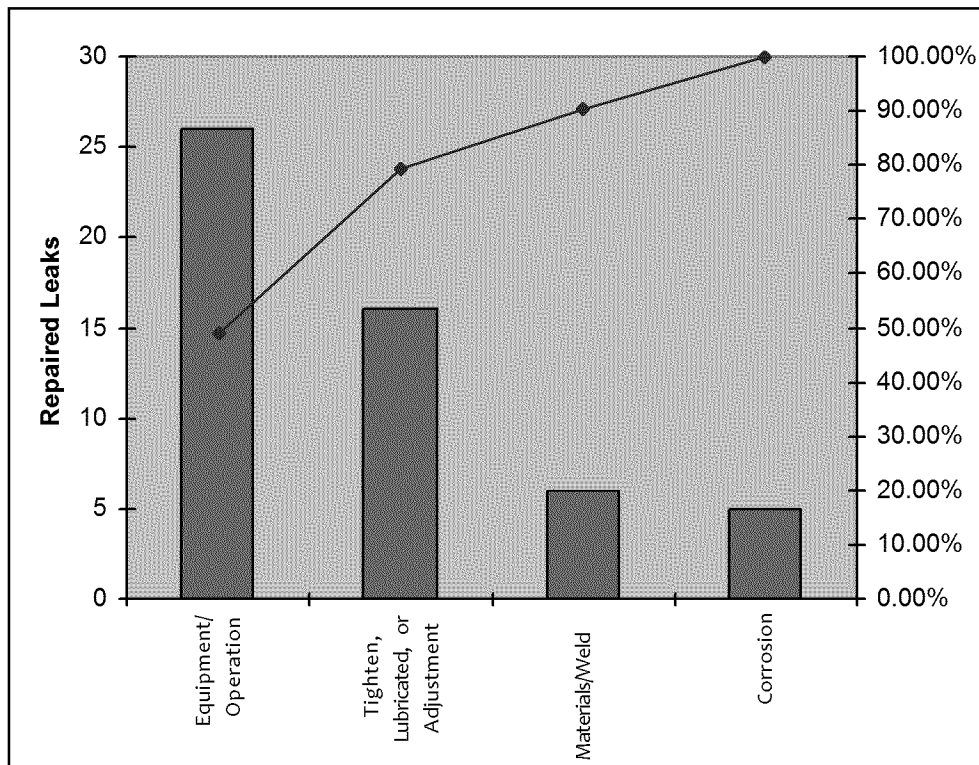
Figure 1 - Leaks by Cause

Figure 1 below conveys the same data in chart form. The chart displays the 53 leaks from the category with the highest number of leaks to the category with the lowest number of leaks. The y-axis to the left of the chart identifies the number of leaks per category. The y-axis to the right of the chart identifies the cumulative percentage of total leaks.

- * Equipment-related leaks were the leading cause of leaks repaired as part of this Accelerated Leak Survey. Equipment leaks occur on transmission appurtenances and include failures at threaded components, gaskets, valve packing, etc. PG&E found that most of these equipment leaks were associated with PG&E high pressure regulator (HPR) sets serving one to two customers and on facilities generally less than 1 inch in diameter.

- * The next highest cause of leaks fell within the category “Other.” These are leaks where PG&E performed an immediate response and repaired the leak by tightening, lubricating, or adjusting. The 16 leaks identified in this category could have been considered equipment leaks as they are associated with thread and lubrication components failure. These leaks are also ones that, as discussed below and in the attached expert consultant’s report, may not even have been reportable in the first place.¹³

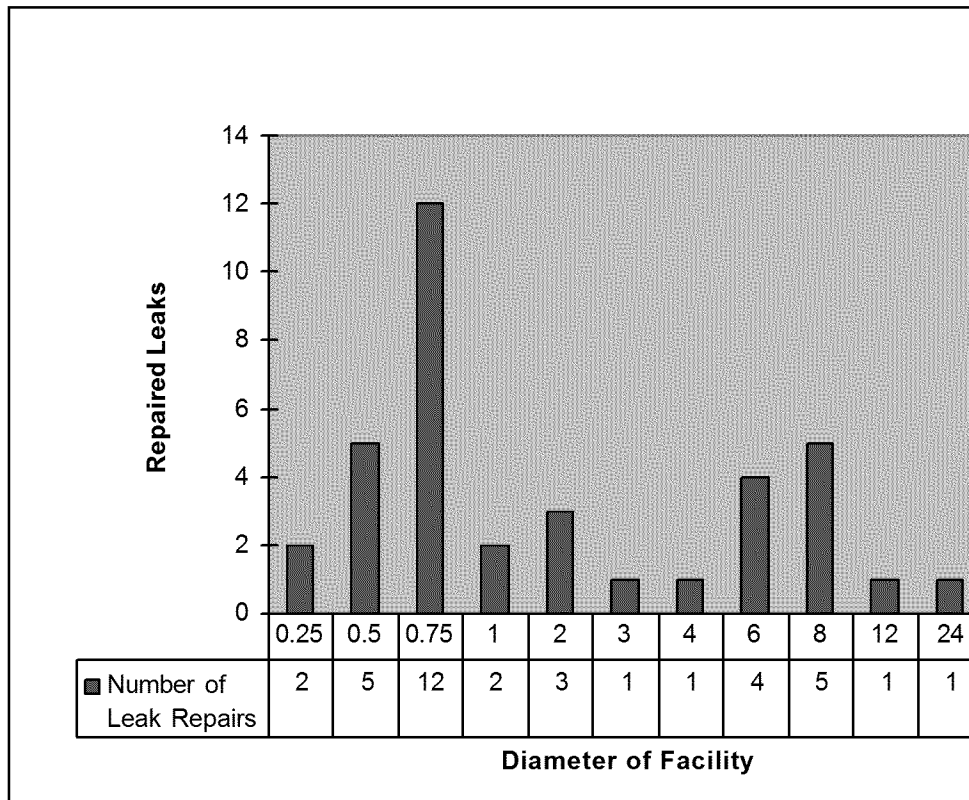
Figure 2 - Size of Facility

Reviewing the size of the facility where the leak occurs can provide insight on leaks where additional focus may be needed. Figure 2, below, includes all transmission/gathering leaks with the exception of leaks repaired by tightening, lubrication, or adjustment.

As shown by Figure 2 above, ninety-five percent of the leaks found and repaired (excluding the 16 leaks repaired by tightening, lubrication or adjustment) were on facilities less than 12 inches in diameter. Two leaks were found on facilities equal to or greater than 12 inches in diameter, as follows:

- * On October 6, 2010, an indication of a potential leak was identified via the Accelerated Leak Survey on Line 153 in the City of Oakland. The leak was caused by external corrosion along a welded seam of pipe. A 25-foot section of 24 inch diameter pipeline was removed and replaced to complete the repair.

-
- * On October 11, 2010, an indication of a potential leak was identified via the Accelerated Leak Survey on Line 177A near PG&E's Cumming Creek Pressure Limiting Station near Fortuna in Humboldt County. The leak was found to be caused by a pin-hole within a girth weld. A sleeve was welded into place to complete the repair.
