**PACIFIC GAS AND ELECTRIC COMPANY'S SUPPORTING
INFORMATION FOR LIFTING OPERATING PRESSURE
RESTRICTIONS ON THE SUCTION SIDE OF TOPOCK
COMPRESSOR STATION**

Topock Compressor Station and Pipeline River Crossings

Topock Compressor Station

Repair actions taken as a result of pressure testing

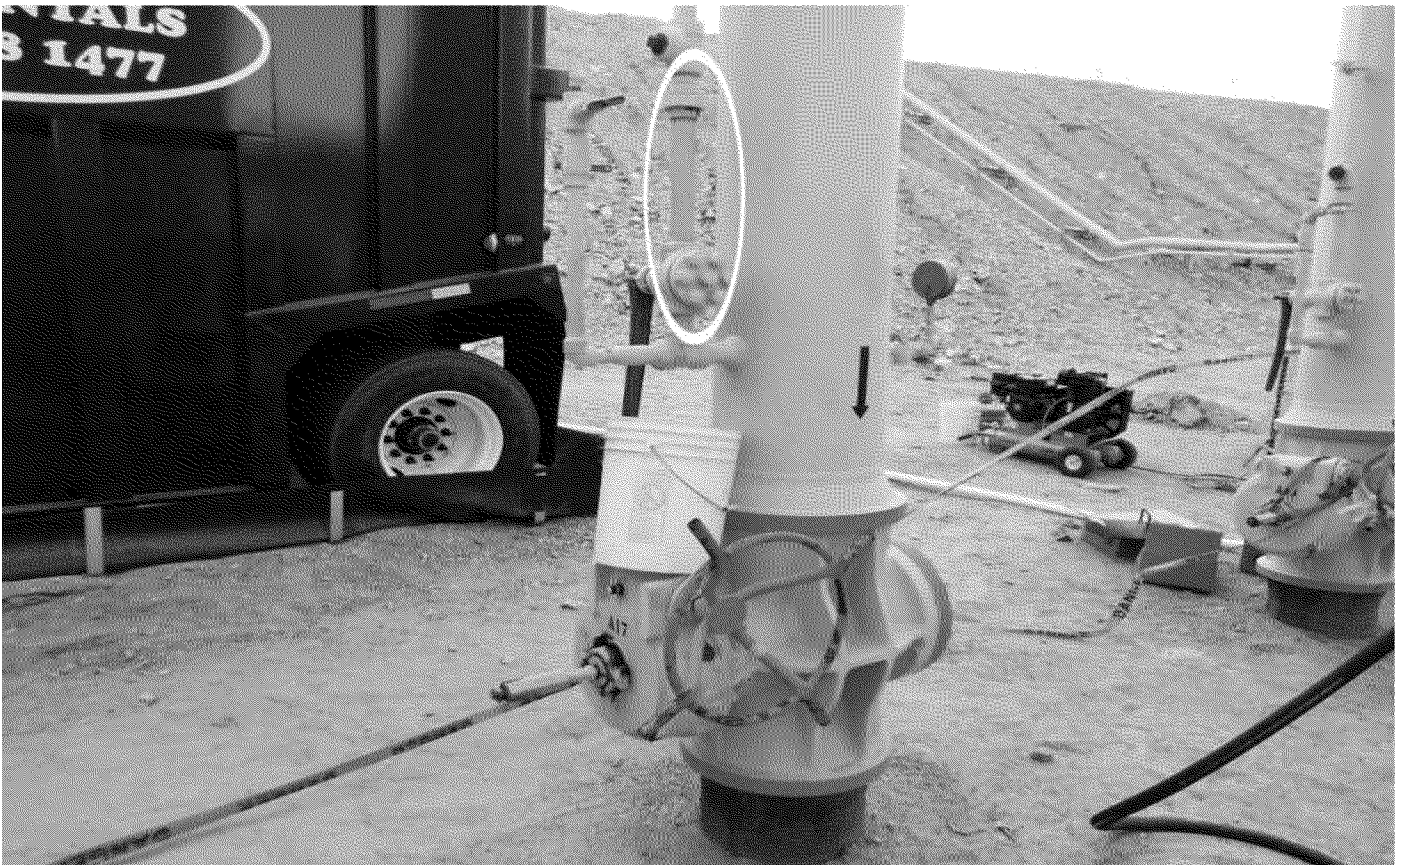
4,5	Scrubber 3A line - Union above relief valve and 16" flanged connection at scrubber inlet.	Leaking water captured in bucket and kiddie pool, respectively. Union and 16" flanged connections torqued.
6,7,8	Scrubber 4A line - 16" orifice meter, sight glass union, and vertical 16" flanged connection at top of scrubber.	Leaking water captured in bucket and kiddie pool. Orifice meter existing gasket removed and new gasket installed. Union and 16" flanged connection torqued.
8,9	Scrubber 5A line - 16" vertical flanged connection at top of scrubber, sight glass union	Leaking water captured in a bucket. Union and 16" flanged connection torqued.
A-3 Test		
10	K5 suction valve - flanged connection	Leaking water captured in a kiddie pool. Flanged connection torqued.

Photo #4 – 3A Scrubber line relief valve union

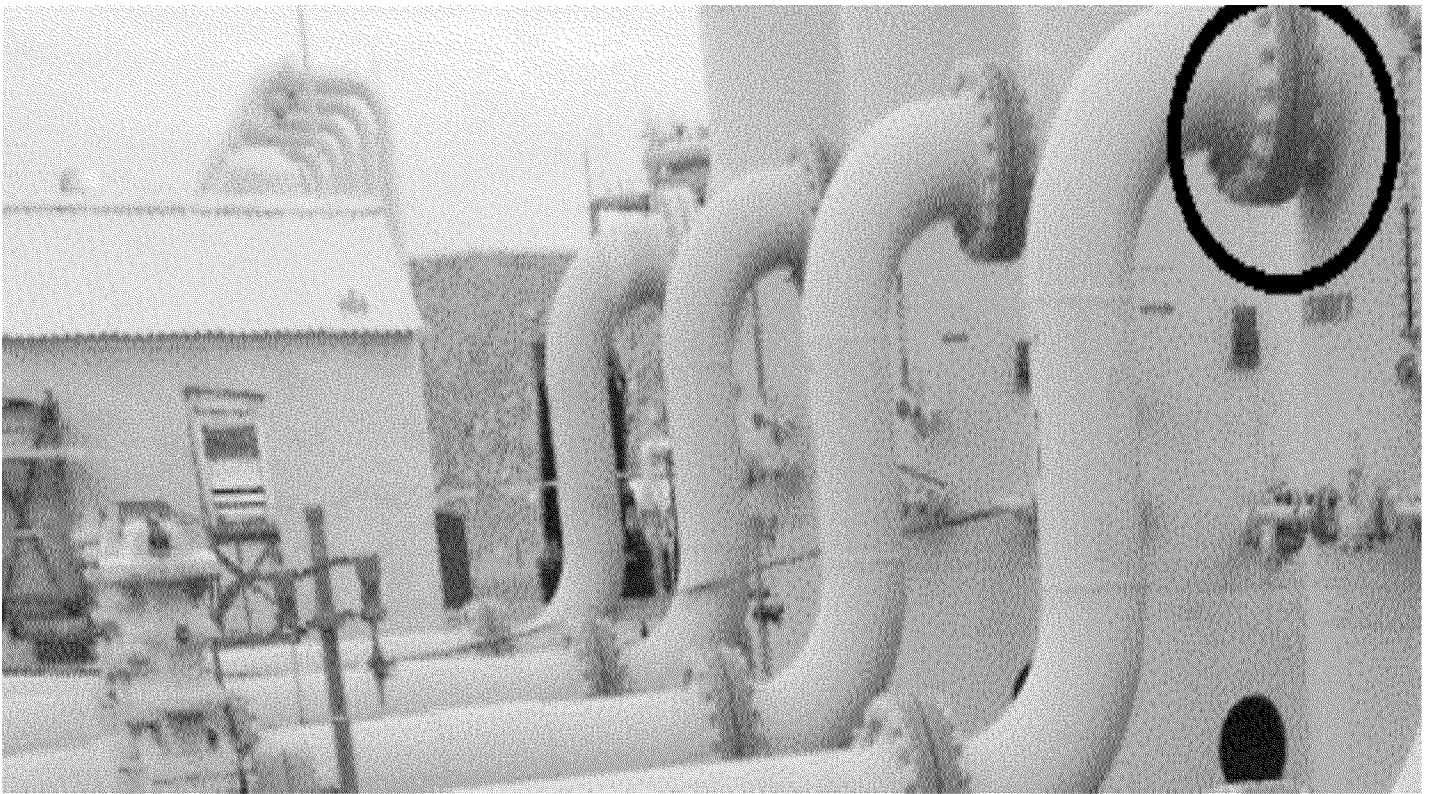
Photo #5 – 3A Scrubber line 16” flanged connection

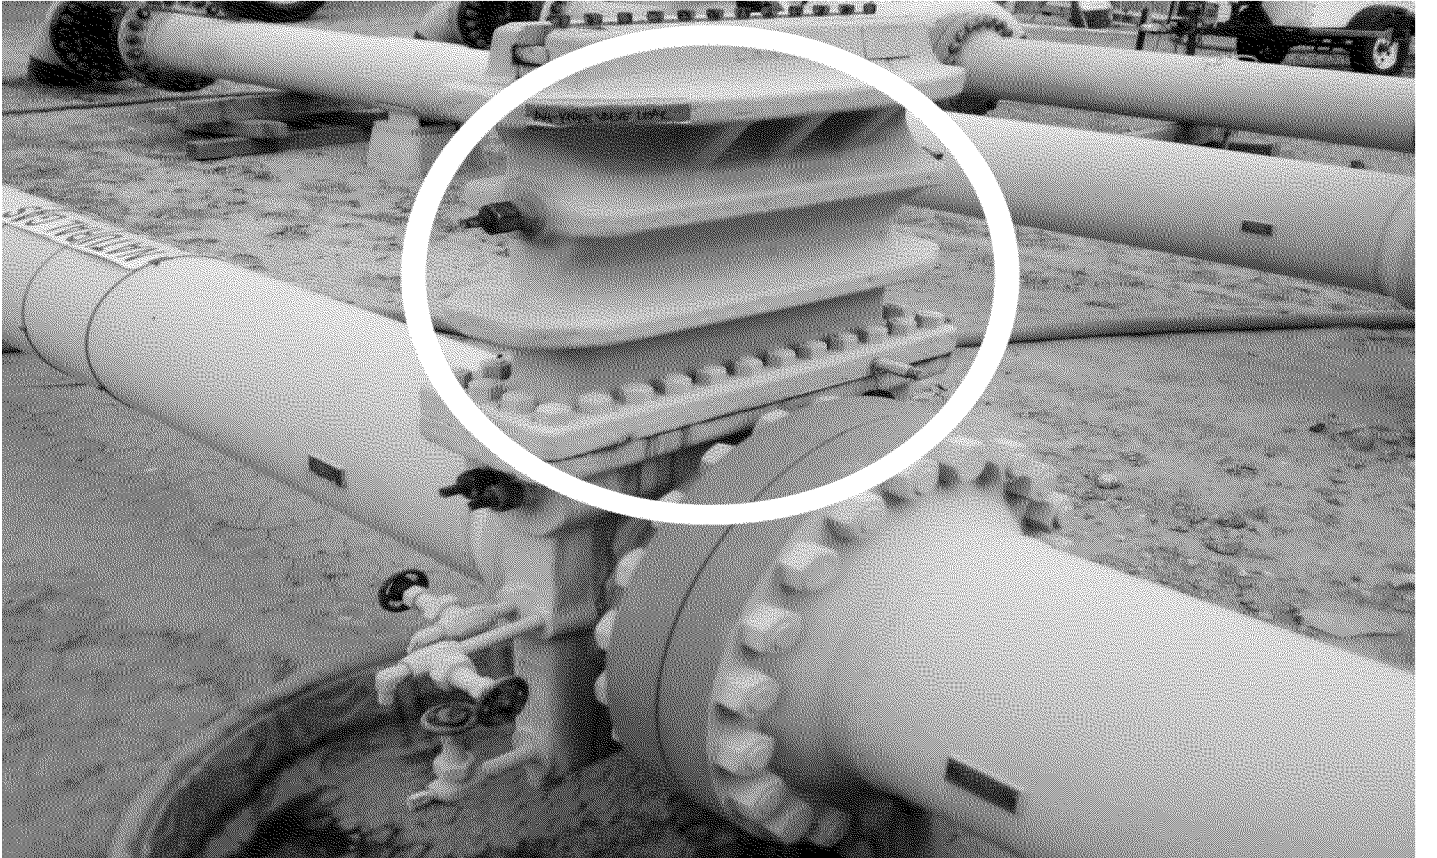
Photo #6 – 4A Scrubber line orifice meter

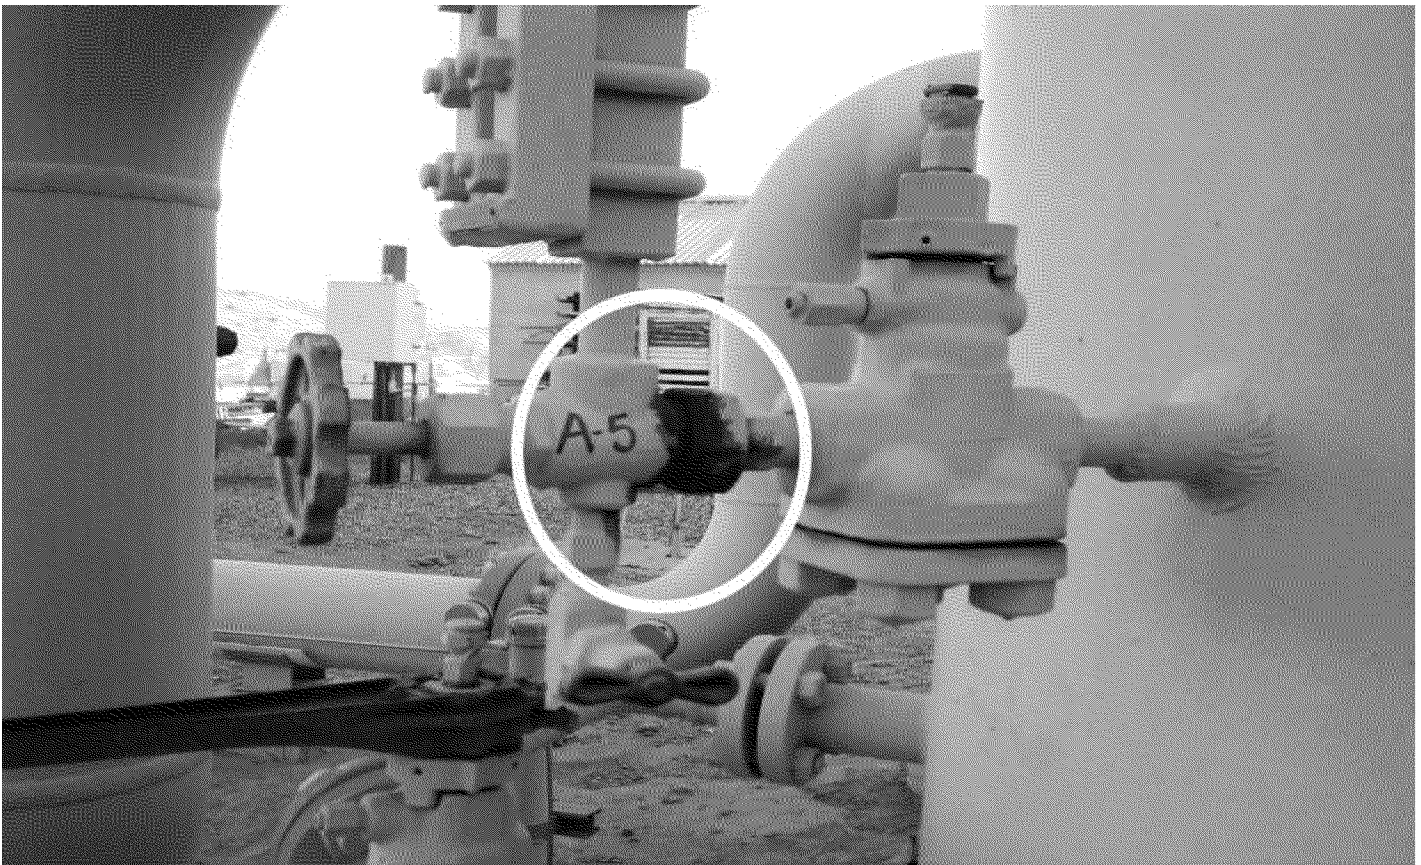
Photo #9 – 5A Scrubber line sight glass union

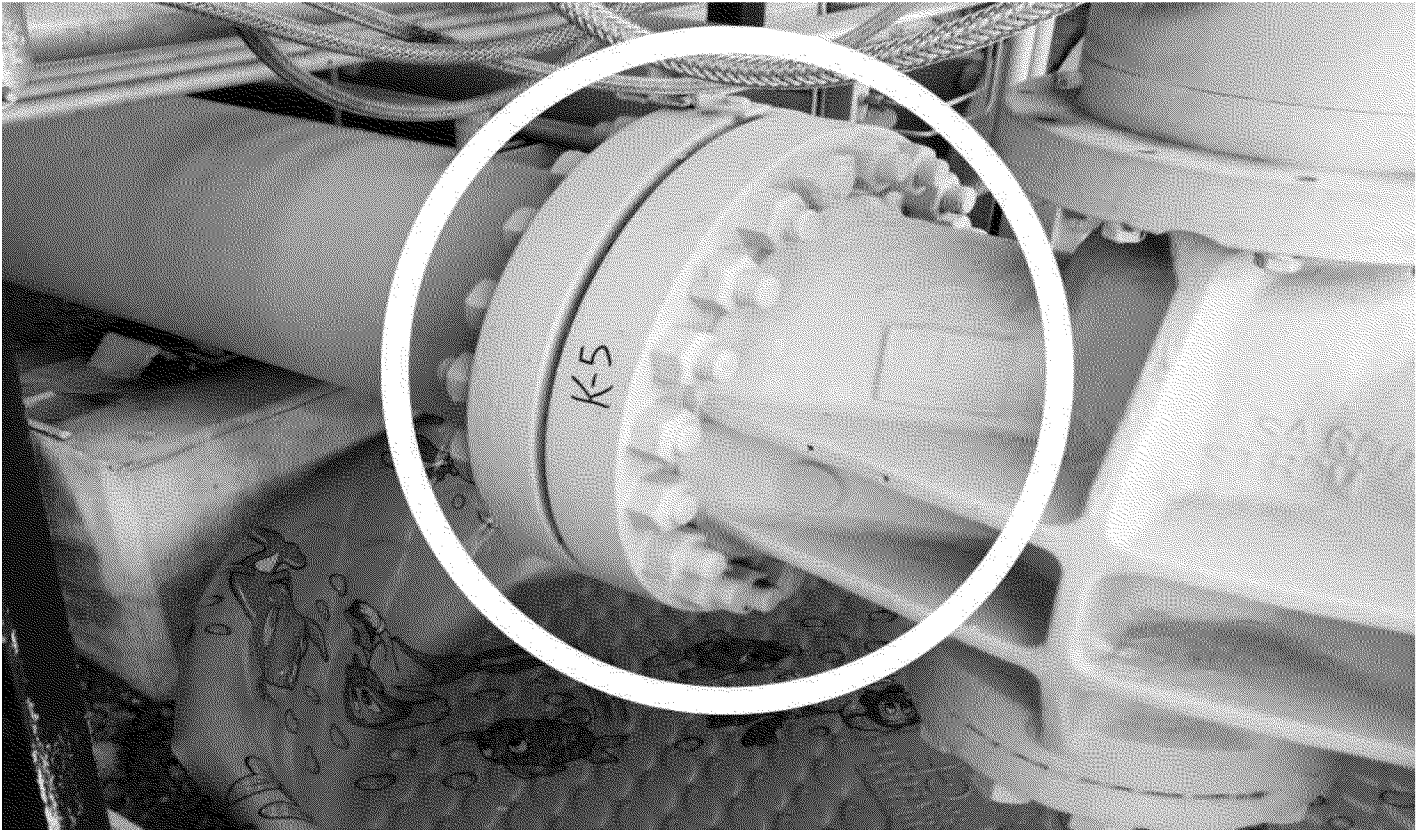
Photo #10 - K5 suction valve flanged connection

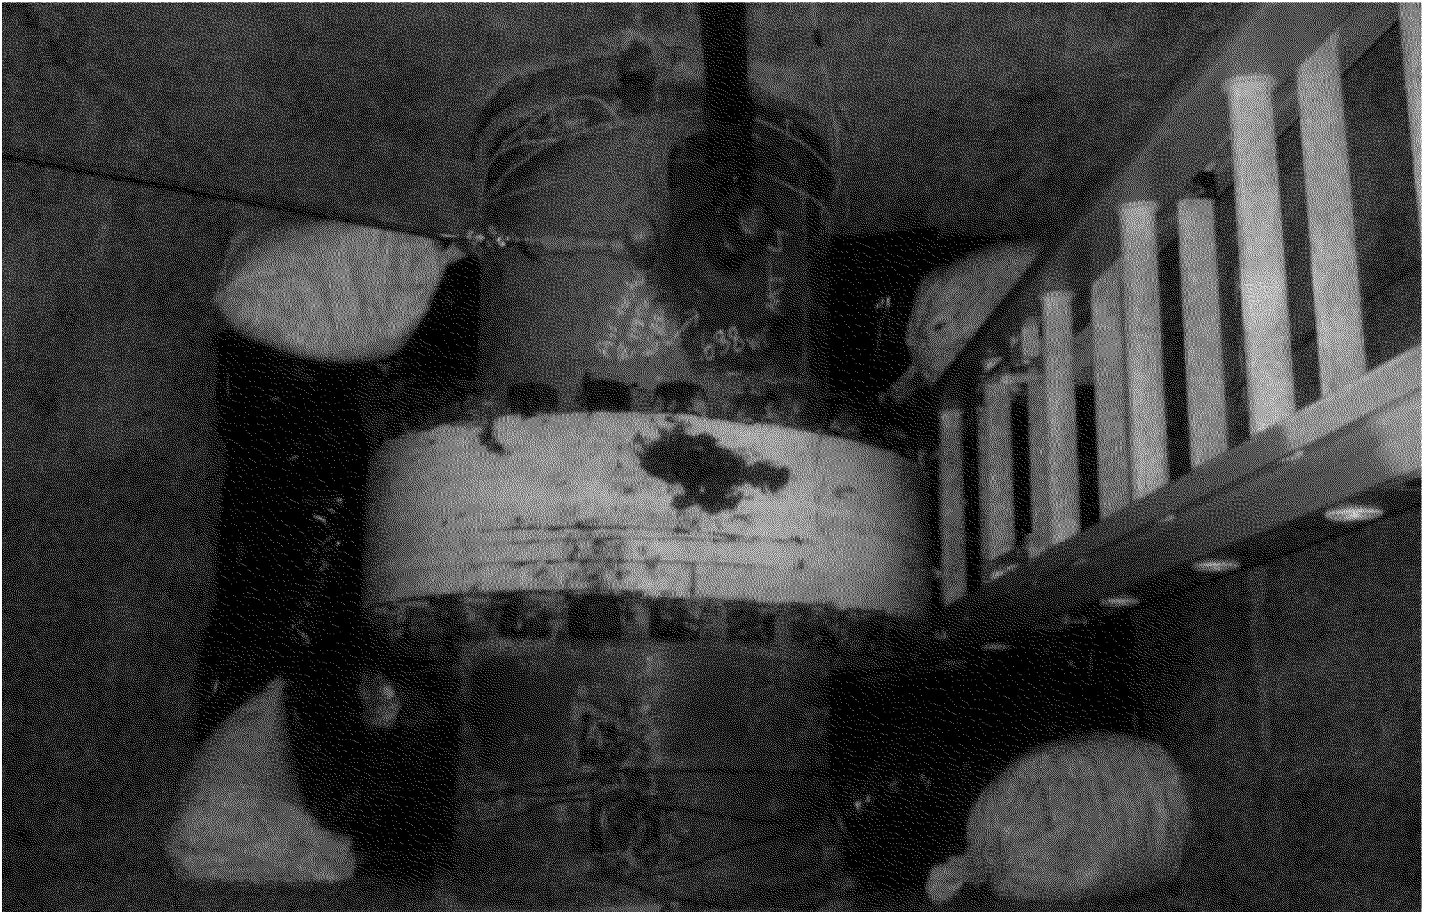
Topock Suction Piping Hydrotest leak and repair summary "B side testing"		AECOM
Photo #	Location	Methodology of capturing leaks and repairs done
B-1 Test		
11	B1 valve insulating flange	Leaking water captured in a kiddie pool. Insulating flange spread apart, existing gaskets removed and new gasket installed.
12	B3 valve insulating flange	Leaking water captured in a kiddie pool. Insulating flange spread apart, existing gaskets removed and new gasket installed.
B-2 Tests		
13	Scrubber 1B line – 16" flanged connection east of B7 valve, orifice meter	Leaking water captured in a kiddie pool. 16" flanged connection gasket removed and new gasket installed. Orifice meter existing gasket removed and new gasket installed.
13,14	Scrubber 2B line - 16" flanged connection immediately after orifice meter	Leaking water captured in kiddie pool. Existing gasket removed and replaced with new gasket. Scrubber 2B line subsequently included in B2-3 hydrotest.

Photo #12 – B3 valve insulating flange

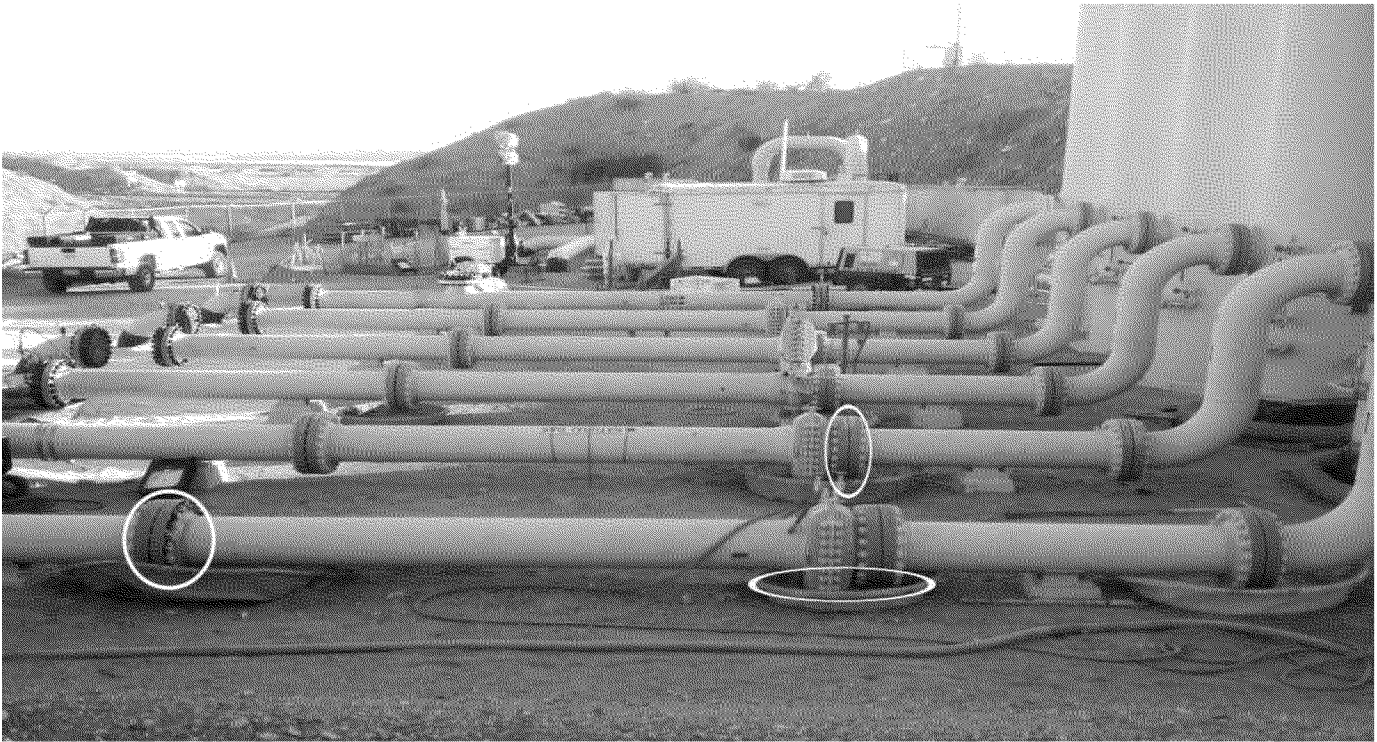
Photo #13 – 1B and 2B Scrubber lines flanged connections and orifice meter

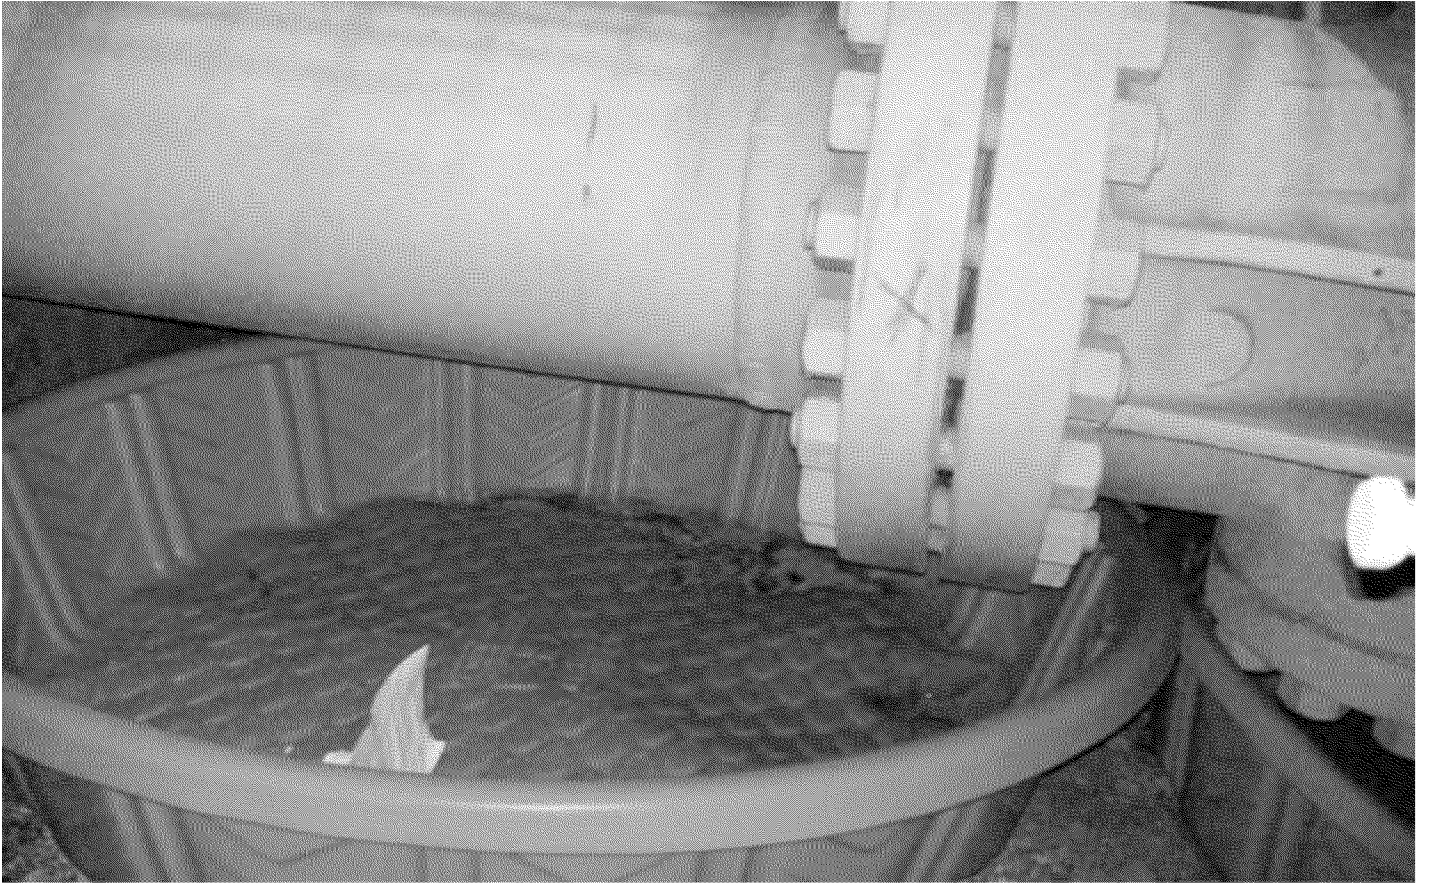
15	Scrubber 5B line - 16" vertical flanged connection at top of scrubber	Water captured in plastic containment at base of scrubber. Existing gasket removed and replaced with new gasket. Scrubber 5B line subsequently included in B2-3 hydrotest.
15	Scrubber 6B line - 16" horizontal flanged connection at top of scrubber	Water captured in plastic containment at base of scrubber. 16" flanged connection torqued.
B-3 Test		
16	K9 suction valve - flanged connection	Flanged connection torqued.

Photo #16 - K9 suction valve flanged connection
