**PACIFIC GAS AND ELECTRIC COMPANY'S SUPPORTING
INFORMATION FOR LIFTING OPERATING PRESSURE
RESTRICTIONS ON THE SUCTION SIDE OF TOPOCK
COMPRESSOR STATION**

**PACIFIC GAS AND ELECTRIC COMPANY'S SUPPORTING
INFORMATION FOR LIFTING OPERATING PRESSURE
RESTRICTIONS ON THE SUCTION SIDE OF
TOPOCK COMPRESSOR STATION**

**ERRATA TO SUPPORTING INFORMATION
FILED: SEPTEMBER 12, 2011**

Repair actions taken as a result of pressure testing

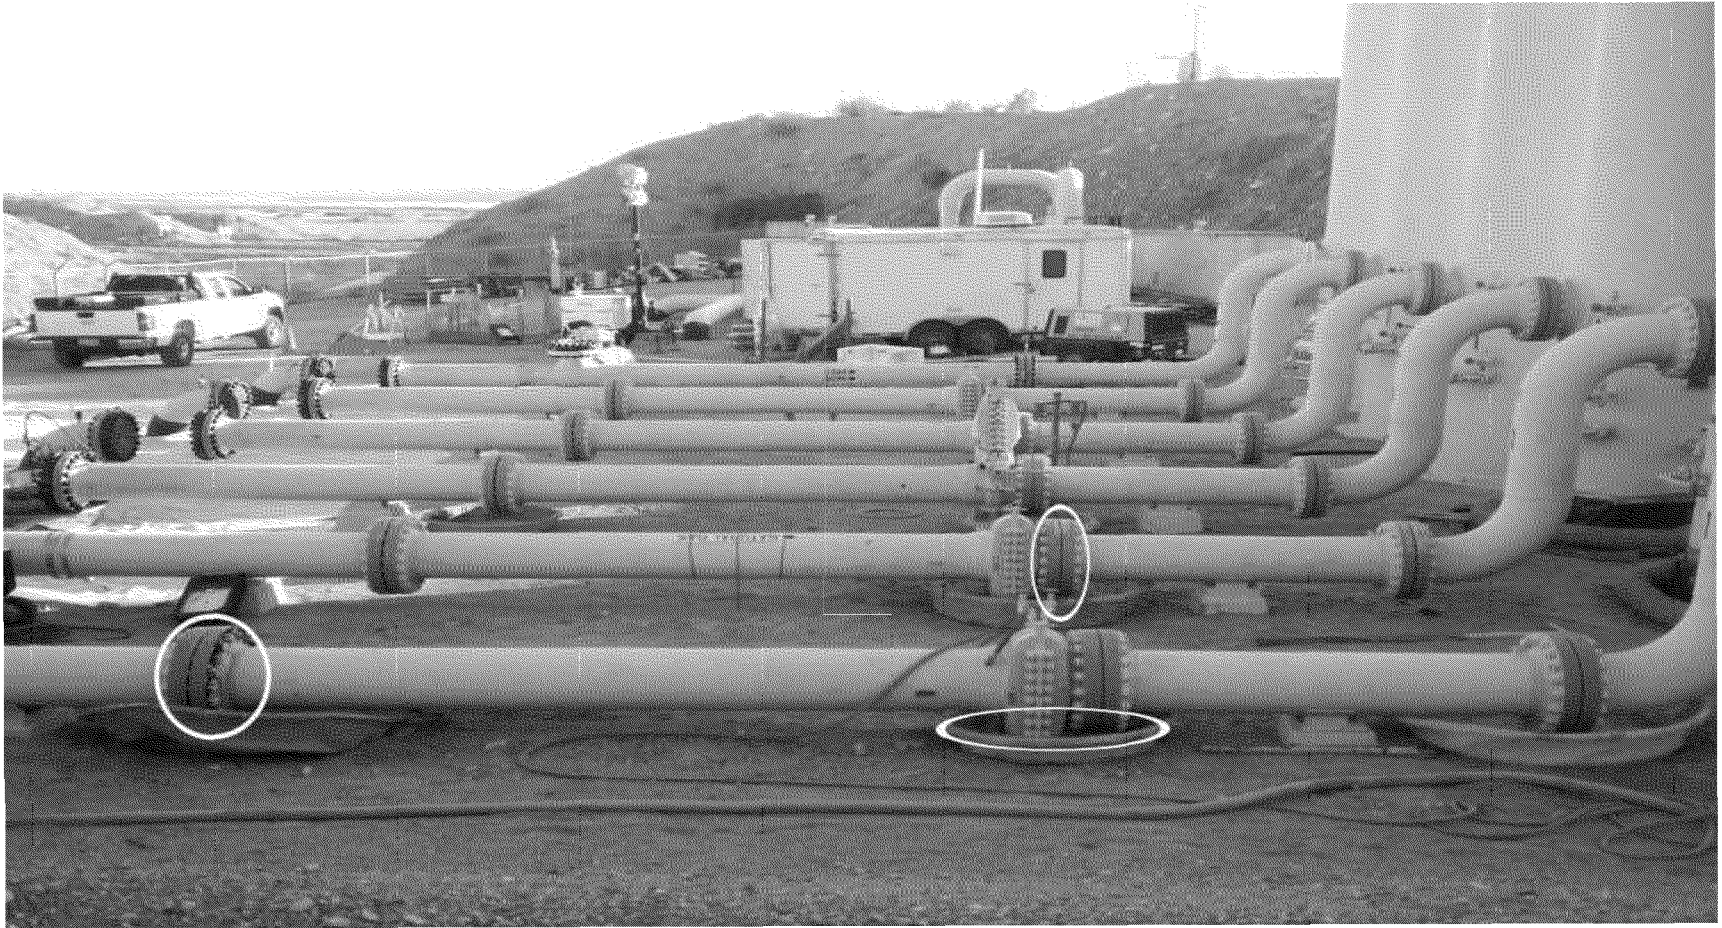
Topock Compressor Station HydroTest "B" section
(Flanged connections)

On the reverse side of the aerial photograph is a picture showing the flanged connections in Section "B" of the Topock hydrostatic test.

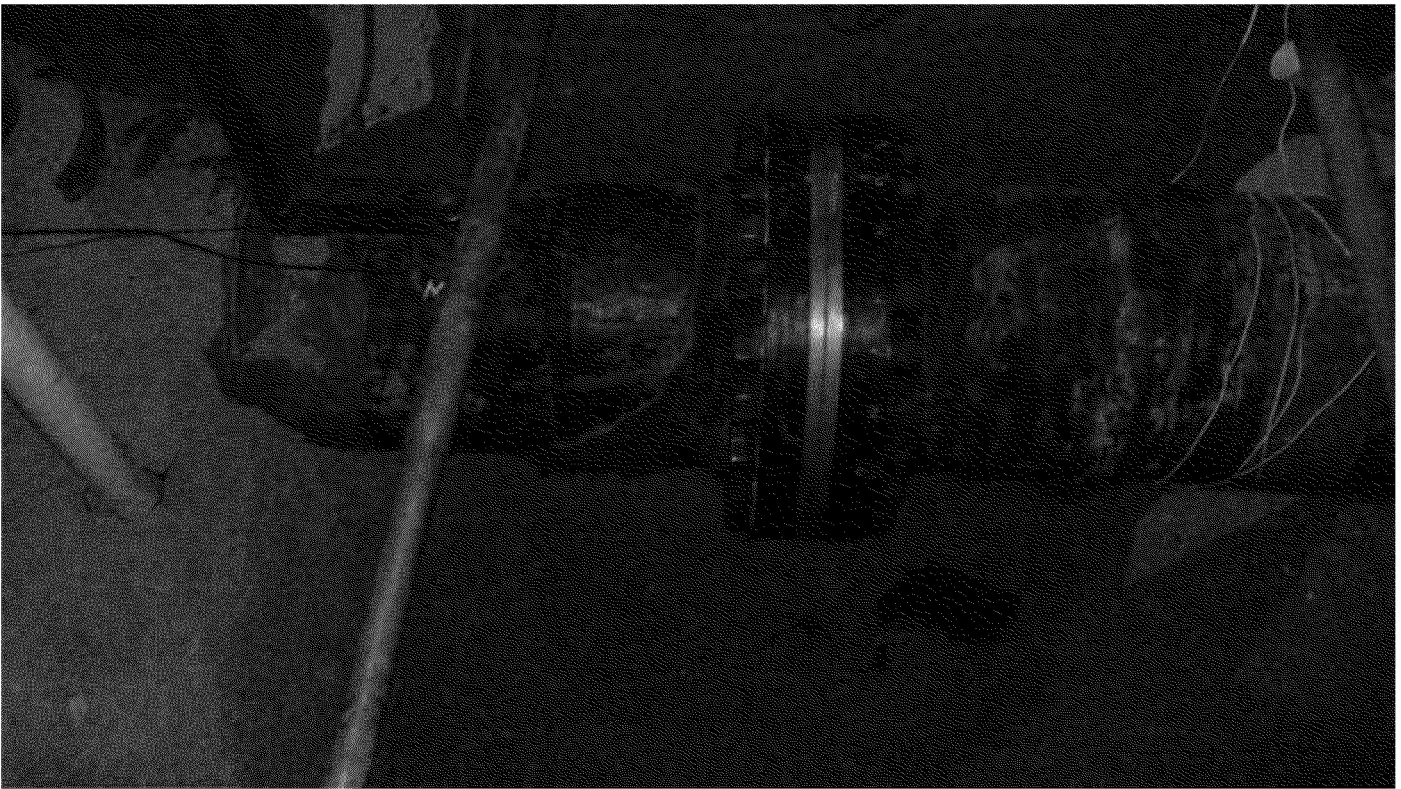
Photo #1 - A1 Valve Insulating flange

Topock Suction Piping Hydrotest leak and repair summary –“A side testing”		AECOM
Photo #	Location	Methodology of capturing leaks and repairs done
A-1 Test		
1	A1 Valve insulating flange	Leak discovered 1 hr 15 min into test as insulating flange was partially excavated. Leak from bottom of insulating flange. Excavation during test to pursue leak source. Leaking water channeled into kiddie pool and pumped back into Baker tanks. Insulating flange spread apart, existing gaskets removed and new gasket installed.
A-2 Tests		
2	Scrubber 1A line - 16" flanged connection immediately after meter element	Leaking water captured in kiddie pool. Existing gasket removed and replaced with new gasket. Scrubber 1A line subsequently included in A2-2 hydrotest.
3	Scrubber 2A line - 16" flanged connection immediately after meter element	Leaking water captured in kiddie pool. Existing gasket removed and replaced with new gasket.

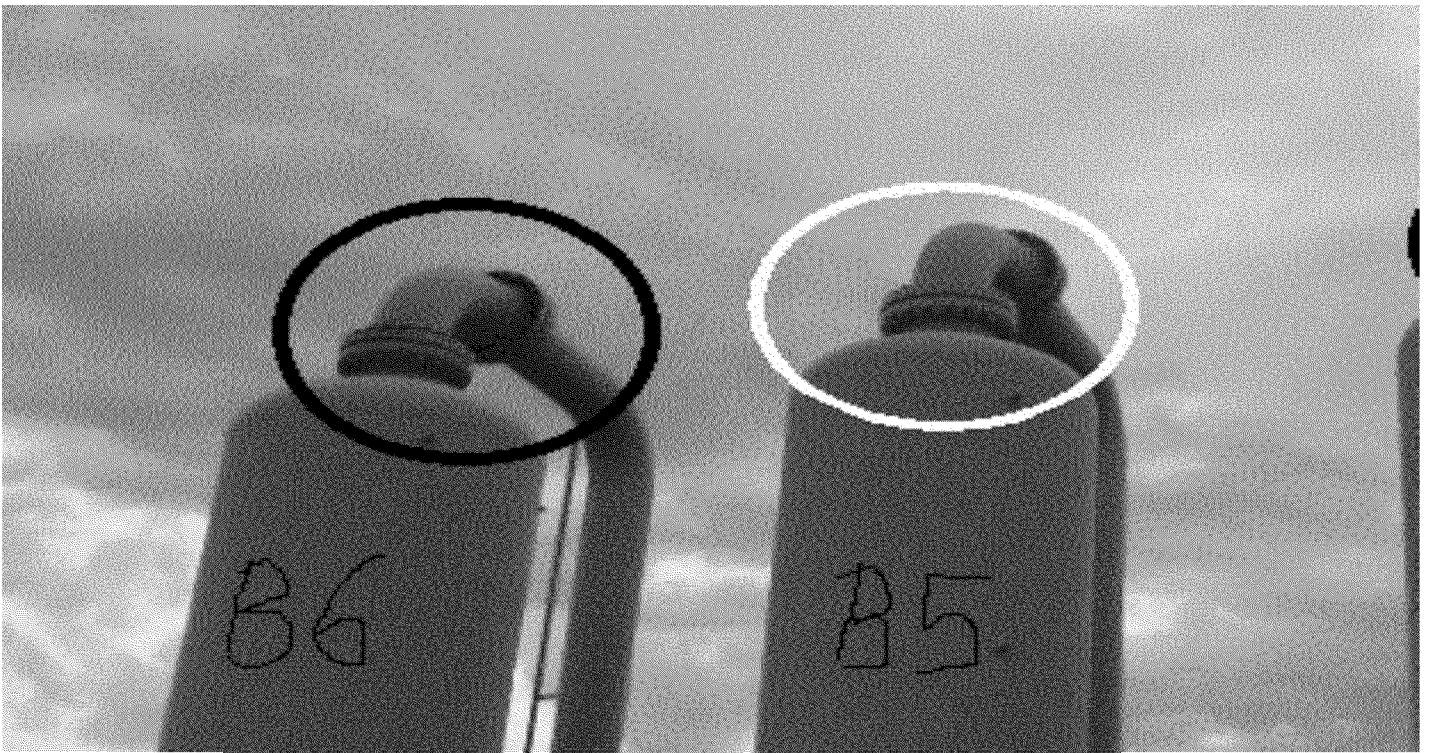
Photo #15 – 5B and 6B Scrubber lines 16” flanged connections

15	Scrubber 5B line - 16" vertical flanged connection at top of scrubber	Water captured in plastic containment at base of scrubber. Existing gasket removed and replaced with new gasket. Scrubber 5B line subsequently included in B2-3 hydrotest.
15	Scrubber 6B line - 16" horizontal flanged connection at top of scrubber	Water captured in plastic containment at base of scrubber. 16" flanged connection torqued.
B-3 Test		
16	K9 suction valve - flanged connection	Flanged connection torqued.
