**PACIFIC GAS AND ELECTRIC COMPANY'S SUPPORTING  
INFORMATION FOR LIFTING OPERATING PRESSURE  
RESTRICTIONS ON THE SUCTION SIDE OF TOPOCK  
COMPRESSOR STATION**

**PACIFIC GAS AND ELECTRIC COMPANY'S SUPPORTING  
INFORMATION FOR LIFTING OPERATING PRESSURE  
RESTRICTIONS ON THE SUCTION SIDE OF  
TOPOCK COMPRESSOR STATION**

## Topock Compressor Station

### Repair actions taken as a result of pressure testing

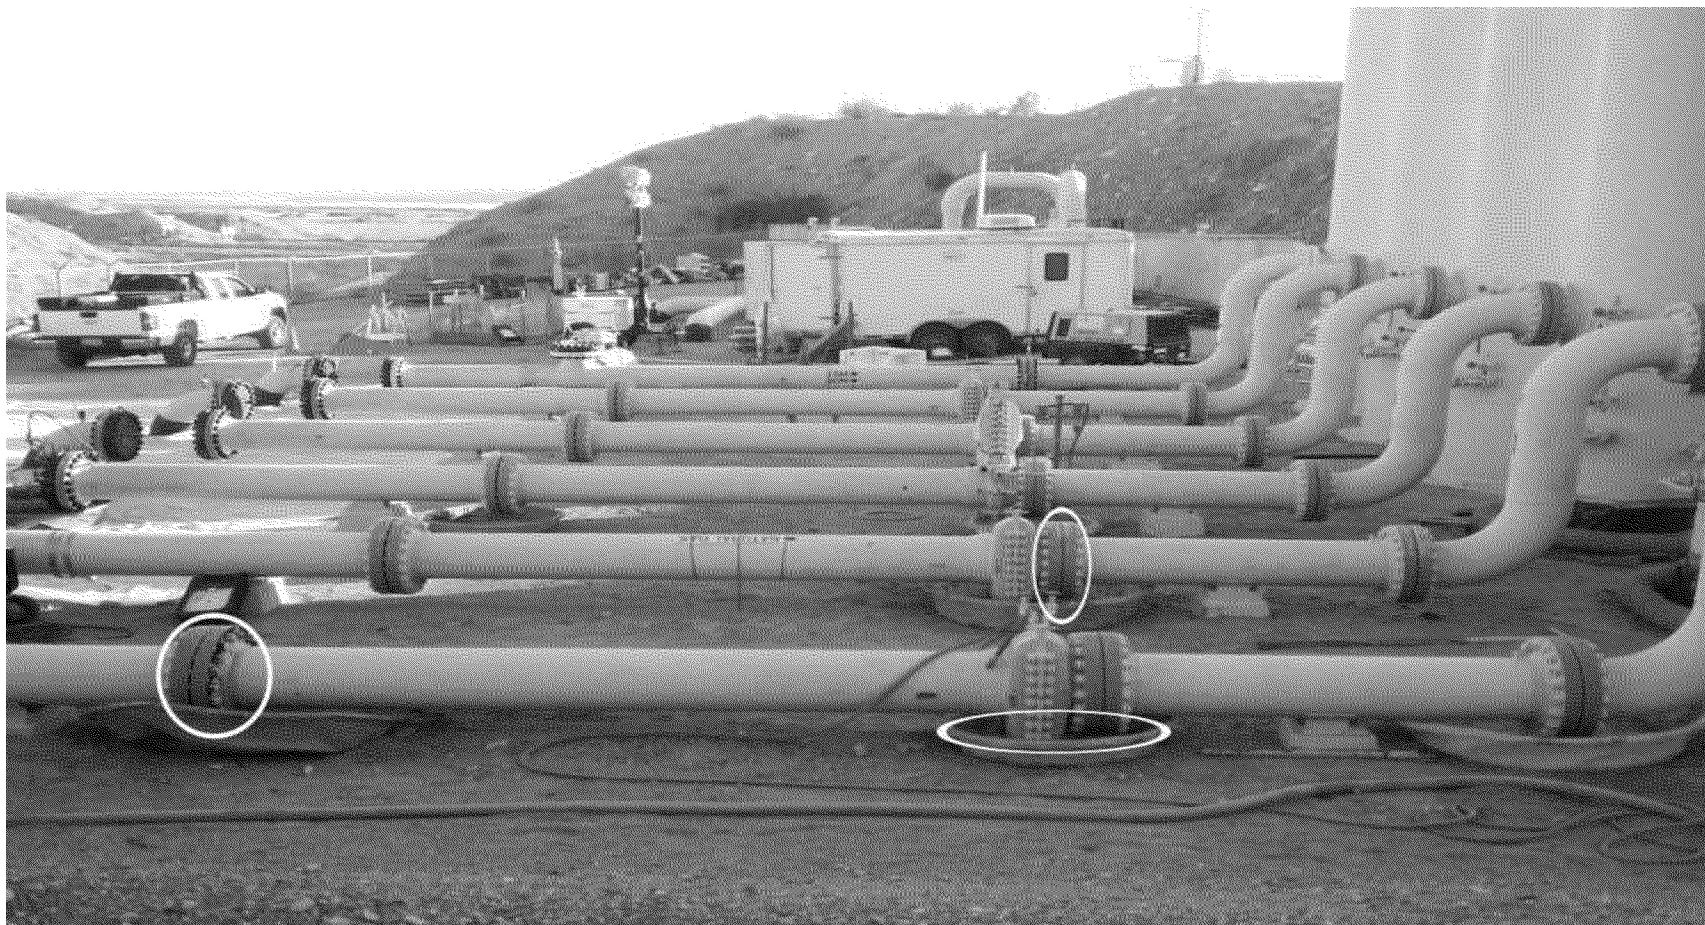
On the reverse side of the aerial photograph is a picture showing the flanged connections in Section "B" of the Topock hydrostatic test.

**Topock Compressor Station HydroTest "B" section**  
*(Flanged connections)*

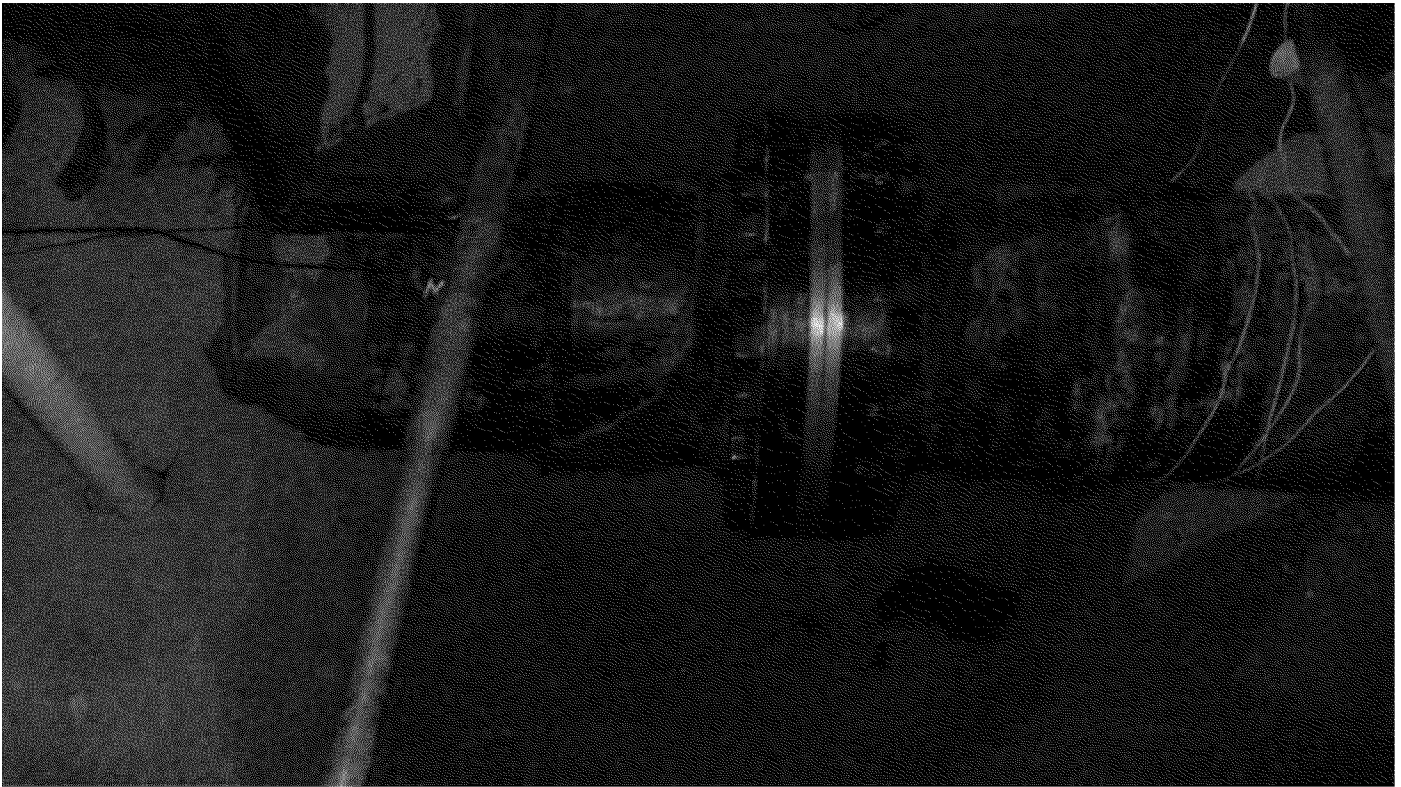
Topock Suction Piping Hydrotest leak and repair summary –“A side testing”		AECOM
Photo #	Location	Methodology of capturing leaks and repairs done
<b>A-1 Test</b>		
1	A1 Valve insulating flange	Leak discovered 1 hr 15 min into test as insulating flange was partially excavated. Leak from bottom of insulating flange. Excavation during test to pursue leak source. Leaking water channeled into kiddie pool and pumped back into Baker tanks. Insulating flange spread apart, existing gaskets removed and new gasket installed.
<b>A-2 Tests</b>		
2	Scrubber 1A line - 16" flanged connection immediately after meter element	Leaking water captured in kiddie pool. Existing gasket removed and replaced with new gasket. Scrubber 1A line subsequently included in A2-2 hydrotest.
3	Scrubber 2A line - 16" flanged connection immediately after meter element	Leaking water captured in kiddie pool. Existing gasket removed and replaced with new gasket.

Photo #1 - A1 Valve Insulating flange

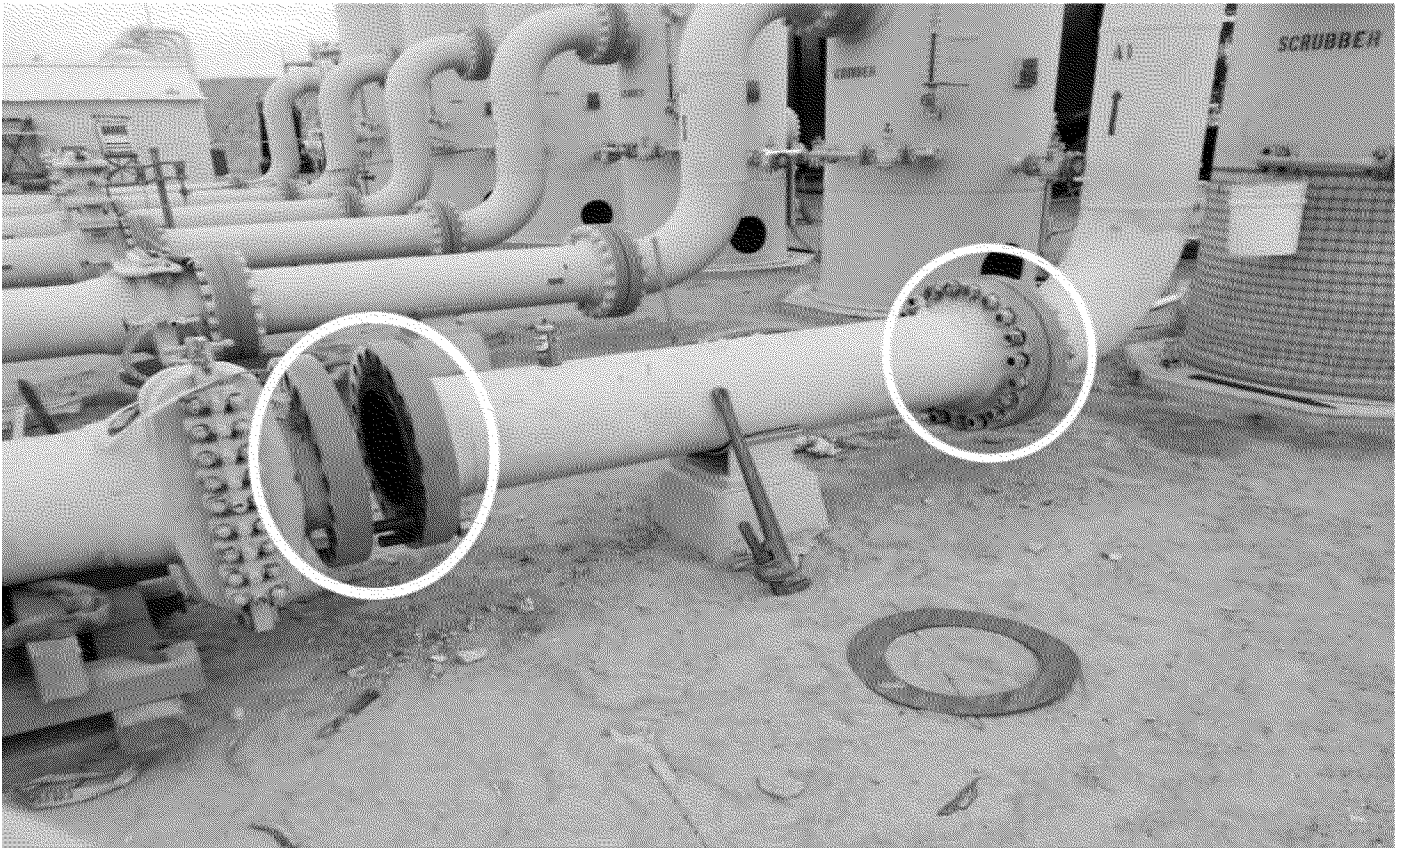
Photo #2 – 1A Scrubber line 16” flanged connection

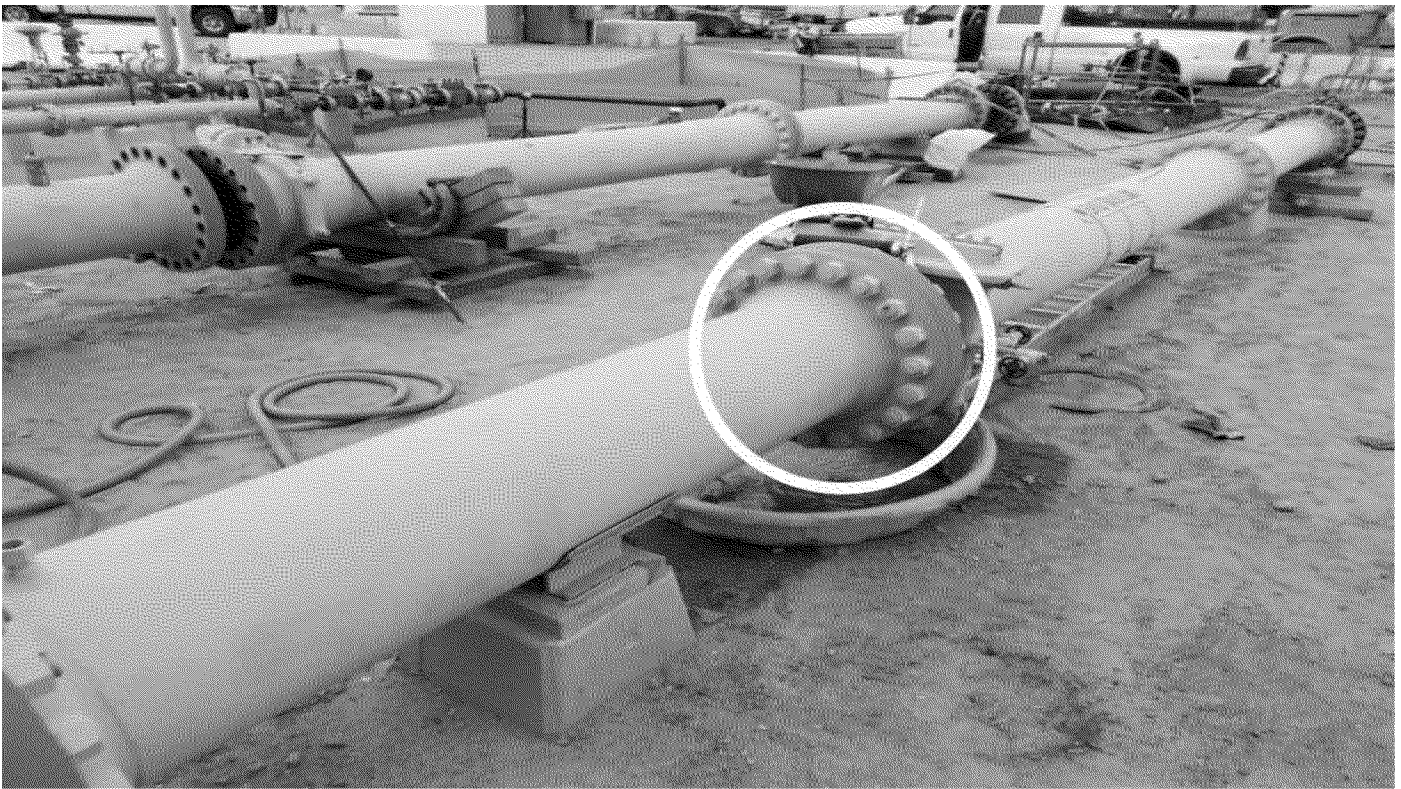
Photo # 3 – 2A Scrubber line 16” flanged connection

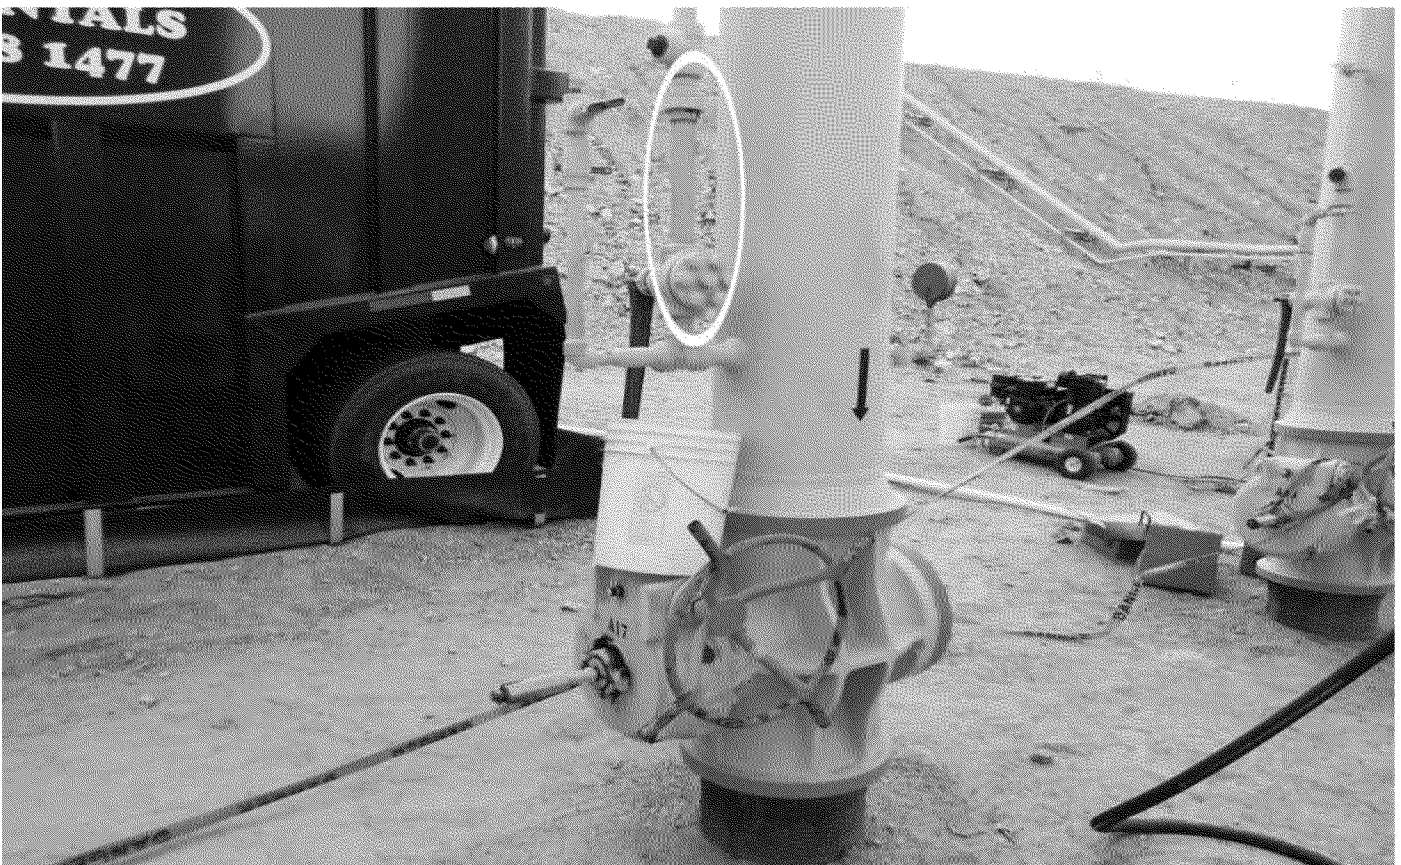
4,5	Scrubber 3A line - Union above relief valve and 16" flanged connection at scrubber inlet.	Leaking water captured in bucket and kiddie pool, respectively. Union and 16" flanged connections torqued.
6,7,8	Scrubber 4A line - 16" orifice meter, sight glass union, and vertical 16" flanged connection at top of scrubber.	Leaking water captured in bucket and kiddie pool. Orifice meter existing gasket removed and new gasket installed. Union and 16" flanged connection torqued.
8,9	Scrubber 5A line - 16" vertical flanged connection at top of scrubber, sight glass union	Leaking water captured in a bucket. Union and 16" flanged connection torqued.
<b>A-3 Test</b>		
10	K5 suction valve - flanged connection	Leaking water captured in a kiddie pool. Flanged connection torqued.

Photo #4 – 3A Scrubber line relief valve union

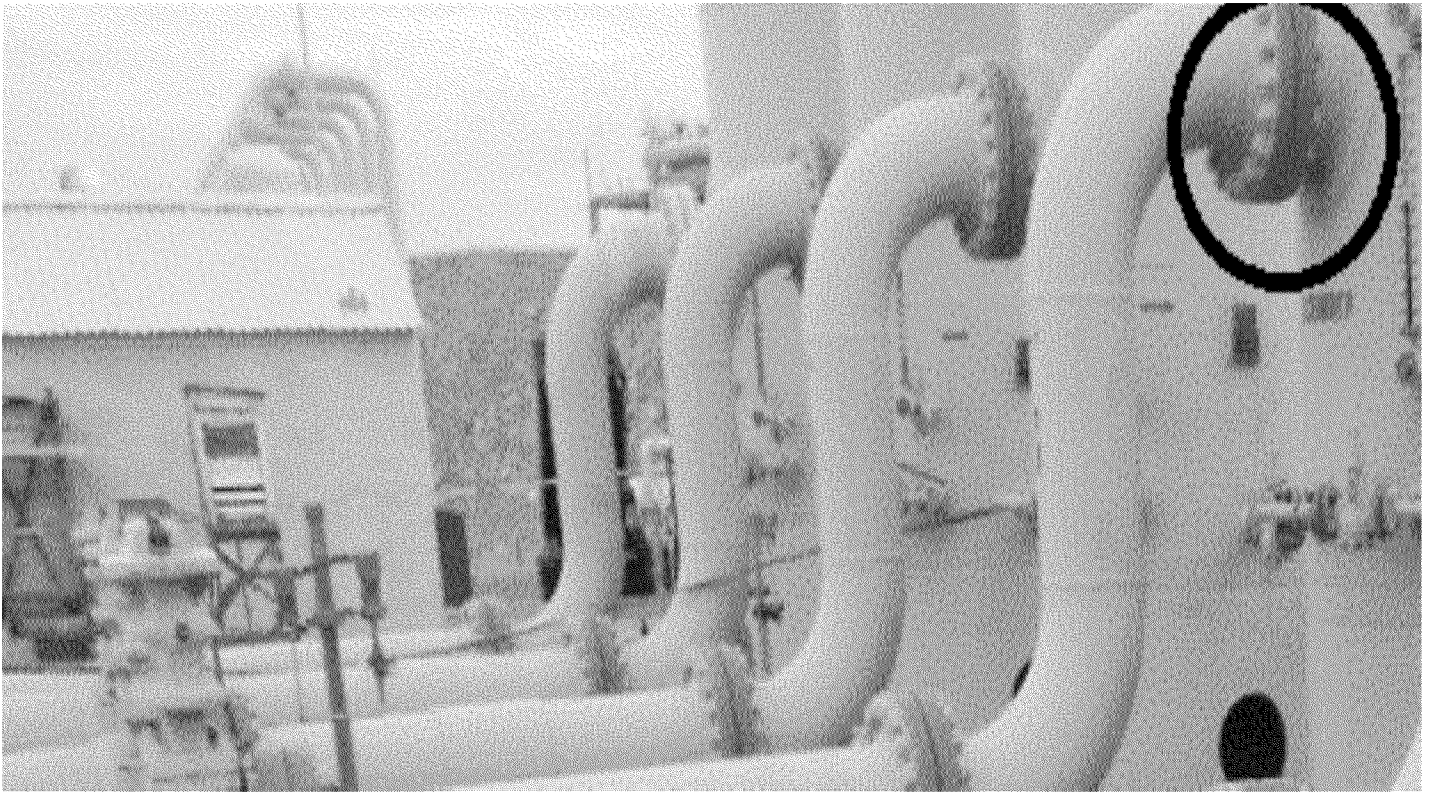
Photo #5 – 3A Scrubber line 16” flanged connection

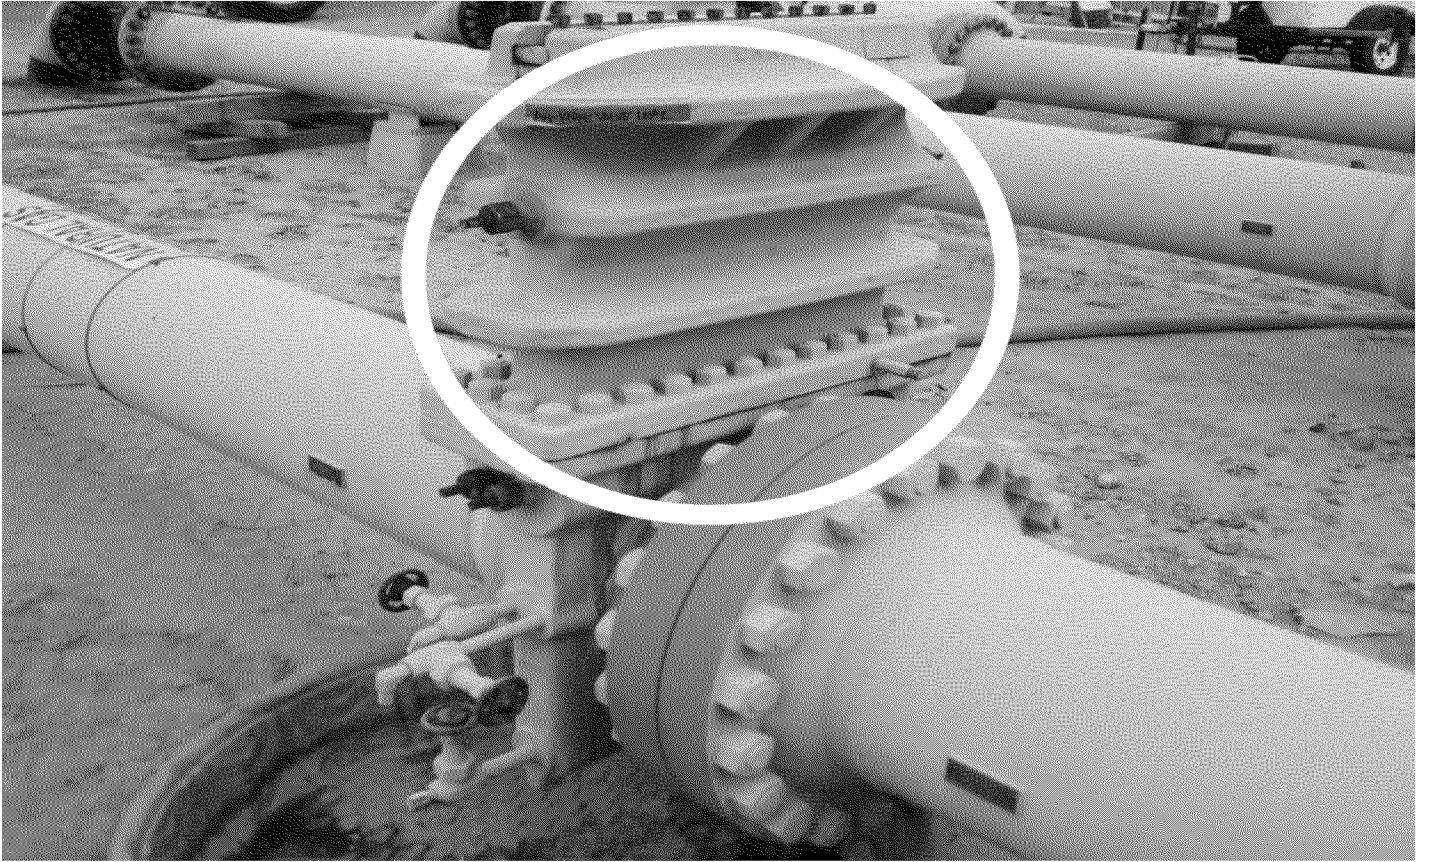
Photo #6 – 4A Scrubber line orifice meter

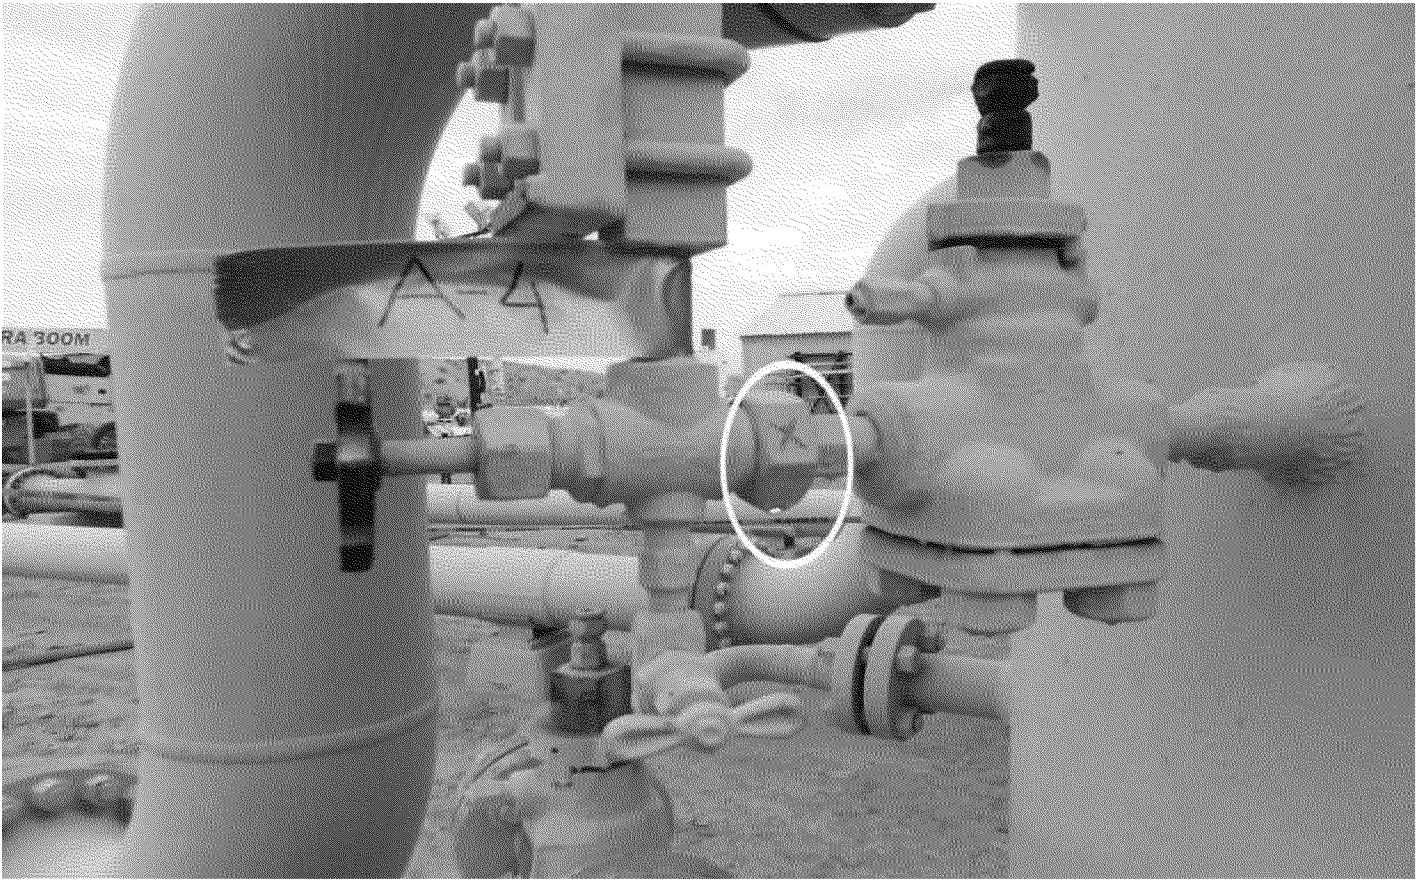
Photo #7 – 4A Scrubber line sight glass union

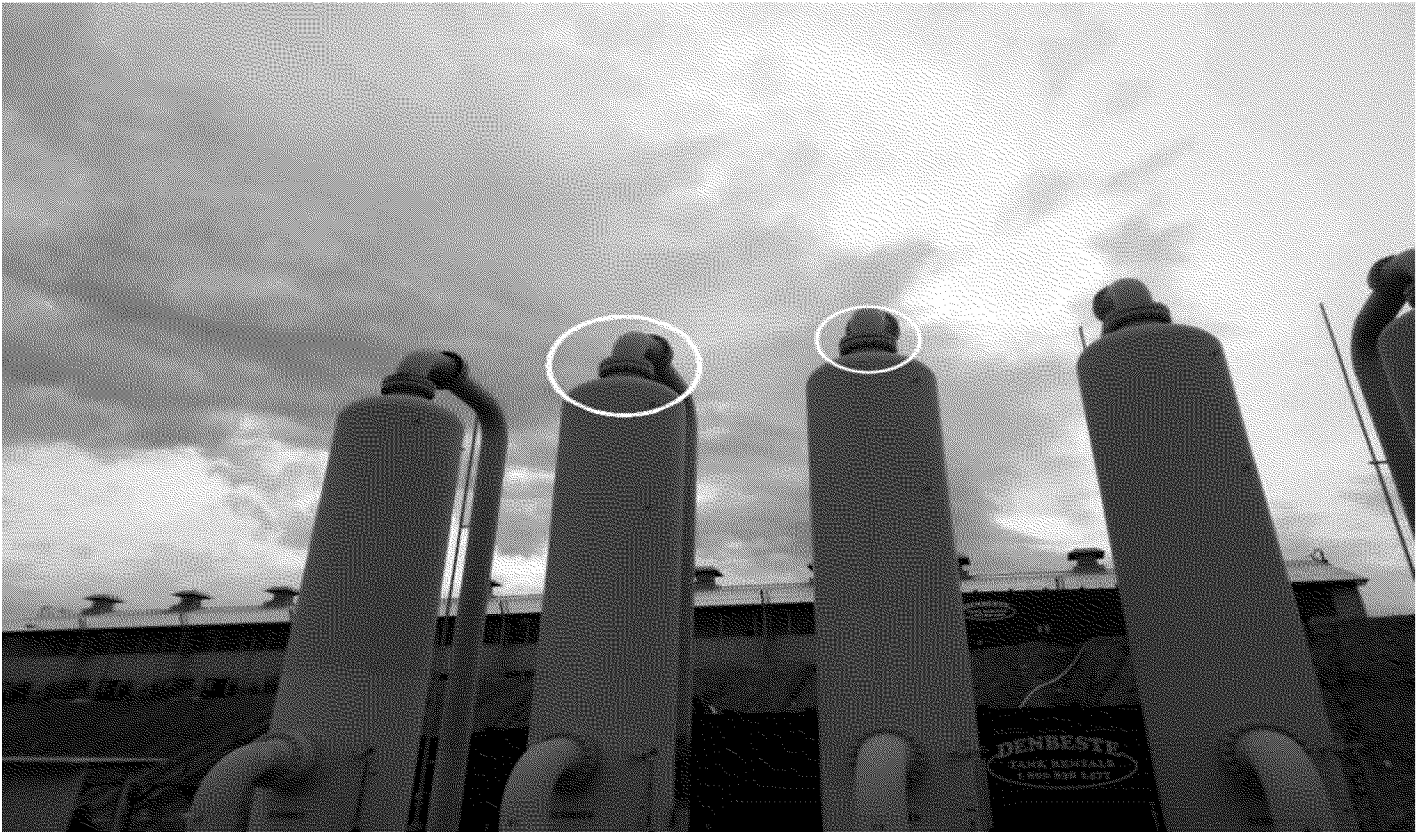
Photo #8 – 4A and 5A Scrubber lines 16" flanged connections

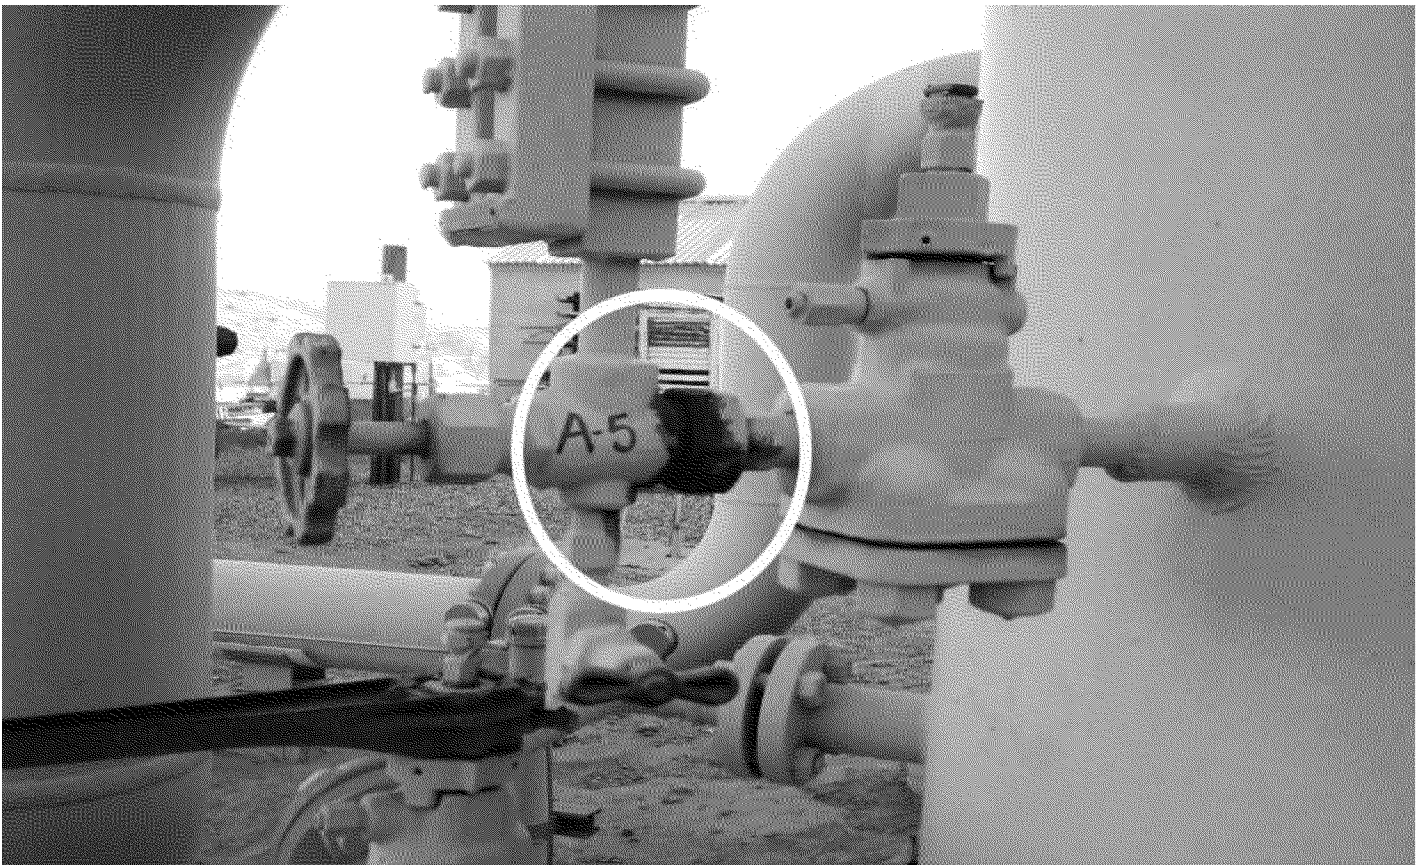
Photo #9 – 5A Scrubber line sight glass union

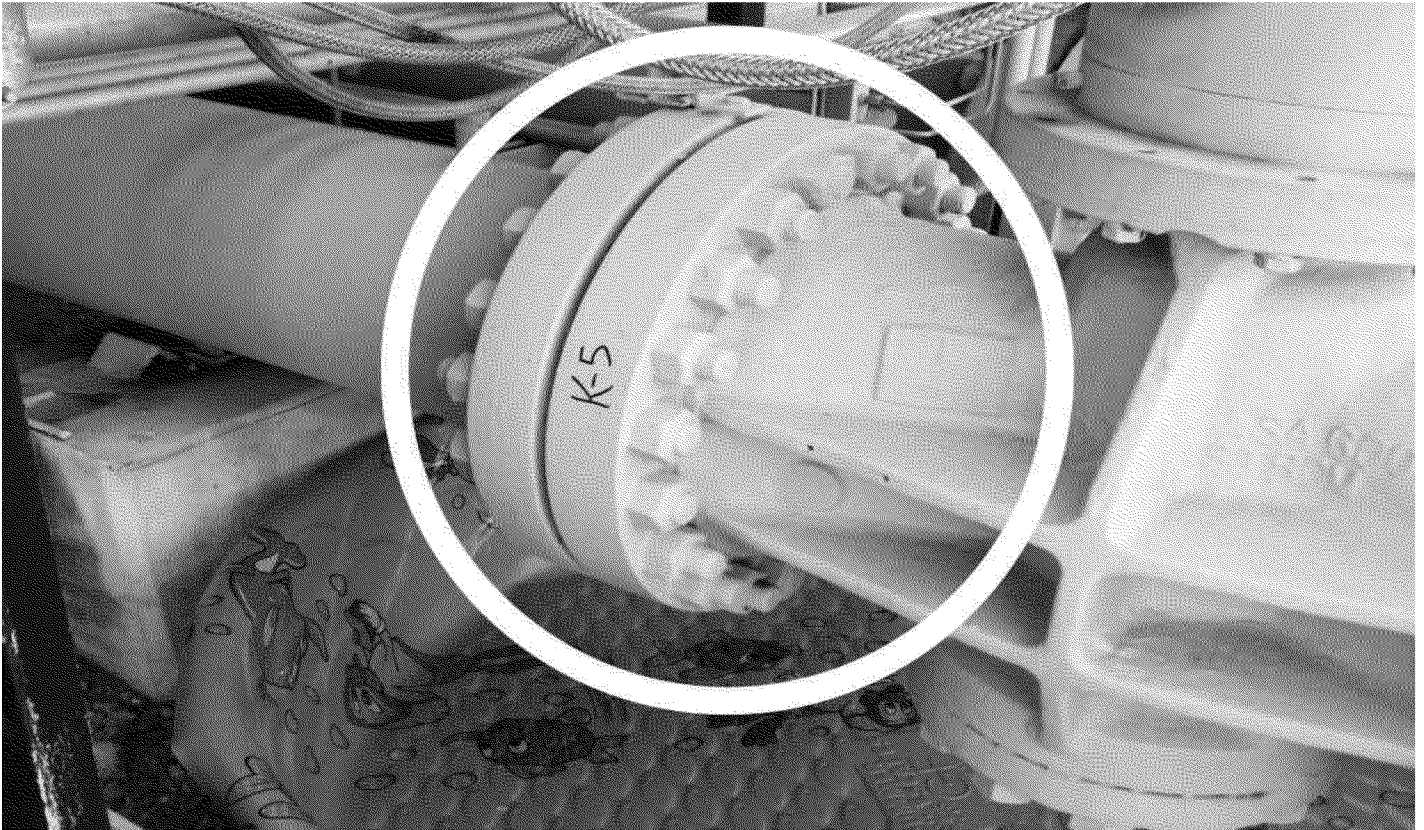
Photo #10 - K5 suction valve flanged connection

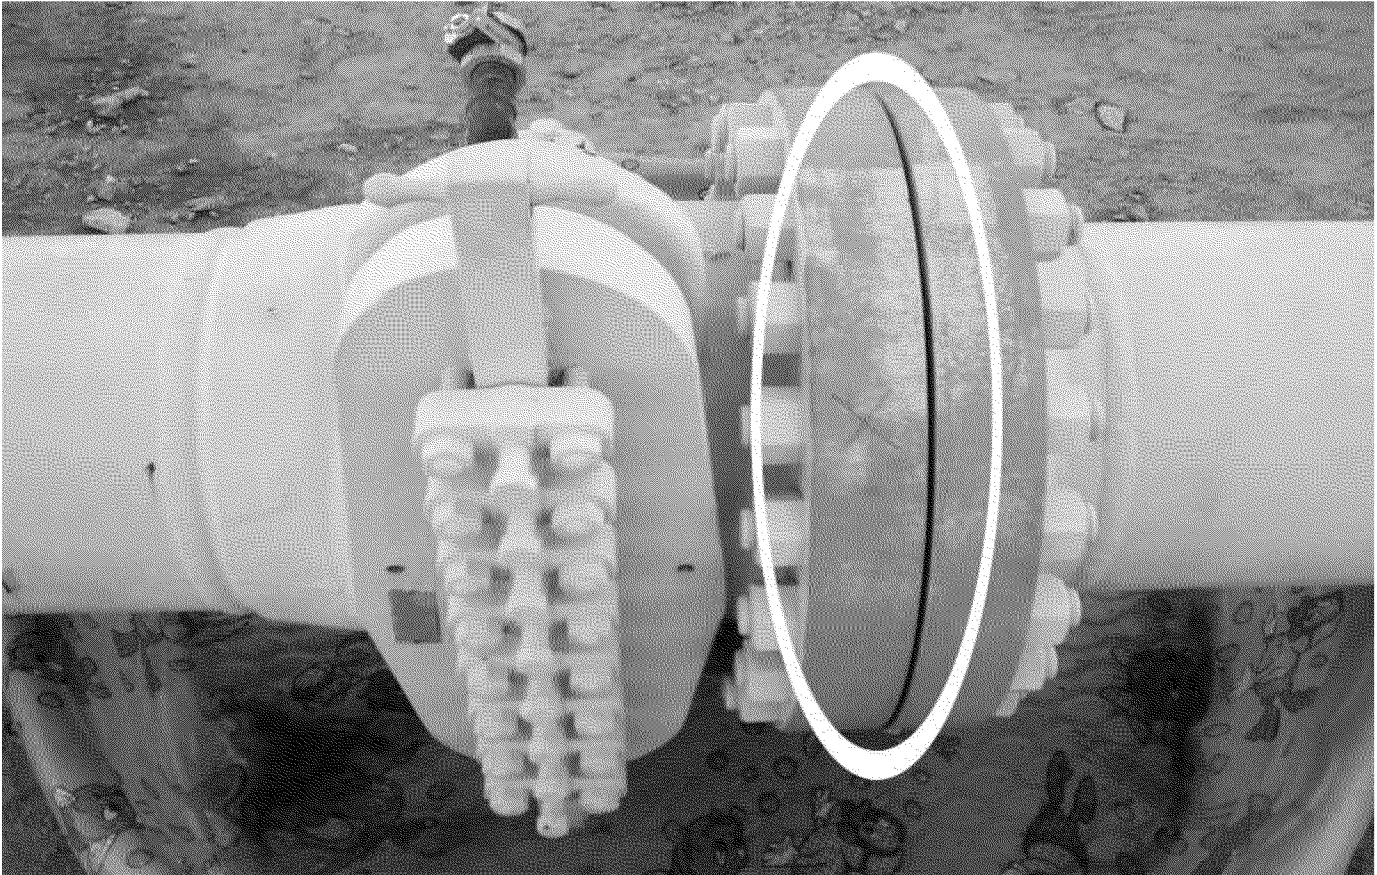
<b>Topock Suction Piping Hydrotest leak and repair summary "B side testing"</b>		<b>AECOM</b>
Photo #	Location	Methodology of capturing leaks and repairs done
<b>B-1 Test</b>		
11	B1 valve insulating flange	Leaking water captured in a kiddie pool. Insulating flange spread apart, existing gaskets removed and new gasket installed.
12	B3 valve insulating flange	Leaking water captured in a kiddie pool. Insulating flange spread apart, existing gaskets removed and new gasket installed.
<b>B-2 Tests</b>		
13	Scrubber 1B line – 16" flanged connection east of B7 valve, orifice meter	Leaking water captured in a kiddie pool. 16" flanged connection gasket removed and new gasket installed. Orifice meter existing gasket removed and new gasket installed.
13,14	Scrubber 2B line - 16" flanged connection immediately after orifice meter	Leaking water captured in kiddie pool. Existing gasket removed and replaced with new gasket. Scrubber 2B line subsequently included in B2-3 hydrotest.

Photo #14 – 2B Scrubber line flanged connection

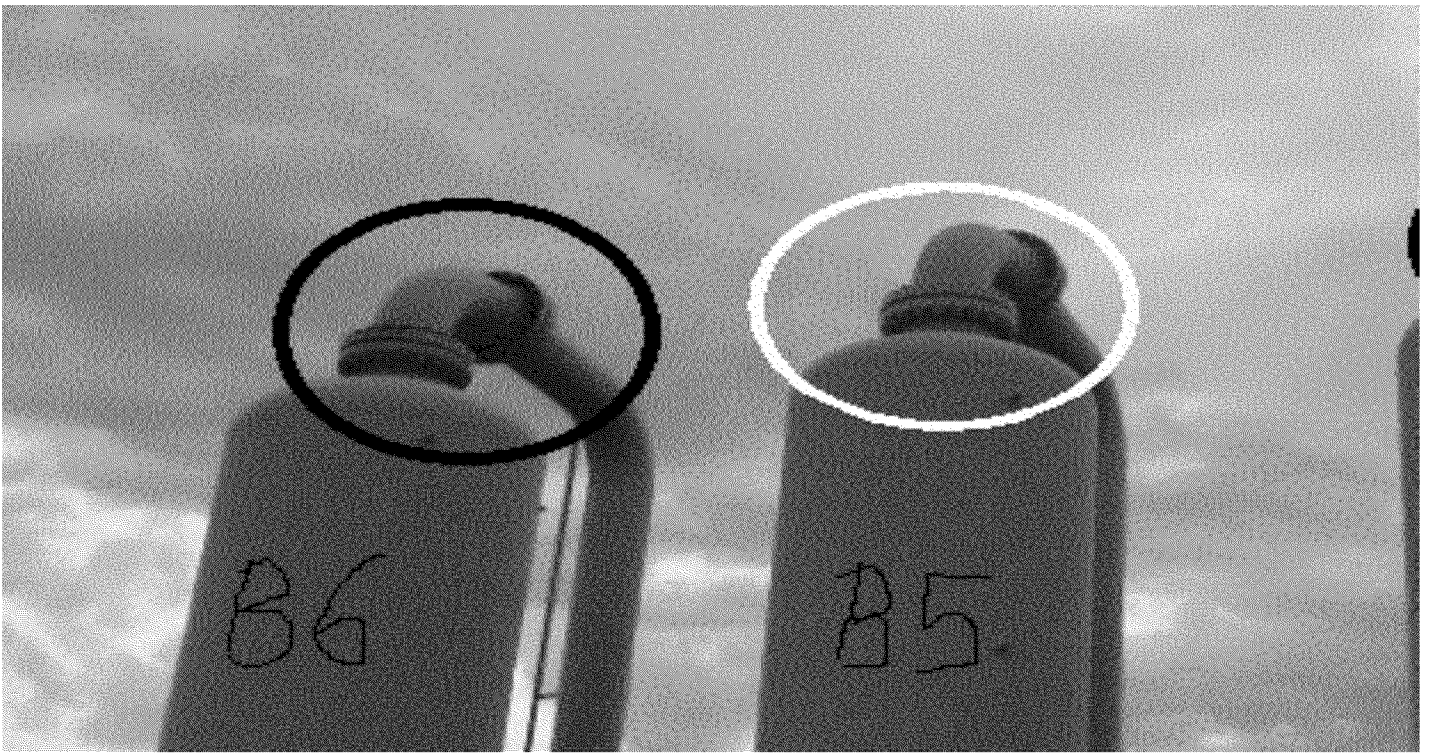
15	Scrubber 5B line - 16" vertical flanged connection at top of scrubber	Water captured in plastic containment at base of scrubber. Existing gasket removed and replaced with new gasket. Scrubber 5B line subsequently included in B2-3 hydrotest.
15	Scrubber 6B line - 16" horizontal flanged connection at top of scrubber	Water captured in plastic containment at base of scrubber. 16" flanged connection torqued.
<b>B-3 Test</b>		
16	K9 suction valve - flanged connection	Flanged connection torqued.

Photo #15 – 5B and 6B Scrubber lines 16” flanged connections

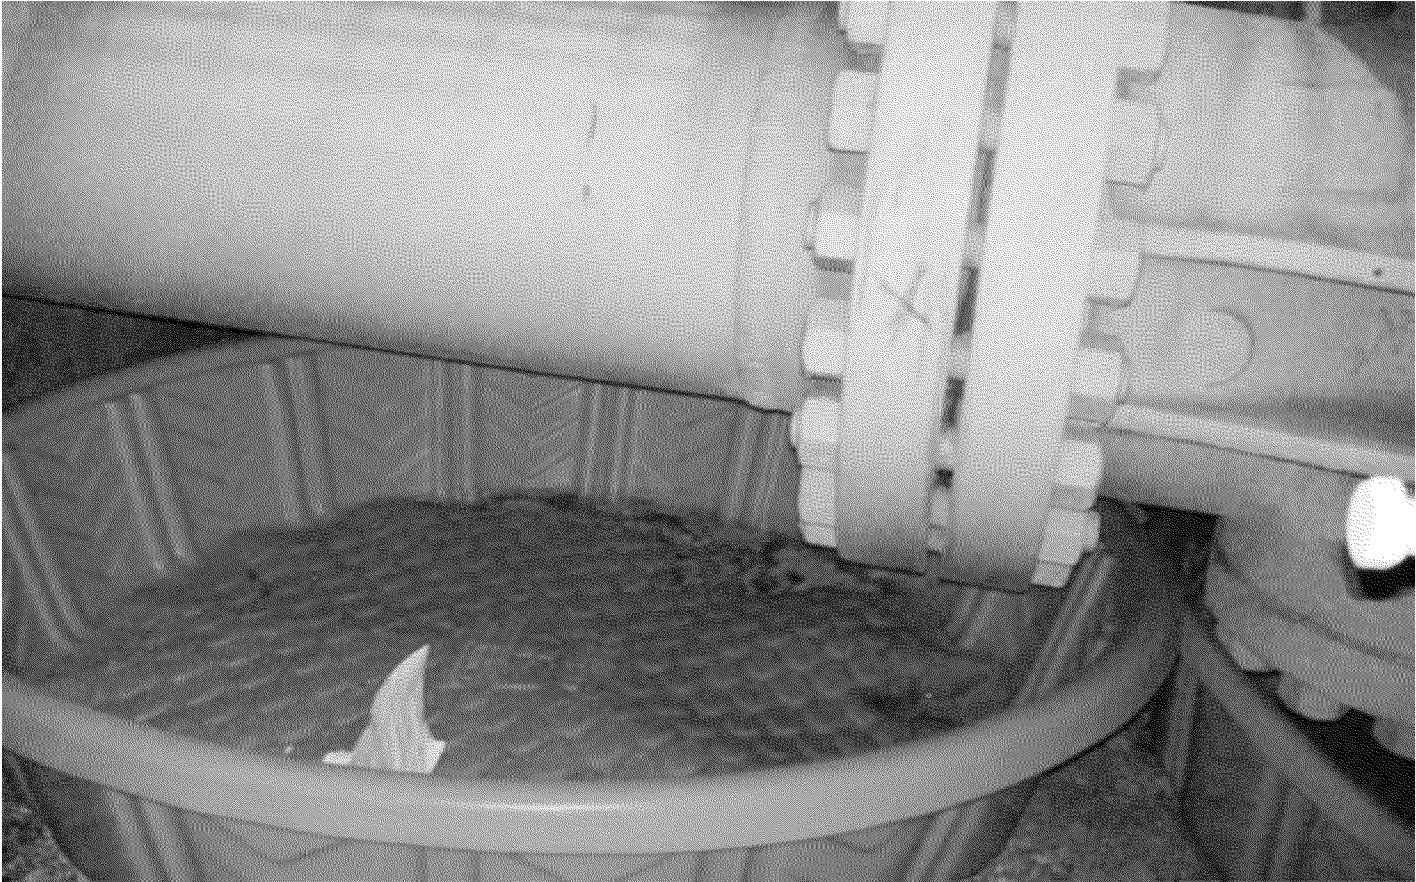
Photo #16 - K9 suction valve flanged connection
