**PACIFIC GAS AND ELECTRIC COMPANY'S SUPPORTING
INFORMATION FOR LIFTING OPERATING PRESSURE
RESTRICTIONS ON THE SUCTION SIDE OF TOPOCK
COMPRESSOR STATION**

**ERRATA TO SUPPORTING INFORMATION
FILED: SEPTEMBER 12, 2011**

Repair actions taken as a result of pressure testing

Topock Suction Piping Hydrotest leak and repair summary –“A side testing”		AECOM
Photo #	Location	Methodology of capturing leaks and repairs done
A-1 Test		
1	A1 Valve insulating flange	Leak discovered 1 hr 15 min into test as insulating flange was partially excavated. Leak from bottom of insulating flange. Excavation during test to pursue leak source. Leaking water channeled into kiddie pool and pumped back into Baker tanks. Insulating flange spread apart, existing gaskets removed and new gasket installed.
A-2 Tests		
2	Scrubber 1A line - 16" flanged connection immediately after meter element	Leaking water captured in kiddie pool. Existing gasket removed and replaced with new gasket. Scrubber 1A line subsequently included in A2-2 hydrotest.
3	Scrubber 2A line - 16" flanged connection immediately after meter element	Leaking water captured in kiddie pool. Existing gasket removed and replaced with new gasket.

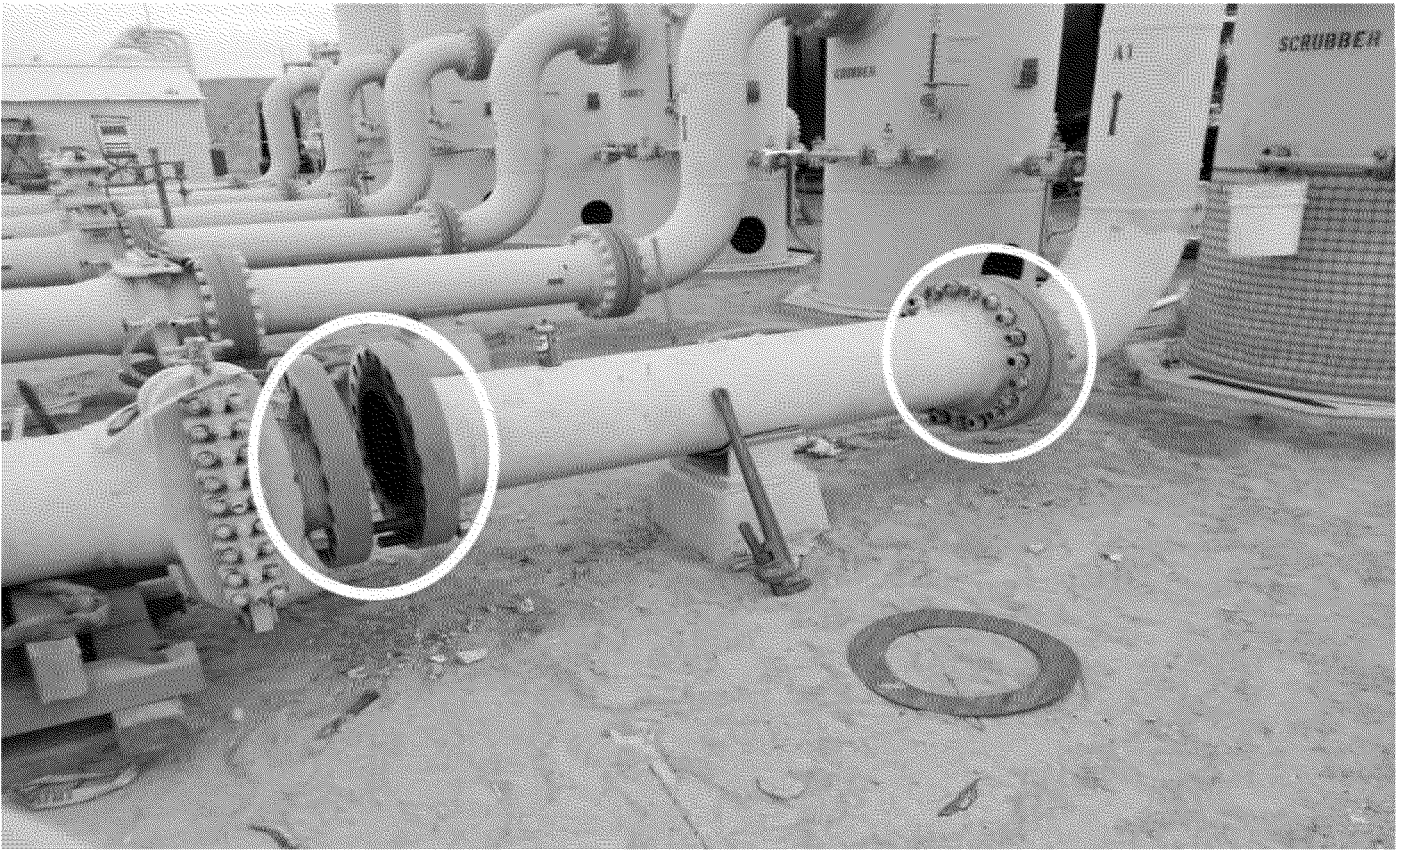
Photo #2 – 1A Scrubber line 16” flanged connection

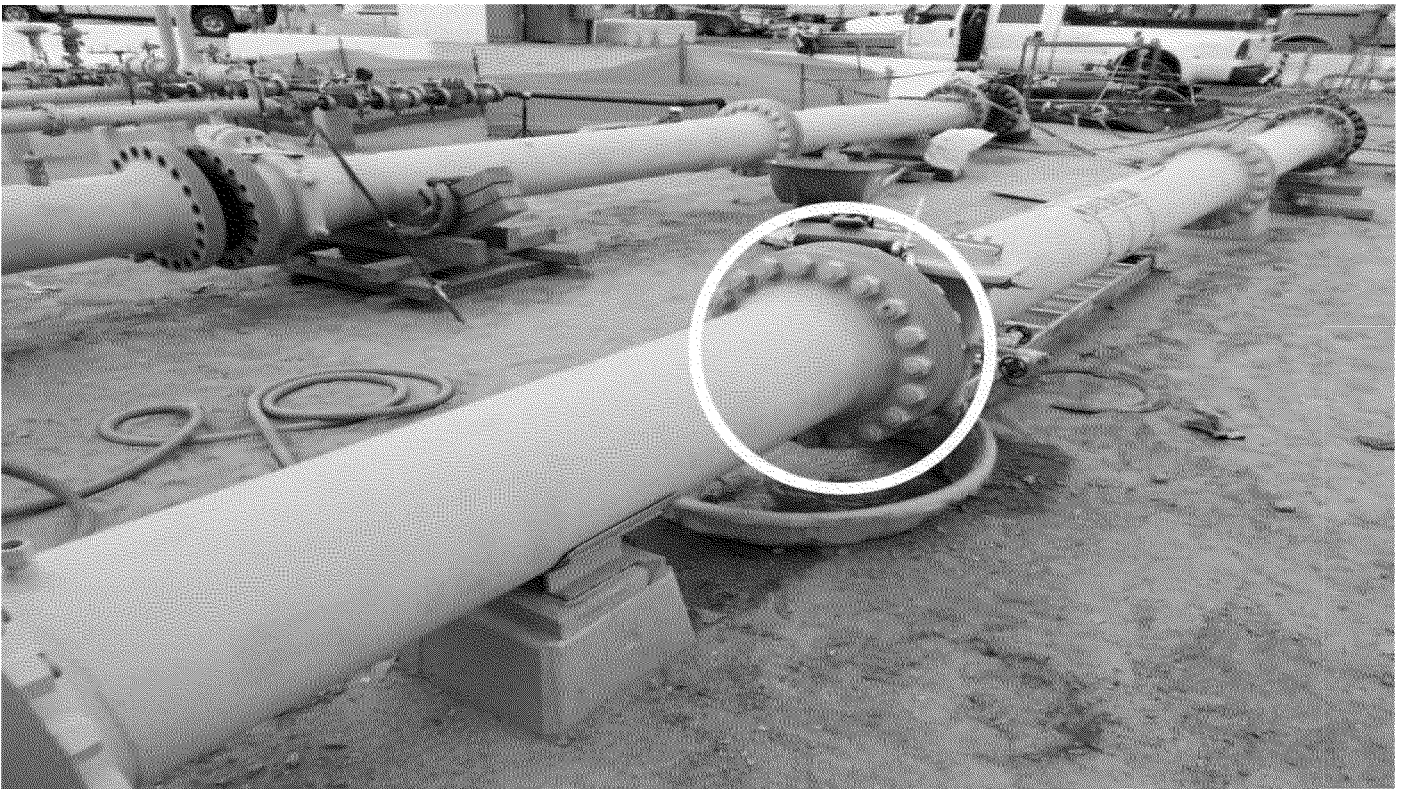
Photo # 3 – 2A Scrubber line 16” flanged connection

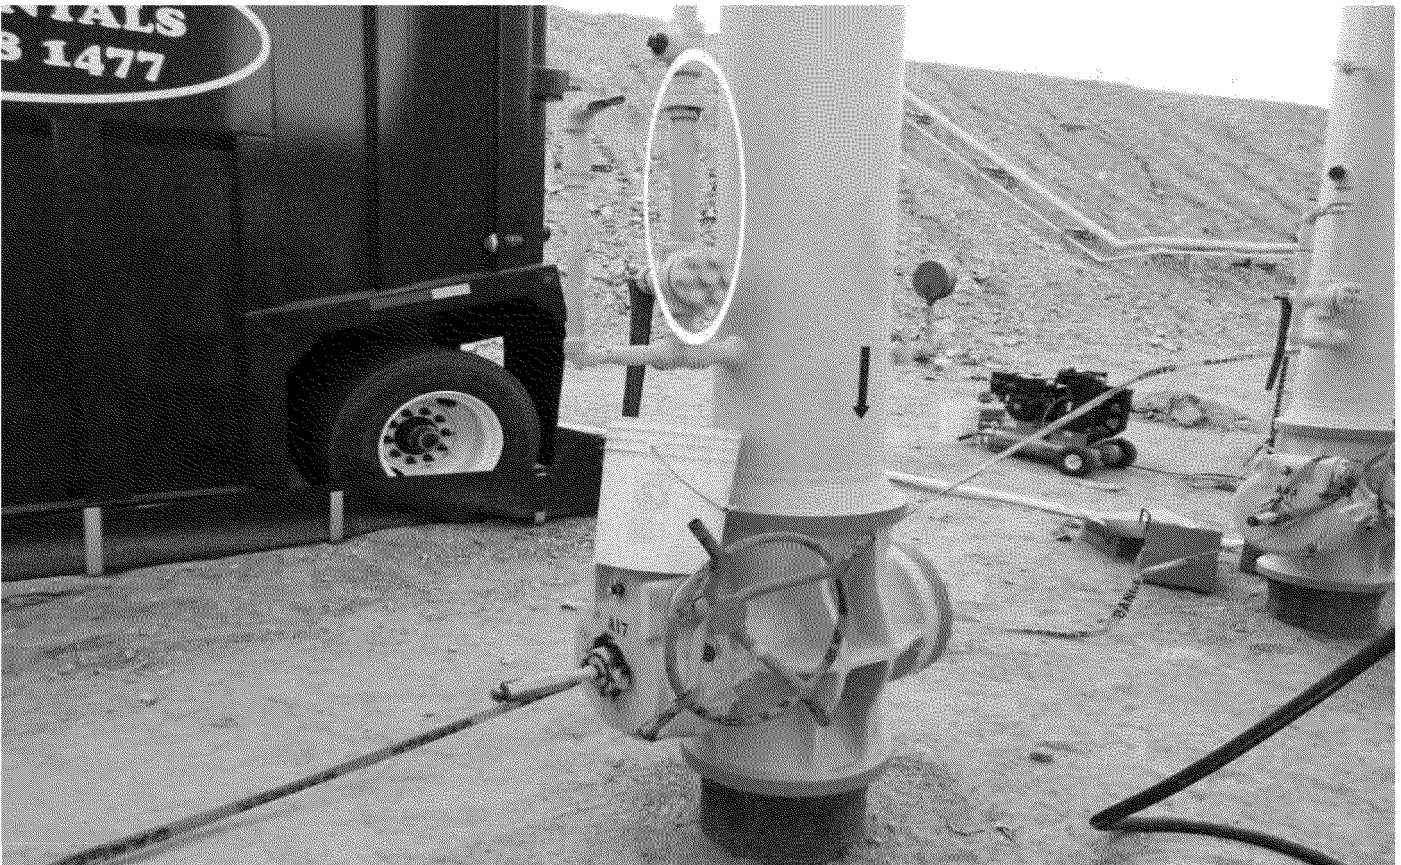
4,5	Scrubber 3A line - Union above relief valve and 16" flanged connection at scrubber inlet.	Leaking water captured in bucket and kiddie pool, respectively. Union and 16" flanged connections torqued.
6,7,8	Scrubber 4A line - 16" orifice meter, sight glass union, and vertical 16" flanged connection at top of scrubber.	Leaking water captured in bucket and kiddie pool. Orifice meter existing gasket removed and new gasket installed. Union and 16" flanged connection torqued.
8,9	Scrubber 5A line - 16" vertical flanged connection at top of scrubber, sight glass union	Leaking water captured in a bucket. Union and 16" flanged connection torqued.
A-3 Test		
10	K5 suction valve - flanged connection	Leaking water captured in a kiddie pool. Flanged connection torqued.

Photo #4 – 3A Scrubber line relief valve union

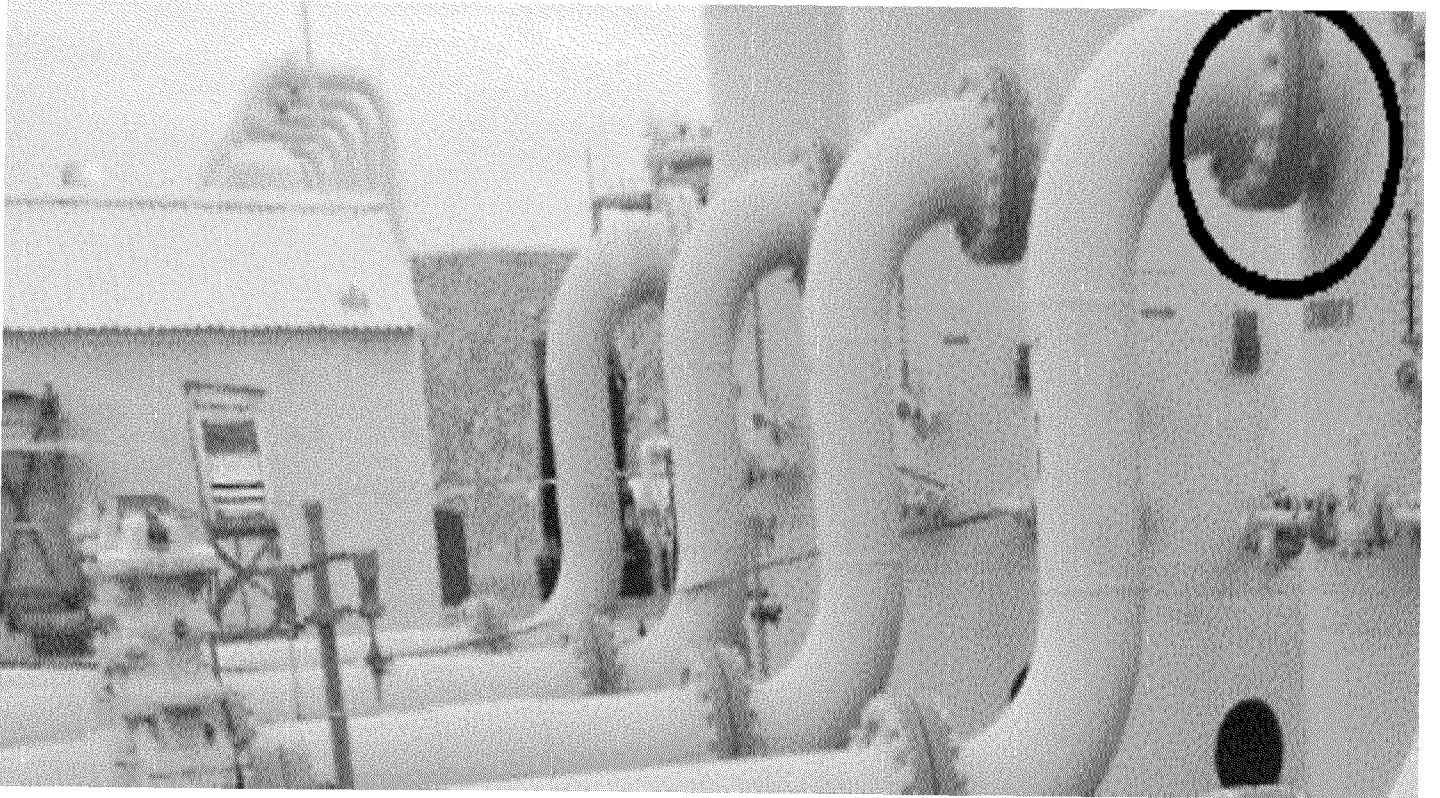
Photo #5 – 3A Scrubber line 16" flanged connection

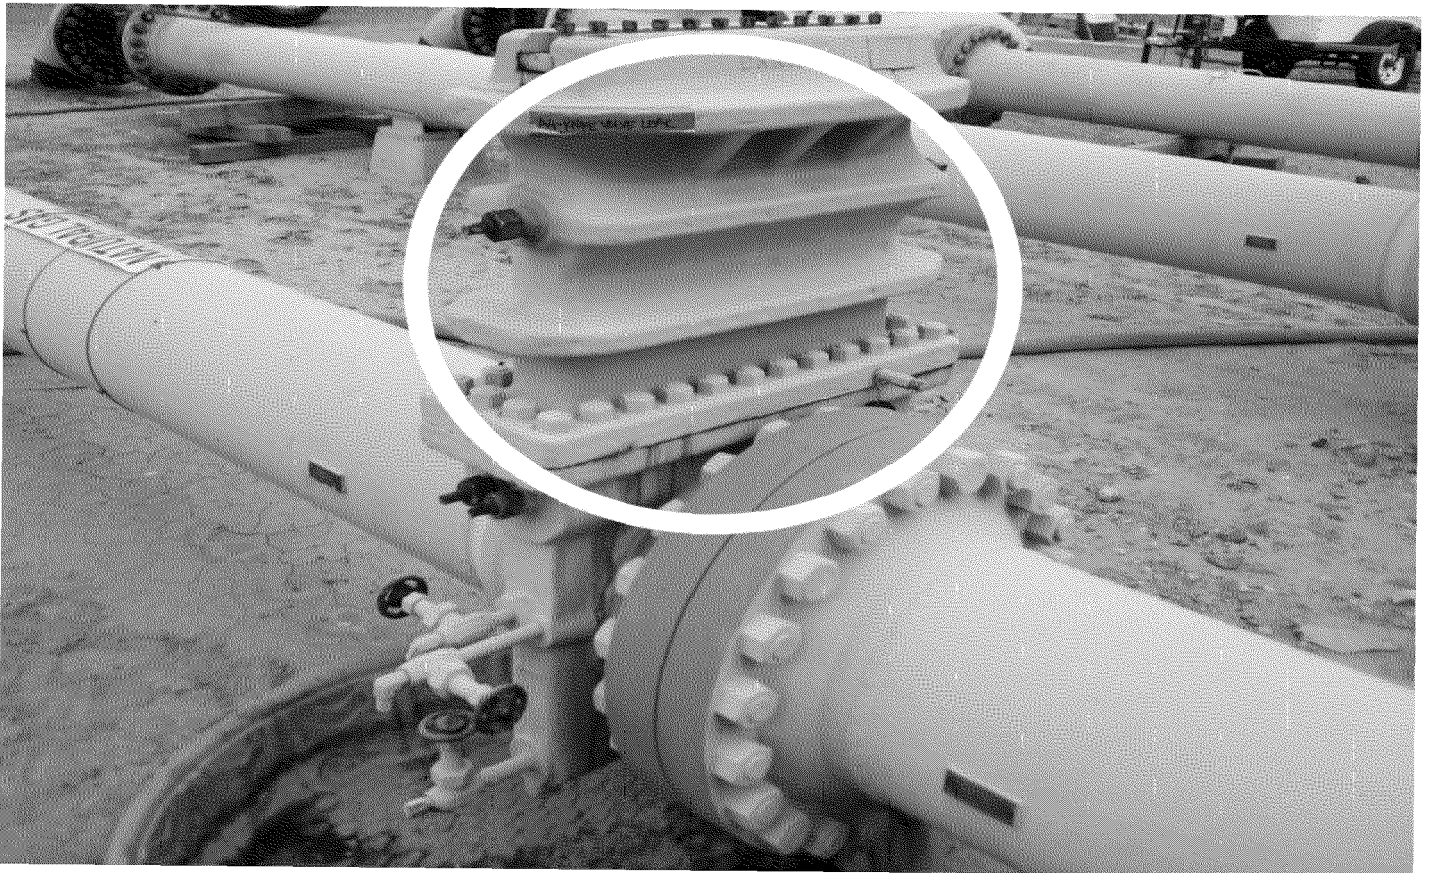
Photo #6 – 4A Scrubber line orifice meter

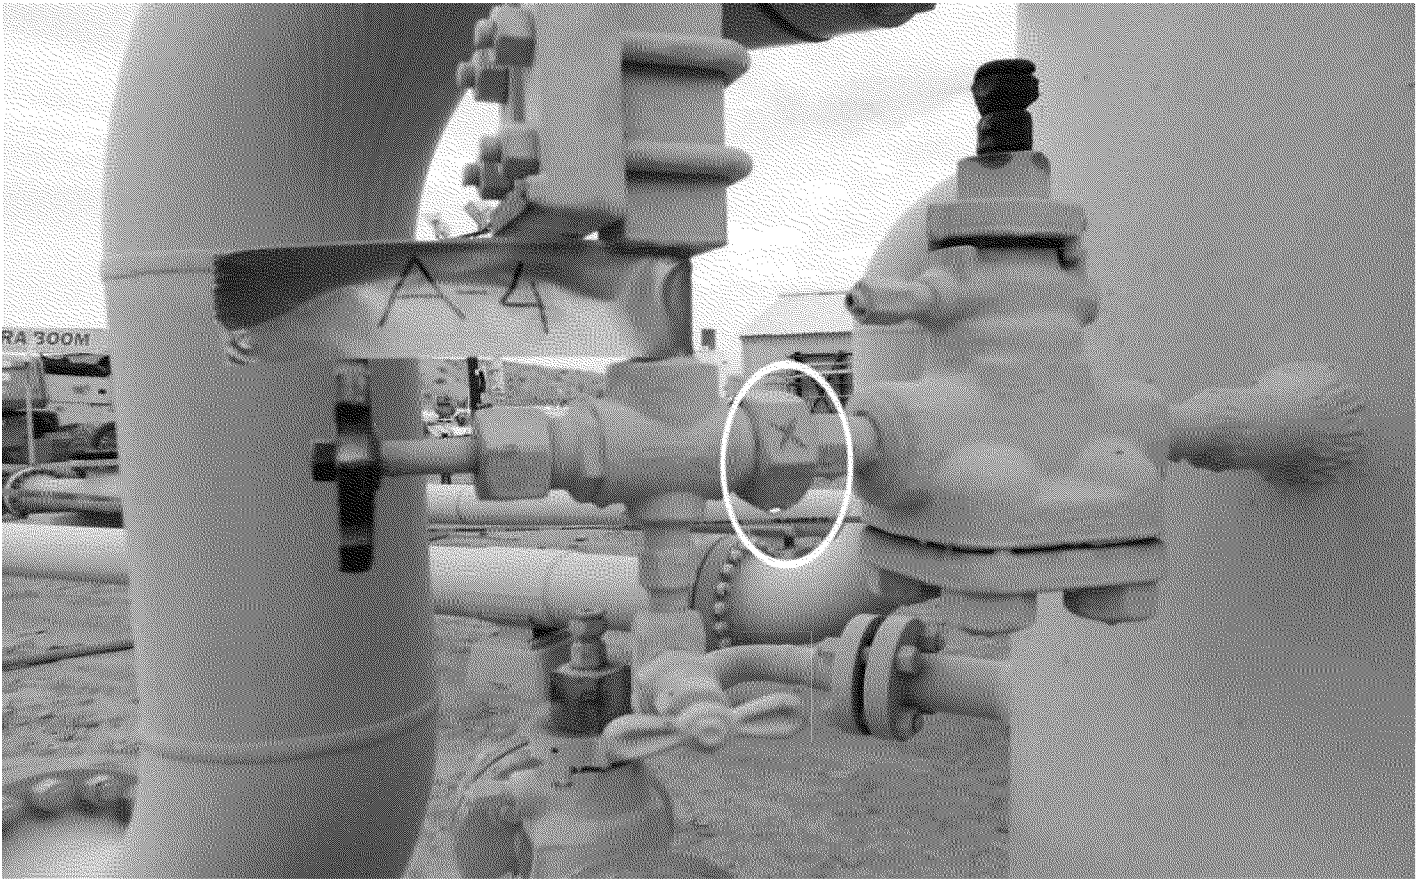
Photo #7 – 4A Scrubber line sight glass union

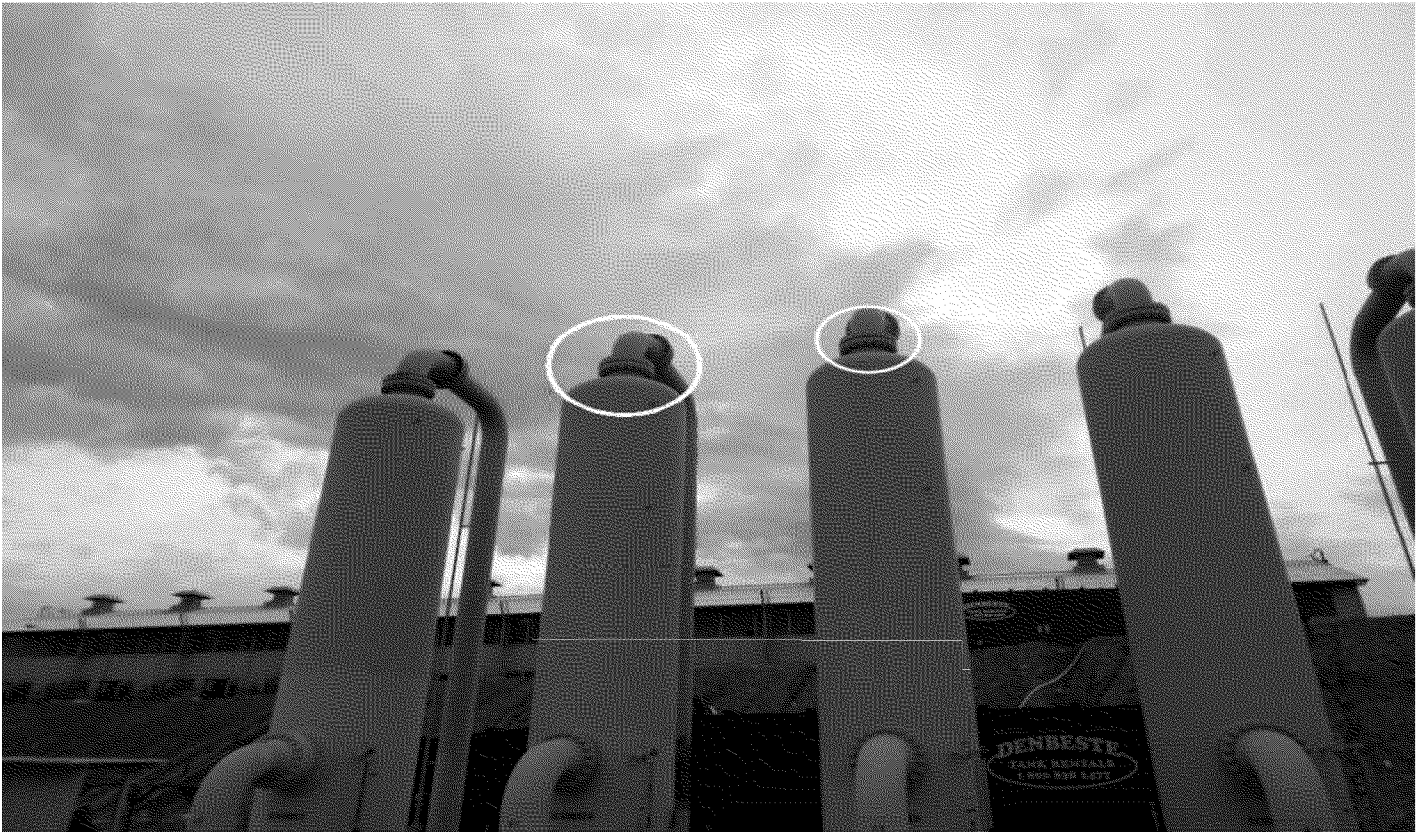
Photo #8 – 4A and 5A Scrubber lines 16" flanged connections

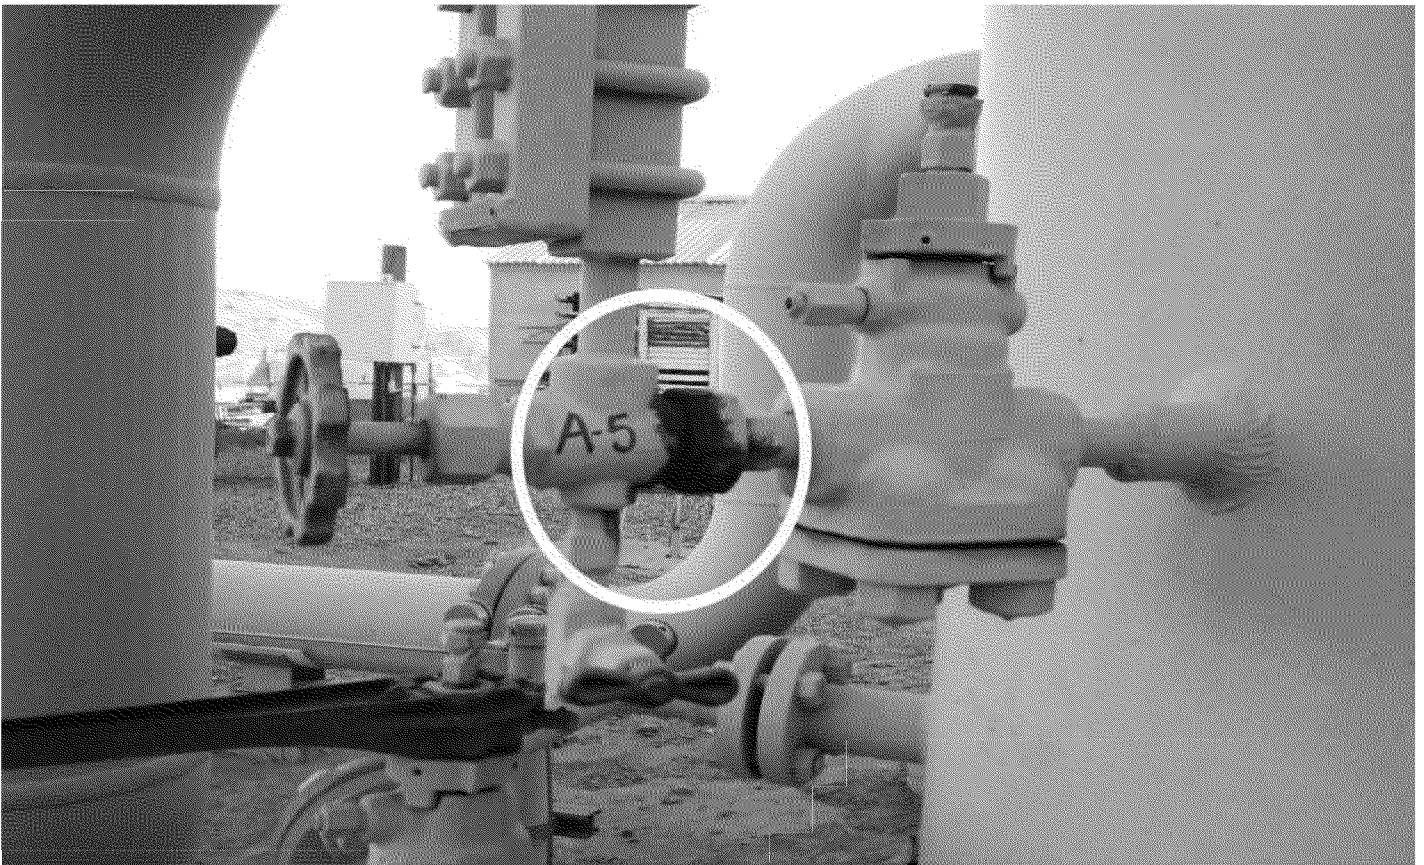
Photo #9 – 5A Scrubber line sight glass union

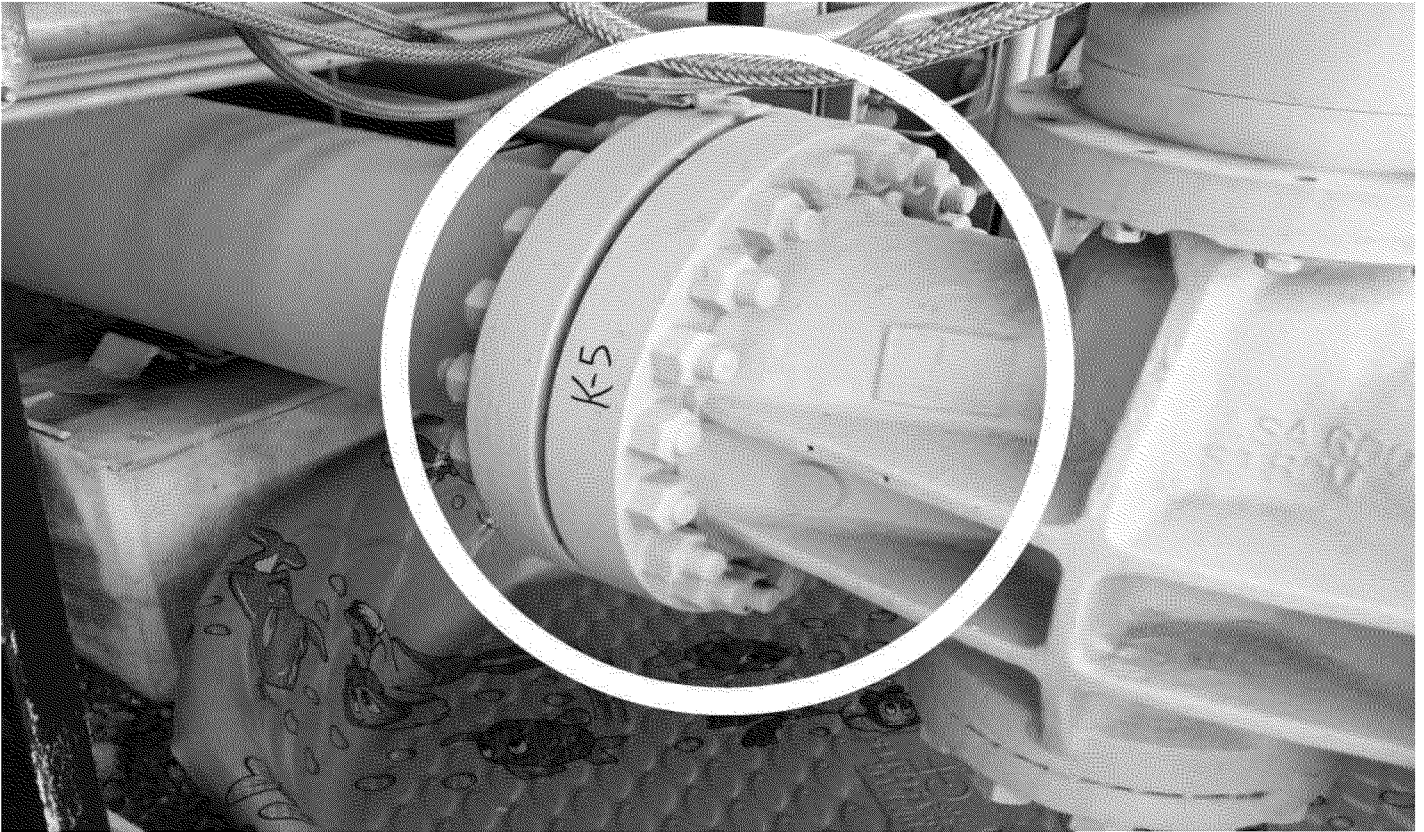
Photo #10 - K5 suction valve flanged connection

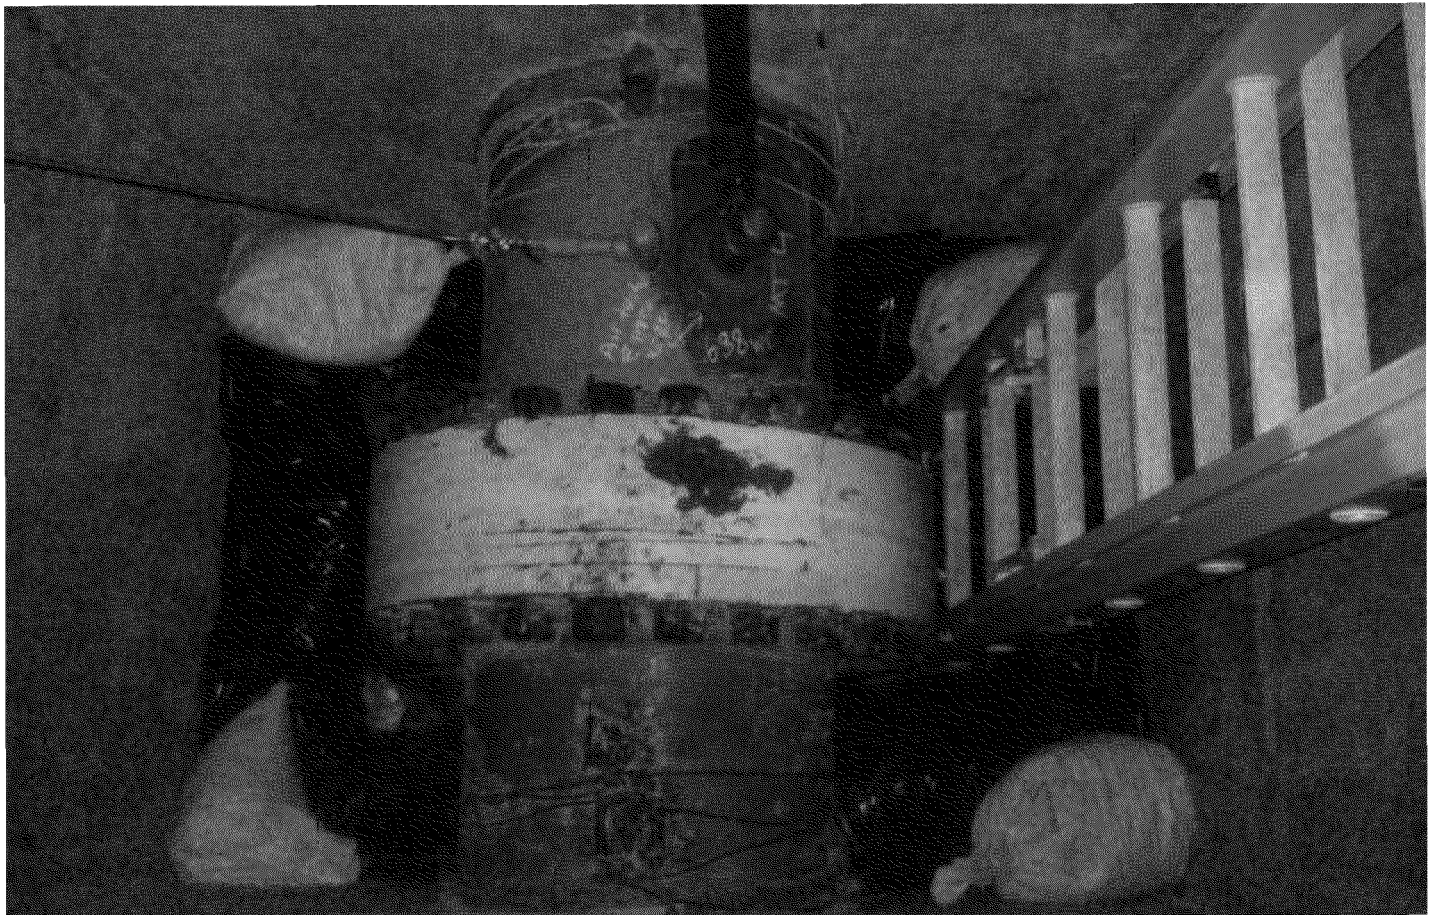
Topock Suction Piping Hydrotest leak and repair summary "B side testing"		AECOM
Photo #	Location	Methodology of capturing leaks and repairs done
B-1 Test		
11	B1 valve insulating flange	Leaking water captured in a kiddie pool. Insulating flange spread apart, existing gaskets removed and new gasket installed.
12	B3 valve insulating flange	Leaking water captured in a kiddie pool. Insulating flange spread apart, existing gaskets removed and new gasket installed.
B-2 Tests		
13	Scrubber 1B line – 16" flanged connection east of B7 valve, orifice meter	Leaking water captured in a kiddie pool. 16" flanged connection gasket removed and new gasket installed. Orifice meter existing gasket removed and new gasket installed.
13,14	Scrubber 2B line - 16" flanged connection immediately after orifice meter	Leaking water captured in kiddie pool. Existing gasket removed and replaced with new gasket. Scrubber 2B line subsequently included in B2-3 hydrotest.

Photo #12 – B3 valve insulating flange

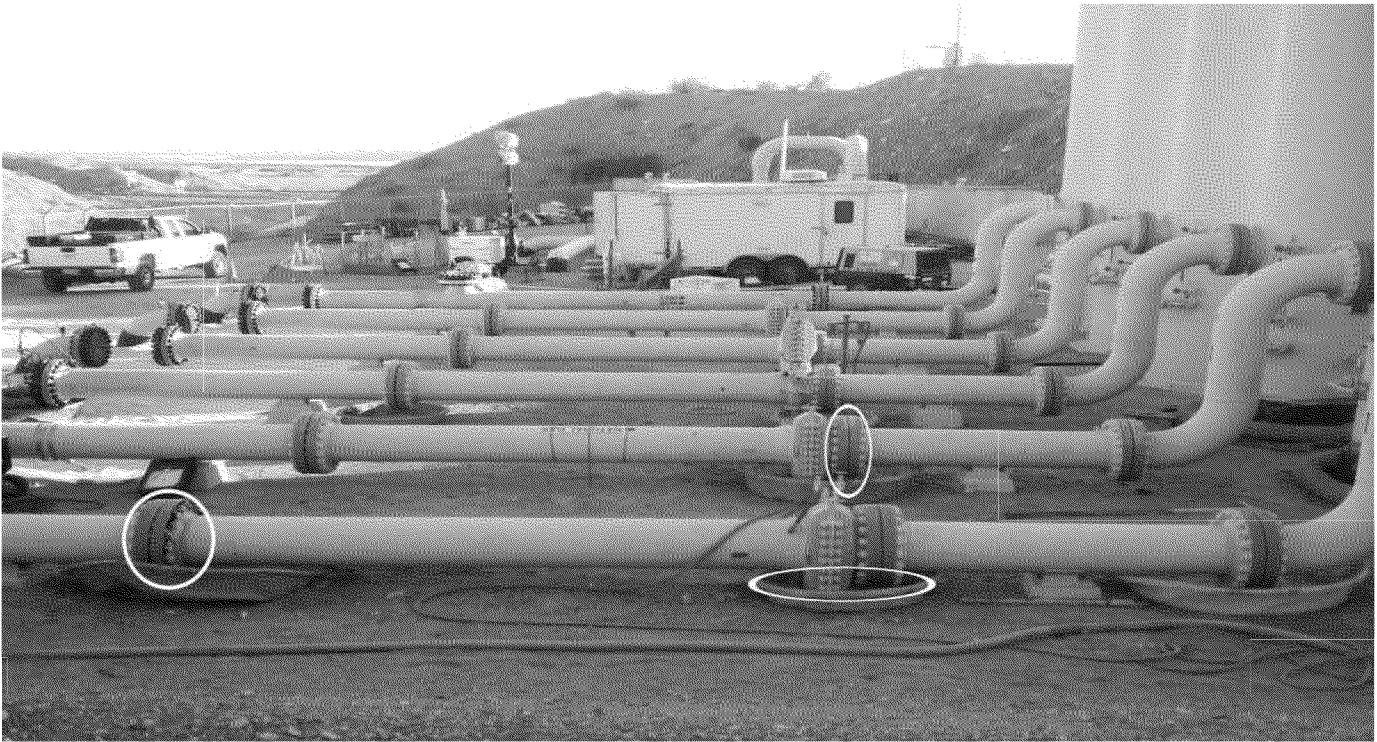
Photo #13 – 1B and 2B Scrubber lines flanged connections and orifice meter

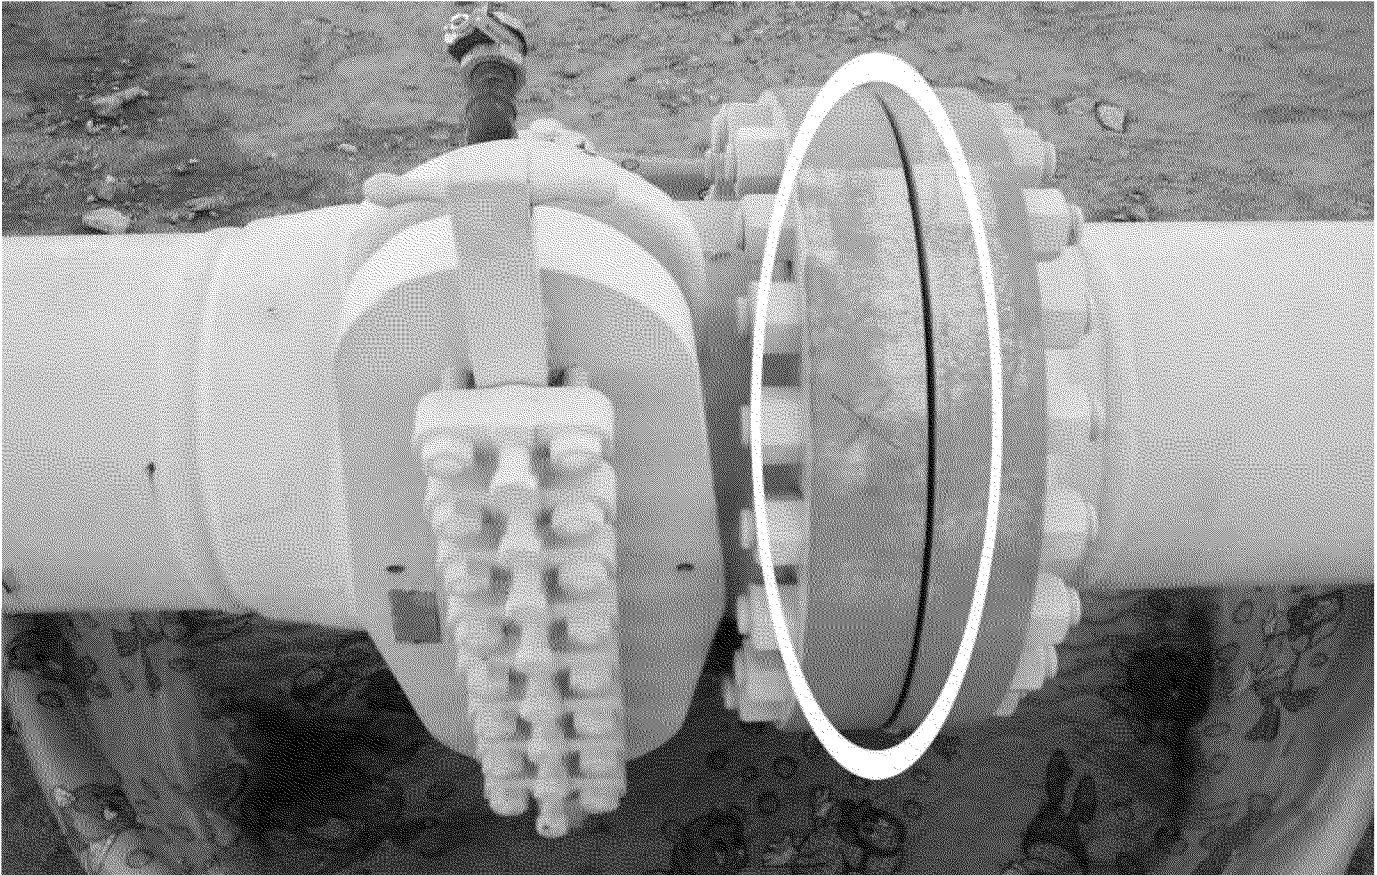
Photo #14 – 2B Scrubber line flanged connection

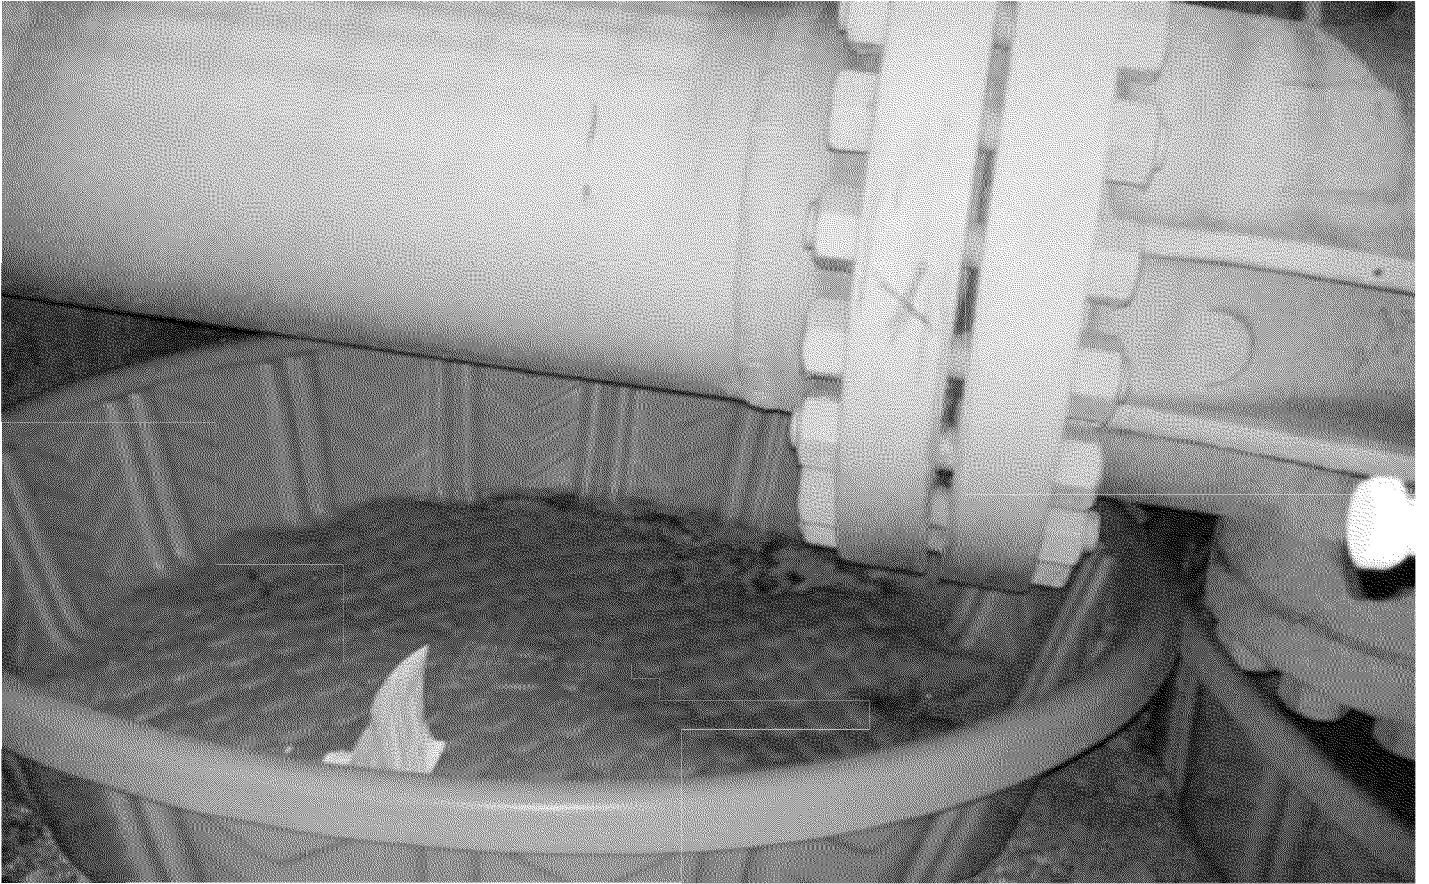
15	Scrubber 5B line - 16" vertical flanged connection at top of scrubber	Water captured in plastic containment at base of scrubber. Existing gasket removed and replaced with new gasket. Scrubber 5B line subsequently included in B2-3 hydrotest.
15	Scrubber 6B line - 16" horizontal flanged connection at top of scrubber	Water captured in plastic containment at base of scrubber. 16" flanged connection torqued.
B-3 Test		
16	K9 suction valve - flanged connection	Flanged connection torqued.

Photo #16 - K9 suction valve flanged connection
