**IN-FIELD SERVICES**  
**GEIS Pipeline Integrity Team NDE**

**Pacific Gas & Electric Company**  
**Hydrostatic Test Dig from November 8, 2011 to January 0, 1900**  
**T30\_L132\_Leak\_MP-15.0029**  
**Documents Contained Within:**

H-Form Report T30\_L132\_Leak MP-15.0029  
NDE Reports of T30\_L132\_Leak MP-15.0029  
Photo Report of T30\_L132\_Leak MP-15.0029

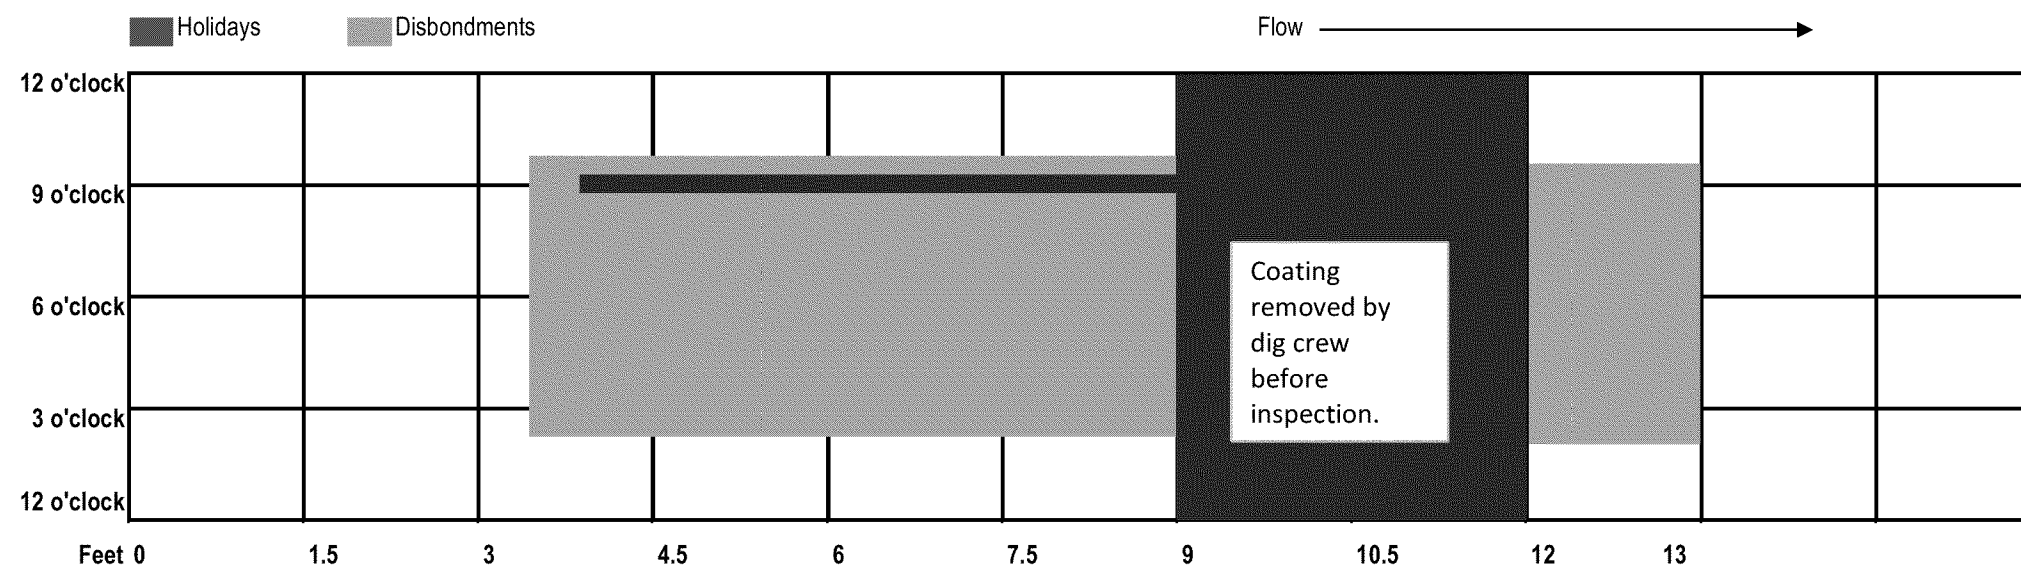
1.9 **Map of Coating Degradation\*:** Zero Reference Point: US Ditch Start  
 \*Note any calcareous deposit locations

Comments: Exposed pipe from -0.00' to 13.00'. The dig crew removed coating from 4ft to 9ft centered around the 9:00 looking for the leak and completely removed the coating from 9ft to 12.35ft. The coating was disbonded from 3ft to 13ft for 2:33 to 9:22.

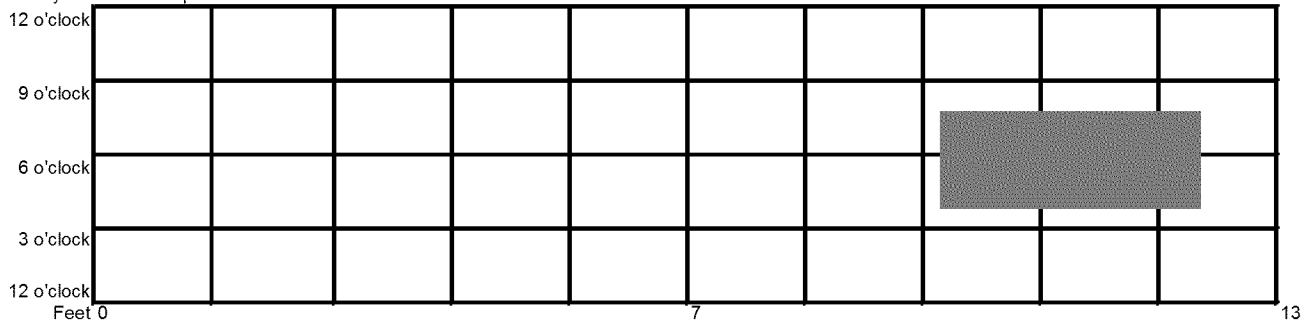
2.8 Overview Map of Corroded Area\*:  
 \*See Pit Depth Measurement Grid for additional information Zero Reference Point: Ditch start

AXD: 10.96' (from US ditch start)  
 Clock: 6:02  
 Axial Length: 3.5"  
 Circumferential Width: 5.8"  
 Max Depth: Through-wall (E7)

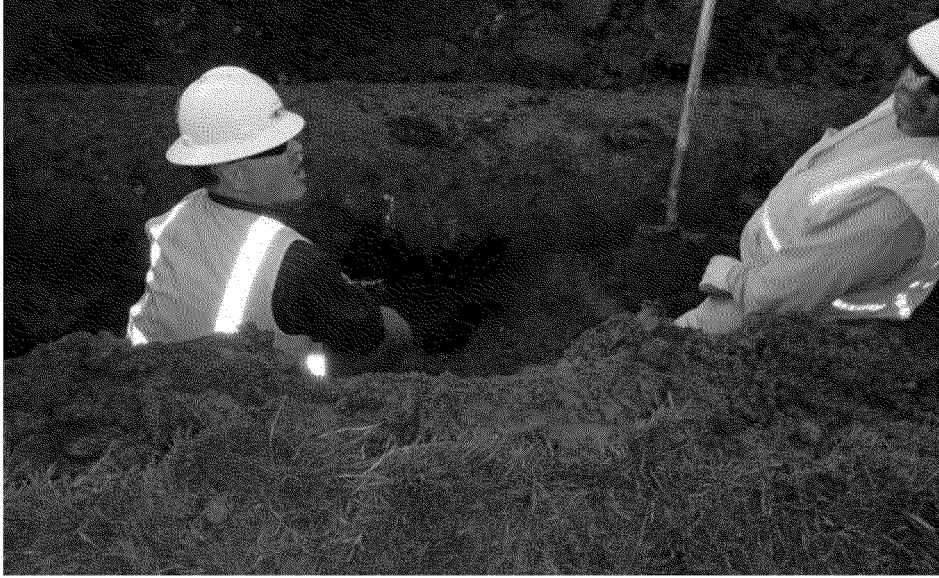
Overview of coating being removed to find leak

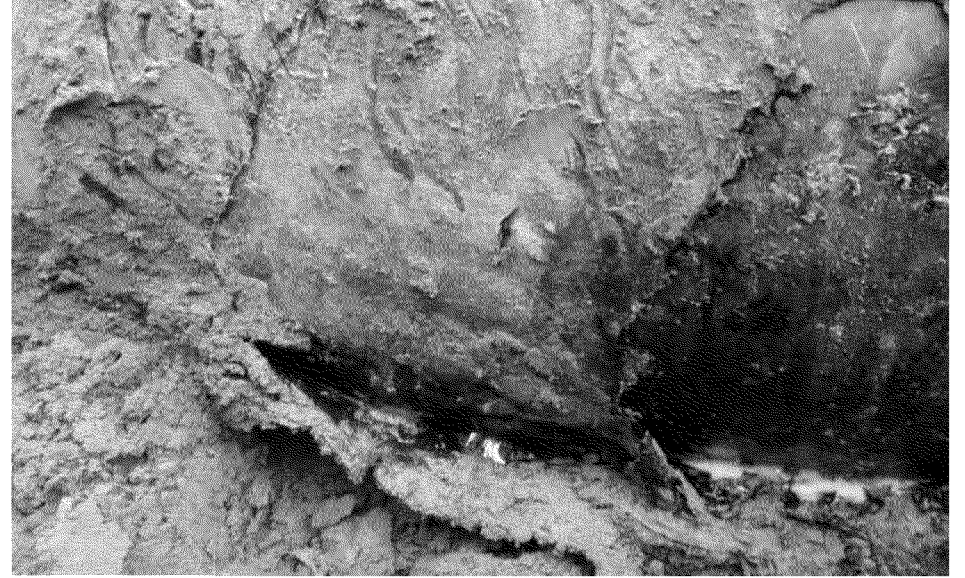
Close up of removed coating to find leak

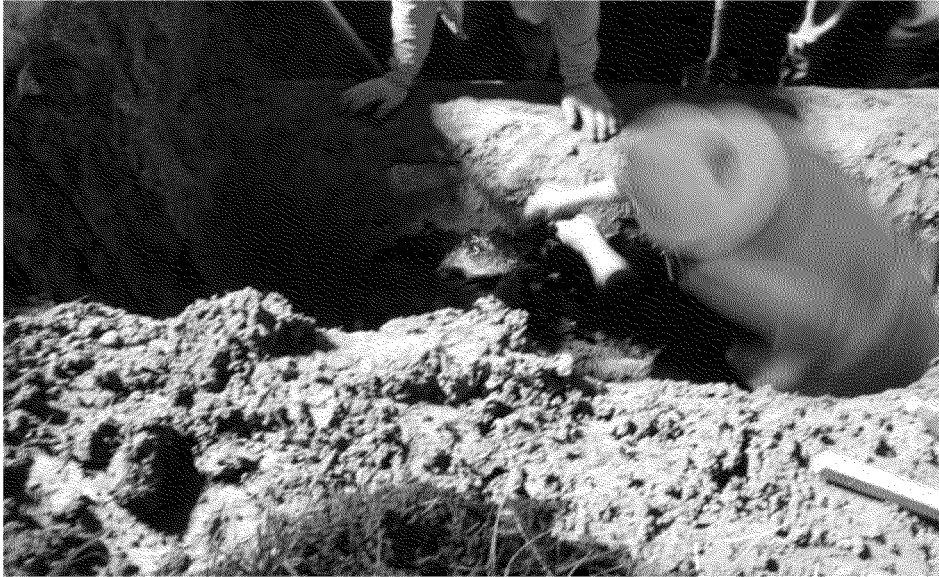
Overview of coating being removed to find leak

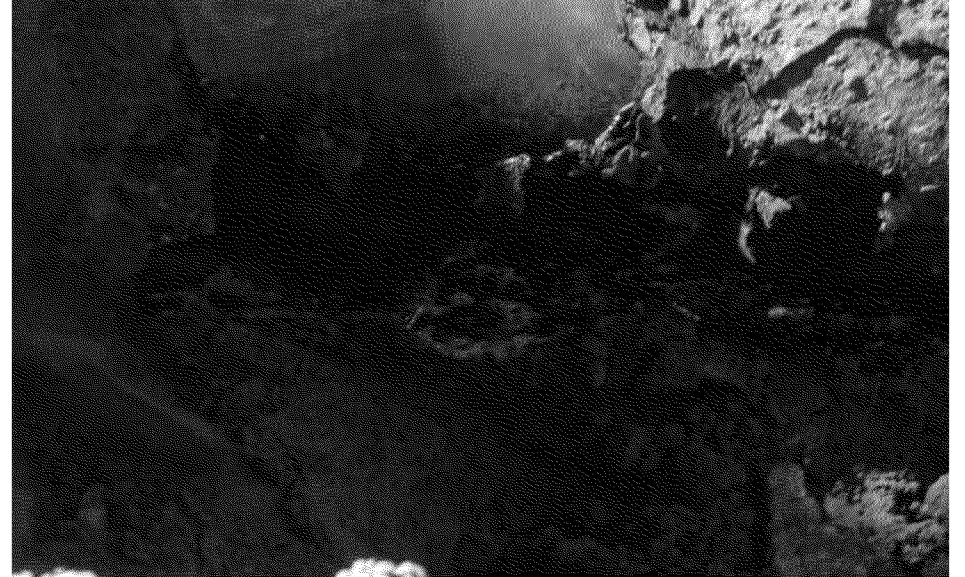
Close up of removed coating to find leak

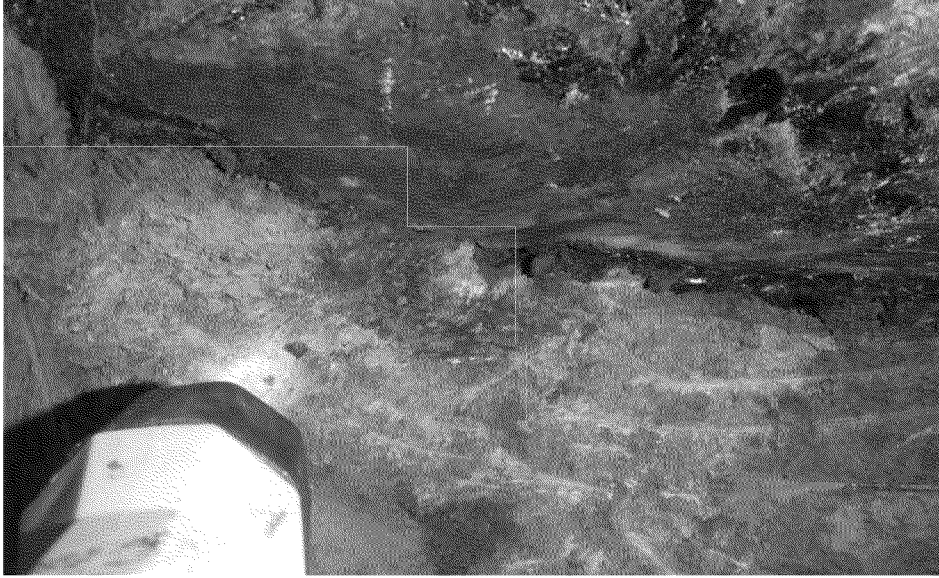
2.4 Damage Found:  
 Corrosion Damage  Yes  No Mechanical Damage  Yes  No  
 Other Damage: Through-wall hole, see attached pages for additional details.

Close up of leak

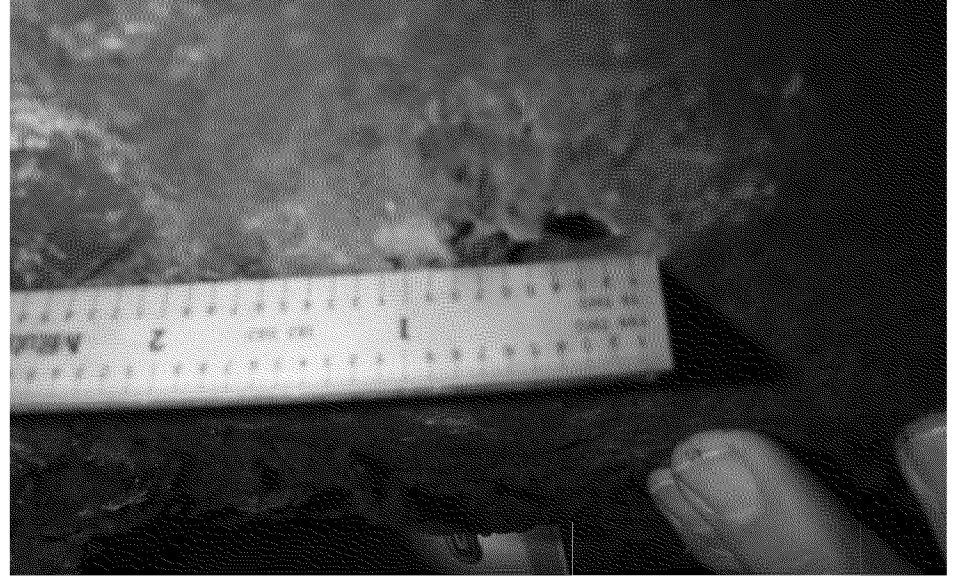
Close up of leak

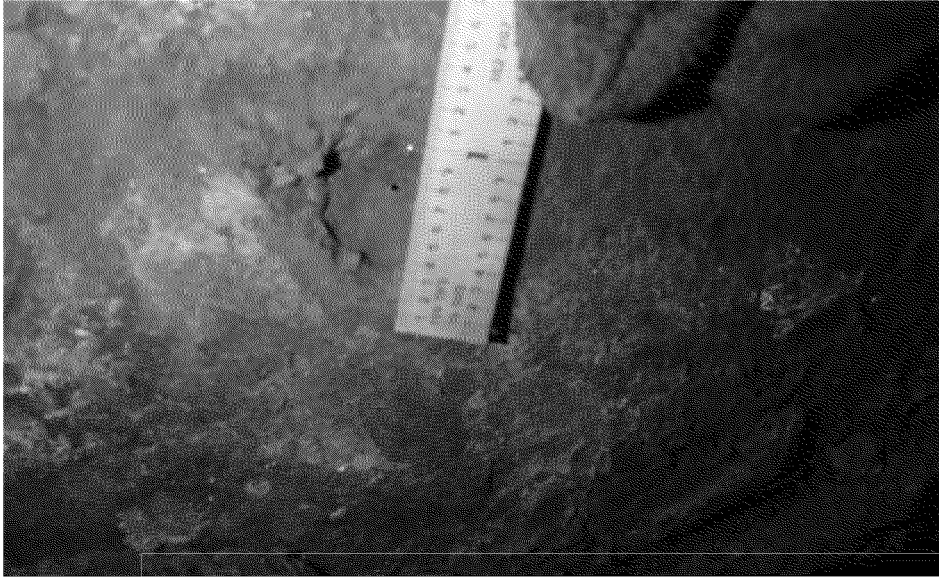
Close up of leak

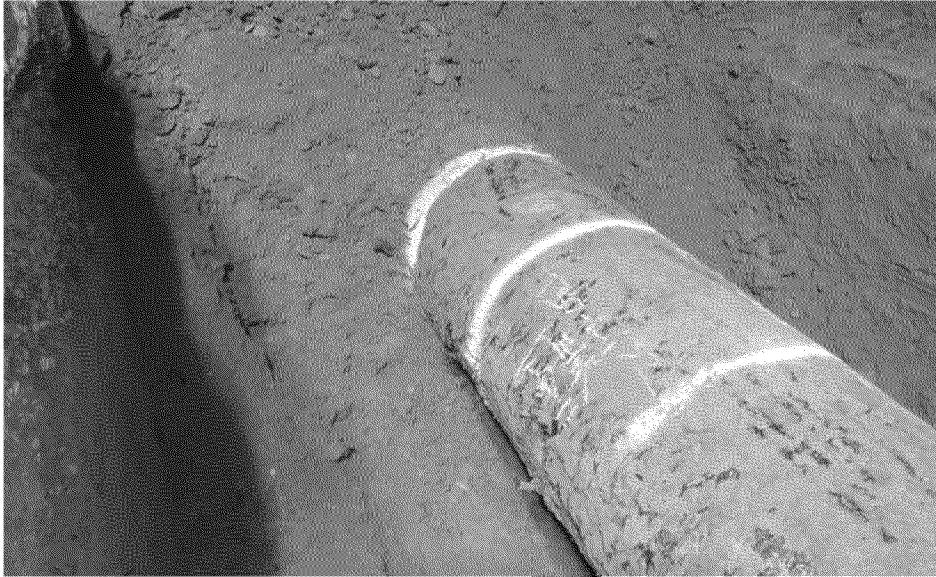
Overview of coating condition 3.00ft to 8.00ft, 3:00 position

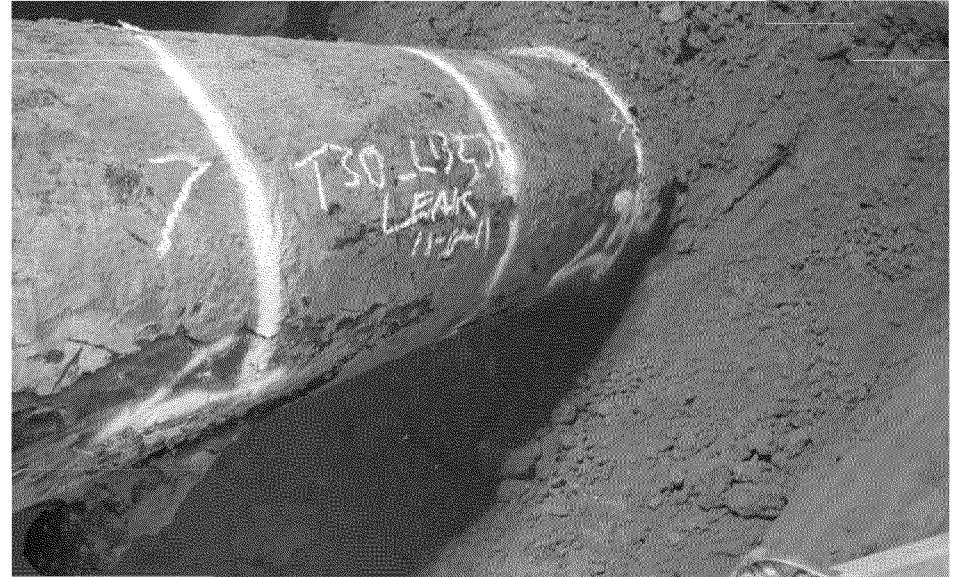
Overview of coating condition 3.00ft to 8.00ft, 9:00 position

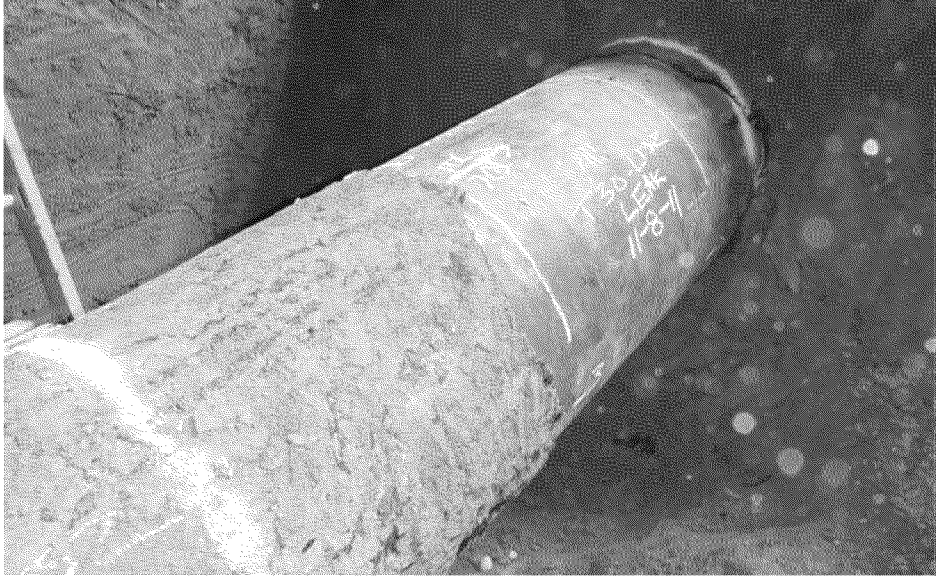
Overview of coating condition 8.00ft to 13.00ft, 3:00 position

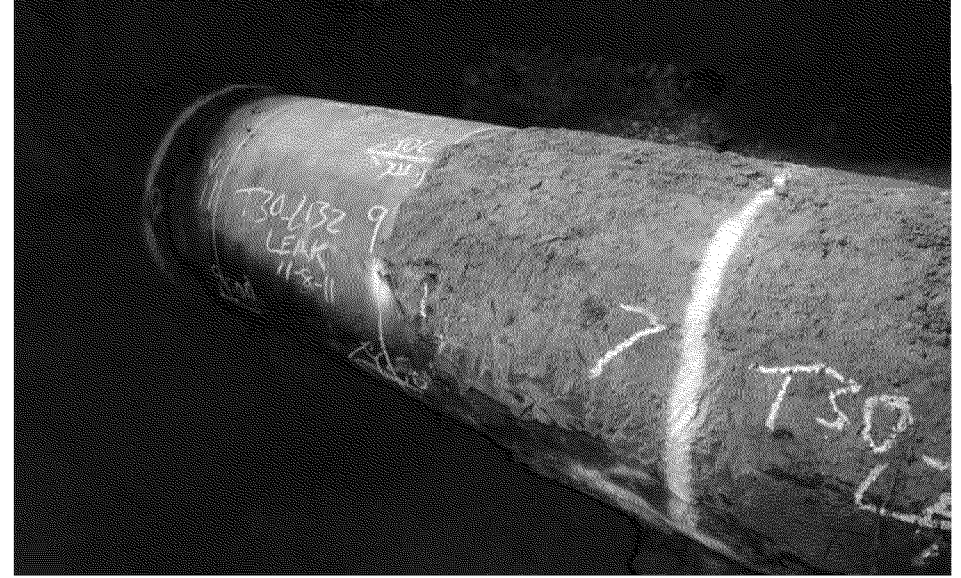
Overview of coating condition 8.00ft to 13.00ft, 9:00 position

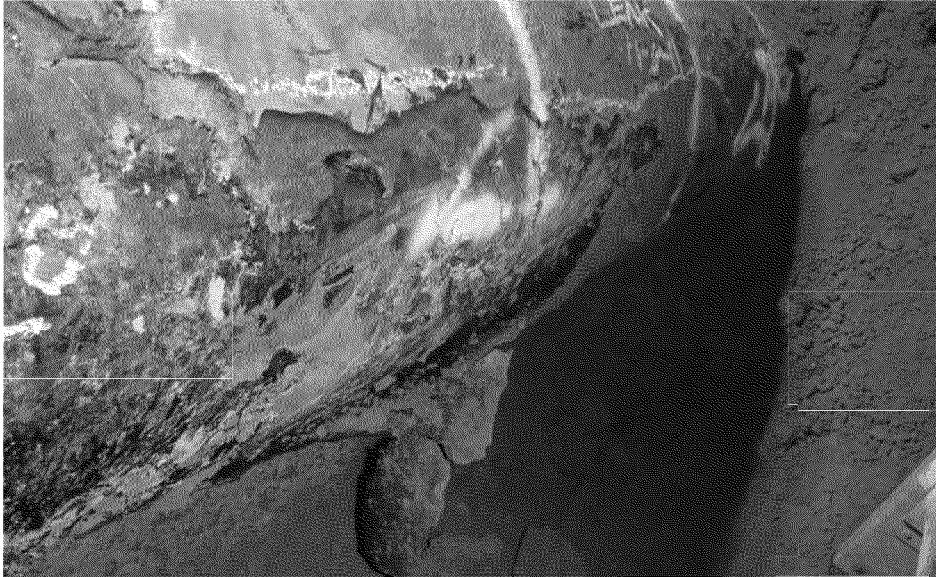
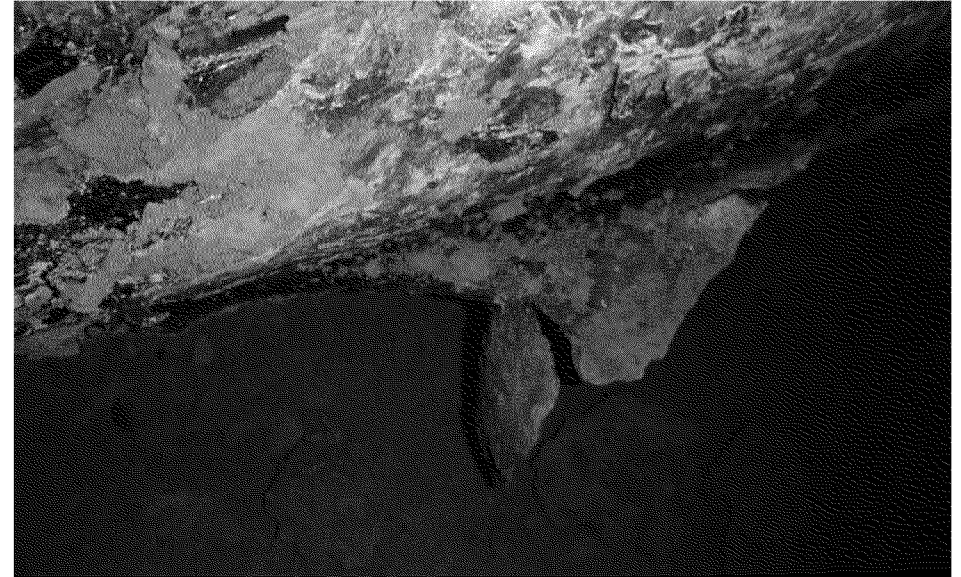
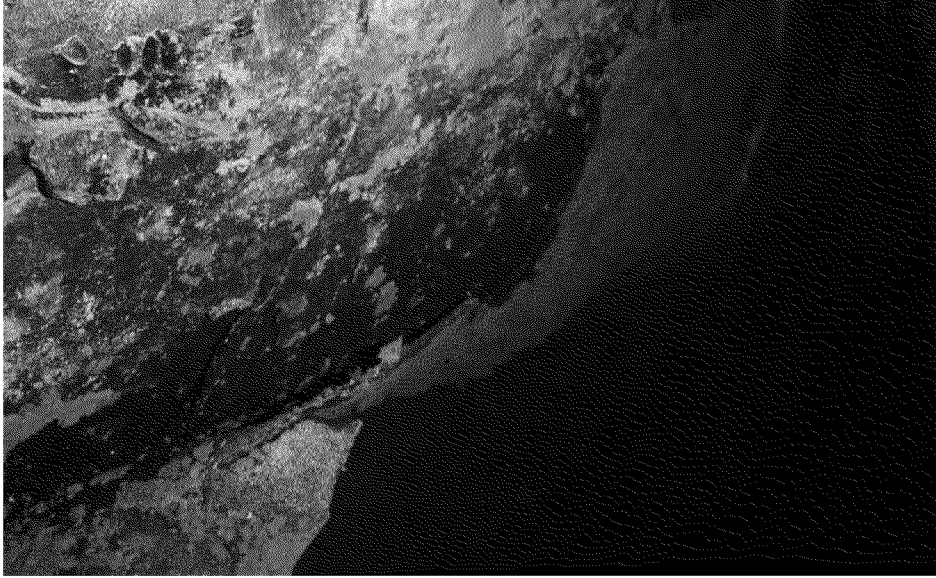
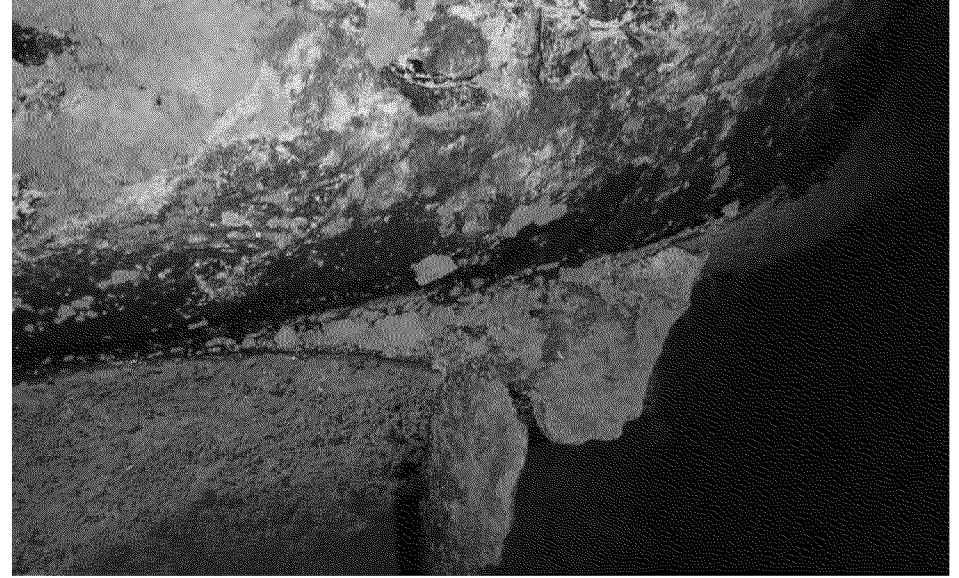
Close up of DIS-01 and coating removed to find leak

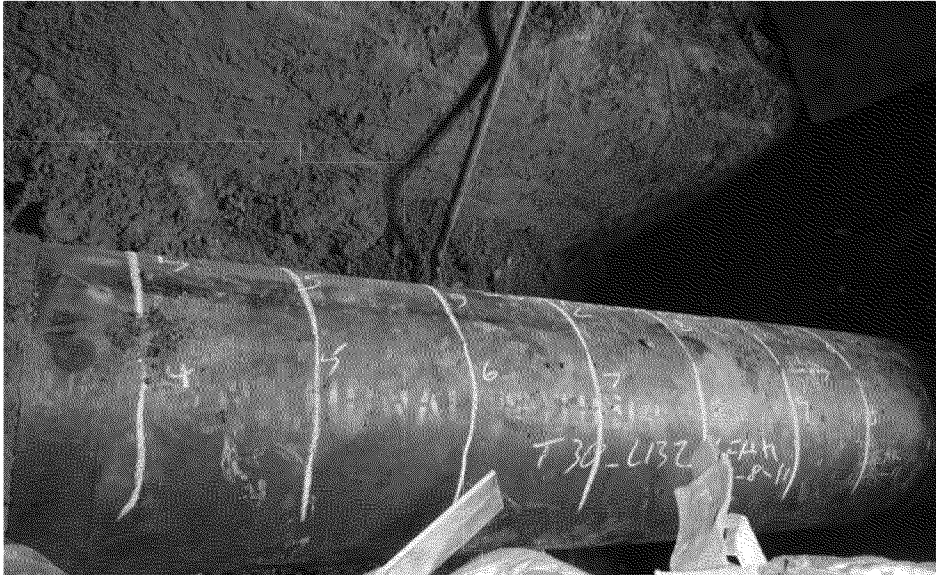
1.13 Corrosion Product Present?:  Yes  No If Yes, Was Sample Taken?:  Yes  No  
 Comments: A deposit was found 10.6ft to 12.35 and was centered at 6:22 with a width of 28.5in.

Overview of deposits layout 3.50ft to 12.35ft, 3:00 position

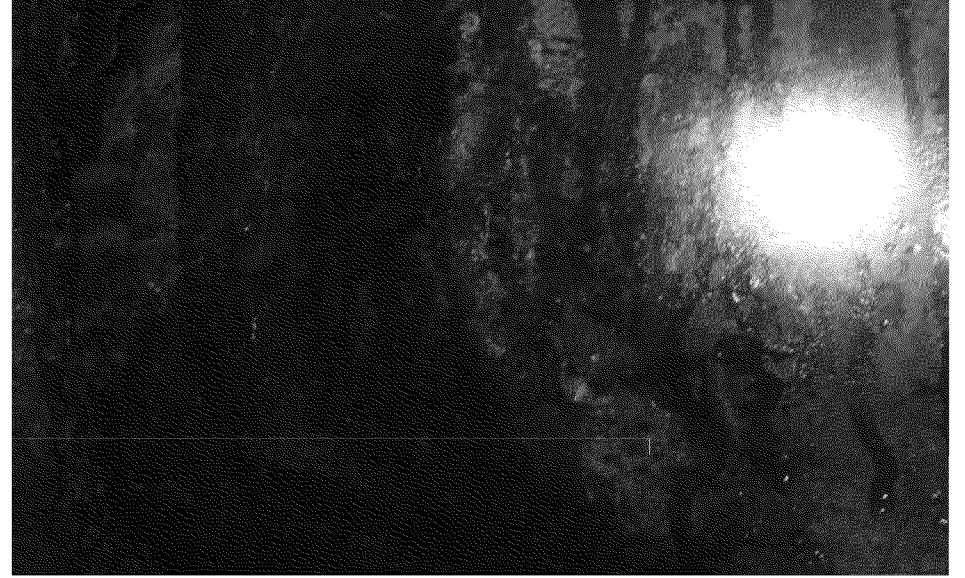
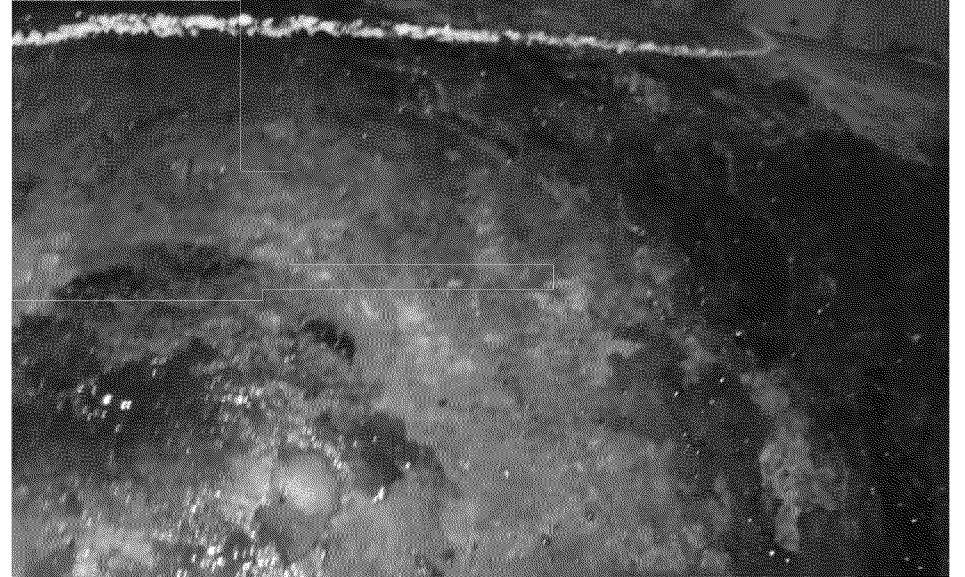
Close up of DEP-01

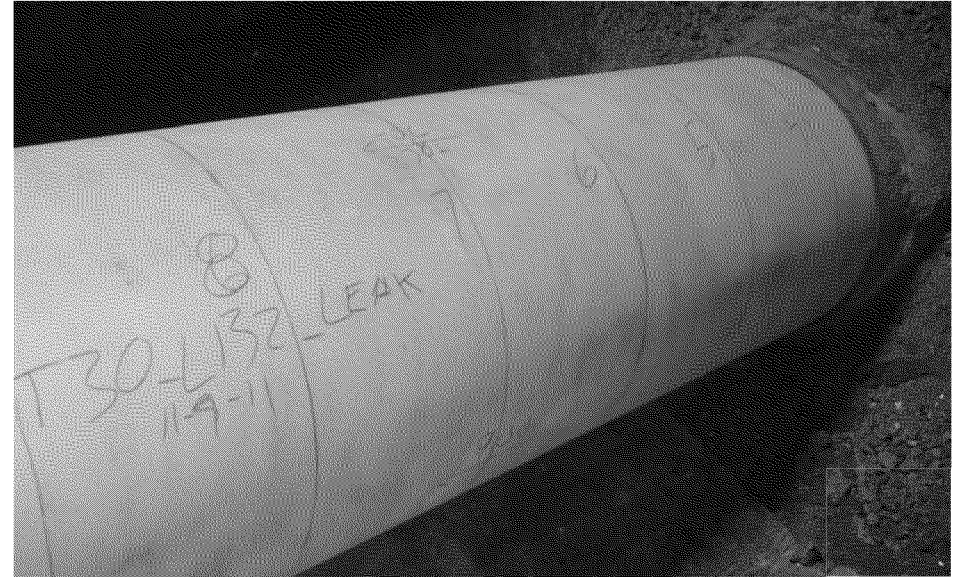
Overview of MPI layout 3.50ft to 8.00ft, 9:00 position

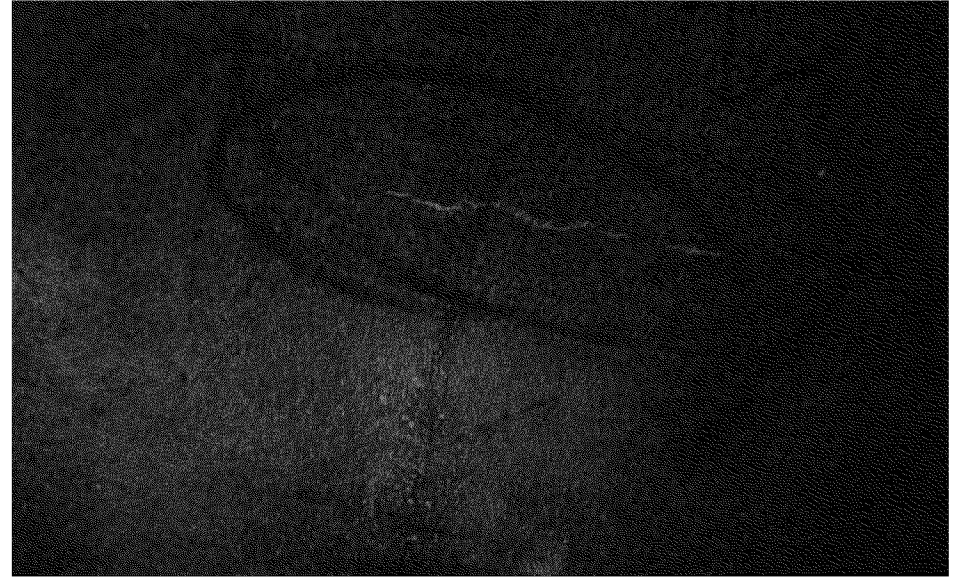
Close up of MT Indications of LIN-02

LIN-19 AXD: 8.15 ft, Clock 7:51, Axial Length: 1.400 in, Circ. W: 1.000 in			
<b>NOTE:</b>			
LIN-01 Thru 19 were remediated by ARB by buffing. Removal was verified with MT. See UT report for information on final wall-thicknesses.

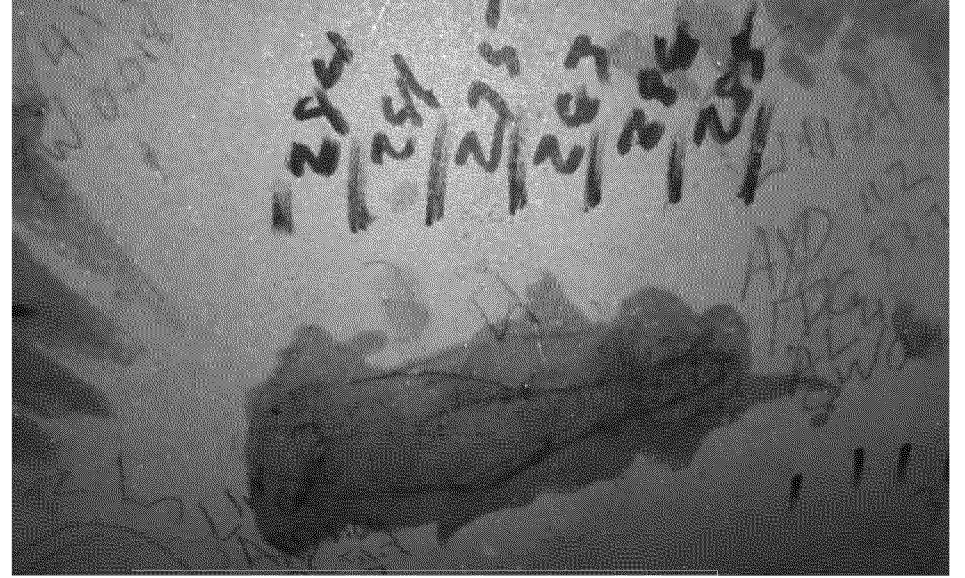
Overview of pre buff area (RWT) LIN-04

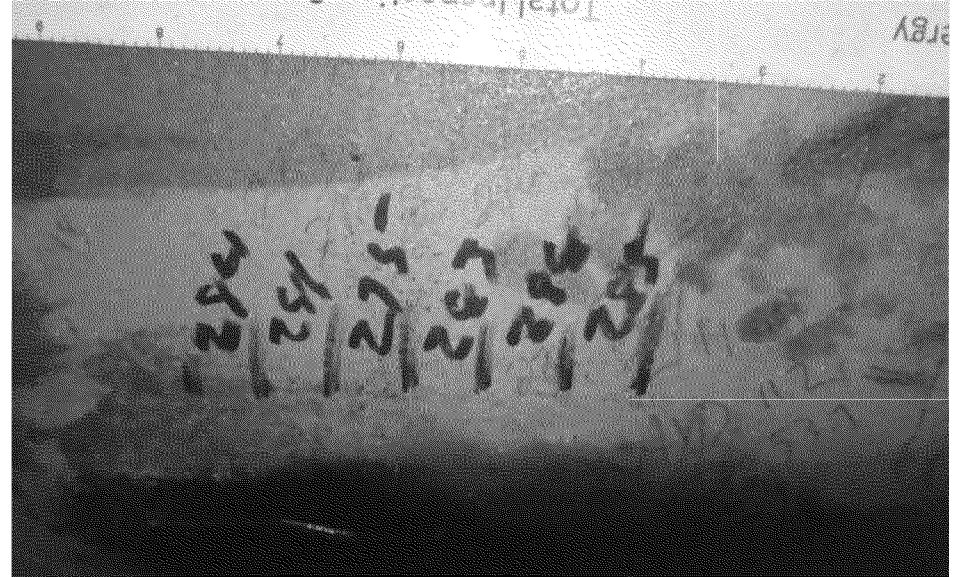
Close up post grind (RWT) of LIN-04

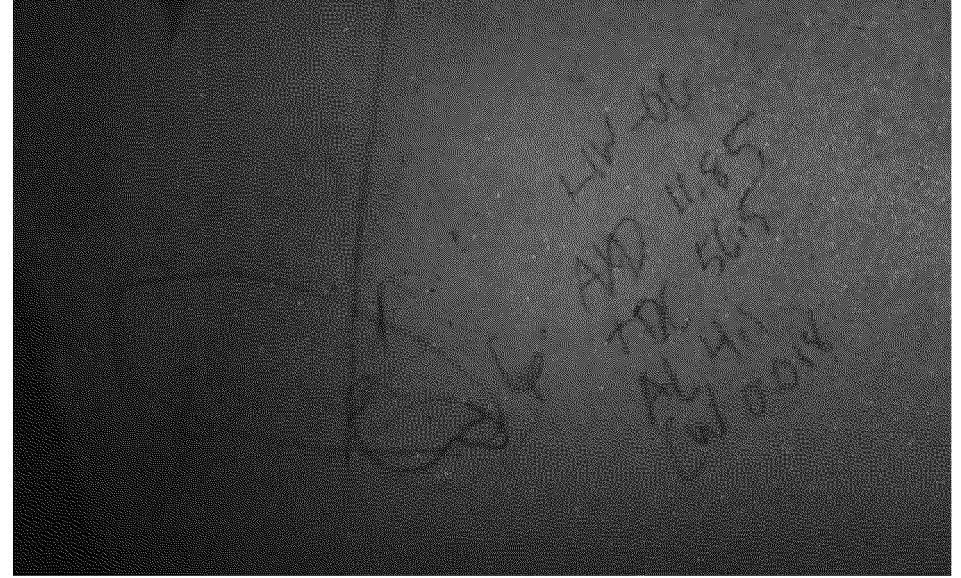
Overview of MT Indications of LIN-06

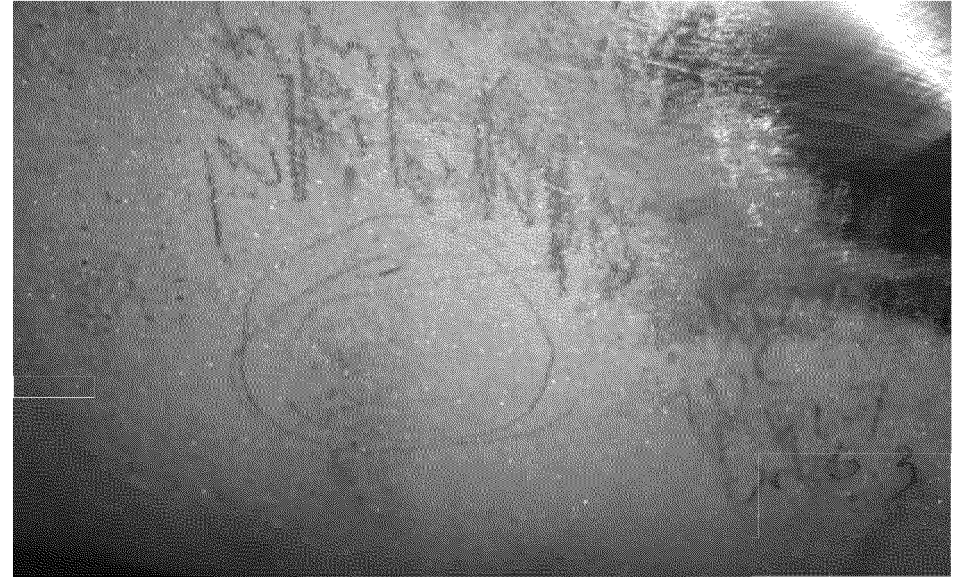
Close up post grind (RWT) of LIN-06

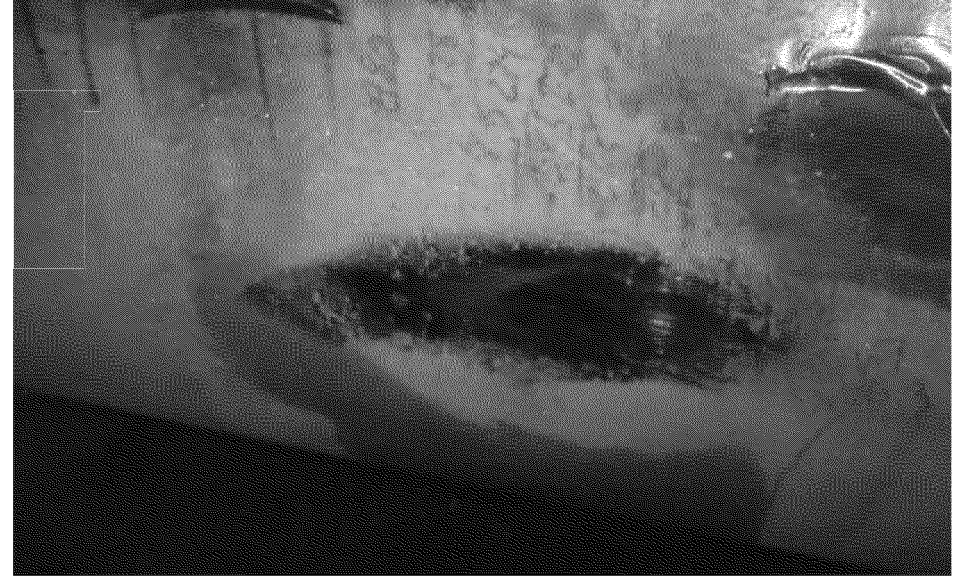
Overview of pre buff area (RWT) LIN-06

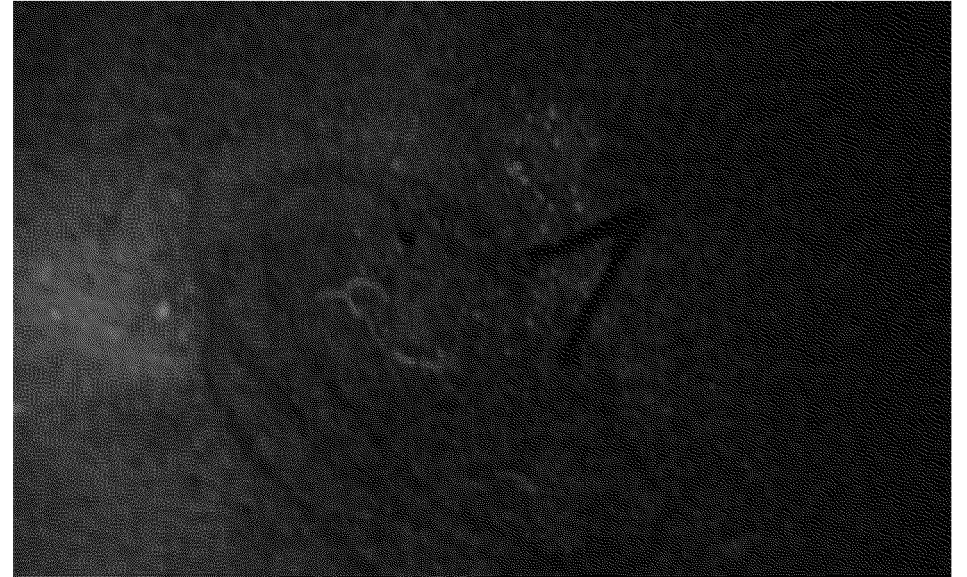
Close up of MT Indications of LIN-07

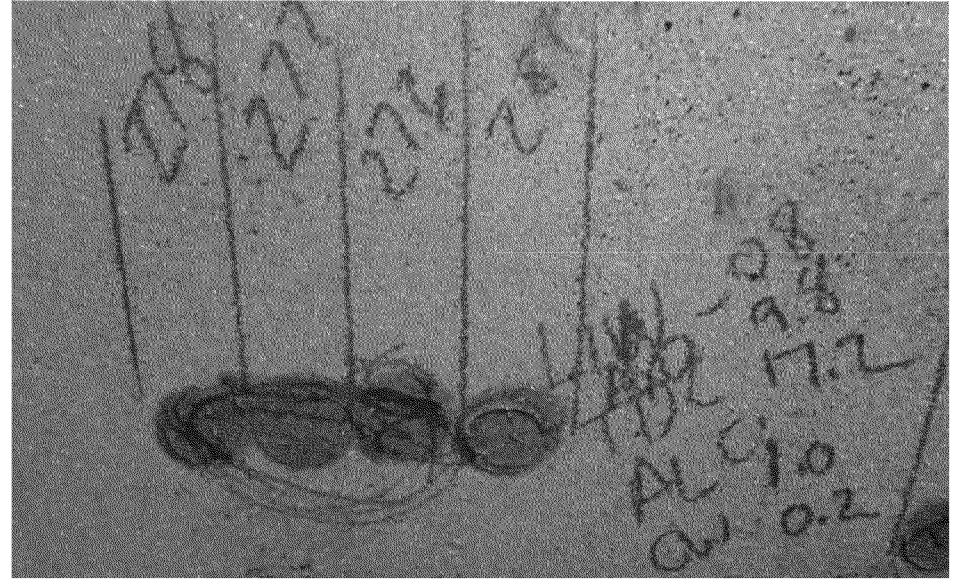
Overview of pre buff area (RWT) LIN-08

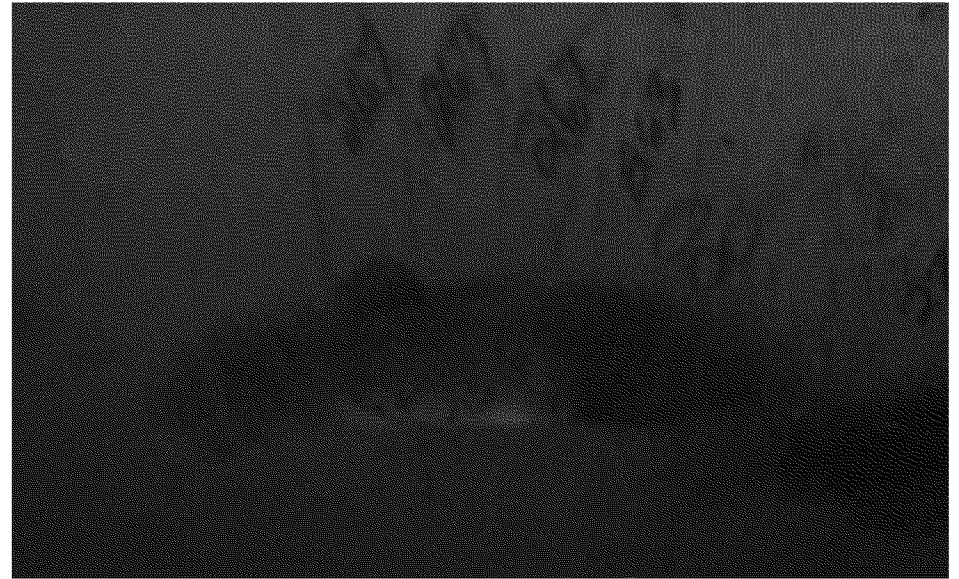
Close up post grind (RWT) of LIN-08

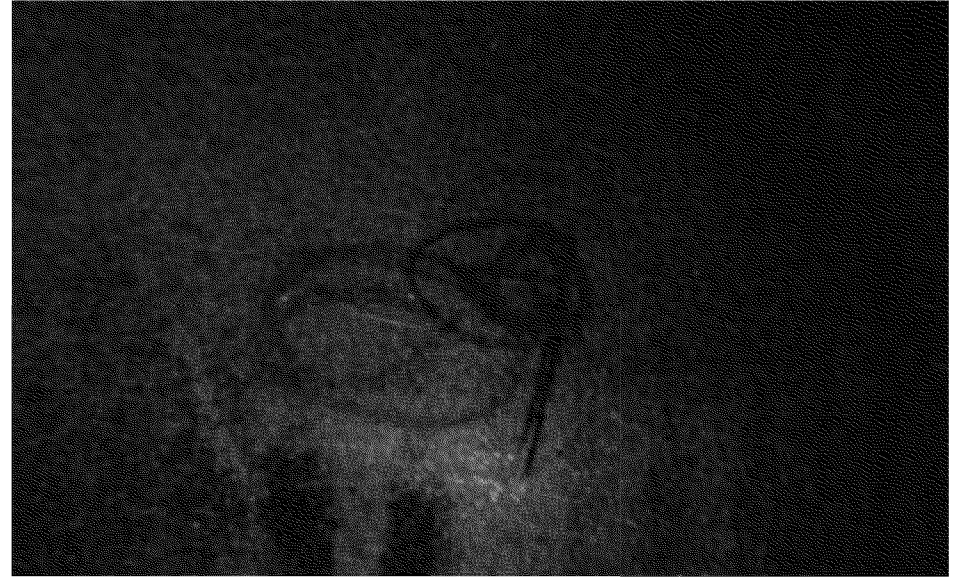
Close up of MT Indications of LIN-09

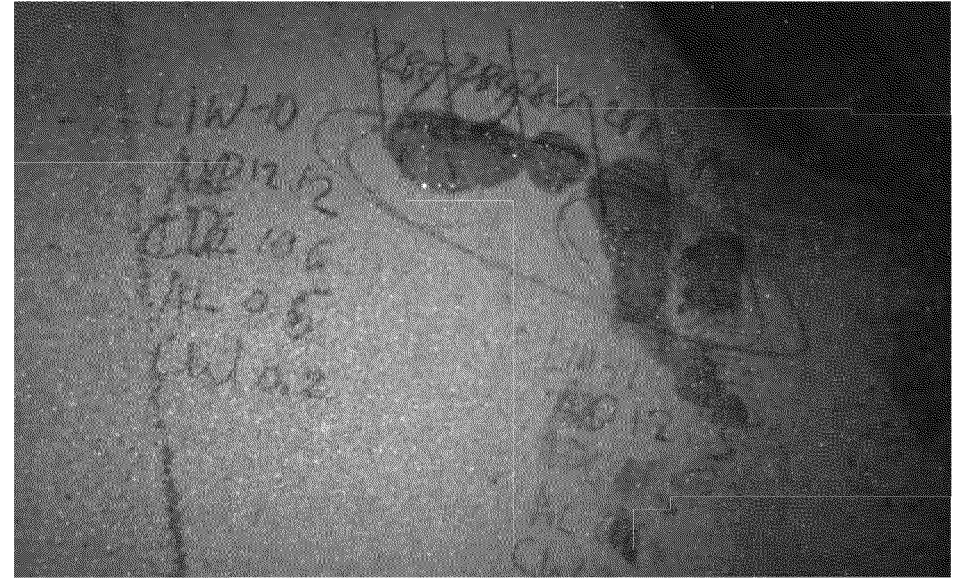
Overview of pre buff area (RWT) LIN-10 & 11

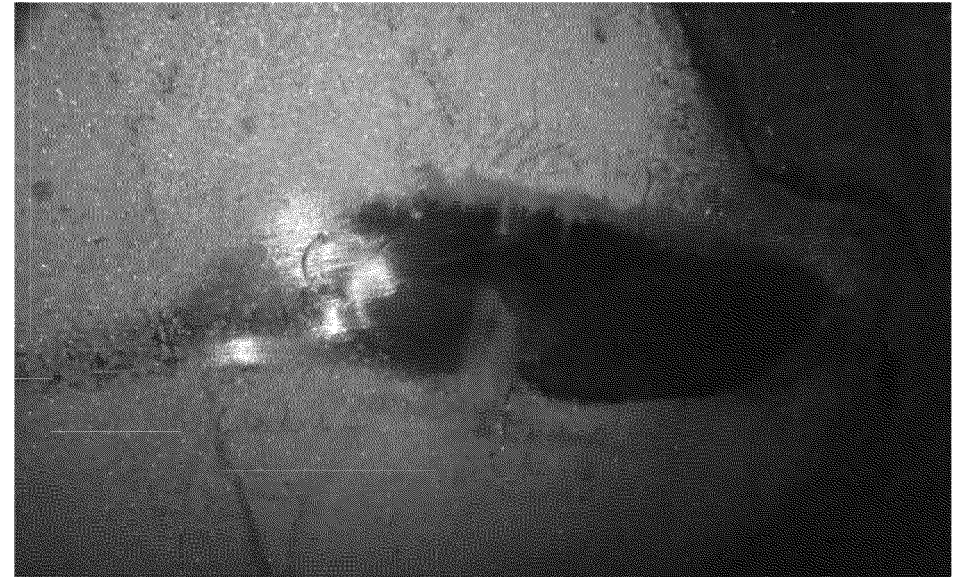
Close up post grind (RWT) of LIN-10 & 11

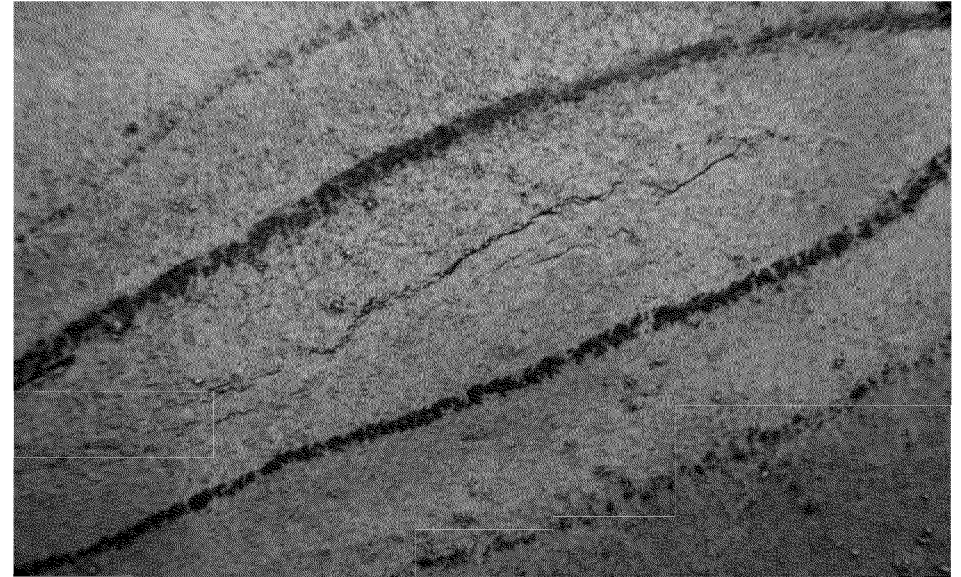
Close up of second inspection MT Indications of LIN-01

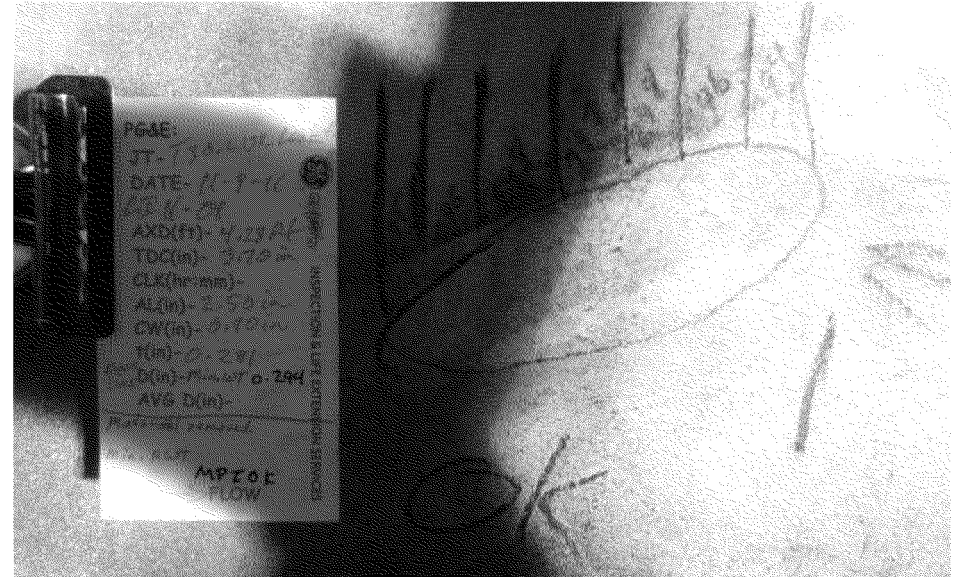
Overview of second inspection post grind (MPIOK) of LIN-01

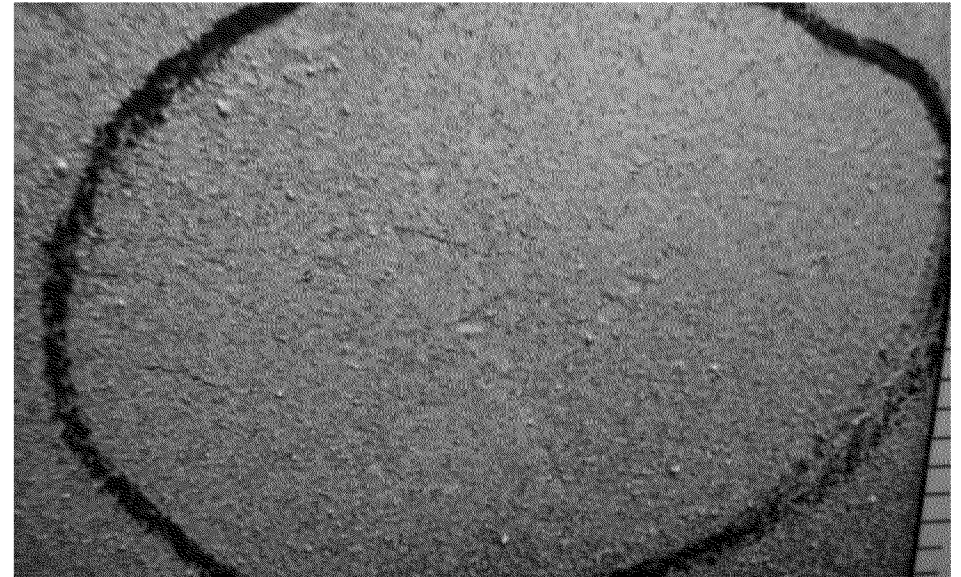
Close up of second inspection MT Indications of LIN-03

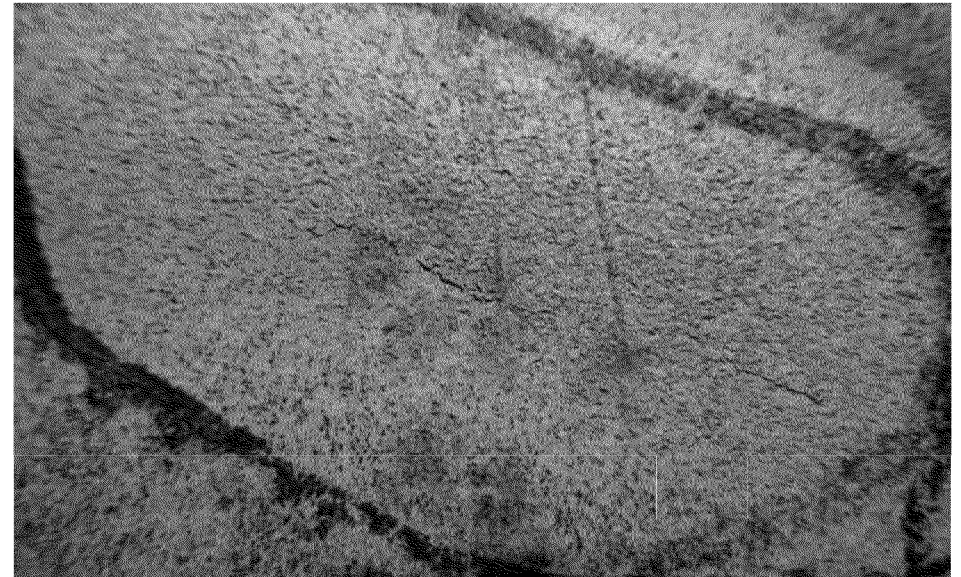
Close up of second inspection MT Indications of LIN-07

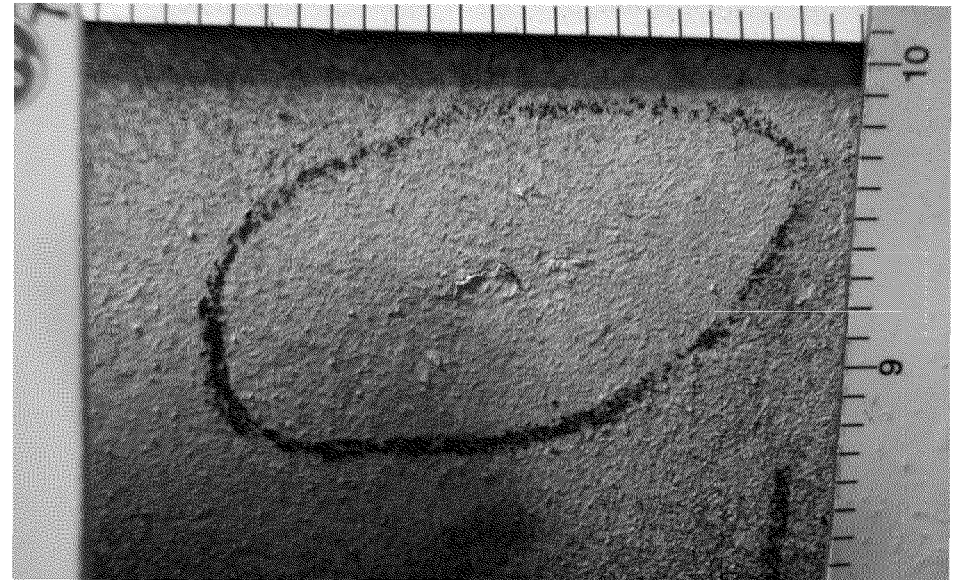
Close up of second inspection MT Indications of LIN-11

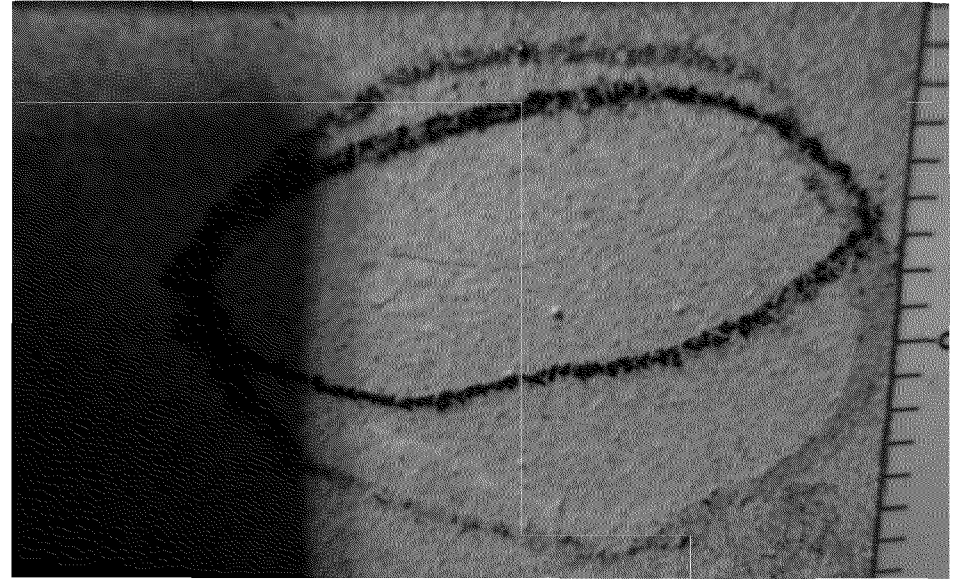
Close up of second inspection MT Indications of LIN-13
