**IN-FIELD SERVICES**  
**GEIS Pipeline Integrity Team NDE**

**Pacific Gas & Electric Company**  
**Hydrostatic Test Dig from November 8, 2011 to January 0, 1900**  
**T30\_L132\_Leak\_MP-15.0029**  
**Documents Contained Within:**

H-Form Report T30\_L132\_Leak MP-15.0029  
NDE Reports of T30\_L132\_Leak MP-15.0029  
Photo Report of T30\_L132\_Leak MP-15.0029

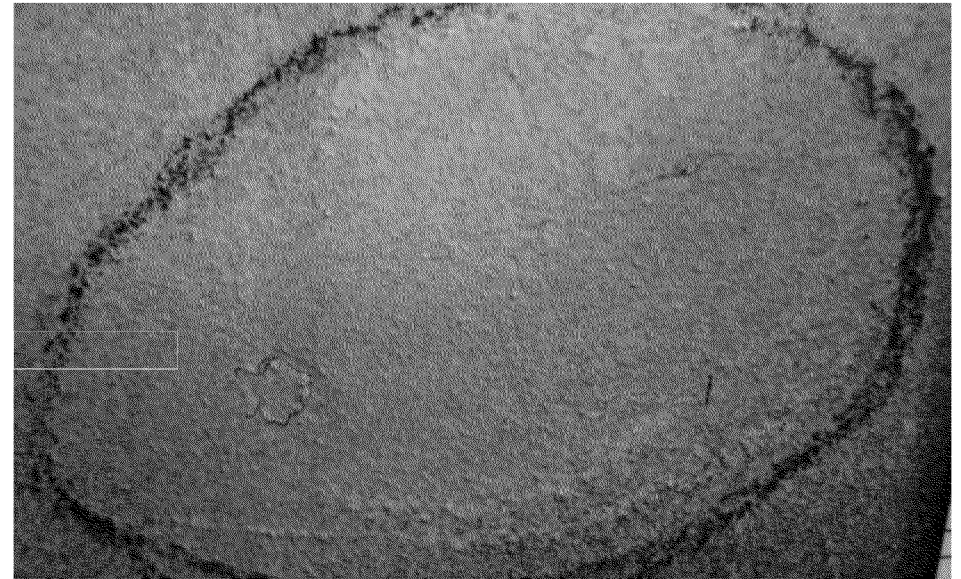
Close up of second inspection MT Indications of LIN-19

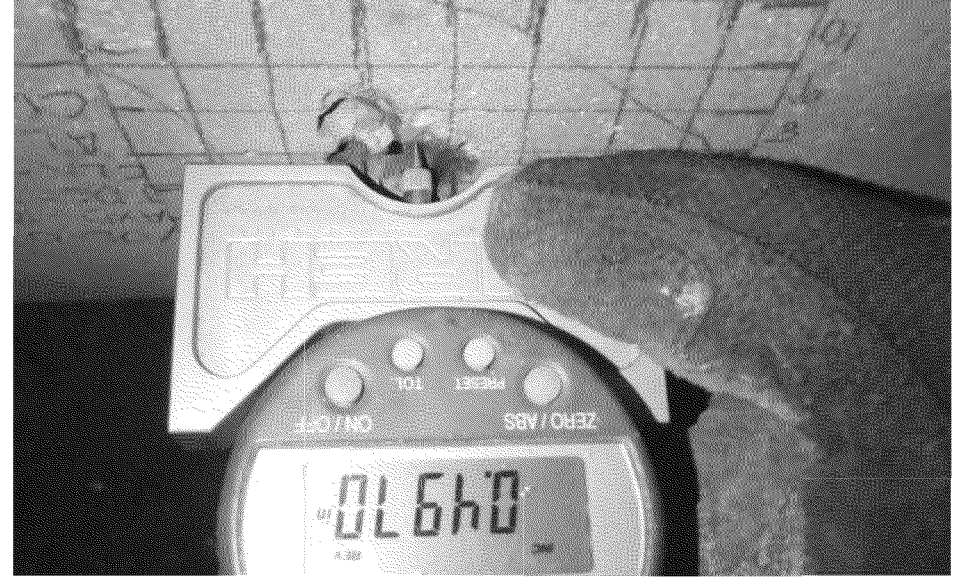
AXD: 10.96' (from US ditch start)  
 Clock: 6:02  
 Axial Length: 3.5"  
 Circumferential Width: 5.8"  
 Max Depth: Through-wall (E7)

Pit gauge measurement VOL-01

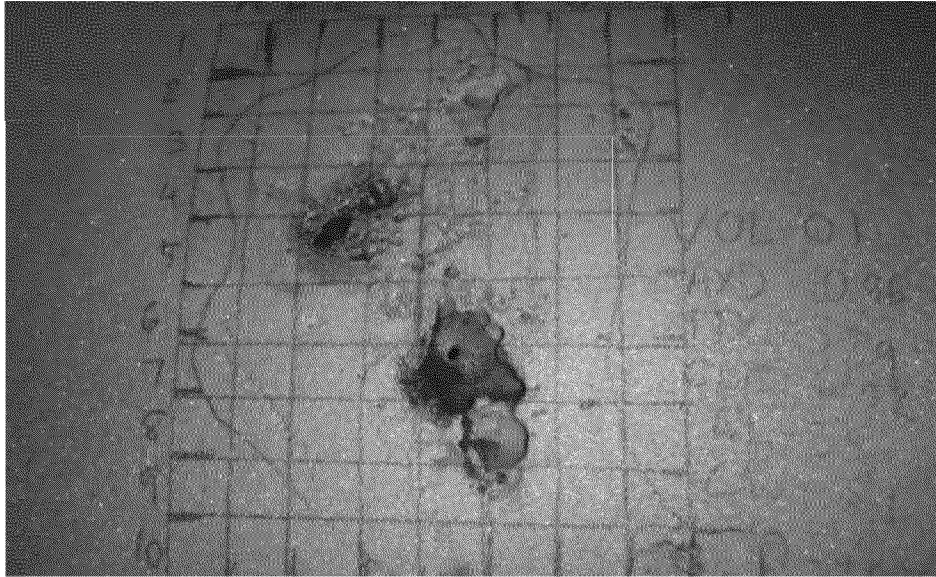
Overview of corrosion grid VOL-01

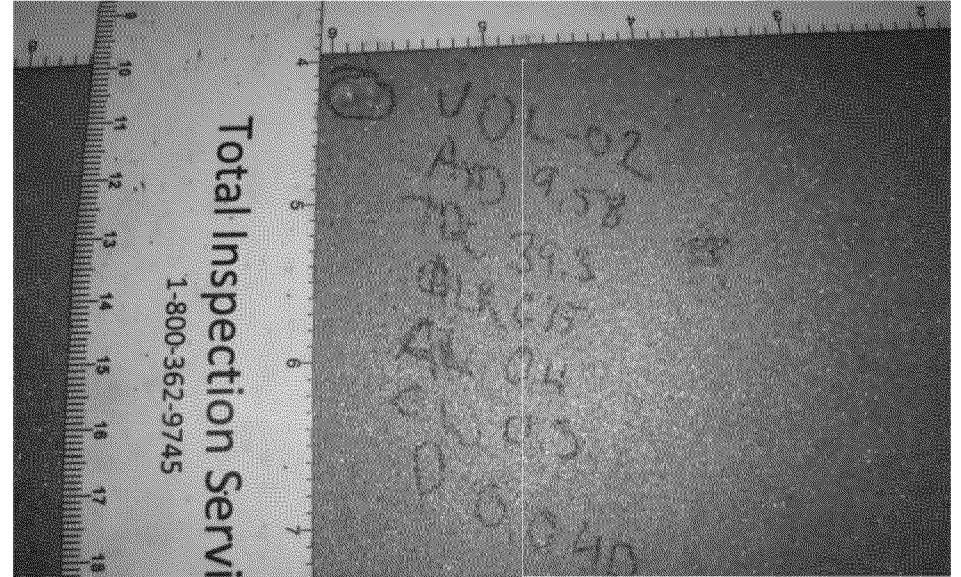
Overview (with measurements) of VOL-02

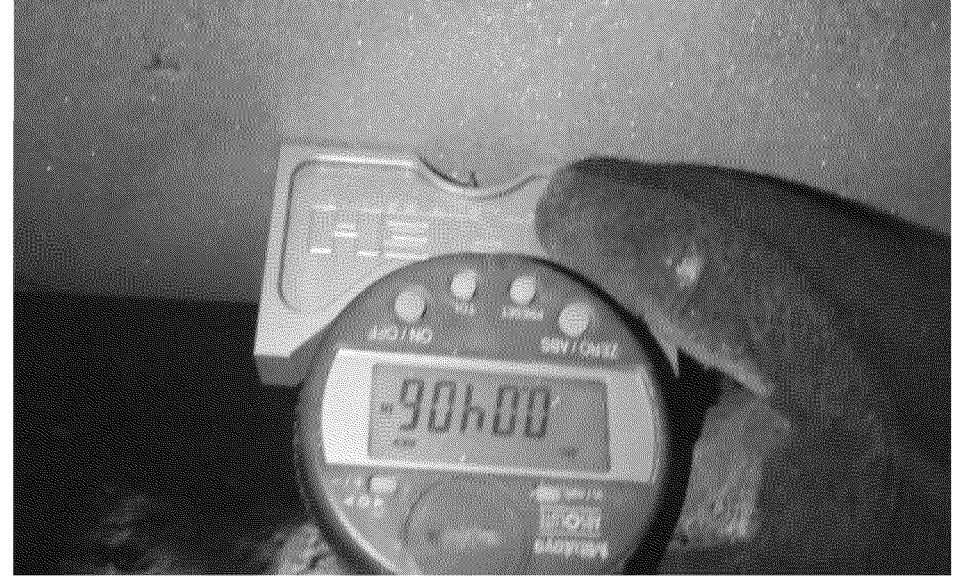
Pit gauge measurement VOL-02

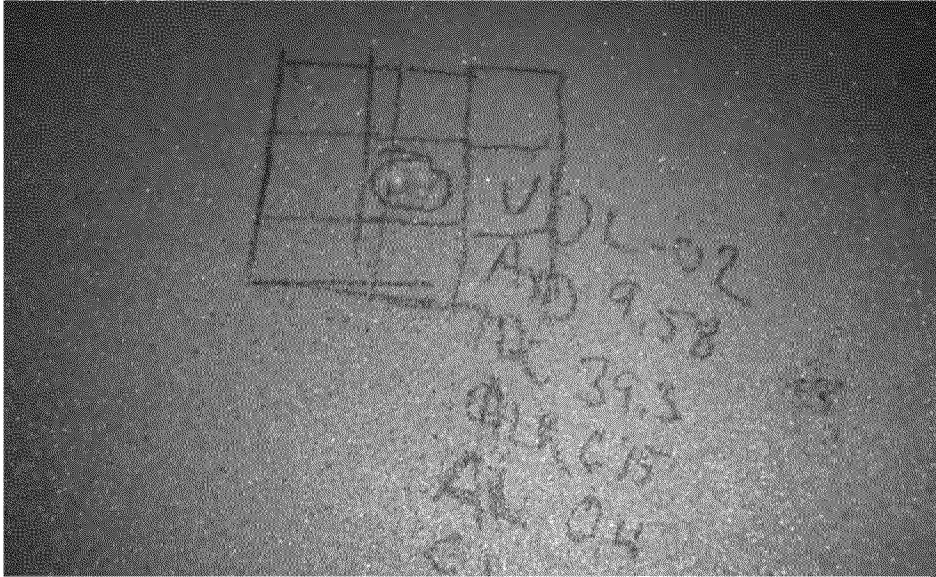
Overview of corrosion grid VOL-02
