Investigation of a Failure of Line 300 at Mile Post 284.14 during Hydrostatic Test 117

MJ Rosenfeld, PE
March 16, 2012

PACIFIC GAS & ELECTRIC COMPANY

0215-1116

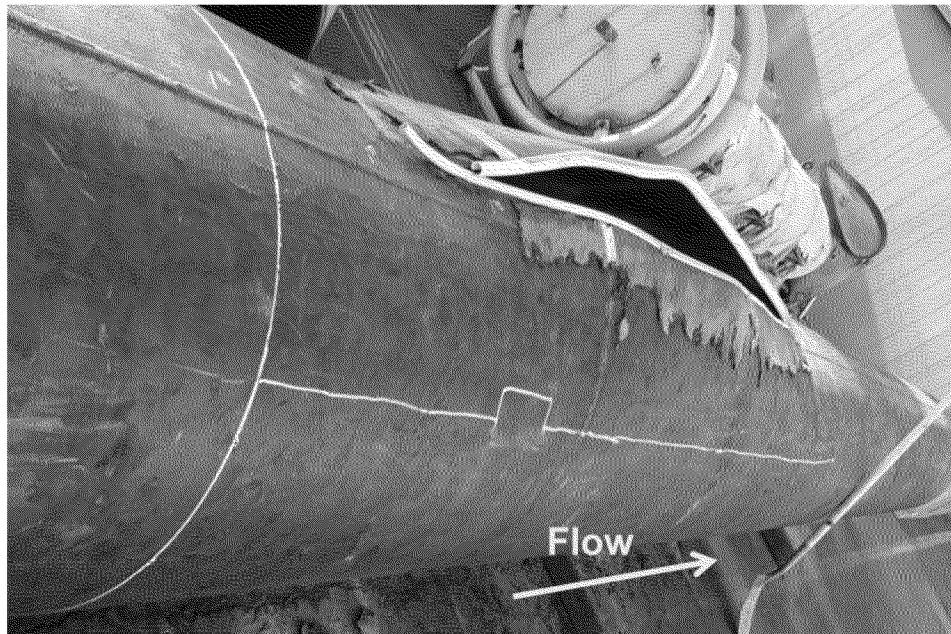
A nominal 40-ft (39-ft, 7-in actual) section centered on the fracture was removed by PG&E and shipped to the PG&E Applied Technical Services facility in San Ramon, CA for initial examination. An overall view of the pipe specimen is shown in Figure 1, viewed looking downstream approximately East to West. Most of the hot applied asphalt coating had been removed except immediately adjacent to the fracture. Slit rubber hoses were placed over the fracture surfaces for mechanical protection. The white lines mark where the specimen was cut to smaller size.

Figure 1. Failure Specimen, Coating Removed, Marked for Cutting (photo by author)

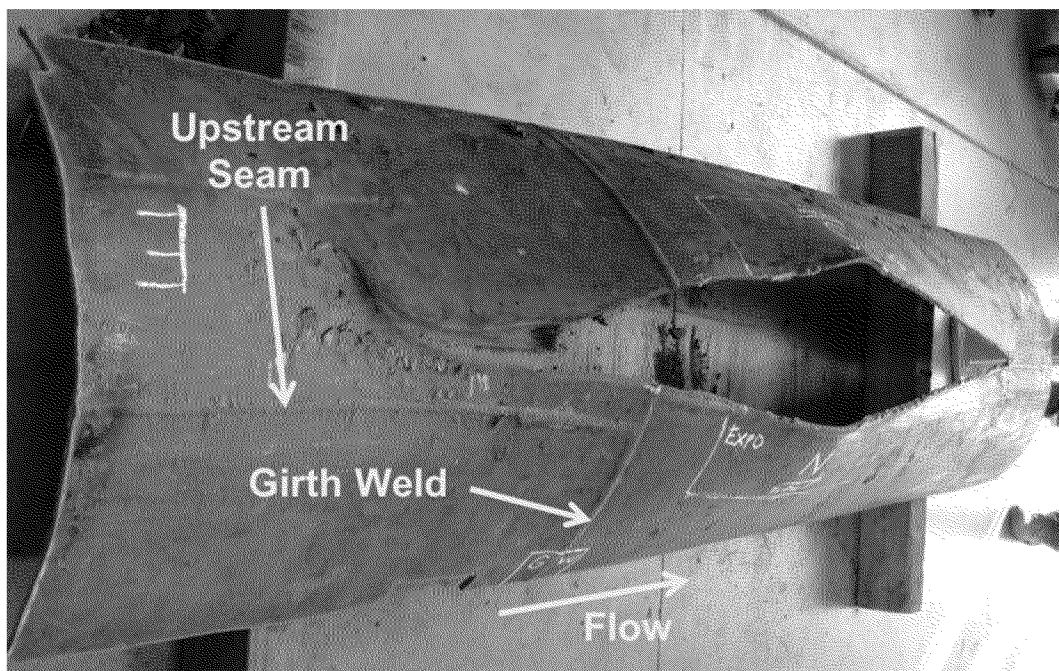
The failure specimen was cut down to manageable size, shown in Figure 2, with remaining coating removed and as marked for further subdivision. The total length of the fracture was 89.5 inches. The fracture intersected a girth weld visible to the right of the locating notch, terminating 19 inches into the upstream pipe joint.

Figure 2. Reduced Size Specimen Containing Fracture (photo by author)

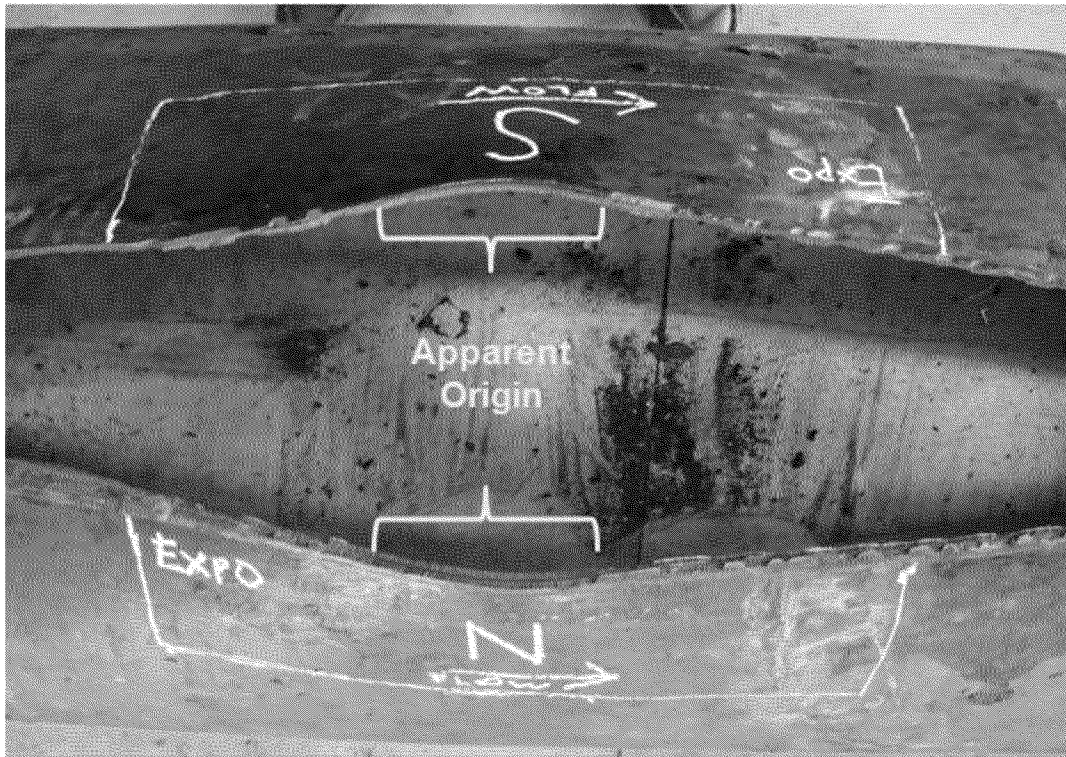
An apparent origin 6.5 inches long was located 14.5 inches downstream of the girth weld. Coupons containing only the central portion of the fracture were cut out to isolate the apparent origin, identified in Figure 3. The apparent origin was confirmed as the probable origin based on its occurrence at the widest point of opening in the rupture, and by the appearance of brittle fracture chevrons in the propagating fracture, which pointed toward the 6.5-inch-long feature.

Figure 3. Coupons of Mating Fracture Segments Containing Apparent Origin (photo by author)

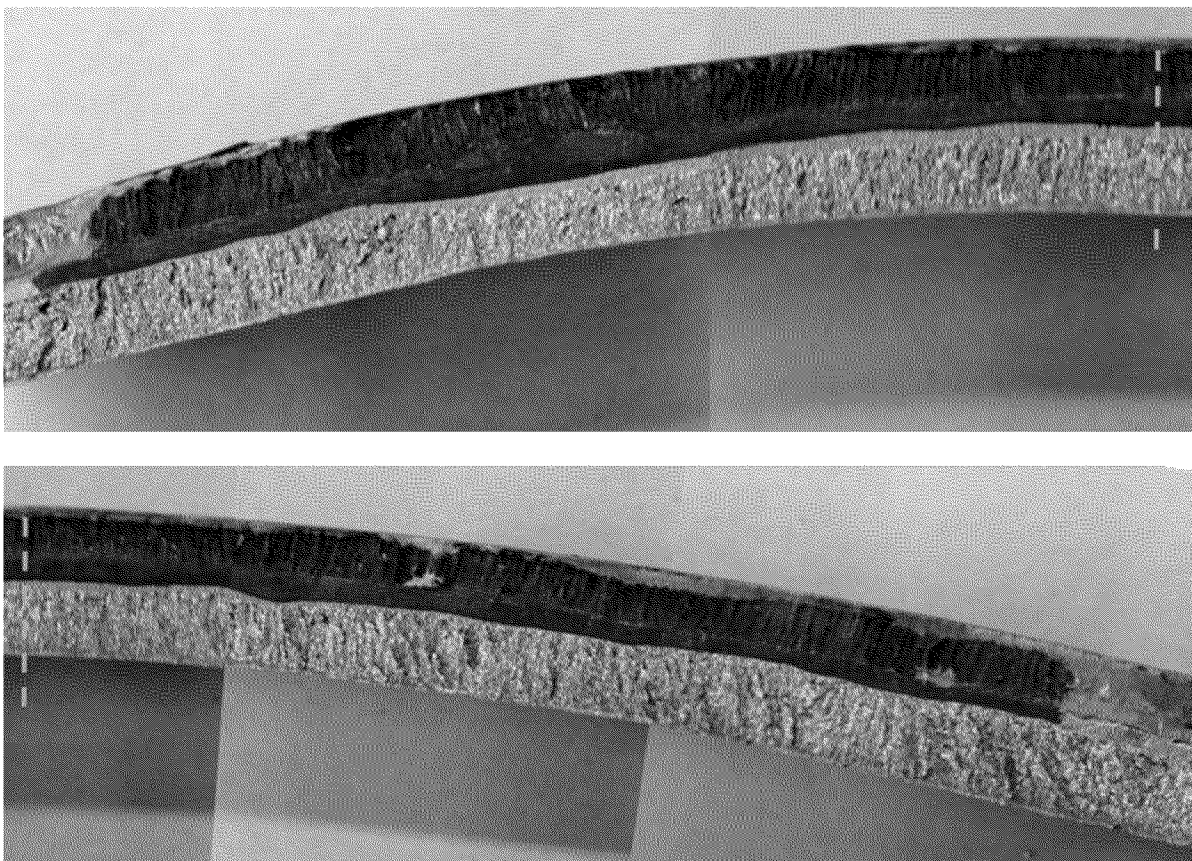
A composite detail of the origin in the condition as discovered is shown in Figure 4 prior to cleaning. The apparent origin is seen to consist of a 6.5-inch-long crack in the outer seam weld deposit. The apparent origin presented a columnar texture typical of certain types of weld cracks, and a dark coloration that could be a stain or oxide. The vertical dashed line in represents match points in the two photos.

An unfused region was present along the center of the weld between the inner and outer seam weld deposits. The dark coloration on the weld crack extended to the unfused region between the weld beads but only over a length essentially coincident with the weld crack. The unfused region extended the full length of the fracture, but did not exhibit the dark coloration beyond the length adjacent to the weld crack. The inner weld deposit exhibited a bright fracture surface consistent with recent brittle fracture. Beyond the 6.5-inch-long defect, the fracture exhibited brittle fracture propagation chevrons that pointed toward the 6.5-inch defect and beyond that transitioning to ductile shear fracture propagation.

Figure 4. Composite of Origin, North Fracture Surface, Before Cleaning, 2X (photo by author)

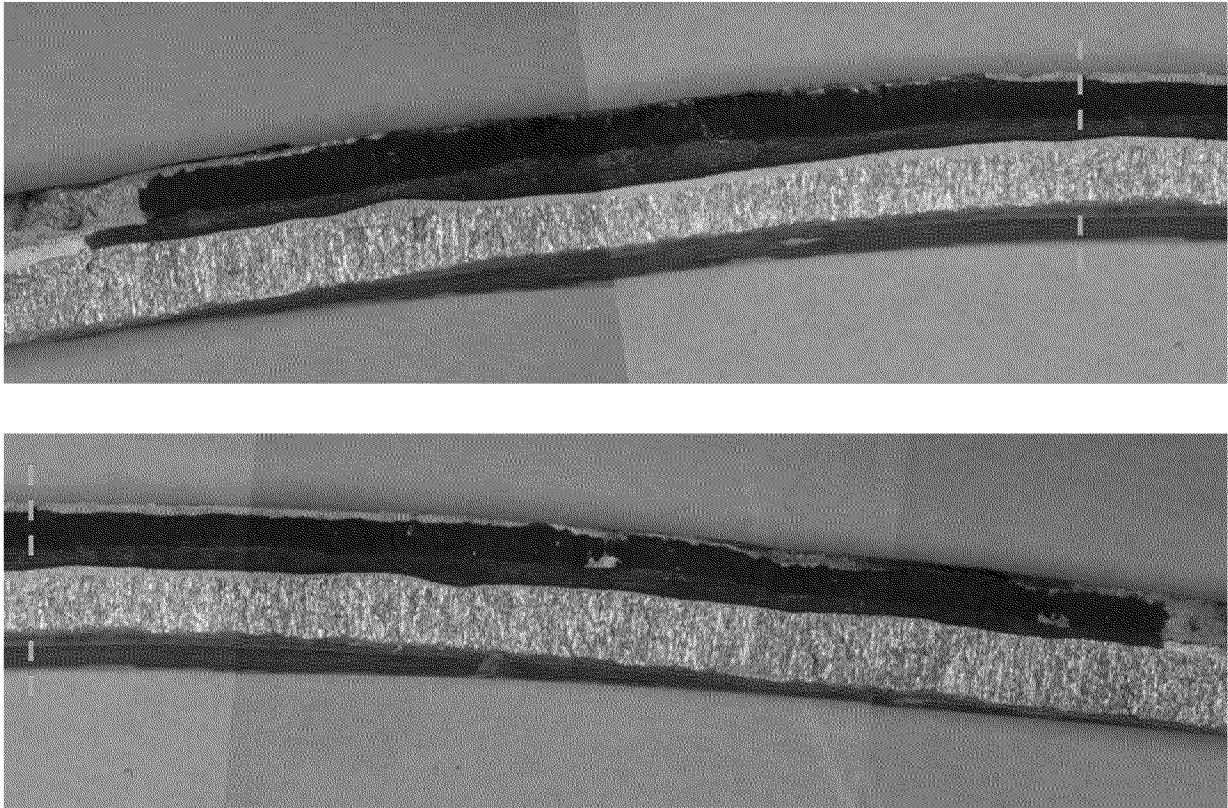
The fracture surface was cleaned in acetone, then xylene, and then a nonoxidizing detergent (Alconox). It was then cleaned ultrasonically in a mild alkaline detergent (Micro 90). The cleaning steps failed to remove the dark coloration on the weld crack, but lightened the coloration on the unfused surfaces, as shown in Figure 5. The vertical dashed line represents match points in the two photos.

The resistance of the dark coloration to a variety of cleaning methods suggested that it was an adherent oxide. The persistence of the dark oxide, position of the crack at the centerline of the outer weld deposit, and visible columnar texture of the crack surface all were consistent with a hot crack, a condition known to occur in submerged arc welds.

Figure 5. Composite of Origin, North Fracture Surface, After Cleaning, 2X (photo courtesy Exponent)

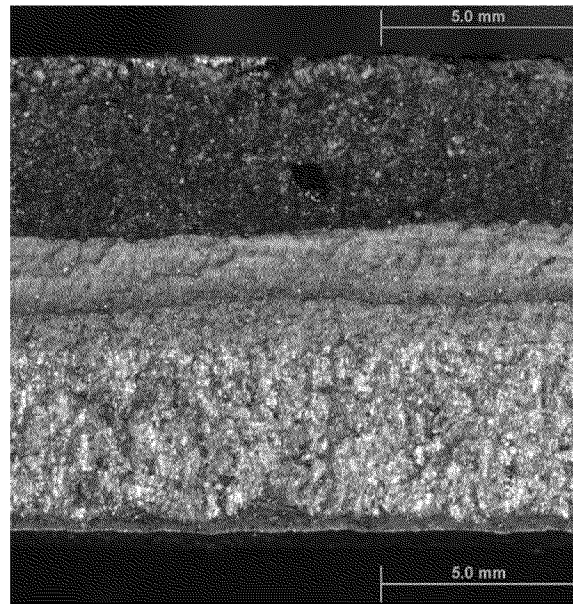
The fracture was examined in a stereomicroscope to resolve features of interest, both before and after cleaning. Figure 6 shows a region of the fracture surface before cleaning. A dark, shiny deposit is evident near the exterior surface and on portions of the fracture in the outer weld deposit.

Figure 6. Fracture Surface Before Cleaning, 5X (photo by Exponent)

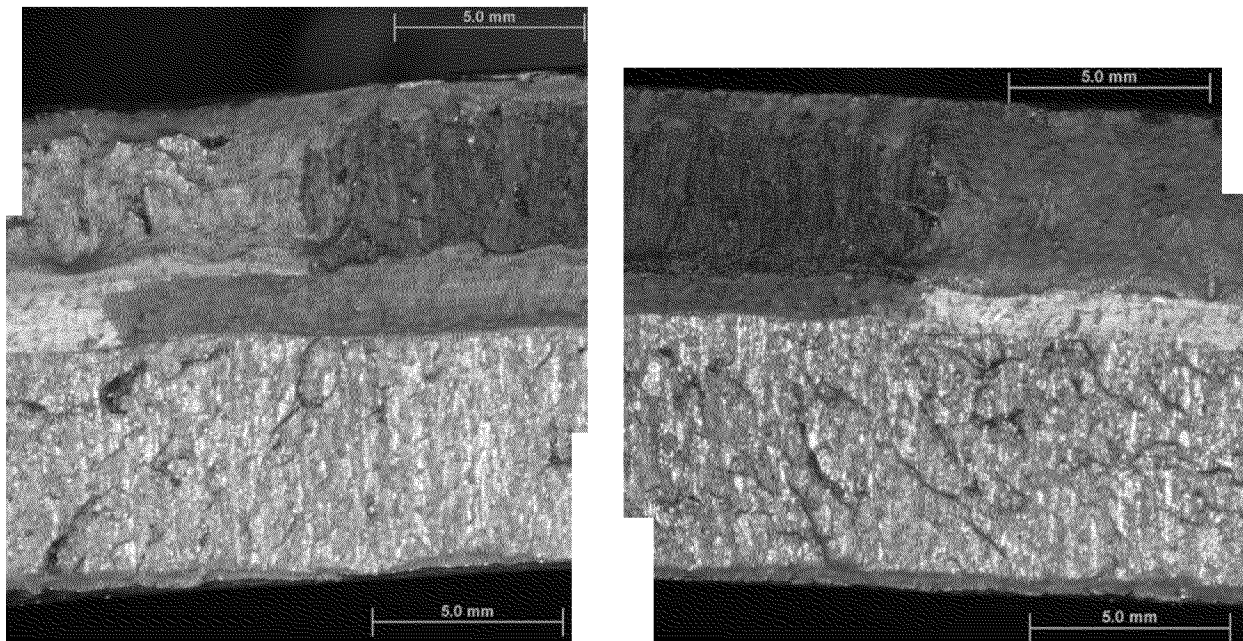
Figure 7 shows both ends of the defect, before cleaning. The dark coloration is present on the weld crack. The unfused surface is the flat region between the oxidized and nonoxidized weld fractures. The dark coloration on the LOP surface disappears beyond the portion that is coincident with the weld crack. The radial dimension of the LOP varied from 0.04 inch to 0.10 inch, based on viewing the surface under low magnification.

Figure 7. Terminations of Origin Defect, North Fracture Surface, 5X (photo by Exponent)

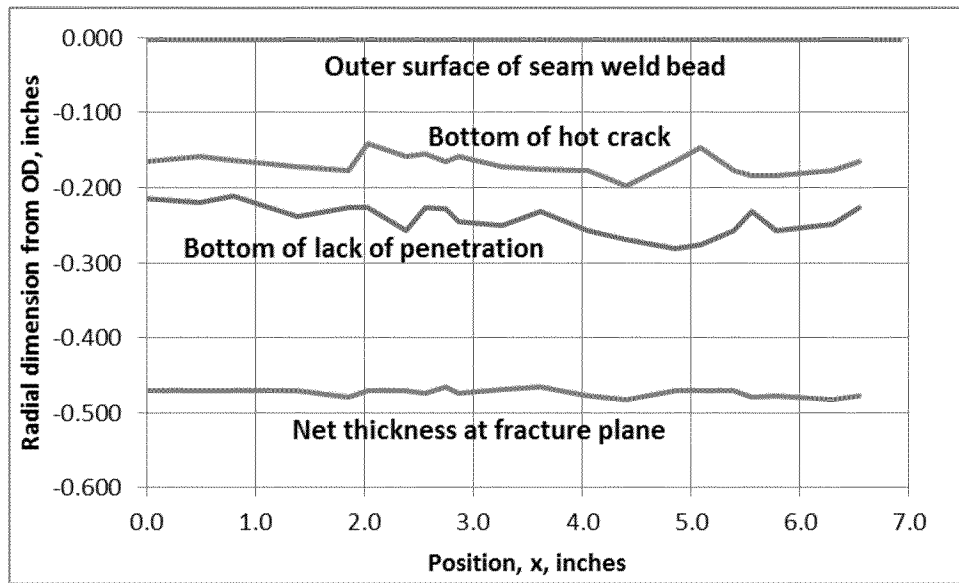
Photographs similar to those in Figure 6 and Figure 7 spanning the full length of the apparent origin and beyond were used to develop a profile of the radial dimensions of the apparent hot crack, the lack of fusion between the inner and outer weld beads, and the net thickness through the fracture plane. The profiles are given in Figure 8, as measured from the intersection of the fracture with the outside surface of the outer weld bead represented at the top of the chart. The average metal thickness through the fracture was 0.473 inch.

Figure 8. Radial Dimensions of Fracture Features

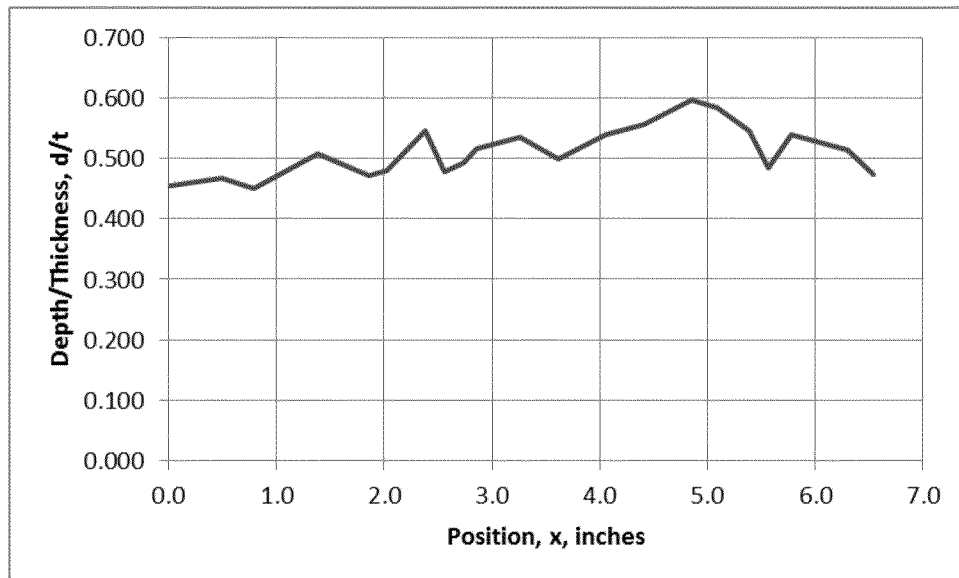
Figure 9. Ratio of Flaw Depth to Metal Thickness

The actual profile of the combined hot crack and LOP defect, from Figure 8, has a ratio of flaw depth to metal thickness (d/t) shown in Figure 9. The average d/t was 0.51 (51% of the metal thickness) with a maximum d/t of 0.60.

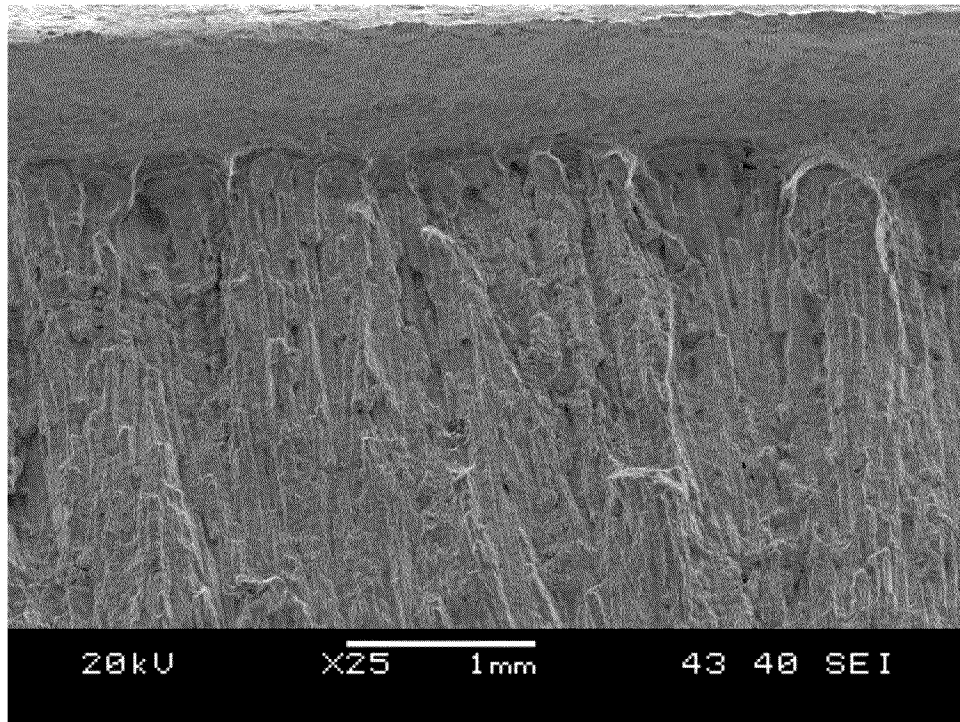
Figure 10. Zone 1 and Upper Part of Zone 2, 25X

Figure 10 shows Zone 1 and the upper portion of Zone 2. Figure 11 is a detail of Zone 1 at high magnification exhibiting a dimpled texture indicating ductile fracture. Zone 1 is interpreted as a ductile shear lip that failed at the time of the hydrostatic test.

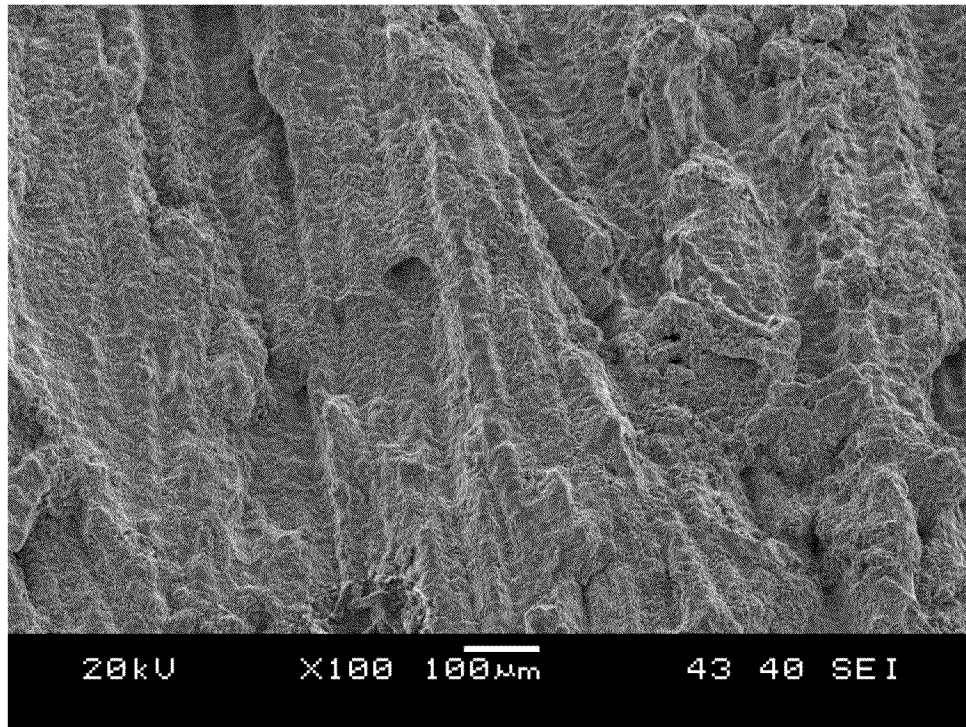
Figure 12. Zone 2 Surface, 100X

Figure 12 shows the typical surface in Zone 2. Zone 2 in Figure 12 and in the lower portion of Figure 10 exhibits the columnar structure of the apparent hot crack in the weld. Figure 13 is a detail of Zone 2 at high magnification. The surface is coated with an adherent oxide. Figure 14 shows a region where Zone 2 penetrates through Zone 1 to the pipe exterior surface (at bracket). The arrow identifies what appears to be extension of the flaw. Figure 15 is a detail of the extension feature at high magnification with Zone 1 in the upper left and Zone 2 in the lower right. While the feature between the two zones lacks the columnar structure of Zone 2, it is coated with an adherent oxide like Zone 2 suggesting that it experienced a similar environmental history as Zone 2. The identified region is interpreted as extension of the hot crack that occurred while the material was still hot.

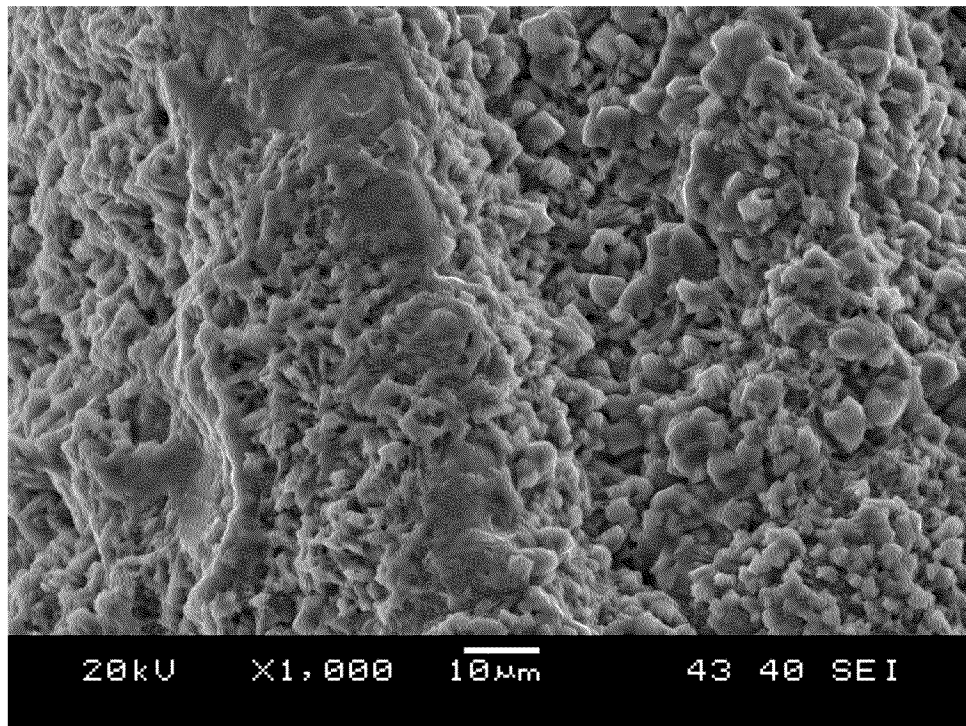
Figure 13. Detail of Zone 2, 1,000X

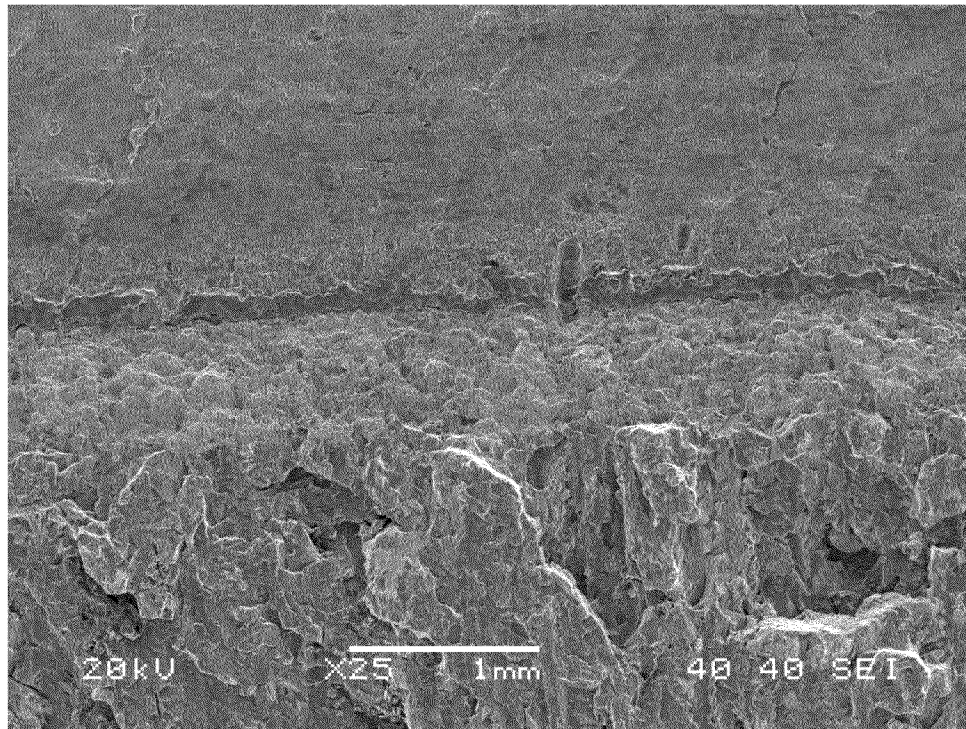
Figure 18. Zone 4 between Lower Part of Zone 3 and Upper Part of Zone 5, 25X

Figure 18 shows a region of fracture comprising Zone 4. Zone 3 is in the upper part of the photo and Zone 5 is in the lower part. Figure 19 and Figure 20 are details in Zone 4 at intermediate and high magnification, respectively. Figure 19 and Figure 20 were not obtained at the same locations. The width of Zone 4 varied significantly. Zone 4 exhibited dimpled, ductile fracture with no oxide. Zone 4 is interpreted as the ductile initiation of the failure that occurred during the hydrostatic pressure test.

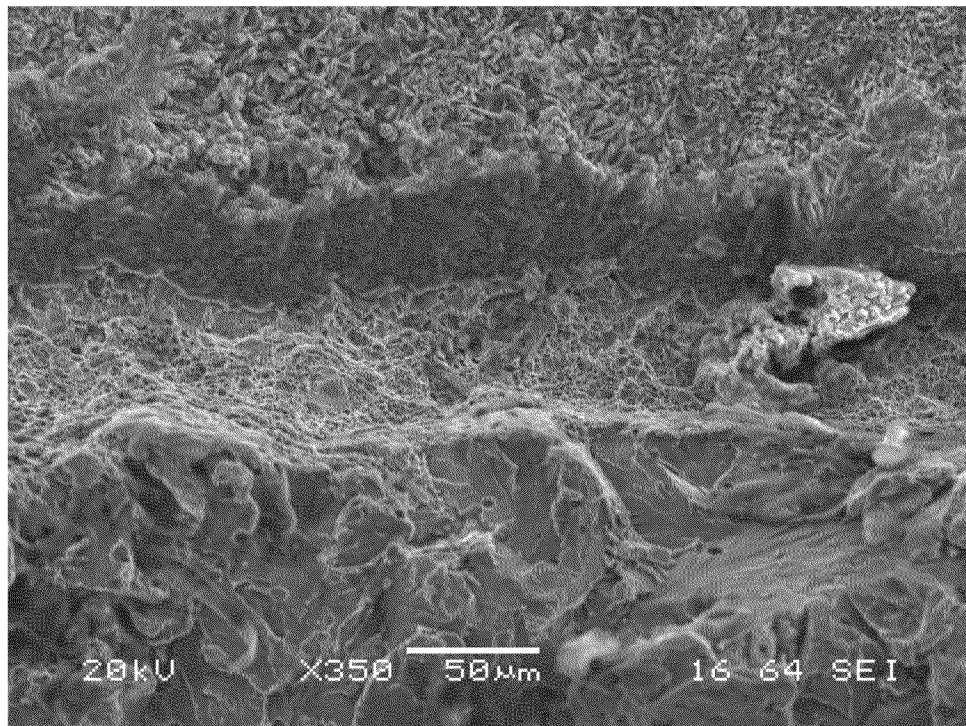
Figure 19. Detail of Zone 4, 350X

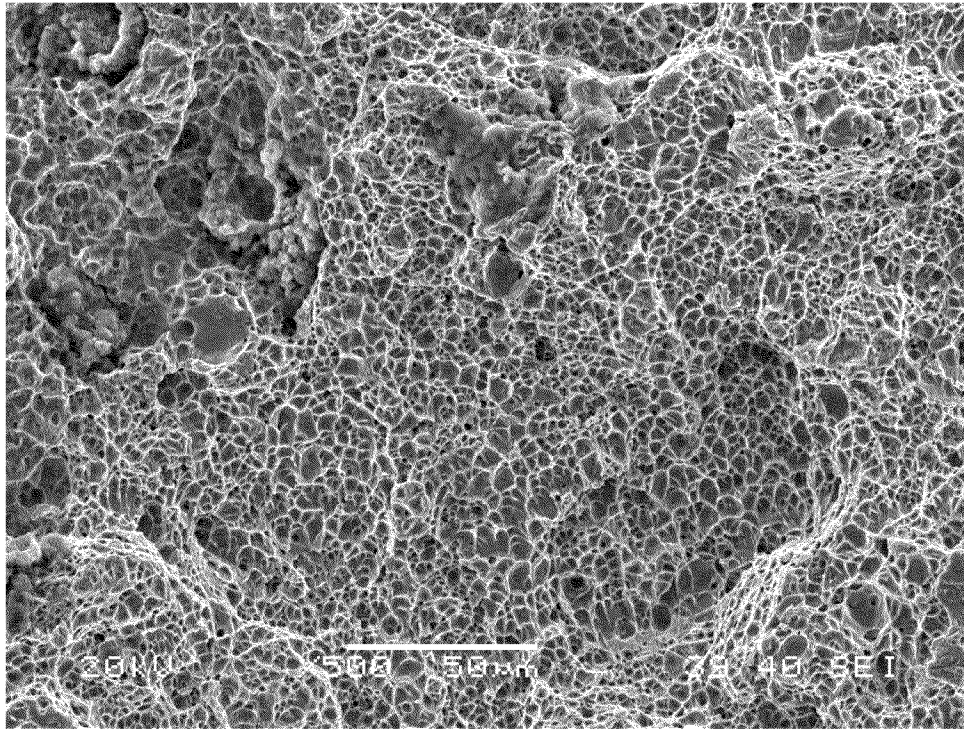
Figure 20. Detail of Zone 4, 500X

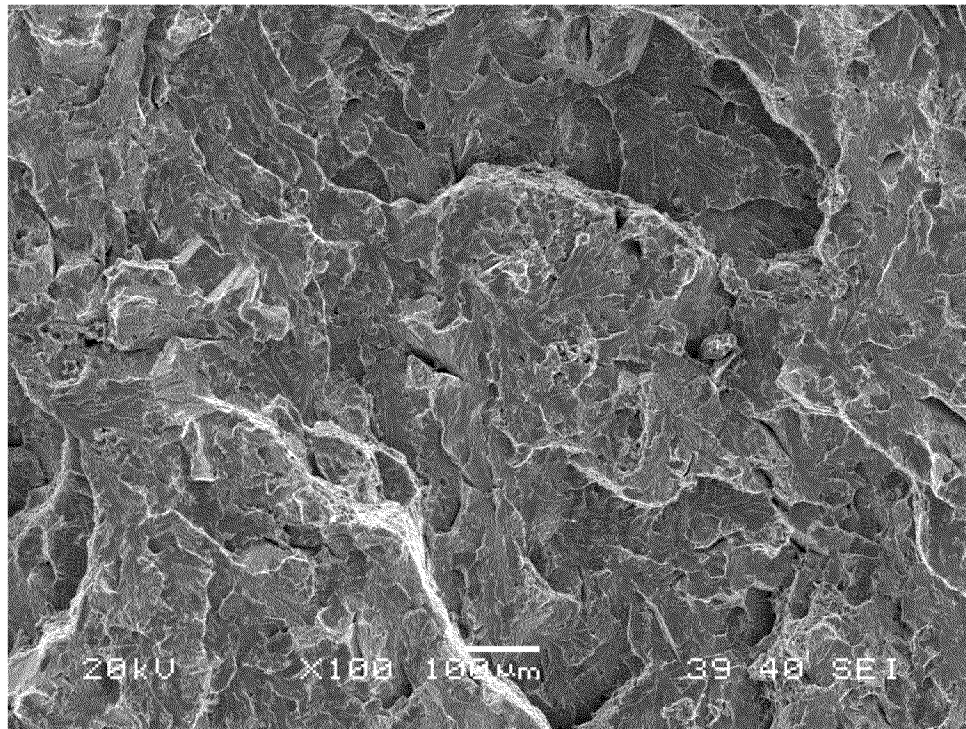
Figure 22. Detail of Zone 5, 100X

Figure 21 shows the typical surface in Zone 5. Figure 22 is a detail of Zone 5 at high magnification. The surface exhibits cleavage planes indicating brittle fracture, and no oxide. Zone 5 represents the propagation of the hydrostatic test fracture through the inner weld deposit.

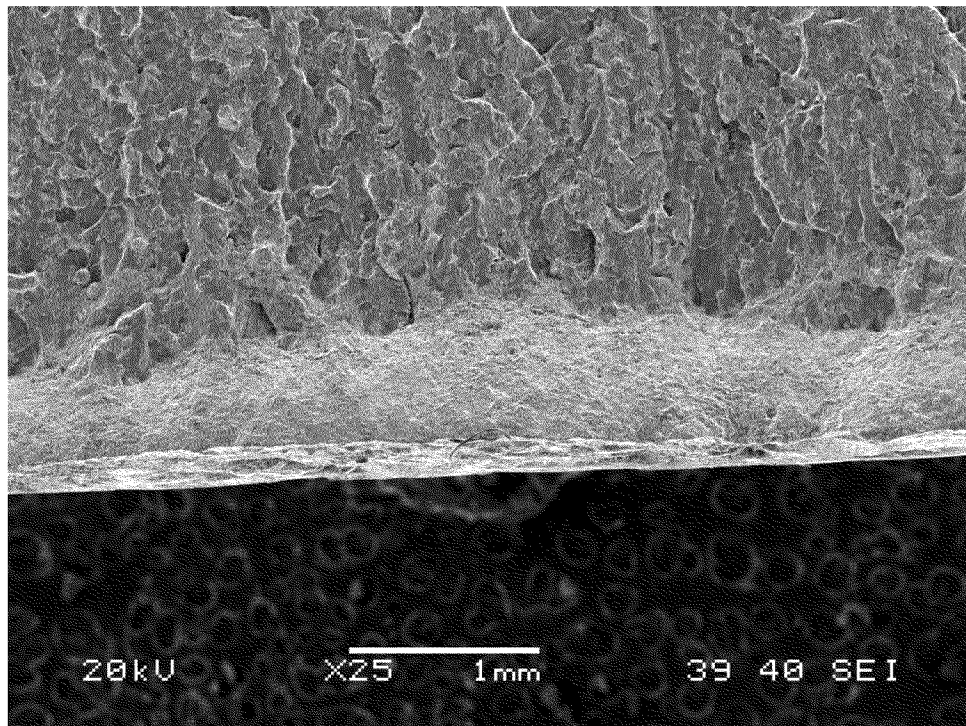
Figure 23. Zone 6 at Bottom of Zone 5, 25X

Figure 23 shows Zone 6 adjacent to the interior pipe surface, and the lower part of Zone 5. Figure 24 is a detail of Zone 6 at high magnification, exhibiting dimpled, ductile fracture with some surface deposits. Zone 6 is interpreted to be a ductile shear lip that developed as the propagating fracture reached the interior surface.

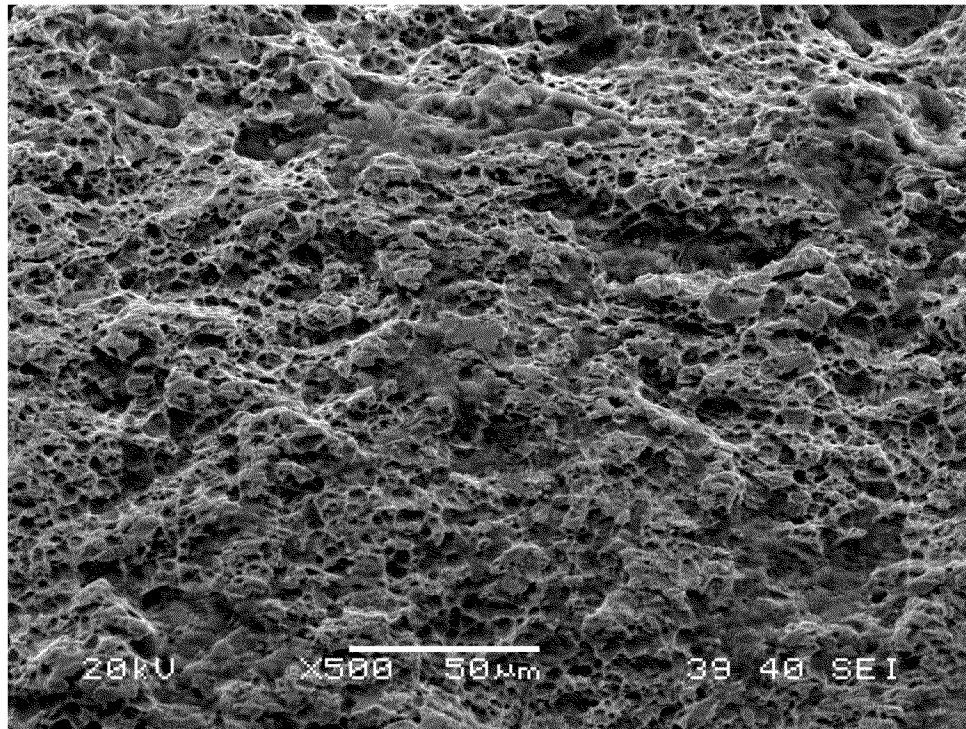
Figure 24. Detail of Zone 6, 500X

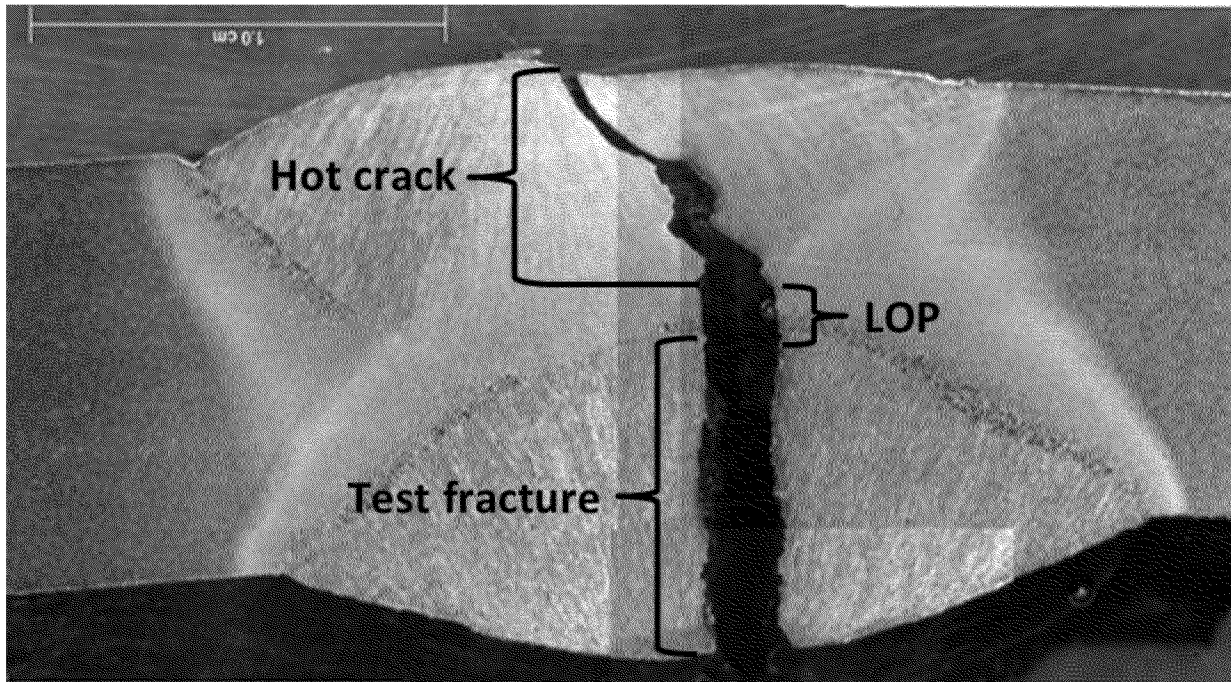
Metallographic sections were prepared through two positions in the 7-inch long apparent hot crack. Composite photographs of metallographic sections through two positions in the origin defect are presented in Figure 25 and Figure 26. Mount "A" was obtained from the upstream end of the hot crack and Mount "B" was removed from the downstream end. The photos are oriented with the pipe exterior surface as the upper surface. The apparent hot crack, LOP, and hydrostatic test fracture are identified.

The inside and outside weld deposits are seen to penetrate to a depth of approximately half of the pipe wall thickness. Penetration was intended to be $2/3$ of the wall thickness in order to provide overlap.¹ Also, the outer weld deposit is seen to be offset laterally approximately 0.2 inch, causing the deepest points of penetration of the two weld passes to miss each other.

Figure 25. Metallographic Cross Section, Mount A, 5X

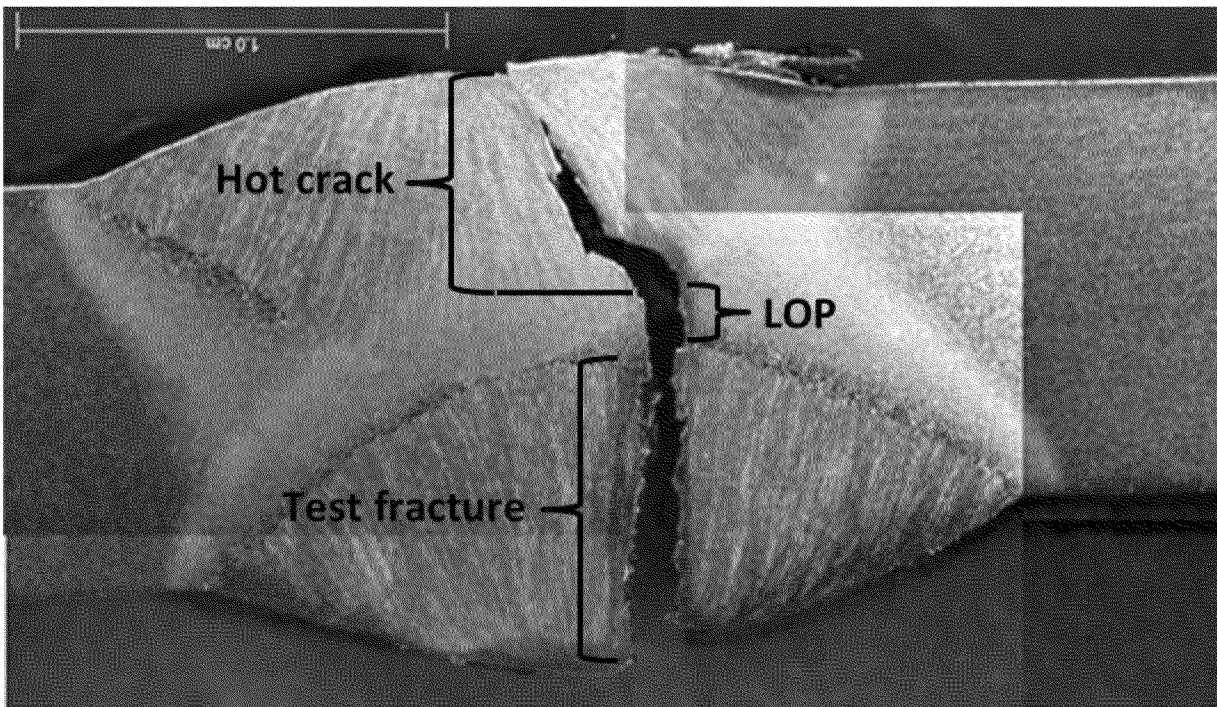
Figure 26. Metallographic Cross Section, Mount B, 5X

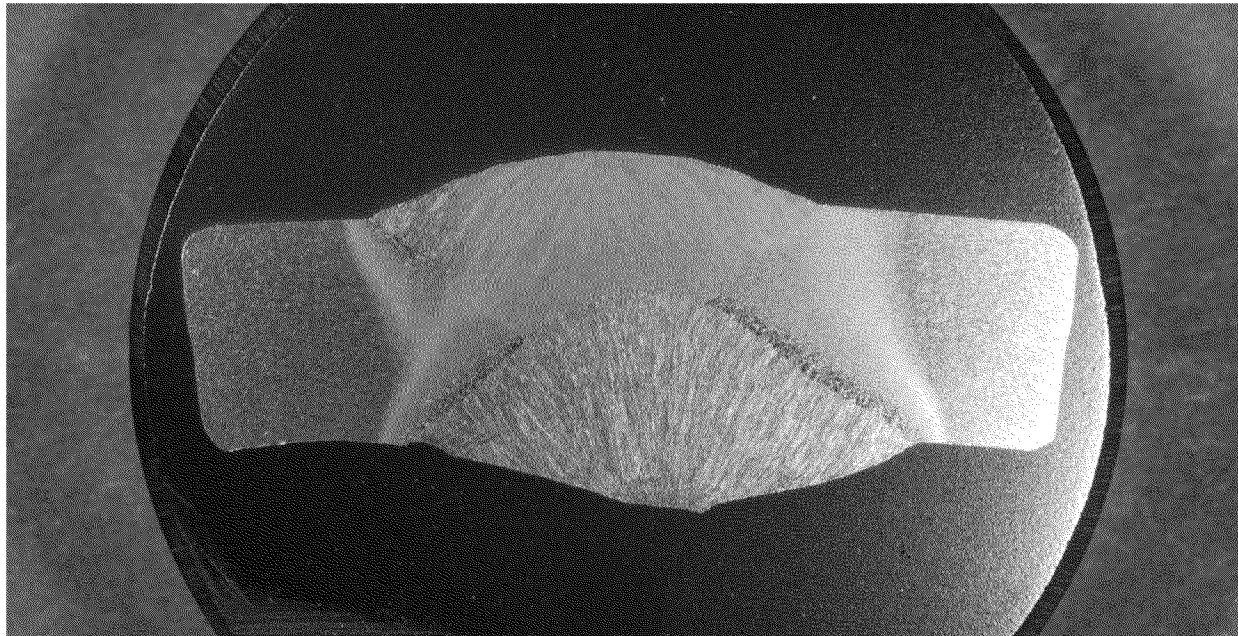
Metallographic sections were also prepared through unfractured portions of the longitudinal seam, one of which (from piece 72493) is shown in Figure 27. The section shows that the outside pass was made first because the inside weld deposit is seen to overlap the outside weld

deposit. There is no LOP feature even with some lateral misalignment of the weld deposits because overlapping penetration was achieved.

Figure 27. Intact Seam Showing Normal Seam Weld Deposition

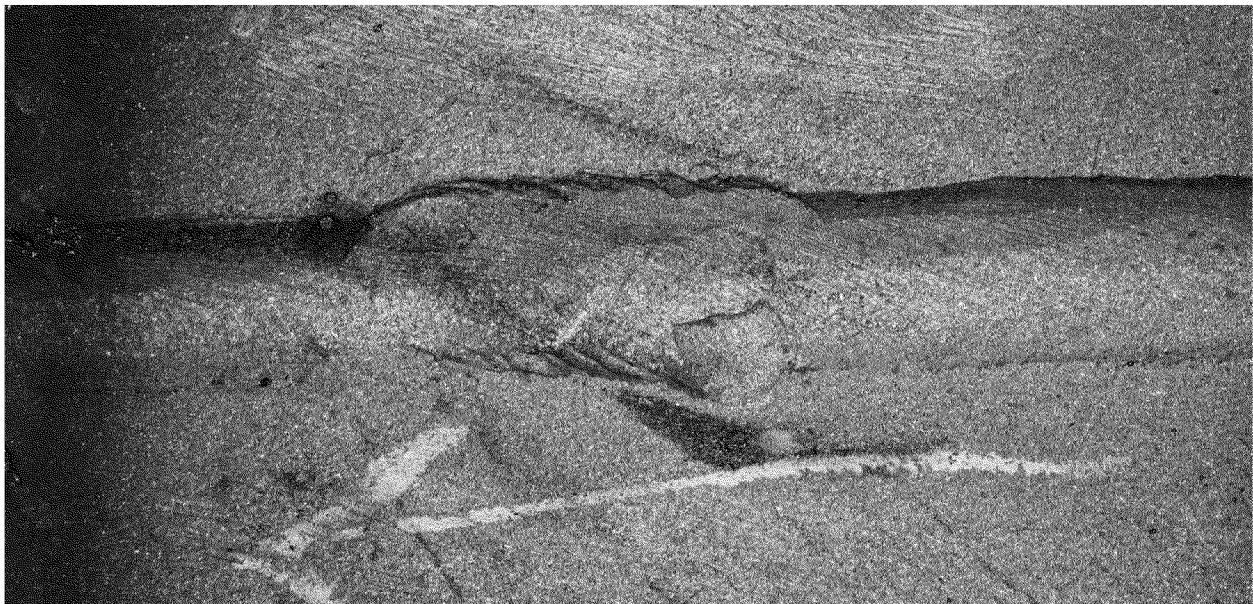
Figure 30 shows a repair made to the inside weld deposit of the longitudinal seam in Piece T117-CE-LS-E. The repair was approximately 2 inches long. Two metallographic sections across the repaired area were made. These are shown in Figure 31 and Figure 32.

Figure 30. Seam Weld Repair, T117-CE-LS-E, Interior Surface

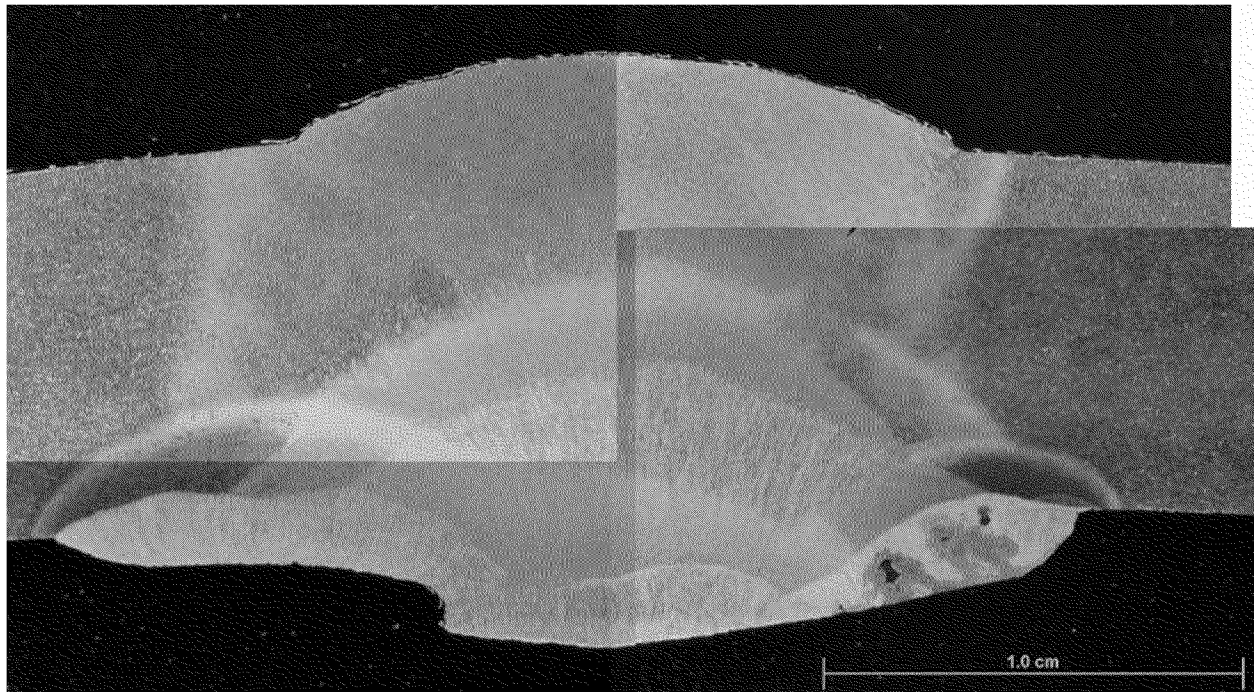
Figure 31. Seam Repair, T117-CE-LS-E, Section A

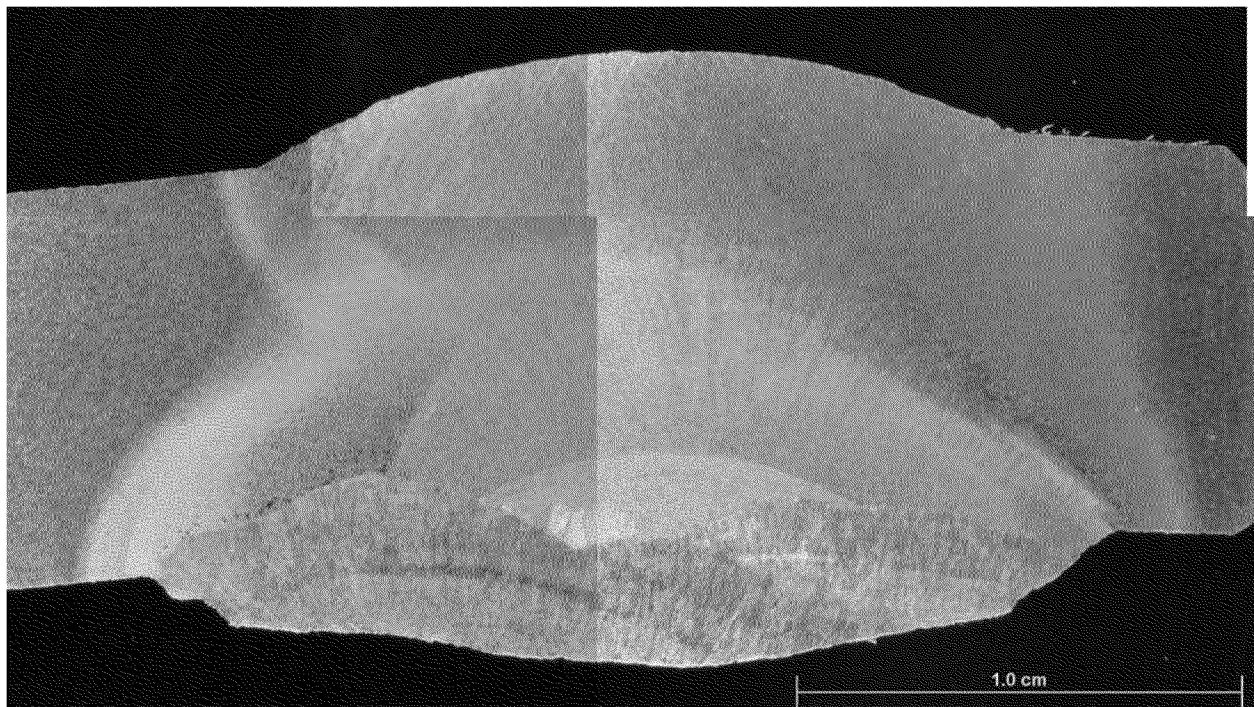
Figure 32. Seam Repair, T117-CE-LS-W, Section B

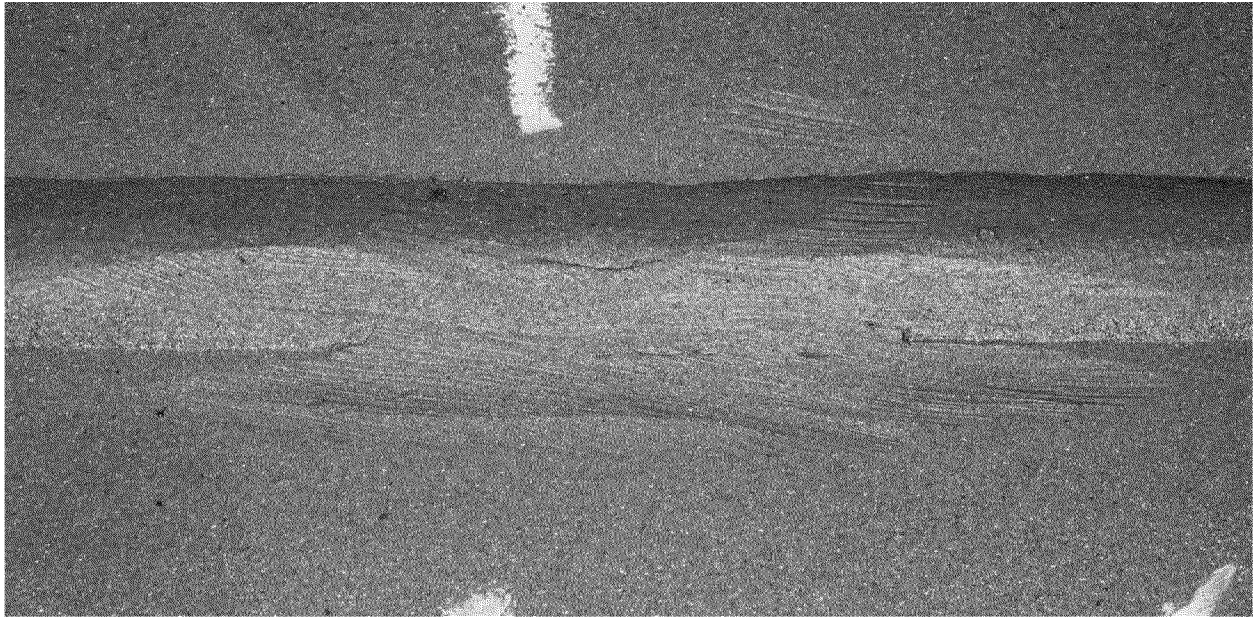
A minor repair was made at another location along the seam, shown from piece T117-CE-LS-W in Figure 33. A metallographic cross section of this area is shown in Figure 34.

Figure 33. Seam Repair, T117-CE-LS-W, Interior Surface

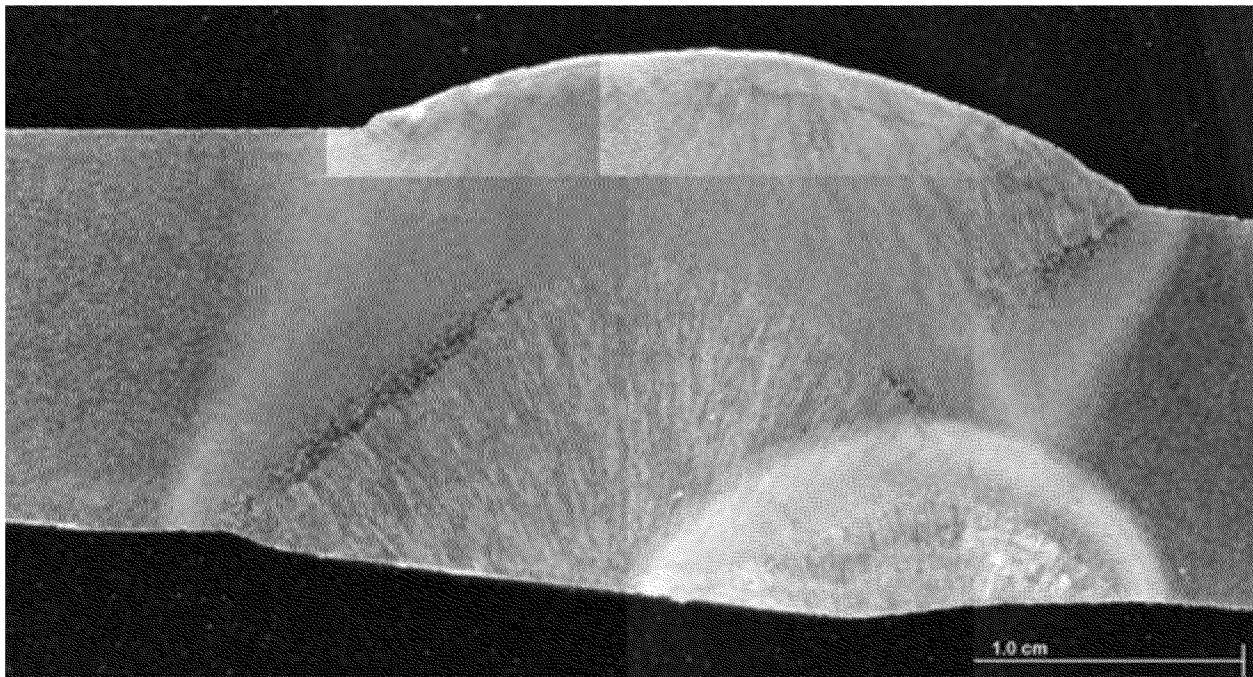
Figure 34. Seam Repair, T117-CD-LS-W, Section A

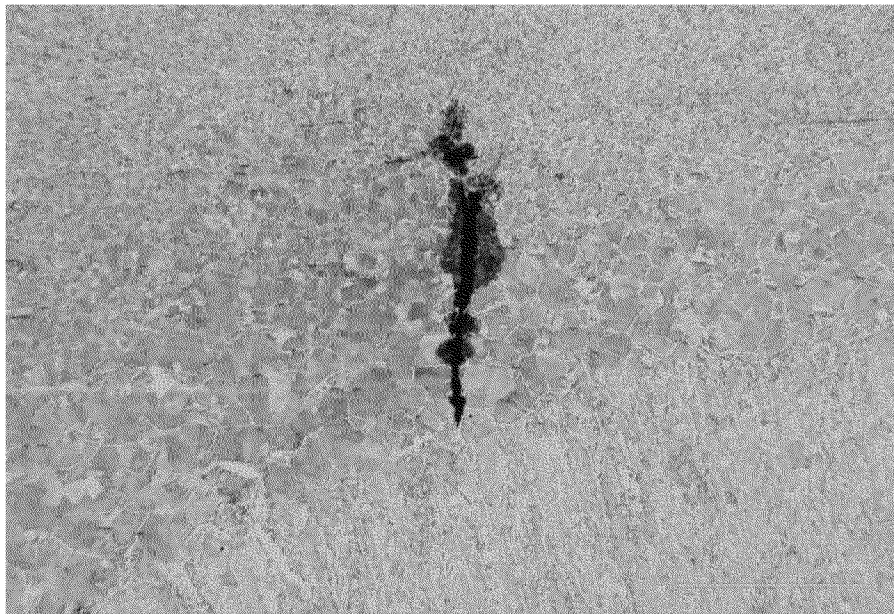
A metallographic section through an intact part of the seam in the center of the failed joint, piece T117-CC-T-W revealed a small hot crack having a radial dimension of approximately 0.12 inch (3 mm). This is shown at high magnification in Figure 35. A lack of penetration between the inner and outer weld passes and having a radial dimension of 0.02 inch (0.5 mm) was also

identified as shown in Figure 36. Neither feature was significant in terms of their effect on the integrity of the pipe.

Figure 36. LOP Feature, T117-CC-T-W (50X)
