Investigation of a Failure of Line 300 at Mile Post 284.14 during Hydrostatic Test 117

MJ Rosenfeld, PE
March 16, 2012

PACIFIC GAS & ELECTRIC COMPANY

0215-1116

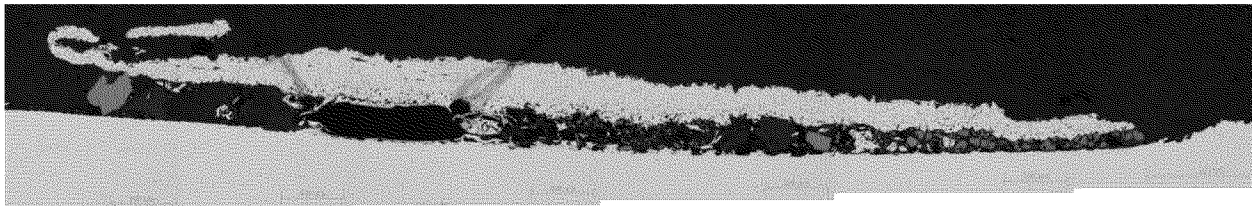
Other metallographic sections were prepared through the longitudinal seam and a surface imperfection in the plate identified by nondestructive examination. These are presented in Appendix A. A section in the seam confirmed another apparent hot crack in the outer seam weld deposit having a radial dimension of approximately 0.12 inch. It was small and uninvolved in the test break.

An indication was discovered on the exterior surface of the pipe body, shown in Figure 37 approximately actual size. It had an overall length less than ½ inch. A metallographic section established that it was a superficial blemish characterized as a surface lap. It had a depth of approximately 0.04 inch (1 mm) and was not oriented radially.

Figure 38. Surface Imperfection, Metallographic Section
