**PG&E Hydrotest Rupture
Line 300B Metallurgical
Examination**

Exponent Failure Analysis Associates
149 Commonwealth Drive
Menlo Park, CA 94025

March 2012

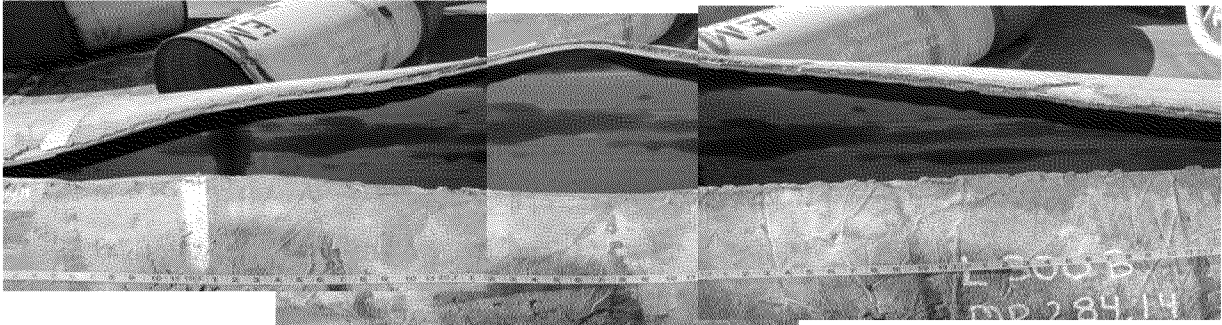
Figure 1. Montage of overall rupture.

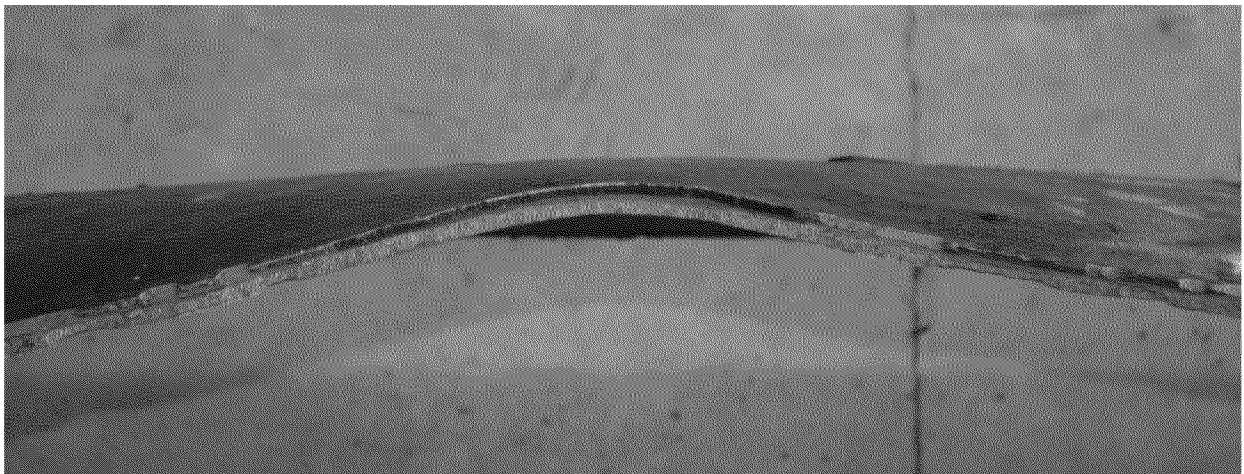
Visual inspection of the fracture surface indicated a darkened area along the outer diameter (OD) weld, located at the rupture area corresponding to the maximum opening, shown in Figure 2 and Figure 3. The darkened area was present on both North and South fracture faces, and extended for approximately seven inches. A relatively shiny strip of un-welded material was observed to extend roughly along the centerline of most of the rupture (not including the squirt weld area), shown in Figure 3. The strip was darkened throughout the origin area. This strip was consistent with lack-of-penetration between the inner and outer submerged arc welds.

Figure 2. Photograph of the darkened area along the outer diameter (OD) weld at the rupture origin.

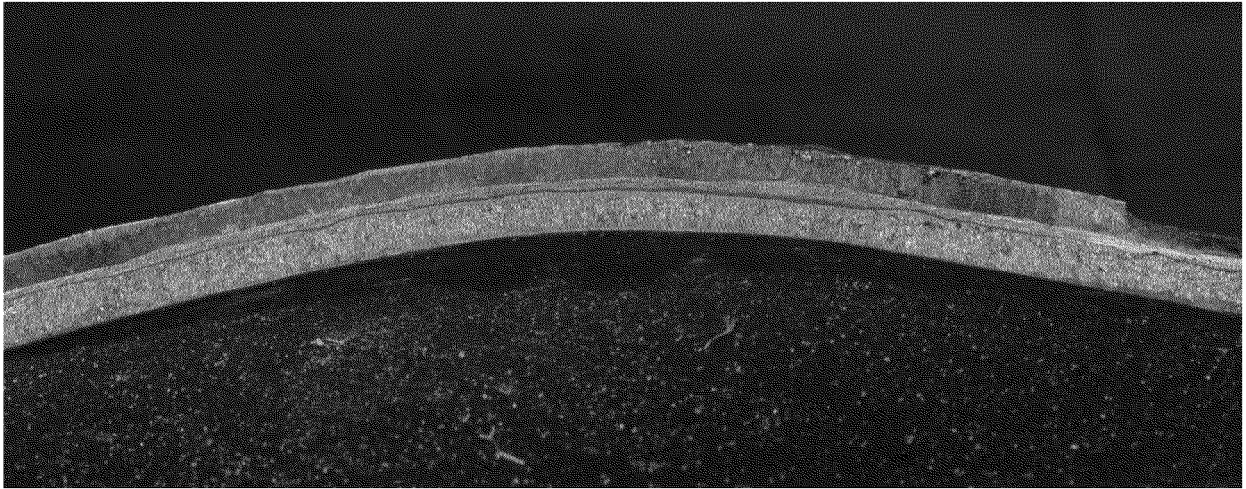
Figure 3. Photograph that shows the darkened OD weld region and the strip roughly along the centerline of the rupture.

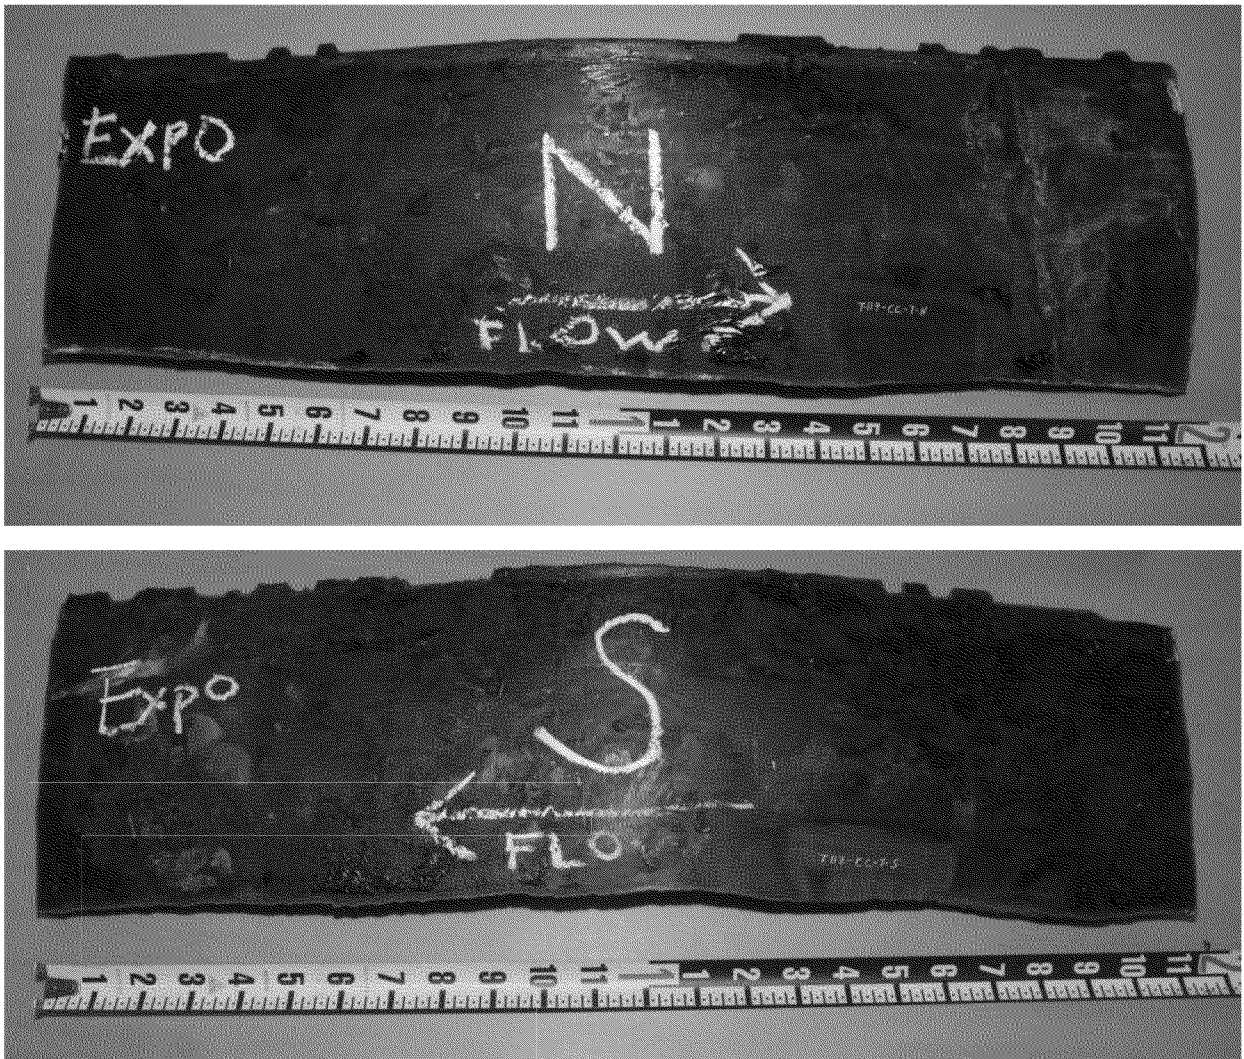
Approximately two feet of the rupture, including the origin, was removed from both sides of the break, shown in Figure 4. The middle of the two-foot sections contained the darkened fracture area. This area was removed from the north side of the break for cleaning, using acetone and ultrasound followed by SEM analysis, shown in Figure 5. A photographic montage of the darkened origin area after cleaning is shown in Figure 6.

Figure 4. Images that show the two sections containing the rupture origin removed for analysis.

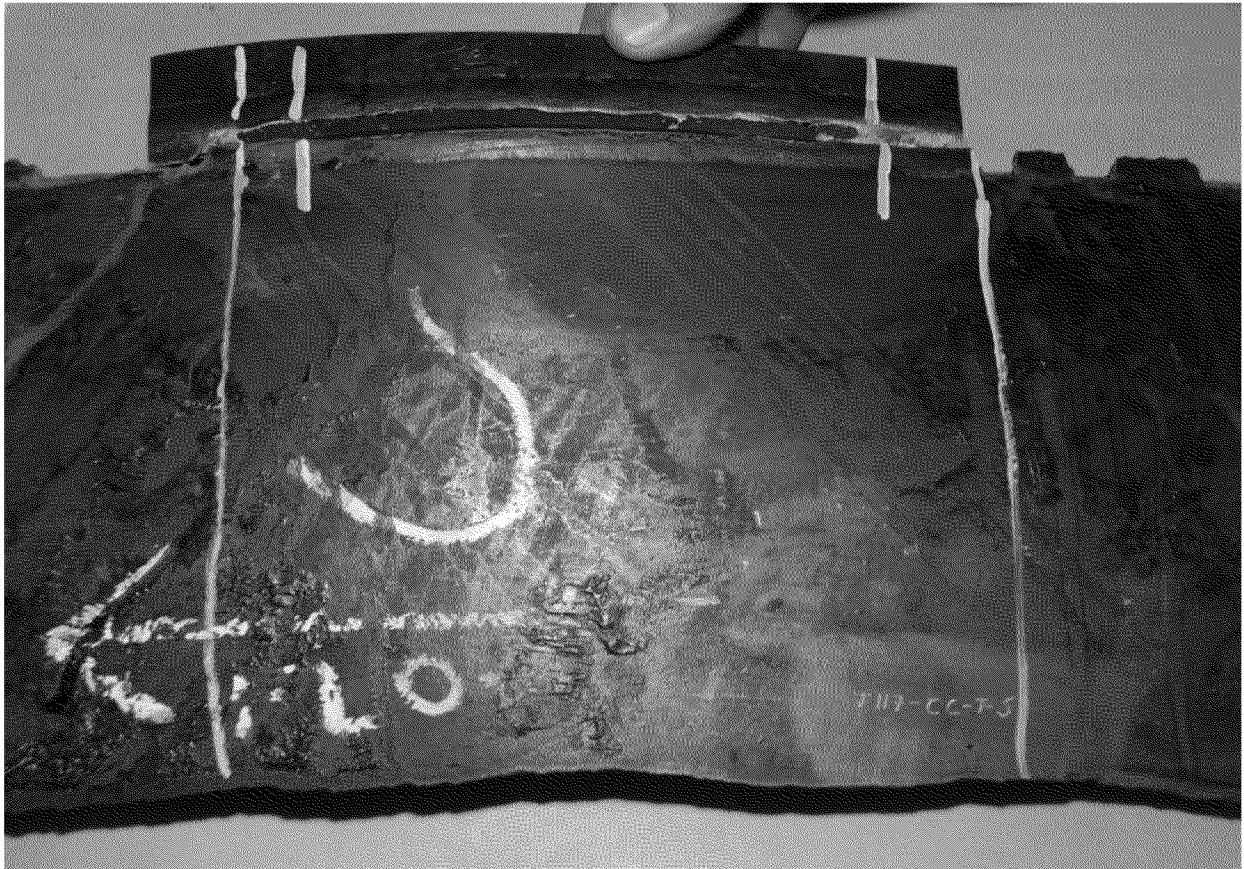
Figure 5. Image that shows the rupture origin section removed the north side, held adjacent to the south side.

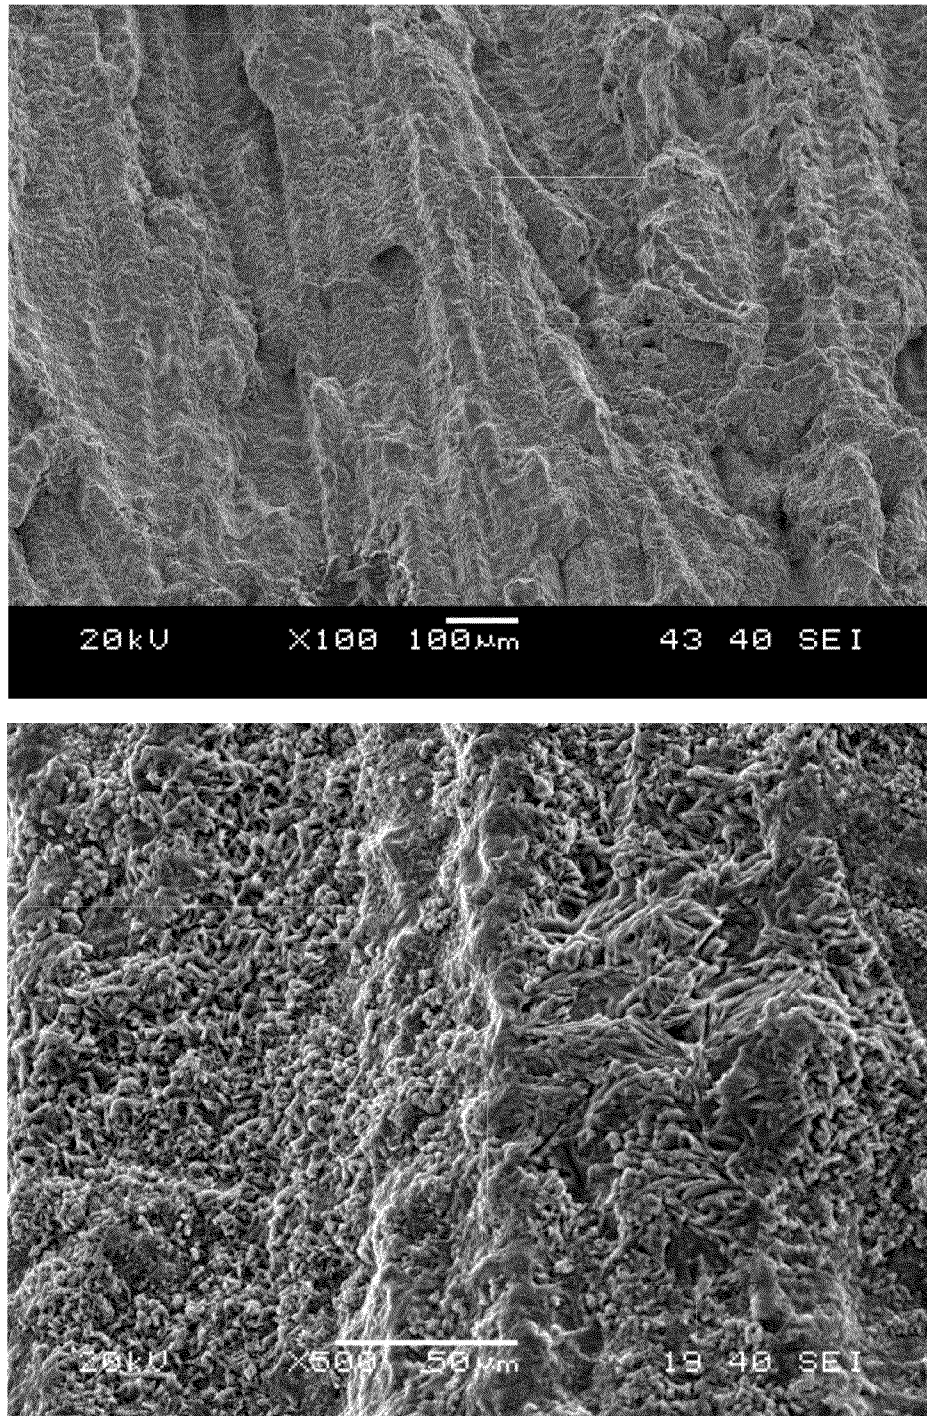
The rupture origin, including the darkened area along the outside weld, was examined using SEM to allow identification of the fracture morphology. SEM analysis indicated that the darkened area exhibited interdendritic fracture morphology, consistent with cracking of the outside weld during final solidification (solidification cracking), also known as hot cracking, shown in Figure 7. The existence of solidification cracking indicates that this discontinuity had been present in the weld since the original manufacture of the pipe. The characteristic interdendritic cracking was observed over the entire darkened portion of the fracture surface. EDS of the interdendritic fracture area indicated elevated oxygen content compared to adjacent non-darkened areas, Figure 8. Thus, EDS results show that the dark coloration is consistent with the existence of an oxide layer. Dark-colored oxides on welded steel surfaces, such as observed at the fracture origin, are typically formed at the relatively high temperatures associated with welding. It is likely that the dark-colored oxide at the fracture origin formed during (or shortly after) the welding process, indicating that the solidification-crack discontinuity was exposed to oxygen during or shortly after welding.

Figure 7. SEM images of the darkened area showing interdendritic fracture morphology, consistent with cracking of the outside weld during final solidification.

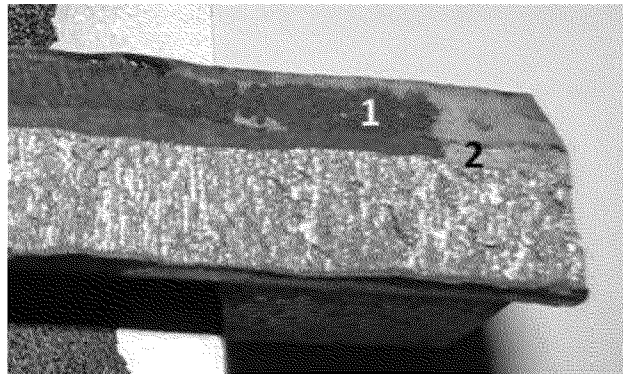
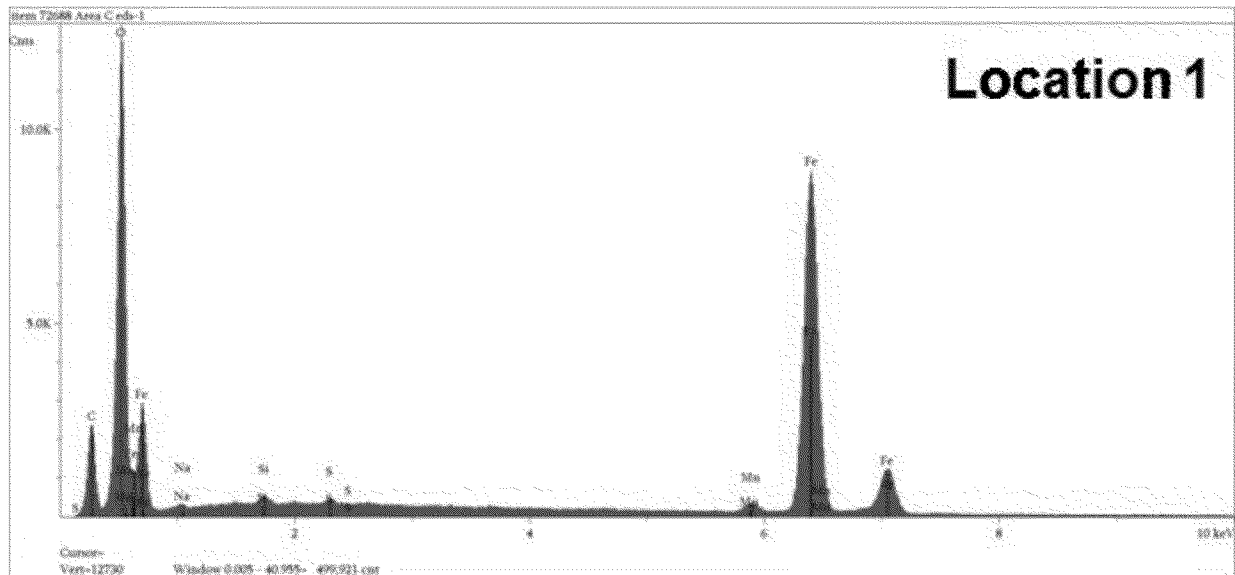
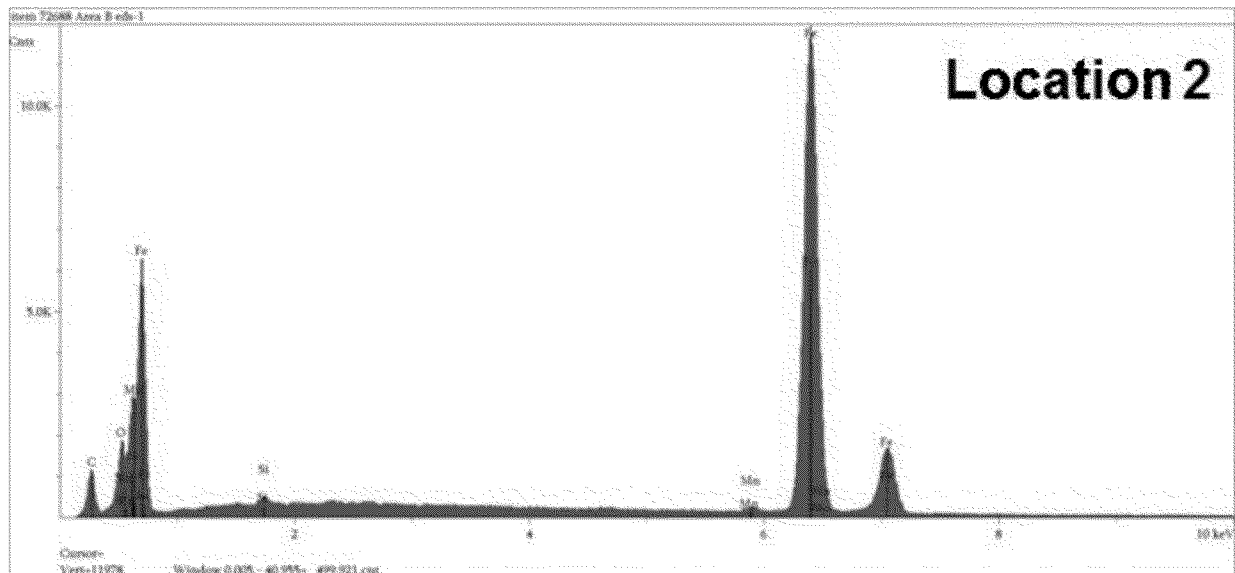
Figure 8. EDS spectra from the interdendritic fracture region (Location 1 in top image), that shows elevated oxygen content compared to an adjacent non-darkened fracture region (Location 2 in top image).

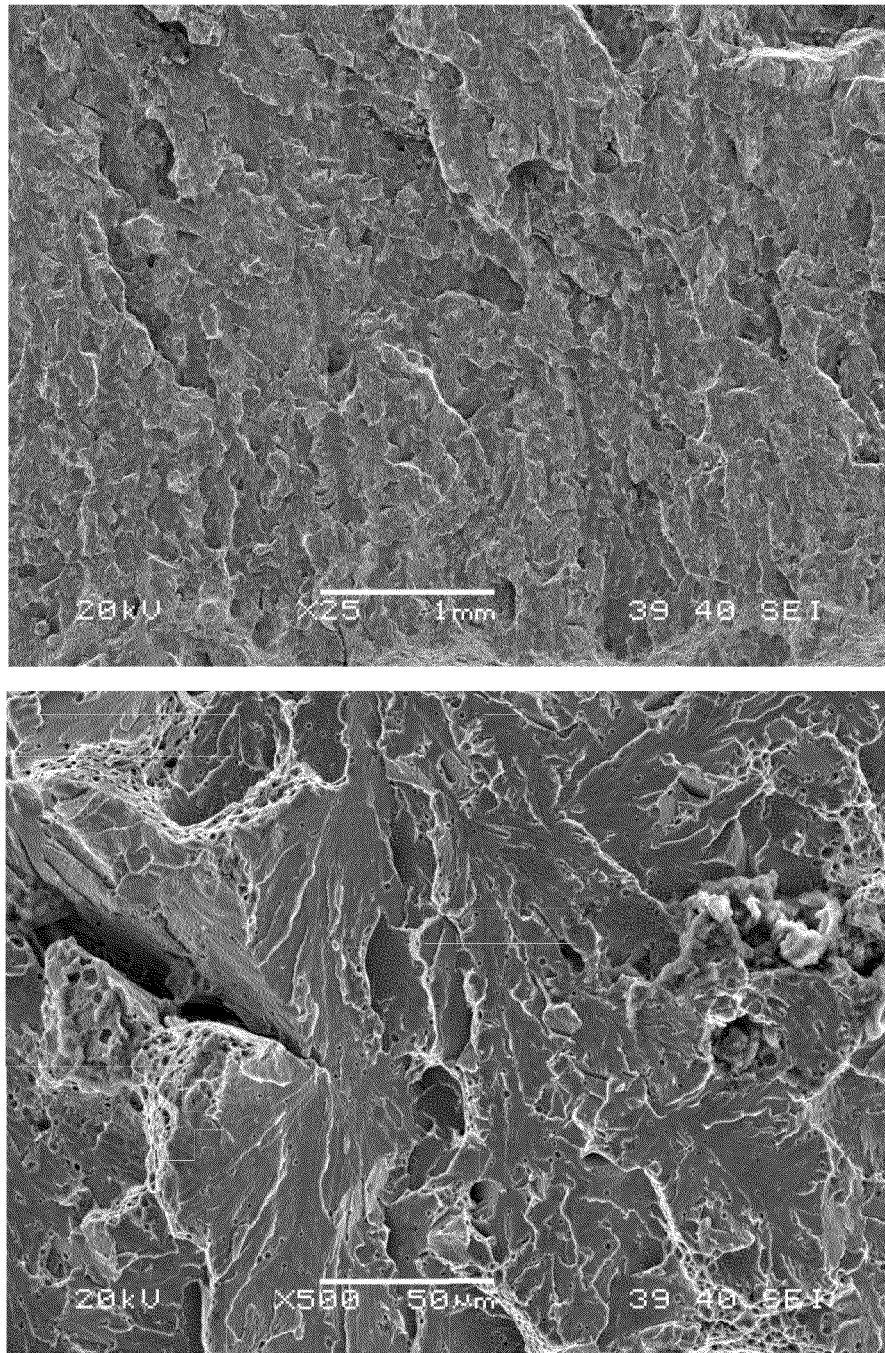
SEM-based fractographic analysis was conducted to identify the fracture morphology for the remainder of the rupture origin. The inner diameter (ID) weld fracture primarily exhibited cleavage fracture morphology, shown in Figure 9, consistent with brittle fracture in steel. This cleavage fracture could have only occurred as a result of the hydrostatic rupture event. Microvoid coalescence morphology was observed at fracture surface locations along the inner and outer surfaces of the pipe, as well as along the weld discontinuity transitions within the pipe, shown in Figure 10. Microvoid coalescence morphology is indicative of ductile fracture in

Figure 9. SEM images of the ID weld fracture surface that show cleavage fracture morphology.

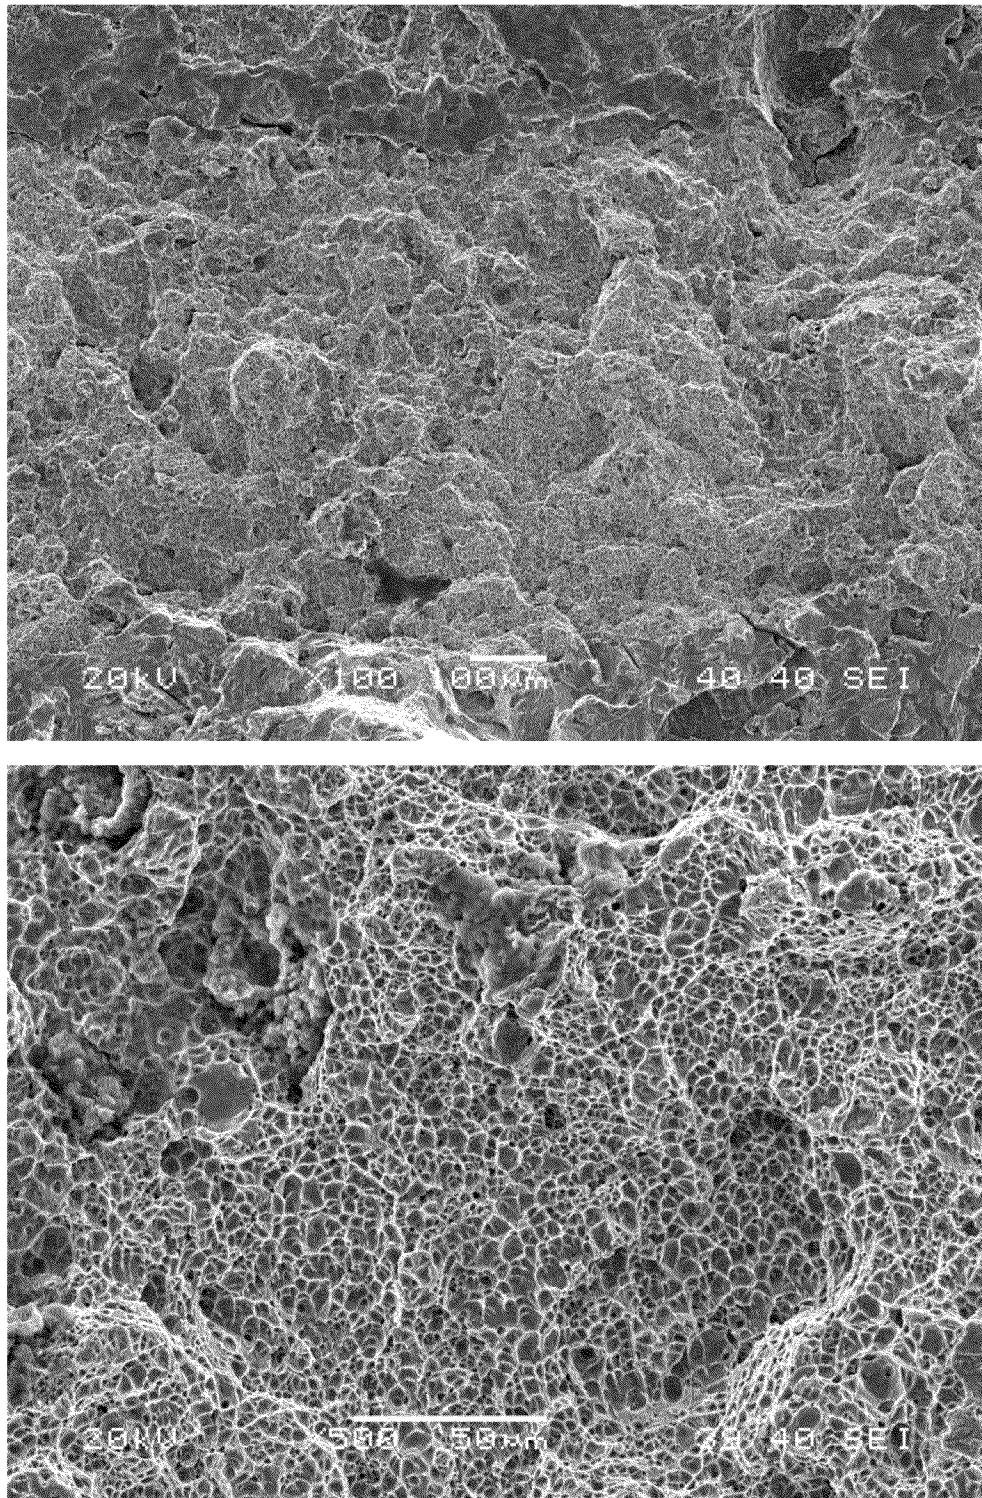
Figure 10. SEM images that show microvoid coalescence near the transition between the lack-of-penetration at the center of the pipe wall and the ID weld.

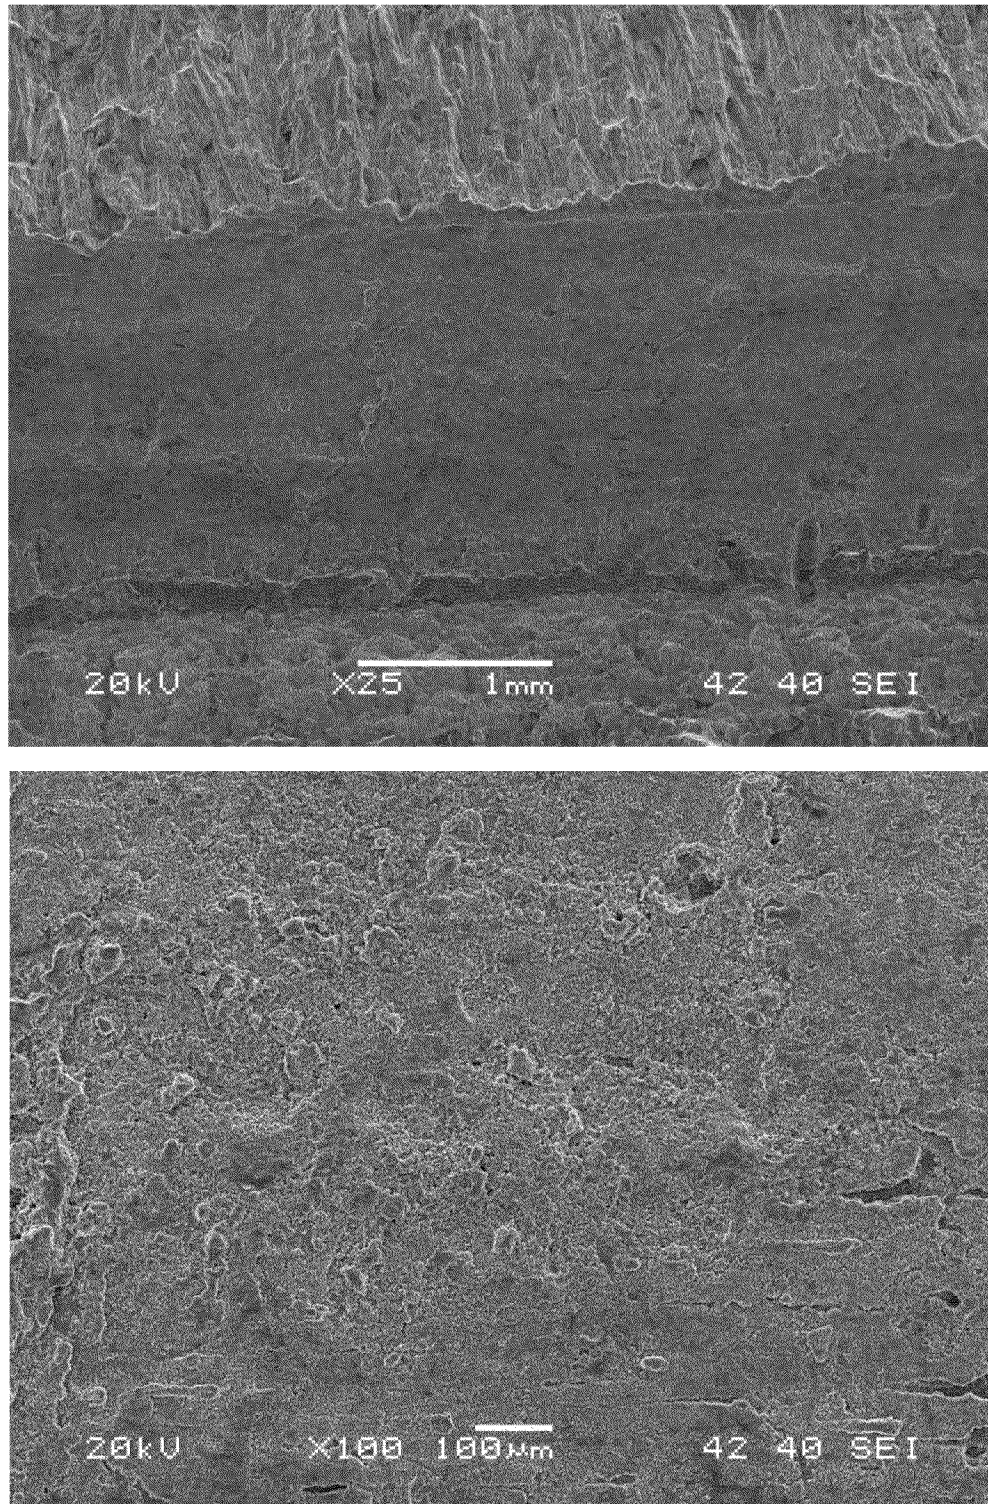
steel. The lack-of-penetration area at the center of the pipe exhibited a relatively flat, featureless morphology, as expected, shown in Figure 11.

Figure 11. SEM images that show a relatively flat, featureless morphology at the lack-of-penetration area in the center of the pipe.

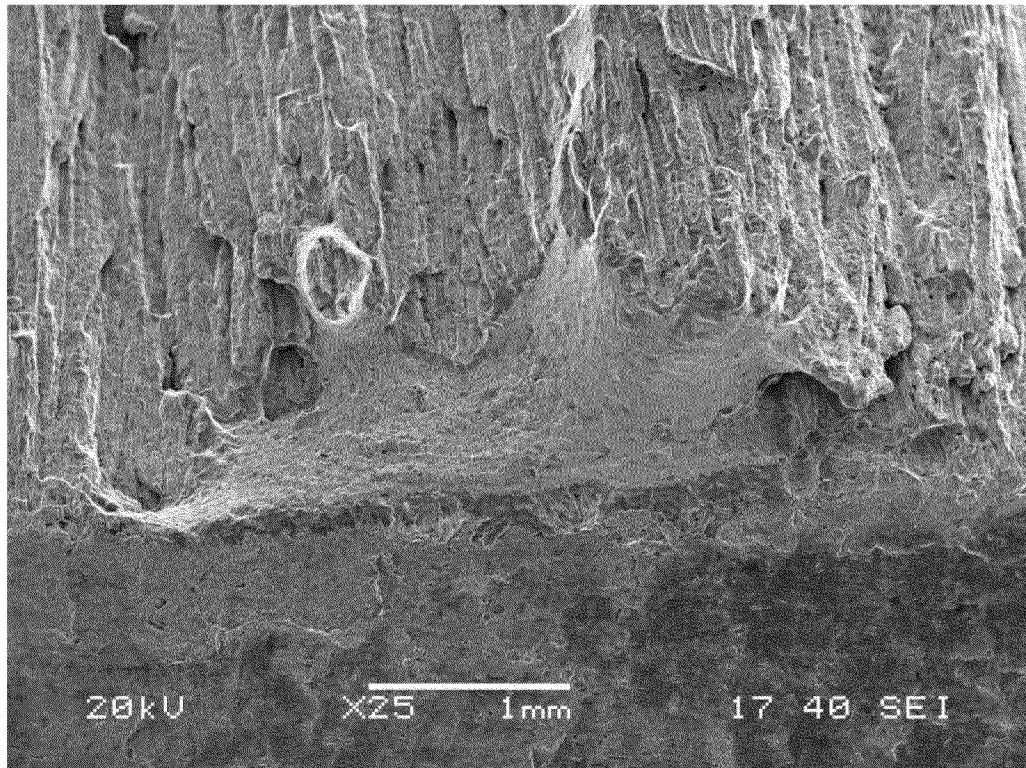
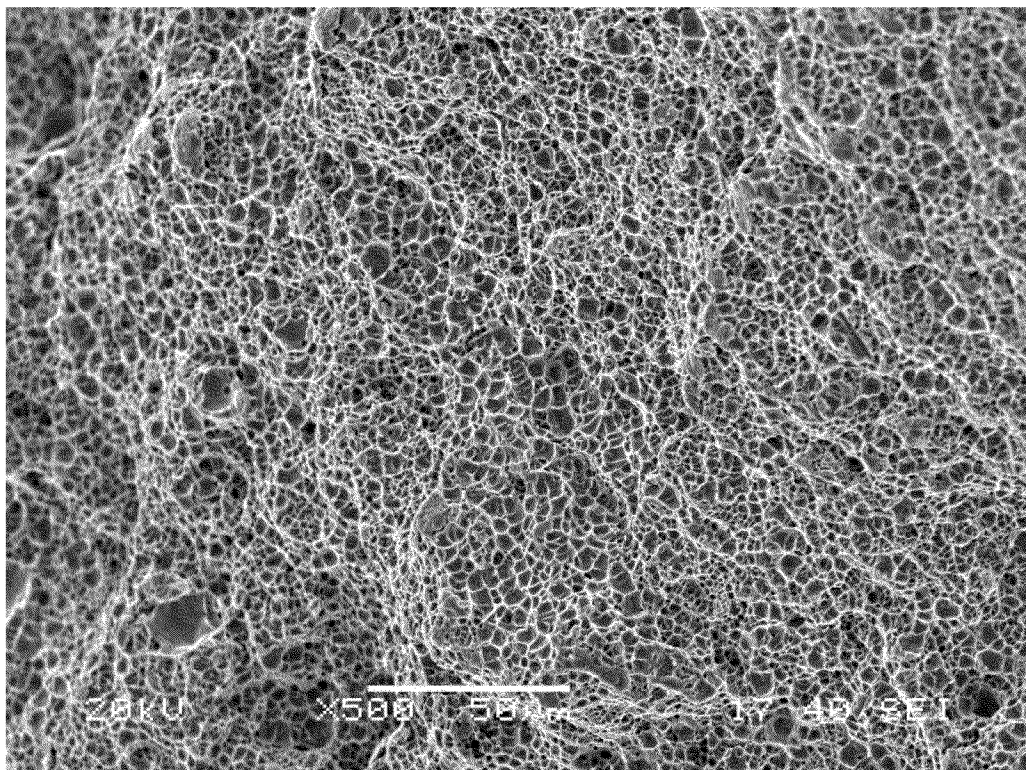
Figure 12. SEM images that show microvoid coalescence in the region between the solidification cracking and lack-of-penetration zones.

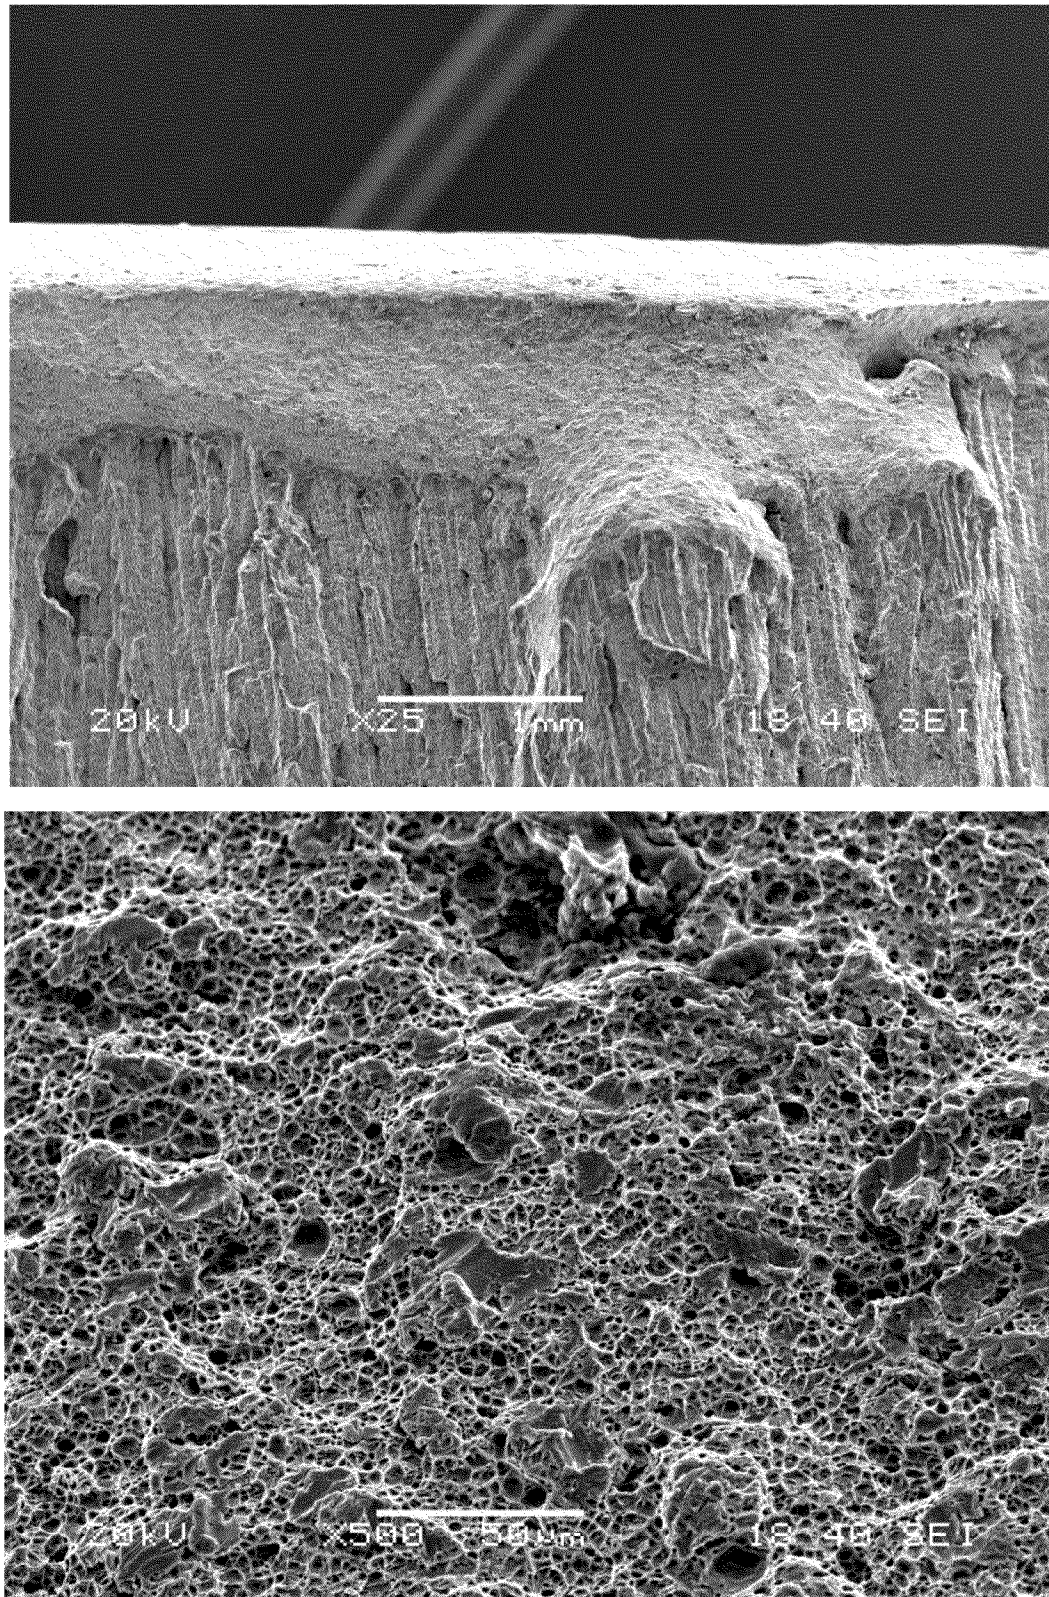
Figure 13. SEM images that show microvoid coalescence above the solidification-cracking zone at the pipe OD.

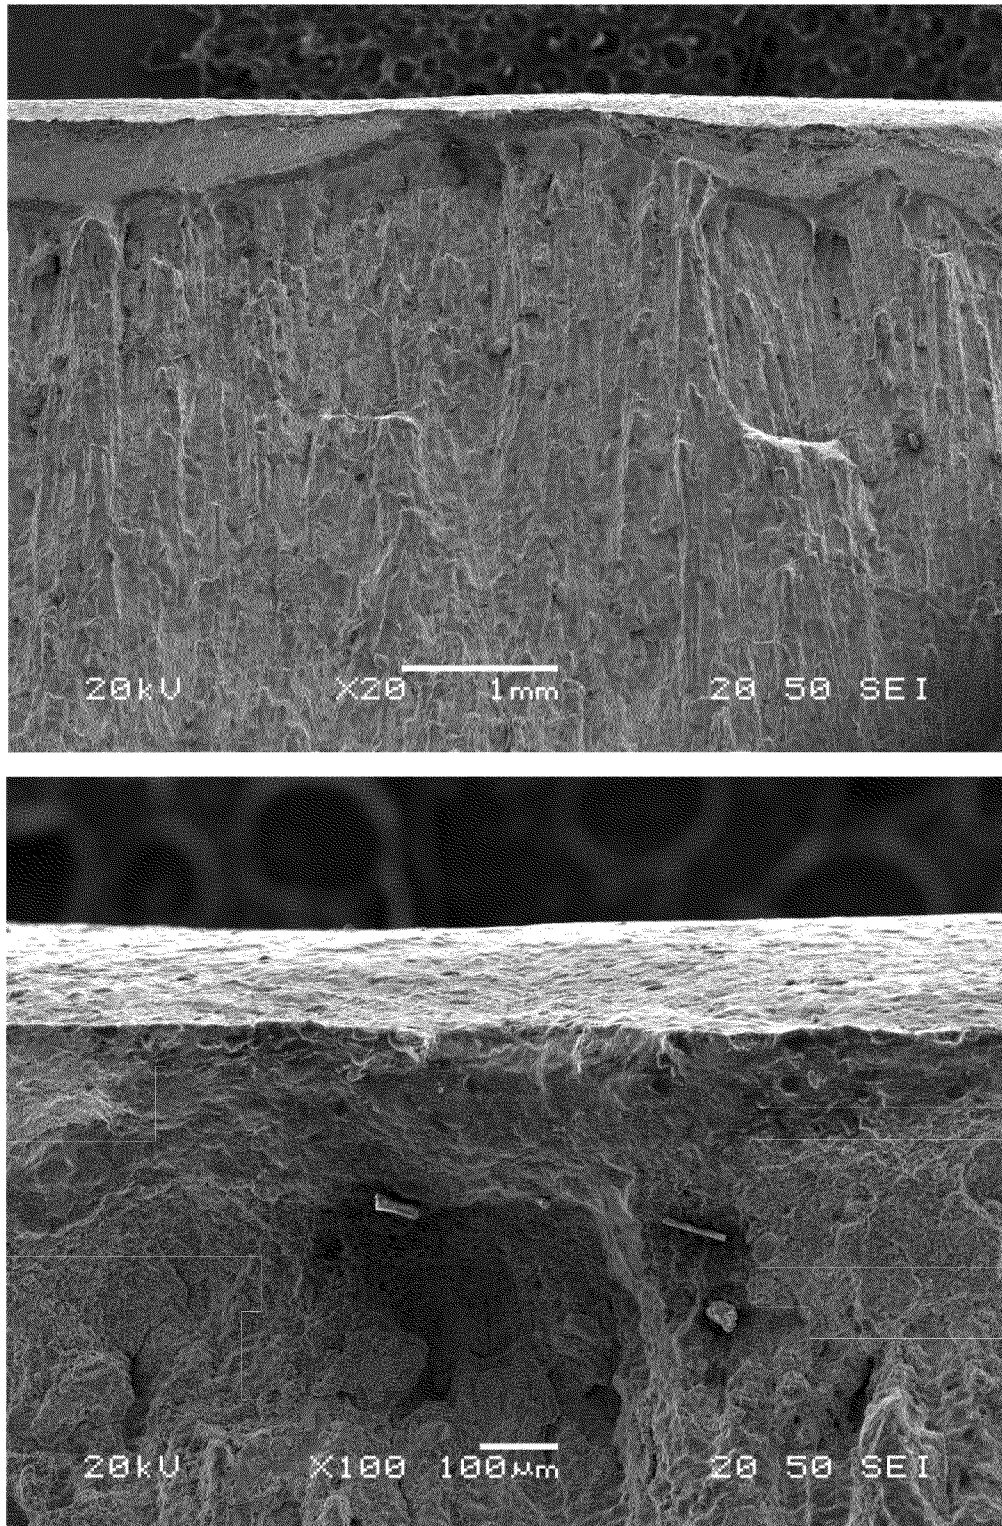
SEM analysis was also conducted to determine whether there was any communication between the observed solidification-cracking region and the pipe outer surface. If there was obvious communication, the solidification-cracking discontinuity may have been visible during external inspection. Our analysis showed that a small portion of the solidification-cracking region, approximately one-millimeter in length, may have contacted the outside surface of the weld, shown in Figure 14. The rest of the fracture area above the solidification cracking discontinuity exhibited microvoid coalescence fracture morphology. Due to the oxidation observed at the discontinuity, some portion of the solidification cracking must have been exposed to the outside environment while the metal was solidified.

Figure 14. SEM images that show a small portion of the solidification-cracking region, approximately one-millimeter in length, that may have contacted the outside surface of the weld.

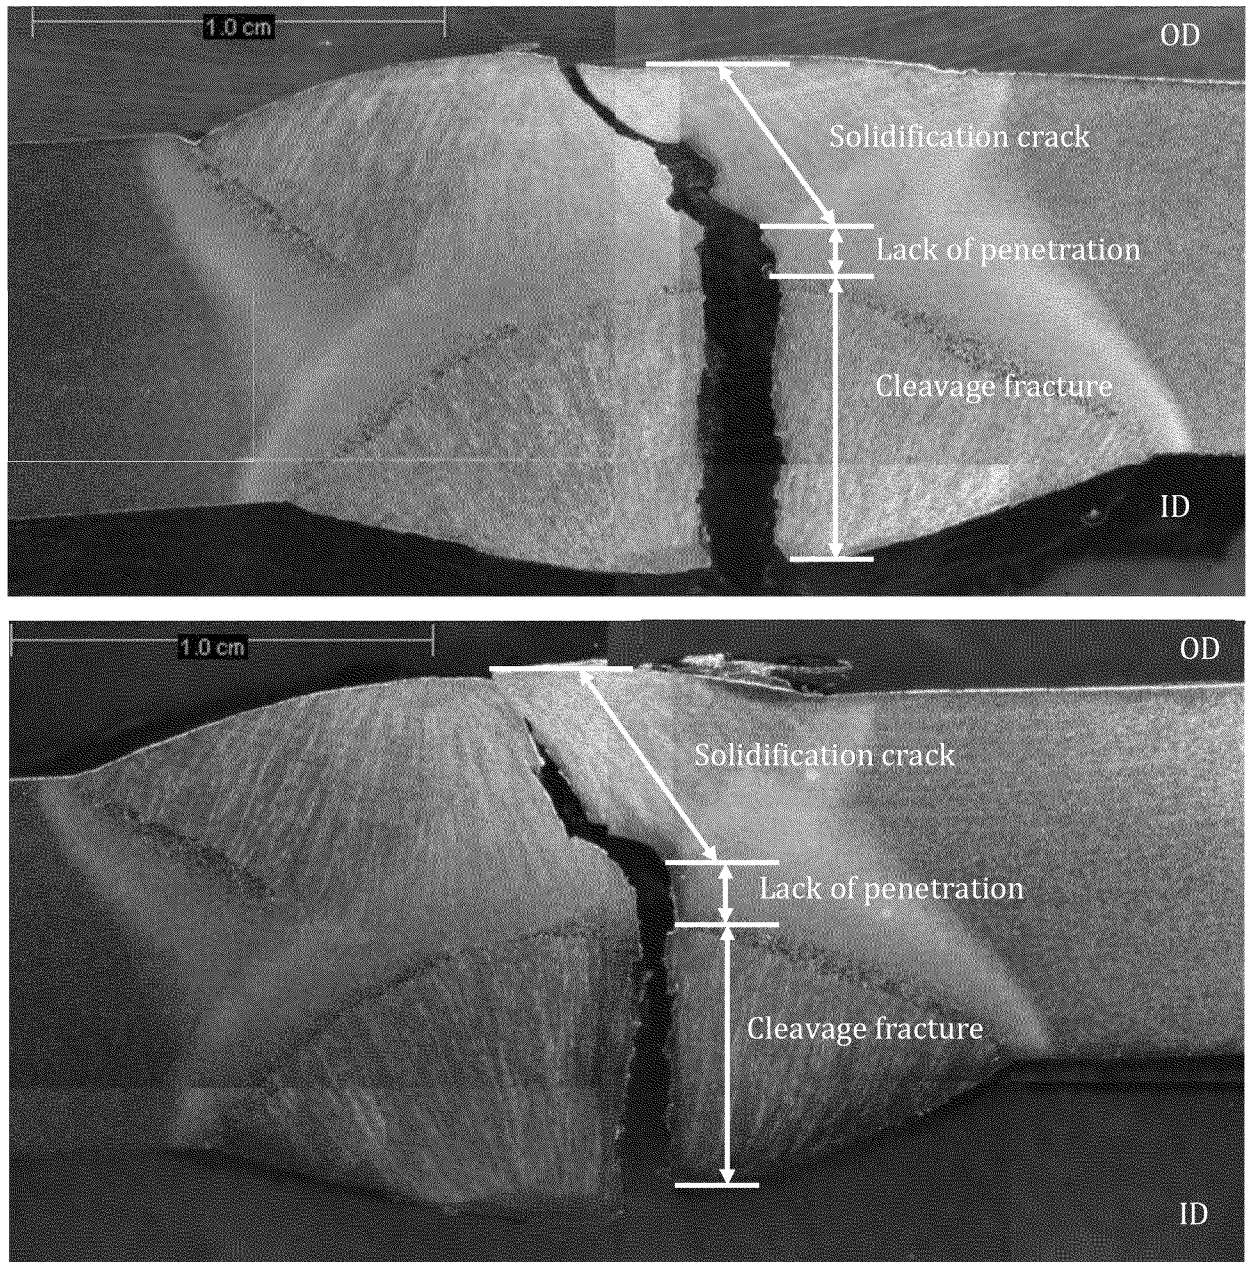
Metallographic specimens were removed from the rupture area, as well as from portions of the intact seam weld, girth welds, base metal, and discontinuities found during visual and non-destructive inspection. Specimens were matched and removed from both sides of the rupture for metallographic analysis, shown in Figure 15. The rupture faces on these samples were placed together, and the specimens were ground and polished perpendicular to the fracture plane. Low magnification analysis of the cross section indicates that the OD weld was made first, and the ID weld was made second on the subject seam weld. Misalignment between the inner and outer welds was observed, shown in Figure 16. Along with small weld sizes, the misalignment contributed to the observed lack of penetration. The current version of API 5L specifies that the maximum misalignment of the weld beads shall not exceed 3 mm (0.1 inch) for pipe with specified wall thicknesses less than 0.8 inch¹. Metallographic analysis of the base metal indicated a proeutectoid ferrite/pearlite base metal microstructure, typical for API X52 base metal material, shown in Figure 17.

Figure 16. Stereomicroscopic montages of the rupture area metallographic specimens that show weld misalignment.

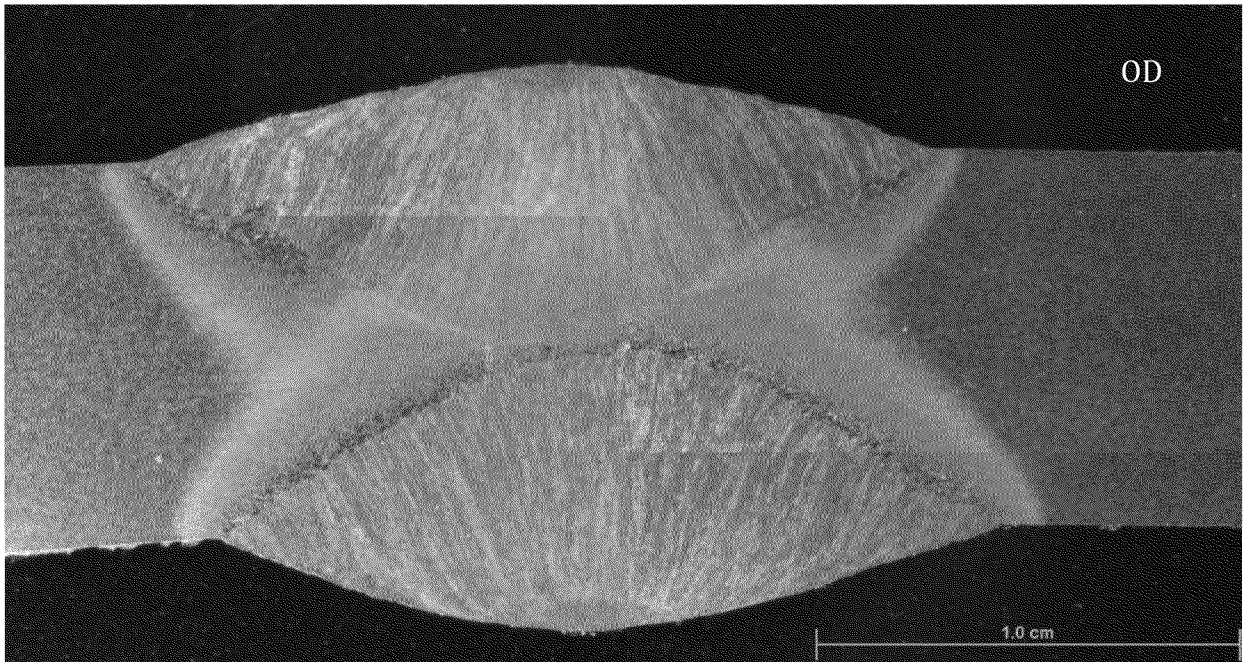
An intact seam weld sample (T117-CC-T-W) was removed from just west of the rupture, shown in Figure 18. A portion of the sample was ground and polished on a plane perpendicular to the length of the weld. Inner and outer weld misalignment and lack-of-penetration was observed, shown in Figure 19. Lack of penetration was observed at the center of the weld, shown in Figure 20, and a relatively small area of solidification cracking was observed within the OD weld, shown in Figure 21.

Figure 19. Stereomicroscopic montage that shows the T117-CC-T-W weld seam.

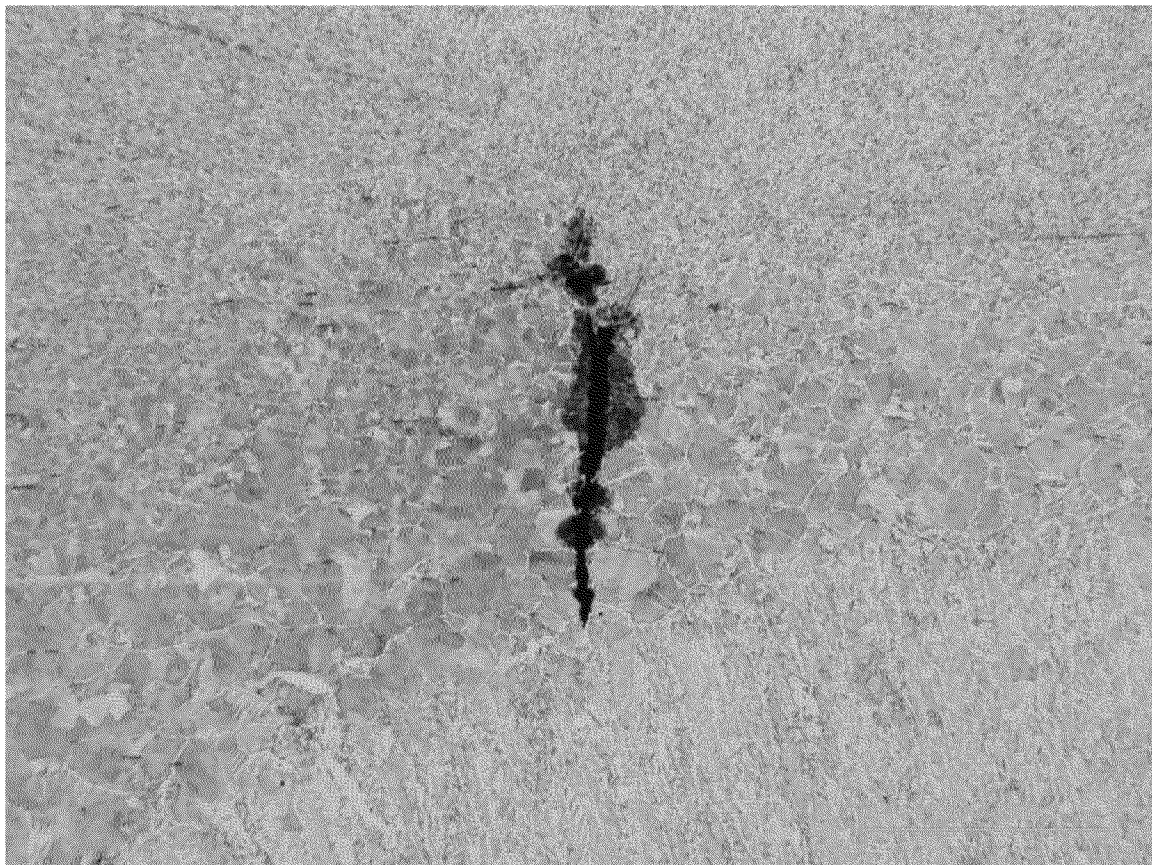
Figure 20. Metallographic image of the lack-of-penetration in Sample T117-CC-T-W.

The subject seam-weld rupture also exhibited un-fused material at the center of the weld, caused by lack-of-penetration between the inner and outer welds. Lack-of-penetration occurs in DSAW pipe when the weld metal from inner and outer welds does not intersect. In this case, small welds, as well as misalignment between the inner and outer welds, resulted in the lack-of-penetration. The lack-of-penetration contributed to the hydrotest failure.
