**PG&E Hydrotest Rupture
Line 300B Metallurgical
Examination**

Exponent Failure Analysis Associates
149 Commonwealth Drive
Menlo Park, CA 94025

March 2012

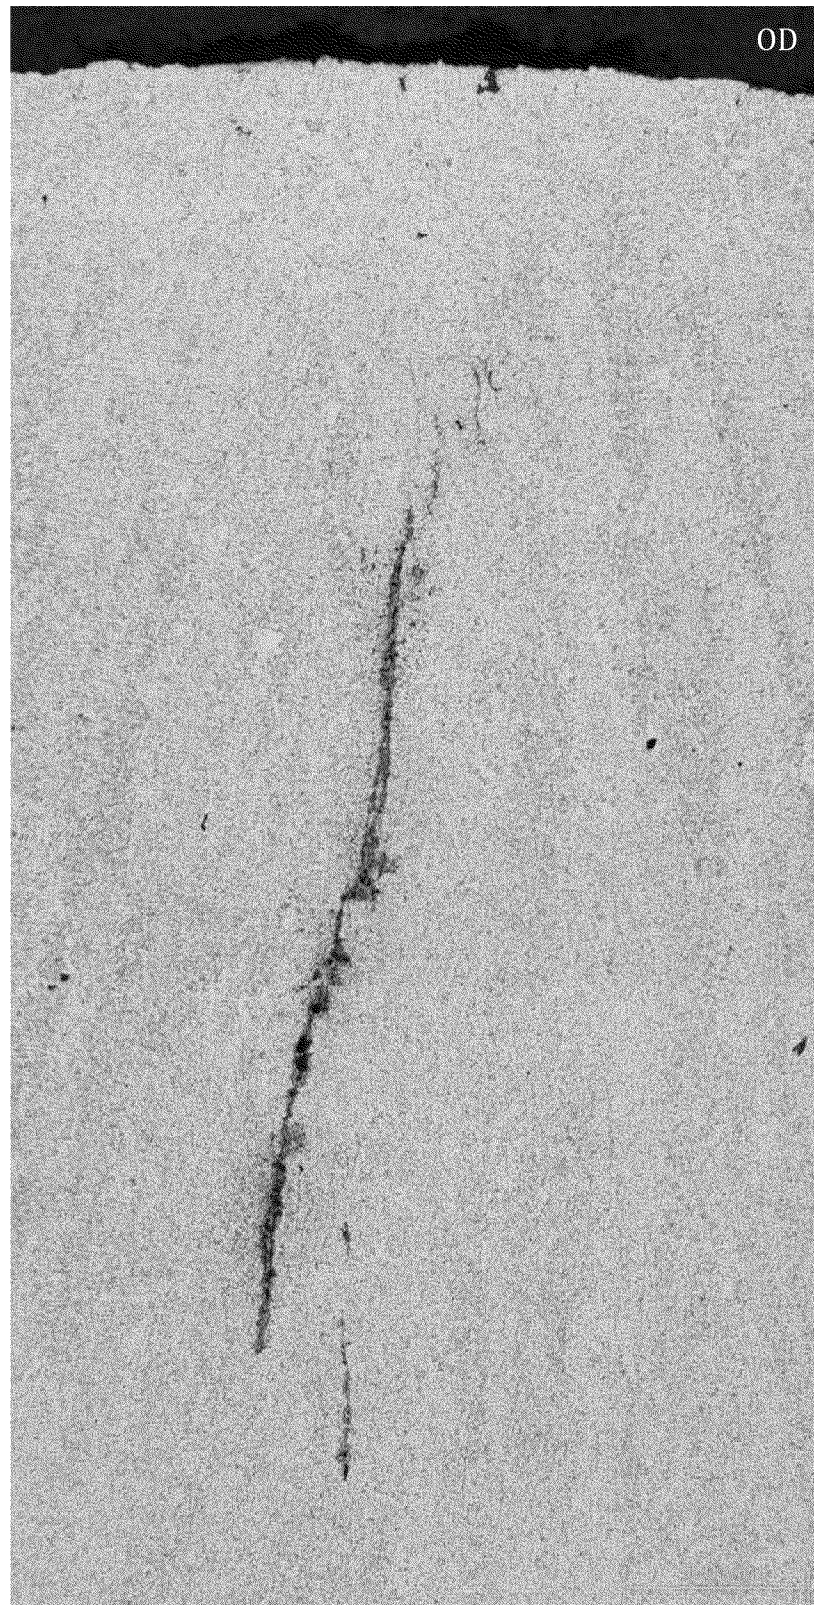
An intact seam weld sample (T117-CC-T-W) was removed from just west of the rupture, shown in Figure 18. A portion of the sample was ground and polished on a plane perpendicular to the length of the weld. Inner and outer weld misalignment and lack-of-penetration was observed, shown in Figure 19. Lack of penetration was observed at the center of the weld, shown in Figure 20, and a relatively small area of solidification cracking was observed within the OD weld, shown in Figure 21.

Figure 21. Metallographic montage of OD weld solidification-cracking in Sample T117-CC-T-W.

Solidification cracking (also referred to as hot cracking) can occur in carbon and low-alloy steel welds when the solidifying metal cannot support the thermally or mechanically-induced strain from the welding process. The cracks typically follow the weld centerline, do not always come to the surface, and are typically heavily oxidized,² consistent with the discontinuity observed in the Line 300B hydrotest rupture. Interdendritic segregation of impurity elements such as sulfur and phosphorus (as well as carbon, nickel, niobium, and boron) contribute to solidification cracking. High sulfur content is one of the most common causes of solidification cracking in welded steels.³ In submerged arc-welds, bead shape, joint restraint, pre-heat temperatures, and correct electrode and flux combinations can affect susceptibility to solidification cracking.⁴ Carbon and sulfur content above current specified maximum levels for X52 was noted for three of the four specimens tested from the Line 300B pipe. Due to the relative proximity to the factory girth weld and associated “squirt” welds, the solidification cracking in the L-300B hydrotest failure may have been associated with cracking from poor mechanical restraint common at joint ends in early 1950-era double submerged arc-welds.⁵

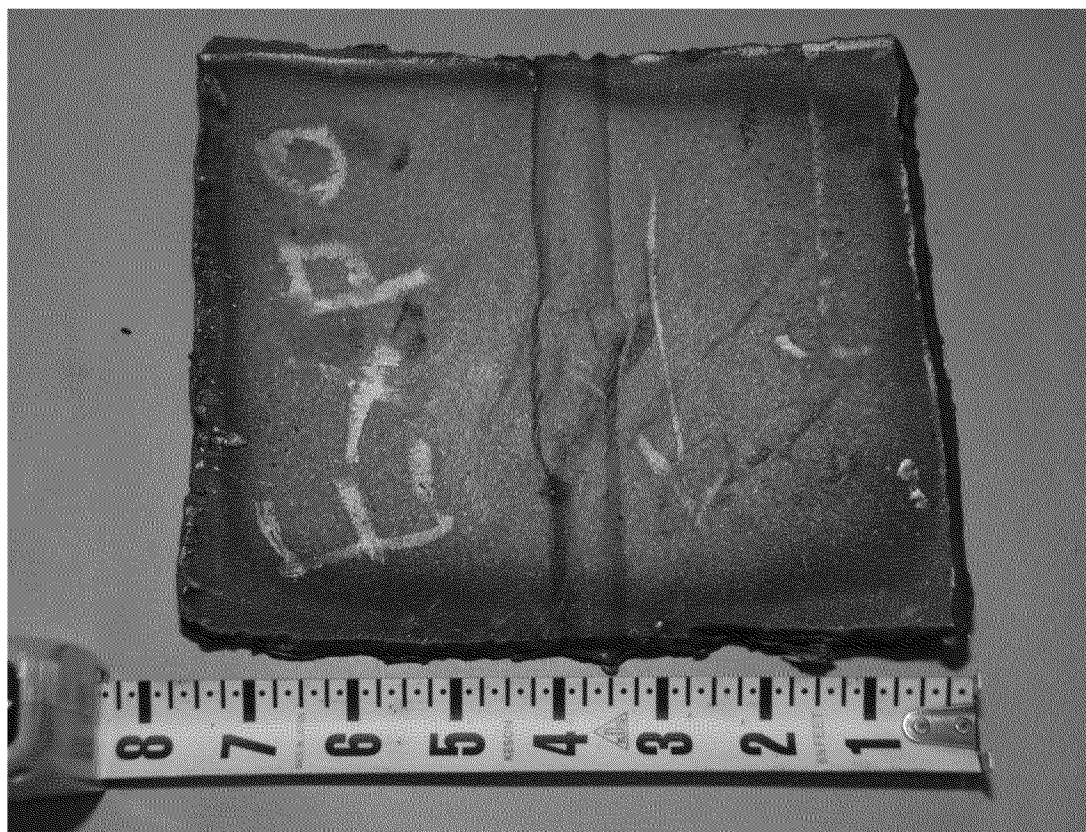
Weld discontinuities were visually observed along the ID seam weld both east and west of the rupture. These discontinuities were identified and marked for further metallographic analysis; an example is shown in Figure 23. The samples were cross sectioned, ground, and polished to allow metallographic examination on a plane perpendicular to the longitudinal axis of the pipe. Metallographic examination of these ID weld discontinuities confirmed that they were repair welds, as evidenced by extra deposited weld metal along the ID welds; examples are shown in Figure 24. The repair welding process observed on these welds did not affect their structural integrity.

Figure 23. Images showing an example of a weld discontinuity observed along the ID seam weld.

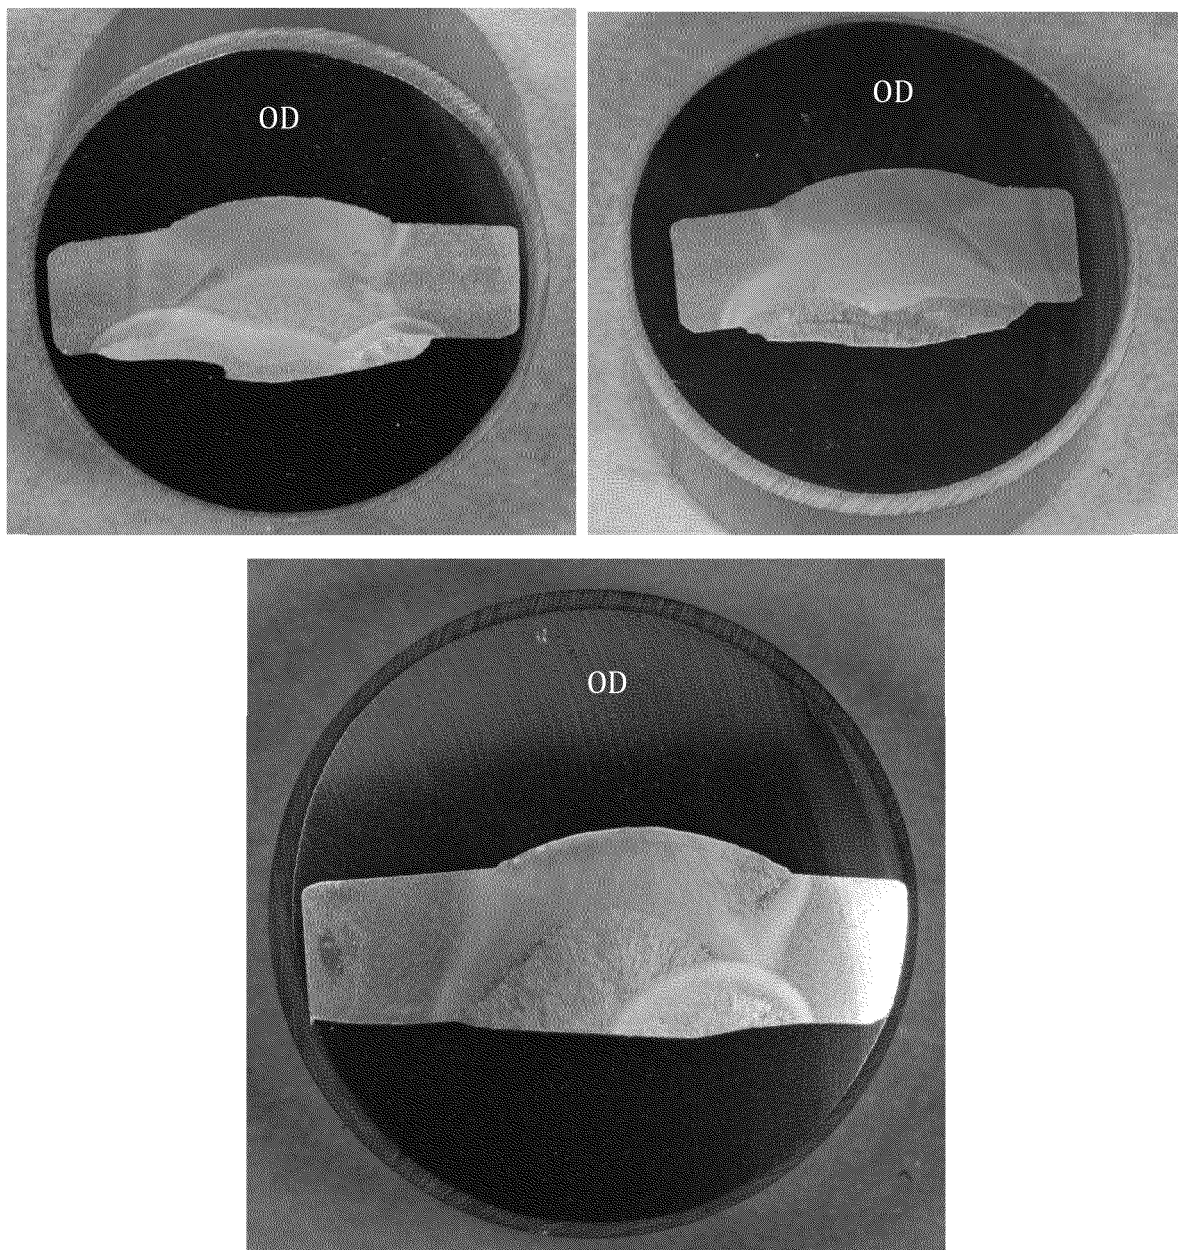
Figure 24. Images of metallographic cross-sections showing ID repair welds.

Metallographic examination of seam weld anomalies found during visual inspection indicated that repairs had been made along the submerged-arc weld. These weld repairs were relatively minor, did not leave large discontinuities, and did not affect the integrity of the pipe.

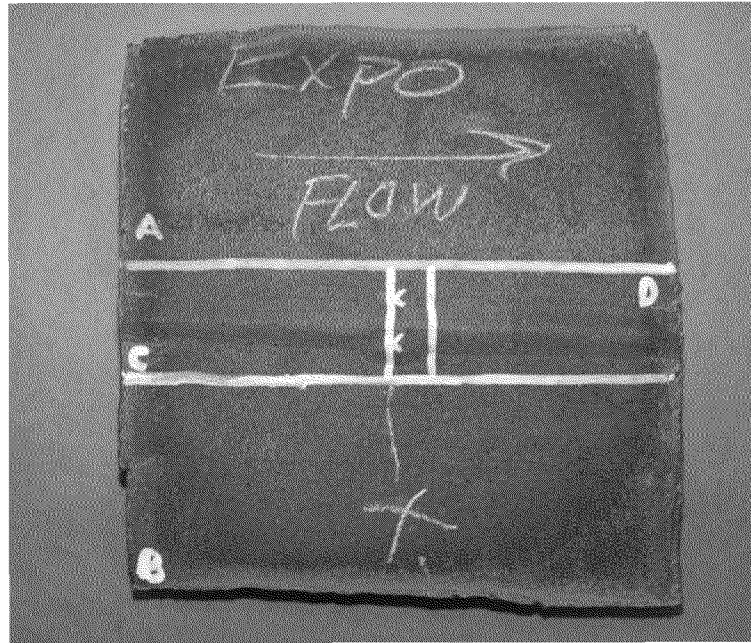
Weld “buttons” were observed on the pipe OD seam, downstream of the rupture site, and were removed for metallographic examination, shown in Figure 25. The buttons were cross sectioned along a plane perpendicular to the pipe axis and prepared using standard metallographic techniques. Metallographic analysis showed no apparent defects associated with these repair welds along the OD seam (Figure 26). Thus, this OD weld-repair process did not reduce the structural integrity of the pipe.

Figure 25 Window that contains specimen marking and the two OD “button” welds.

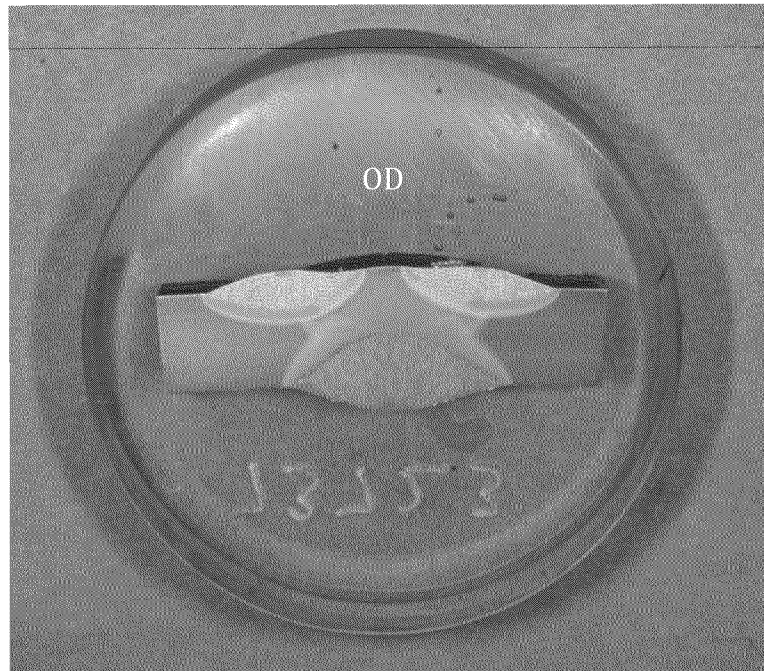
Figure 26 Photograph of OD weld button metallographic mount.
