Investigation of a Failure of Line 300 at Mile Post 284.14 during Hydrostatic Test 117

MJ Rosenfeld, PE
March 16, 2012

Kiefner & Associates, Inc.
585 Scherers Court
Worthington, Ohio 43085

PACIFIC GAS & ELECTRIC COMPANY

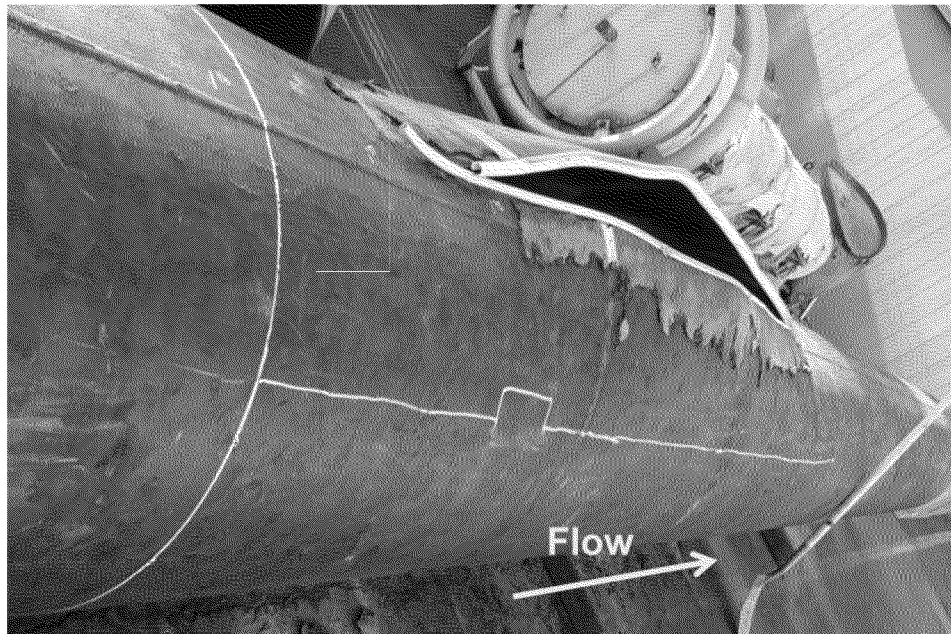
A nominal 40-ft (39-ft, 7-in actual) section centered on the fracture was removed by PG&E and shipped to the PG&E Applied Technical Services facility in San Ramon, CA for initial examination. An overall view of the pipe specimen is shown in Figure 1, viewed looking downstream approximately East to West. Most of the hot applied asphalt coating had been removed except immediately adjacent to the fracture. Slit rubber hoses were placed over the fracture surfaces for mechanical protection. The white lines mark where the specimen was cut to smaller size.

Figure 1. Failure Specimen, Coating Removed, Marked for Cutting (photo by author)

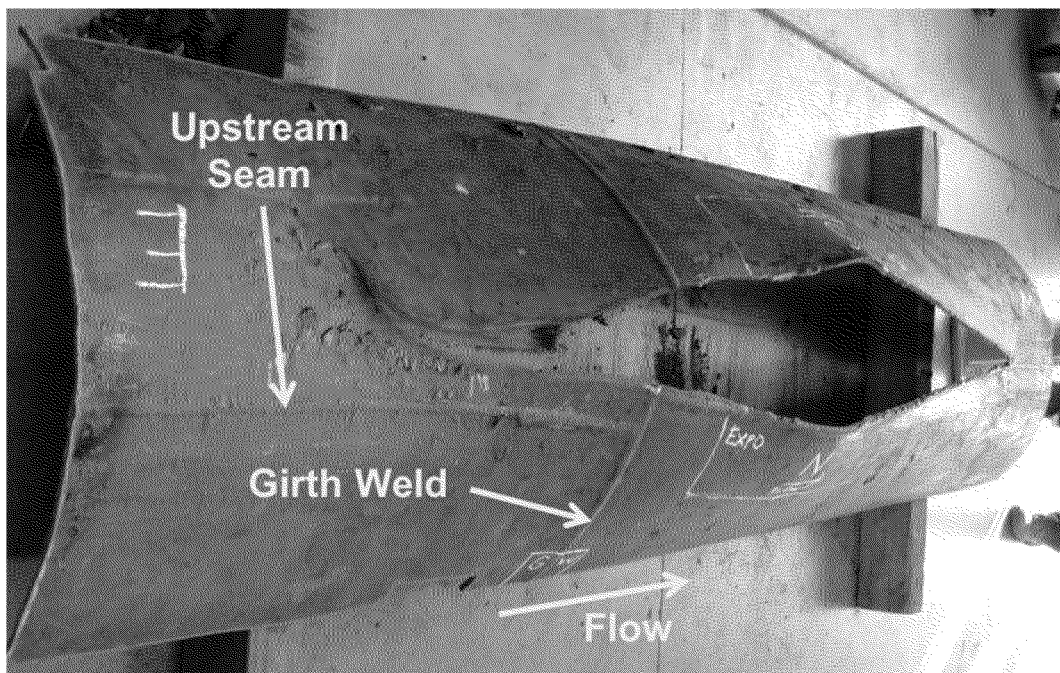
The failure specimen was cut down to manageable size, shown in Figure 2, with remaining coating removed and as marked for further subdivision. The total length of the fracture was 89.5 inches. The fracture intersected a girth weld visible to the right of the locating notch, terminating 19 inches into the upstream pipe joint.

Figure 2. Reduced Size Specimen Containing Fracture (photo by author)

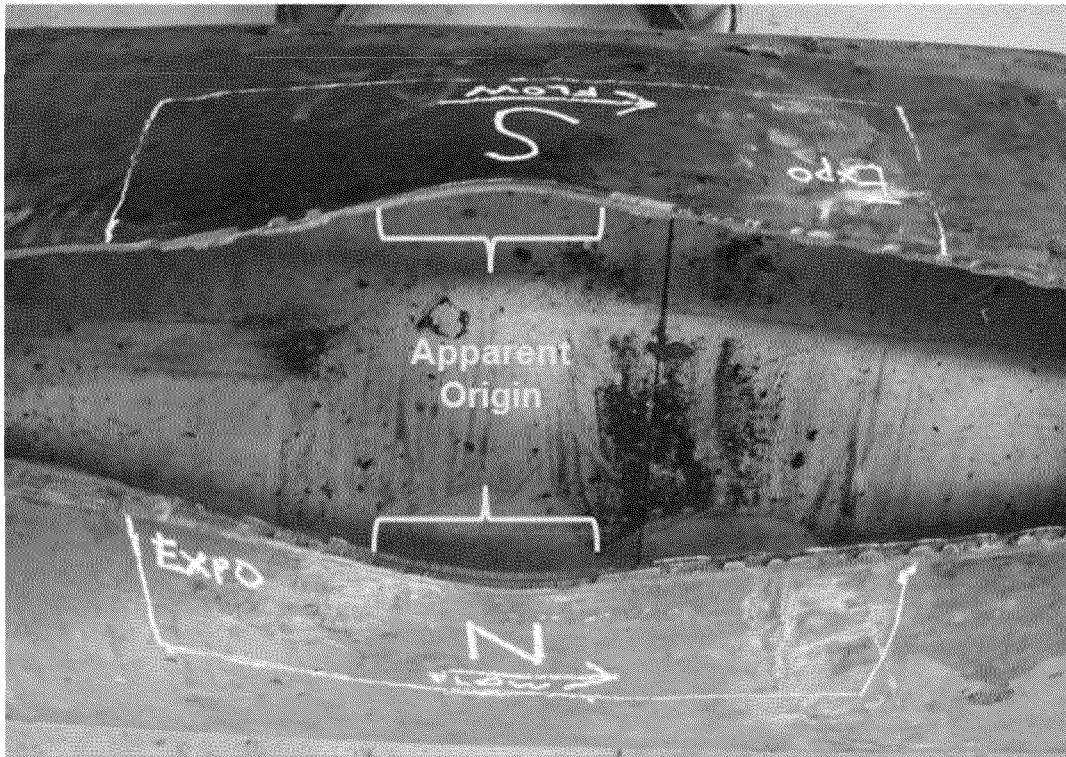
An apparent origin 6.5 inches long was located 14.5 inches downstream of the girth weld. Coupons containing only the central portion of the fracture were cut out to isolate the apparent origin, identified in Figure 3. The apparent origin was confirmed as the probable origin based on its occurrence at the widest point of opening in the rupture, and by the appearance of brittle fracture chevrons in the propagating fracture, which pointed toward the 6.5-inch-long feature.

Figure 3. Coupons of Mating Fracture Segments Containing Apparent Origin (photo by author)

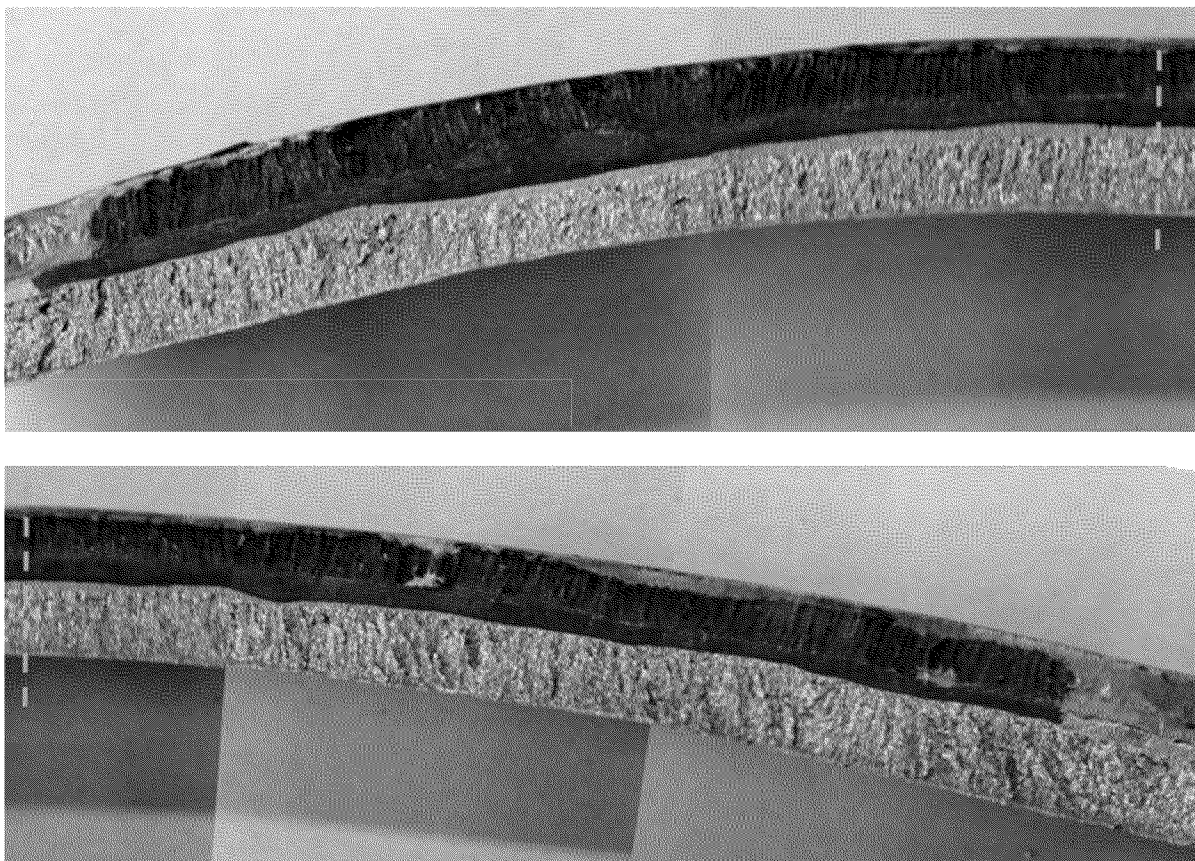
A composite detail of the origin in the condition as discovered is shown in Figure 4 prior to cleaning. The apparent origin is seen to consist of a 6.5-inch-long crack in the outer seam weld deposit. The apparent origin presented a columnar texture typical of certain types of weld cracks, and a dark coloration that could be a stain or oxide. The vertical dashed line in represents match points in the two photos.

An unfused region was present along the center of the weld between the inner and outer seam weld deposits. The dark coloration on the weld crack extended to the unfused region between the weld beads but only over a length essentially coincident with the weld crack. The unfused region extended the full length of the fracture, but did not exhibit the dark coloration beyond the length adjacent to the weld crack. The inner weld deposit exhibited a bright fracture surface consistent with recent brittle fracture. Beyond the 6.5-inch-long defect, the fracture exhibited brittle fracture propagation chevrons that pointed toward the 6.5-inch defect and beyond that transitioning to ductile shear fracture propagation.

Figure 4. Composite of Origin, North Fracture Surface, Before Cleaning, 2X (photo by author)

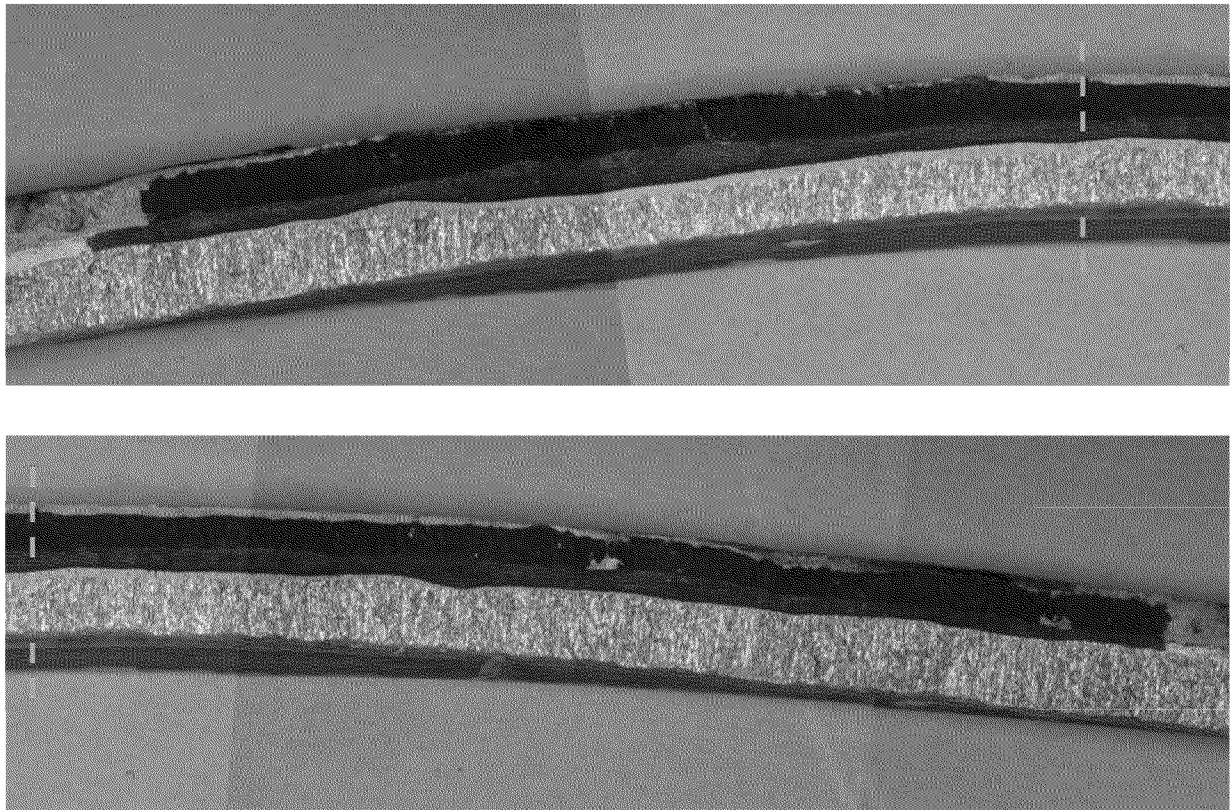
The fracture surface was cleaned in acetone, then xylene, and then a nonoxidizing detergent (Alconox). It was then cleaned ultrasonically in a mild alkaline detergent (Micro 90). The cleaning steps failed to remove the dark coloration on the weld crack, but lightened the coloration on the unfused surfaces, as shown in Figure 5. The vertical dashed line represents match points in the two photos.

The resistance of the dark coloration to a variety of cleaning methods suggested that it was an adherent oxide. The persistence of the dark oxide, position of the crack at the centerline of the outer weld deposit, and visible columnar texture of the crack surface all were consistent with a hot crack, a condition known to occur in submerged arc welds.

Figure 5. Composite of Origin, North Fracture Surface, After Cleaning, 2X (photo courtesy Exponent)

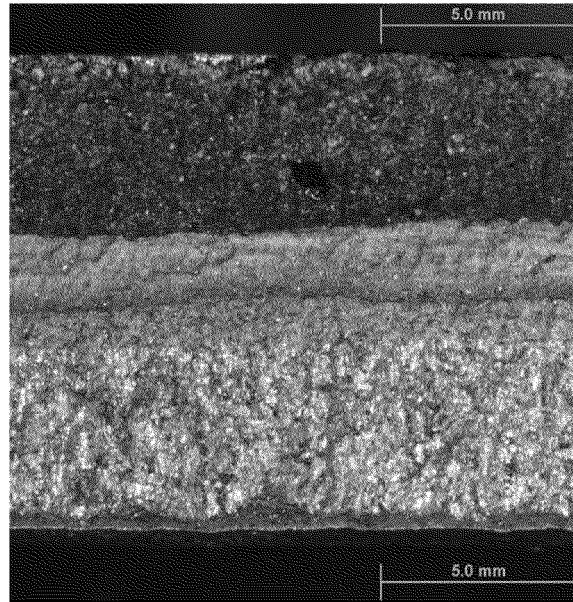
The fracture was examined in a stereomicroscope to resolve features of interest, both before and after cleaning. Figure 6 shows a region of the fracture surface before cleaning. A dark, shiny deposit is evident near the exterior surface and on portions of the fracture in the outer weld deposit.

Figure 6. Fracture Surface Before Cleaning, 5X (photo by Exponent)

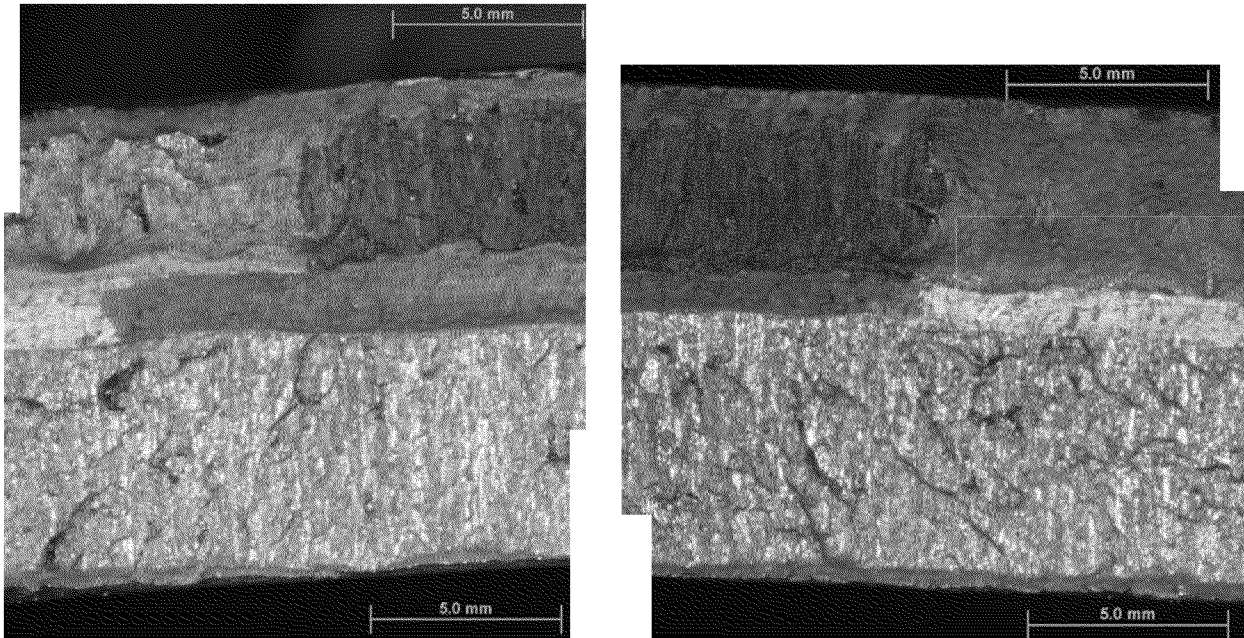
Figure 7 shows both ends of the defect, before cleaning. The dark coloration is present on the weld crack. The unfused surface is the flat region between the oxidized and nonoxidized weld fractures. The dark coloration on the LOP surface disappears beyond the portion that is coincident with the weld crack. The radial dimension of the LOP varied from 0.04 inch to 0.10 inch, based on viewing the surface under low magnification.

Figure 7. Terminations of Origin Defect, North Fracture Surface, 5X (photo by Exponent)

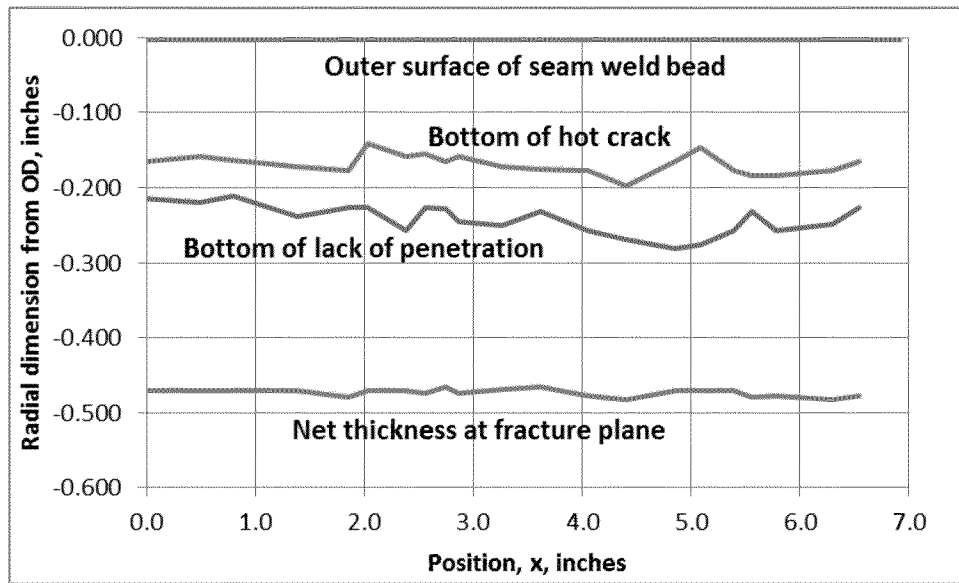
Photographs similar to those in Figure 6 and Figure 7 spanning the full length of the apparent origin and beyond were used to develop a profile of the radial dimensions of the apparent hot crack, the lack of fusion between the inner and outer weld beads, and the net thickness through the fracture plane. The profiles are given in Figure 8, as measured from the intersection of the fracture with the outside surface of the outer weld bead represented at the top of the chart. The average metal thickness through the fracture was 0.473 inch.

Figure 8. Radial Dimensions of Fracture Features

modified to consider the actual profile of the defect.¹³ The analysis was performed using the flaw profile in Figures 8 and 9, along with the lowest measured seam yield strength and tensile strength values of 69 ksi and 89 ksi, respectively, and an average metal thickness of 0.473 inch in the portion that fractured. Considering the flaw to be strictly flow-stress dependent (which would be the case with a blunt metal-loss defect, or a planar flaw in a material having very high toughness), the estimated failure pressure was 1,556 psig. This estimate significantly exceeded the actual failure pressure of 998 psig, indicating a toughness-dependency and/or an interaction with the LOP extending beyond the hot crack.

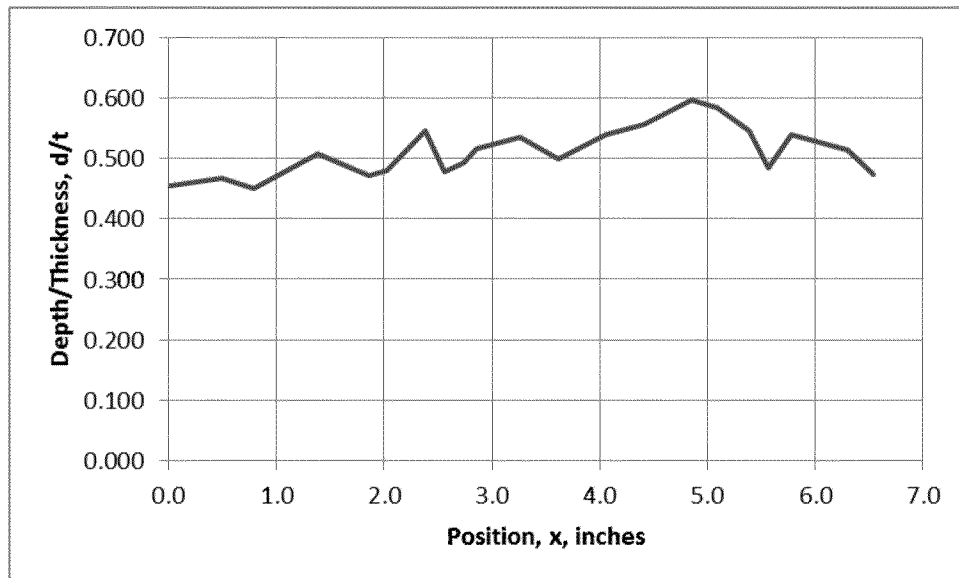
Figure 9. Ratio of Flaw Depth to Metal Thickness

The actual profile of the combined hot crack and LOP defect, from Figure 8, has a ratio of flaw depth to metal thickness (d/t) shown in Figure 9. The average d/t was 0.51 (51% of the metal thickness) with a maximum d/t of 0.60.

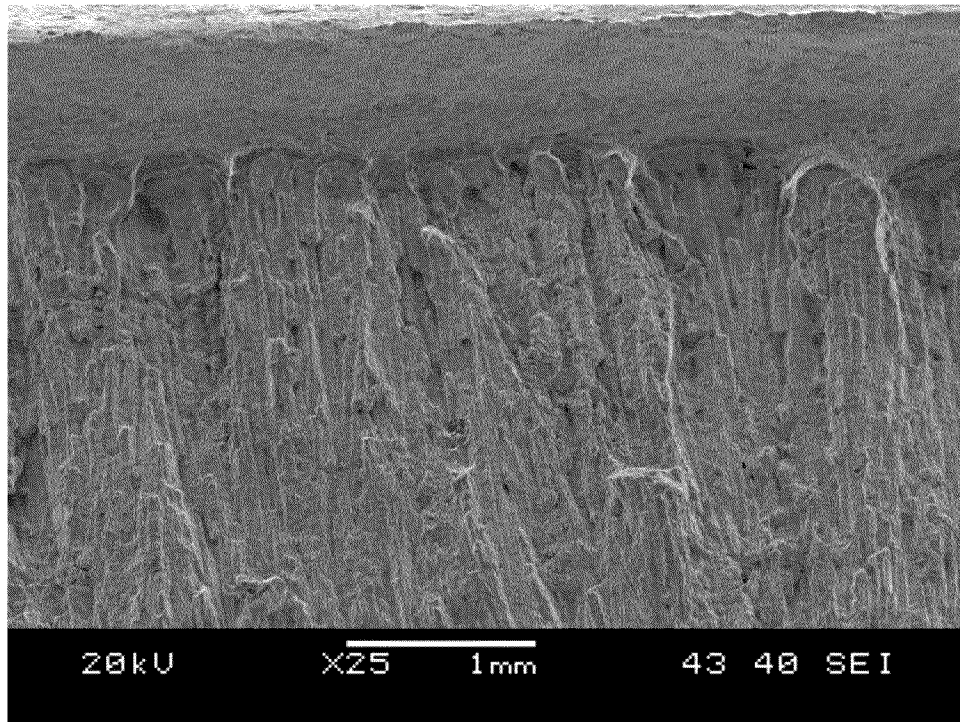
Figure 10. Zone 1 and Upper Part of Zone 2, 25X

Figure 10 shows Zone 1 and the upper portion of Zone 2. Figure 11 is a detail of Zone 1 at high magnification exhibiting a dimpled texture indicating ductile fracture. Zone 1 is interpreted as a ductile shear lip that failed at the time of the hydrostatic test.

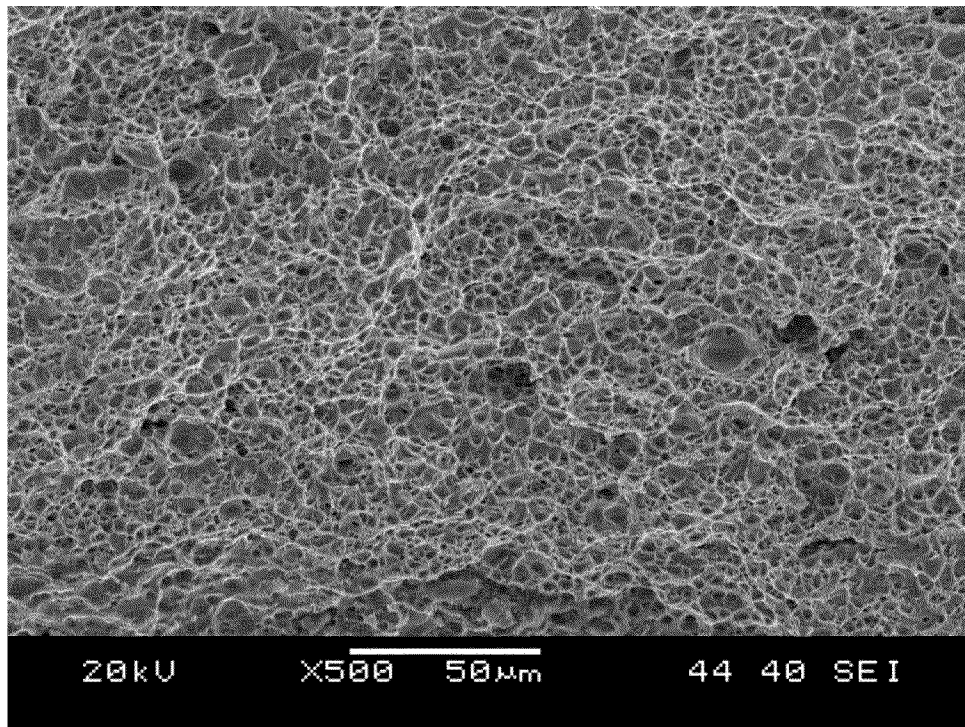
Figure 11. Detail in Zone 1, 500X

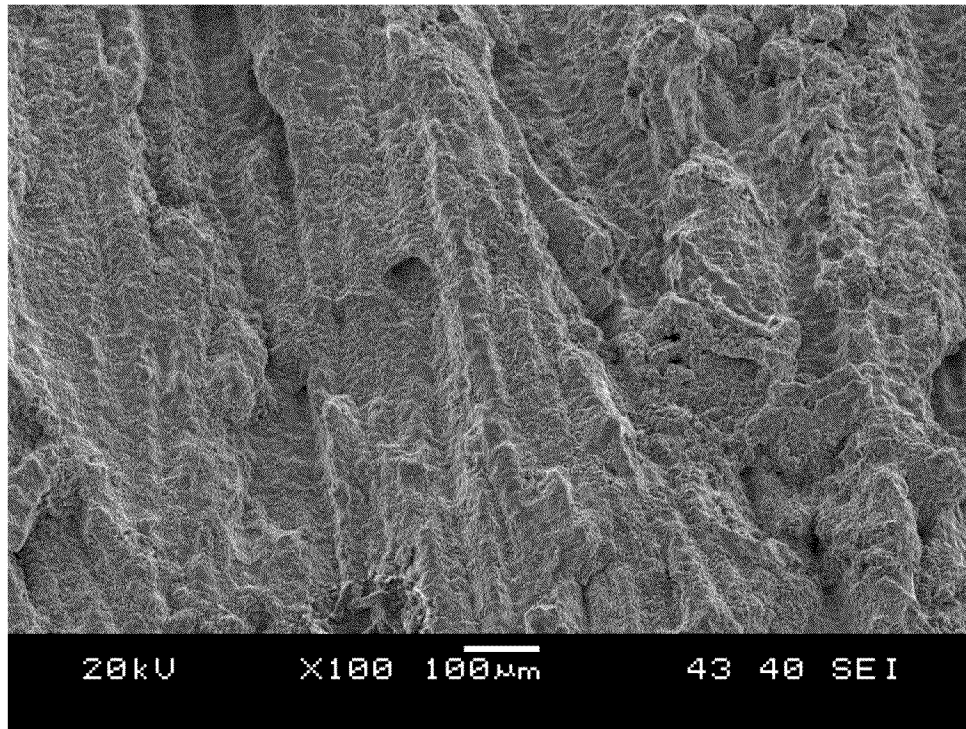
Figure 12. Zone 2 Surface, 100X

Figure 12 shows the typical surface in Zone 2. Zone 2 in Figure 12 and in the lower portion of Figure 10 exhibits the columnar structure of the apparent hot crack in the weld. Figure 13 is a detail of Zone 2 at high magnification. The surface is coated with an adherent oxide. Figure 14 shows a region where Zone 2 penetrates through Zone 1 to the pipe exterior surface (at bracket). The arrow identifies what appears to be extension of the flaw. Figure 15 is a detail of the extension feature at high magnification with Zone 1 in the upper left and Zone 2 in the lower right. While the feature between the two zones lacks the columnar structure of Zone 2, it is coated with an adherent oxide like Zone 2 suggesting that it experienced a similar environmental history as Zone 2. The identified region is interpreted as extension of the hot crack that occurred while the material was still hot.

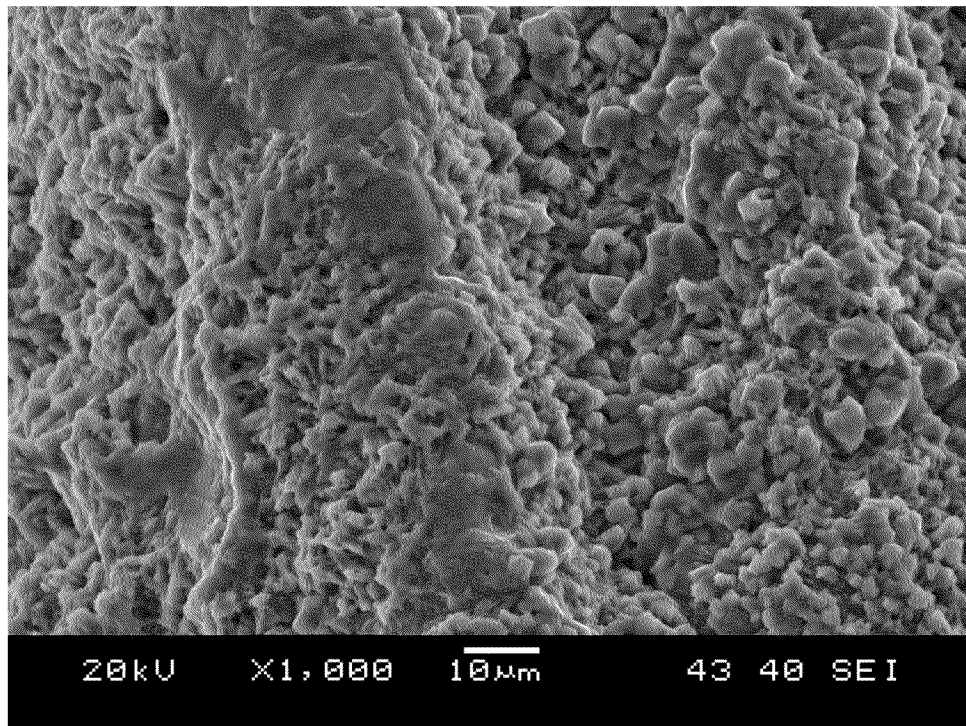
Figure 13. Detail of Zone 2, 1,000X

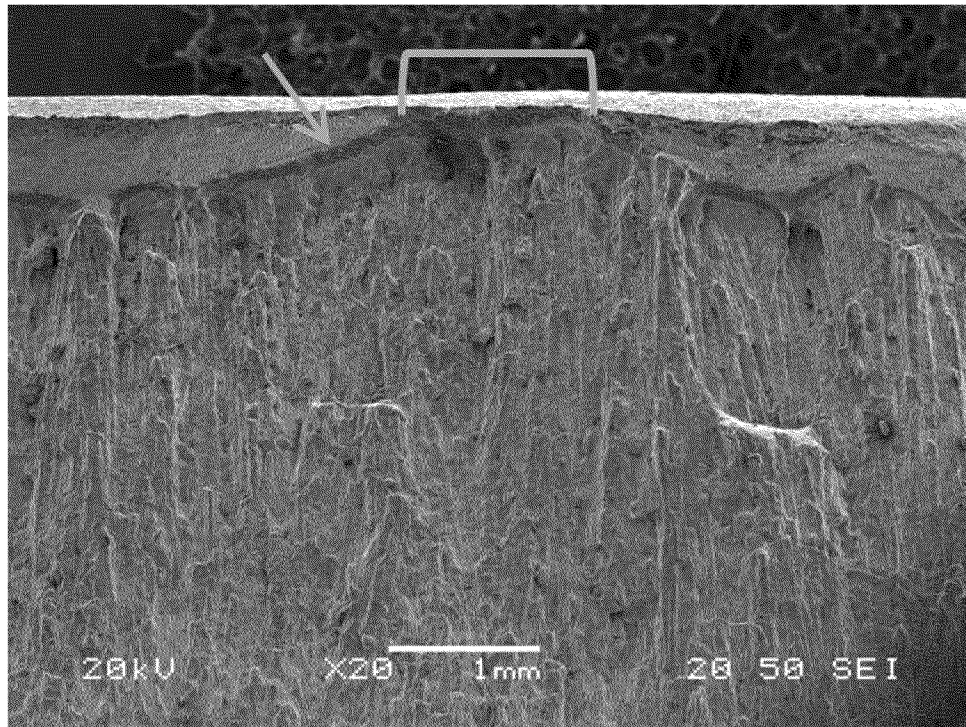
Figure 14. Local Extension of Zone 2 to Exterior Surface, 20X

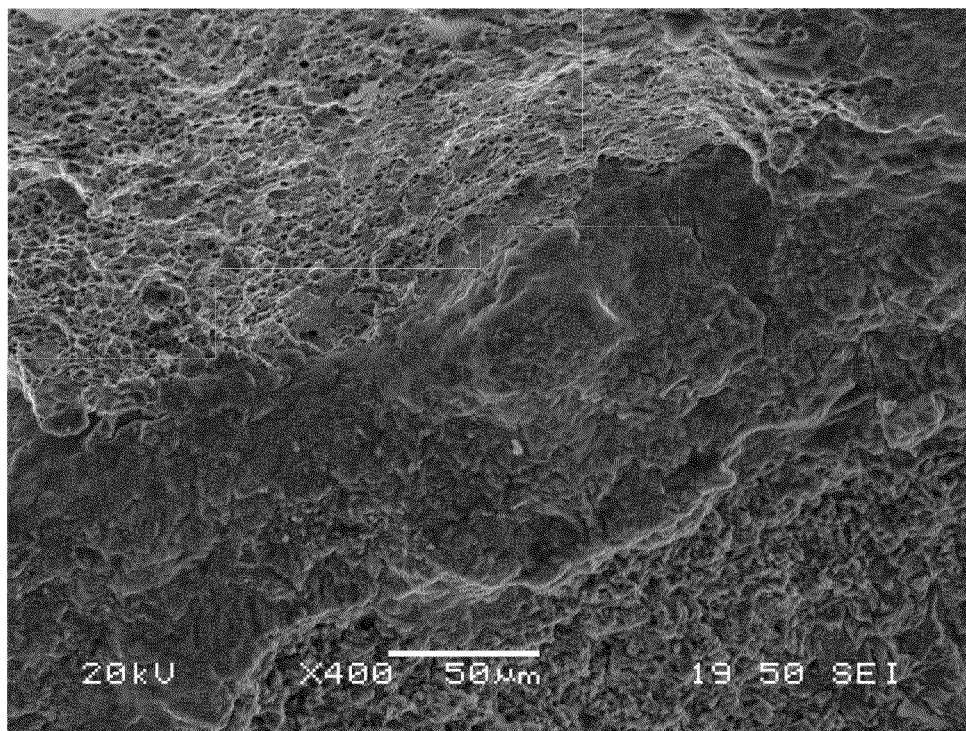
Figure 15. Detail at Edge of Zone 1 Extension, 400X

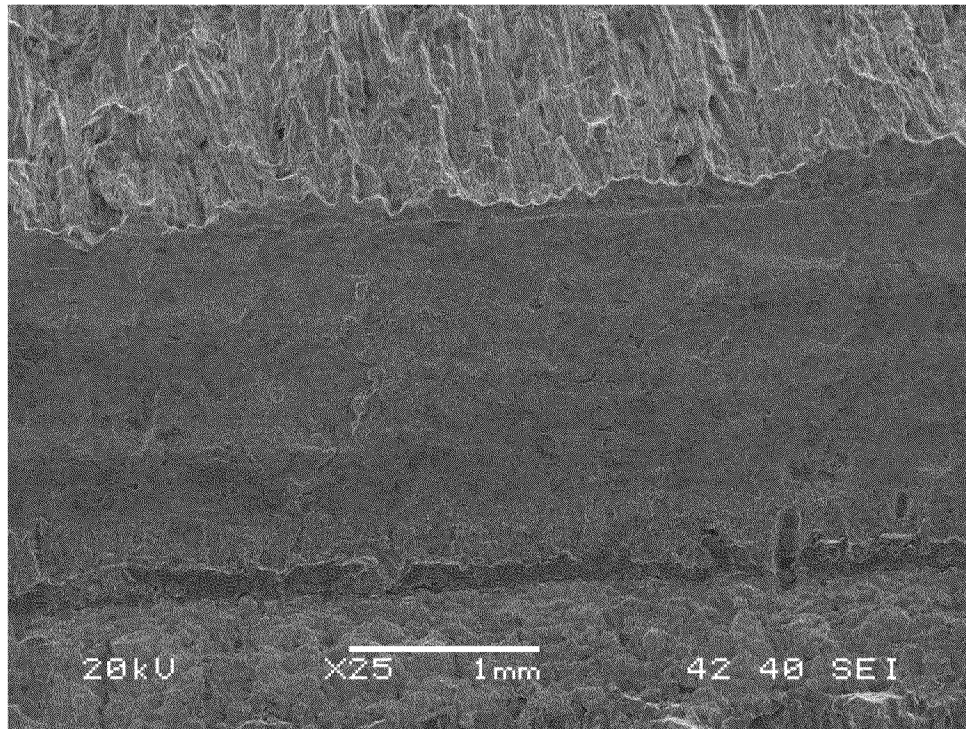
Figure 16. Zone 3 Surface, 25X

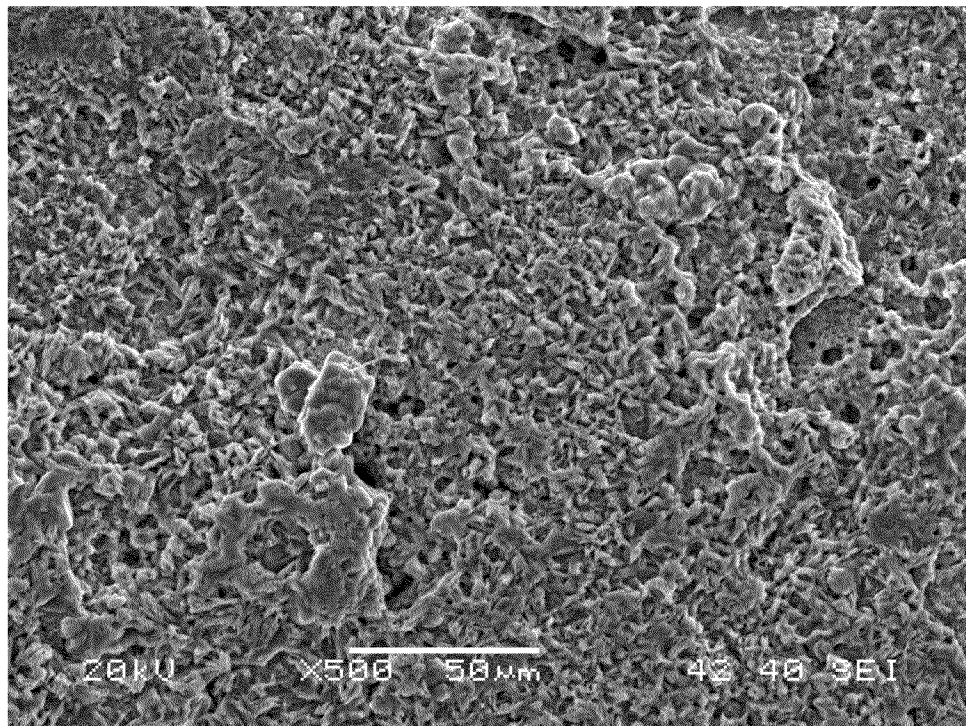
Figure 17. Detail of Zone 3, 500X

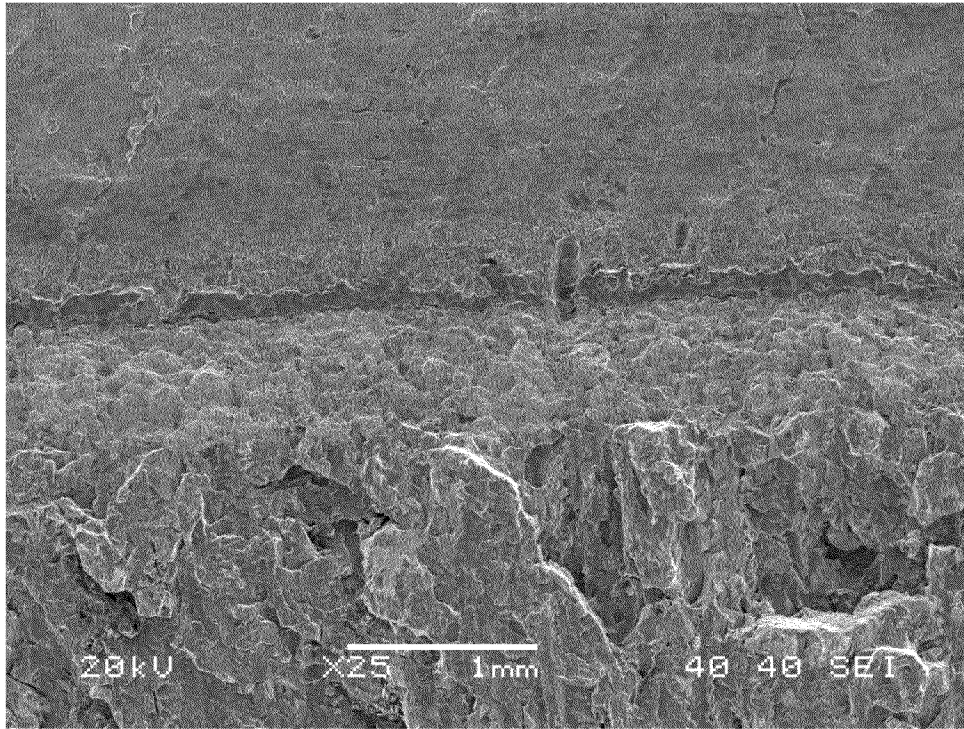
Figure 18. Zone 4 between Lower Part of Zone 3 and Upper Part of Zone 5, 25X

Figure 18 shows a region of fracture comprising Zone 4. Zone 3 is in the upper part of the photo and Zone 5 is in the lower part. Figure 19 and Figure 20 are details in Zone 4 at intermediate and high magnification, respectively. Figure 19 and Figure 20 were not obtained at the same locations. The width of Zone 4 varied significantly. Zone 4 exhibited dimpled, ductile fracture with no oxide. Zone 4 is interpreted as the ductile initiation of the failure that occurred during the hydrostatic pressure test.

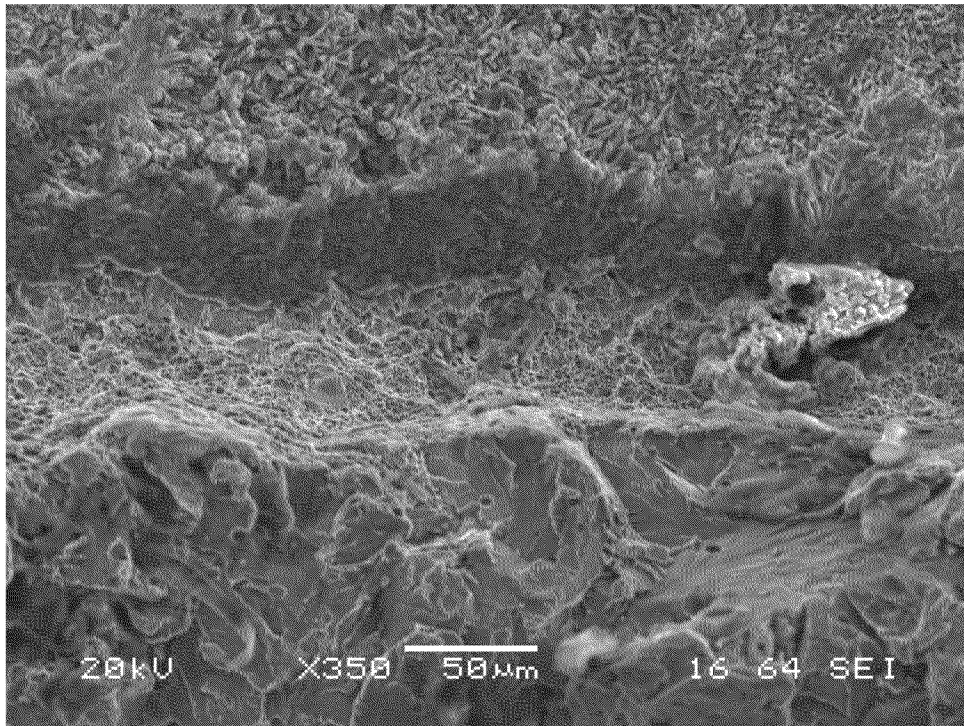
Figure 19. Detail of Zone 4, 350X

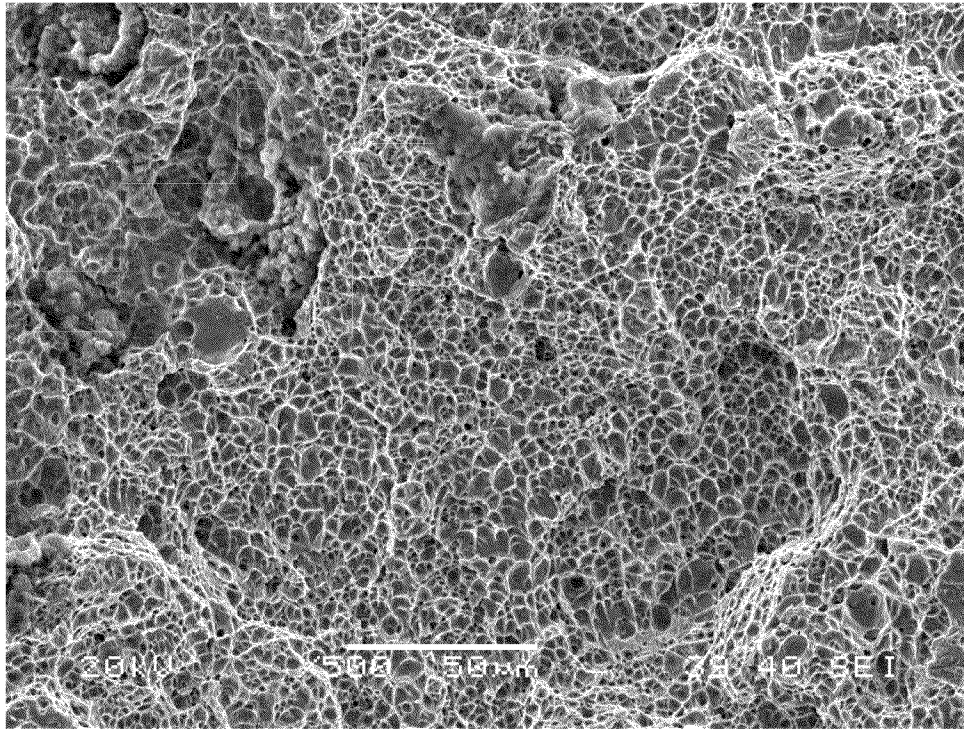
Figure 20. Detail of Zone 4, 500X

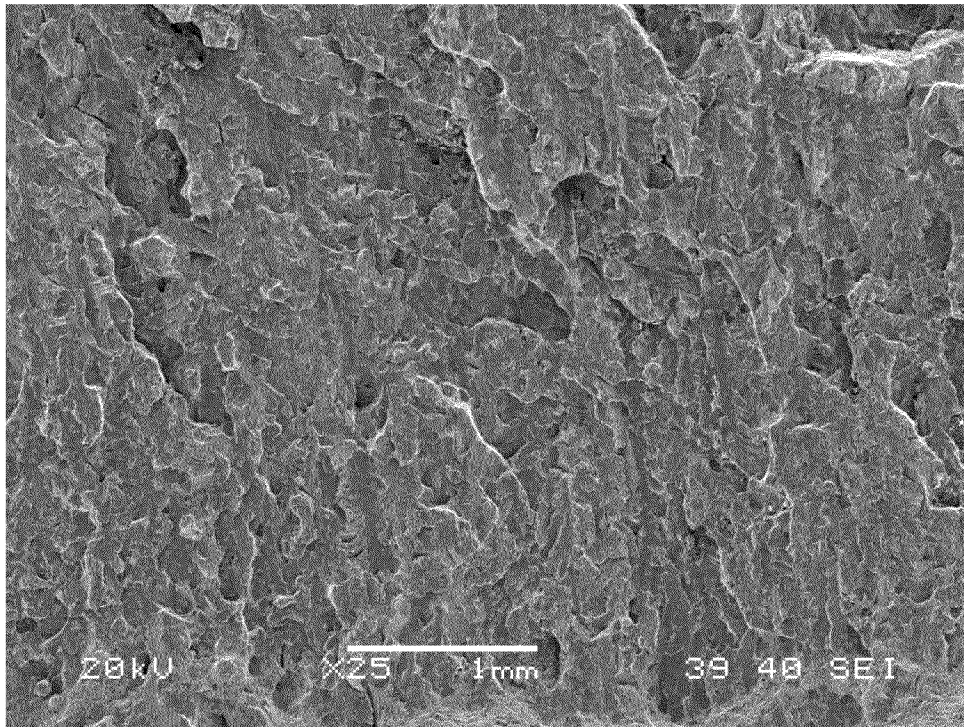
Figure 21. Zone 5 Surface, 25X

Figure 21 shows the typical surface in Zone 5. Figure 22 is a detail of Zone 5 at high magnification. The surface exhibits cleavage planes indicating brittle fracture, and no oxide. Zone 5 represents the propagation of the hydrostatic test fracture through the inner weld deposit.

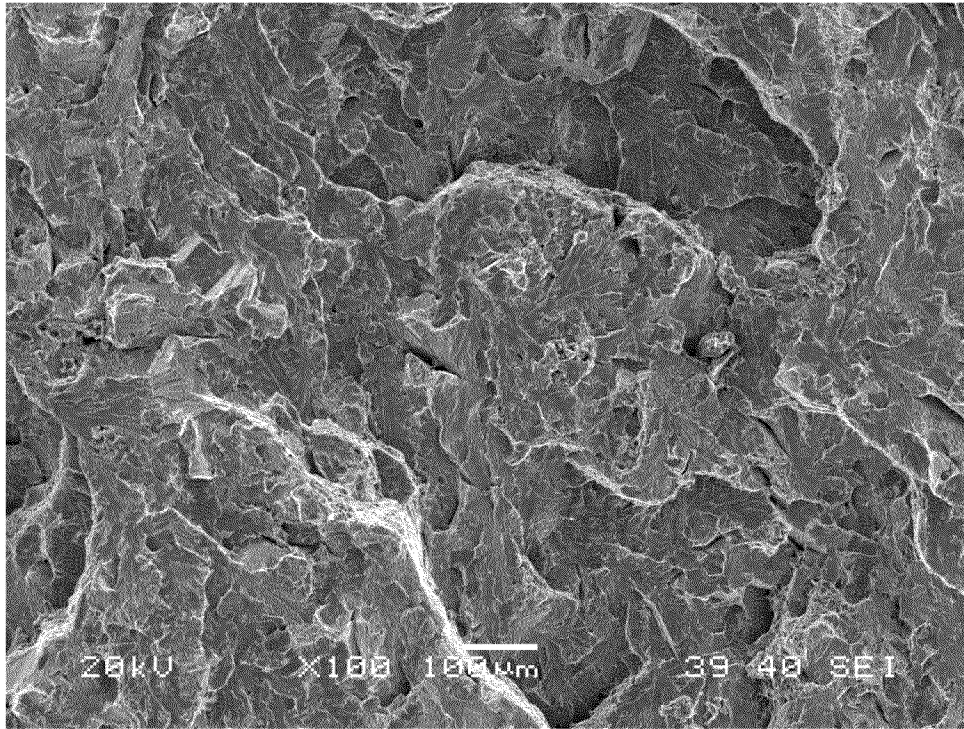
Figure 22. Detail of Zone 5, 100X

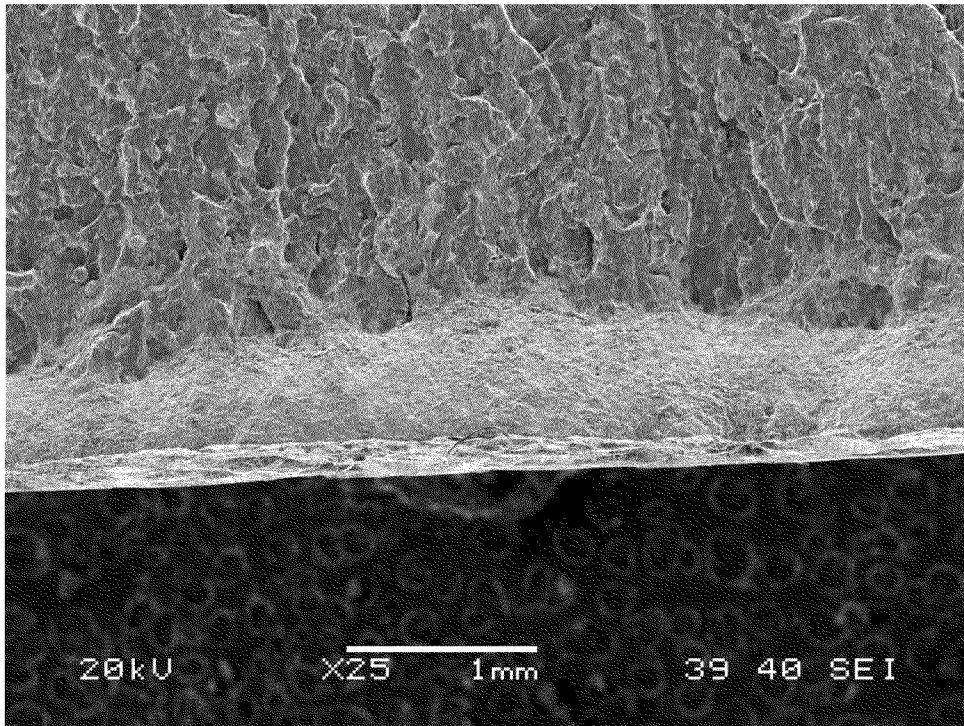
Figure 23. Zone 6 at Bottom of Zone 5, 25X

Figure 23 shows Zone 6 adjacent to the interior pipe surface, and the lower part of Zone 5. Figure 24 is a detail of Zone 6 at high magnification, exhibiting dimpled, ductile fracture with some surface deposits. Zone 6 is interpreted to be a ductile shear lip that developed as the propagating fracture reached the interior surface.

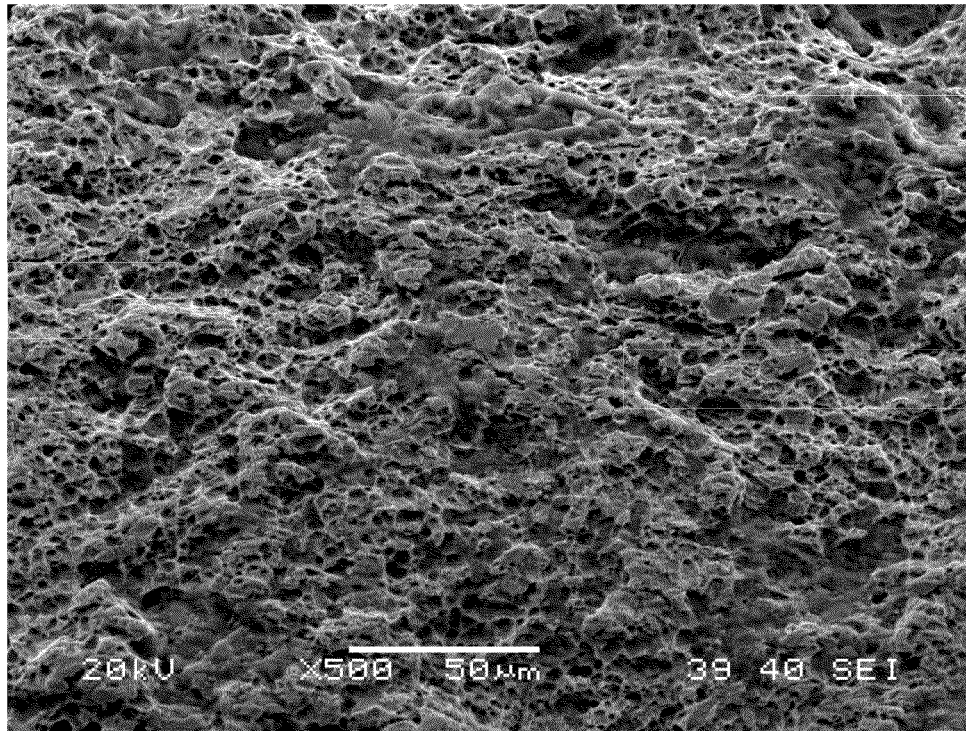
Figure 24. Detail of Zone 6, 500X

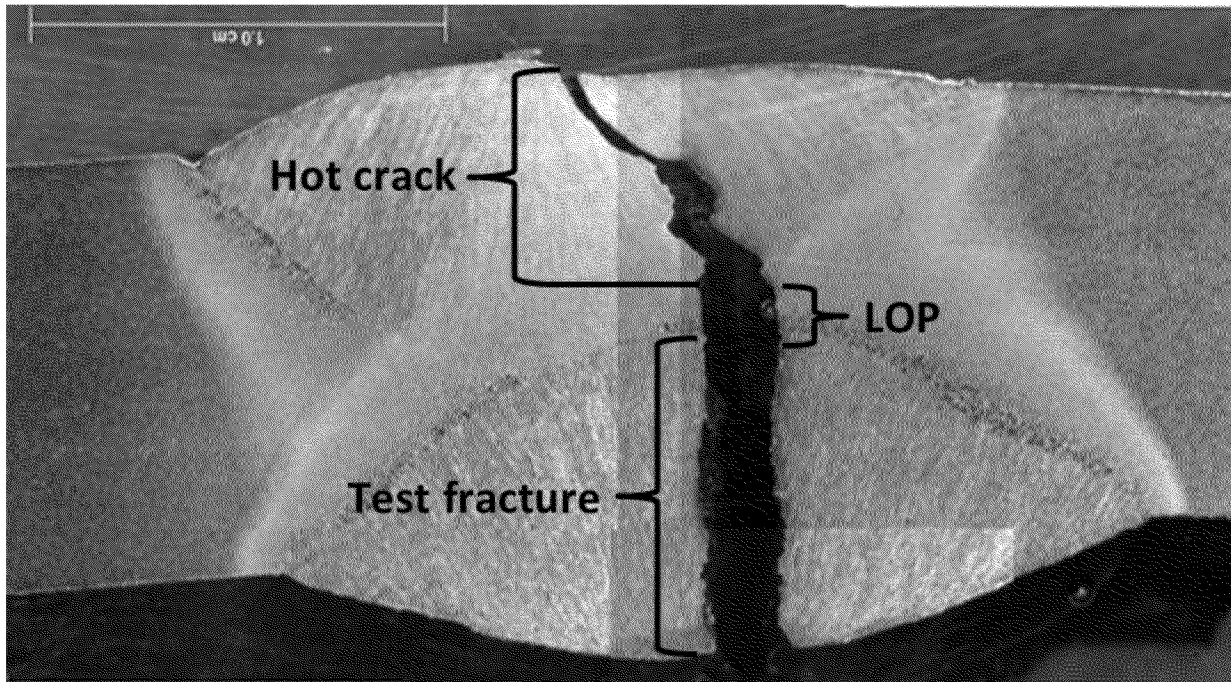
Metallographic sections were prepared through two positions in the 7-inch long apparent hot crack. Composite photographs of metallographic sections through two positions in the origin defect are presented in Figure 25 and Figure 26. Mount "A" was obtained from the upstream end of the hot crack and Mount "B" was removed from the downstream end. The photos are oriented with the pipe exterior surface as the upper surface. The apparent hot crack, LOP, and hydrostatic test fracture are identified.

The inside and outside weld deposits are seen to penetrate to a depth of approximately half of the pipe wall thickness. Penetration was intended to be $2/3$ of the wall thickness in order to provide overlap.¹ Also, the outer weld deposit is seen to be offset laterally approximately 0.2 inch, causing the deepest points of penetration of the two weld passes to miss each other.

Figure 25. Metallographic Cross Section, Mount A, 5X

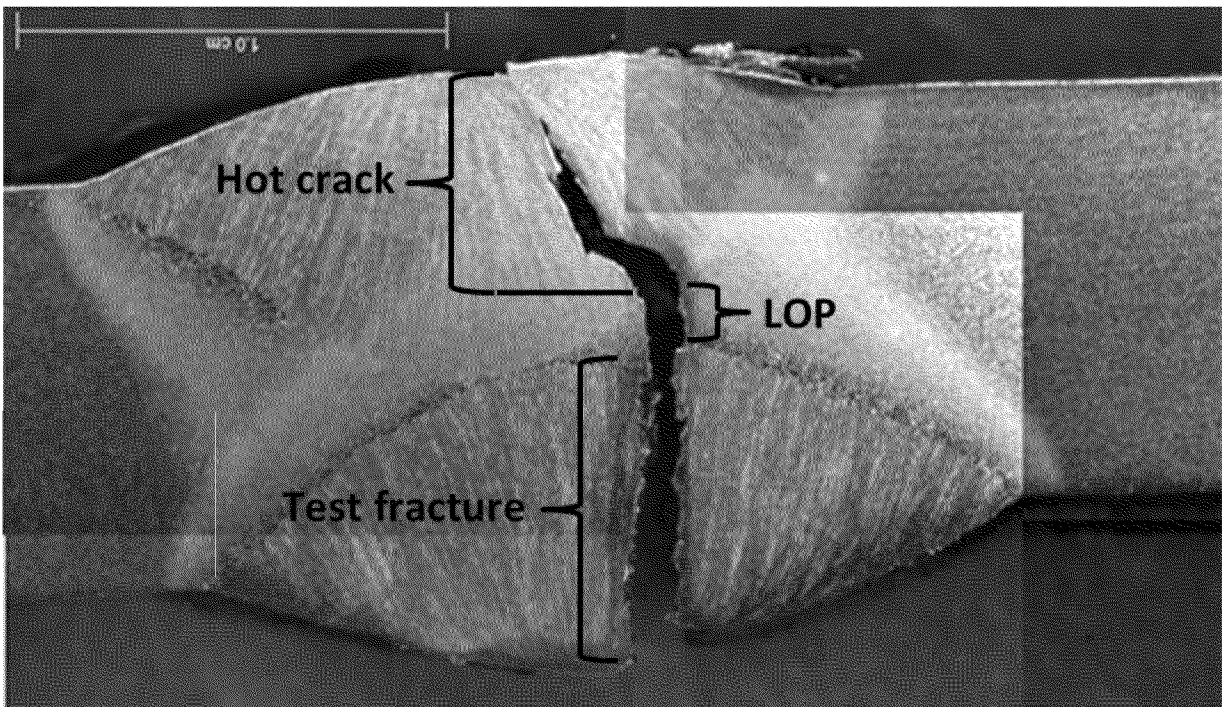
Figure 26. Metallographic Cross Section, Mount B, 5X

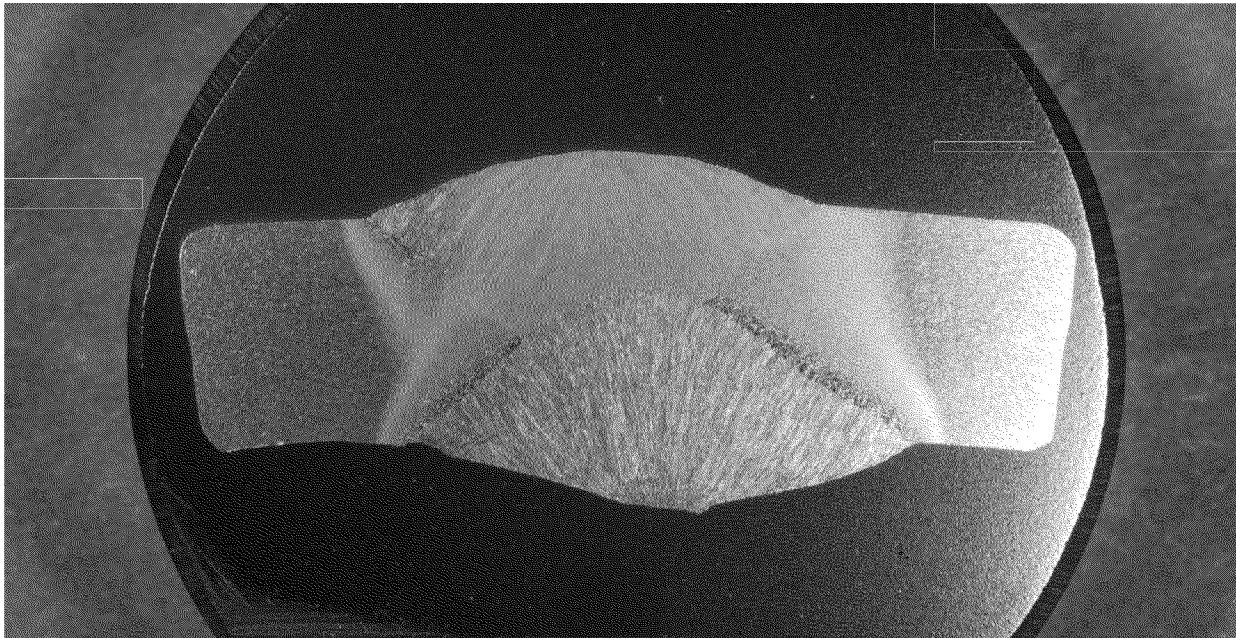
Metallographic sections were also prepared through unfractured portions of the longitudinal seam, one of which (from piece 72493) is shown in Figure 27. The section shows that the outside pass was made first because the inside weld deposit is seen to overlap the outside weld

deposit. There is no LOP feature even with some lateral misalignment of the weld deposits because overlapping penetration was achieved.

Figure 27. Intact Seam Showing Normal Seam Weld Deposition
