Investigation of a Failure of Line 300 at Mile Post 284.14 during Hydrostatic Test 117

MJ Rosenfeld, PE
March 16, 2012

Kiefner & Associates, Inc.
585 Scherers Court
Worthington, Ohio 43085

PACIFIC GAS & ELECTRIC COMPANY

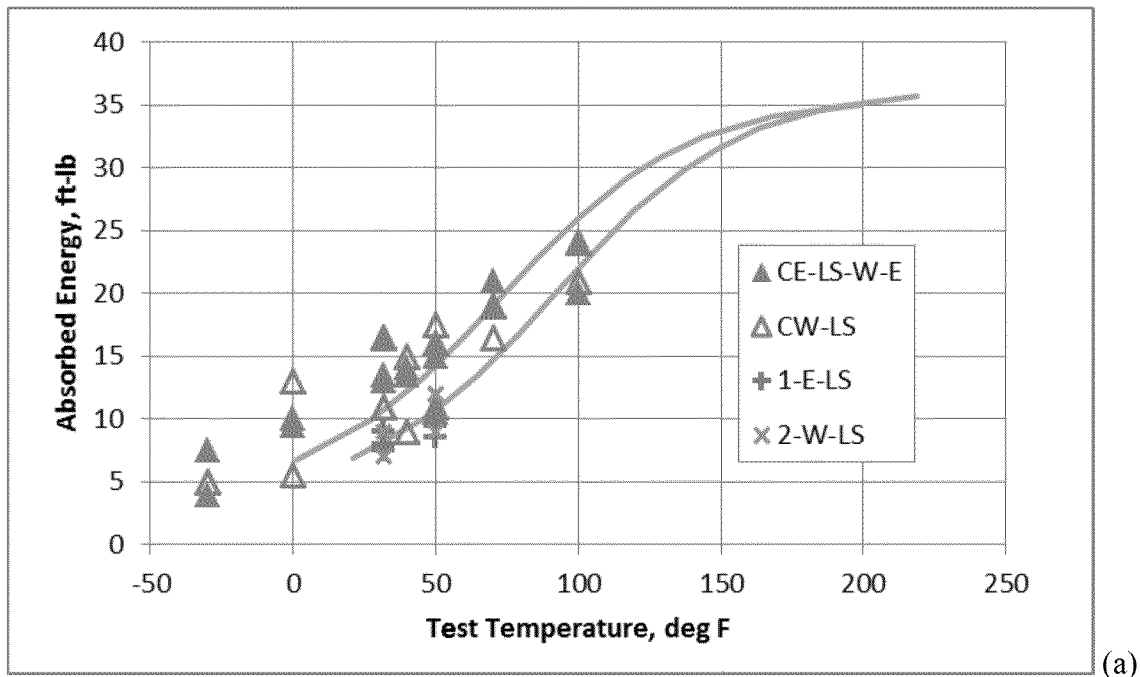
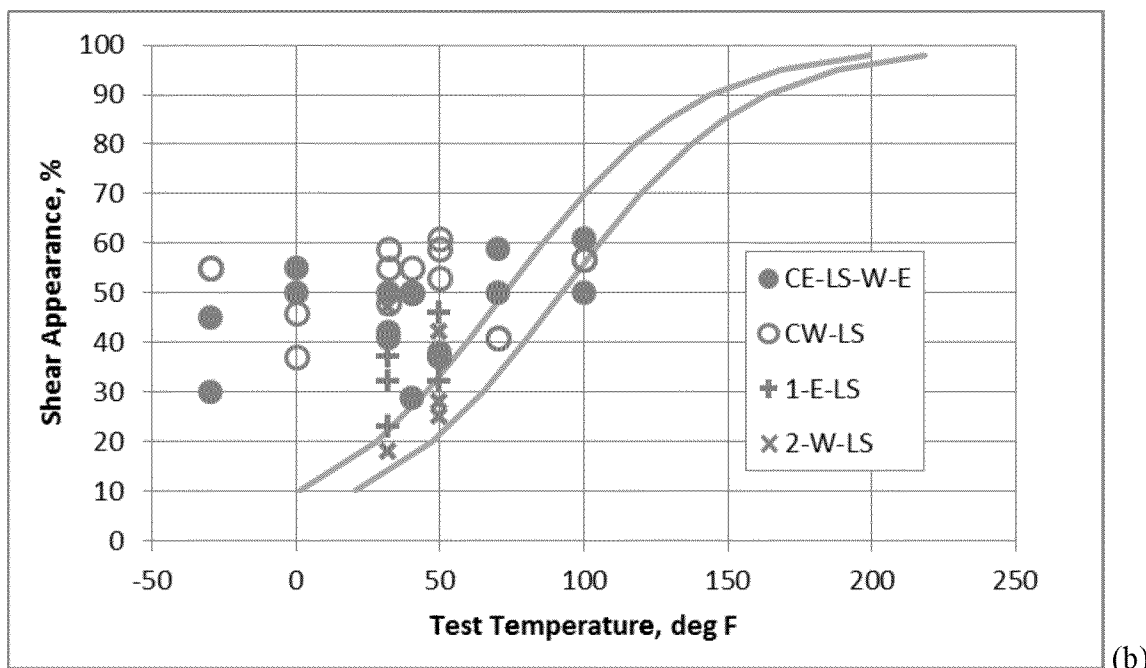
The tests were not performed to a sufficiently high temperature to capture the full toughness transition curve up to the ductile upper shelf or 100% shear appearance. For purposes of interpretation, the full transition curves were extrapolated using an empirical technique.⁵ The extrapolated curves were prepared using the averaged test results at the two warmest test temperatures, 70 F and 100 F. Extrapolations from these two temperatures were fairly consistent.

Figure 28. CVN Test Results for Seam Weld Specimens

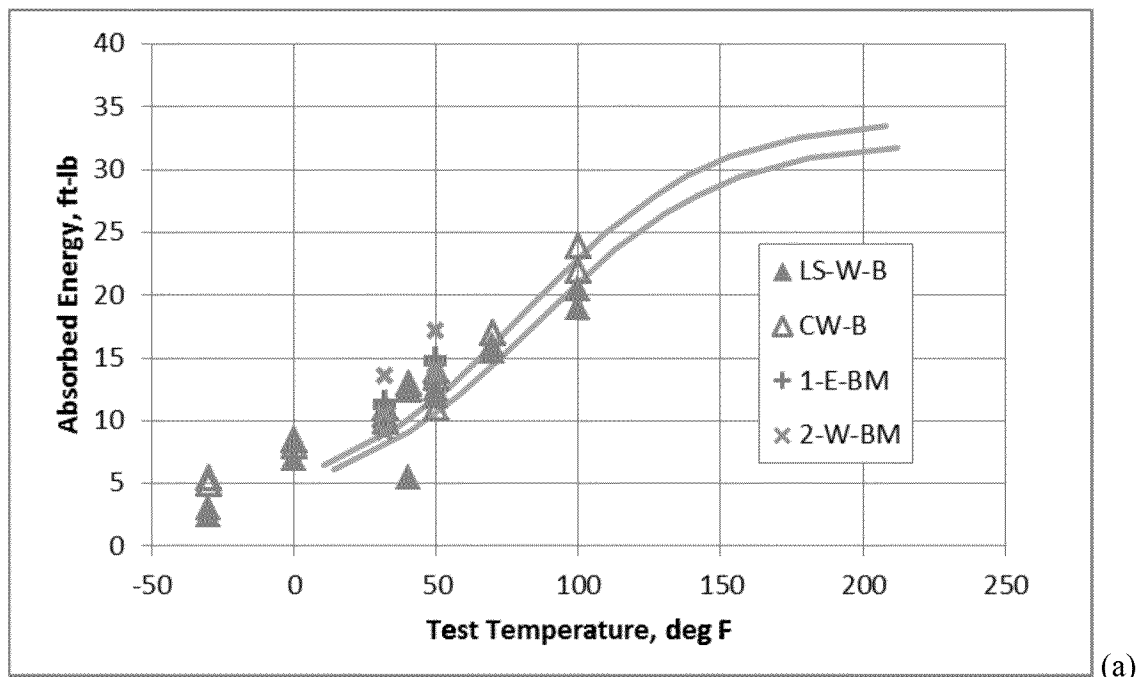
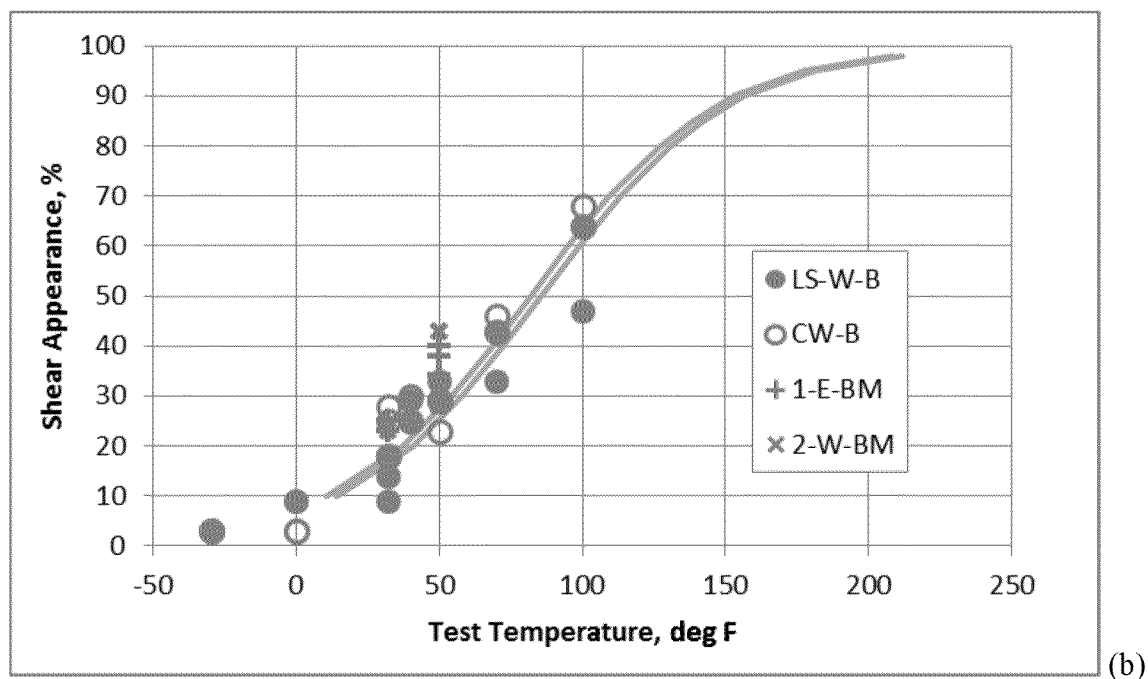
Figure 29. CVN Test Results for Pipe Body Specimens

The interpreted CVN properties are summarized in Table 4. The upper shelf absorbed energy for the 80% full-size CVN specimens was estimated to be 35 ft-lb for the weld and 33 ft-lb for the pipe body, corresponding to equivalent full-size (10-mm x 10-mm specimen) upper shelf absorbed energy levels of 44 ft-lb and 41 ft-lb, respectively. The 80% full-size CVN specimens are 2/3 of the full-scale thickness of the plate and weld so no adjustment for a specimen-size

effect is necessary to interpret the transition temperature.⁶ The results indicate that the transition temperature defined by 50% Shear Appearance, and the minimum upper shelf temperature defined at 85% Shear Appearance are both well above the typical operating temperature. This is consistent with the brittle fracture observed on the test fracture surfaces even though the upper shelf absorbed energy exceeds the arrest toughness of 34 ft-lb.⁷ Fracture control was not a recognized practice in the design of gas pipelines, and CVN properties were not specified by API 5LX or PG&E specifications, at the time this pipe was manufactured.

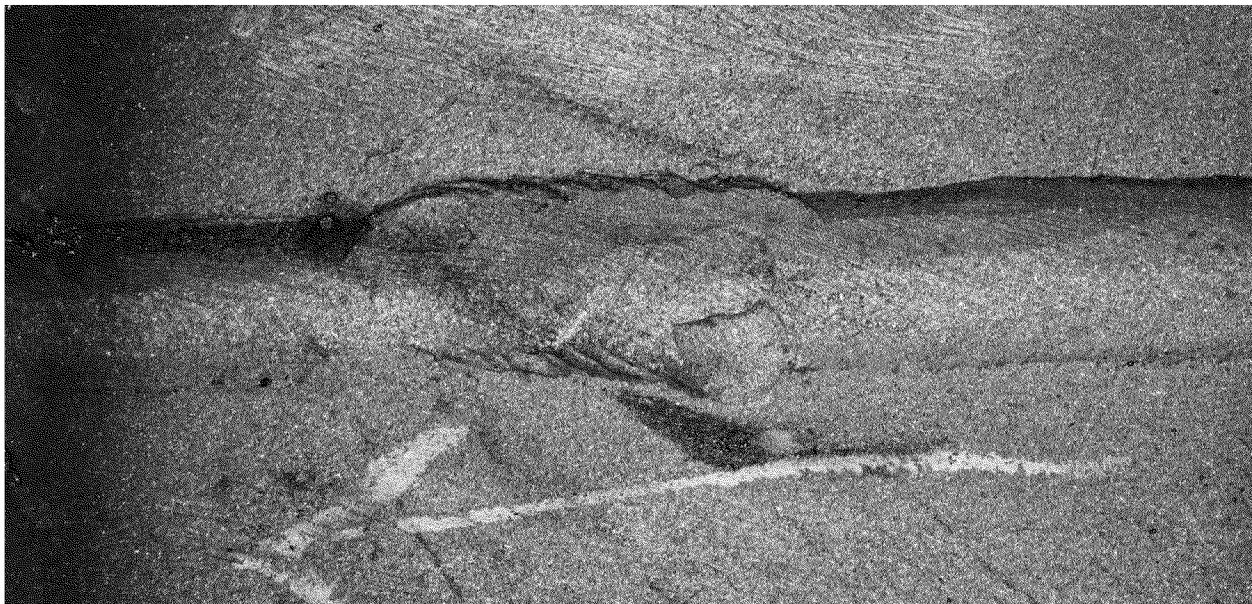
Figure 30 shows a repair made to the inside weld deposit of the longitudinal seam in Piece T117-CE-LS-E. The repair was approximately 2 inches long. Two metallographic sections across the repaired area were made. These are shown in Figure 31 and Figure 32.

Figure 30. Seam Weld Repair, T117-CE-LS-E, Interior Surface

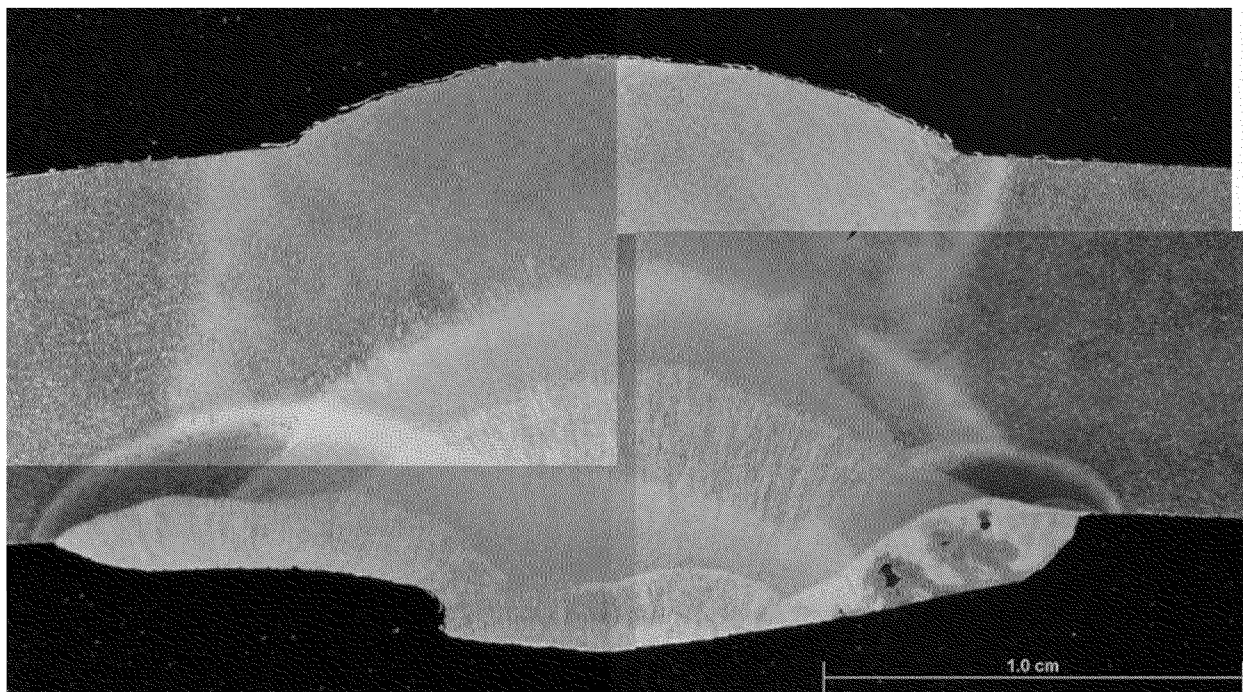
Figure 31. Seam Repair, T117-CE-LS-E, Section A

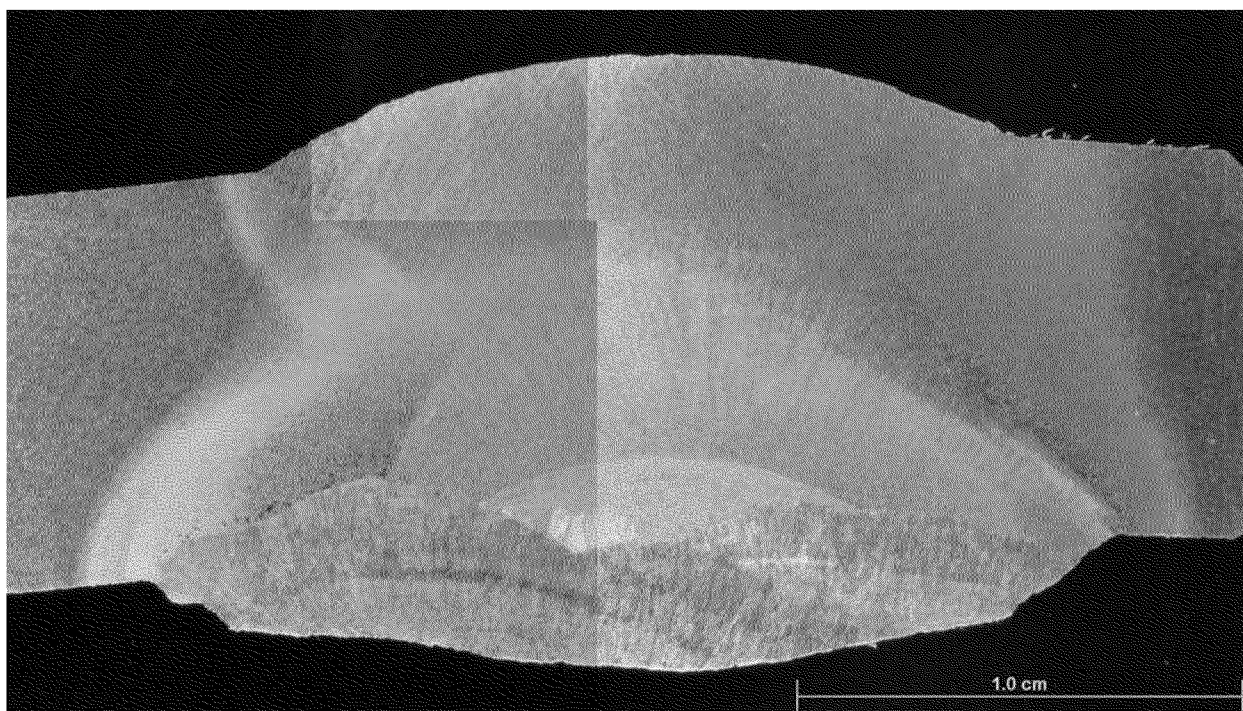
Figure 32. Seam Repair, T117-CE-LS-W, Section B

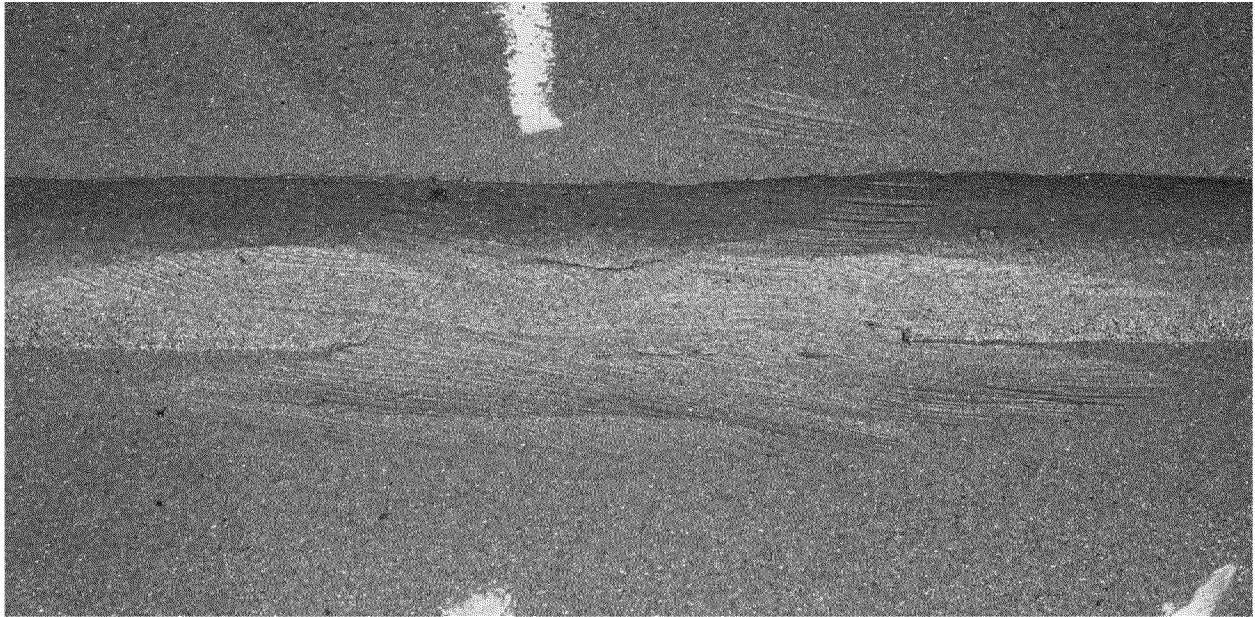
A minor repair was made at another location along the seam, shown from piece T117-CE-LS-W in Figure 33. A metallographic cross section of this area is shown in Figure 34.

Figure 33. Seam Repair, T117-CE-LS-W, Interior Surface

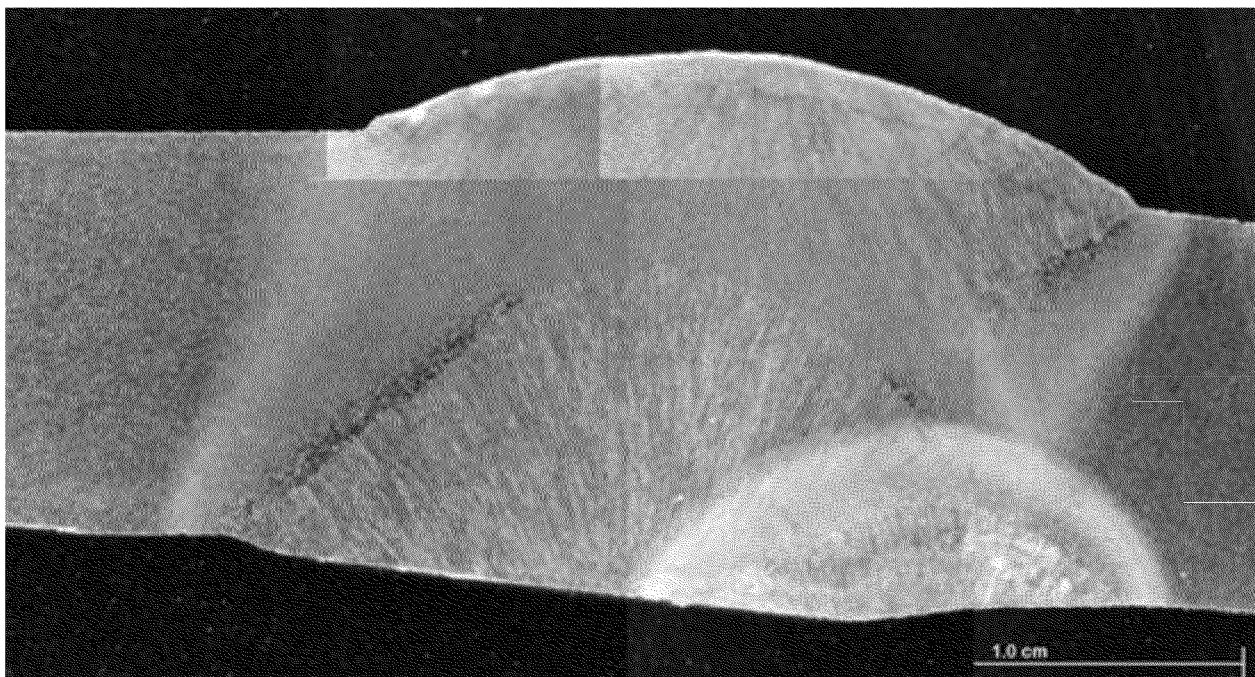
Figure 34. Seam Repair, T117-CD-LS-W, Section A

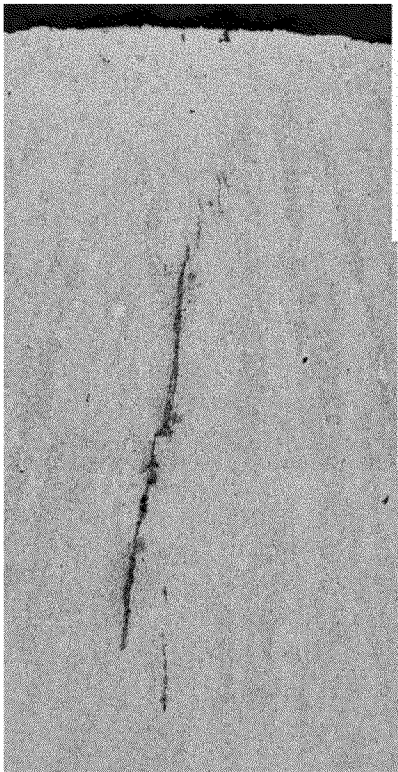
A metallographic section through an intact part of the seam in the center of the failed joint, piece T117-CC-T-W revealed a small hot crack having a radial dimension of approximately 0.12 inch (3 mm). This is shown at high magnification in Figure 35. A lack of penetration between the inner and outer weld passes and having a radial dimension of 0.02 inch (0.5 mm) was also

identified as shown in Figure 36. Neither feature was significant in terms of their effect on the integrity of the pipe.

Figure 35. Hot Crack, T117-CC-T-W (25X)

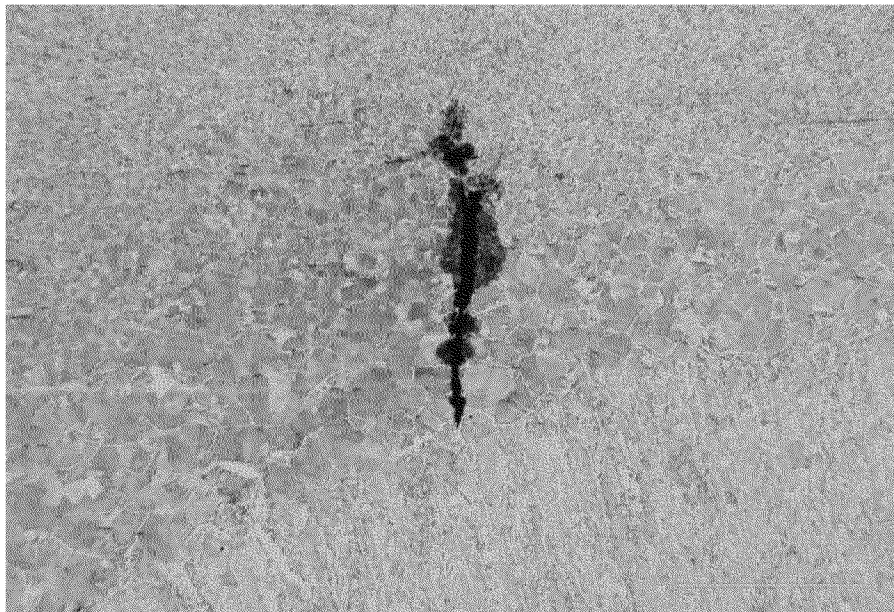
Figure 36. LOP Feature, T117-CC-T-W (50X)

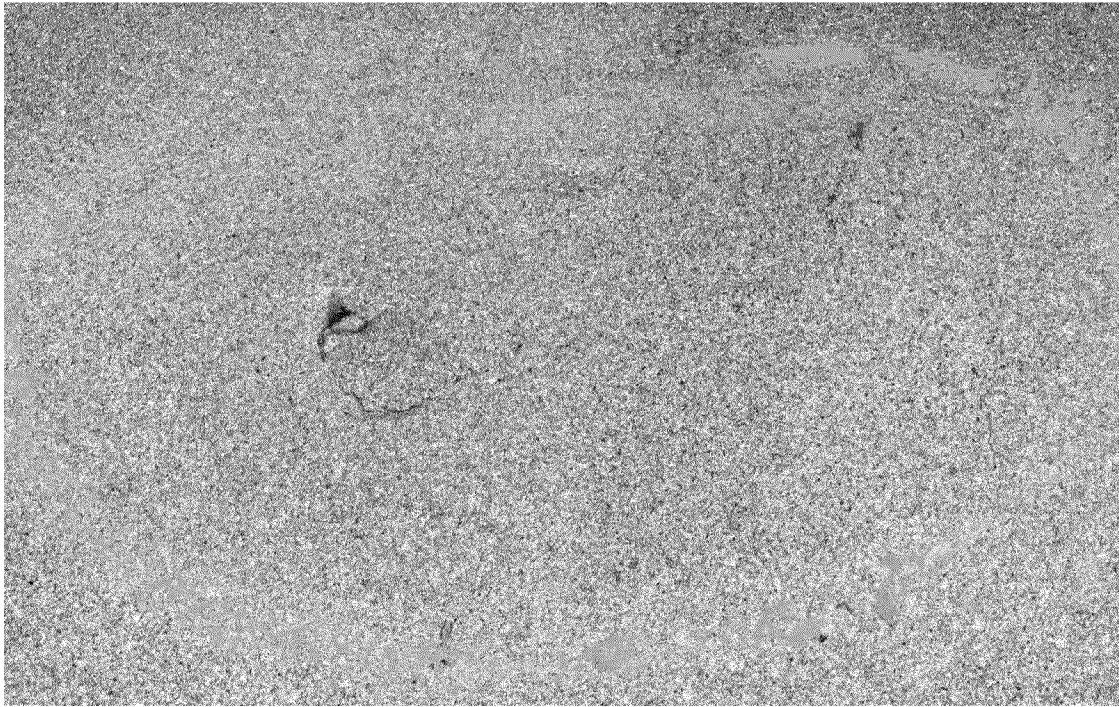
An indication was discovered on the exterior surface of the pipe body, shown in Figure 37 approximately actual size. It had an overall length less than ½ inch. A metallographic section established that it was a superficial blemish characterized as a surface lap. It had a depth of approximately 0.04 inch (1 mm) and was not oriented radially.

Figure 37. Surface Imperfection, T117-CE-LS-W

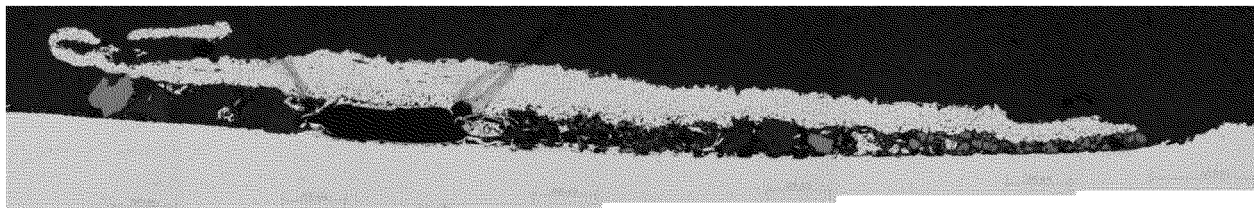
Other metallographic sections were prepared through the longitudinal seam and a surface imperfection in the plate identified by nondestructive examination. These are presented in Appendix A. A section in the seam confirmed another apparent hot crack in the outer seam weld deposit having a radial dimension of approximately 0.12 inch. It was small and uninvolved in the test break.

Figure 38. Surface Imperfection, Metallographic Section
