Form H: Direct Examination Data Sheet - Page 1 of 10

<u>DA/ILI</u>		<u>DA</u>		<u>ILI</u>	
Route Number:	T47_L153_A	N-Segment:	NA	ILI Log Distance:	NA
Date of Excavation:	7/9/2011	IMA Number:	NA	RMP-11 Ref. Section:	Table 5.6.2
Mile Point:	Redacted	Region Number:	NA	Reference Girth Weld:	NA
Examination Performed By:	Redacted	Subregion # (ICDA):	NA	Distance From Girth Weld:	NA
PG&E Project Manager:	Redacted	Stationing:	NA		
Approved By:	NA				
Order Number:	NA

MAGNETIC PARTICLE EXAMINATION REPORT							<input type="checkbox"/> Nuclear	<input checked="" type="checkbox"/> Non-Nuclear	
To: Pacific Gas & Electric Company				From: Redacted		Date: 7/9/2011			
Project: T-47-L153-A									
Purchase Order No:				GEIS Job No: LAPI0005

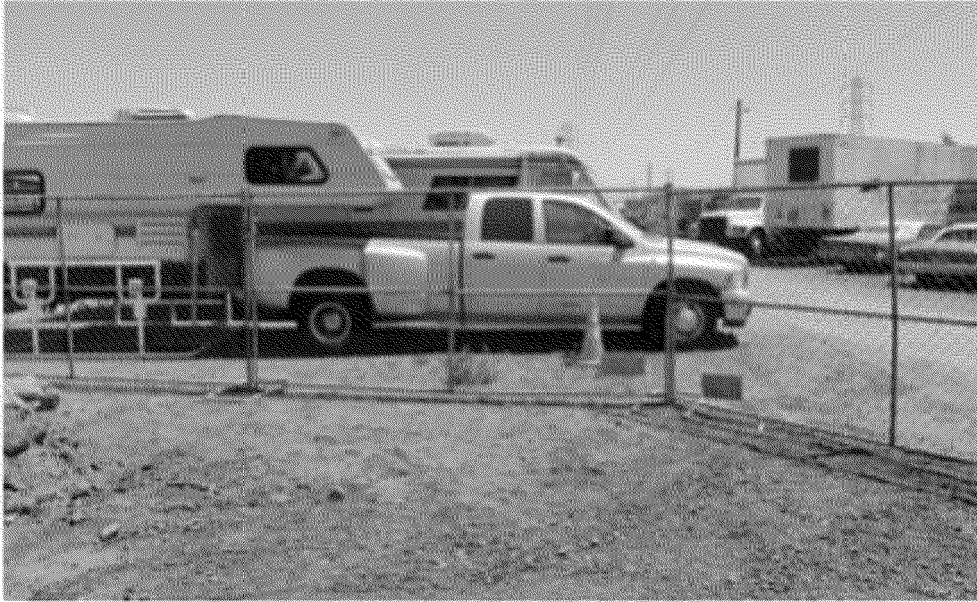
Topography looking upstream

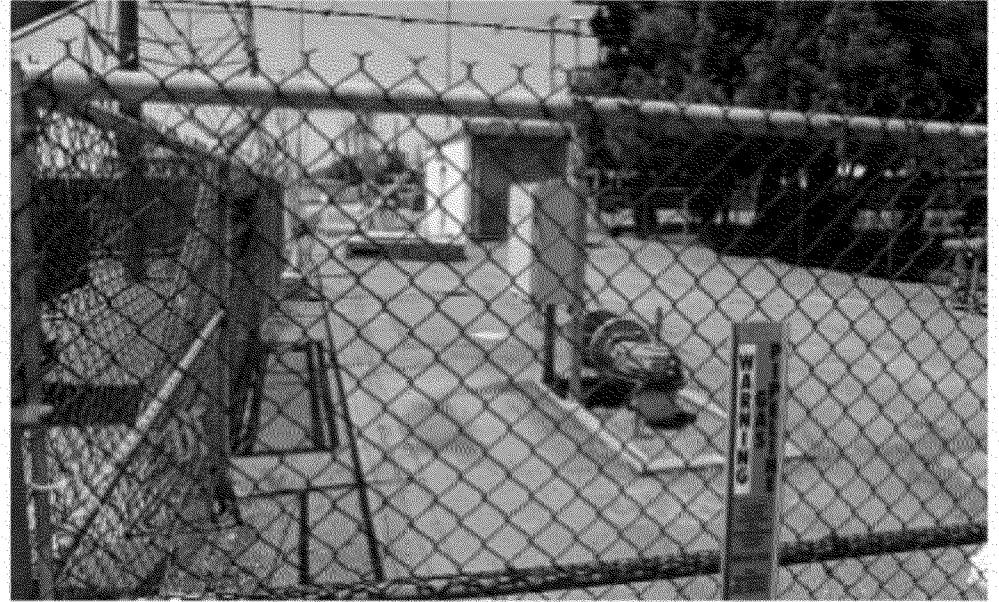
Topography looking downstream

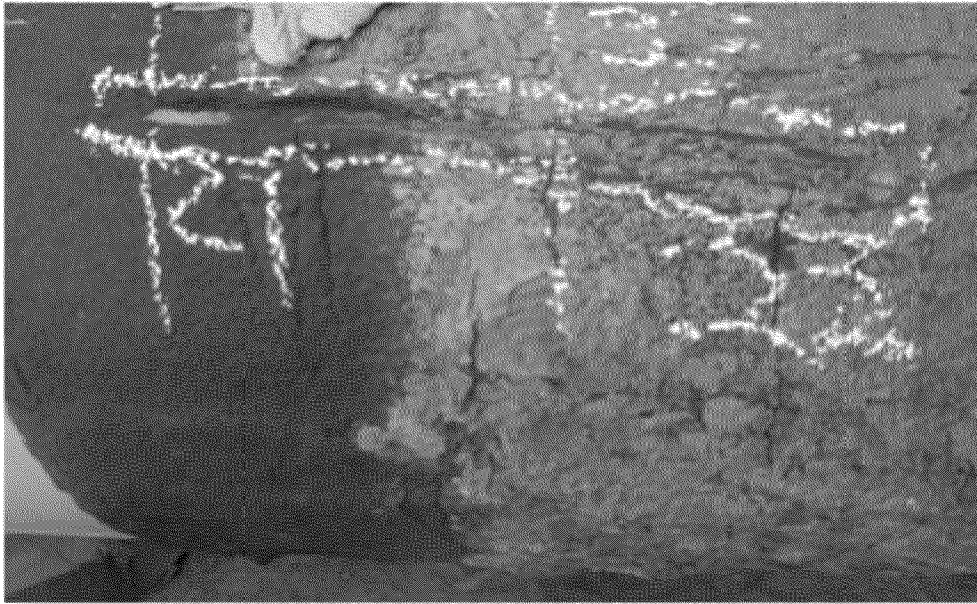
Overview of coating condition @ 3:00 position

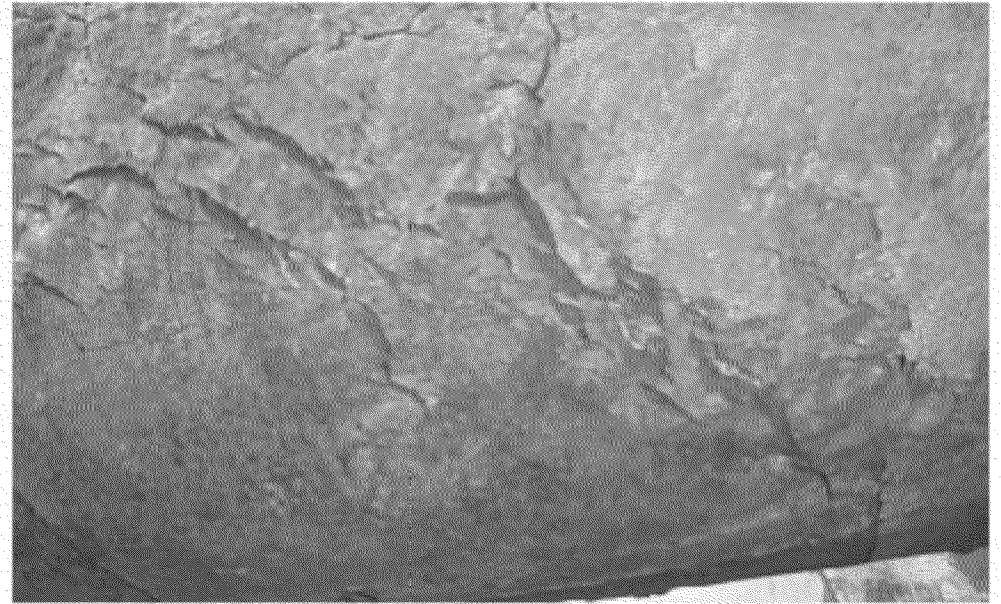
Overview of coating condition @ 9:00 position

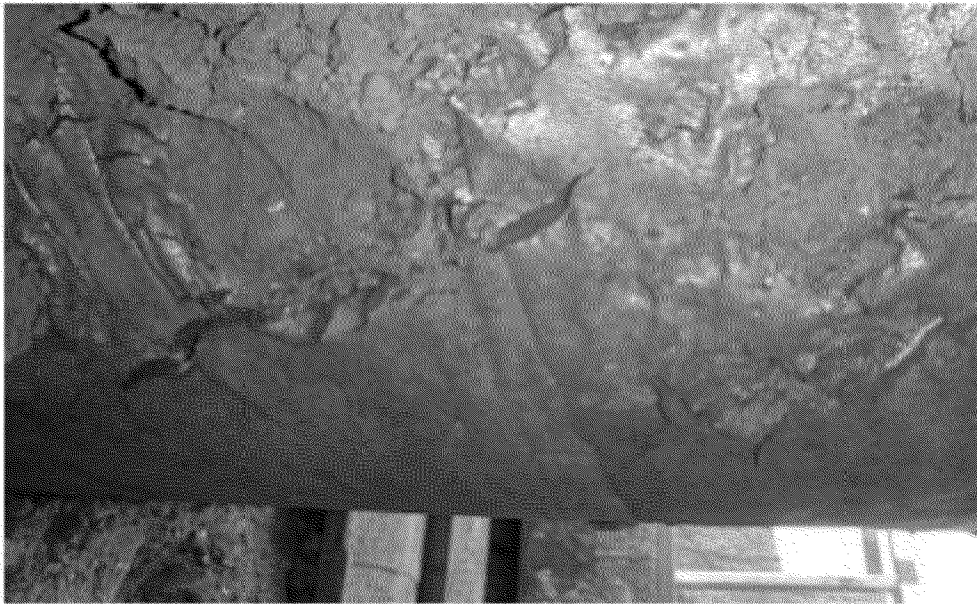
Overview of coating condition @ 6:00 position

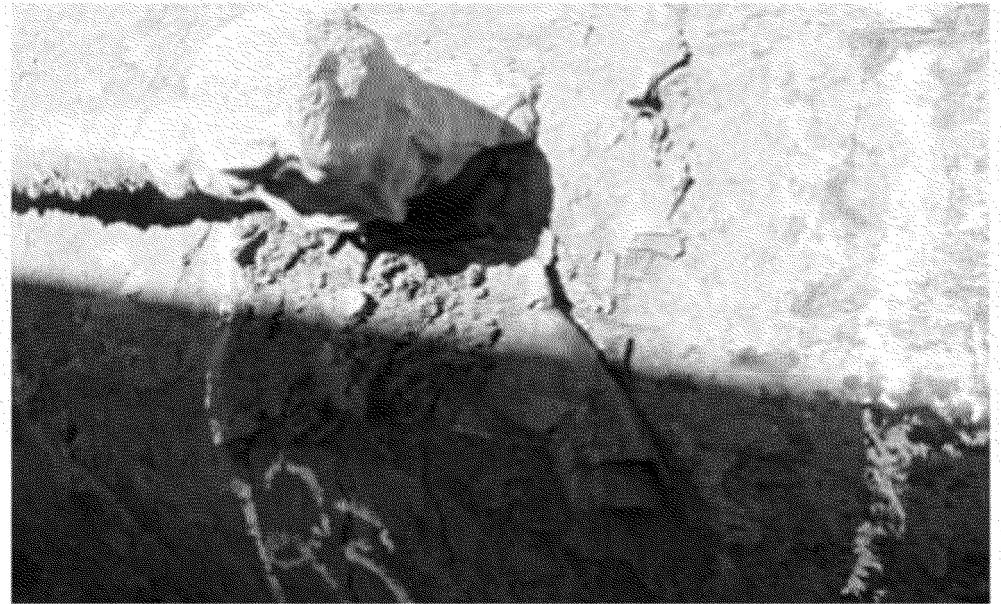
Overview of coating condition @ 12:00 position

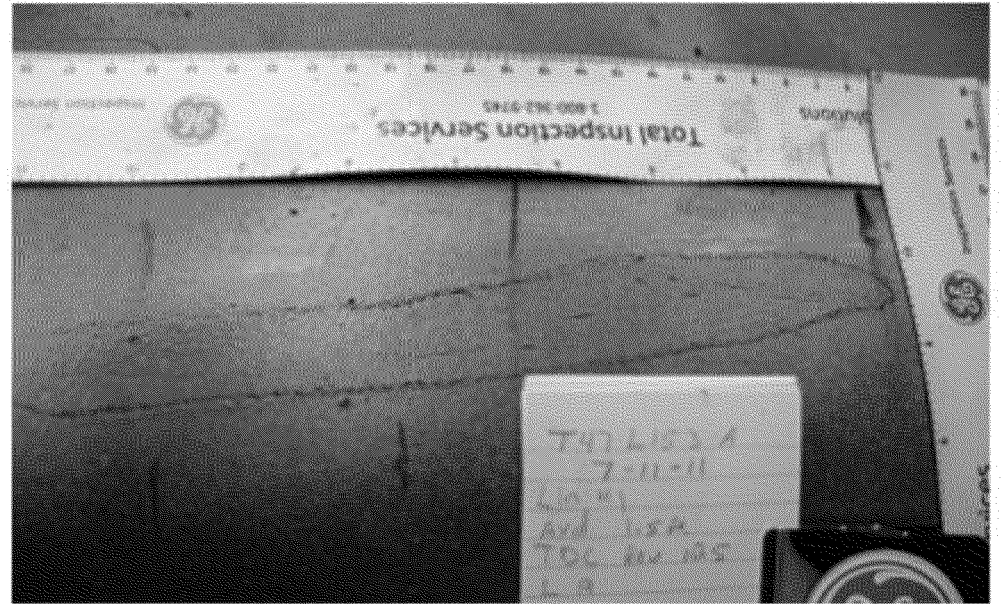
Overview of MT Indications of LIN-01

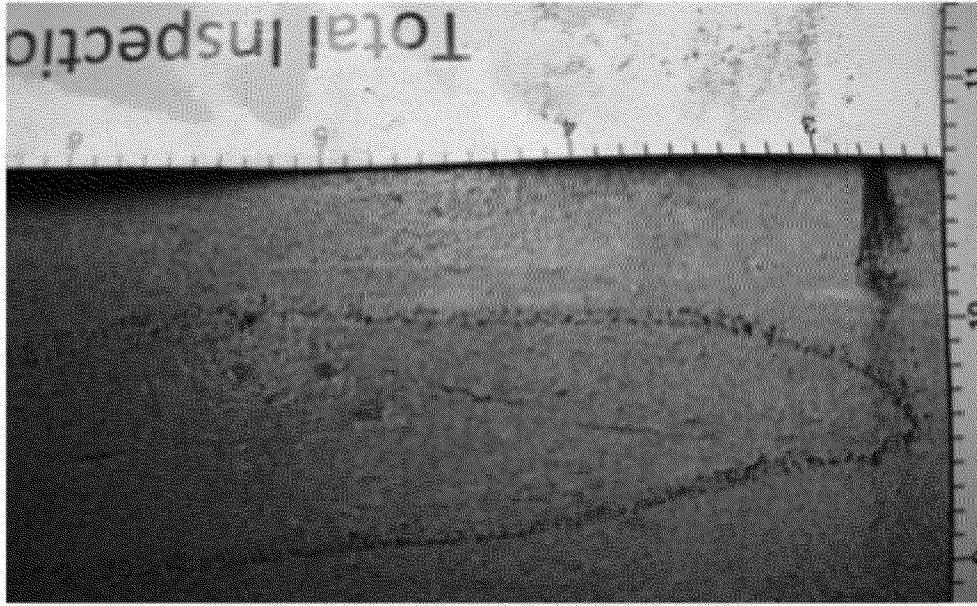
Close up of MT indications of LIN-01

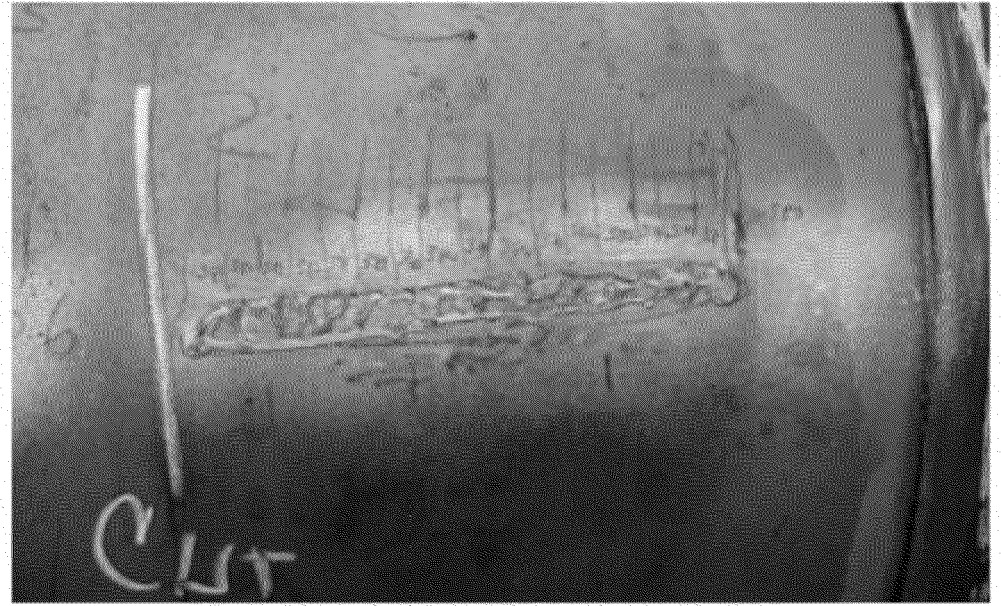
Overview of pre-grind area (RWT) LIN-01

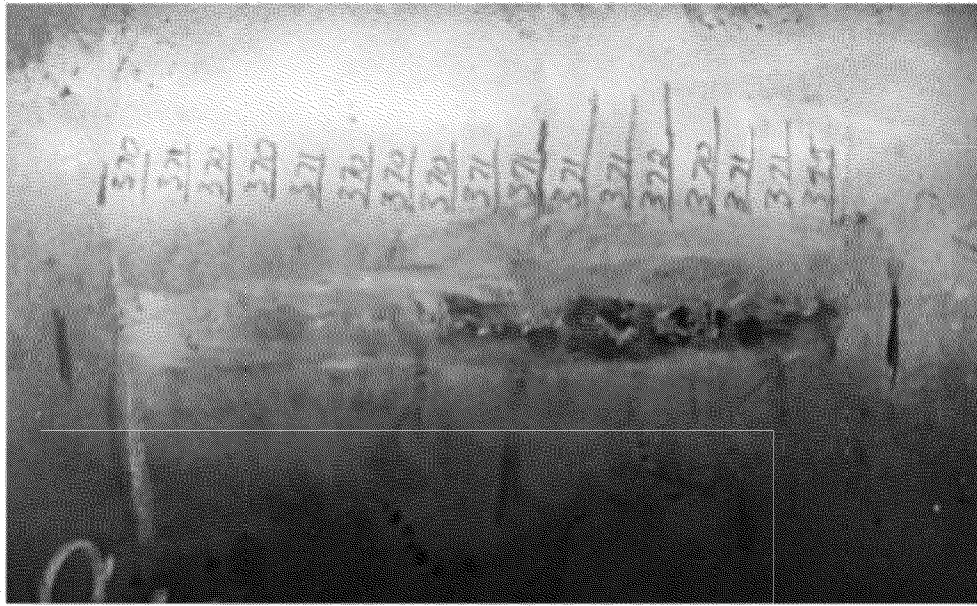
Overview post-grind (RWT) of LIN-01

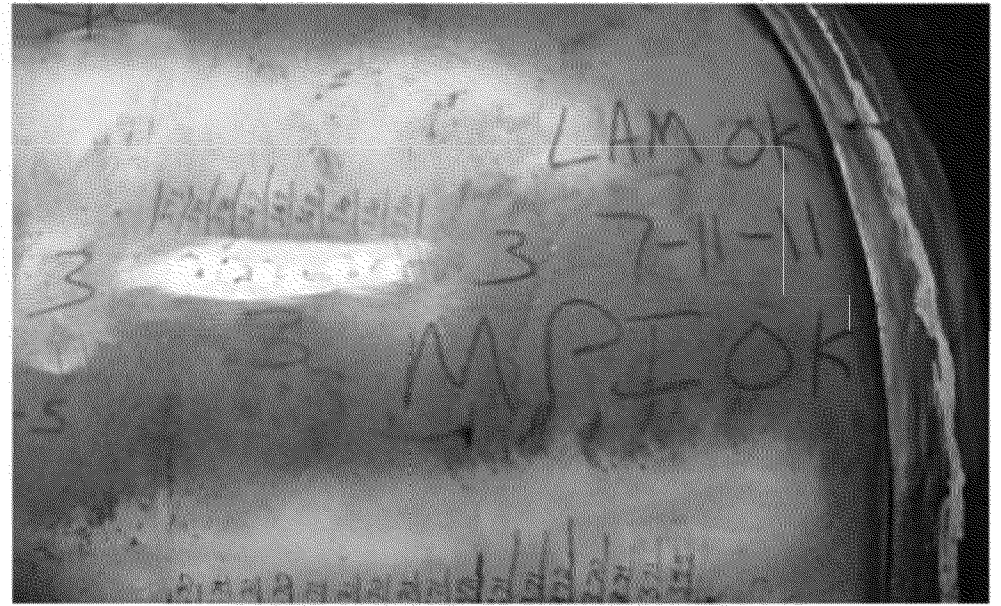
Overview post-grind (MPIOK) of LIN-01

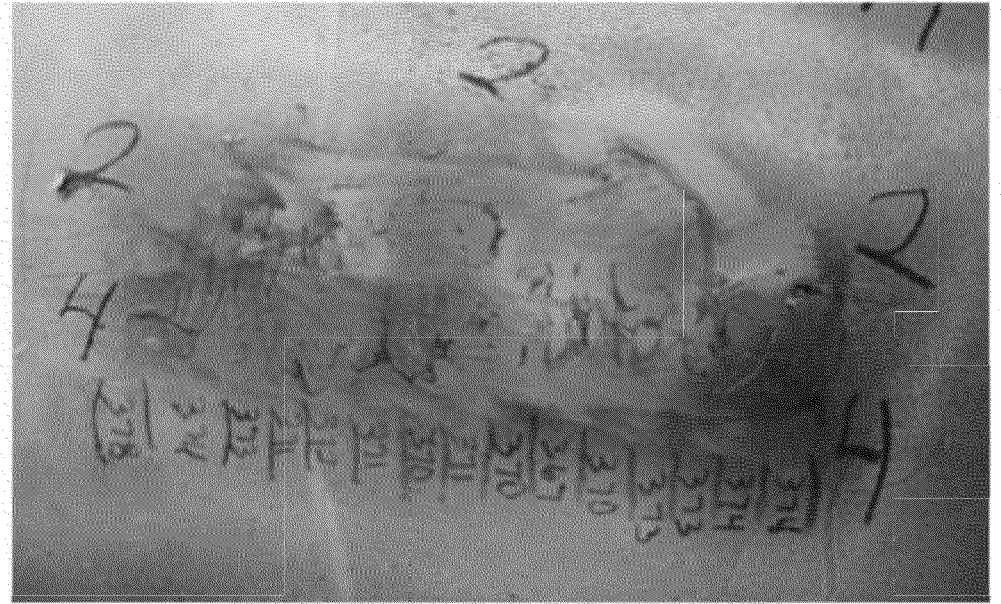
Overview post grind (RWT) of LIN-02

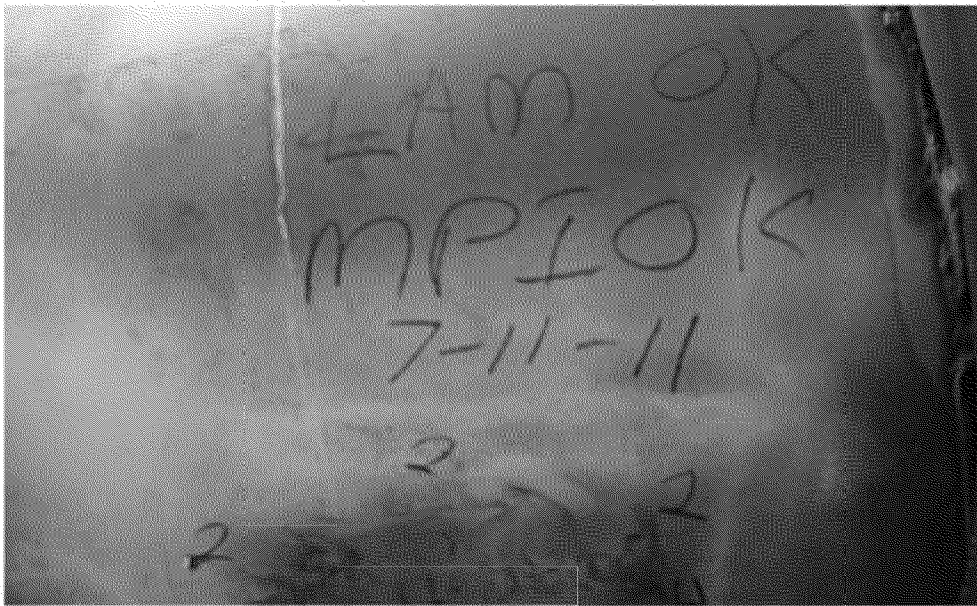
Overview post grind (MPIOK) of LIN-02

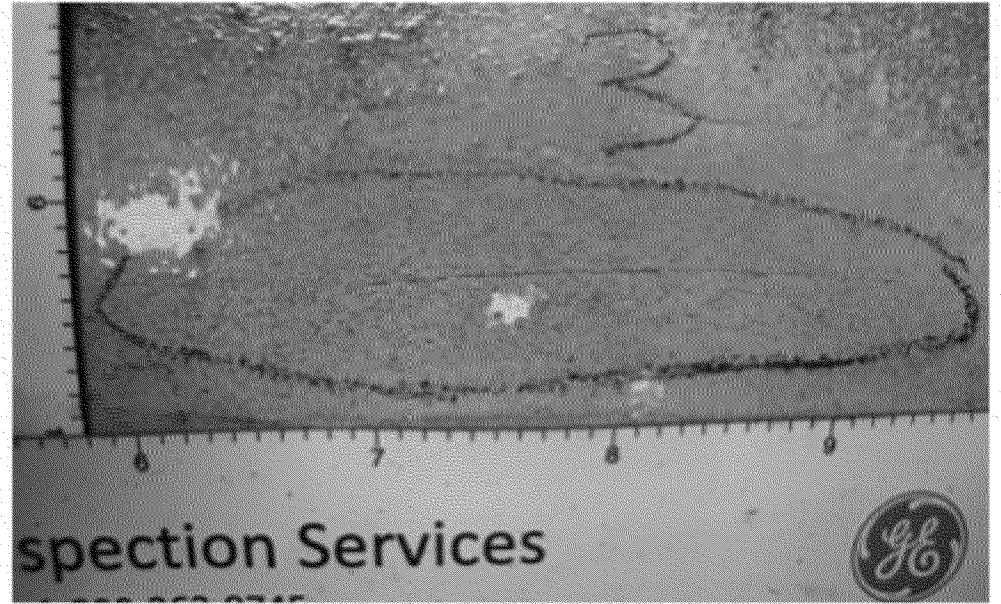
Close up of MT Indications of LIN-03

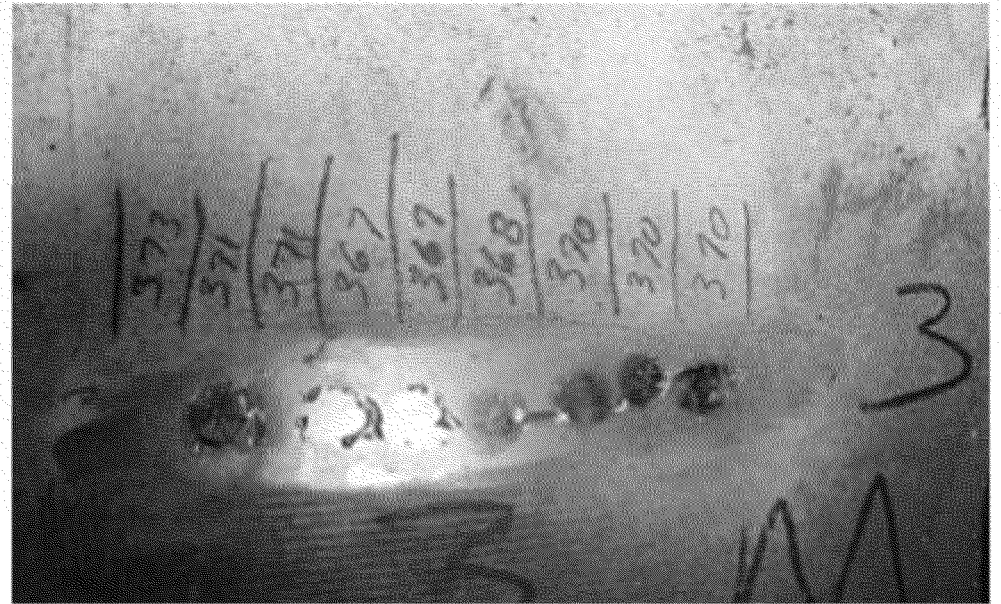
Overview post grind (RWT) of LIN-03

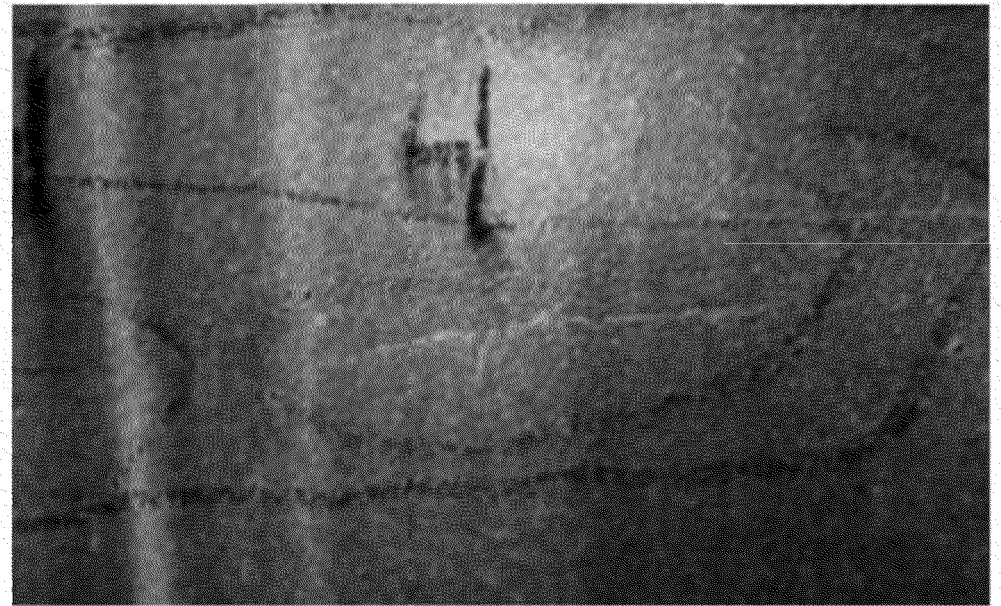
Overview of MT Indications of LIN-04

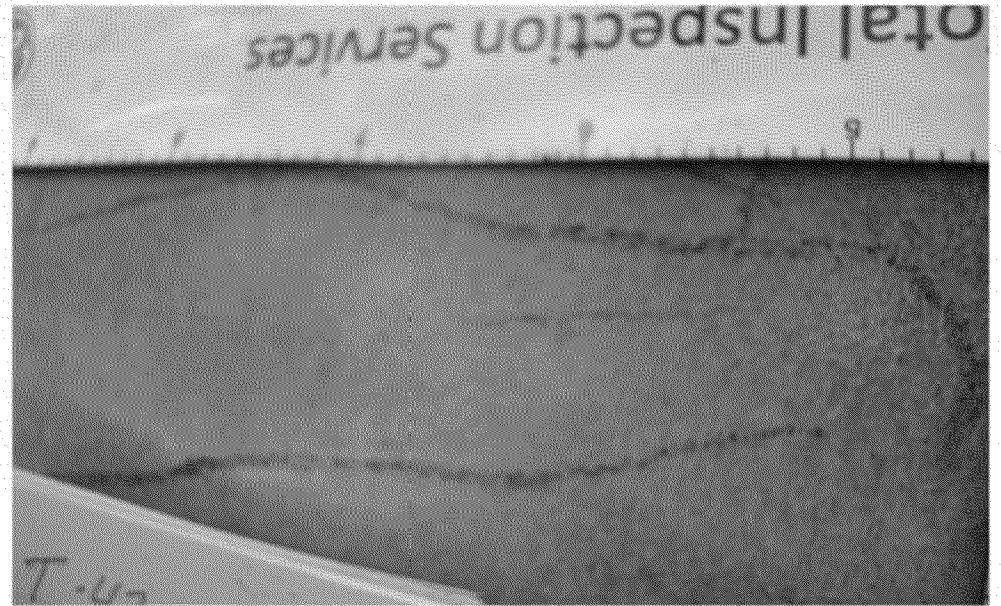
Close up of MT Indications of LIN-04

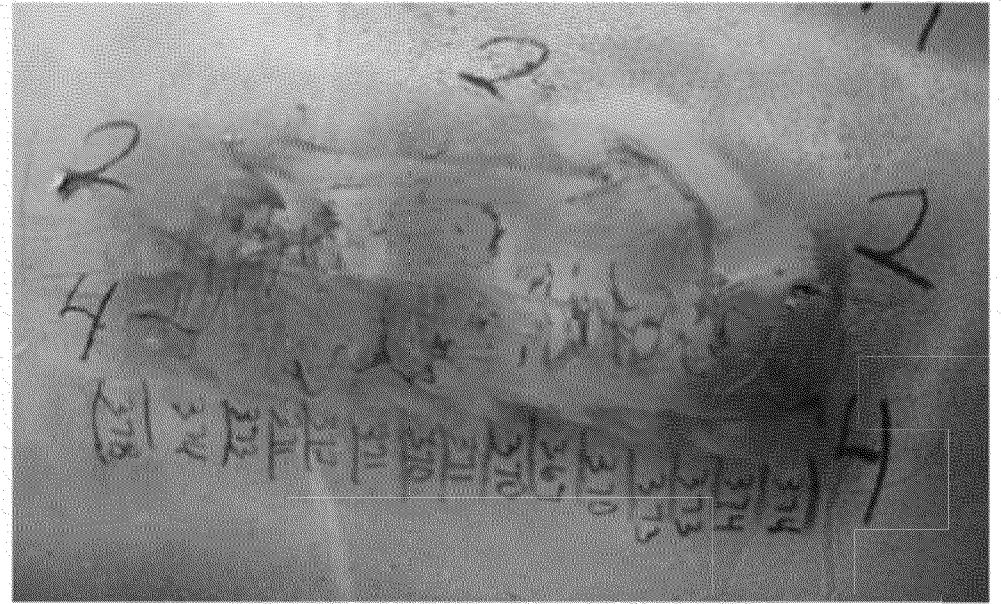
Overview post grind (RWT) of LIN-04

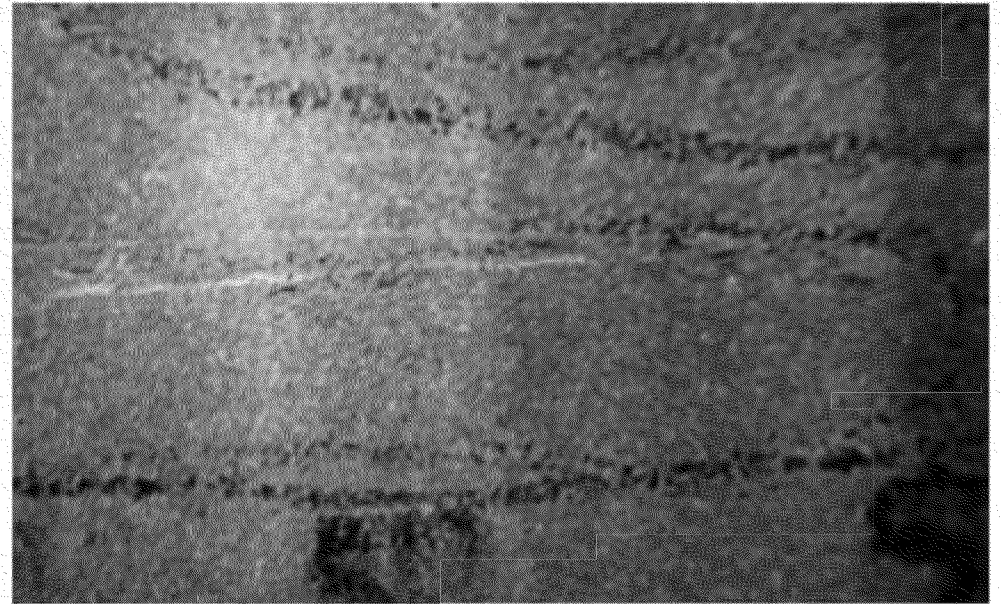
Overview of MT Indications of LIN-05

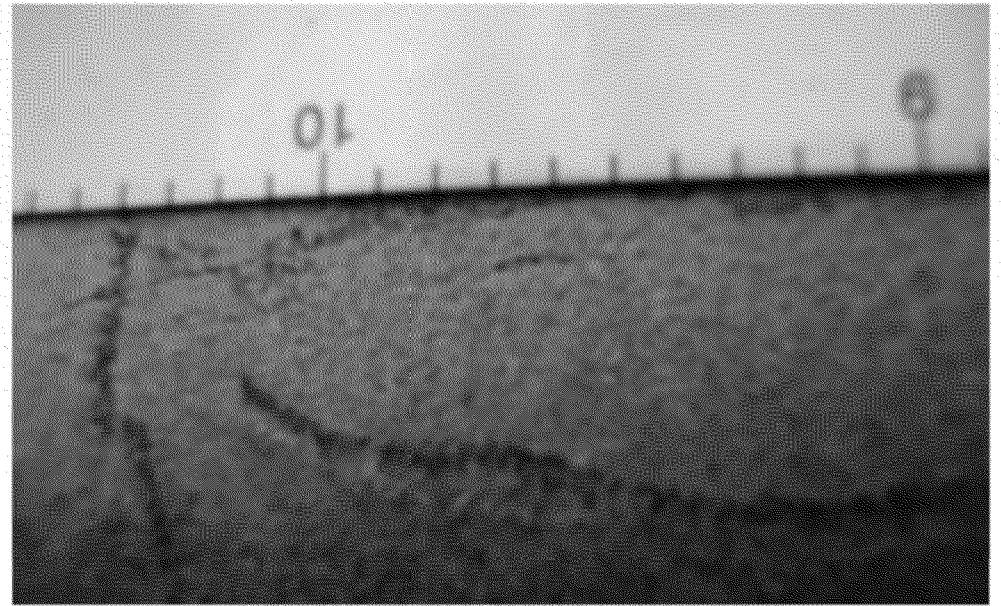
Close up of MT Indications of LIN-05

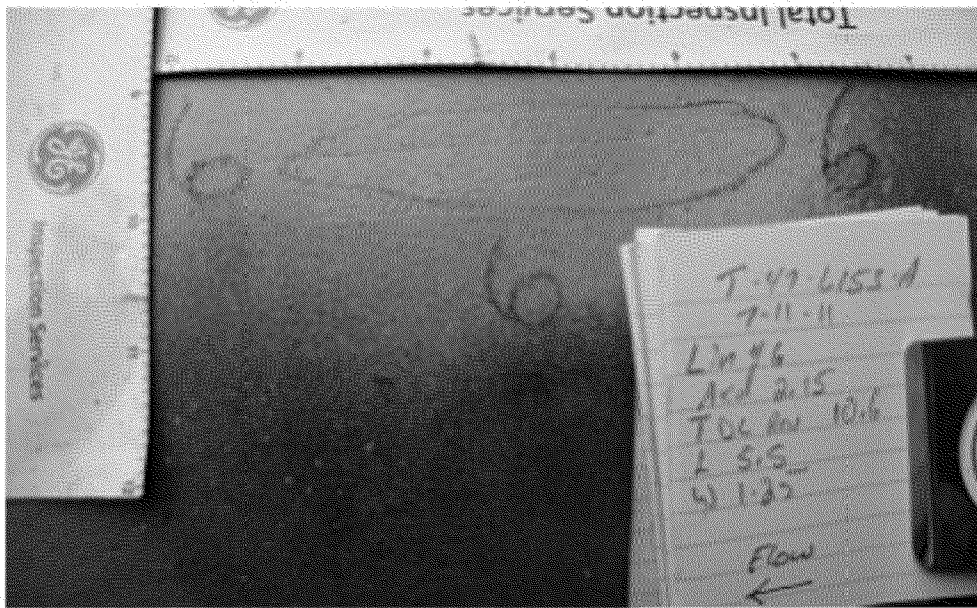
Overview of MT Indications of LIN-06

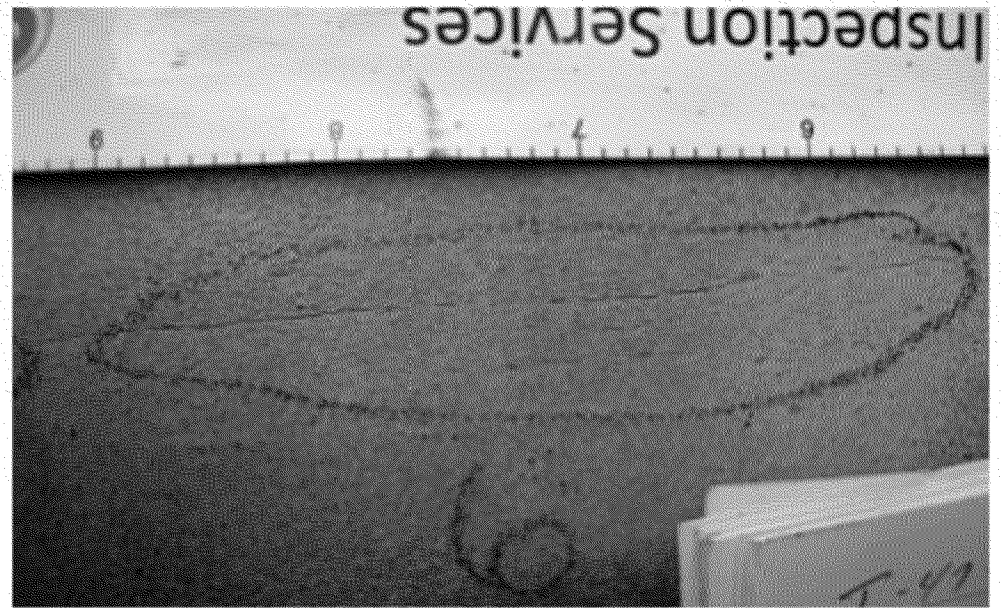
Close up of MT Indications of LIN-06

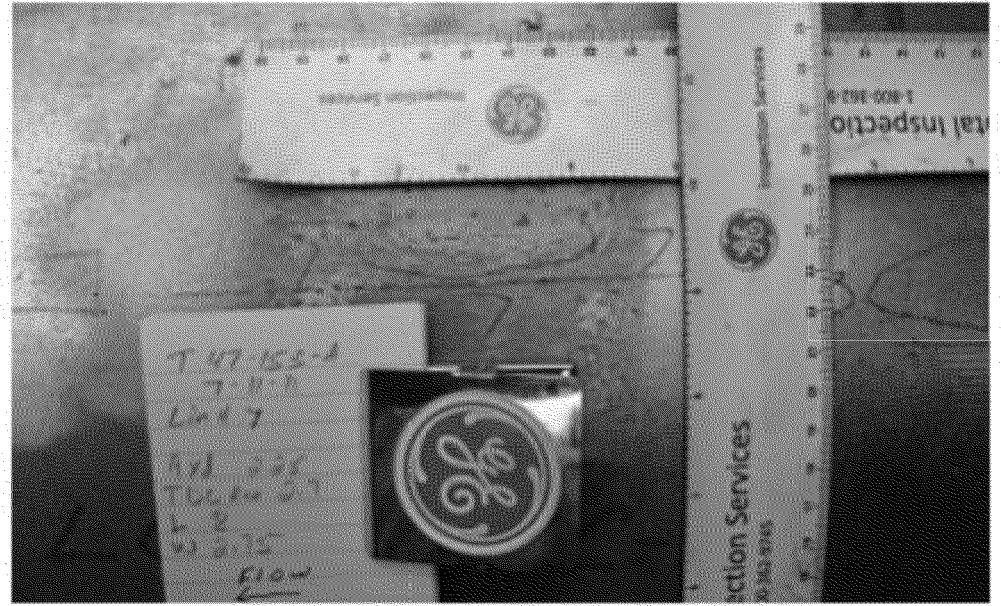
Overview of MT Indications of LIN-07

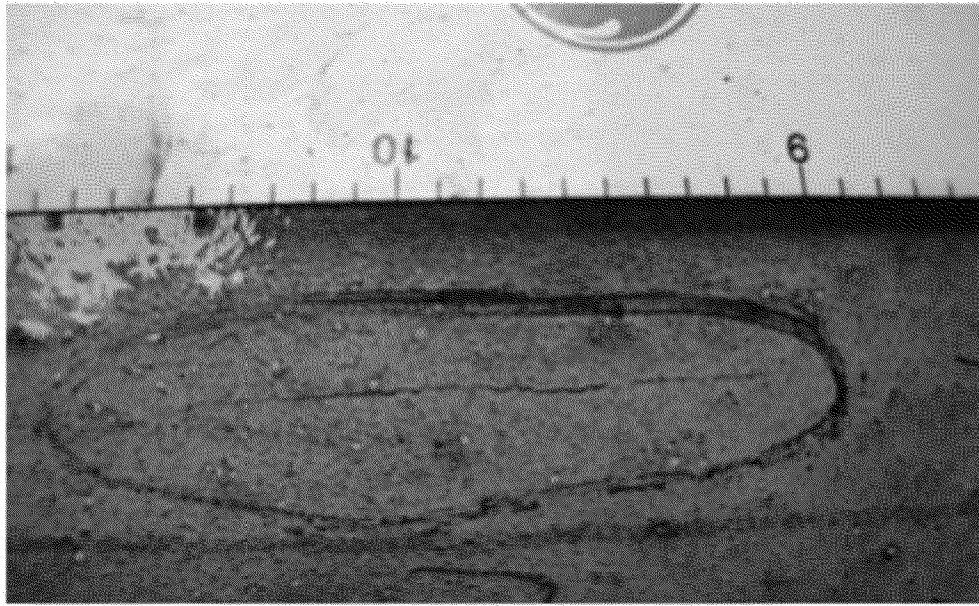
Close up of MT Indications of LIN-07

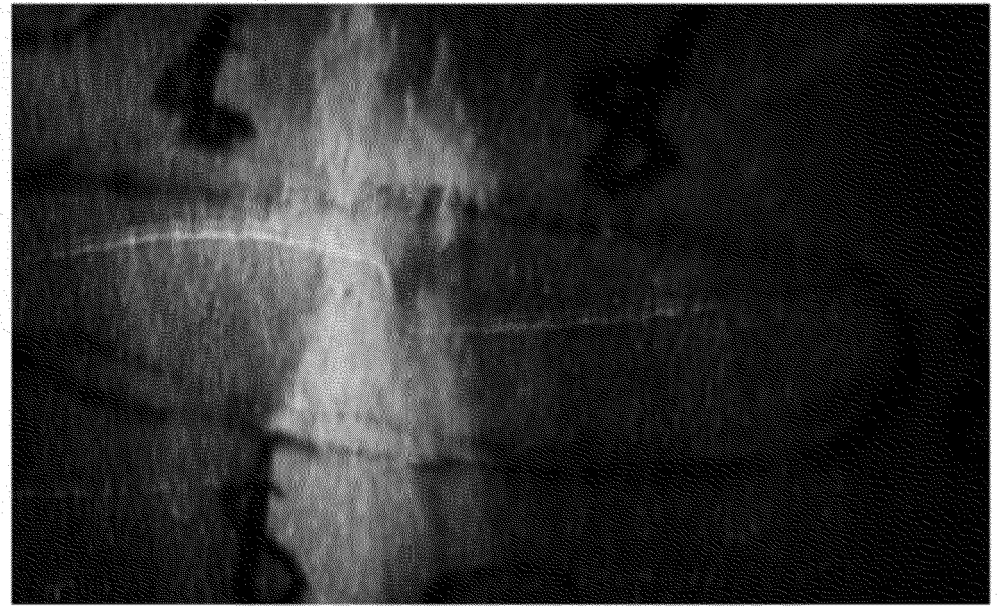
Overview of MT Indications of LIN-08

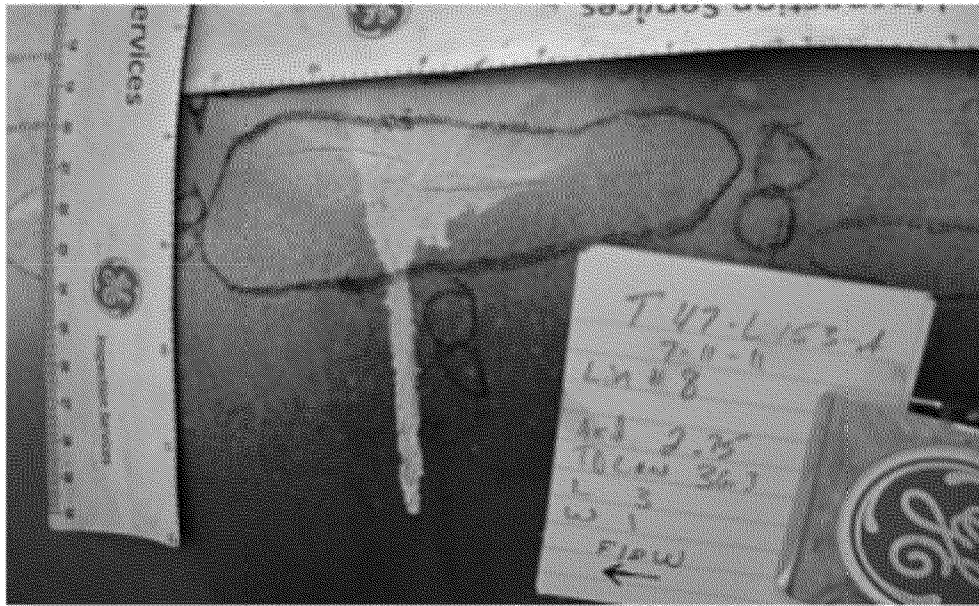
Overview of MT Indications of LIN-08

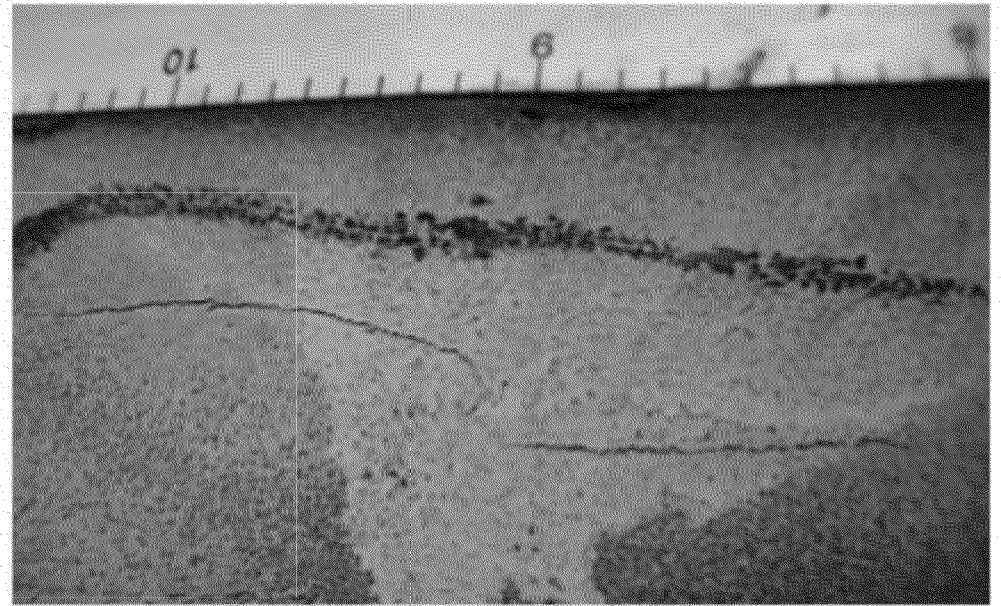
Close up of MT Indications of LIN-08

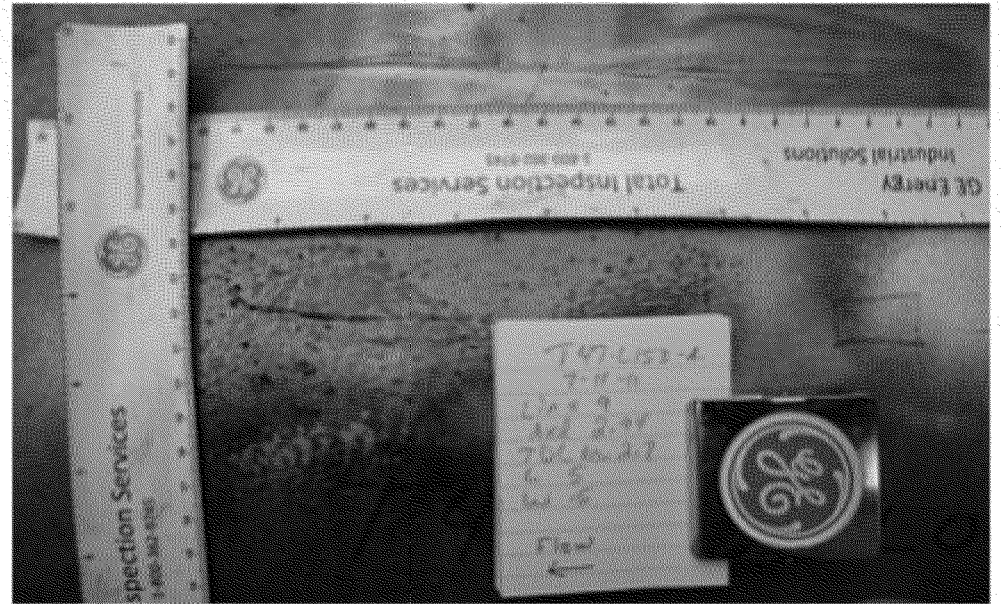
Overview of MT Indications of LIN-09

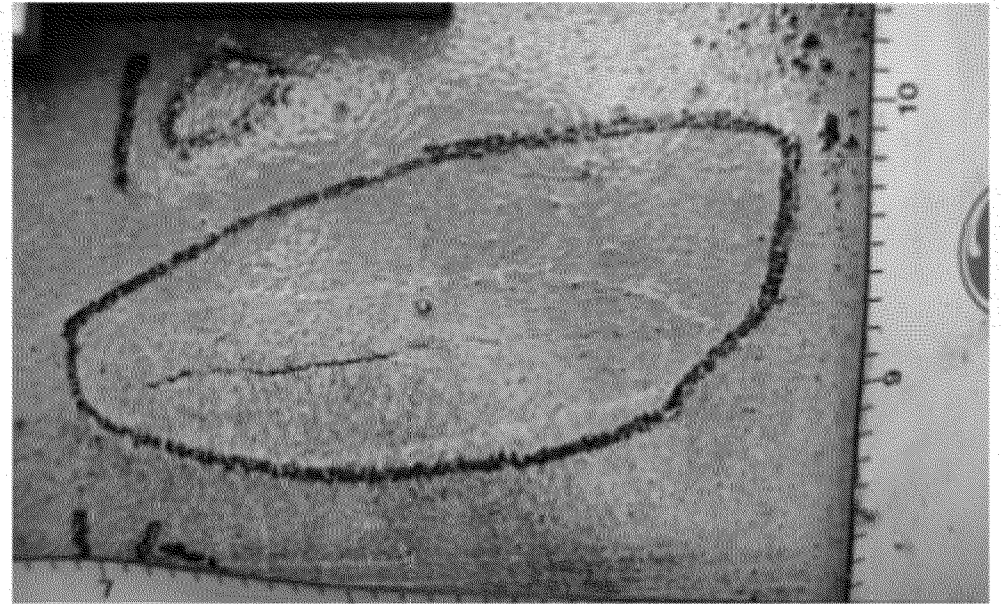
Close up of MT Indications of LIN-10

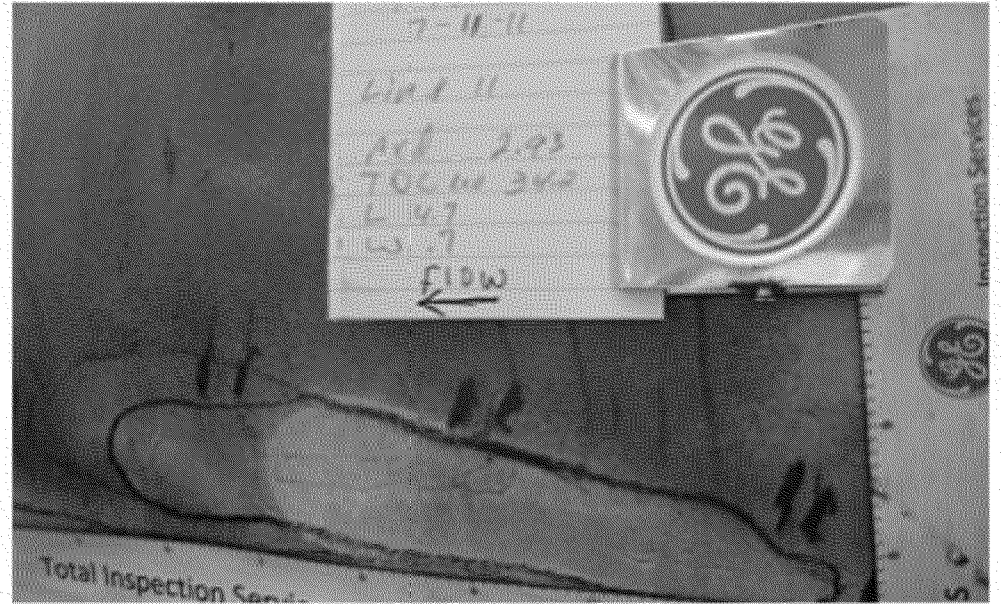
Overview of MT Indications of LIN-11

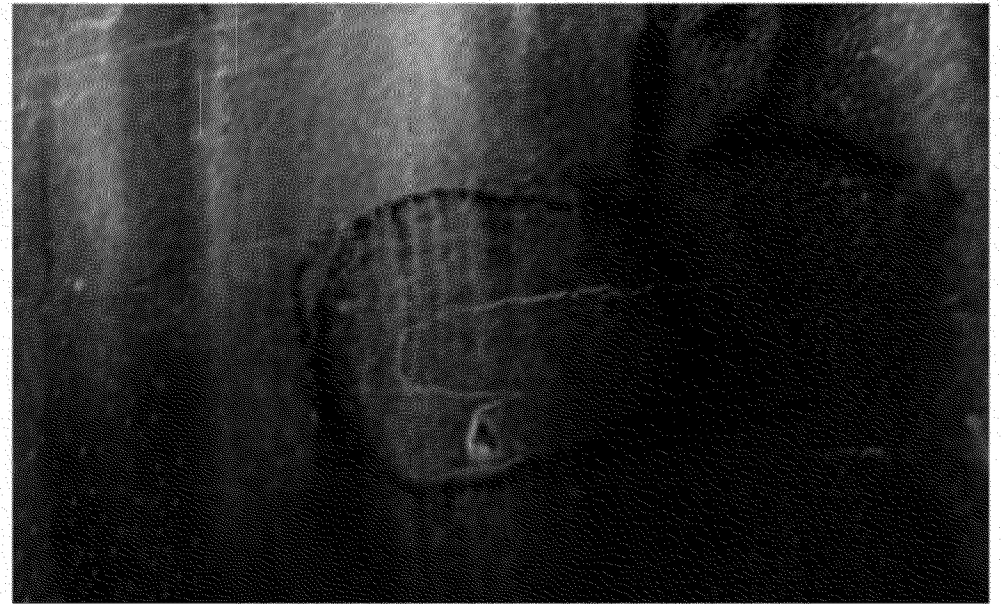
Overview of MT Indications of LIN-12

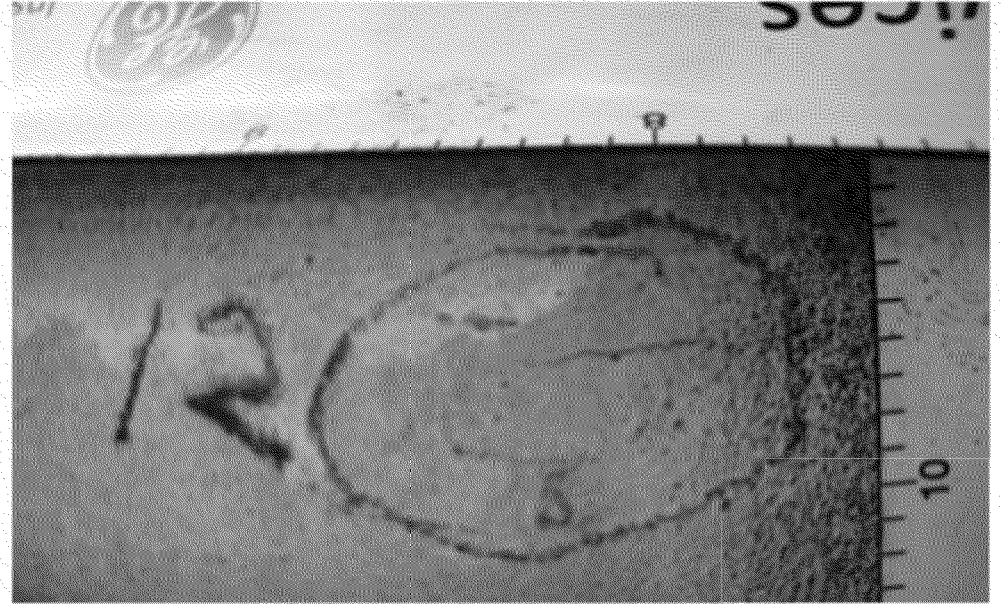
Close up of MT Indications of LIN-12

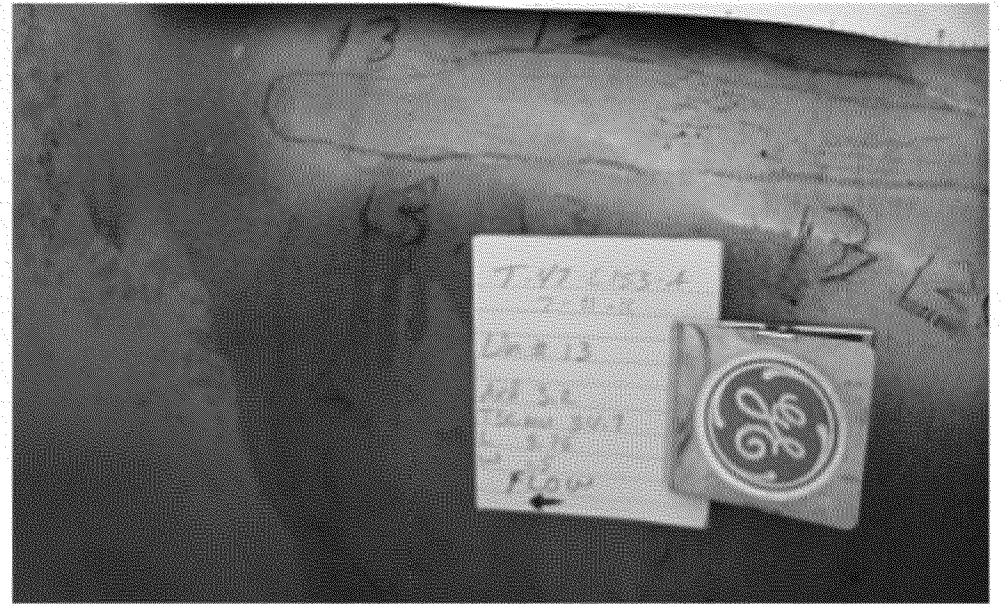
Overview of MT Indications of LIN-13

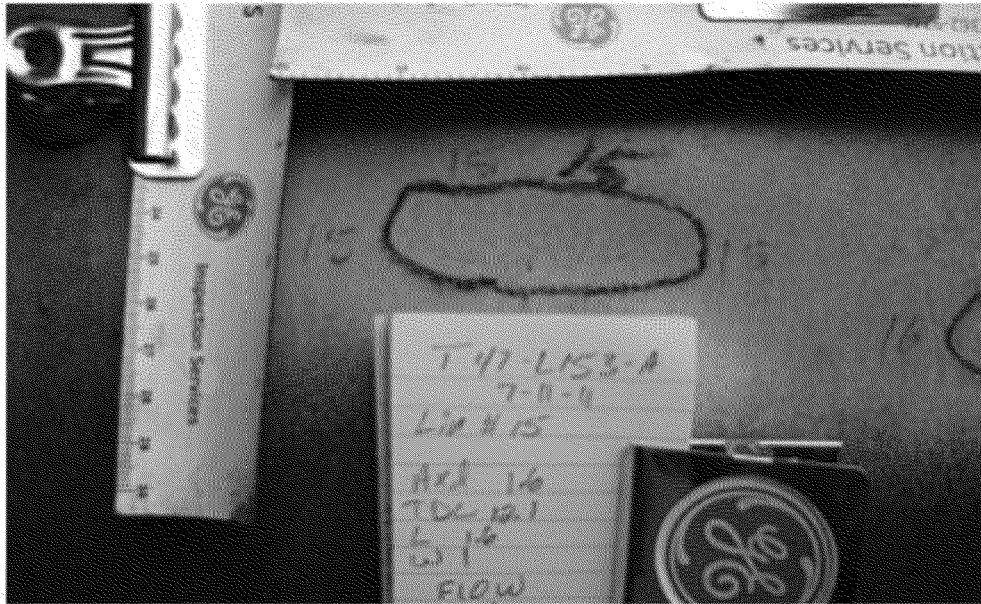
Overview of MT Indications of LIN-15

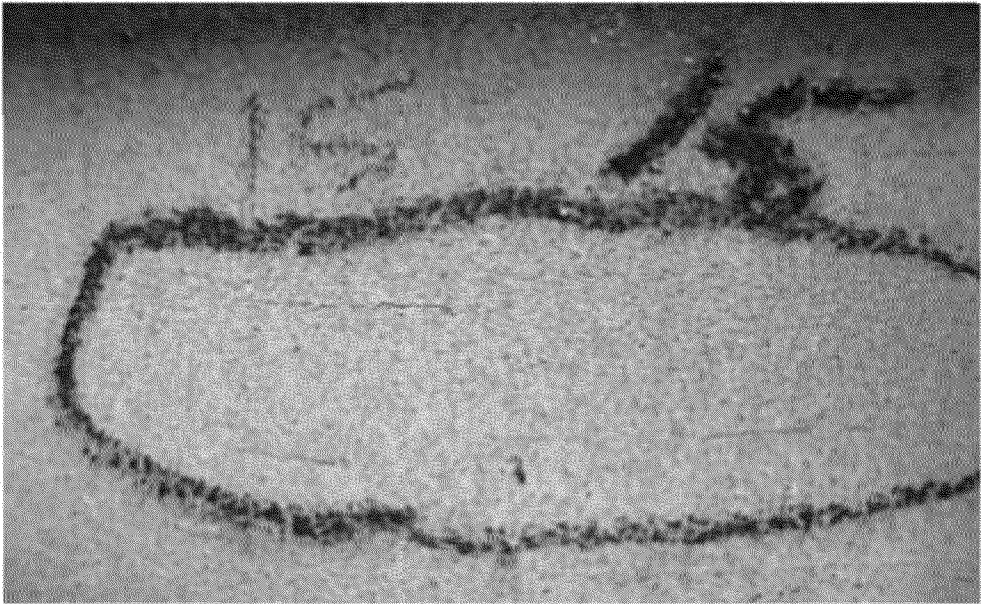
Close up of MT Indications of LIN-15

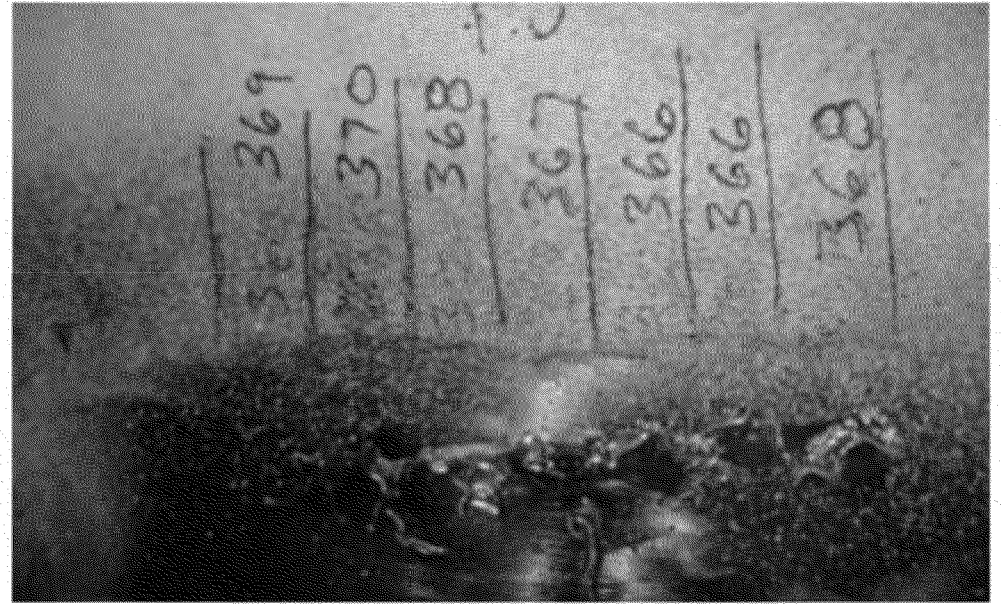
Overview post grind (RWT) of LIN-15

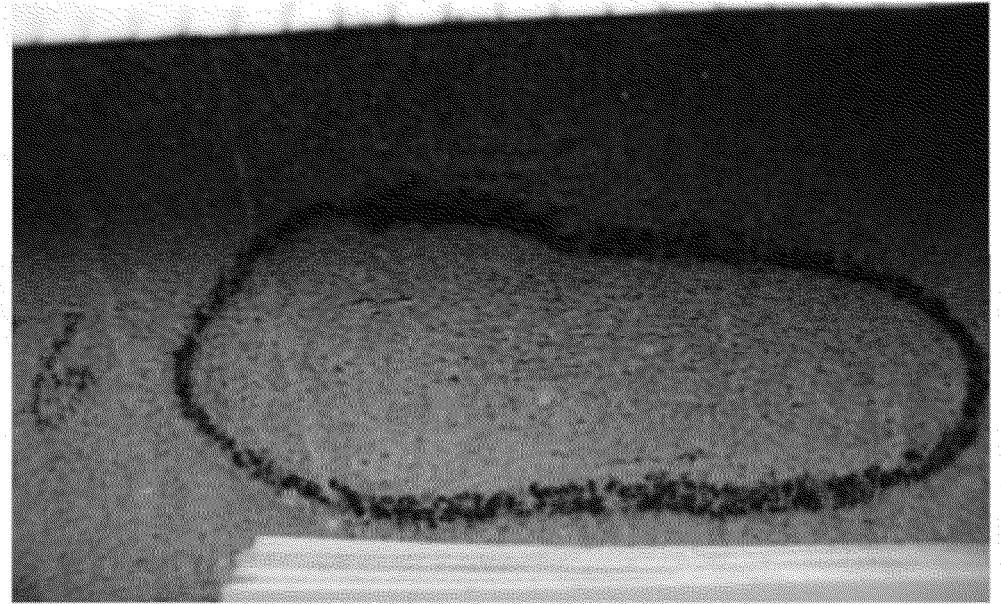
Close up of MT Indications of LIN-16
