Form H: Direct Examination Data Sheet - Page 1 of 10

<u>DA/ILI</u>		<u>DA</u>		<u>ILI</u>	
Route Number:	T47_L153_A	N-Segment:	NA	ILI Log Distance:	NA
Date of Excavation:	7/9/2011	IMA Number:	NA	RMP-11 Ref. Section:	Table 5.6.2
Mile Point:	Redacted	Region Number:	NA	Reference Girth Weld:	NA
Examination Performed By:	Redacted	Subregion # (ICDA):	NA	Distance From Girth Weld:	NA
PG&E Project Manager:	Redacted	Stationing:	NA		
Approved By:	NA				
Order Number:	NA

MAGNETIC PARTICLE EXAMINATION REPORT							<input type="checkbox"/> Nuclear	<input checked="" type="checkbox"/> Non-Nuclear	
To: Pacific Gas & Electric Company				From: Redacted		Date: 7/9/2011			
Project: T-47-L153-A									
Purchase Order No:				GEIS Job No: LAPI0005

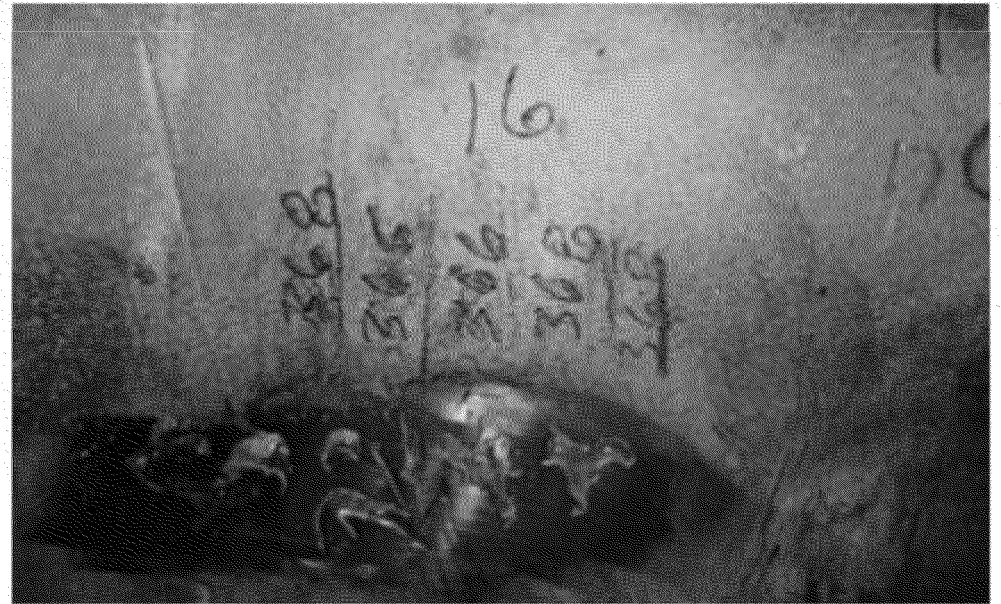
Overview post-grind (RWT) of LIN-16

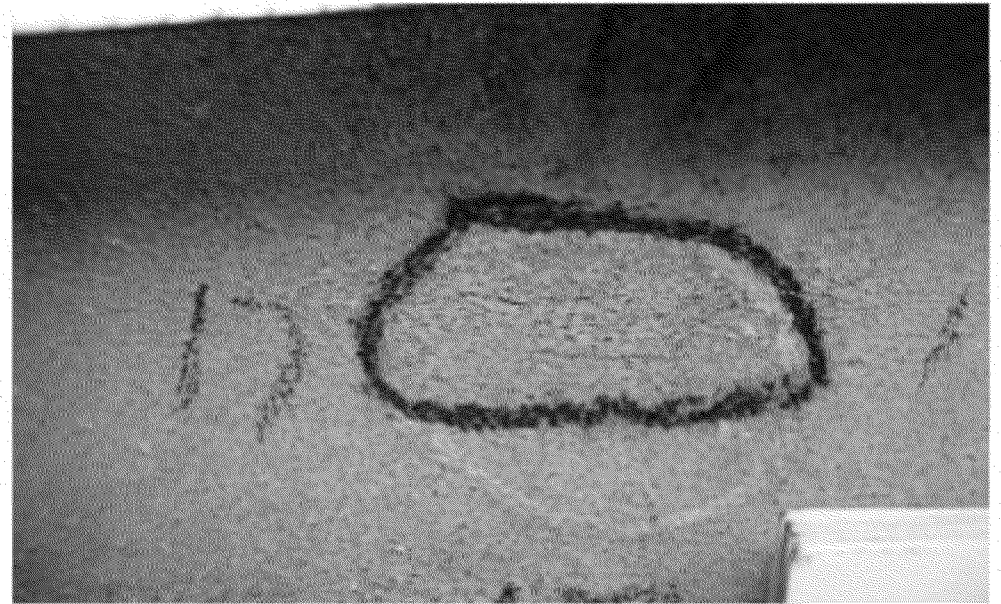
Close up of MT Indications of LIN-17

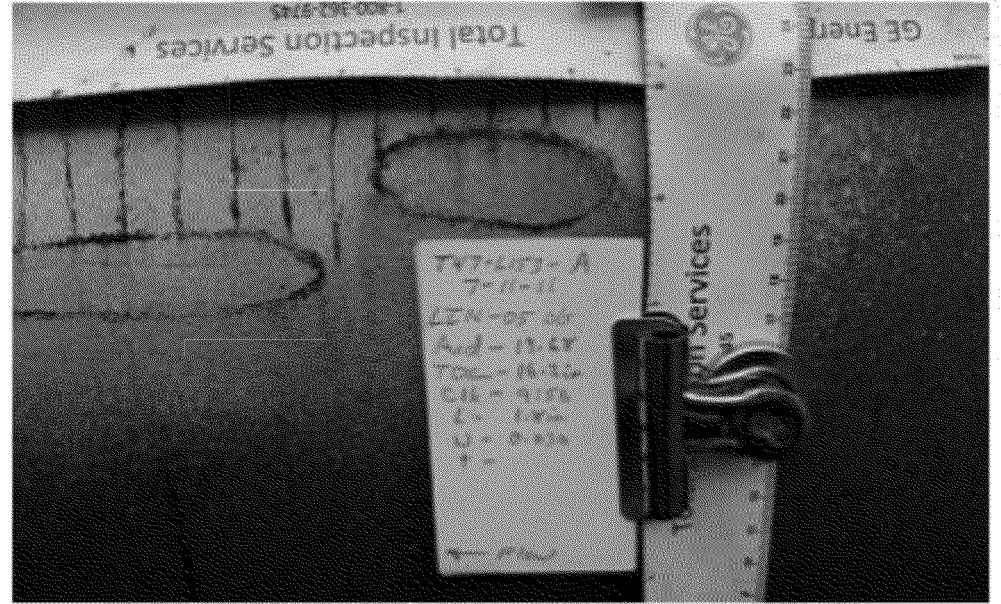
Overview of MT Indications of down stream LIN-05

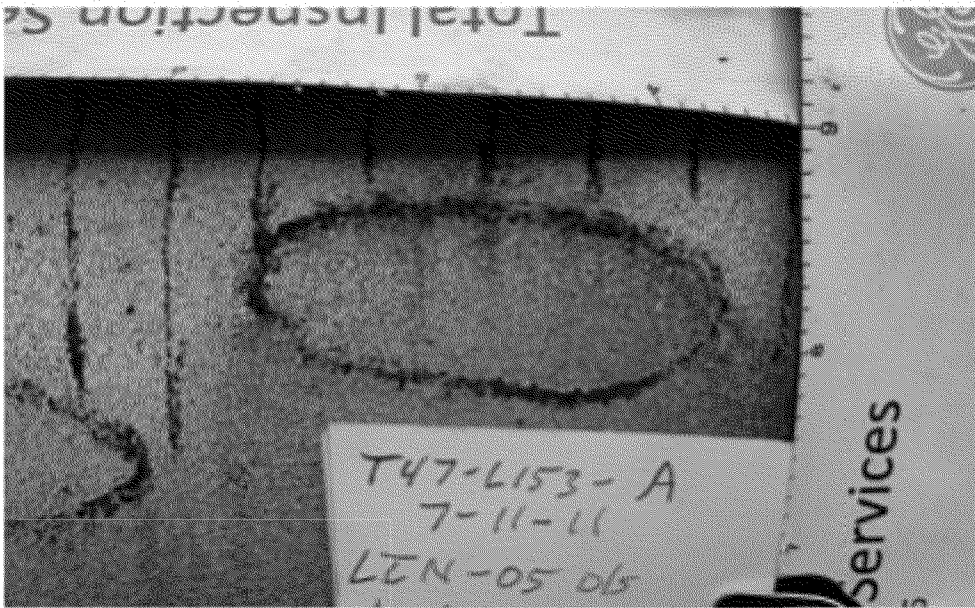
Close up of MT Indications of down stream LIN-05

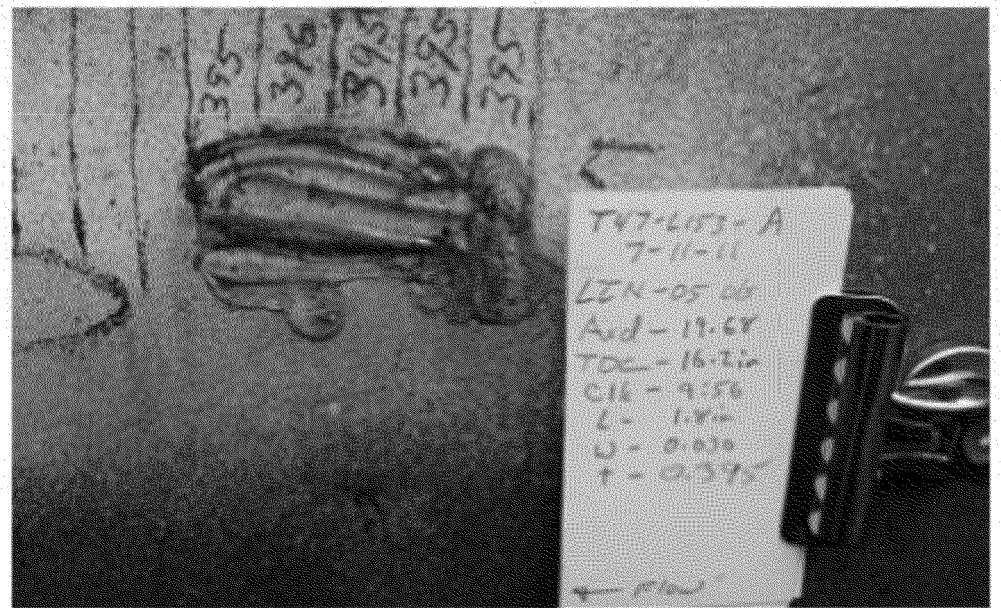
Overview of pre grind area (RWT) down stream LIN-05

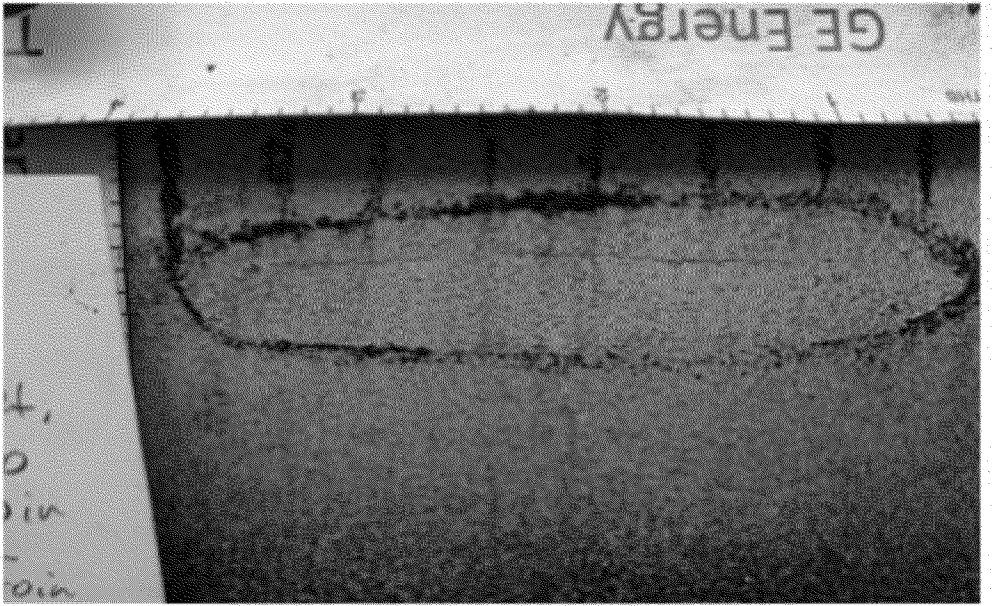
Overview of MT Indications of down stream LIN-06

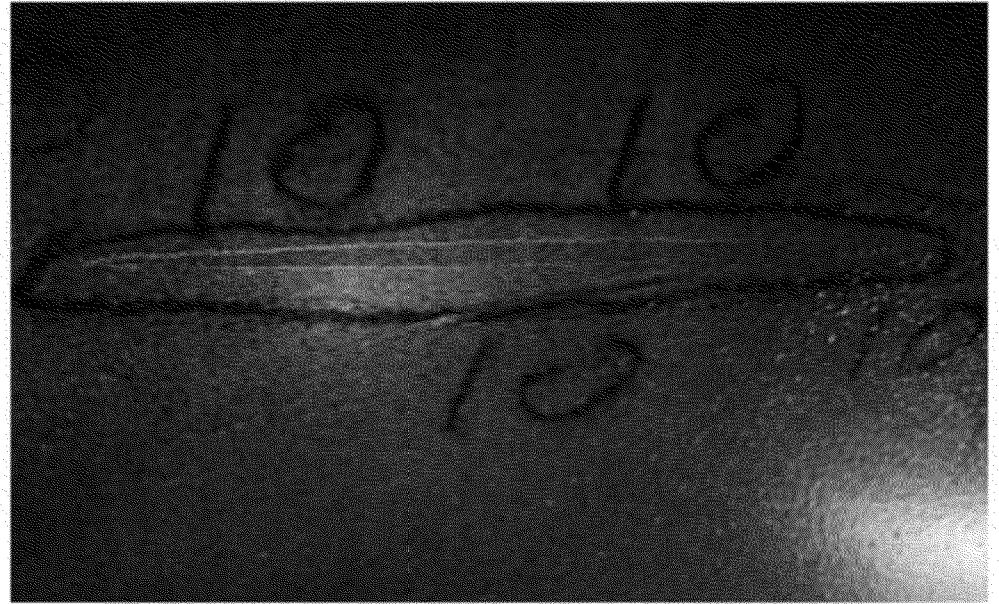
Overview of MT Indications of down stream LIN-10

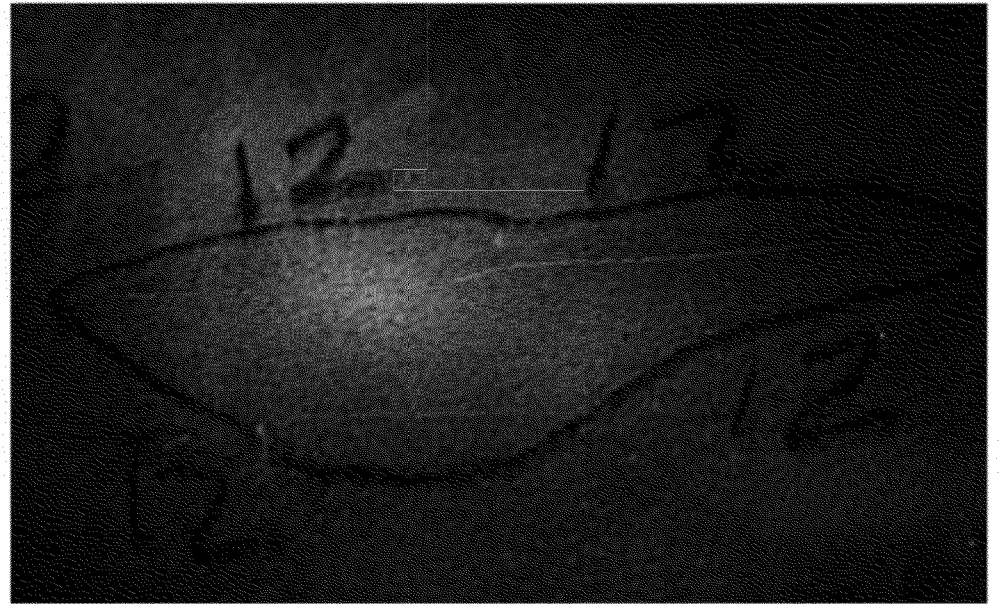
Overview of MT Indications of down stream LIN-12

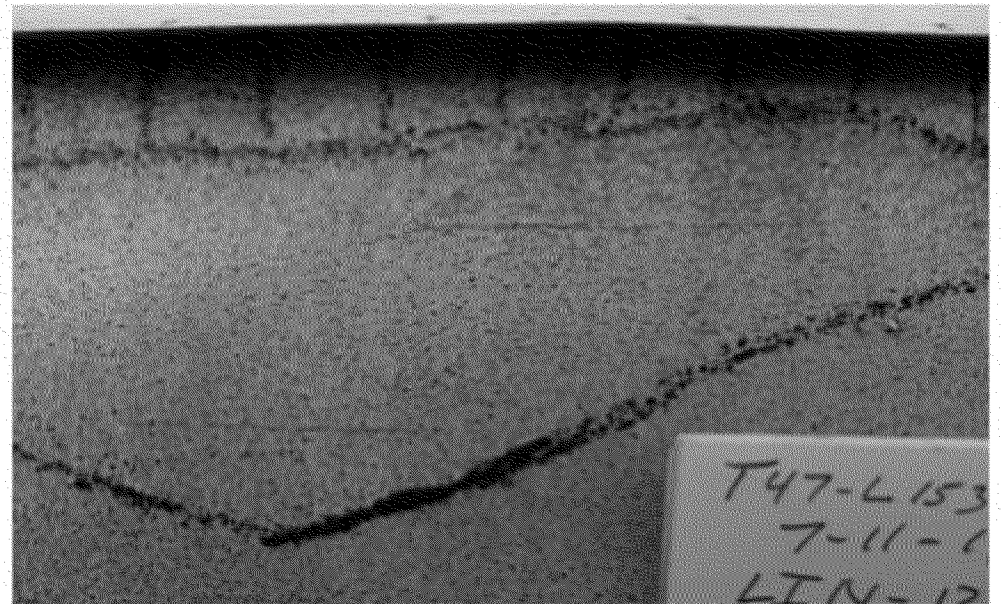
Close up of MT Indications of LIN-12

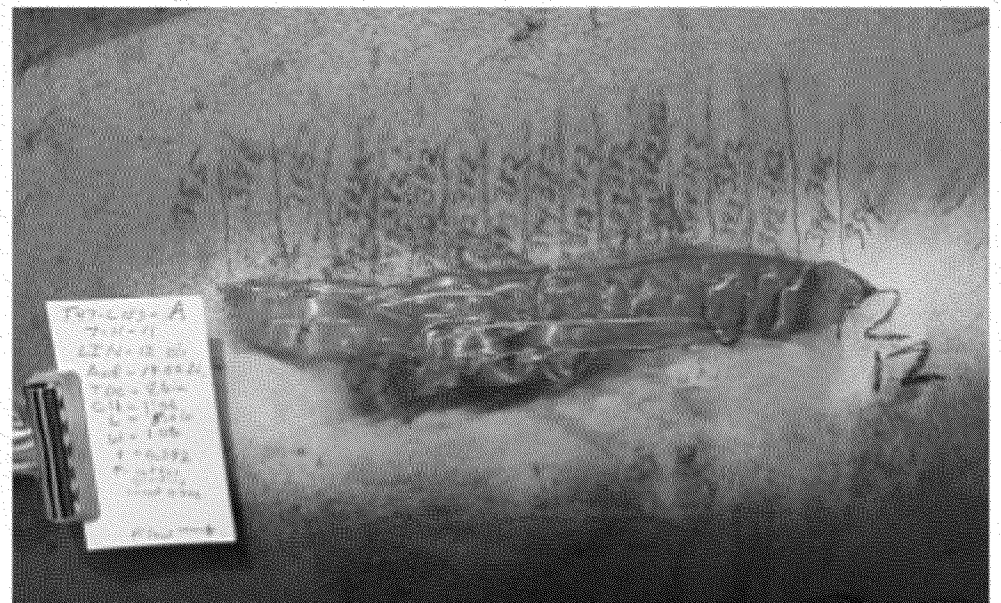
Overview post grind (RWT) of LIN-12
