Form H: Direct Examination Data Sheet - Page 1 of 10

<u>DA/ILI</u>		<u>DA</u>		<u>ILI</u>	
Route Number:	T47_L153_C	N-Segment:	NA	ILI Log Distance:	NA
Date of Excavation:	7/6/2011	IMA Number:	NA	RMP-11 Ref. Section:	Table 5.6.2
Mile Point:	Redacted	Region Number:	NA	Reference Girth Weld:	NA
Examination Performed By:	Redacted	Subregion # (ICDA):	NA	Distance From Girth Weld:	NA
PG&E Project Manager:	Redacted	Stationing:	NA		
Approved By:	NA				
Order Number:	NA

MAGNETIC PARTICLE EXAMINATION REPORT							<input type="checkbox"/> Nuclear	<input checked="" type="checkbox"/> Non-Nuclear	
To: Pacific Gas & Electric Company				From: Redacted		Date: 7/9/2011			
Project: T-47-L153-C									
Purchase Order No:				GEIS Job No: LAPI0005

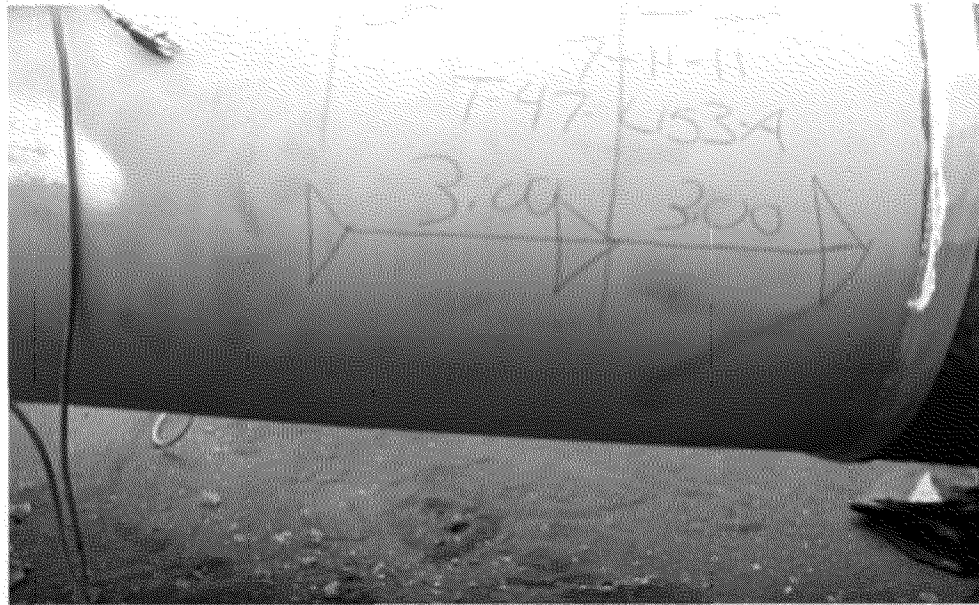
Reference: Summary <input checked="" type="checkbox"/> See Attachment				Results of Inspection:				
<p>12" By 12" UT Grid @ 6:00 position on pipe lamination scan 12" on Both sides of the US & DS cut line lamination scan 12" on Both sides of the revised DS cut line</p> <p>Mid-wall lamination was found on downstream cut line. The cut line was moved further downstream so it would be located in the cut out portion of the pipe</p> <p>** Please See the Attached Pages for Additional Information.</p>				<p>- No relevant indications at time of inspection. - One relevant indications at time of inspection. - No relevant indications at time of inspection.</p>				
Copy To: GE Inspection Services				Requested By: Redacted		Reported By (Technician): Redacted		
				<input checked="" type="checkbox"/> Customer Specifications		NDT Supervisor:		
				<input checked="" type="checkbox"/> Accept <input type="checkbox"/> Reject		Redacted

MPI area extended to 34ft due to lamination in cut line area

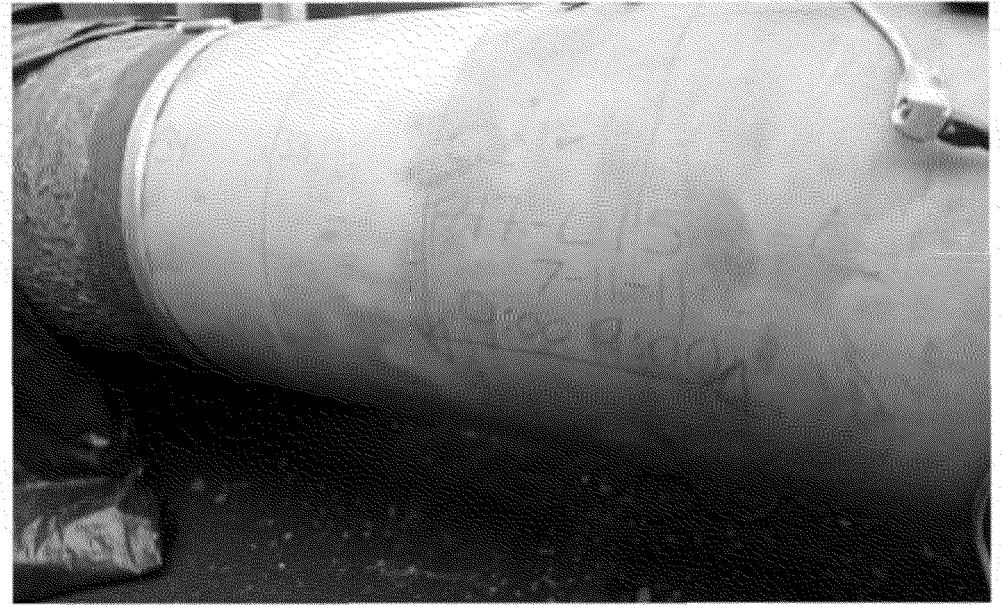
MPI area extended to 34ft due to lamination in cut line area

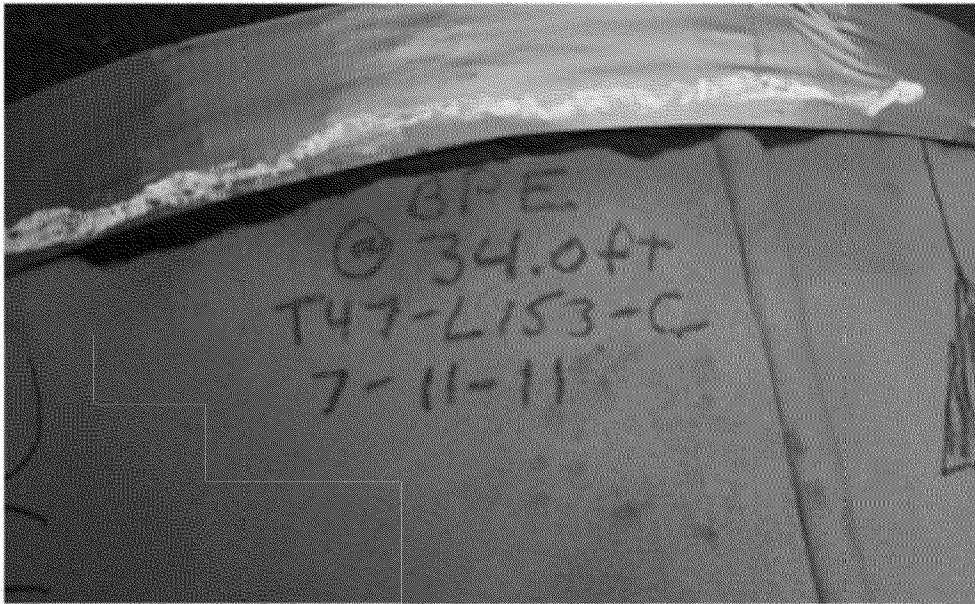
Overview of bare pipe end extended due to lamination

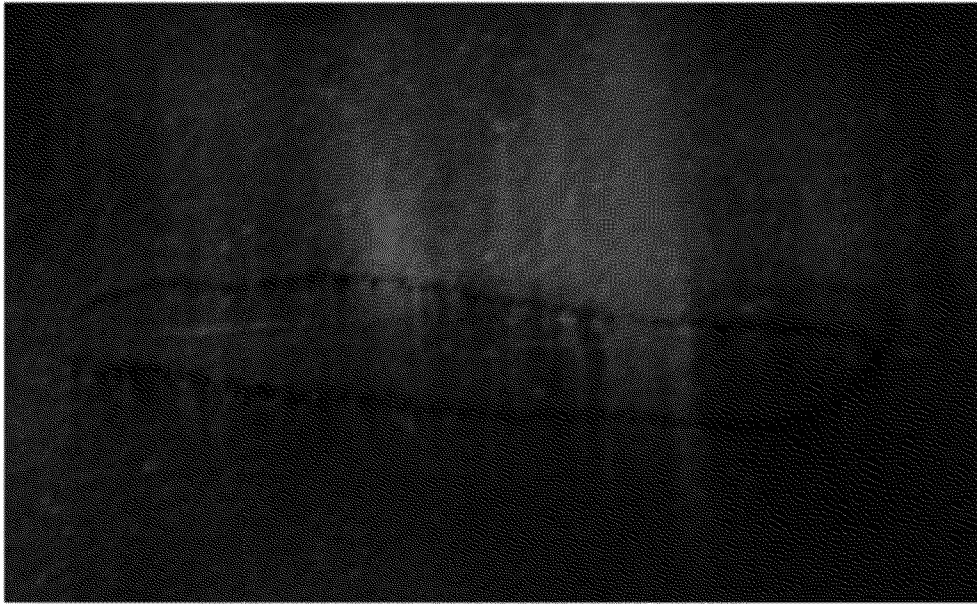
2.6 Wet Fluorescent Mag. Part Is Required. Comments: See MT & Photo report. 1 linear indication, and 1 midwall lamination.
 Were there any linear indications? Yes No If Yes, attach NDE report electronically as part of the H-Form. Report to include black light and white light photos of indications.

Overview of MT Indications of LIN-01

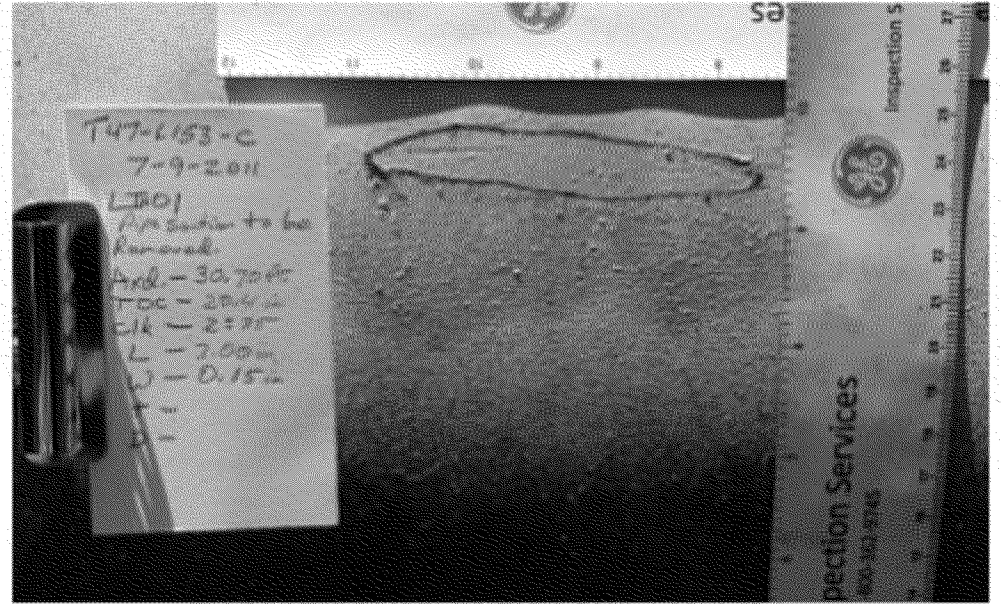
Overview (with measurements) of LIN-01

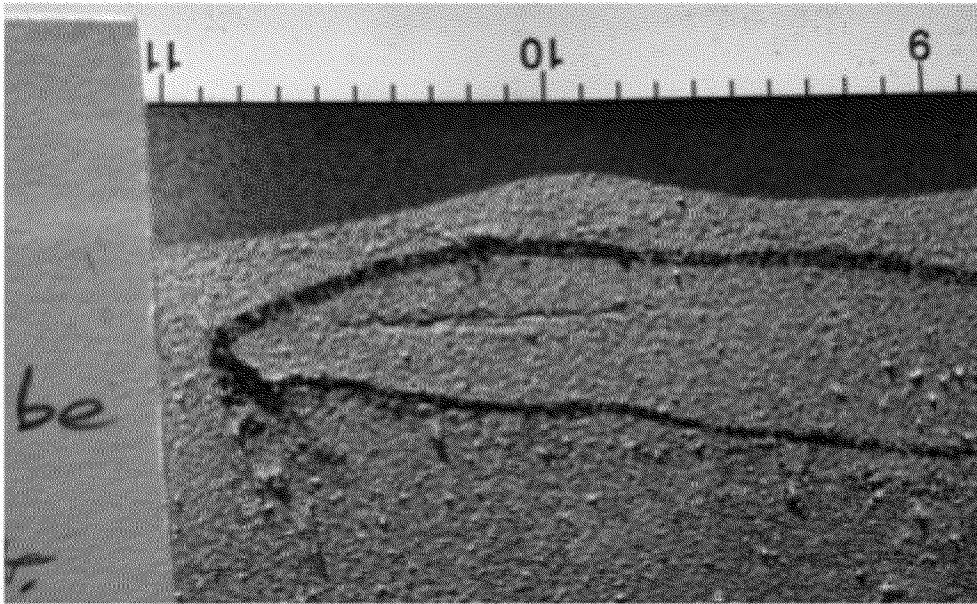
Close up of MT Indications of LIN-01

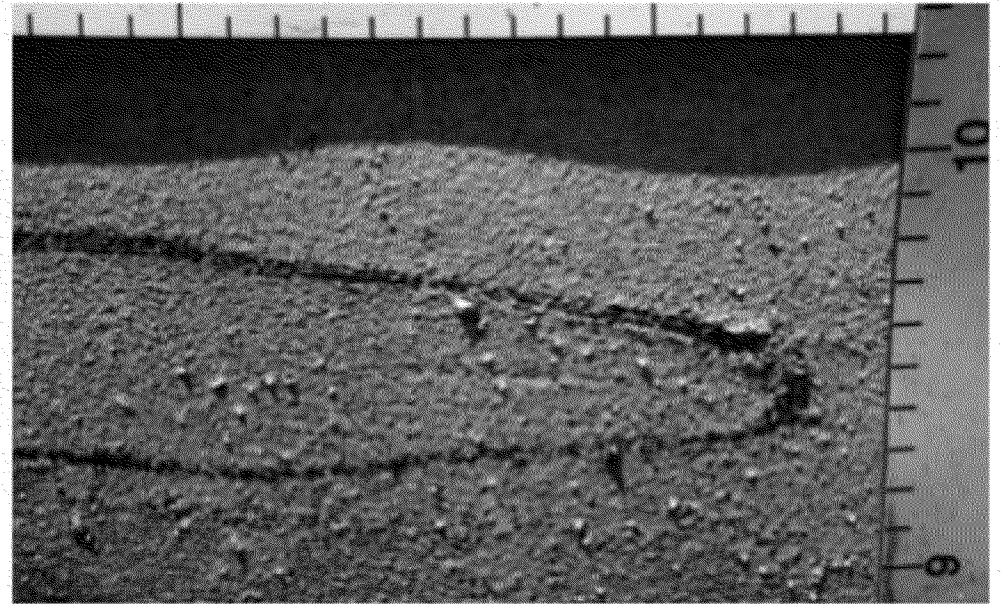
Close up of MT Indications of LIN-01

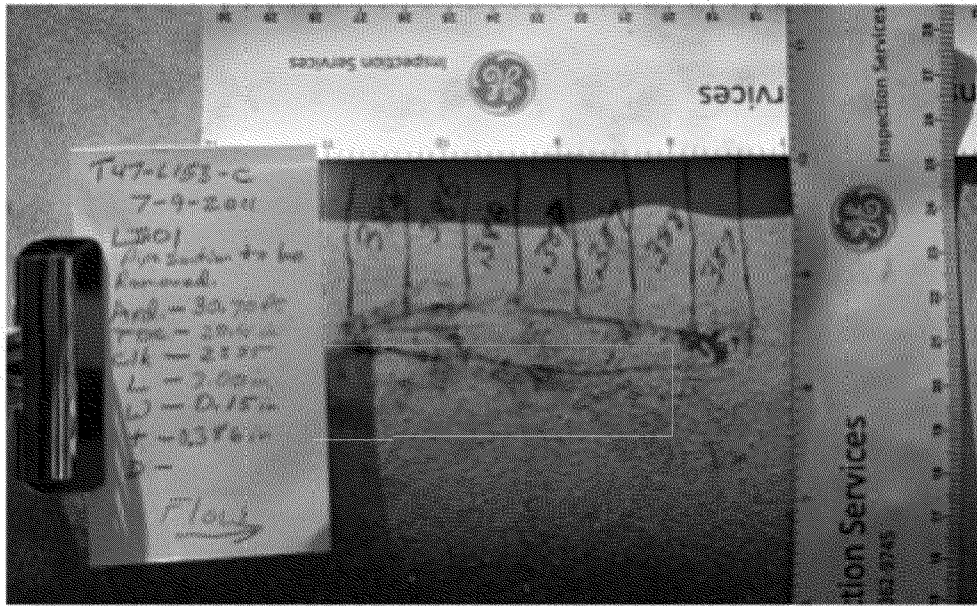
Overview with UT baseline thickness measurements of LIN-01

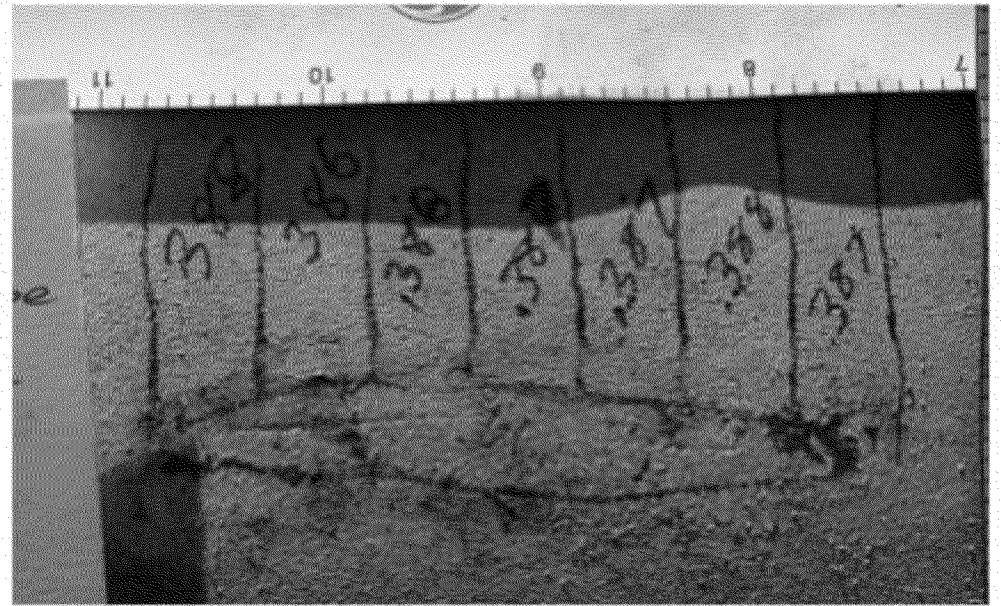
Closeup with UT baseline thickness measurements of LIN-01

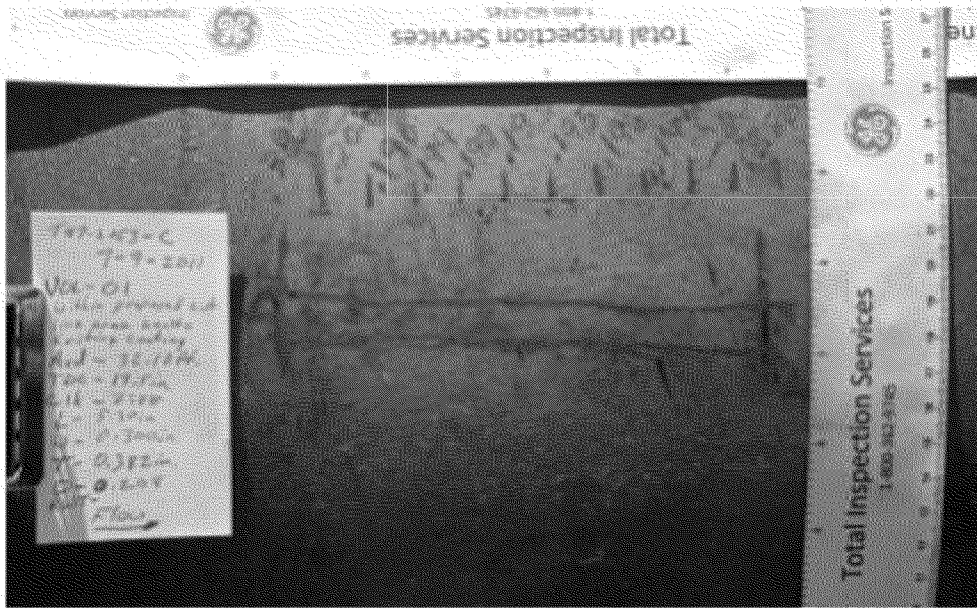
Overview with UT baseline thickness measurements of VOL-01

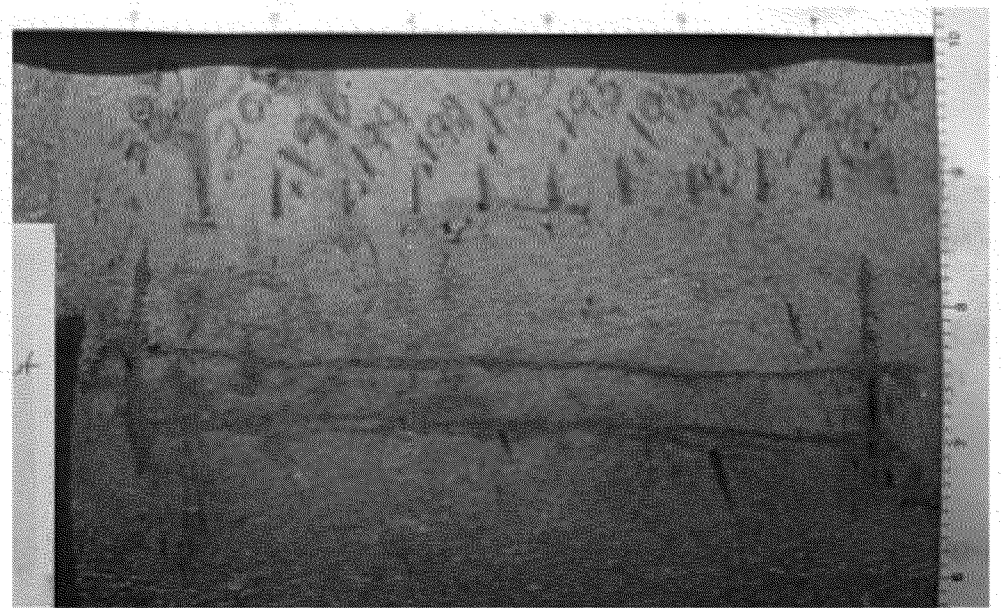
Closeup with UT baseline thickness measurements of VOL-01
