Investigation of a Failure of Line 300 at Mile Post 284.14 during Hydrostatic Test 117

MJ Rosenfeld, PE
March 16, 2012

Kiefner & Associates, Inc.
585 Scherers Court
Worthington, Ohio 43085

PACIFIC GAS & ELECTRIC COMPANY

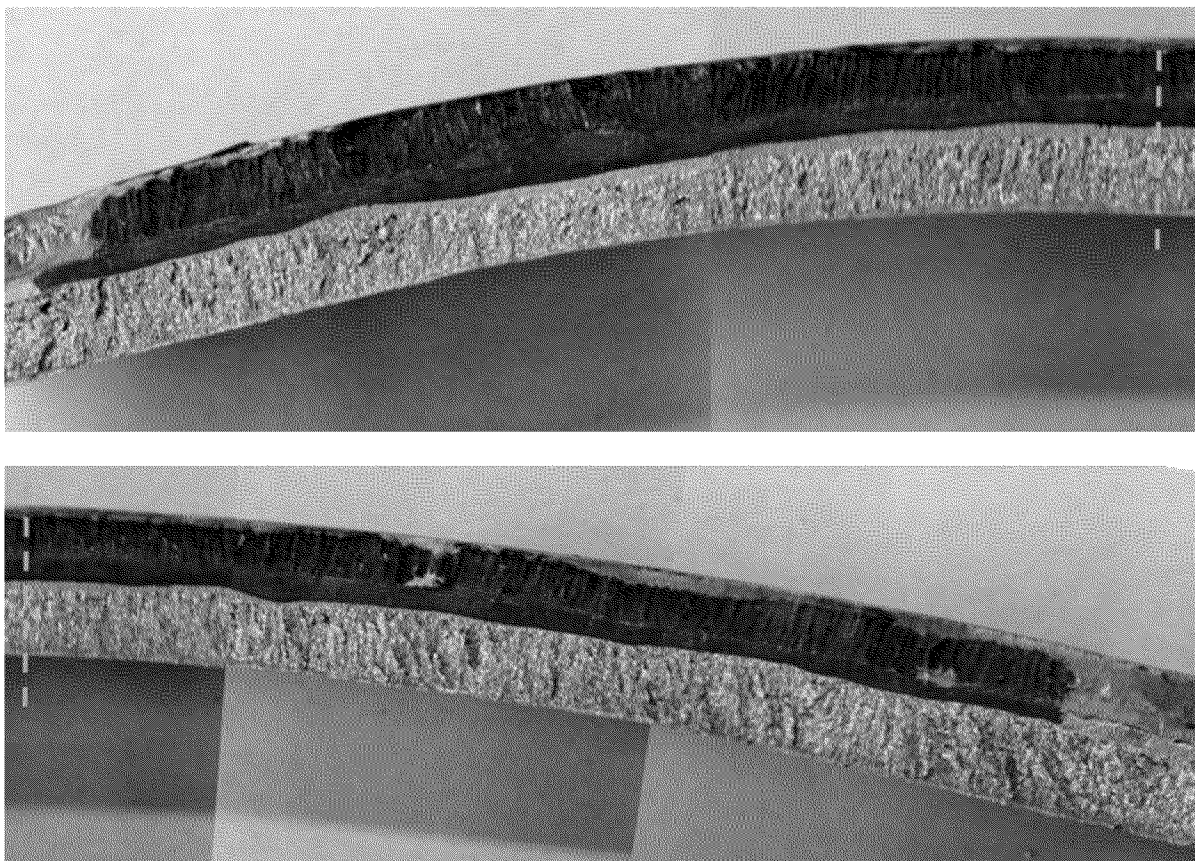
Figure 4. Composite of Origin, North Fracture Surface, Before Cleaning, 2X (photo by author)

A composite detail of the origin in the condition as discovered is shown in Figure 4 prior to cleaning. The apparent origin is seen to consist of a 6.5-inch-long crack in the outer seam weld deposit. The apparent origin presented a columnar texture typical of certain types of weld cracks, and a dark coloration that could be a stain or oxide. The vertical dashed line in represents match points in the two photos.

An unfused region was present along the center of the weld between the inner and outer seam weld deposits. The dark coloration on the weld crack extended to the unfused region between the weld beads but only over a length essentially coincident with the weld crack. The unfused region extended the full length of the fracture, but did not exhibit the dark coloration beyond the length adjacent to the weld crack. The inner weld deposit exhibited a bright fracture surface consistent with recent brittle fracture. Beyond the 6.5-inch-long defect, the fracture exhibited brittle fracture propagation chevrons that pointed toward the 6.5-inch defect and beyond that transitioning to ductile shear fracture propagation.

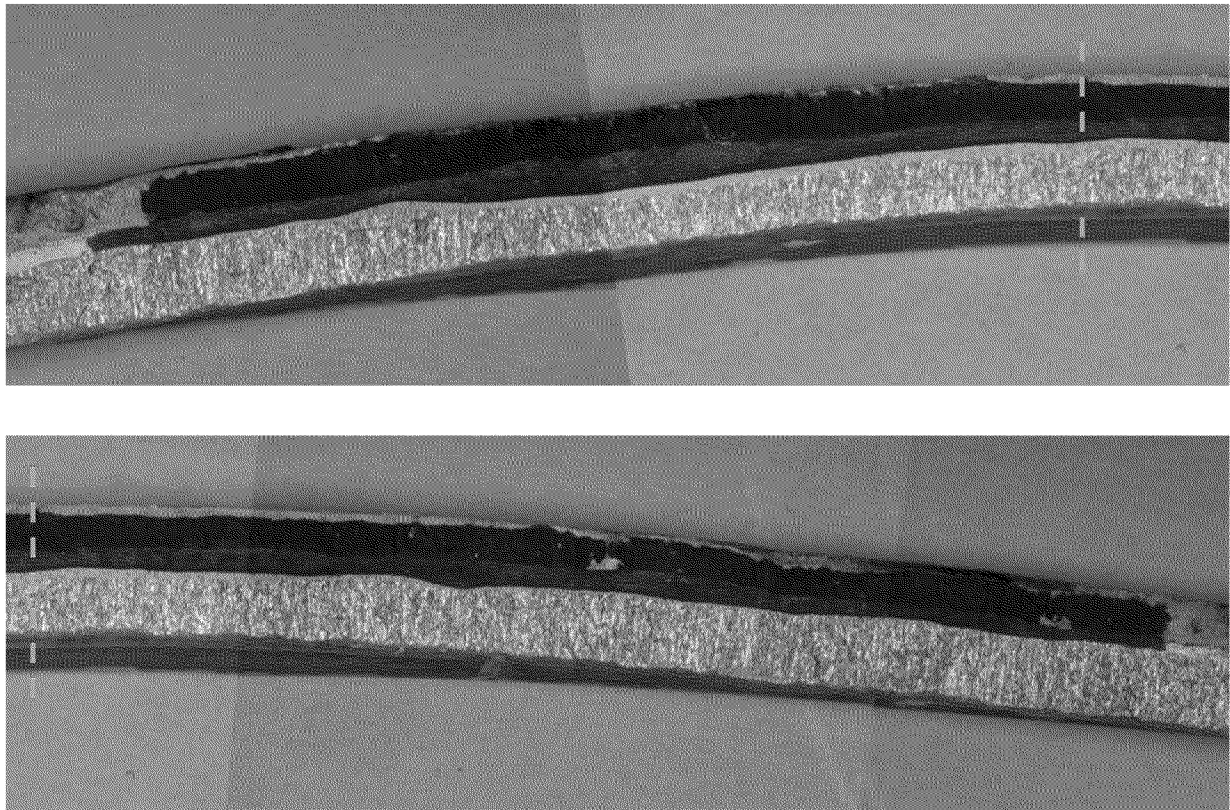
Figure 5. Composite of Origin, North Fracture Surface, After Cleaning, 2X (photo courtesy Exponent)

The fracture surface was cleaned in acetone, then xylene, and then a nonoxidizing detergent (Alconox). It was then cleaned ultrasonically in a mild alkaline detergent (Micro 90). The cleaning steps failed to remove the dark coloration on the weld crack, but lightened the coloration on the unfused surfaces, as shown in Figure 5. The vertical dashed line represents match points in the two photos.

The resistance of the dark coloration to a variety of cleaning methods suggested that it was an adherent oxide. The persistence of the dark oxide, position of the crack at the centerline of the outer weld deposit, and visible columnar texture of the crack surface all were consistent with a hot crack, a condition known to occur in submerged arc welds.

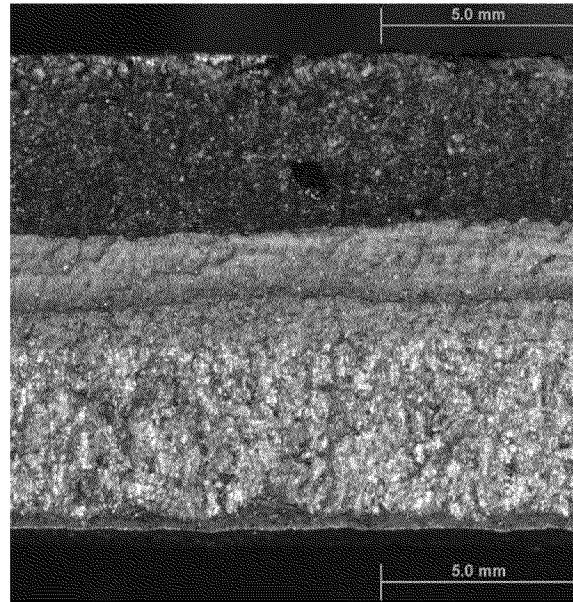
Figure 6. Fracture Surface Before Cleaning, 5X (photo by Exponent)

The fracture was examined in a stereomicroscope to resolve features of interest, both before and after cleaning. Figure 6 shows a region of the fracture surface before cleaning. A dark, shiny deposit is evident near the exterior surface and on portions of the fracture in the outer weld deposit.

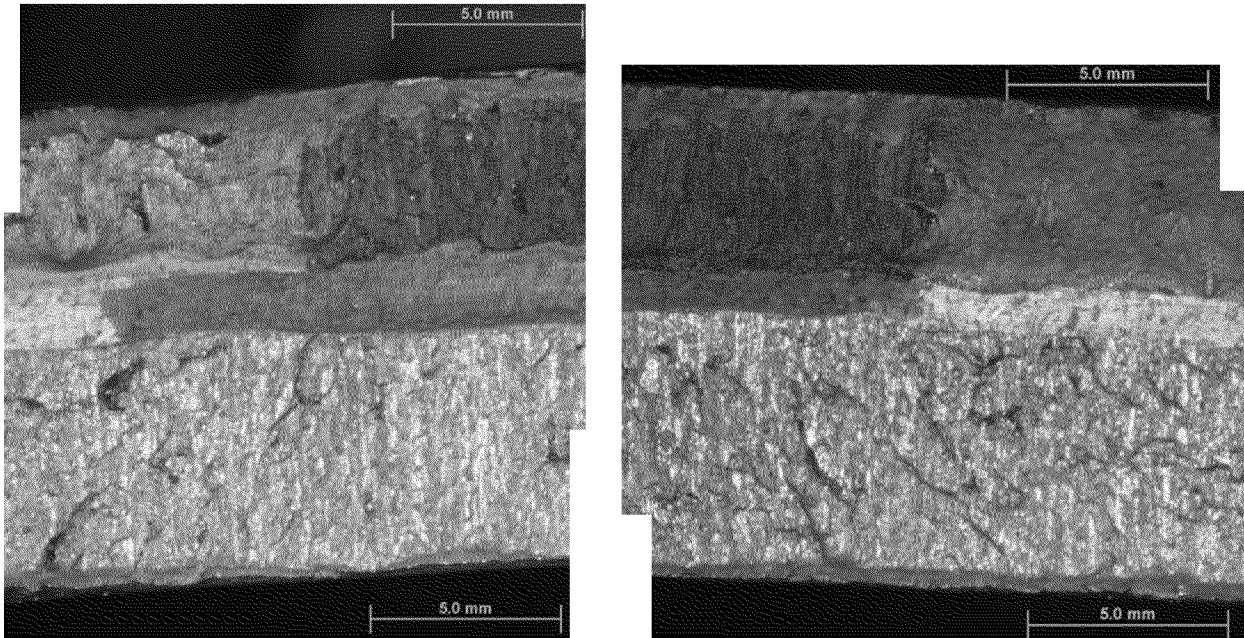
Figure 7. Terminations of Origin Defect, North Fracture Surface, 5X (photo by Exponent)

Figure 7 shows both ends of the defect, before cleaning. The dark coloration is present on the weld crack. The unfused surface is the flat region between the oxidized and nonoxidized weld fractures. The dark coloration on the LOP surface disappears beyond the portion that is coincident with the weld crack. The radial dimension of the LOP varied from 0.04 inch to 0.10 inch, based on viewing the surface under low magnification.

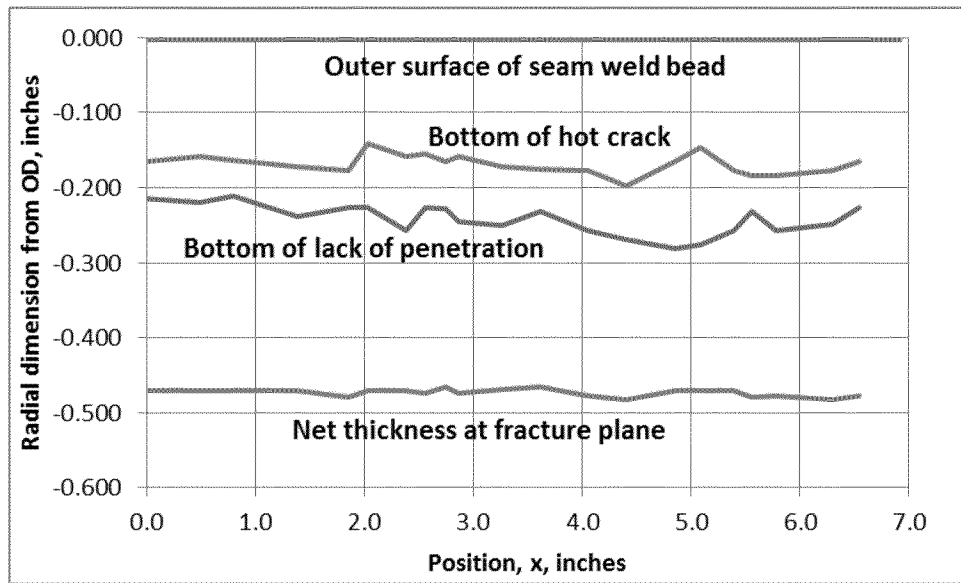
Figure 8. Radial Dimensions of Fracture Features

Photographs similar to those in Figure 6 and Figure 7 spanning the full length of the apparent origin and beyond were used to develop a profile of the radial dimensions of the apparent hot crack, the lack of fusion between the inner and outer weld beads, and the net thickness through the fracture plane. The profiles are given in Figure 8, as measured from the intersection of the fracture with the outside surface of the outer weld bead represented at the top of the chart. The average metal thickness through the fracture was 0.473 inch.

modified to consider the actual profile of the defect.¹³ The analysis was performed using the flaw profile in Figures 8 and 9, along with the lowest measured seam yield strength and tensile strength values of 69 ksi and 89 ksi, respectively, and an average metal thickness of 0.473 inch in the portion that fractured. Considering the flaw to be strictly flow-stress dependent (which would be the case with a blunt metal-loss defect, or a planar flaw in a material having very high toughness), the estimated failure pressure was 1,556 psig. This estimate significantly exceeded the actual failure pressure of 998 psig, indicating a toughness-dependency and/or an interaction with the LOP extending beyond the hot crack.

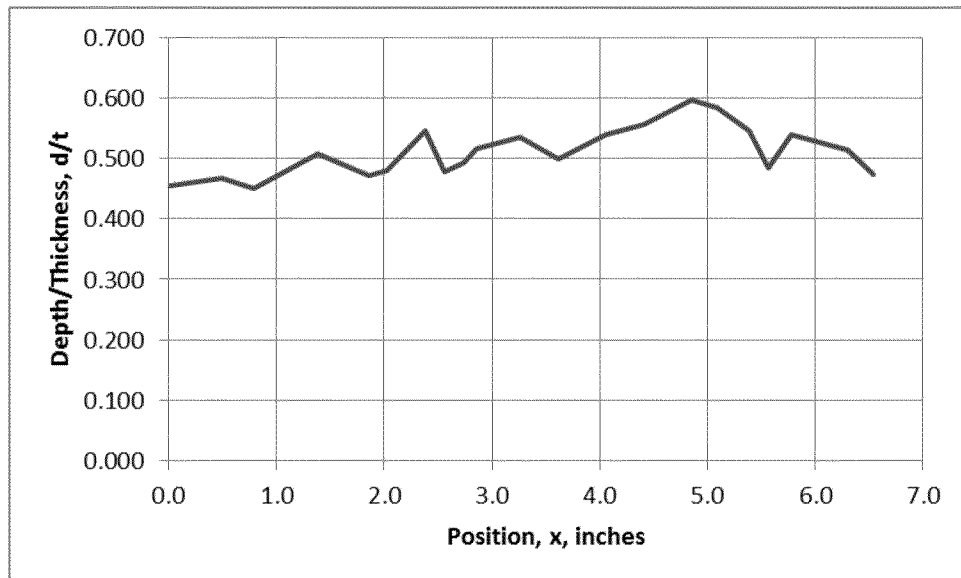
Figure 9. Ratio of Flaw Depth to Metal Thickness

The actual profile of the combined hot crack and LOP defect, from Figure 8, has a ratio of flaw depth to metal thickness (d/t) shown in Figure 9. The average d/t was 0.51 (51% of the metal thickness) with a maximum d/t of 0.60.

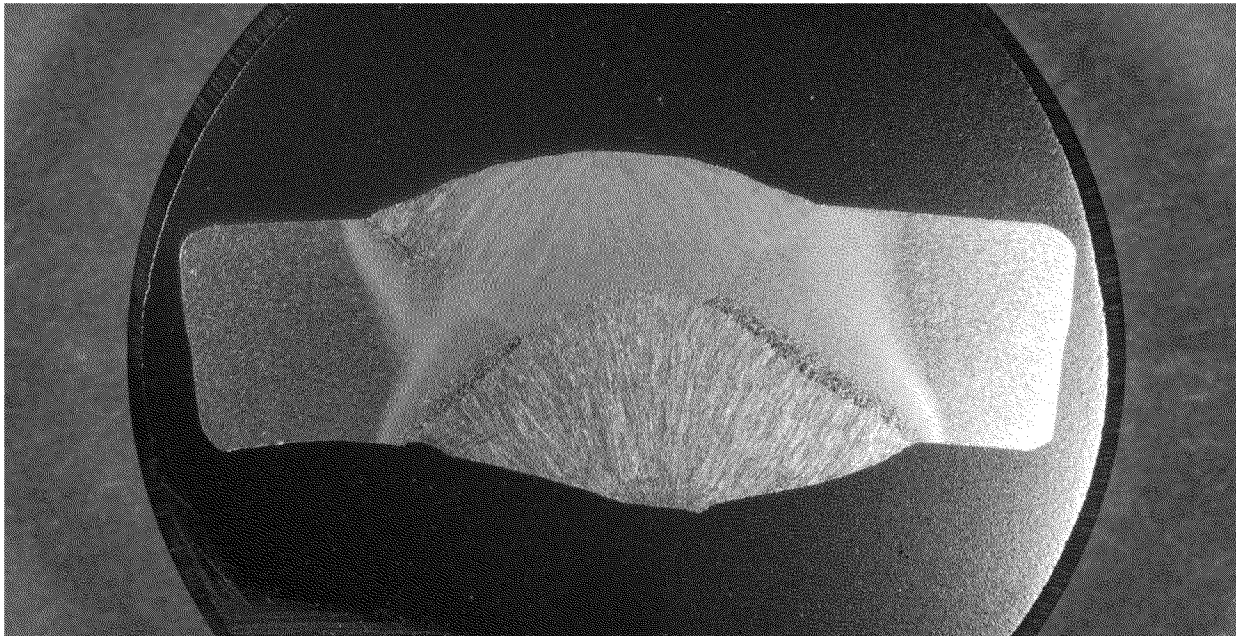
Figure 27. Intact Seam Showing Normal Seam Weld Deposition

Metallographic sections were also prepared through unfractured portions of the longitudinal seam, one of which (from piece 72493) is shown in Figure 27. The section shows that the outside pass was made first because the inside weld deposit is seen to overlap the outside weld

deposit. There is no LOP feature even with some lateral misalignment of the weld deposits because overlapping penetration was achieved.

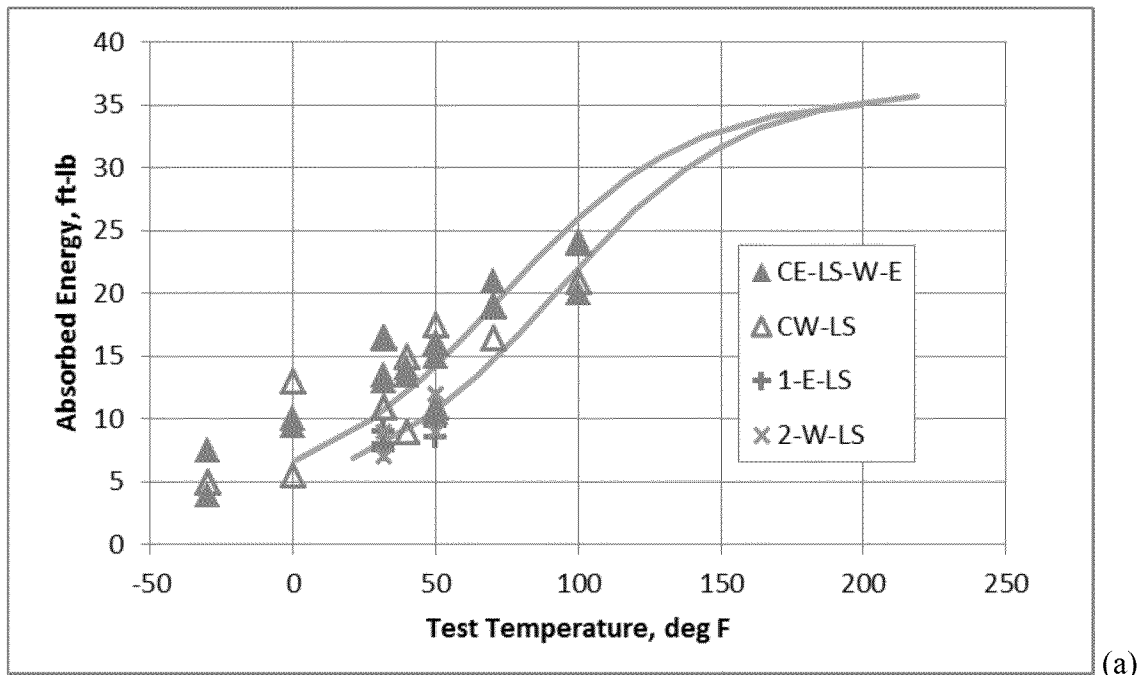
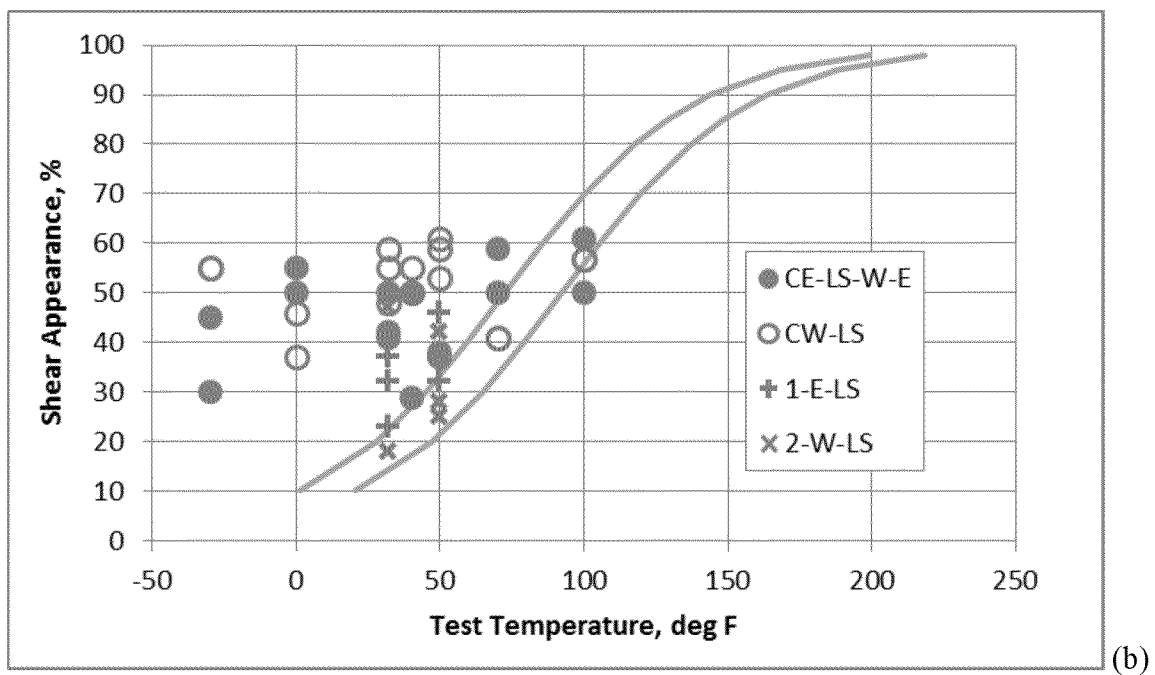
Figure 28. CVN Test Results for Seam Weld Specimens

The tests were not performed to a sufficiently high temperature to capture the full toughness transition curve up to the ductile upper shelf or 100% shear appearance. For purposes of interpretation, the full transition curves were extrapolated using an empirical technique.⁵ The extrapolated curves were prepared using the averaged test results at the two warmest test temperatures, 70 F and 100 F. Extrapolations from these two temperatures were fairly consistent.

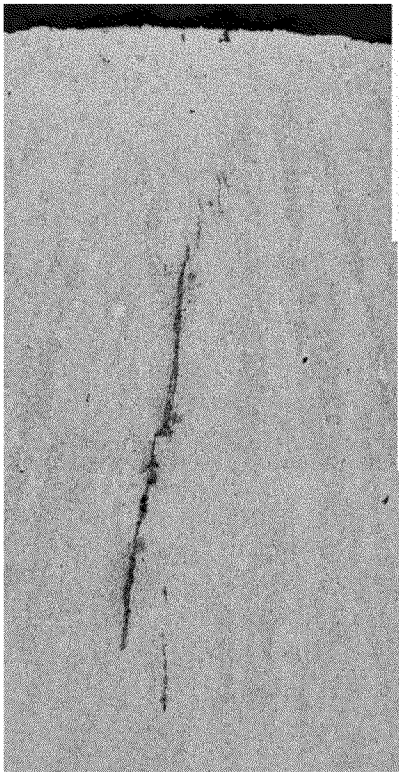
Figure 35. Hot Crack, T117-CC-T-W (25X)

A metallographic section through an intact part of the seam in the center of the failed joint, piece T117-CC-T-W revealed a small hot crack having a radial dimension of approximately 0.12 inch (3 mm). This is shown at high magnification in Figure 35. A lack of penetration between the inner and outer weld passes and having a radial dimension of 0.02 inch (0.5 mm) was also

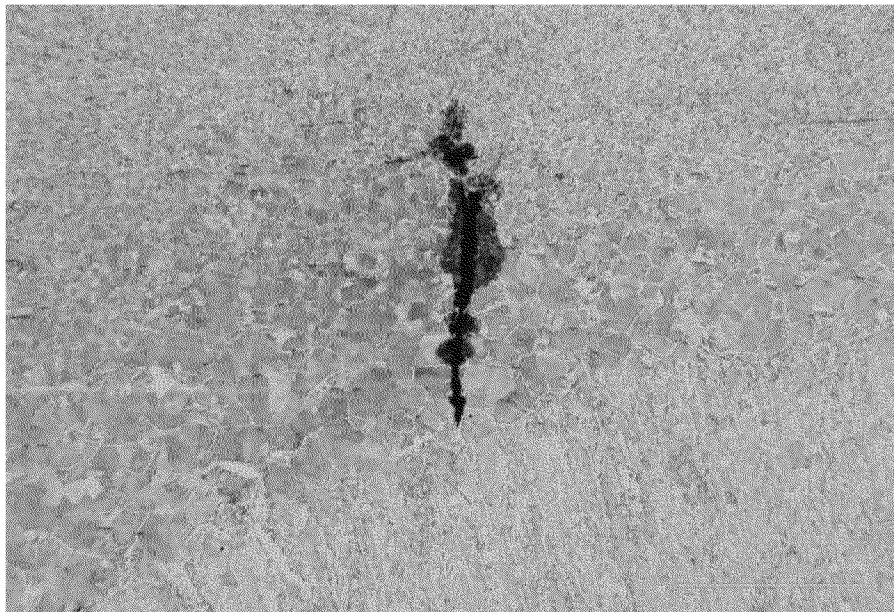
Figure 36. LOP Feature, T117-CC-T-W (50X)

identified as shown in Figure 36. Neither feature was significant in terms of their effect on the integrity of the pipe.
