Date: March 20, 1989
To: GOLDEN GATE REGION
From: GAS SYSTEM DESIGN
Subject: Failure of Longitudinal Weld on
30-Inch Steel Pipe

MATERIAL AND/OR EQUIPMENT - PROBLEM OR FAILURE REPORT

Date March 1, 1989 File # 4152
To GAS SYSTEM DESIGN
From TECHNICAL AND ECOLOGICAL SERVICES
Subject [REDACTED] 30" Transmission Line Failure

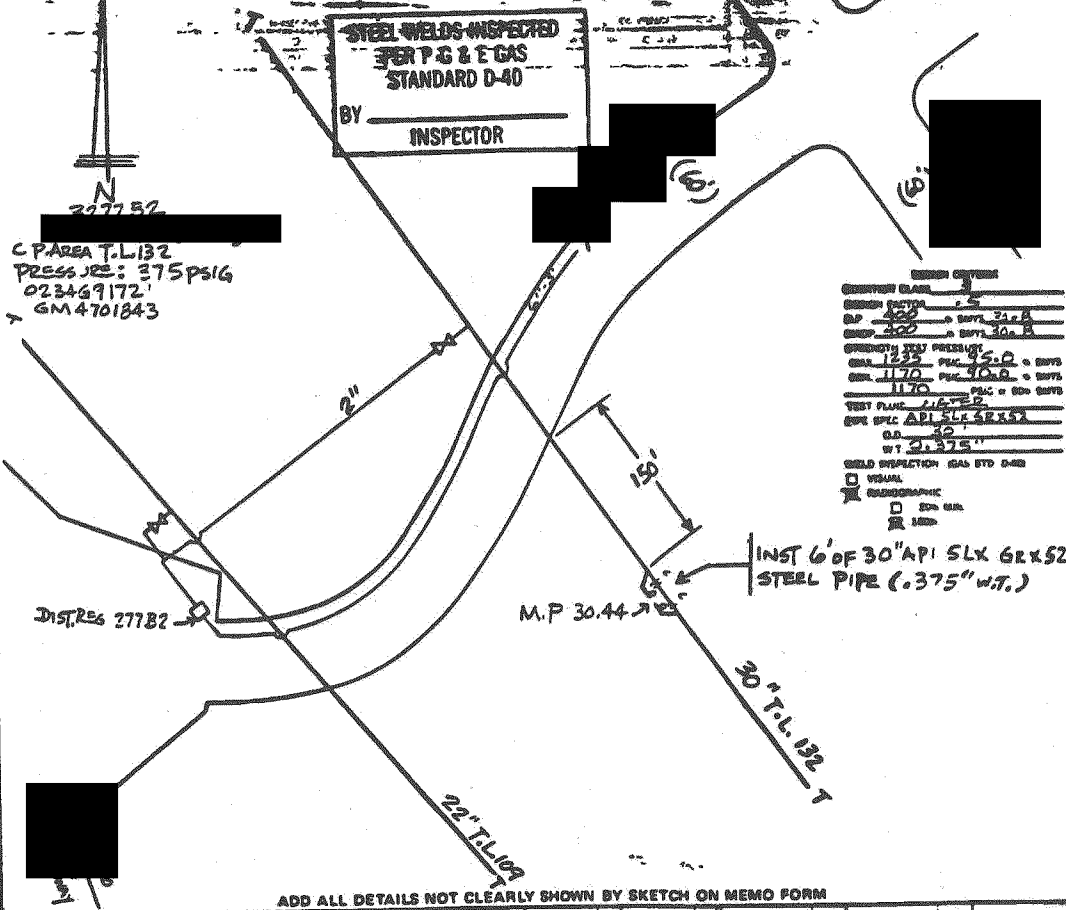
SKETCH OF WORK - Foreman to correct & charge for work - showing D.K. by installing form

IT IS NECESSARY TO REPLACE A 6' SECTION OF 30" T.L. 132 DUE TO A LONGITUDINAL WELD DEFECT.
