Date: March 20, 1989
To: GOLDEN GATE REGION
From: GAS SYSTEM DESIGN
Subject: Failure of Longitudinal Weld on
30-Inch Steel Pipe

MATERIAL AND/OR EQUIPMENT - PROBLEM OR FAILURE REPORT

Date March 1, 1989 File # 4152
To GAS SYSTEM DESIGN
From TECHNICAL AND ECOLOGICAL SERVICES
Subject [REDACTED] 30" Transmission Line Failure

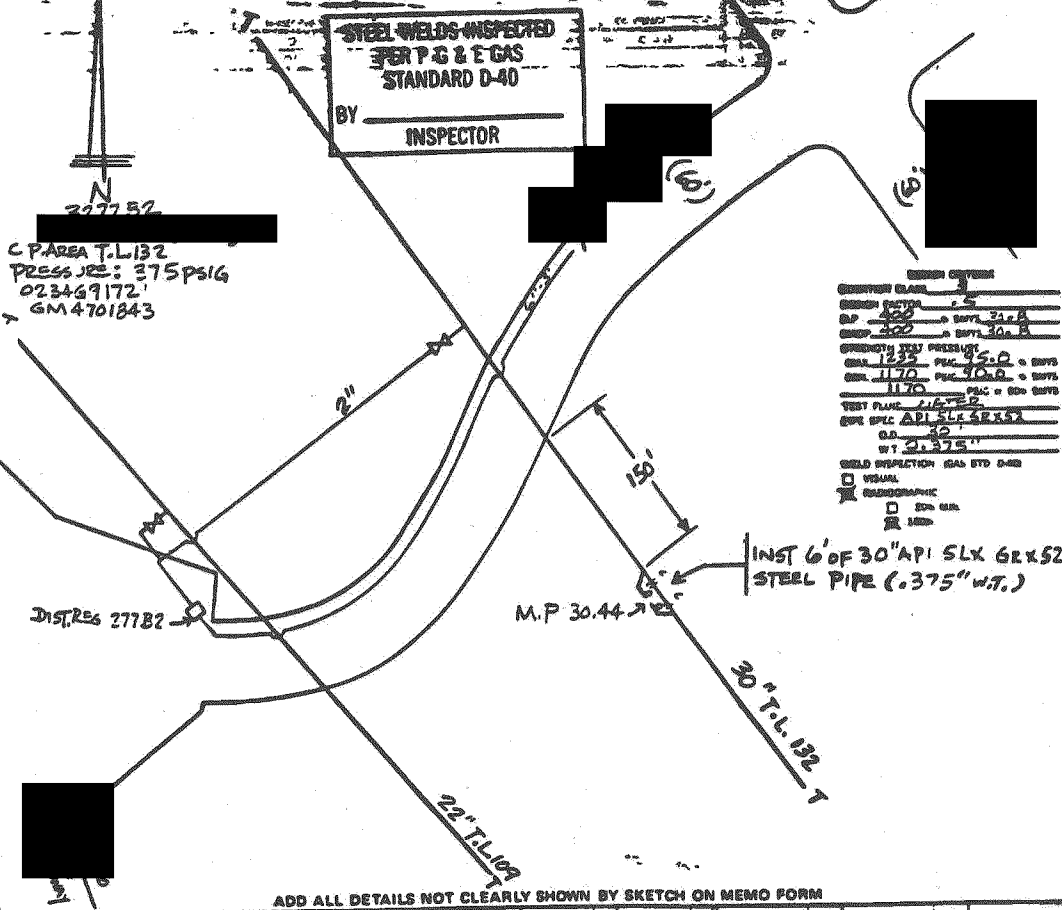
SKETCH OF WORK - Foreman to correct & change as needed - showing O.K. by initials & date

IT IS NECESSARY TO REPLACE A 6' SECTION OF 30" T.L. 132 DUE TO A LONGITUDINAL WELD DEFECT.
