Date: March 20, 1989
To: GOLDEN GATE REGION
From: GAS SYSTEM DESIGN
Subject: Failure of Longitudinal Weld on
30-Inch Steel Pipe

MATERIAL AND/OR EQUIPMENT - PROBLEM OR FAILURE REPORT

Date March 1, 1989 File# 4152
To GAS SYSTEM DESIGN
From TECHNICAL AND ECOLOGICAL SERVICES
Subject [REDACTED] 30" Transmission Line Failure

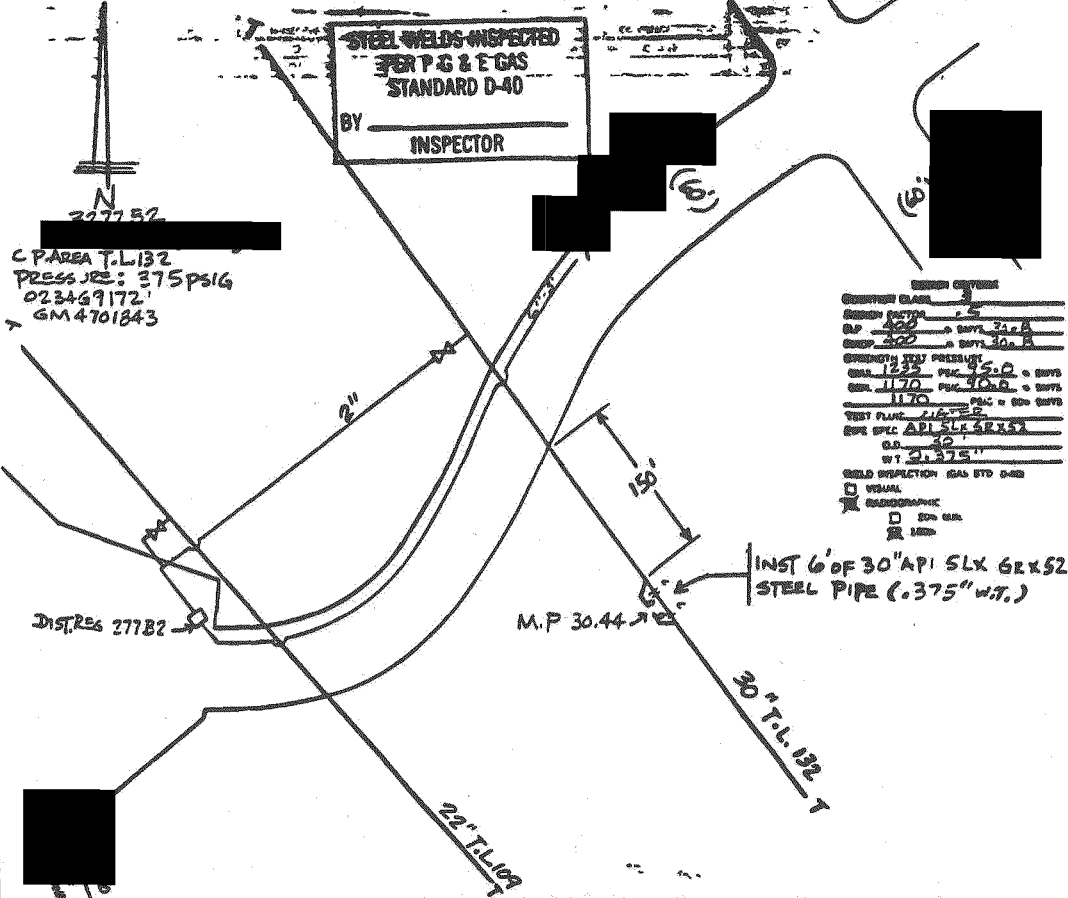
SKETCH OF WORK - Foreman to submit 2 sheets of work - showing D.C. by installation

IT IS NECESSARY TO REPLACE A 6' SECTION OF 30" T.L. 132 DUE TO A LONGITUDINAL WELD DEFECT.

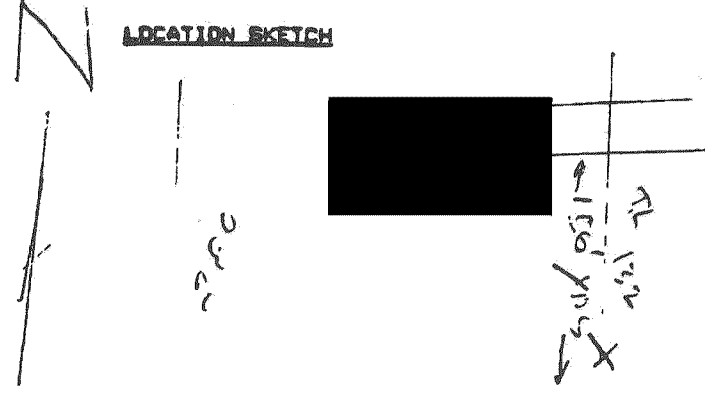
LOCATION SKETCH

REPAIR REPORT
 LOCATION: San Jose
 MISC. INFO/REMARKS: 11-4-RH G&S Replaced 30" Pipe
 REPAIR DATE: 10/28/99
 JOB CODE: M Capital, R Maintenance
 LINE SIZE: 30 inches
 LINE MATERIAL: Cast Iron or Ductile Iron, Copper, Steel or Wrought Iron, Alloy A, TE 416, Plastic other than 'A' or 'T', Other
 LINE USE: Distribution Main, Service, Transmission Main, Gathering Main, Distribution Feeder Main
 FOR SERVICE ON: Aboveground? Yes No
 Material of Main Connected to Service: Cast Iron, Steel, Plastic
 LEAK CAUSE: Corrosion, Damage by Outside Forces, Signs, Damage by Electrical Failure, Construction Defects, Material Failure, Cast Iron Fracture, Other
 LEAK SOURCE: Birth Hole, Longitudinal Hole, Other Holes, Body of Pipe, Valve, Scraper Trap, Tap Connection, Drop, Compressor Components, Gas Cooler, Physical (Mechanical) Joint, Fitting, Bell Joint, Regulator, Other
 TYPE REPAIR: Temporary, Permanent
 REPAIR CODE: Weld Over Sleeve or Cap, Patch Applied, Clamp, Replace Pipe, Tighten Cap or Bolt, Bell Joint Clamp, Bell Joint Seal, Other
