Date: March 20, 1989
To: GOLDEN GATE REGION
From: GAS SYSTEM DESIGN
Subject: Failure of Longitudinal Weld on
30-Inch Steel Pipe

MATERIAL AND/OR EQUIPMENT - PROBLEM OR FAILURE REPORT

Date March 1, 1989 File# 4152
To GAS SYSTEM DESIGN
From TECHNICAL AND ECOLOGICAL SERVICES
Subject [REDACTED] 30" Transmission Line Failure

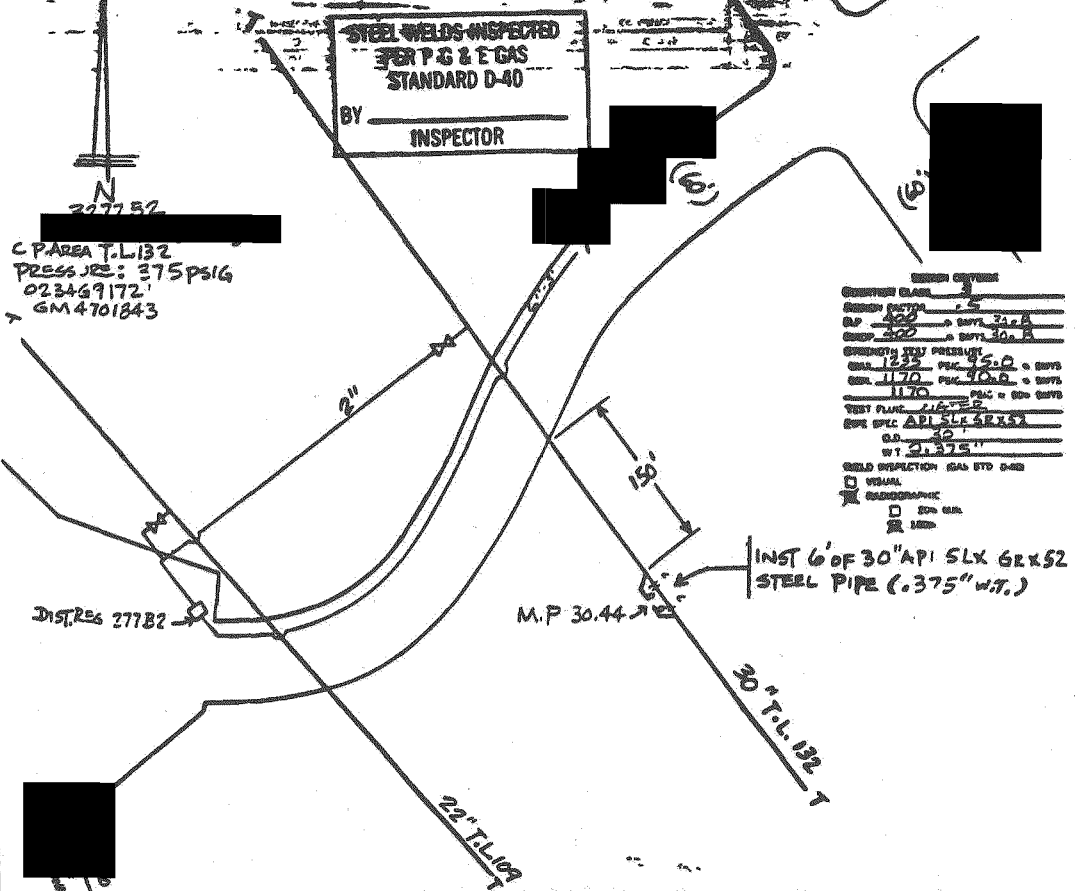
SKETCH OF WORK - Foreman to submit 3 copies of this sketch to the District Engineer's Office by the following date:

NECESSITY FOR PROPOSED WORK AND DESCRIPTION THEREOF
IT IS NECESSARY TO REPLACE A 6' SECTION OF 30" T.L. 132 DUE TO A LONGITUDINAL WELD DEFECT.

ACCOUNT	SUB ACCOUNT	SPECIAL CODE	DESCRIPTION OF DIRECT COST ITEMS	WEEKDAYS OF EST BUDGET	LABOR	AMOUNT (Dollars Only)			
						MATERIAL	EMPLOYEE RELATED COST	CONTRACT & OUTSIDE SERVICES	OTHER
02 132	3475 6034		SHUTDOWN AND RESTORE MAIN	40	5800		75	1000	
02 132	3664 2040		REPAIR LONGITUDINAL WELD DEFECT	22	3190	300		5000

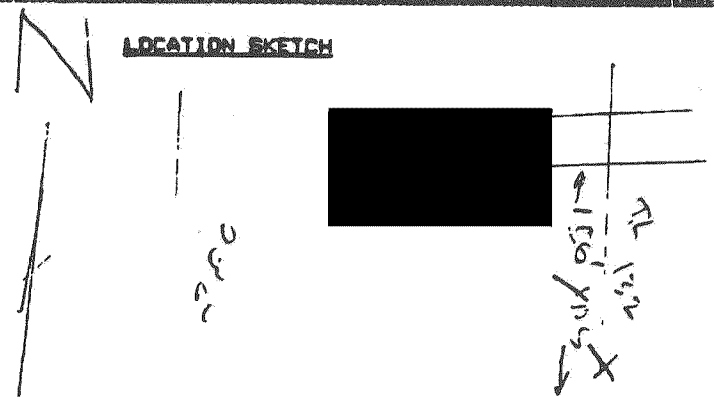
LOCATION SKETCH

REPAIR REPORT
 LOCATION: San Jose
 MISC. INFO/REMARKS: 11-4-RH G&S Replaced 30" Pipe
 REPAIR DATE: 10/28/99
 JOB CODE: M Capital, R Maintenance
 LINE SIZE: 30" x 1.913 inches
 LINE MATERIAL: Cast Iron or Ductile Iron, Copper, Steel or Wrought Iron, Alloy A, TE 416, Plastic other than "A" or "T", Other
 LINE USE: Distribution Main, Service, Transmission Main, Gathering Main, Distribution Feeder Main
 FOR SERVICE ON: Aboveground? Yes No
 Material of Main Connected to Service: Cast Iron, Steel, Plastic
 LEAK CAUSE: Corrosion, Damage by Outside Forces, Signs, Damage by Electrical Failure, Construction Defects, Material Failure, Cast Iron Fractures, Other
 LEAK SOURCE: Birth Hole, Longitudinal Hole, Other Holes, Body of Pipe, Valve, Scraper Trap, Tap Connection, Drop, Compressor Components, Gas Cooler, Physical (Mechanical) Joint, Fitting, Bell Joint, Regulator, Other
 TYPE REPAIR: Temporary, Permanent
 REPAIR CODE: Weld Over Sleeve or Cap, Patch Welded, Clamp, Replace Pipe, Tighten Cap or Bolt, Bell Joint Clamp, Bell Joint Seal, Other
